**Photo 1 – FAA supplied quartering view of the left, rear side of the airplane in a cornfield.**

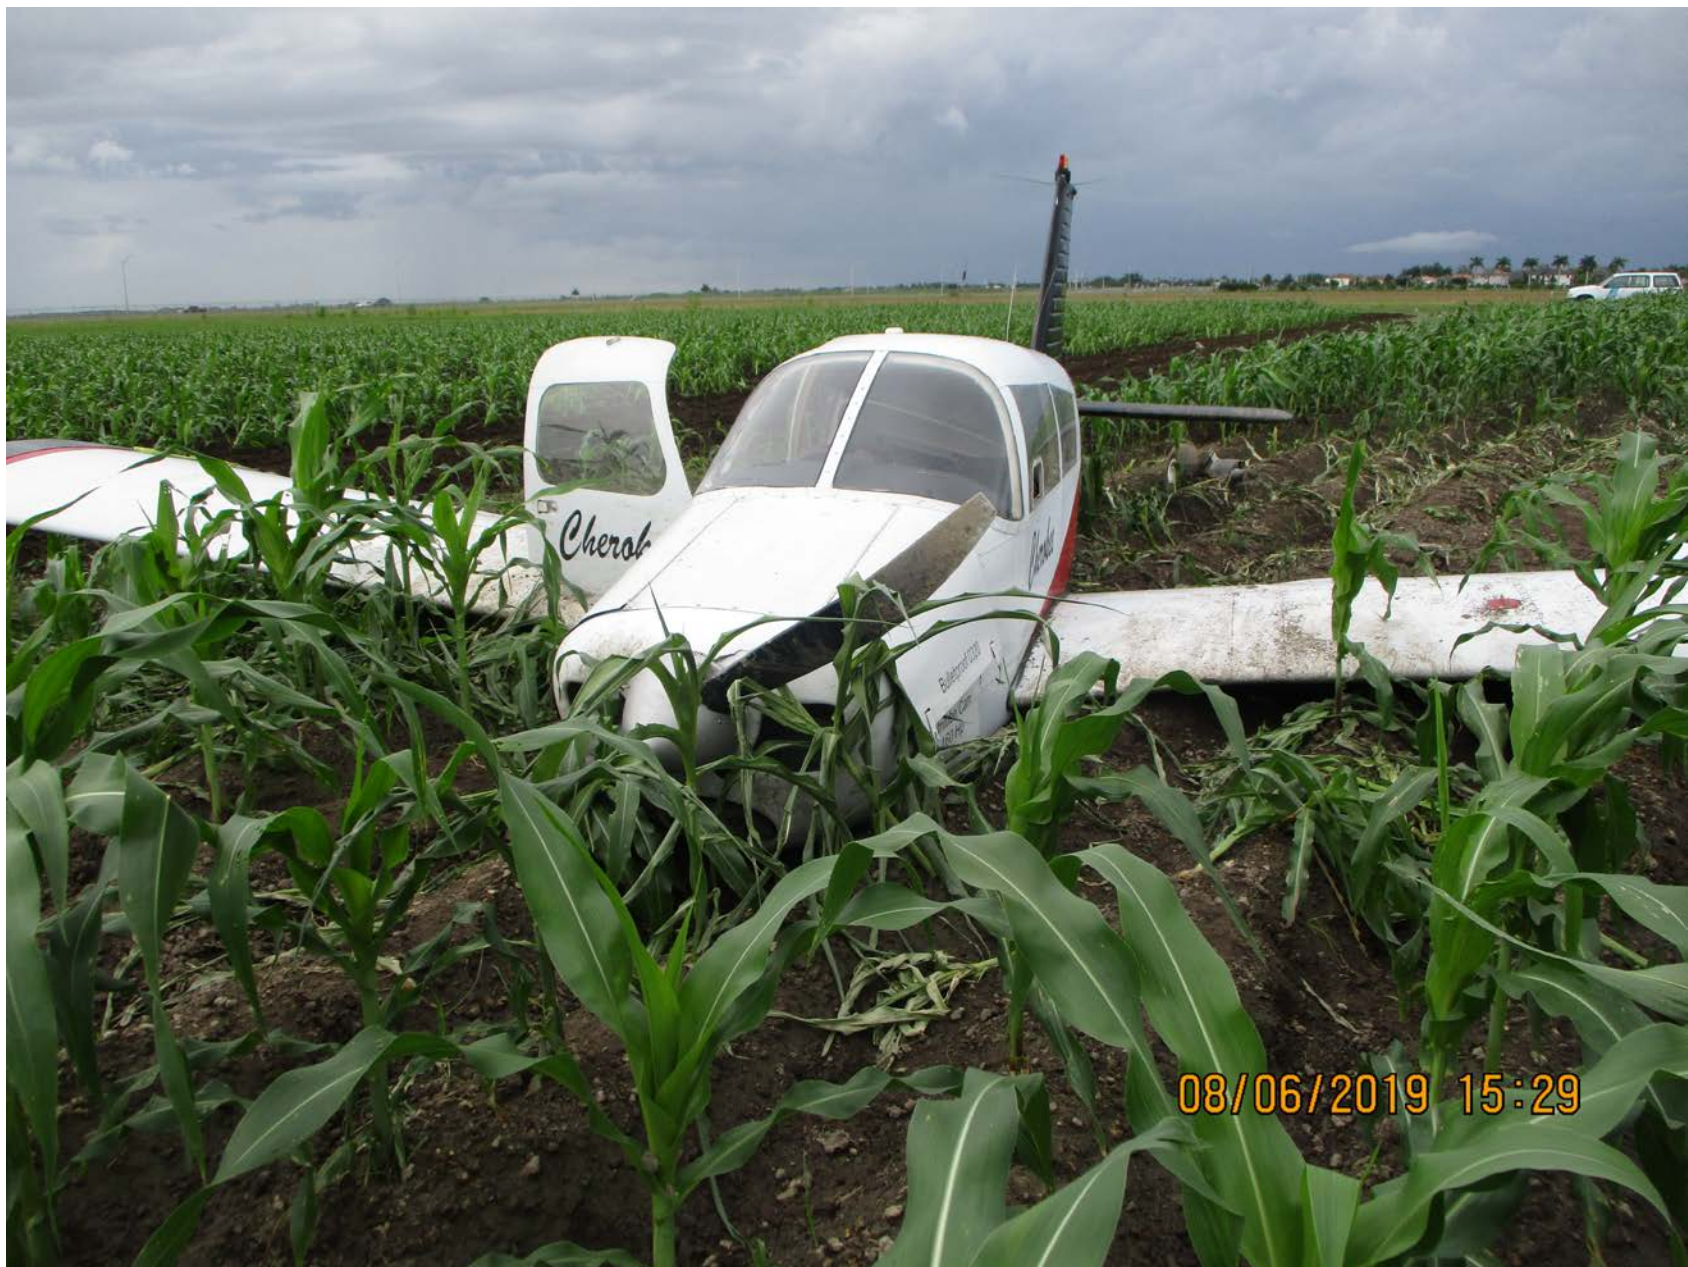
**Photo 2 - FAA supplied view of the front side of the airplane in a cornfield.**

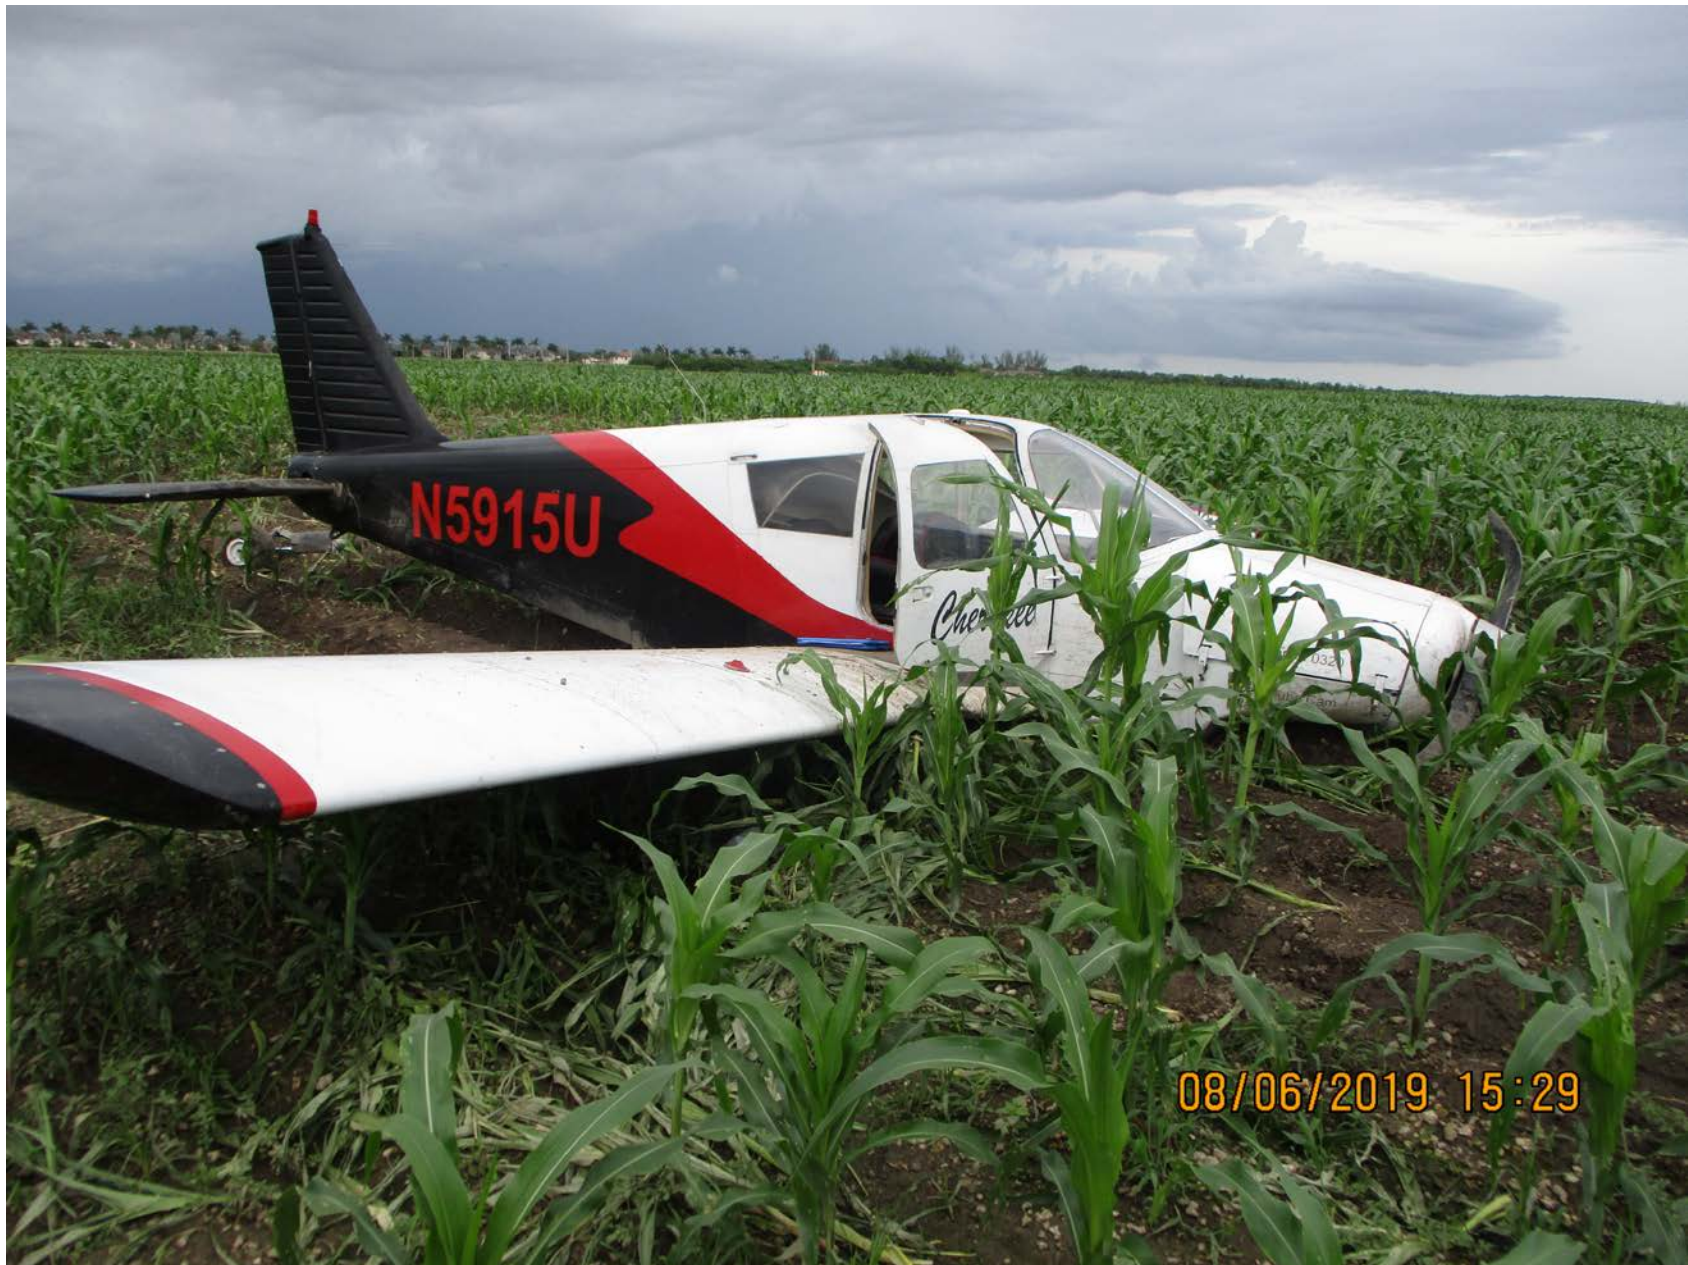
**Photo 3 - FAA supplied quartering view of the right, front side of the airplane in a cornfield.**

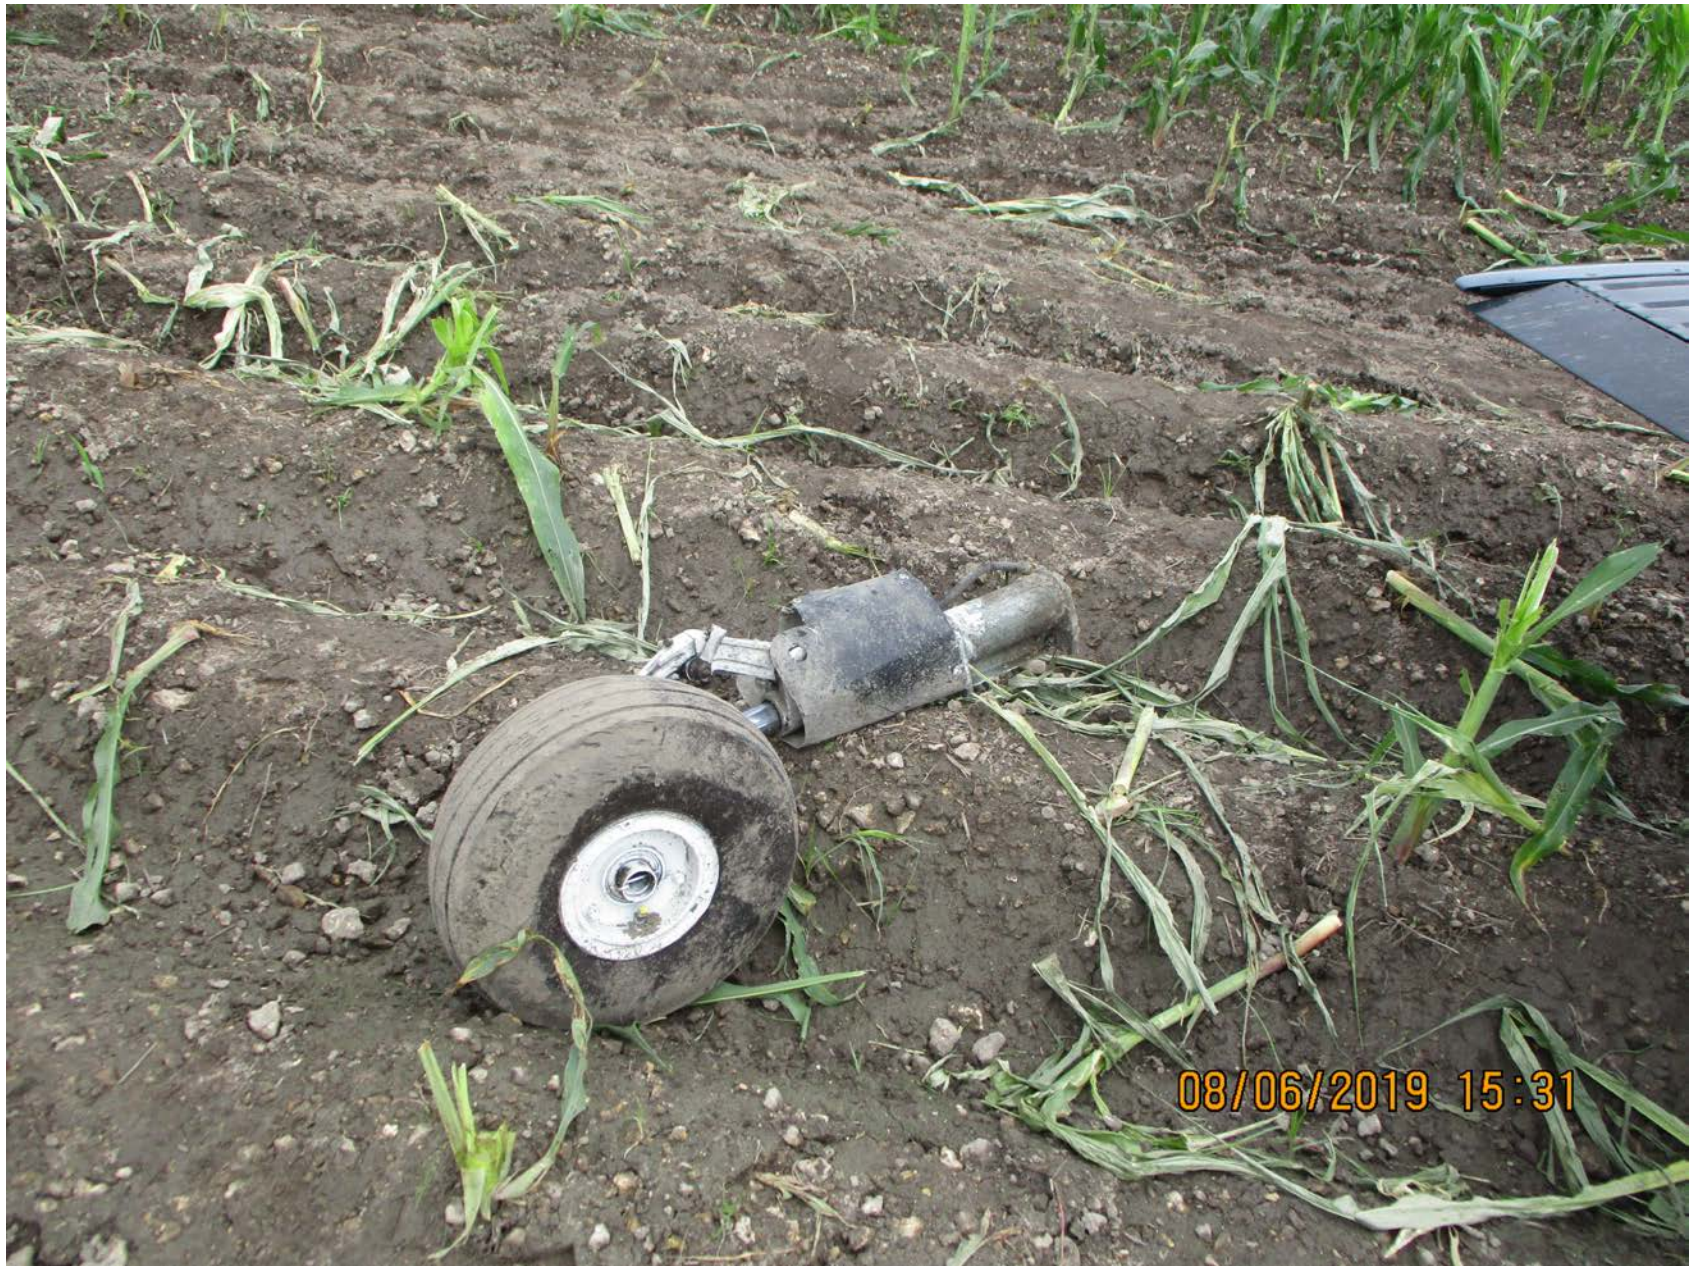
**Photo 4 - FAA supplied view of a landing gear.**

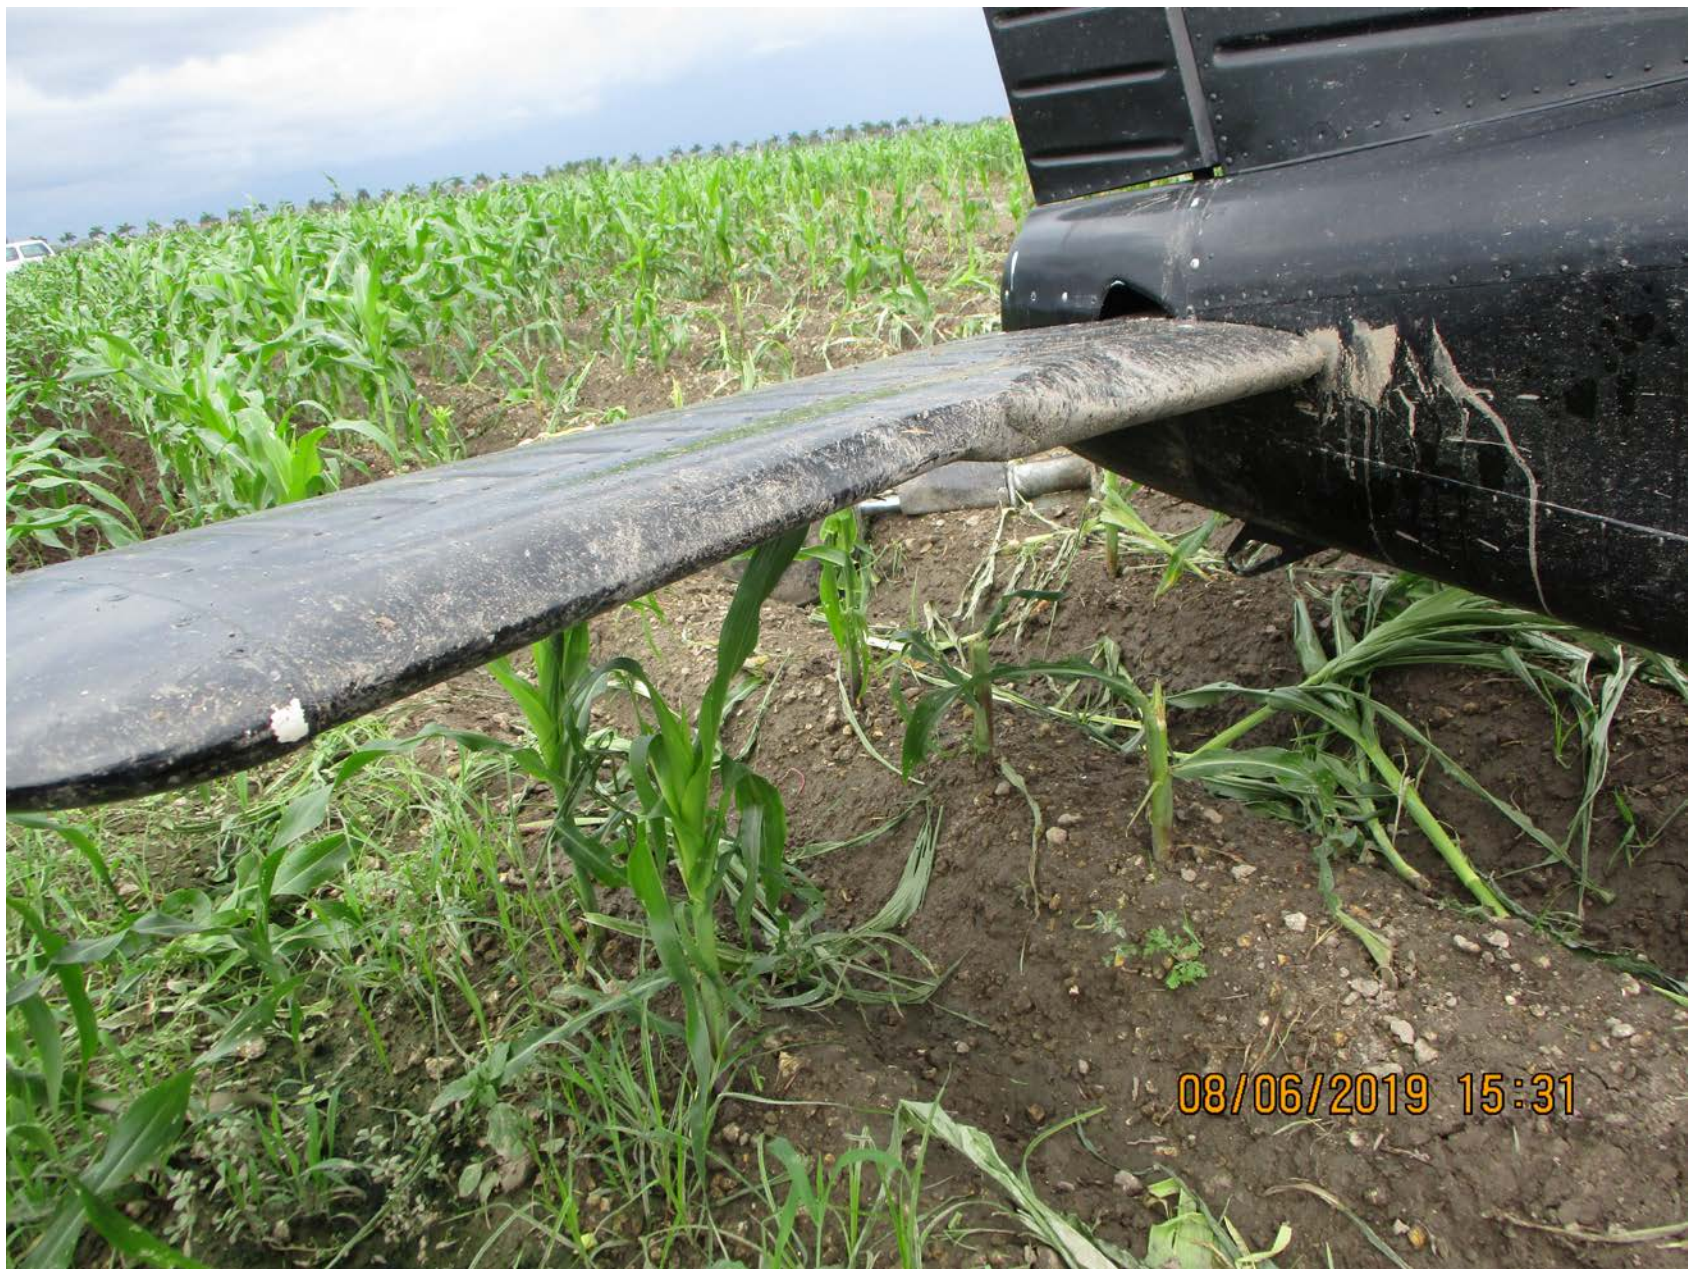
**Photo 5 - FAA supplied view of the right horizontal stabilizer exhibiting leading edge damage. a landing gear.**

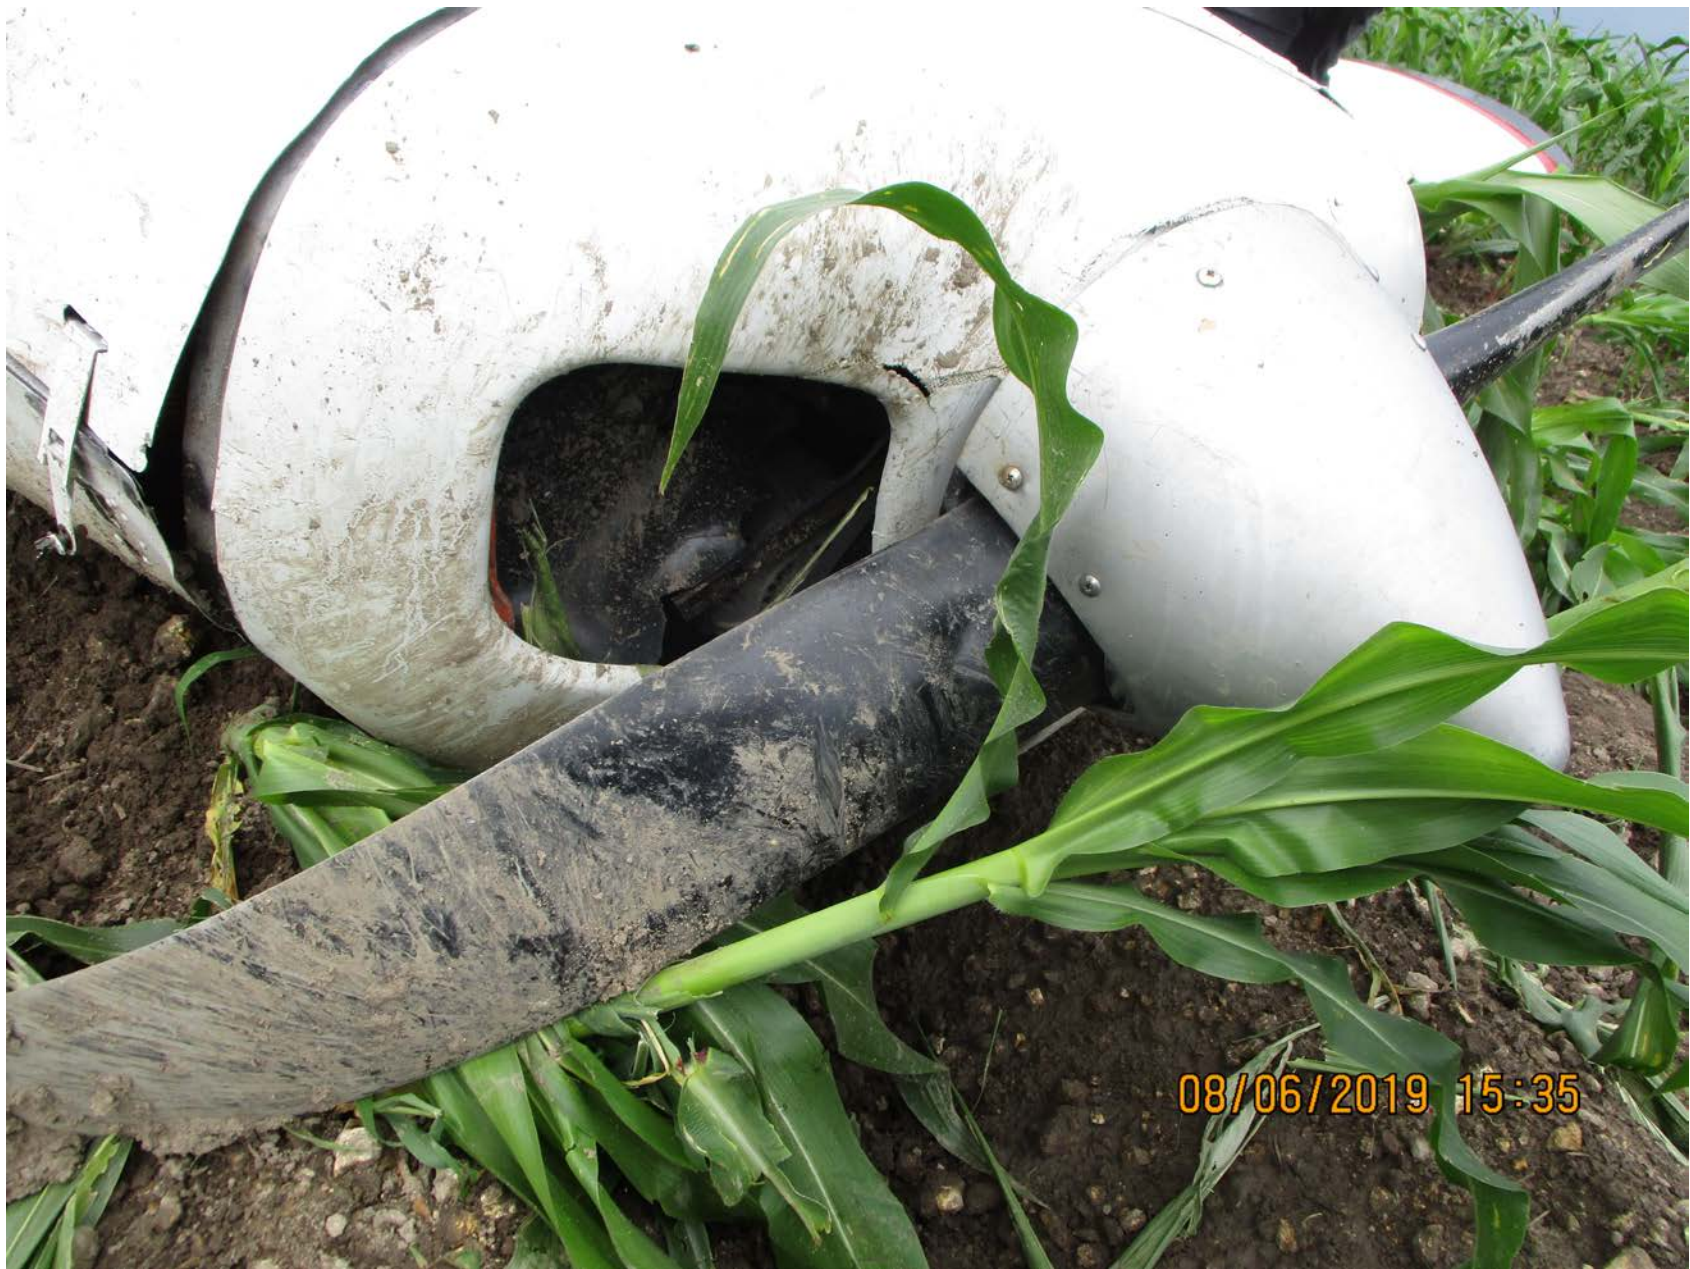
**Photo 6 - FAA supplied view of a propeller blade and cowling.**

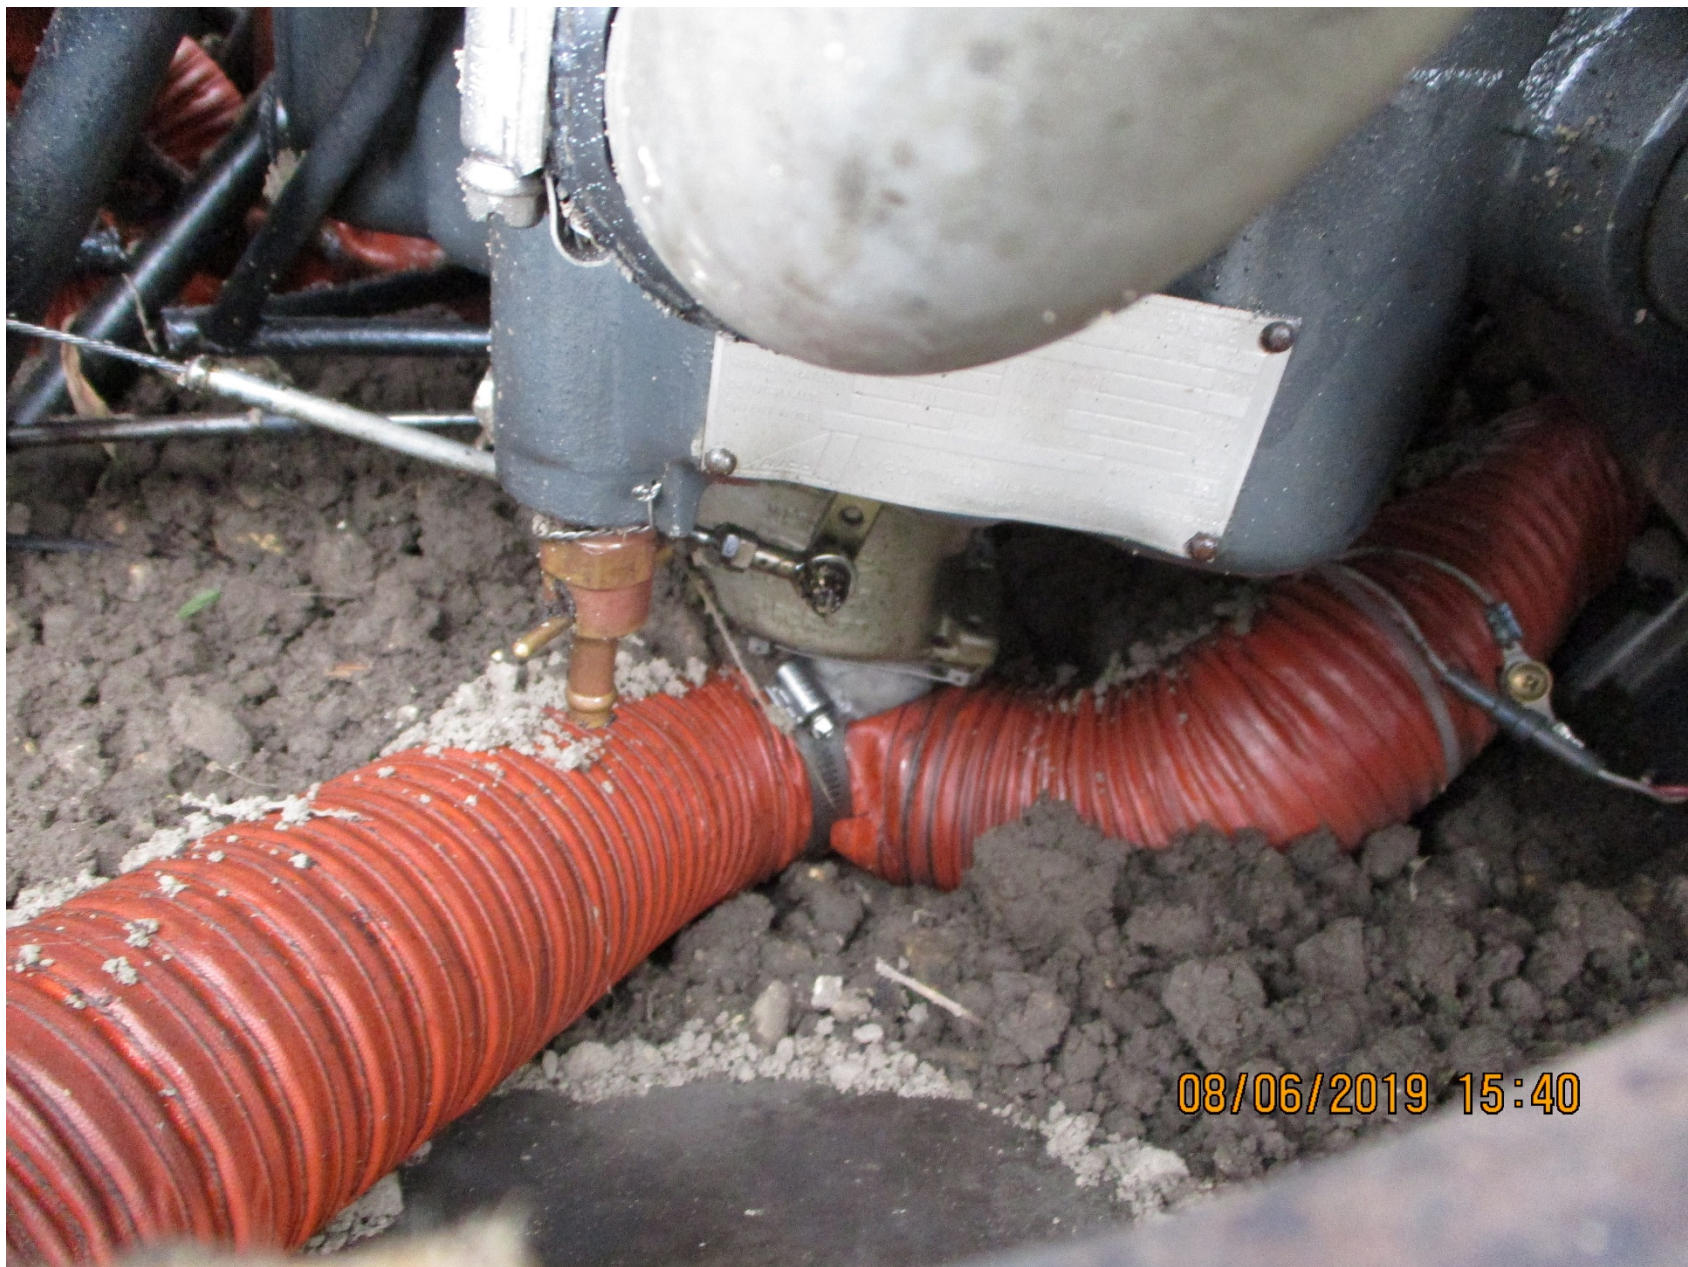
**Photo 7 - FAA supplied view of the carburetor and its linkage.**

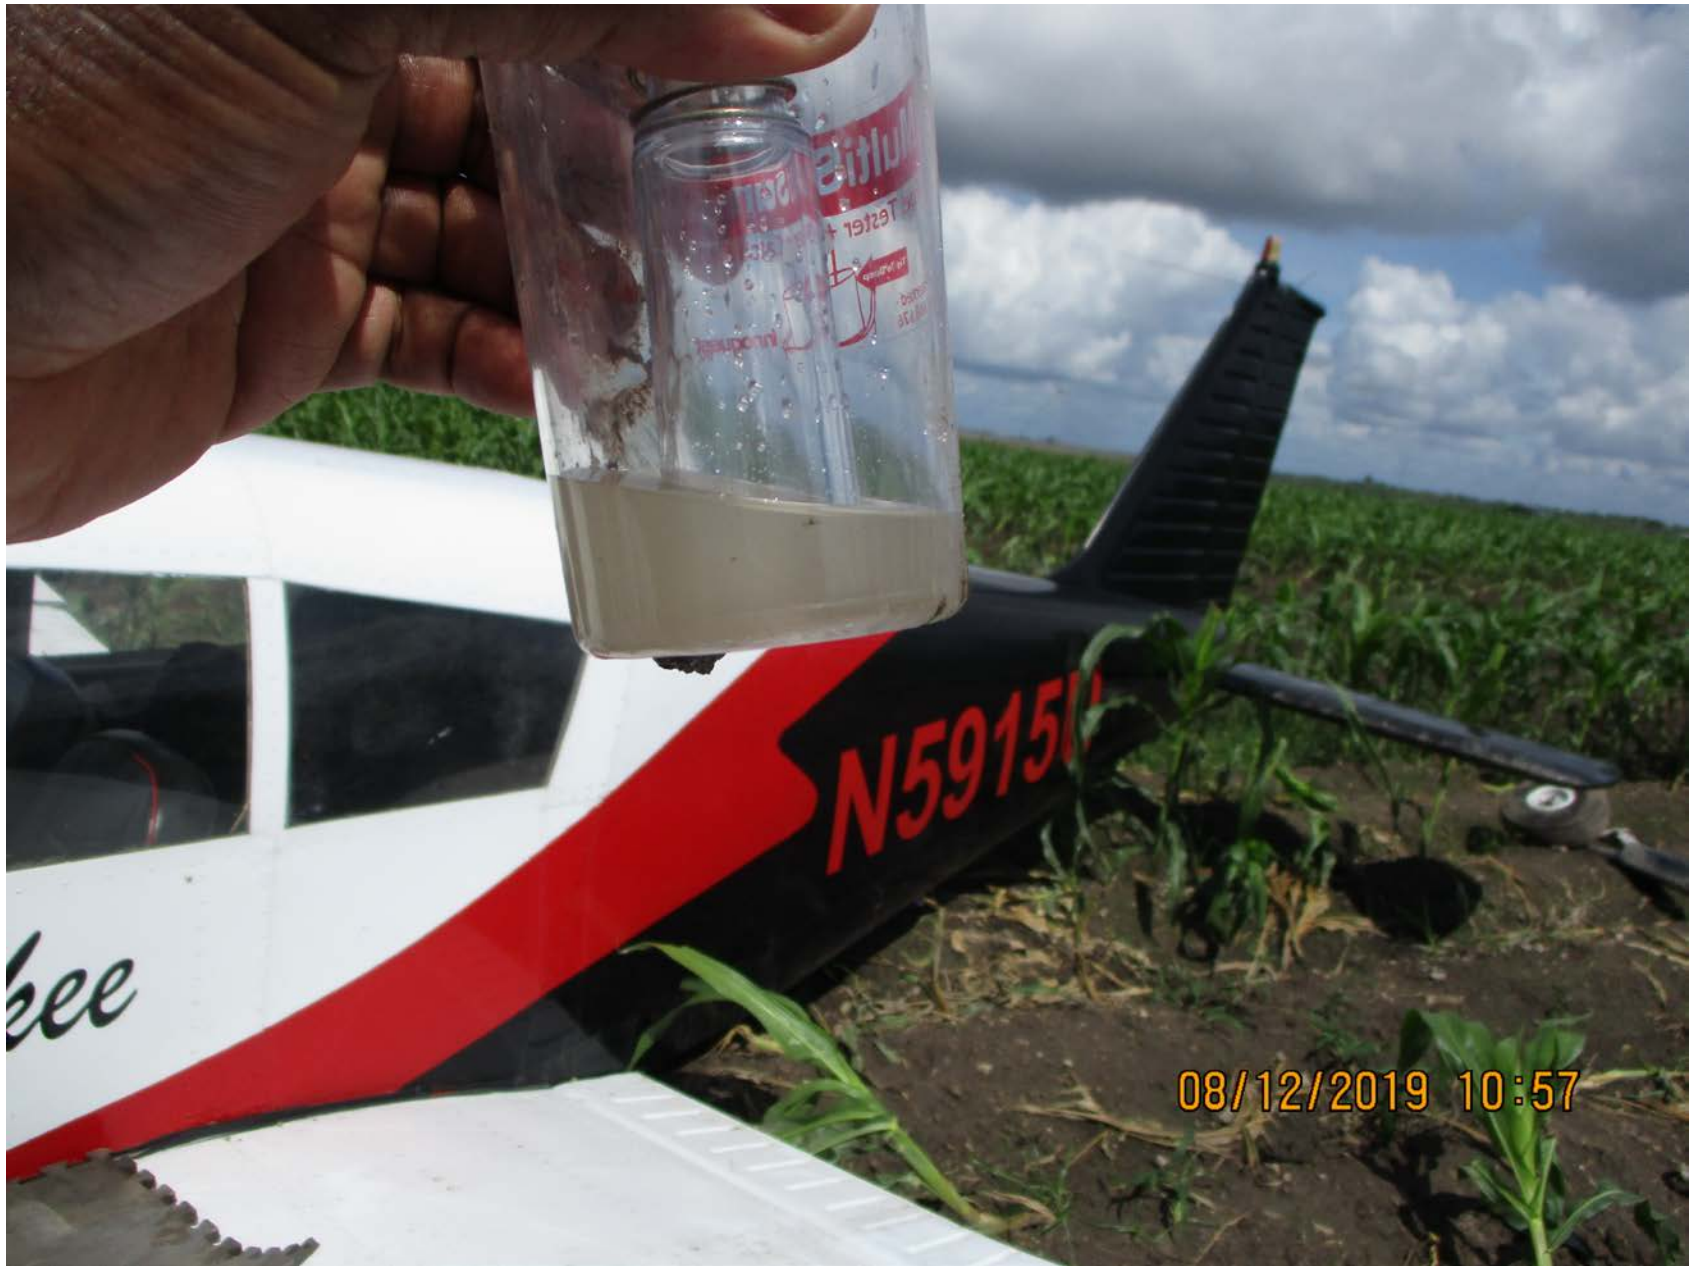
**Photo 8 - FAA supplied view of a sample from the left wing's sump. The sample contains a cloudy colored liquid.**

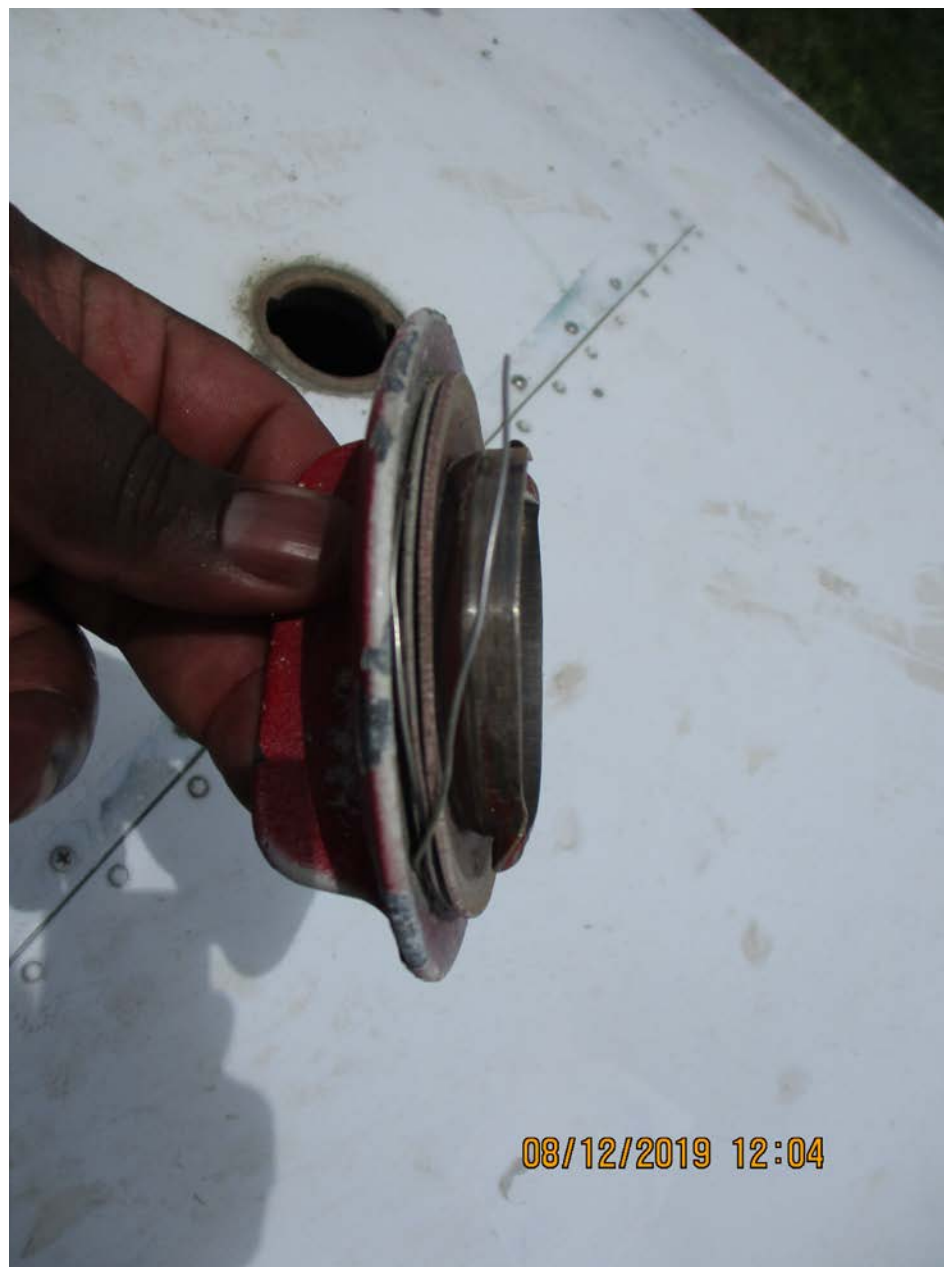
**Photo 9 - FAA supplied view of a fuel cap with safety wire wrapped above its gasket.**

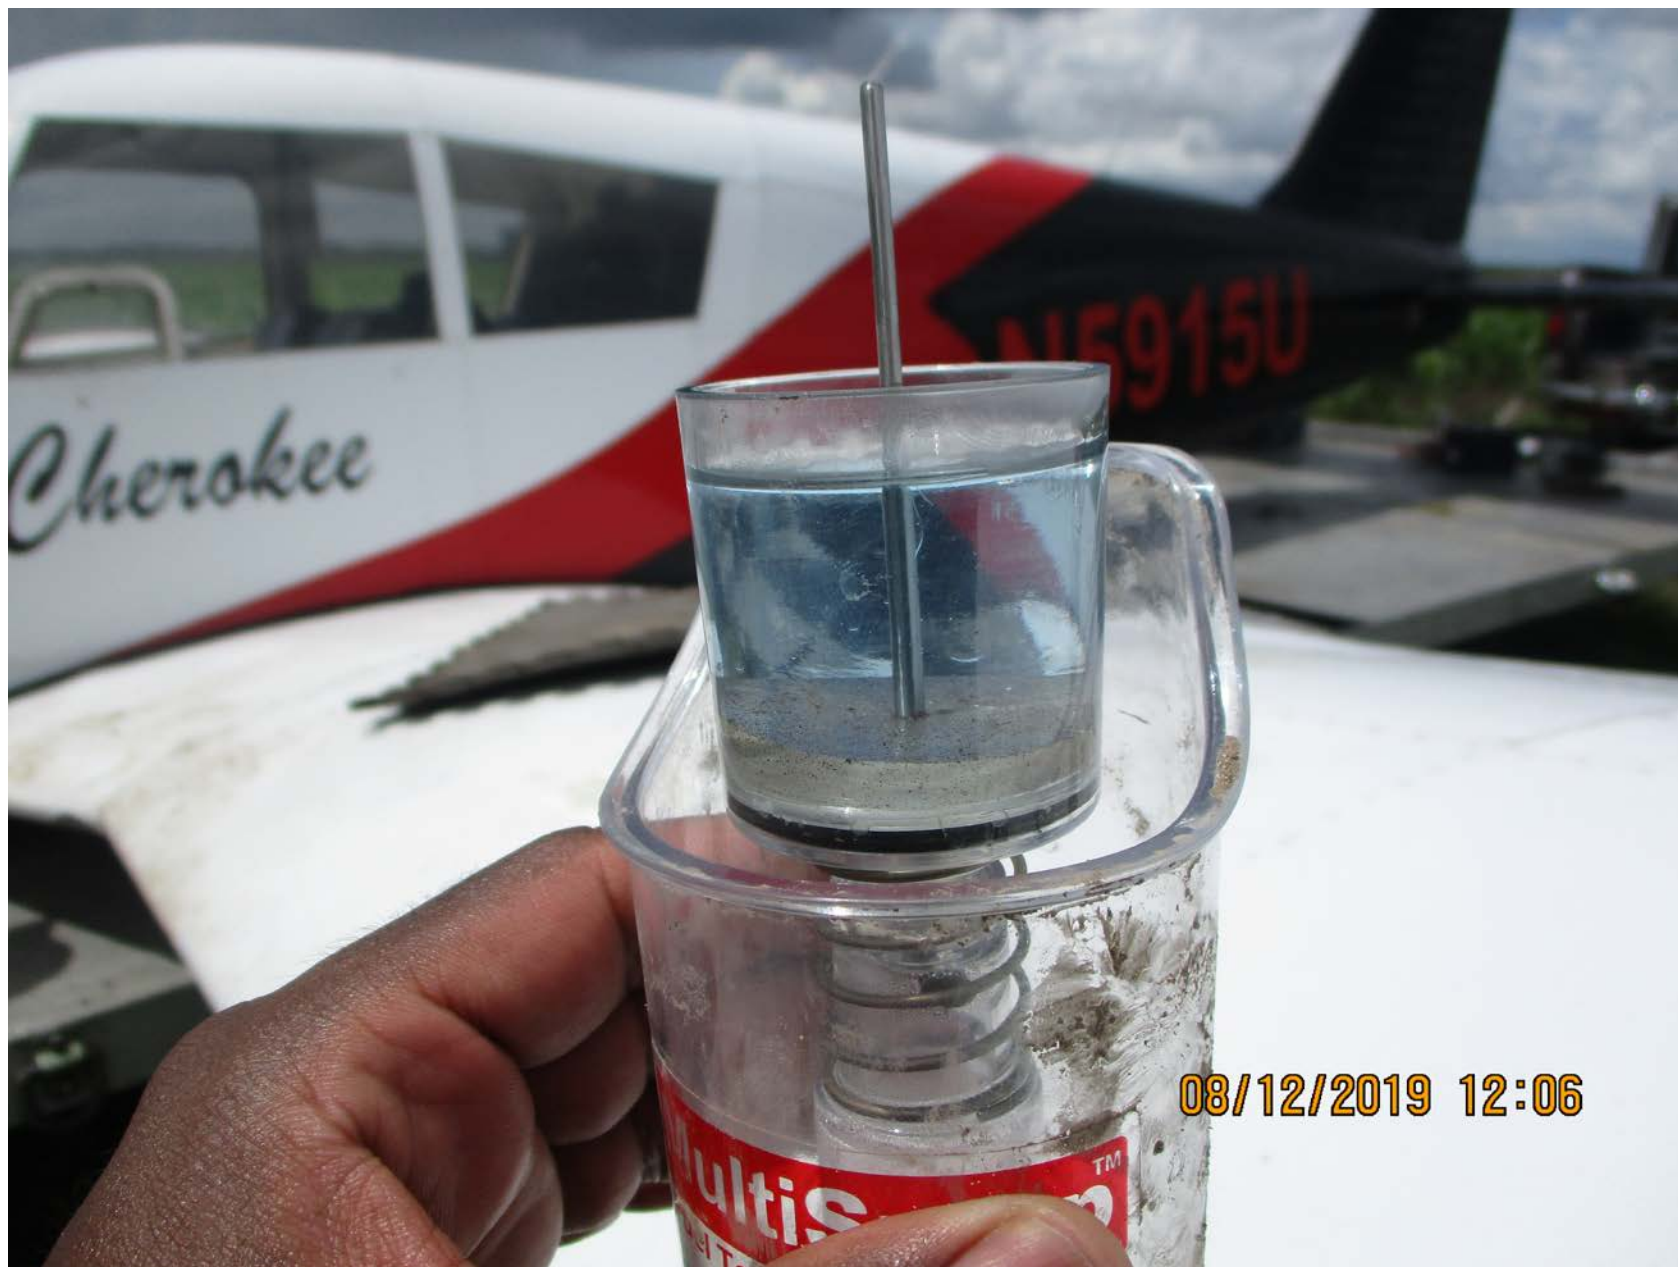
**Photo 10 - FAA supplied view of an additional sample from the left wing's sump. The sample contains a cloudy colored liquid at the bottom of the sampler and a blue colored liquid above the cloudy layer.**

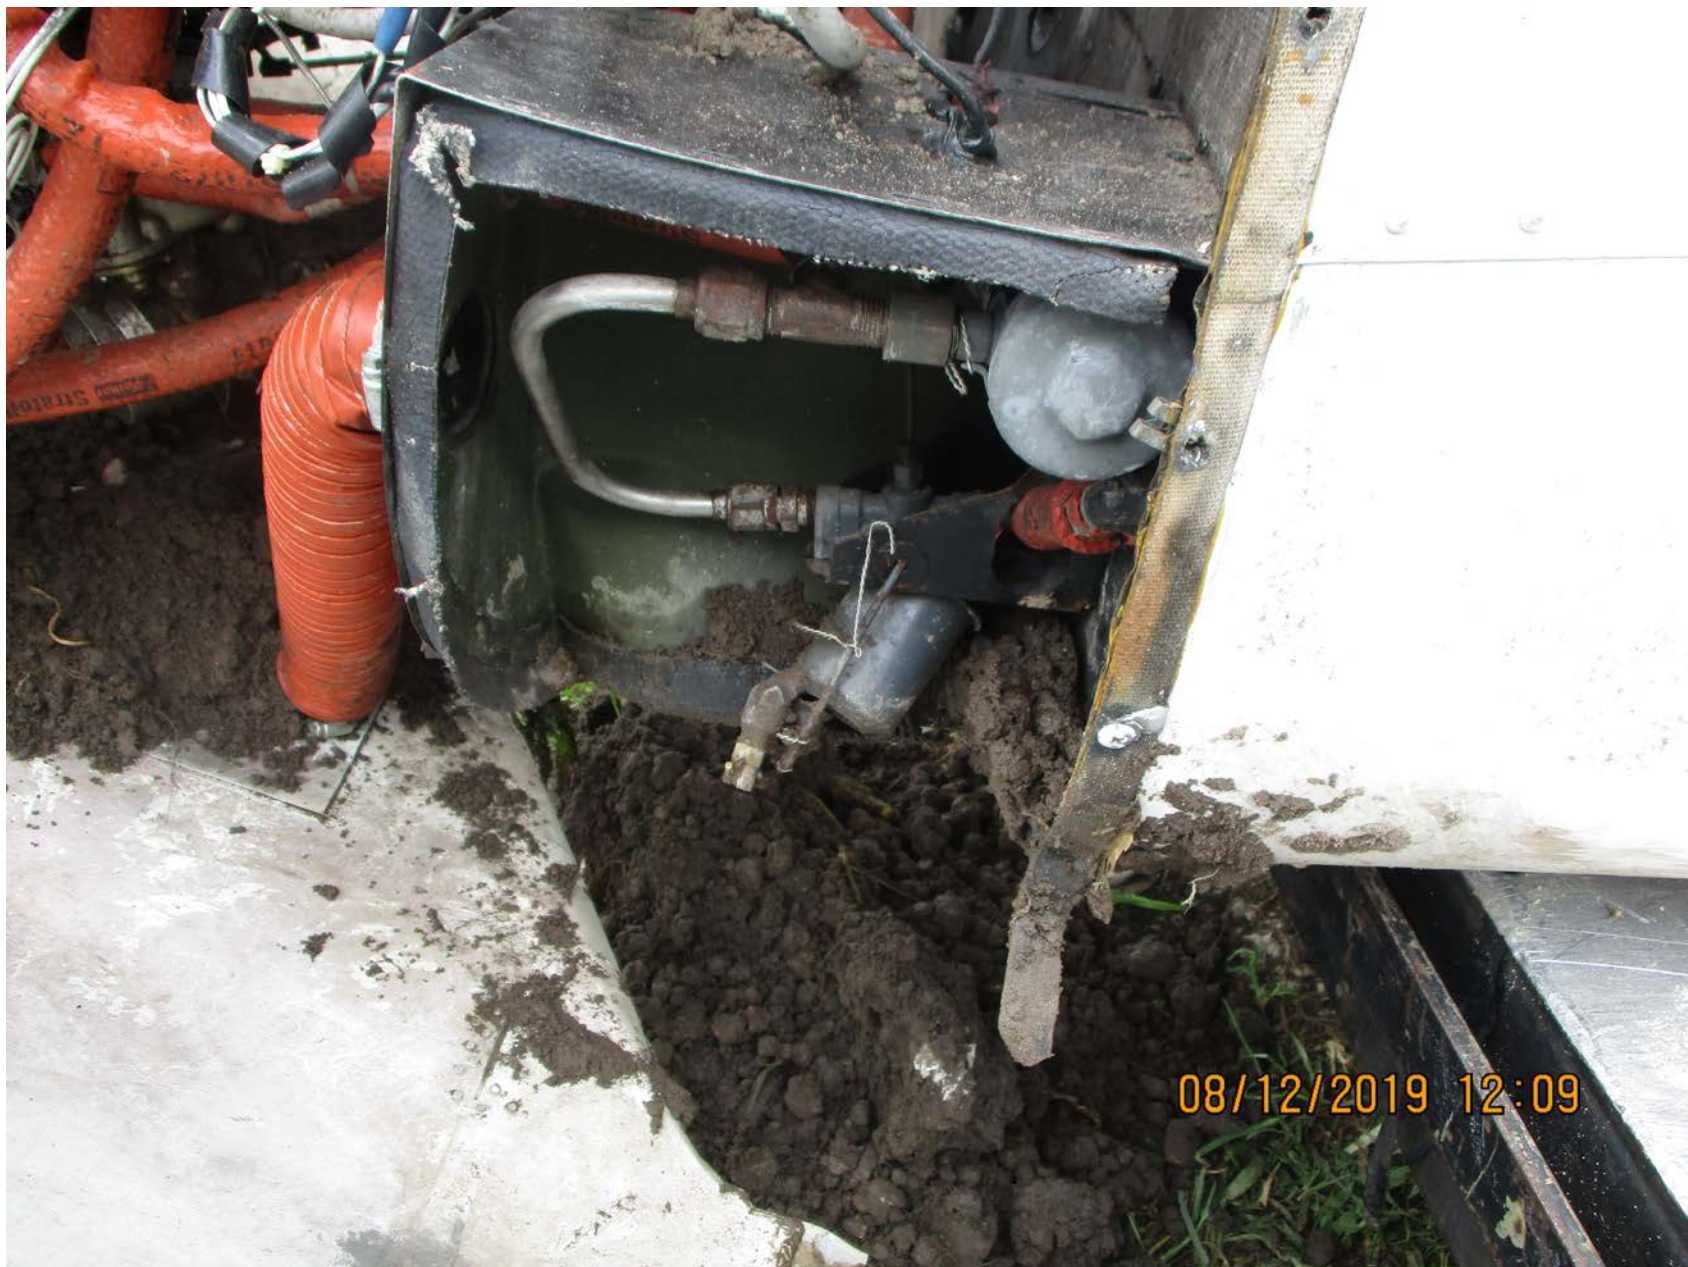
**Photo 11 - FAA supplied view of the gascolator.**

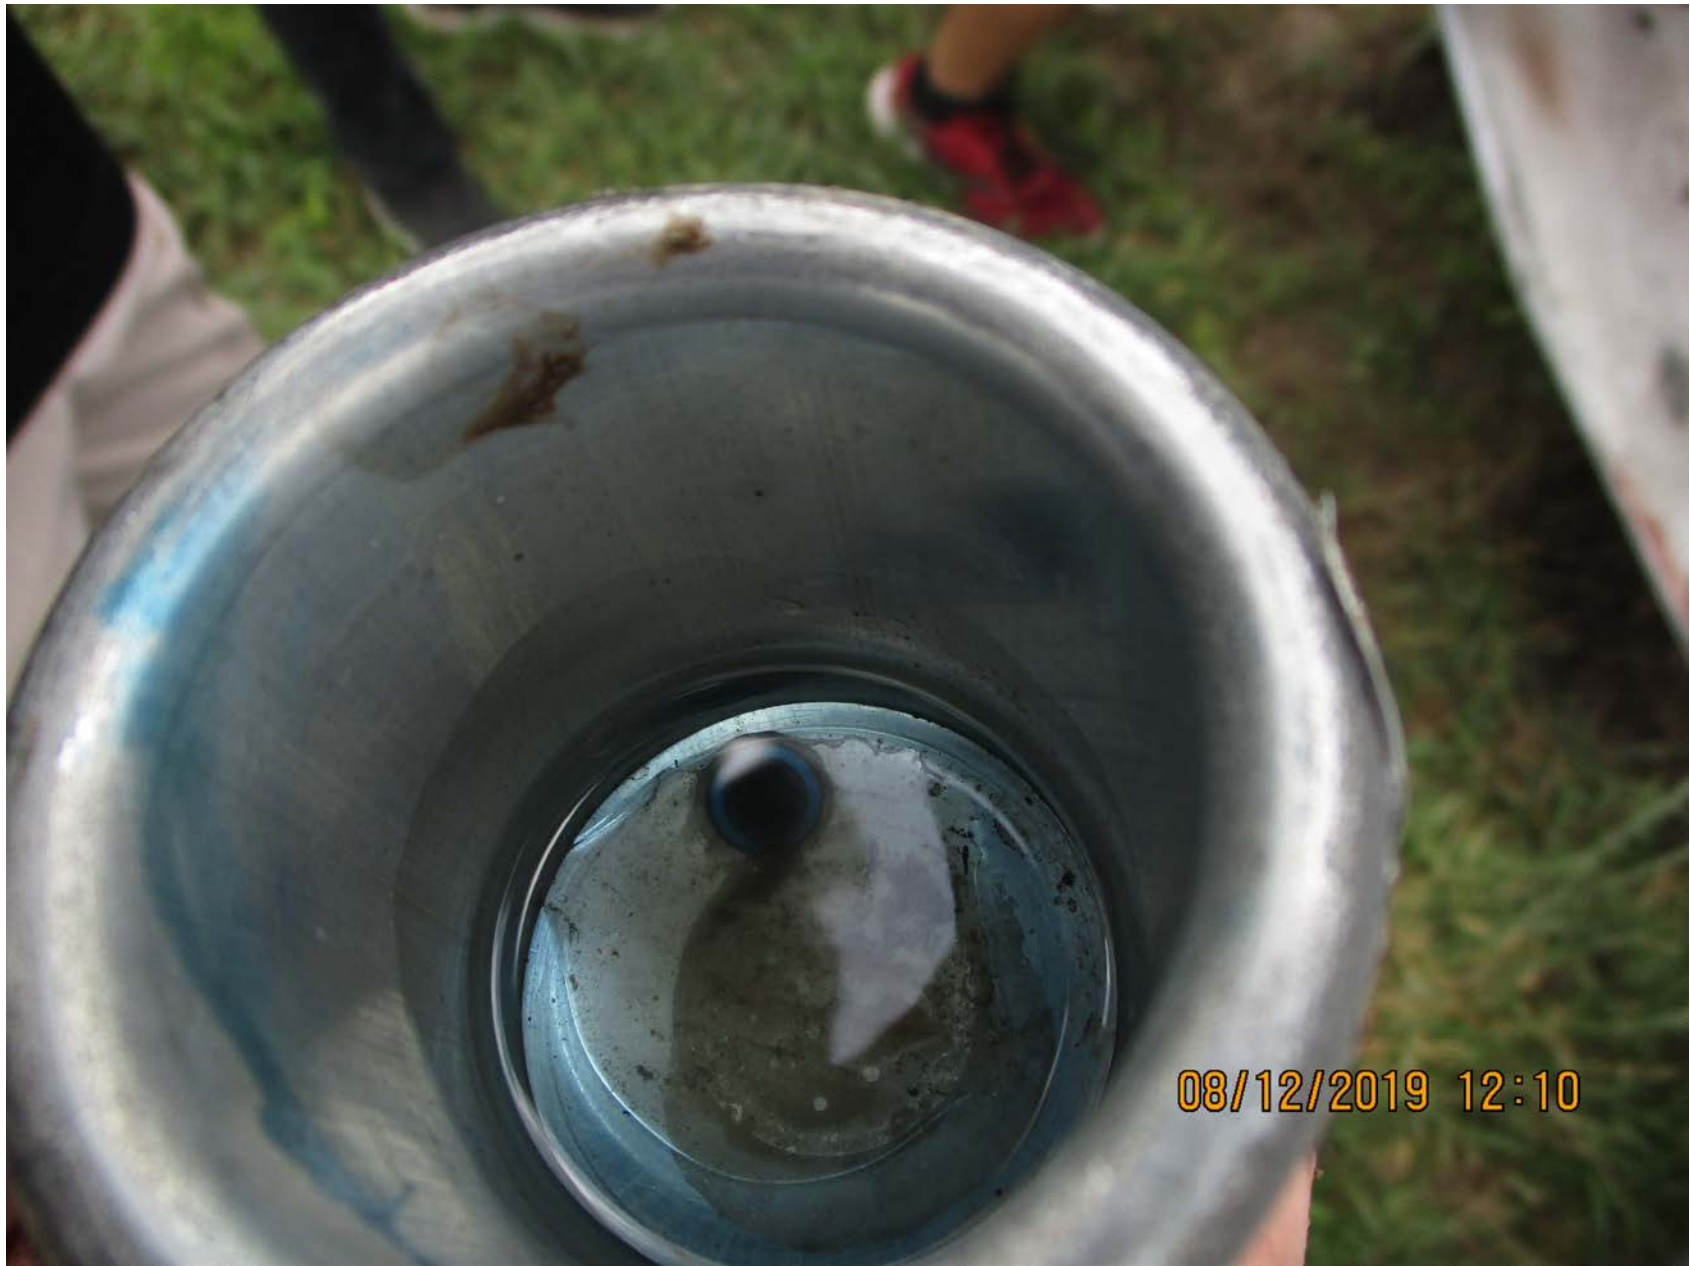
**Photo 12 - FAA supplied view of the inside of the gascolator bowl.**
