**Photo 1 – FAA supplied quartering view of the left, rear side of the airplane in a cornfield.**

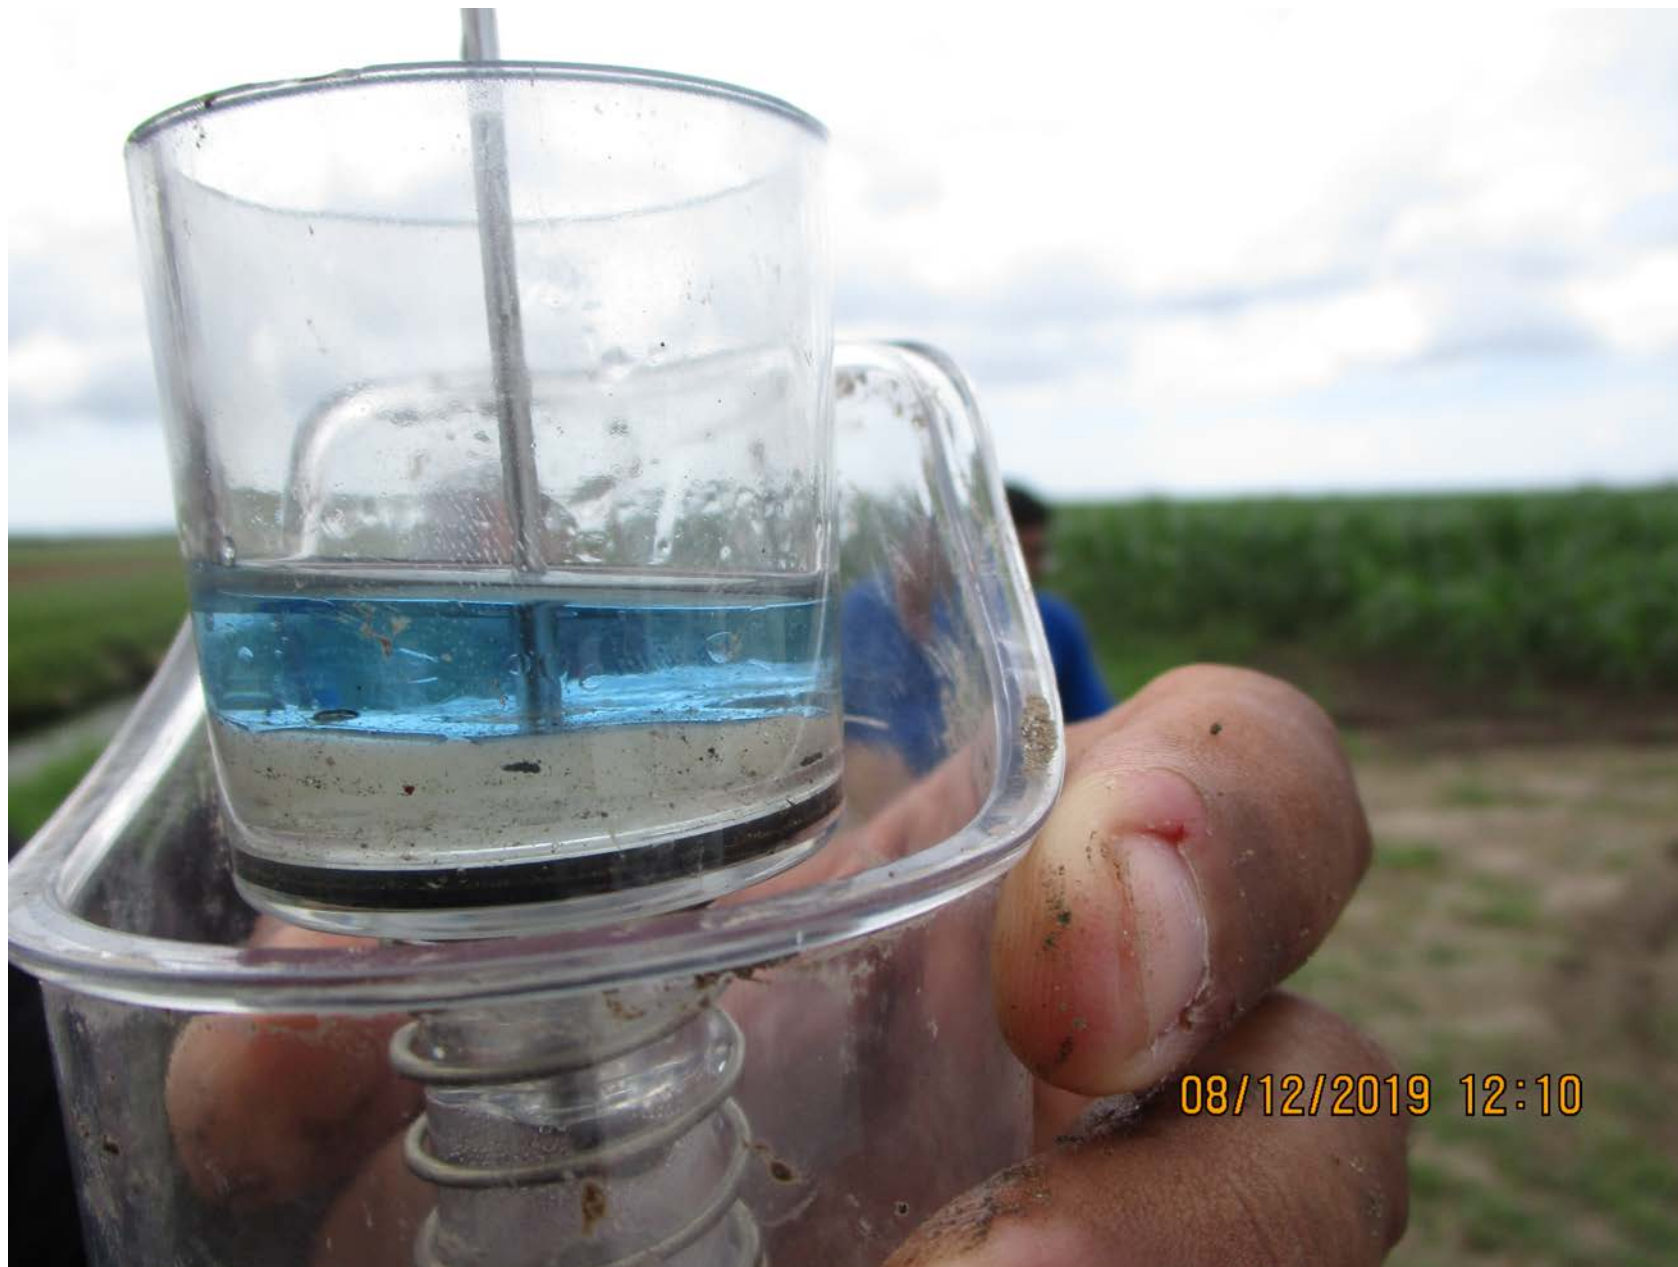
**Photo 13 - FAA supplied view of a liquid sample from the gascolator bowl. The sample contains a cloudy colored liquid at the bottom of the sampler and a blue colored liquid above the cloudy layer.**

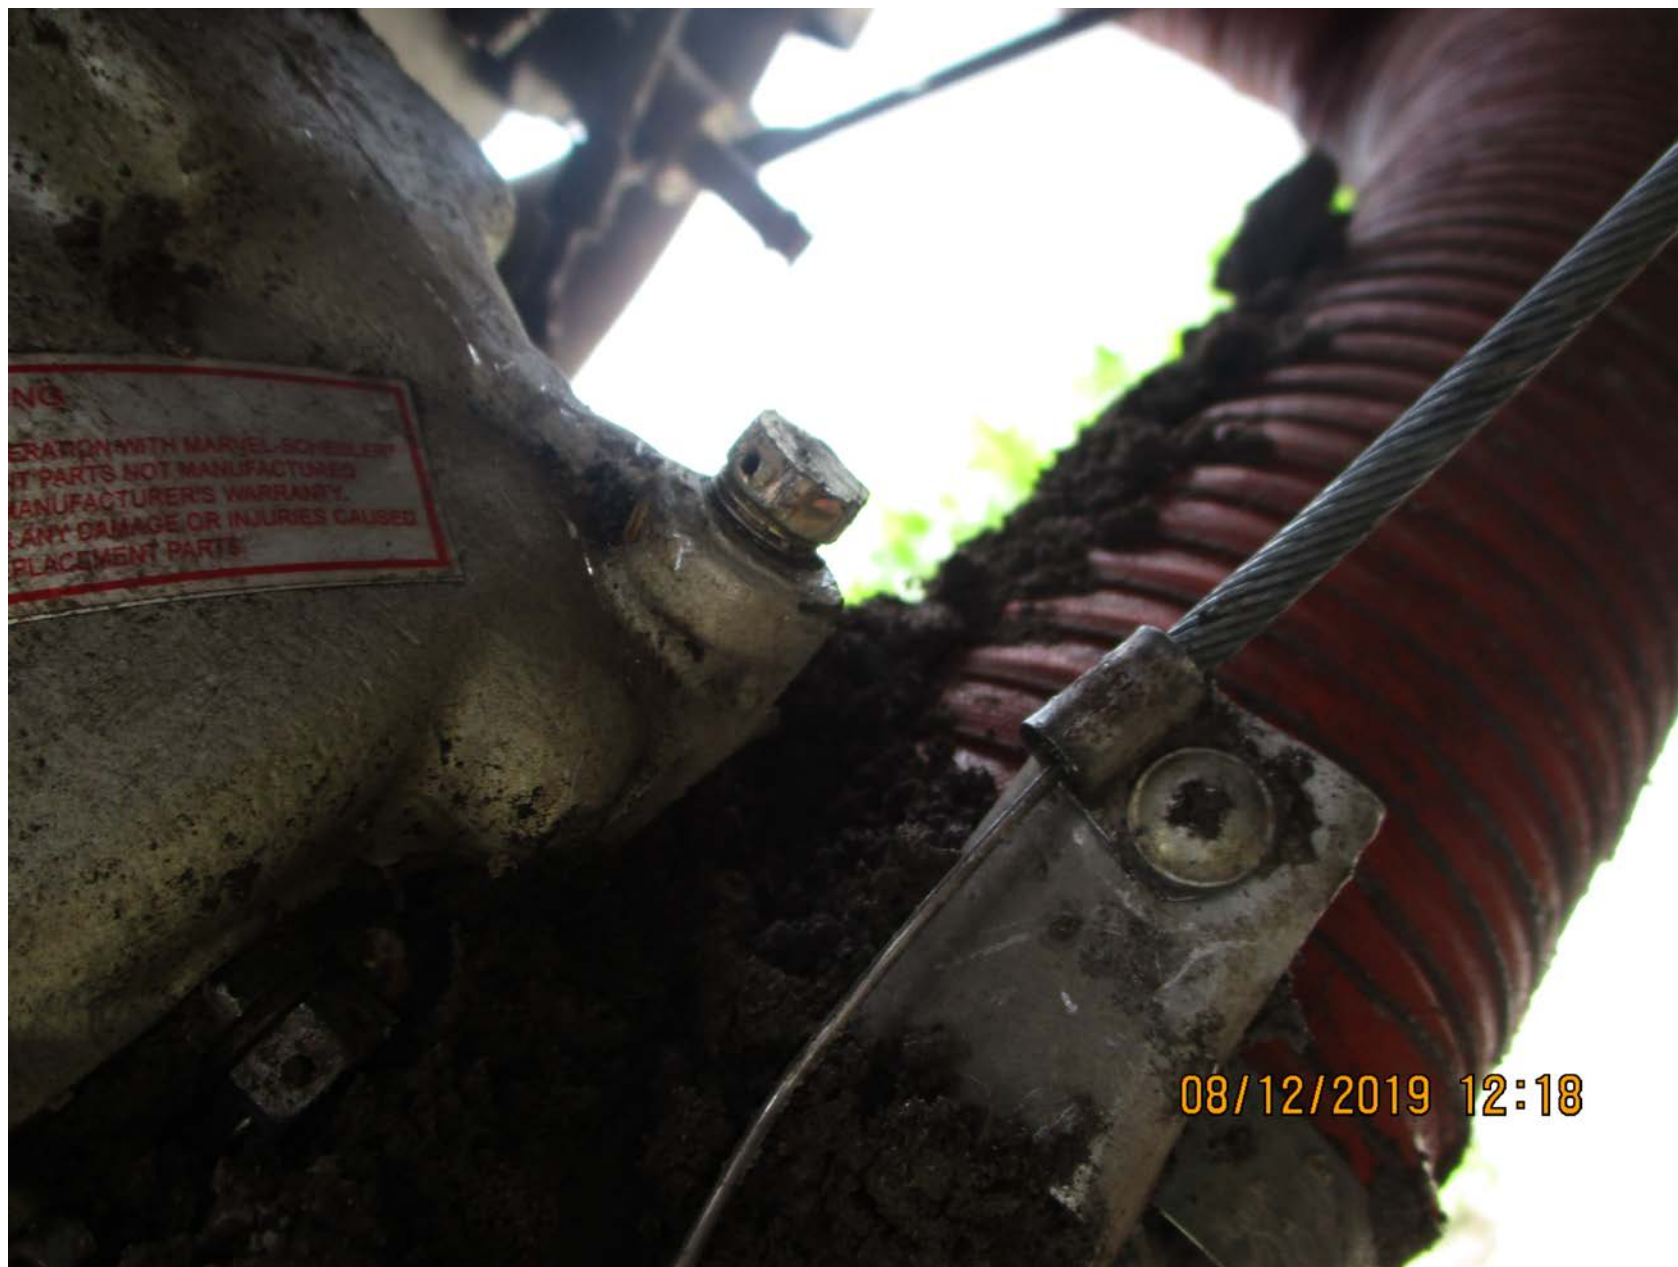
Photo 14 - FAA supplied view of the lower side of the carburetor.

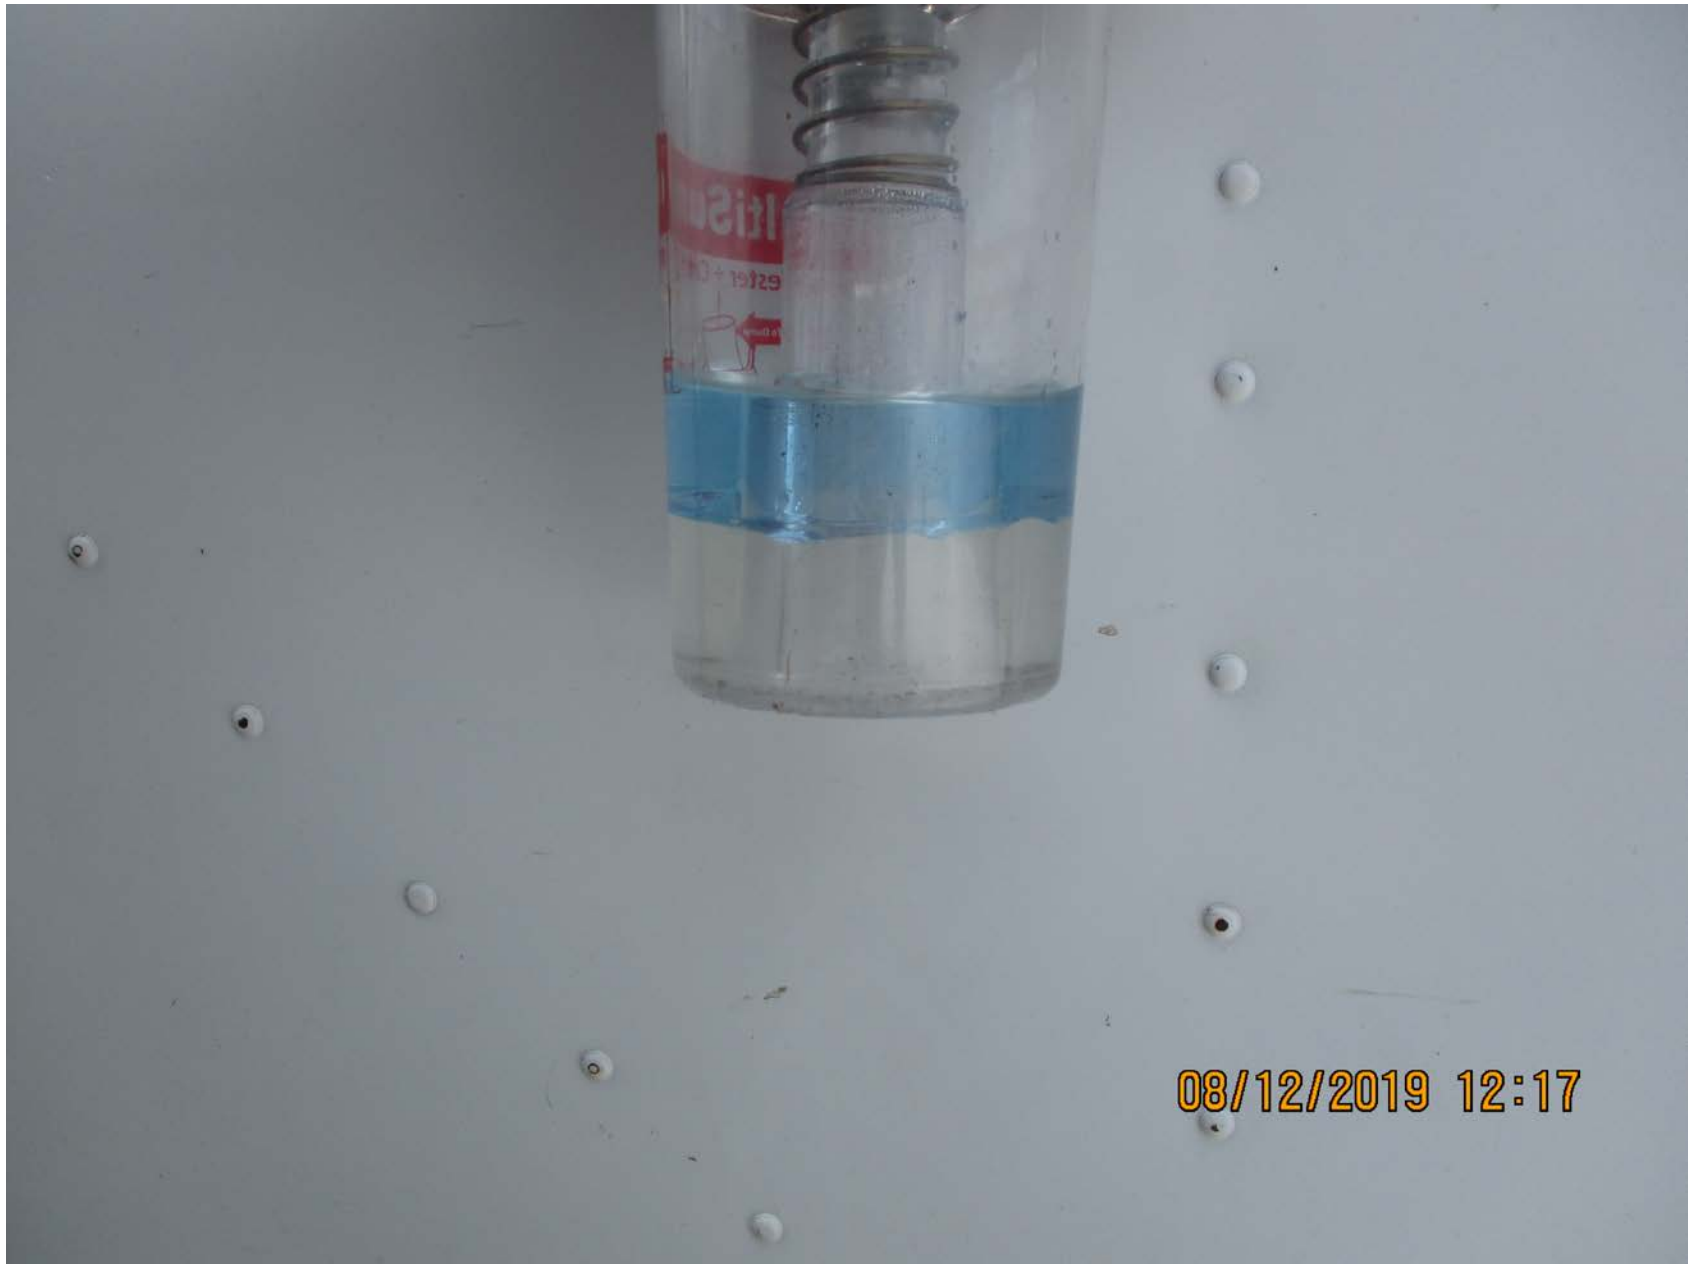
**Photo 15 - FAA supplied view of a sample of liquid from the carburetor bowl. The sample contains a cloudy colored liquid at the bottom of the sampler and a blue colored liquid above the cloudy layer.**

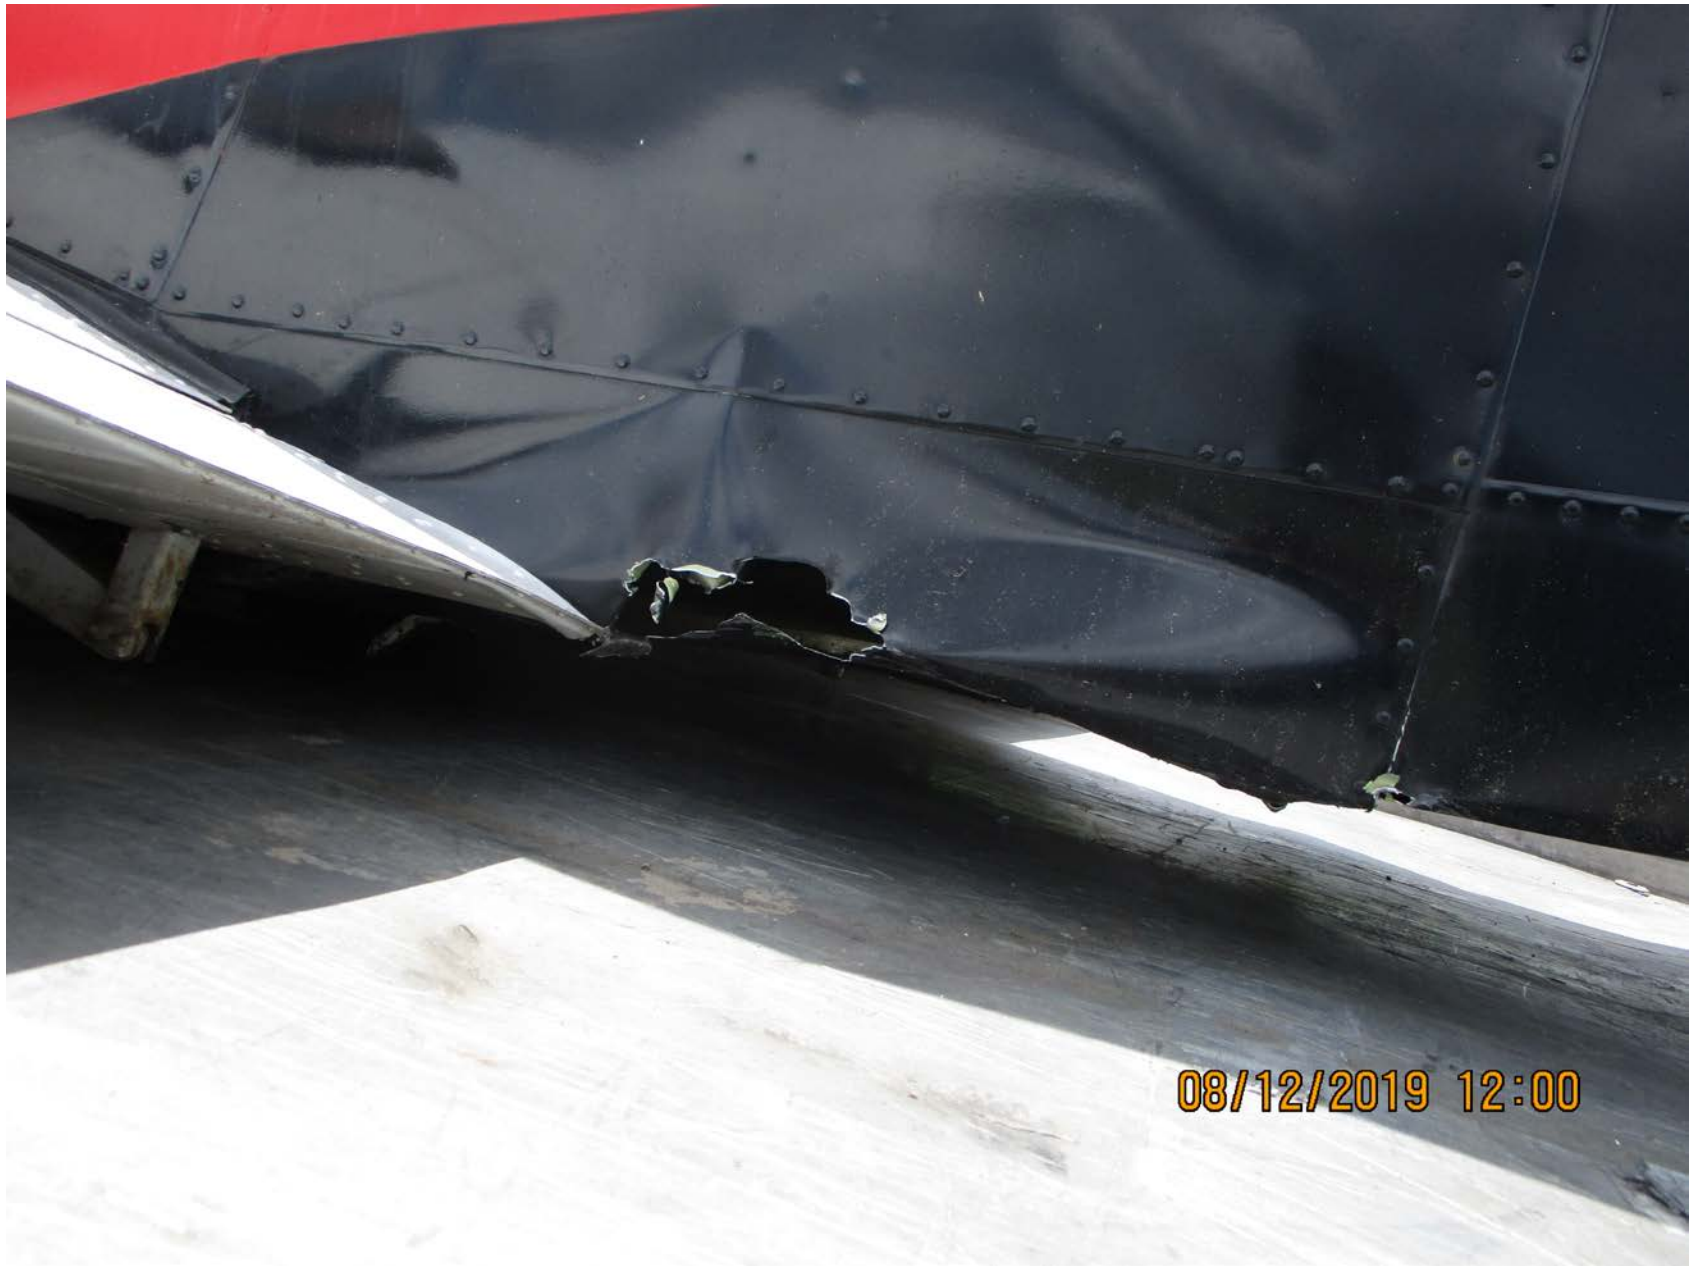
**Photo 16 - FAA supplied view of damage to the left fuselage.**

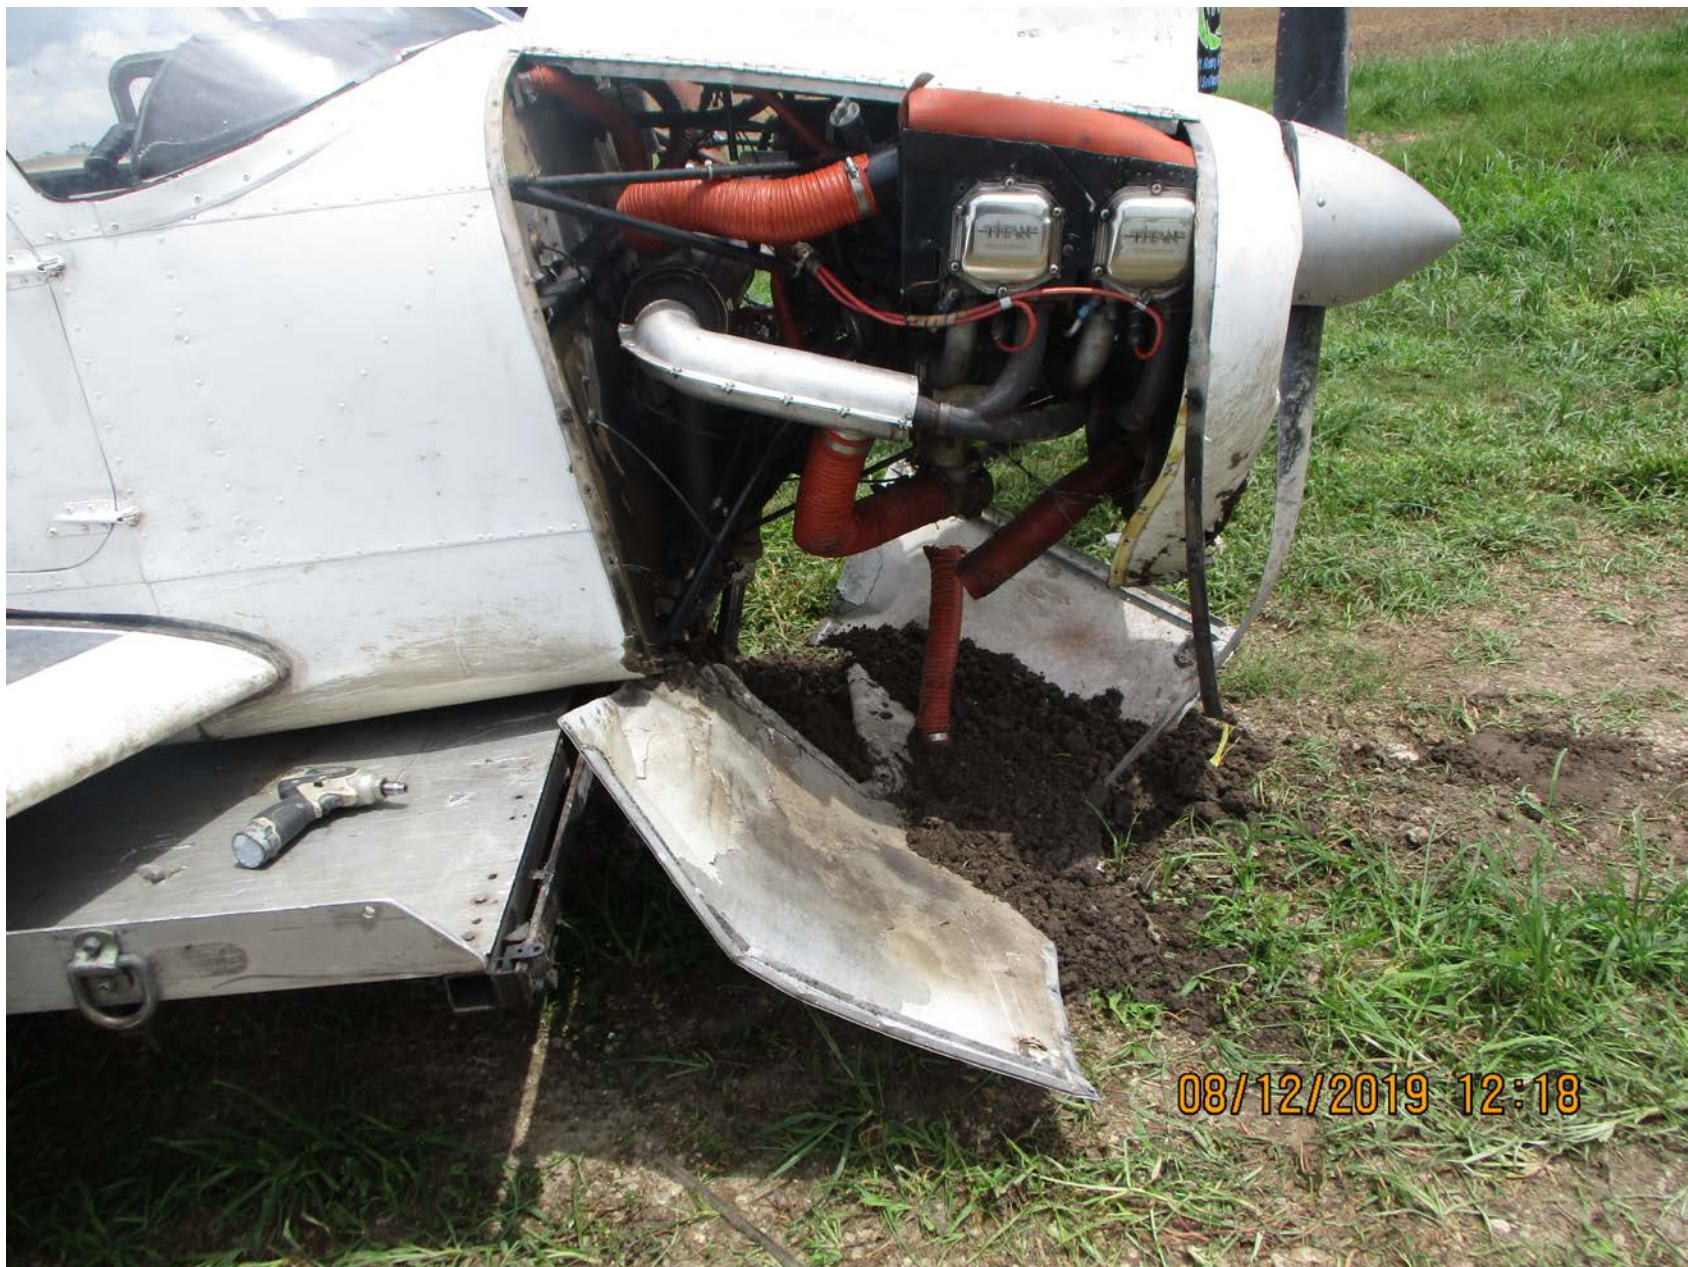
**Photo 17 - FAA supplied view of the right side of the engine.**

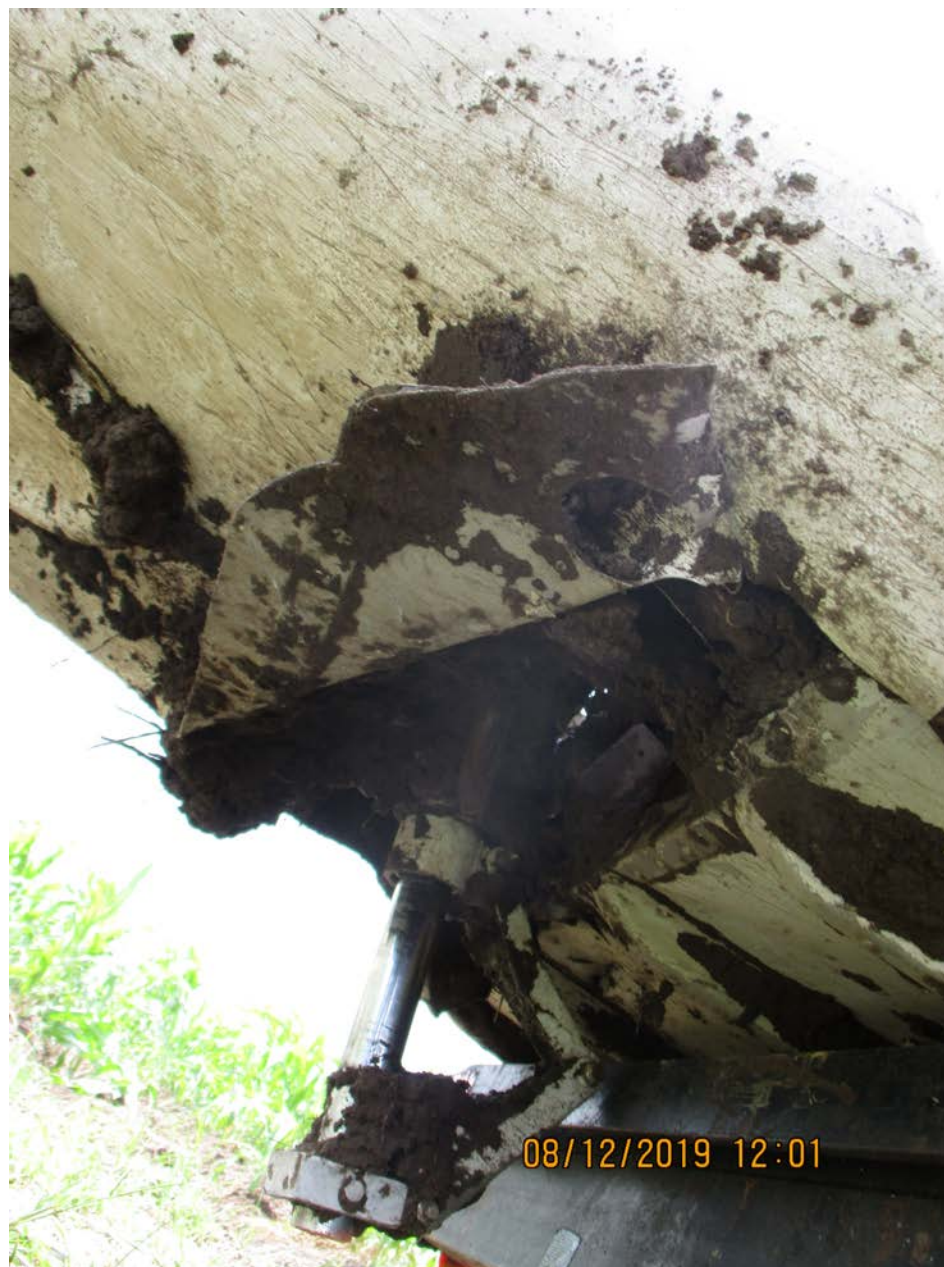
**Photo 18 - FAA supplied view of the nose landing gear scissors. The landing gear below the scissors is not present.**
