# ENGINE EXAMINATION REPORT

## N1609V

| AIRCRAFT MAKE & MODEL | Cessna 172K |
| FILE NUMBER | 19-049 |

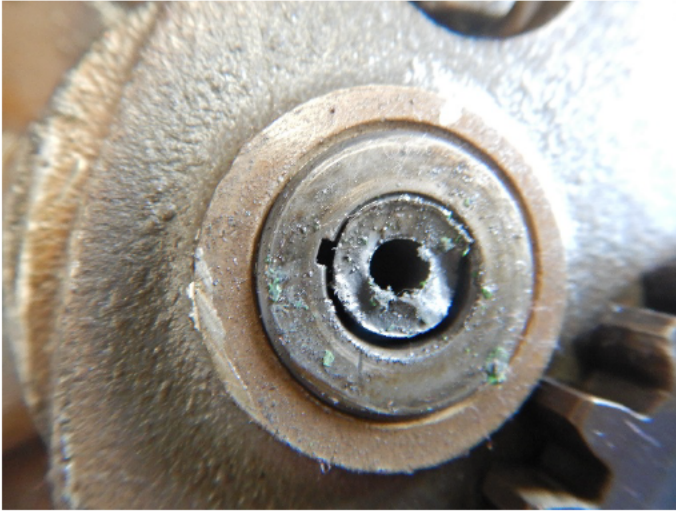
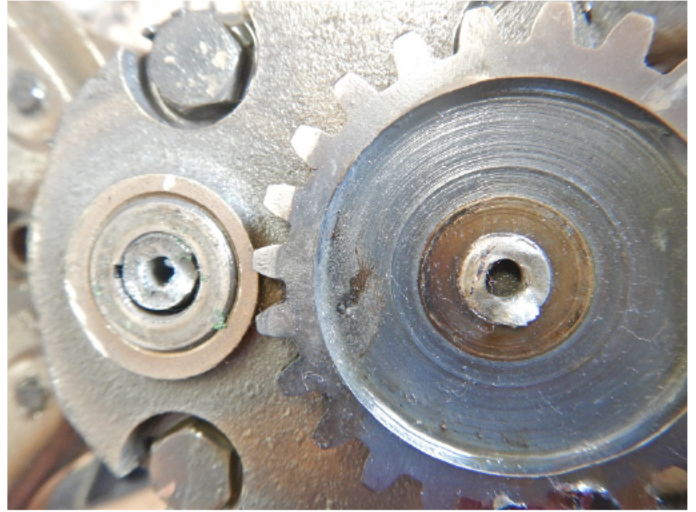
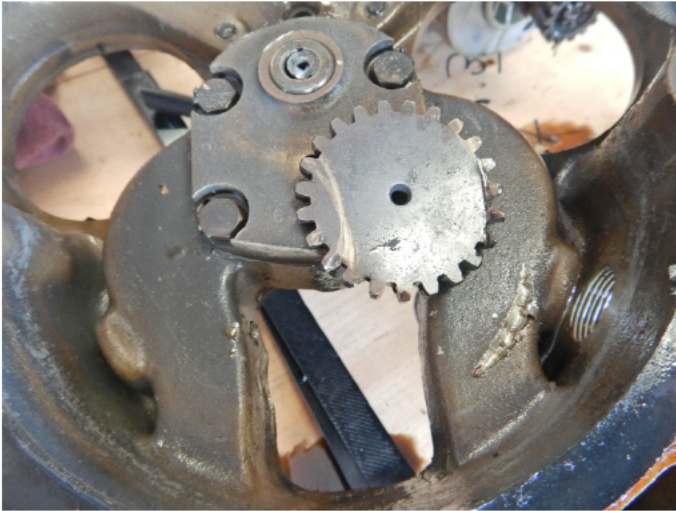
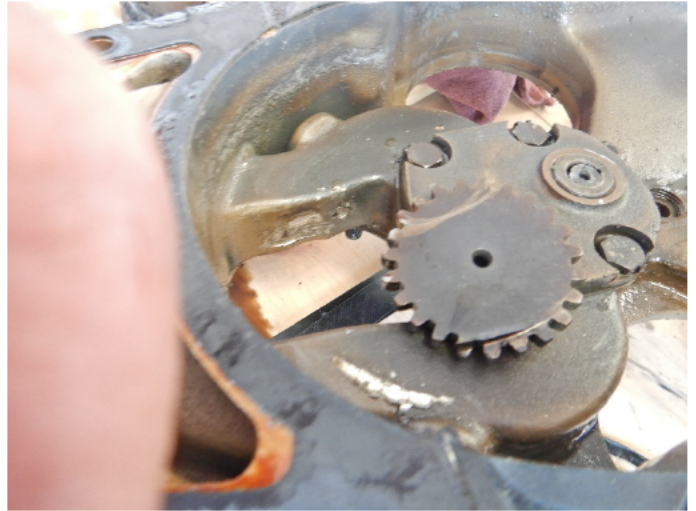
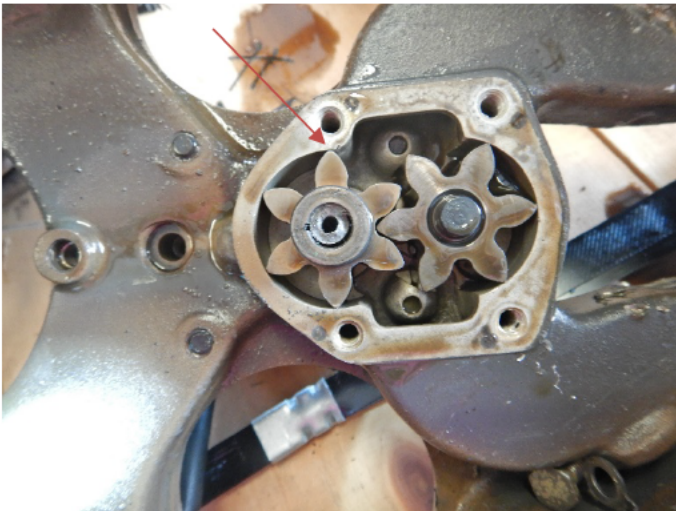
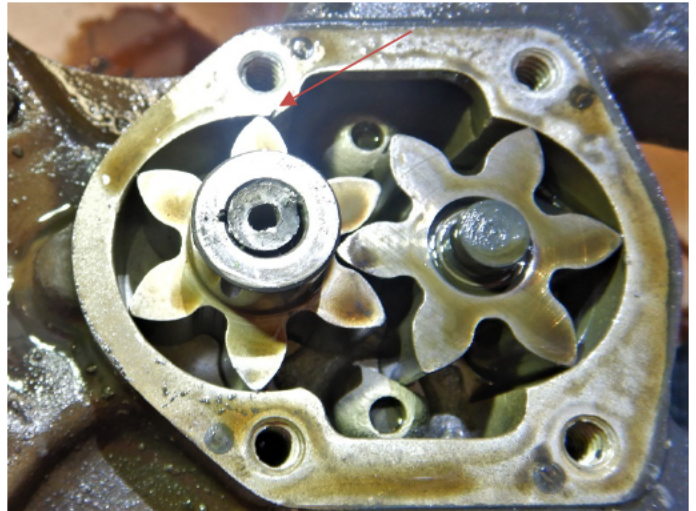
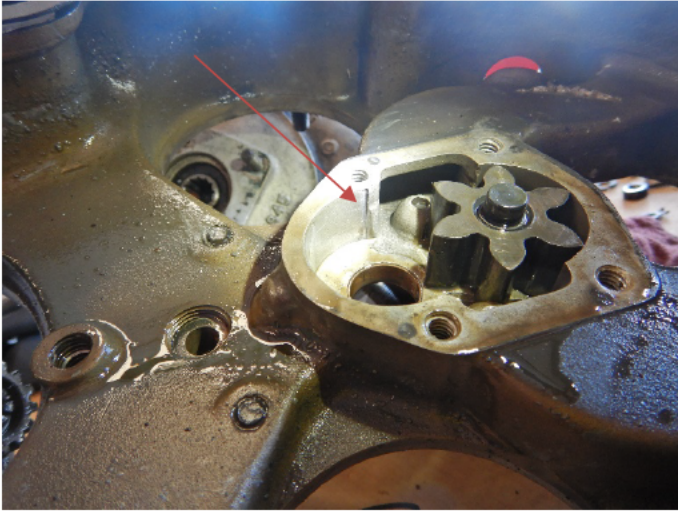
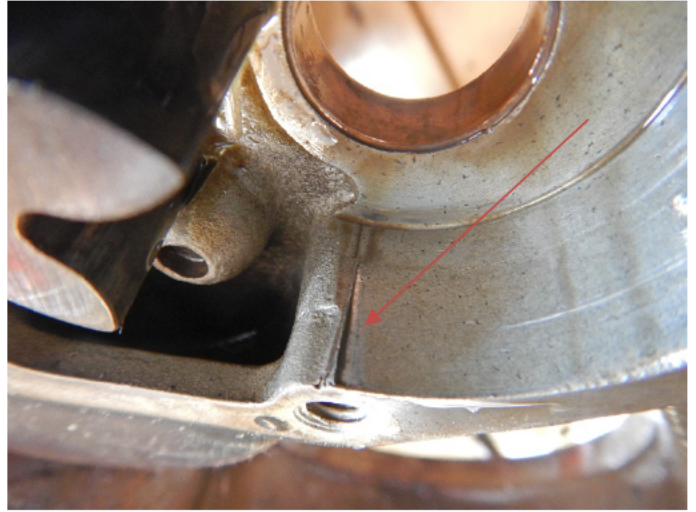
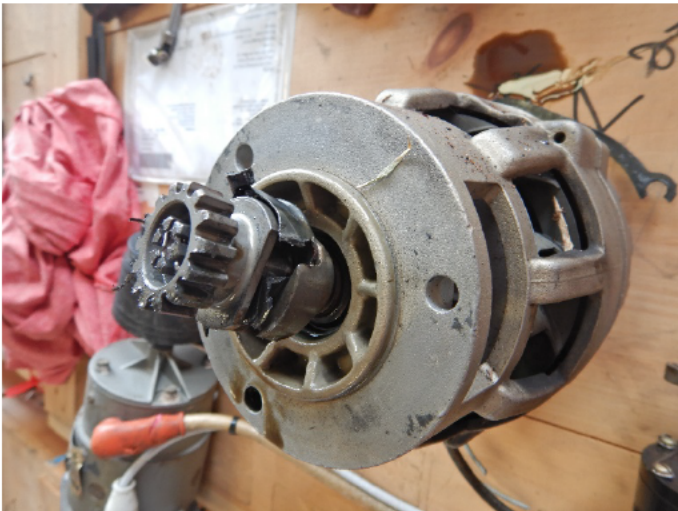
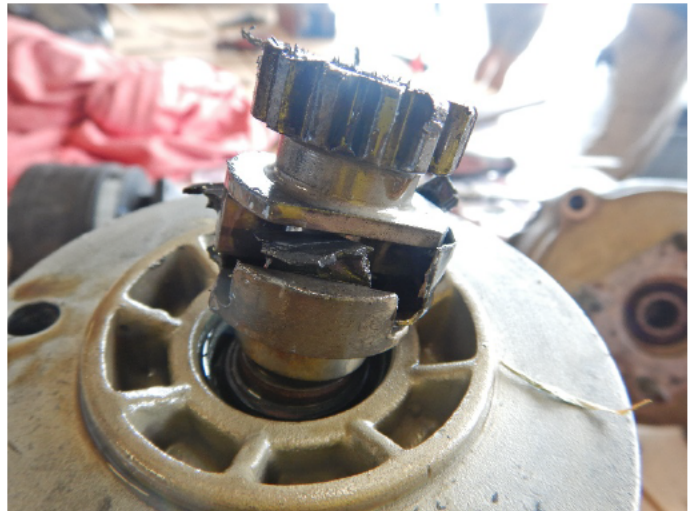
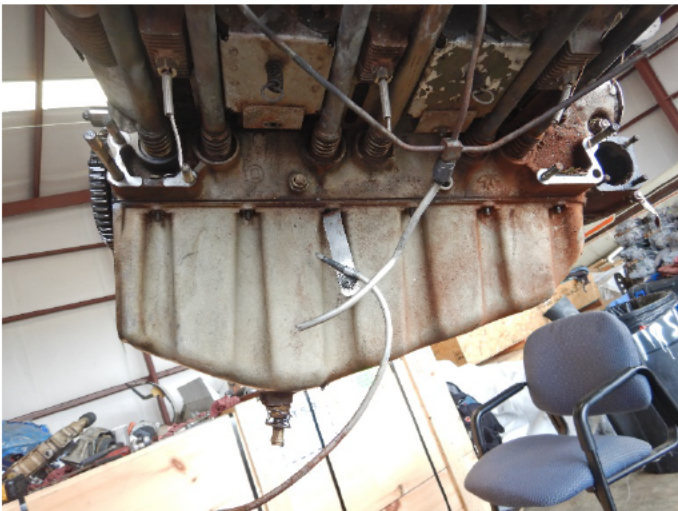
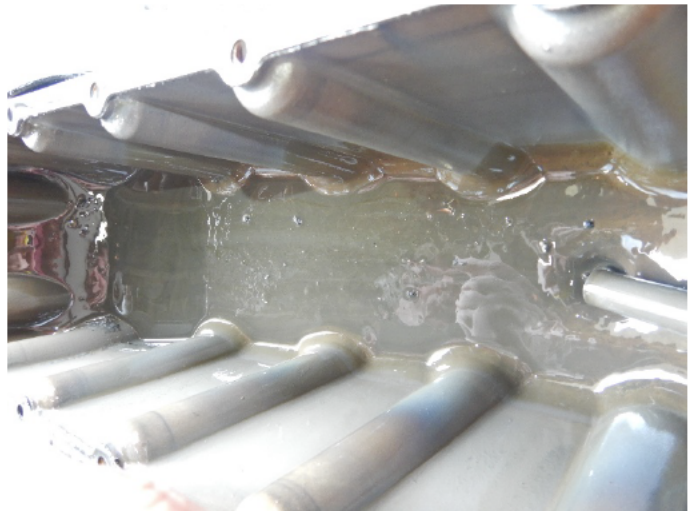
The engine driven alternator was removed, and damage was noted to the drive gear and drive coupling. The separated oil pump drive gear was found lying loose inside the accessory case. The drive gear exhibited shear lips where the shaft had separated from the gear. The accessory case was removed to gain access to the oil pump. The oil pump was disassembled and examined. No hard particle passage was noted. The oil pump gears would only rotate partially. Damage was noted to the pump body blocking the driven oil gear from rotating. See red arrows in the oil pump photos on pages 12 and 13.
