# NATIONAL TRANSPORTATION SAFETY BOARD

## MATERIALS LABORATORY FACTUAL REPORT

Report No. 20-023

Place : North Garden, Virginia  
Date : August 8, 2019  
Vehicle : Cessna R172, N1609V  
NTSB No. : CEN19LA258  
Investigator : Daniel Baker, AS-CEN

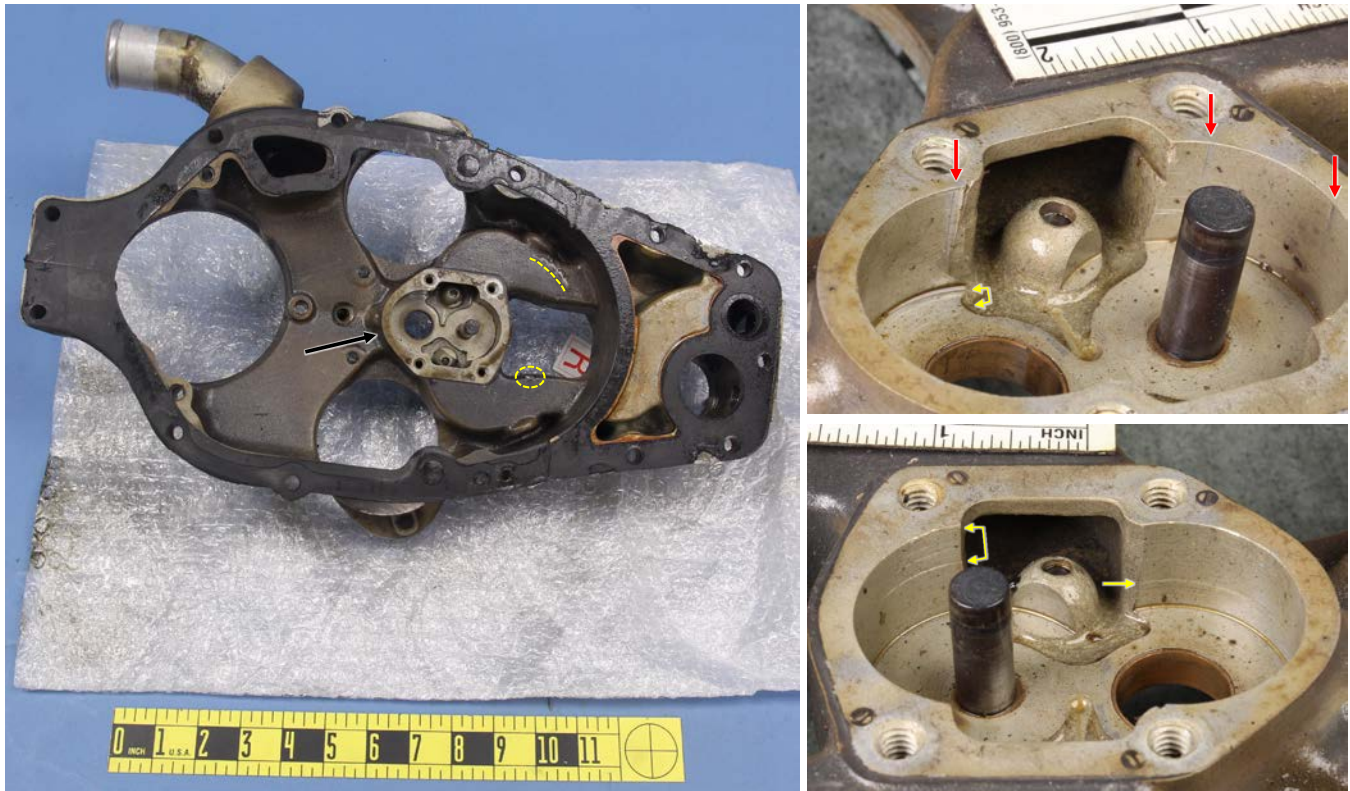
An internal view of the as-received crankcase accessory cover and closer views of the integral oil pump housing, identified by the unlabeled black arrow, are shown in figure 1. The base and sidewalls of the oil pump housing exhibited some evidence of circumferential scars consistent with abrasive wear. Typical examples observed are indicated with yellow arrows. There were also three indentation marks around the housing sidewalls which spanned from the base of the housing to the top of the sidewall, parallel to the gear axes, as indicated by the red arrows. The indentation mark spacing was consistent with the internal gear teeth tip spacing. The internal surface of the accessory cover had areas of local mechanical damage as highlighted by yellow dashed lines.

Figure 1: An internal view of the accessory case cover is shown on the left, the black arrow indicates the oil pump housing location. The yellow dashed lines highlight areas of mechanical damage. Closer views of the oil pump housing are shown on the right. The red arrows indicate indentation marks observed on the housing sidewalls that were consistent with internal gear teeth spacing. Examples of circumferential scars observed on the sidewalls and base of the housing are highlighted with yellow arrows.

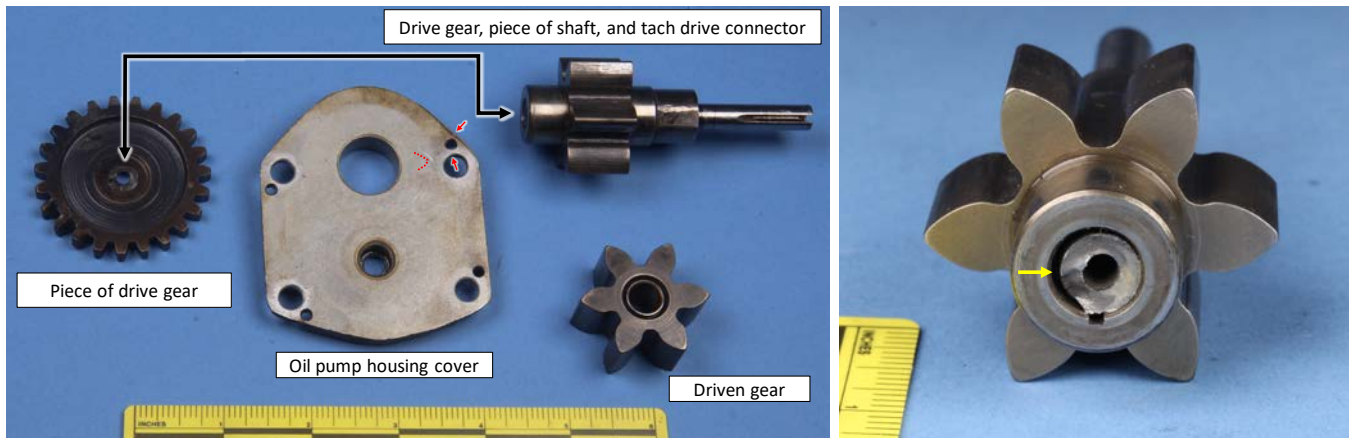
Figure 2 shows a photograph of the other components that were received, including a piece of the oil pump drive gear (23 teeth), the internal oil pump drive gear (6 teeth, with extended hub bosses), the mating shaft piece of the 23 tooth oil pump drive gear (retained in the hub of the 6 tooth drive gear), the internal oil pump driven gear (6 teeth, constant width), the oil pump housing cover, and the tachometer drive connector (attached to the shaft piece of the oil pump drive gear).

The internal surface of the oil pump housing cover exhibited fine circumferential scratches at interface surfaces with the internal gears. There was also one indentation mark on the surface of the drive gear side that matched the profile of a drive gear tooth. Through cracks were evident between the large and small fastener holes and between the small fastener hole and the edge of the part nearest the indentation mark.

The 23-tooth oil pump drive gear was marked "649506" on the flat side<sup>1</sup>. Approximately nine of the teeth exhibited compressive mechanical damage consistent with misalignment and mechanical contact with other components. It was evident this gear was made with an integral shaft portion which extended from the gear hub. The shaft portion separated from the web of the gear near the transition radius in the area indicated by unlabeled black arrows. The shaft portion was retained within the internal drive gear hub and its threads were engaged with the tachometer drive connector. The tachometer drive connector was unfastened from the fractured shaft which was then carefully removed from the gear hub for further evaluation. At the shaft-to-web transition, the shaft diameter was reduced by a machined flat-bottom groove that exhibited a rougher surface finish than the larger diameter bearing surface of the shaft, which was smooth and uniform. The reduced diameter section of the shaft extended approximately 0.15 inches from the radiused shoulder to the fracture surface and exhibited lateral deformation relative to the shaft axis, consistent with a ductile bending or shear fracture mode. The oil pump drive gear fracture surfaces were cleaned using soapy water and a soft bristled brush followed by a water rinse and ultrasonic acetone cleaning prior to further evaluation.

Figure 2: The oil pump gears with tachometer drive connector still attached, and the internal surface of the oil pump housing cover are shown in the photograph on the left. The red dashed line highlights an indentation mark on the cover that matched the tooth profile of the 6-tooth drive gear. Two red arrows indicate the location of through-cracks observed between the fastener holes and edge of part. The black arrow indicates where the drive gear separated from an integral shaft which is designed to pass through the largest hole of the cover. A closer view of the drive gear shaft fracture surface is shown on the right. Lateral deformation of the shaft relative to the gear axis was observed and is represented by the yellow arrow.

<sup>1</sup> Teledyne Continental® Aircraft Engine Critical Service Bulletin, CSB 96-5, issued 11 April 1996 identifies oil pump drive gears with part number 649506 be replaced with the applicable replacement gear at next scheduled maintenance interval, not to exceed 100 hours, on the affected new, rebuilt, and overhaul engine models identified. Also affected are field replacement parts purchased from Teledyne Continental Motors from 27 March 1990 to 1 December 1991.

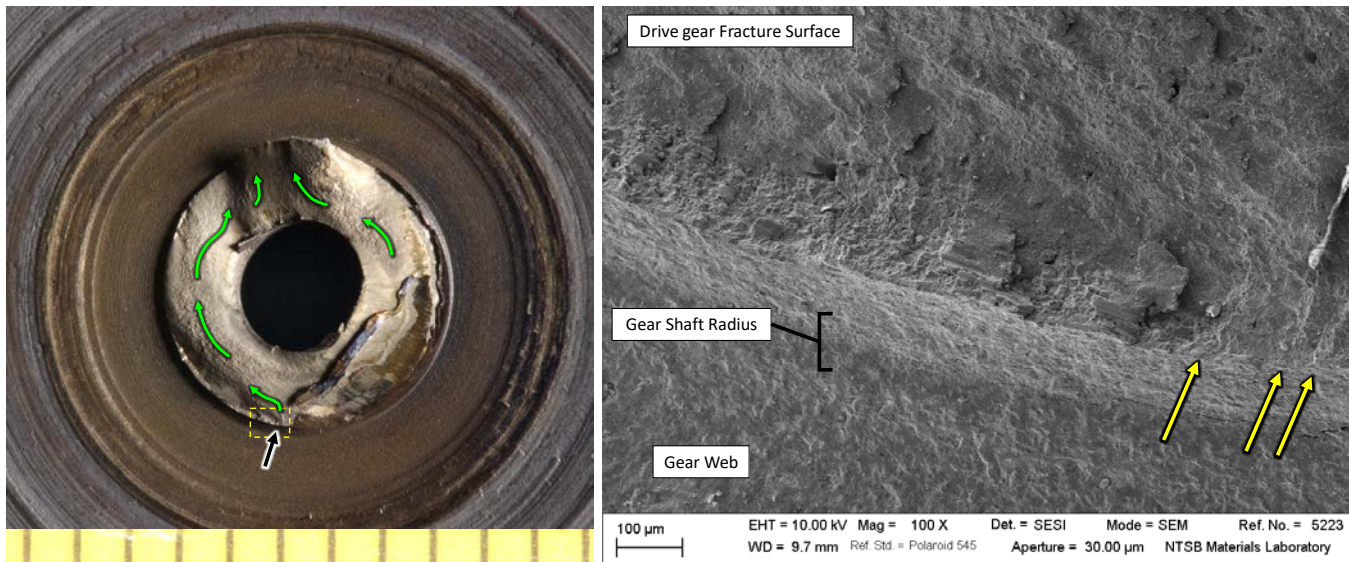
Figure 3 shows a photograph of the gear side of the fracture surface as well as a higher magnification scanning electron microscope (SEM) image of the area highlighted by the yellow box. A circumferential band surrounding the fracture surface was a lighter and shinier shade of brown than the darker brown color of the rest of the part. The outer edge of the band matched the profile of the chamfered hub surface of the internal drive gear. The fracture surface exhibited a relatively flat, dull, and rough surface morphology with a relatively large shear lip feature between the 11 and 1 o'clock positions as oriented in the figure 3 photograph. The shear lip feature spanned between the shaft inner diameter (ID) and outer diameter (OD) and was oriented approximately 45 degrees relative to the gear shaft axis. This shear lip feature was consistent with the location of final separation of a ductile bending (mode I) or shear (mode II) fracture mode. Between the 2 and 6 o'clock positions, there was significant smearing damage over majority of the fracture surface. A flatter and smoother

area of the fracture surface near the OD of the shaft was observed just past the 6 o'clock position and was examined more closely using SEM which revealed radial features emanating perpendicularly from the gear shaft OD near the gear shaft radius. These features resembled ratchet marks<sup>3</sup> and were consistent with multiple fracture origins. Smearing damage over majority of the fracture surface obliterated many of the fine fracture features and no evidence of fatigue striations were found. Some areas of the fracture surface near the shaft OD exhibited intergranular fracture features which were consistent with separation of a case-hardened alloy steel component. Areas examined between the shaft inner and outer diameter that were less obliterated by smearing damage showed microvoid coalescence consistent with monotonic overstress separation.

Figure 3: A photograph of the drive gear fracture surface is shown on the left. Scale markings are 1/16 inches. The area spanning from approximately the 2 to 6 o'clock positions exhibited significant spearing damage, but an apparent origin is highlighted by the black arrow and fracture propagation direction is shown with green arrows. A scanning electron fractograph of the area in the photo identified by the yellow box is shown on the right. Features near the shaft outside diameter that resembled ratchet marks are identified by the yellow arrows and were consistent with multiple fracture origins. Green arrows in the photograph indicate approximate direction of crack propagation which terminated near the 12 o'clock position at a shear lip feature.
