## **Engine Investigation Report**

**Model 250-C20J  
Engine CAE 271024**

**Accident Date: 16 August 2019  
Engine Exam Date: 5 November 2019**

**Omaha Police Department  
Omaha, Nebraska  
N106PD**

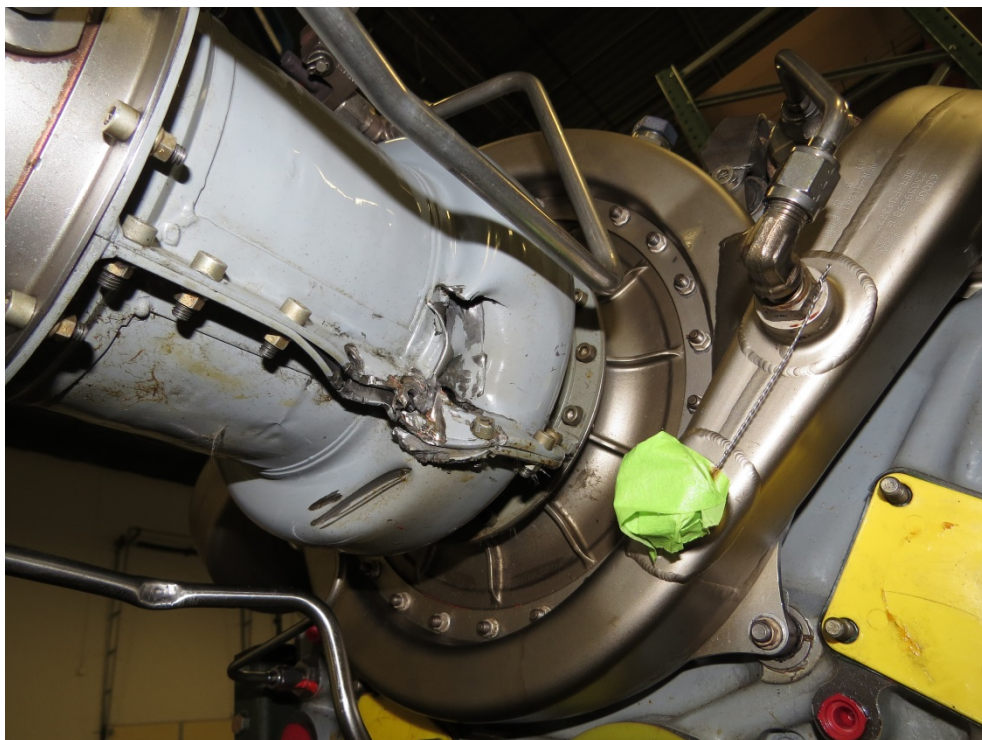
Impact damage was noted on the bottom side of the compressor housing. The damage was consistent with damage typically seen when the engine drive shaft fails while the engine is still running. As the shaft continues to rotate, the liberated end of the drive shaft will flail and strike the underside of the engine's compressor, causing impact damage like that noted on the subject engine.

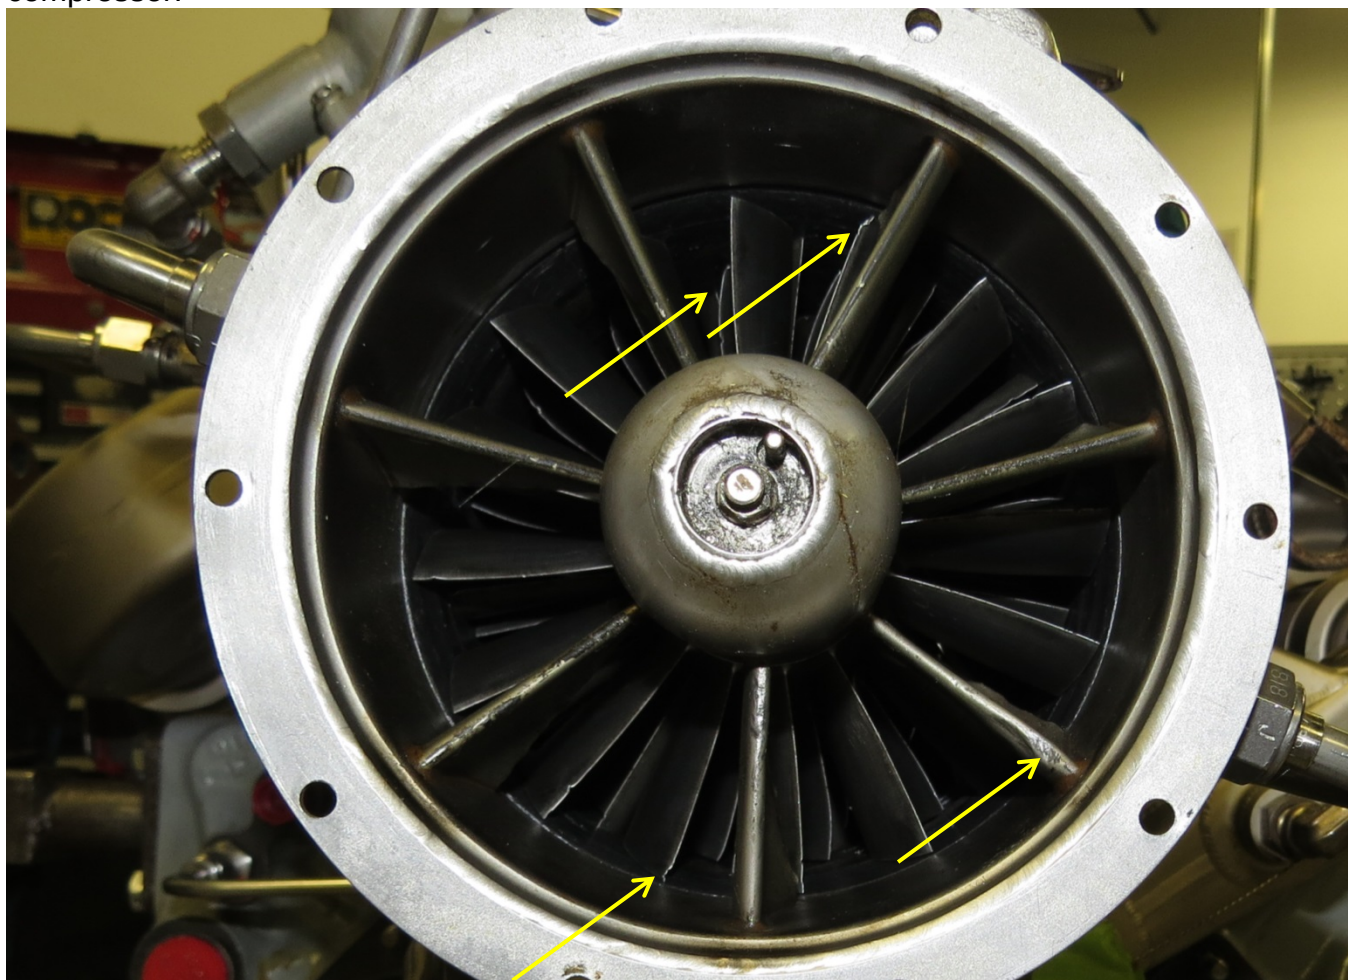
The compressor could be rotated easily by hand. Rotation of the compressor resulted in corresponding rotation of N1 drive pads and the gas-generator turbine. A small hard-body impact mark was noted on a single inlet guide vane. Numerous compressor blades and vanes exhibited hard-body impact and bending in the direction opposite of normal rotation. This damage is typical of that seen when the main drive shaft fails, as noted above. The compressor inlet is exposed to liberated debris from the failed shaft. If the engine continues to run, debris is ingested by the compressor.

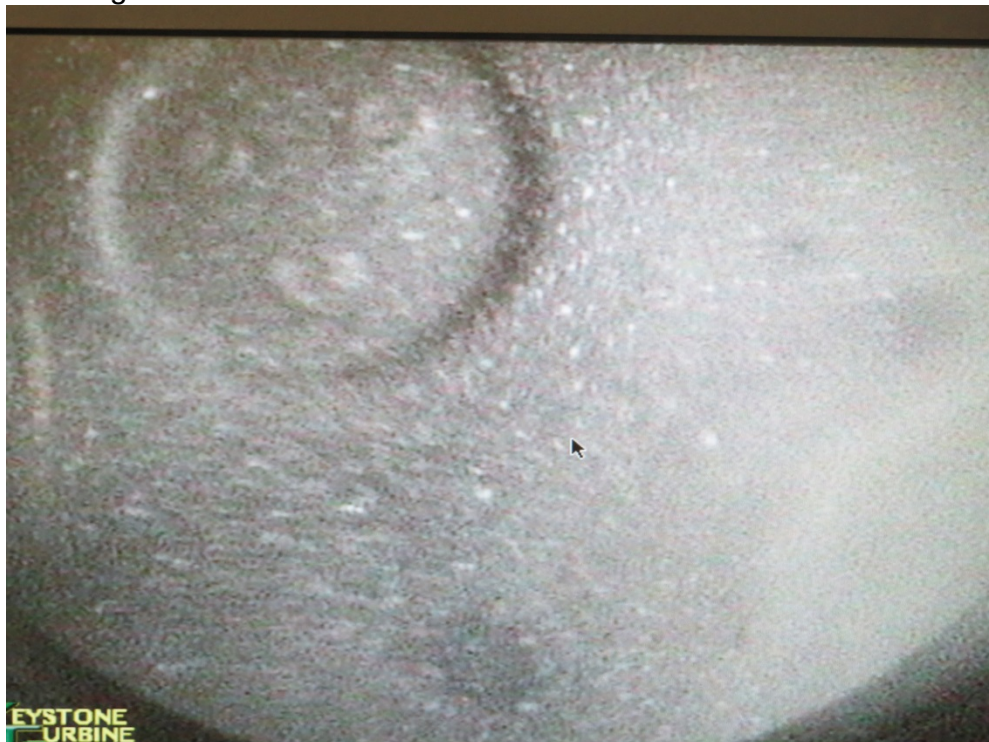
The gas-generator turbine was inspected via a borescope inserted into the fuel spray nozzle port. Inspection revealed no evidence of operational failure or thermal degradation. Bright silver metal splatter was noted throughout the combustion chamber and on the nozzle shield. This splatter is typical of an engine suffering compressor damage while the engine is operating. Small pieces of compressor lining are liberated and carried along the gas path to the combustion chamber, where the heat of combustion melts the metal, which is then deposited throughout the combustion chamber and on the nozzle shield. Several small hard-body impact marks were also noted on the first stage turbine blades.

Metal Splatter on Nozzle Shield.

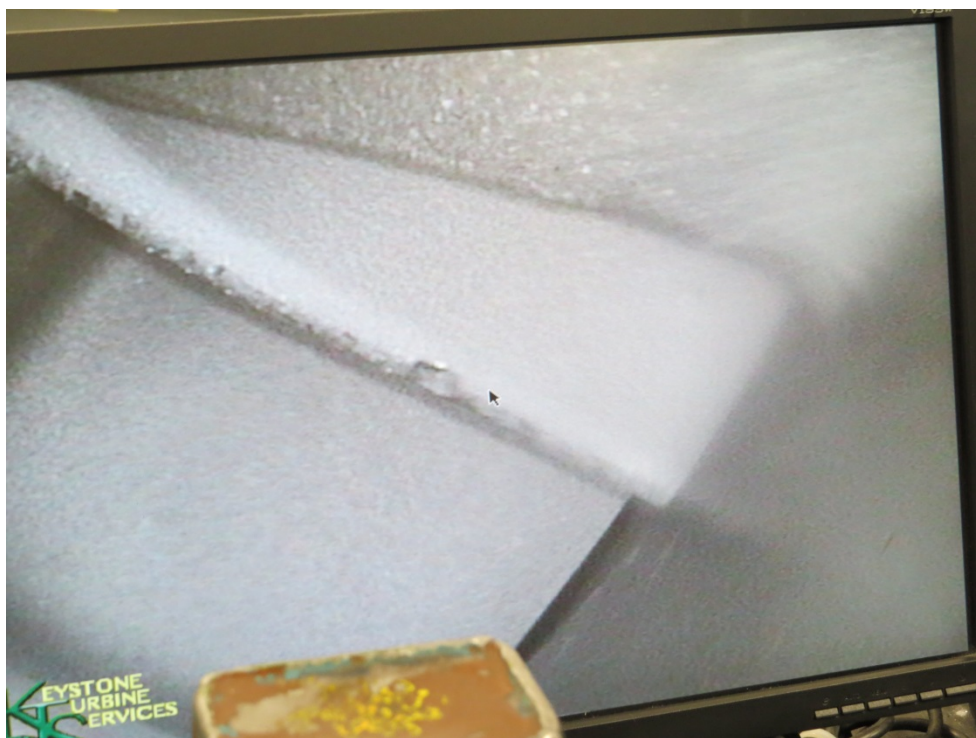
Turbine Blade FOD

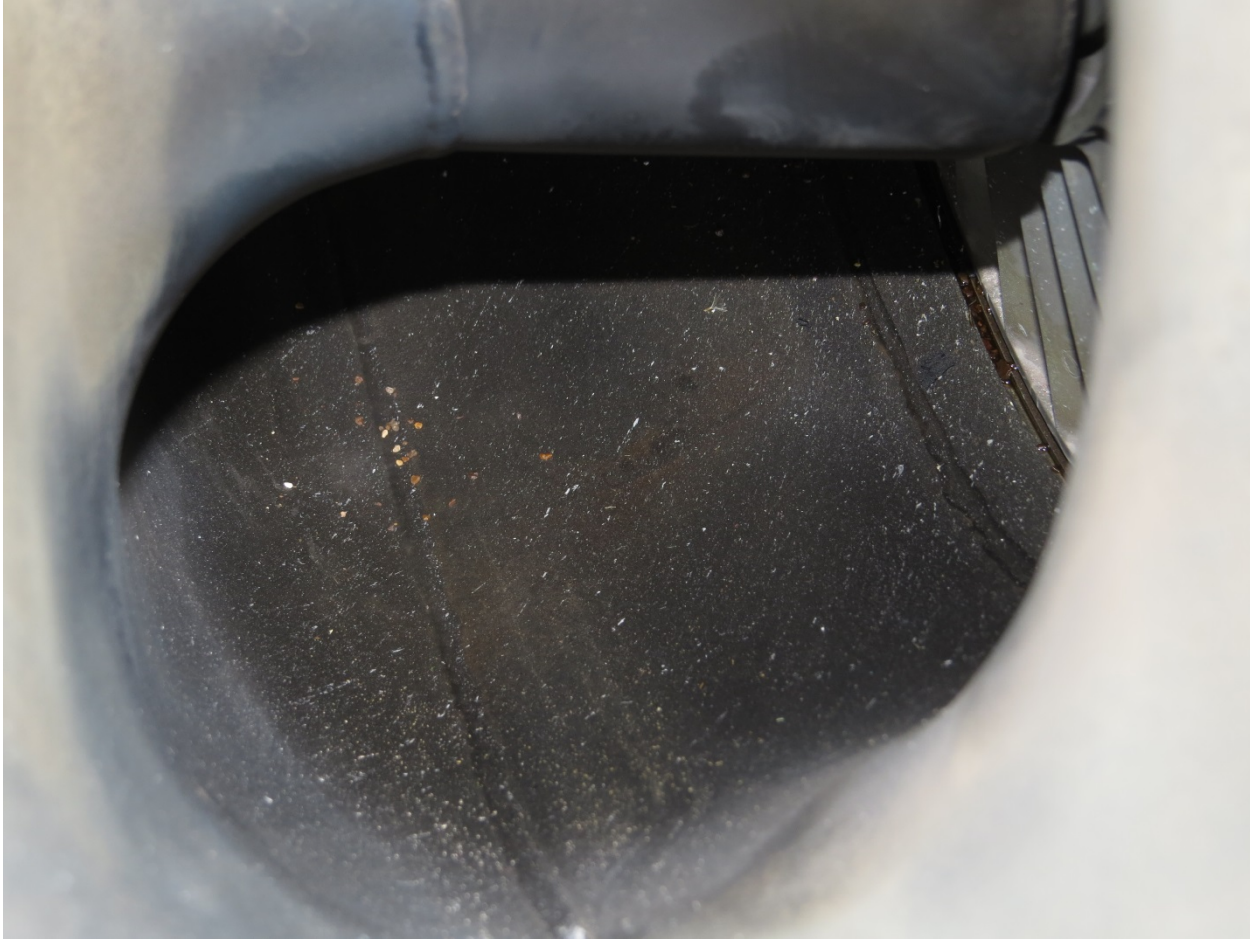
The power turbine could be rotated by hand. Rotation was smooth and resulted in the corresponding rotation of the N2 drive pads and the power output shaft drive. Small metallic debris was found in the exhaust collector, as well as metal splatter similar to that seen in the combustion chamber.

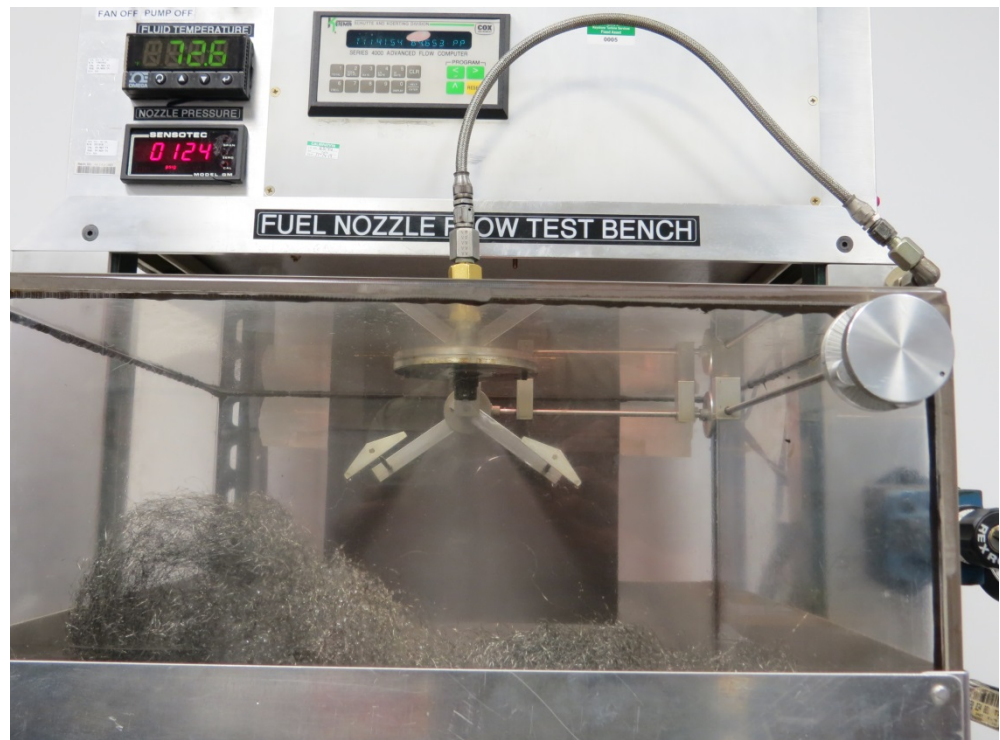
The fuel spray nozzle was removed and bench tested with satisfactory results.

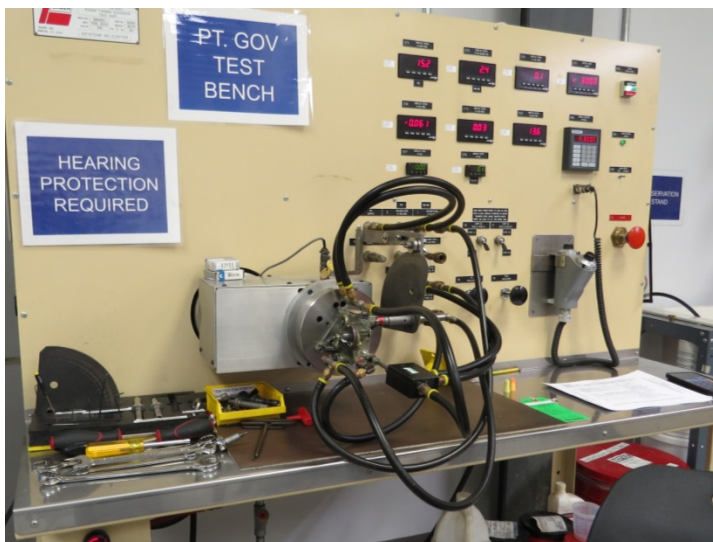
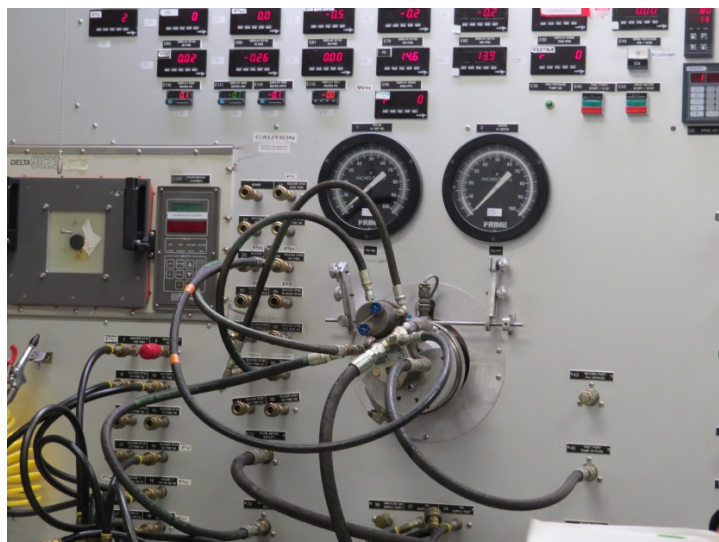
The engine accessories, including the Power Turbine Governor, Fuel Control Unit and Engine-Driven Fuel Pump were bench tested and found to meet operational specifications. The Fuel Pump was disassembled to check for evidence of cavitation or filter blockage; none was found.
