## Air Safety Investigations Aircraft Incident/Accident Technical Report

| Aircraft Incident/<br>Accident Information | Year: 1967 | Make: Beechcraft | Model: V35 |
| | Serial number: D-8581 | | Registration: N6245V |
| Air Safety Investigator: Jennifer D. Barclay | | Report #: ASI-19-CU-T | Report date: 06-23-20 |

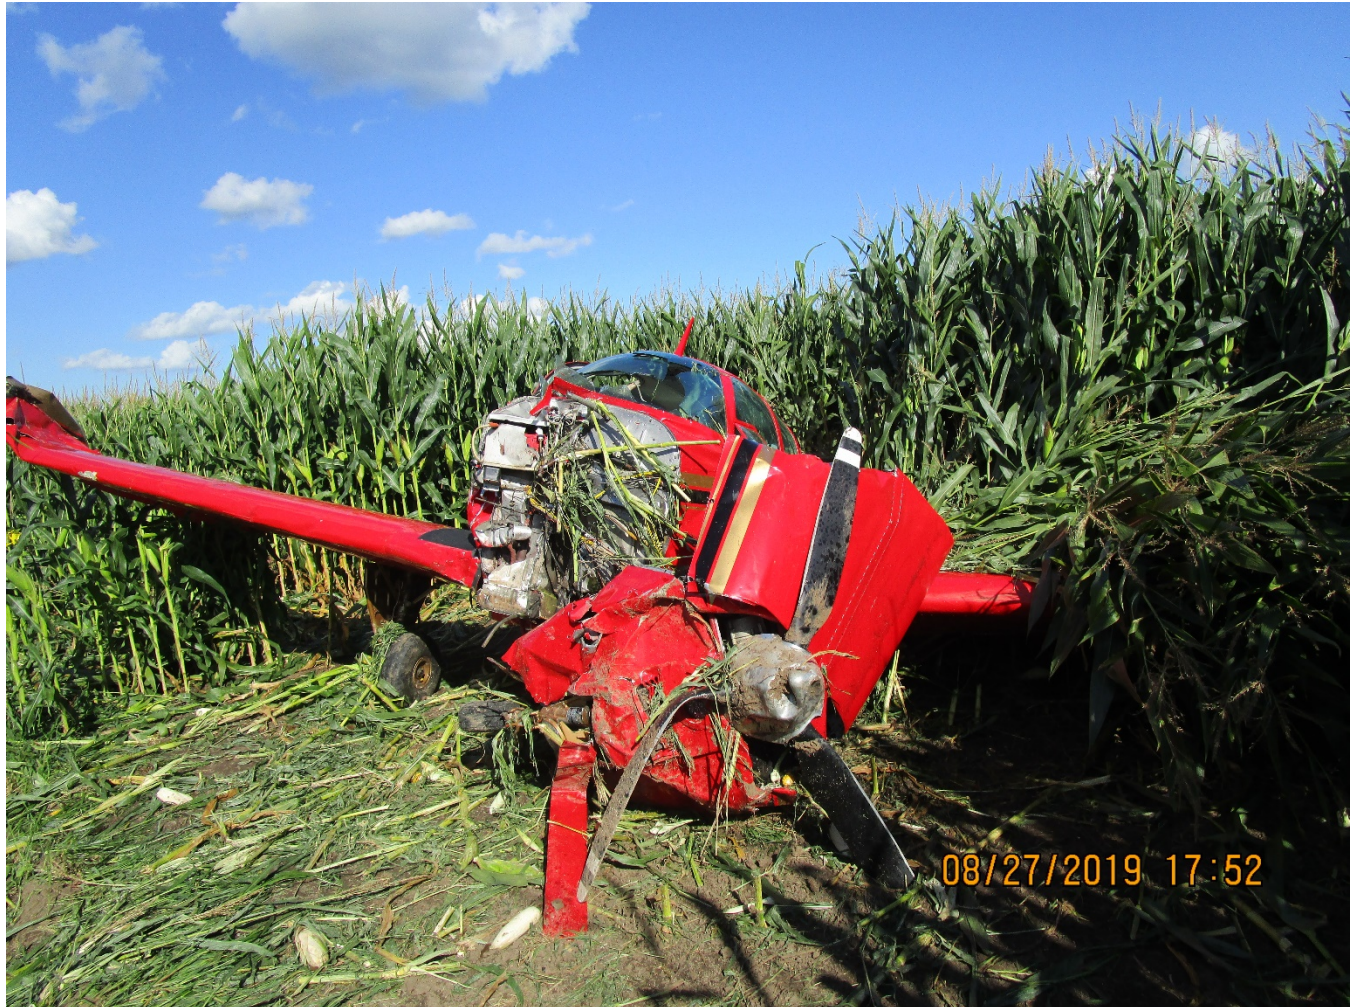
The aircraft impacted a mature cornfield, rotated 180-degrees about the vertical axis and slid backwards before coming to rest. The fuselage remained intact. The right flap was undamaged, the left flap was folded up and forward. Both wingtips sustained impact damage.

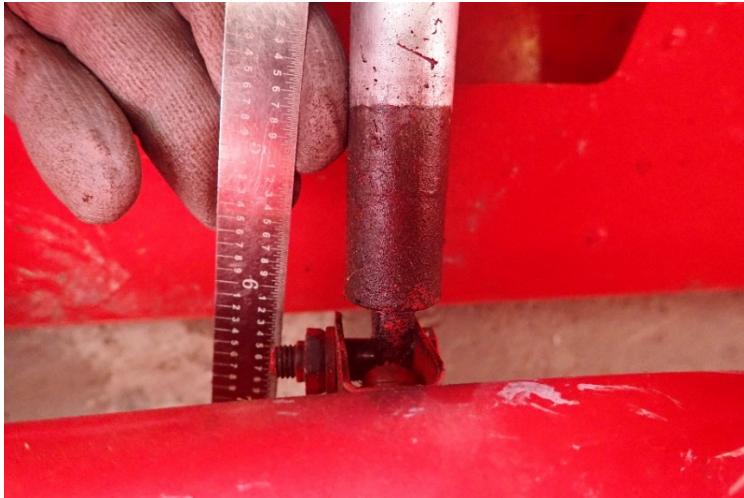
| Flight Control System Information | | |
|---|---|---|
| | Left actuator: 6.6" = outside normal limits | Right actuator: 3.2" ~ between 5-10° |

Recovery personnel stated the flaps were fully extended prior to disassembling the aircraft.

Left flap actuator measurement, ASI-18-CU-081

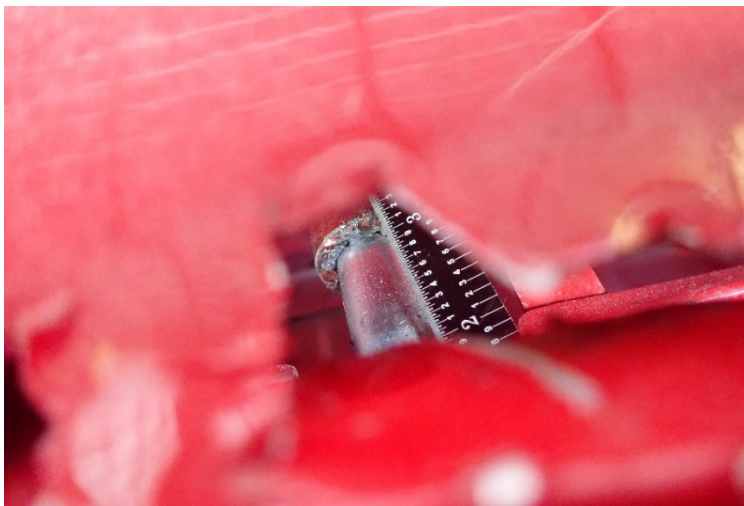
Right flap actuator measurement, ASI-19-CU-075

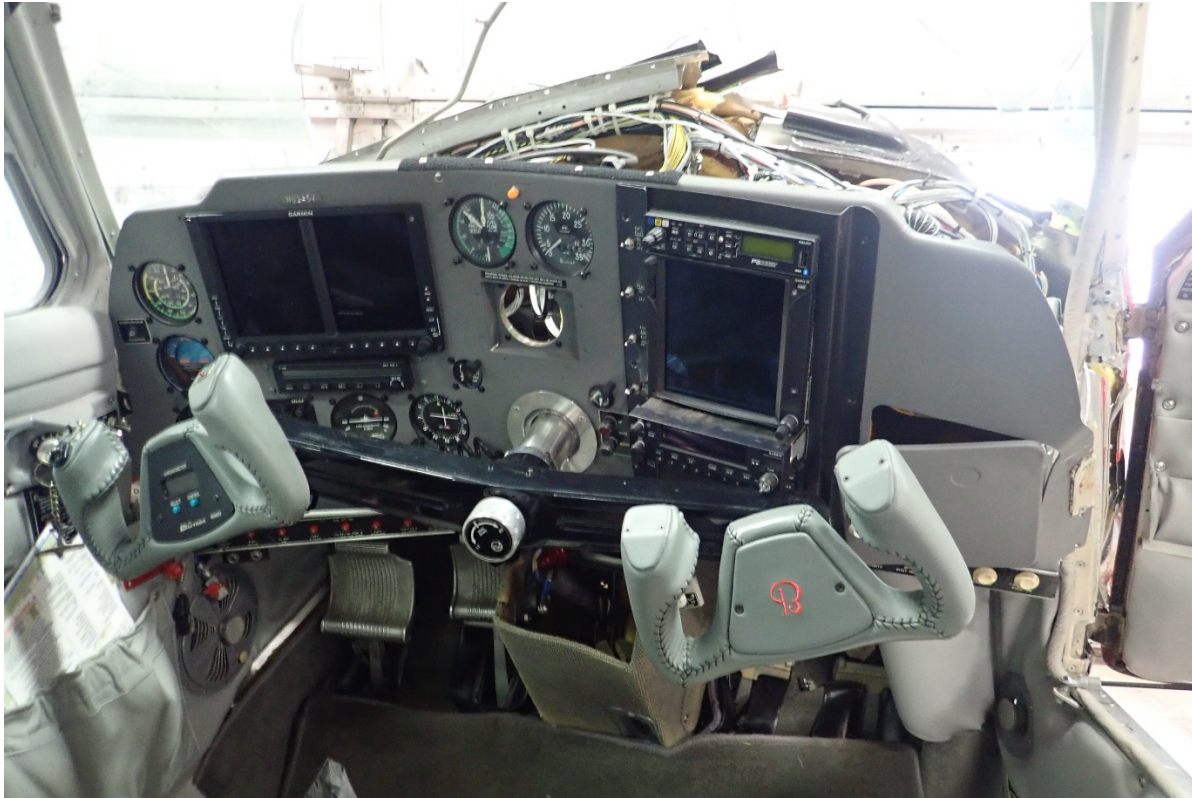
Instrument panel, ASI-19-CU-026

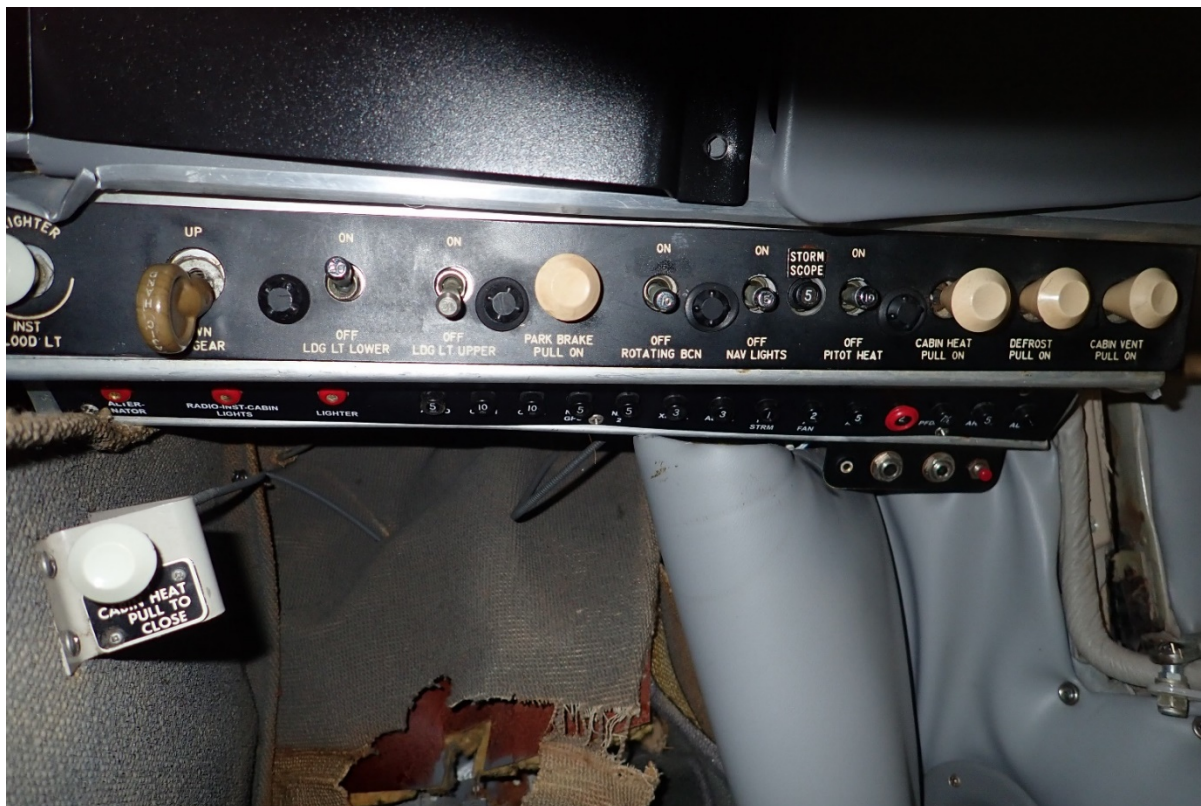
The aircraft was marked with two switches for the landing light, an UPPER and LOWER. The upper switch was in the OFF position; the lower switch was in the ON position.

Switch panel, ASI-19-CU-043

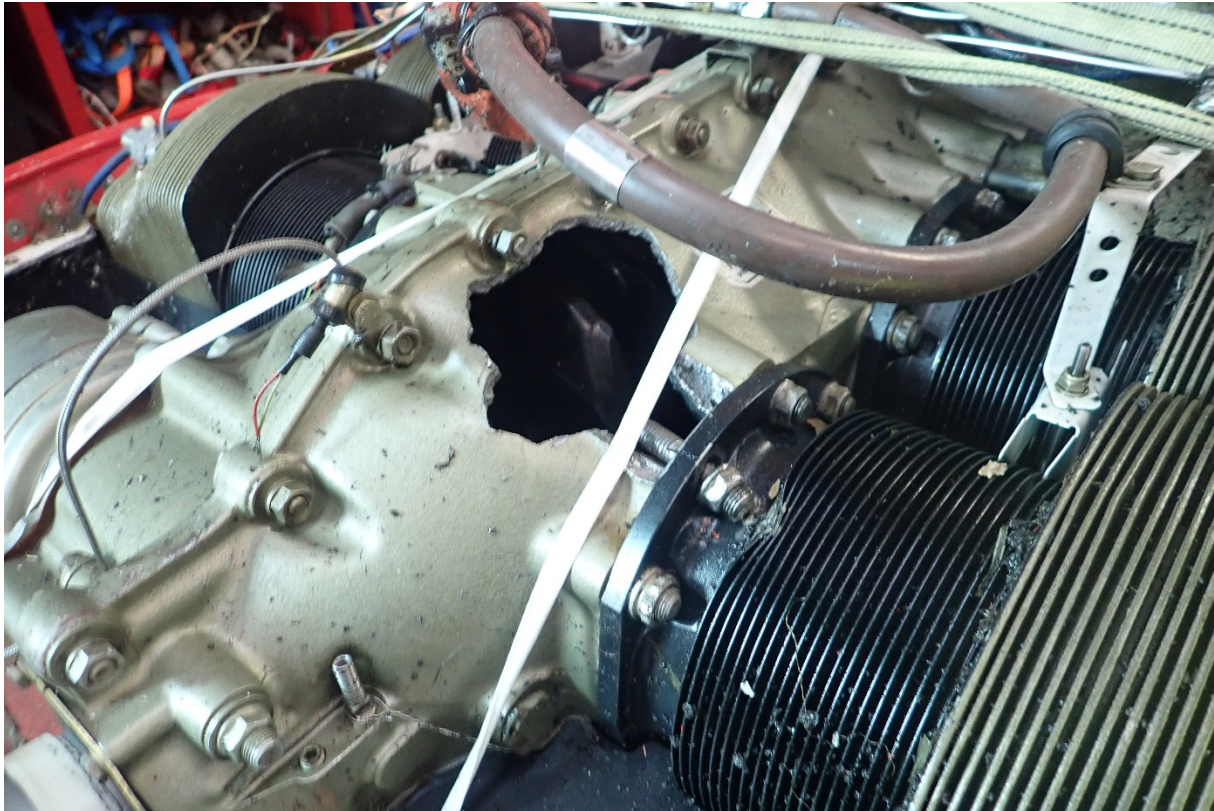
The engine separated from the airframe; it was examined at Continental Aerospace Technologies on 11-19-19. The crankcase had a large hole in it above cylinder 6. Cylinder compression was not attained due to broken connecting rods in cylinders 5 and 6.

Hole in crankcase, ASI-19-CU-093

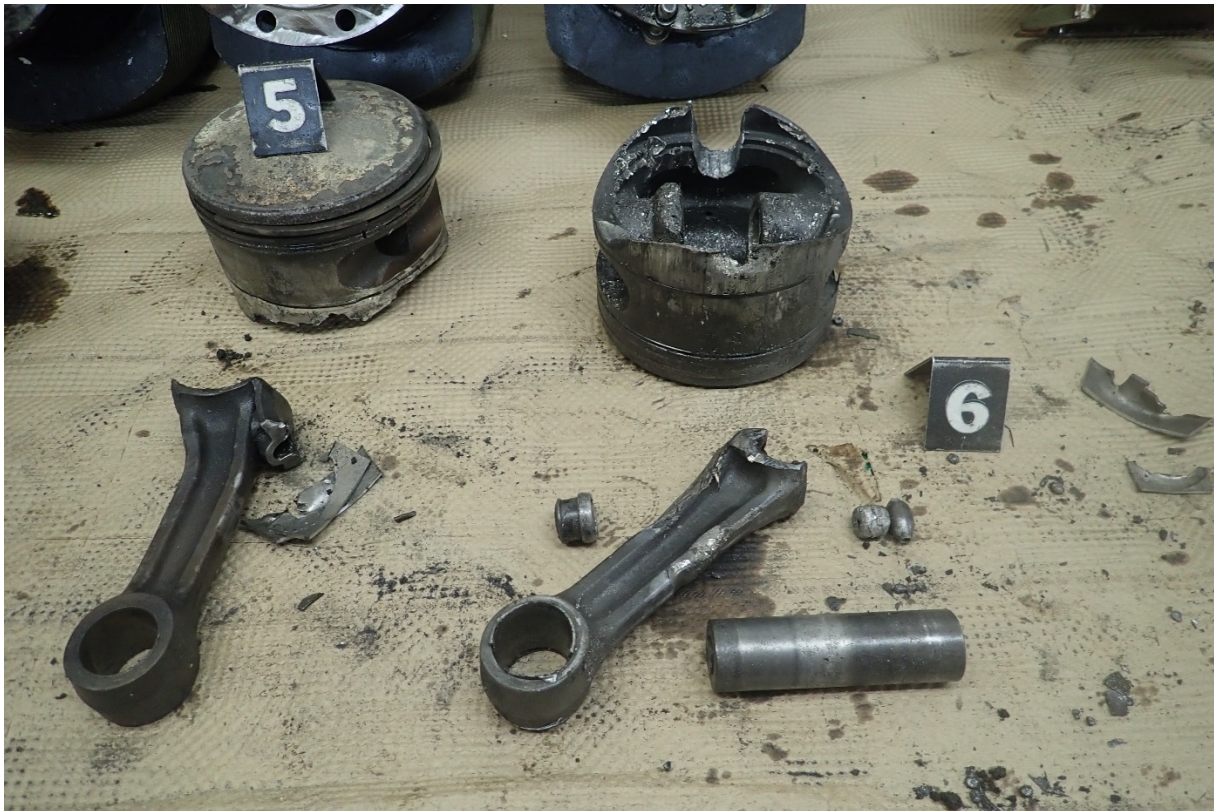
Cylinder 5 & 6 pistons and fractured connecting rods, ASI-19-CU-134

It was determined one of the piston pin plugs in cylinder 6 became loose during engine operation. The piston pin began to move unevenly within the piston pin boss and connecting rod eventually leading to failure of the connecting rod.

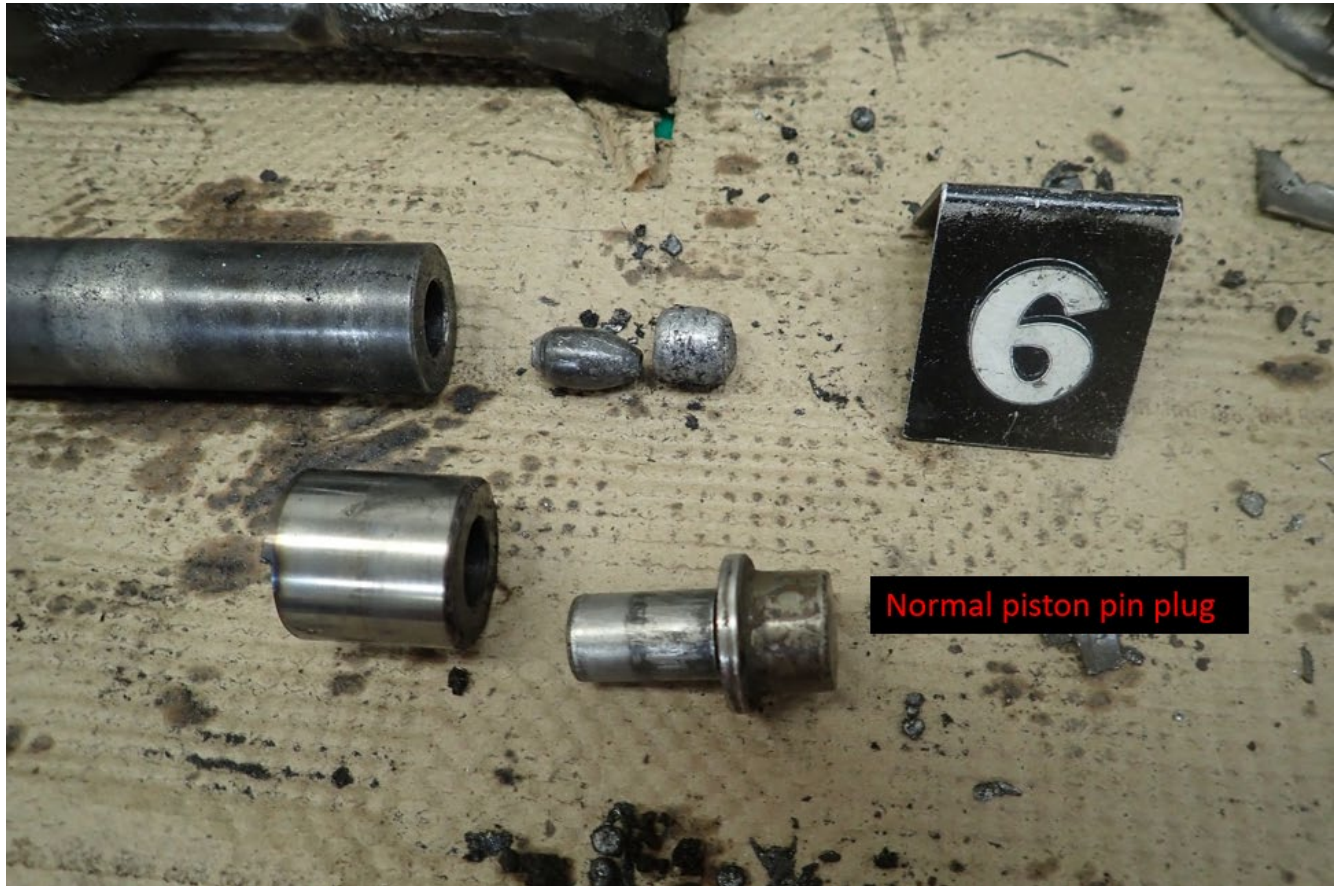
Comparison of piston pin plug from cylinder 6 to a normal plug, ASI-19-CU-136

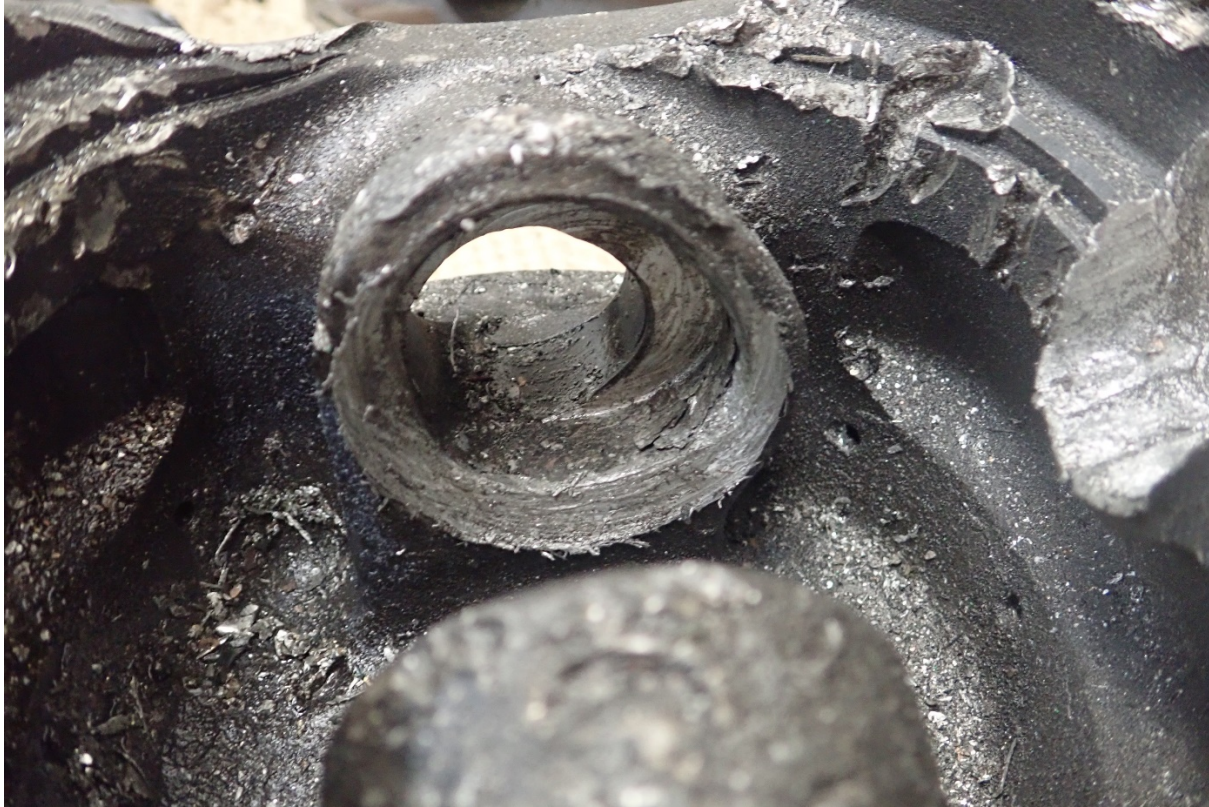
Cylinder 6 piston pin boss, ASI-19-CU-137

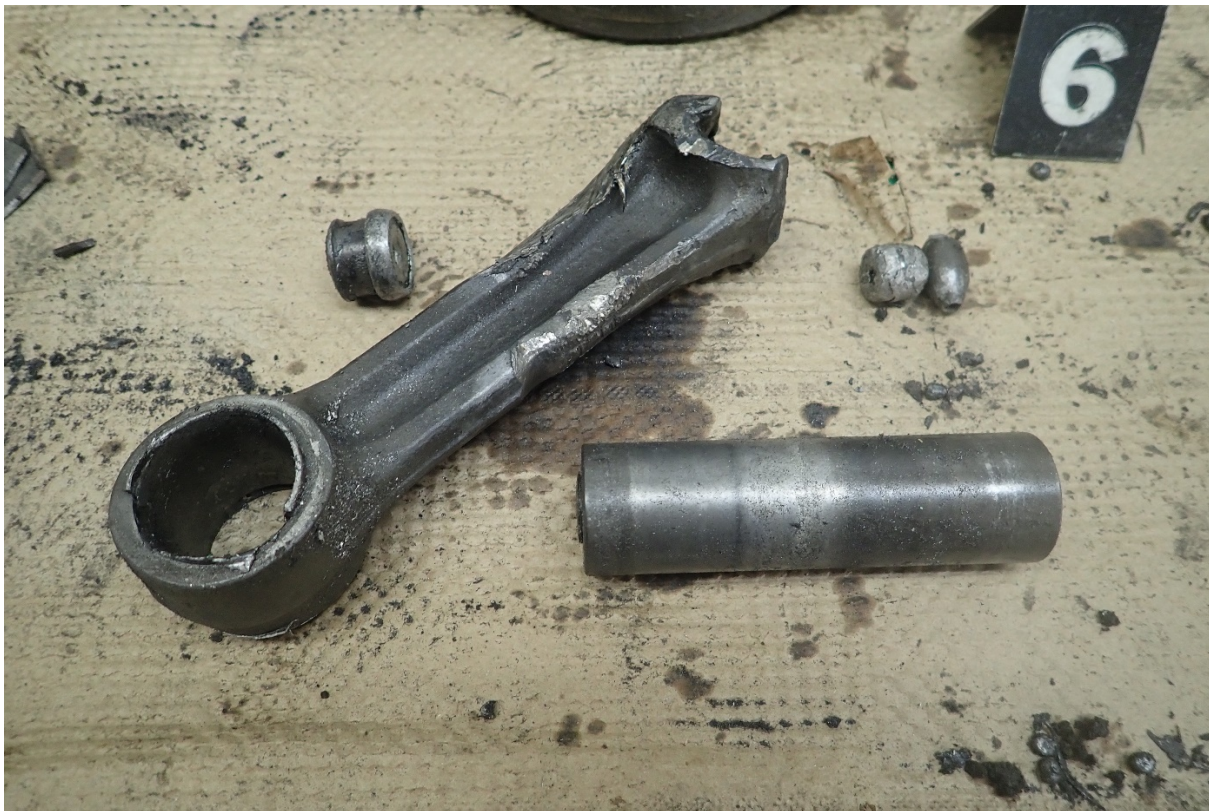
Cylinder 6 connecting rod, piston pin & plug, ASI-19-CU-135

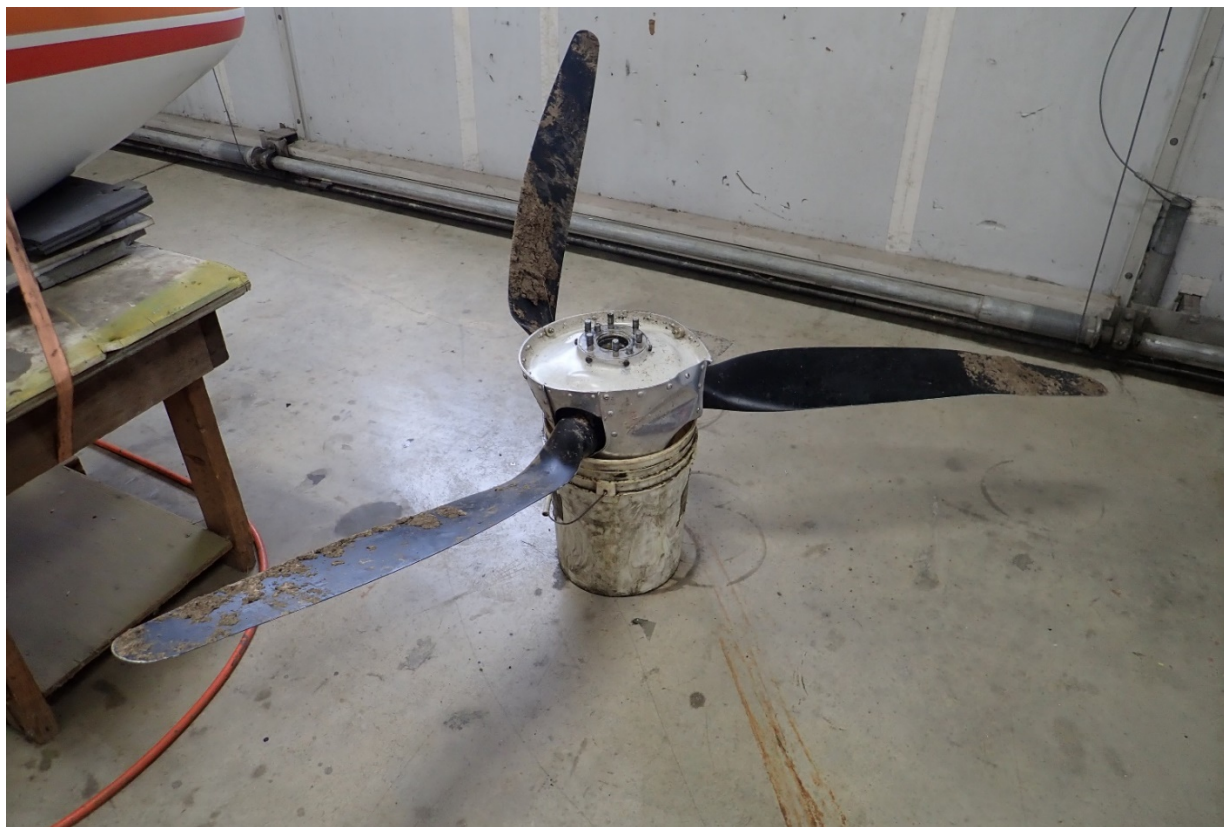
The propeller remained attached to the engine. Blades A & B were bent slightly aft at the root with leading edge polishing. Blade C exhibited a slight S-bend.

Propeller, ASI-19-CU-014
