# NATIONAL TRANSPORTATION SAFETY BOARD

## MATERIALS LABORATORY FACTUAL REPORT

Report No. 20-030

Place : Monroe, WI  
Date : August 27, 2019  
Vehicle : Beech V35 Bonanza, N6245V  
NTSB No. : CEN19LA290  
Investigator : Joshua Lindberg (AS-CEN)

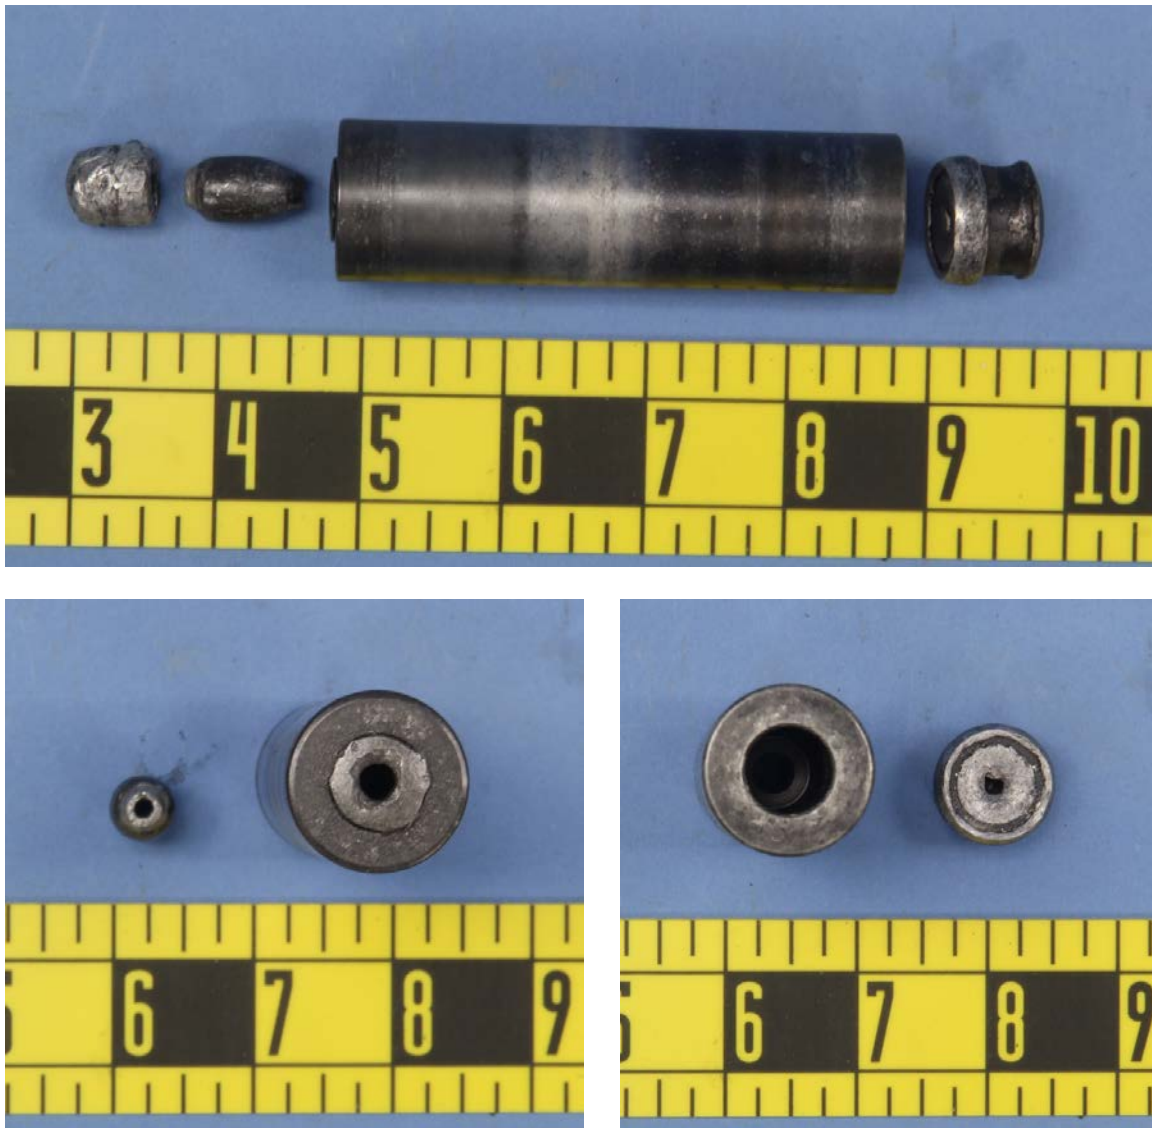
Two piston wrist pins were submitted for examination, an exemplar one that was sectioned and provided for comparison purposes, and one that had fractured. The exemplar wrist pin is shown in Figure 1. The fractured wrist pin is shown in Figure 2.

Figure 2: Overall photos of the fractured wrist pin.

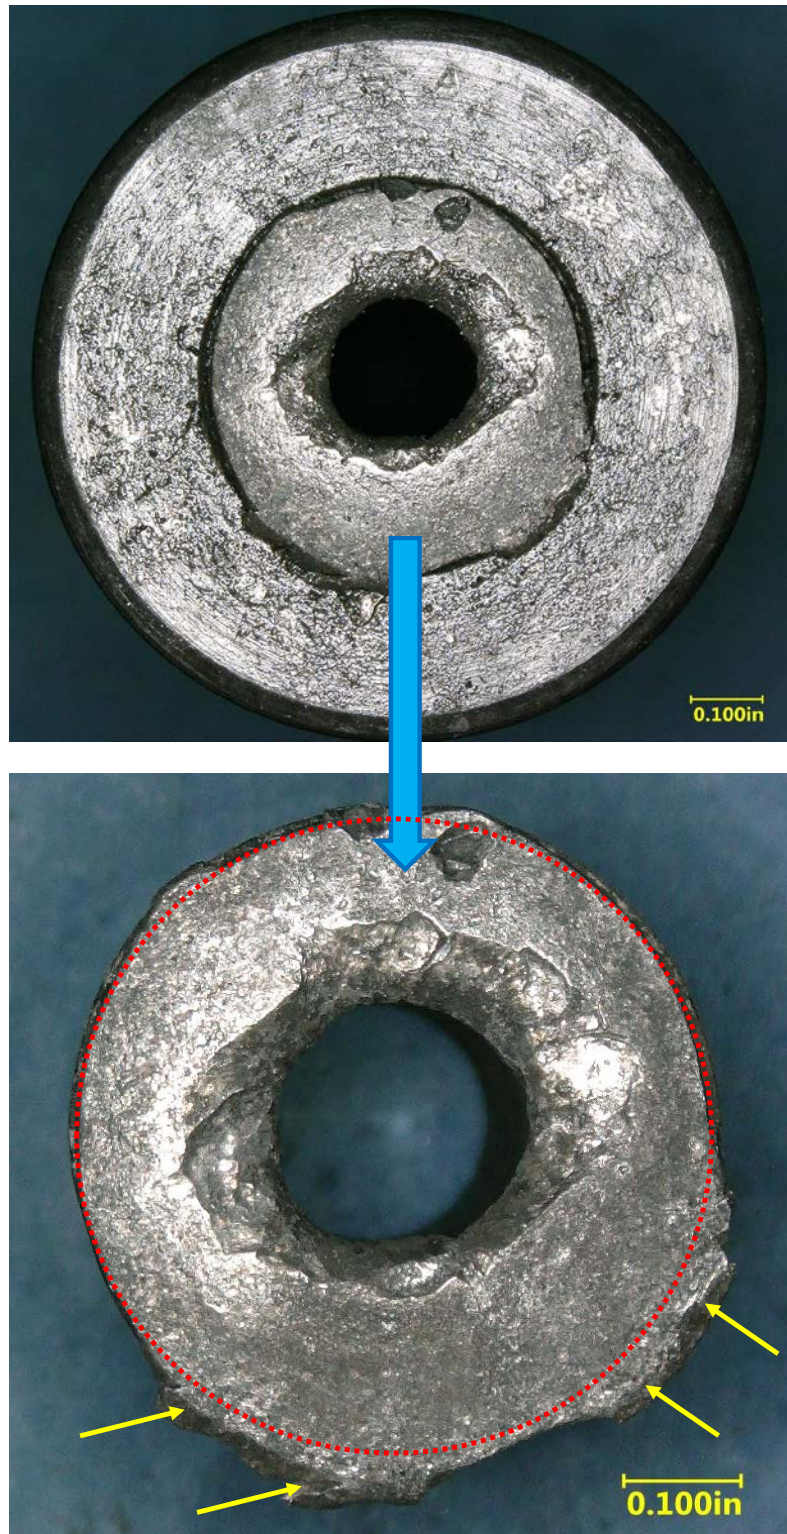
Heavy secondary damage obscured the features on the fracture surfaces of the fractured wrist pin, as shown in Figure 3. Due to the heavy damage, the exact reason for the separation of the pin could not be determined.

Figure 3: Digital microscope images of the fracture surface on the shaft of the fractured wrist pin (top) still assembled to the mating piece and (bottom) after removal and cleaning. The yellow arrows point to a lip of material on the fracture surface. The red dotted line outlines the approximate diameter of the shaft as manufactured.

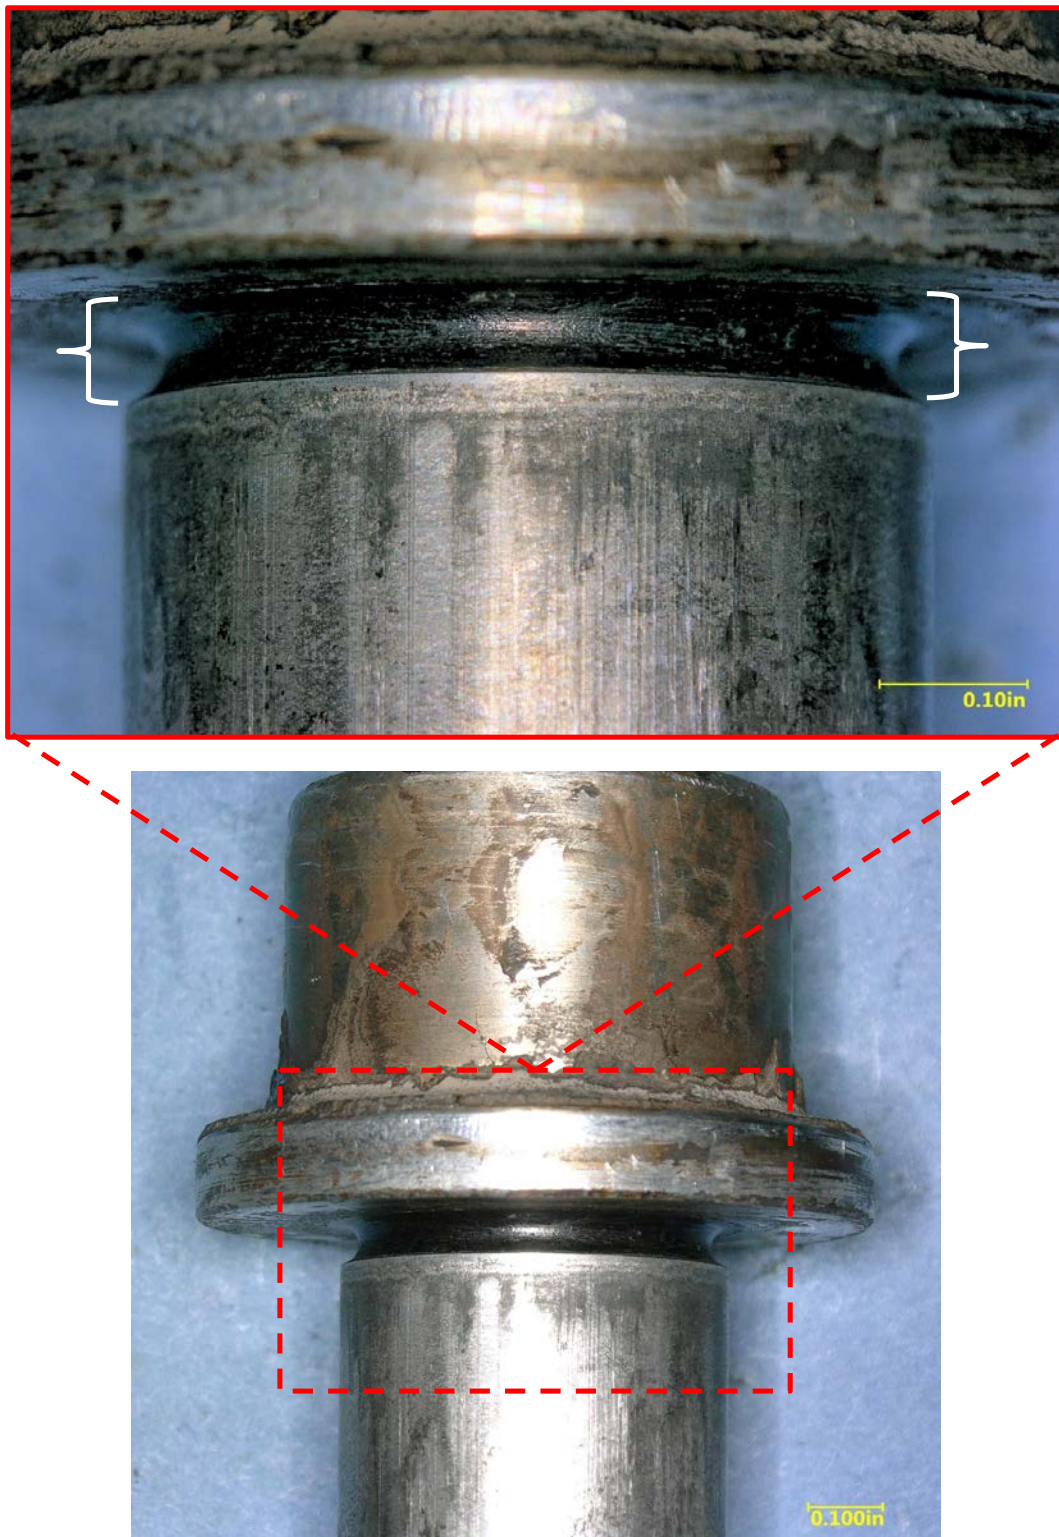
A comparison of the two pins revealed the fractured wrist pin had separated at the shear section between the head and the shaft. The shear section on the exemplar wrist pin is indicated by the white brackets in Figure 4. Figure 5 shows the profile view of the fractured wrist pin. The yellow arrows point to a lip of material that had been pushed over the side of the pin following separation. Yellow arrows in Figure 3 point to the lip of material as seen on the fracture surface. The red dotted line in Figure 3 outlines the approximate diameter of the shaft as manufactured and highlights the movement of the lip of material.

Figure 4: Digital microscope images of the exemplar wrist pin. The white brackets indicate the shear section between the head and the shaft of the pin.

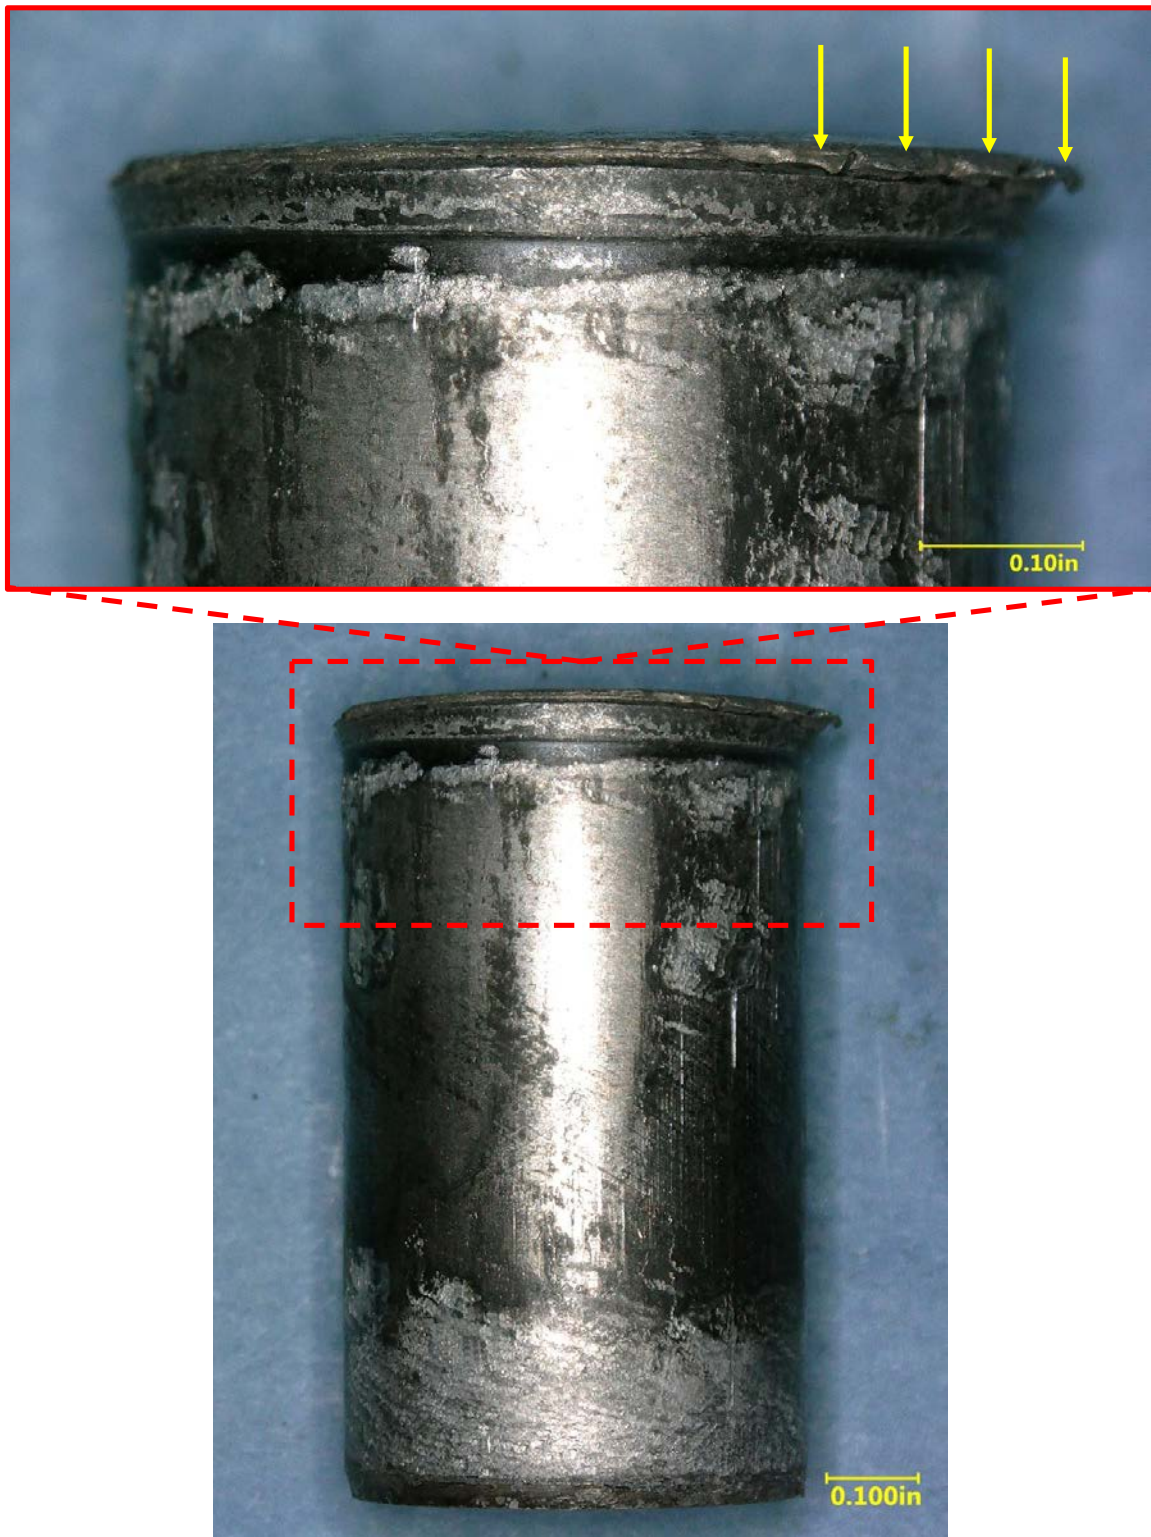
Figure 5: Digital microscope images showing the profile view of the fractured wrist pin. The yellow arrows point to a lip of material that had been pushed over the side of the pin.
