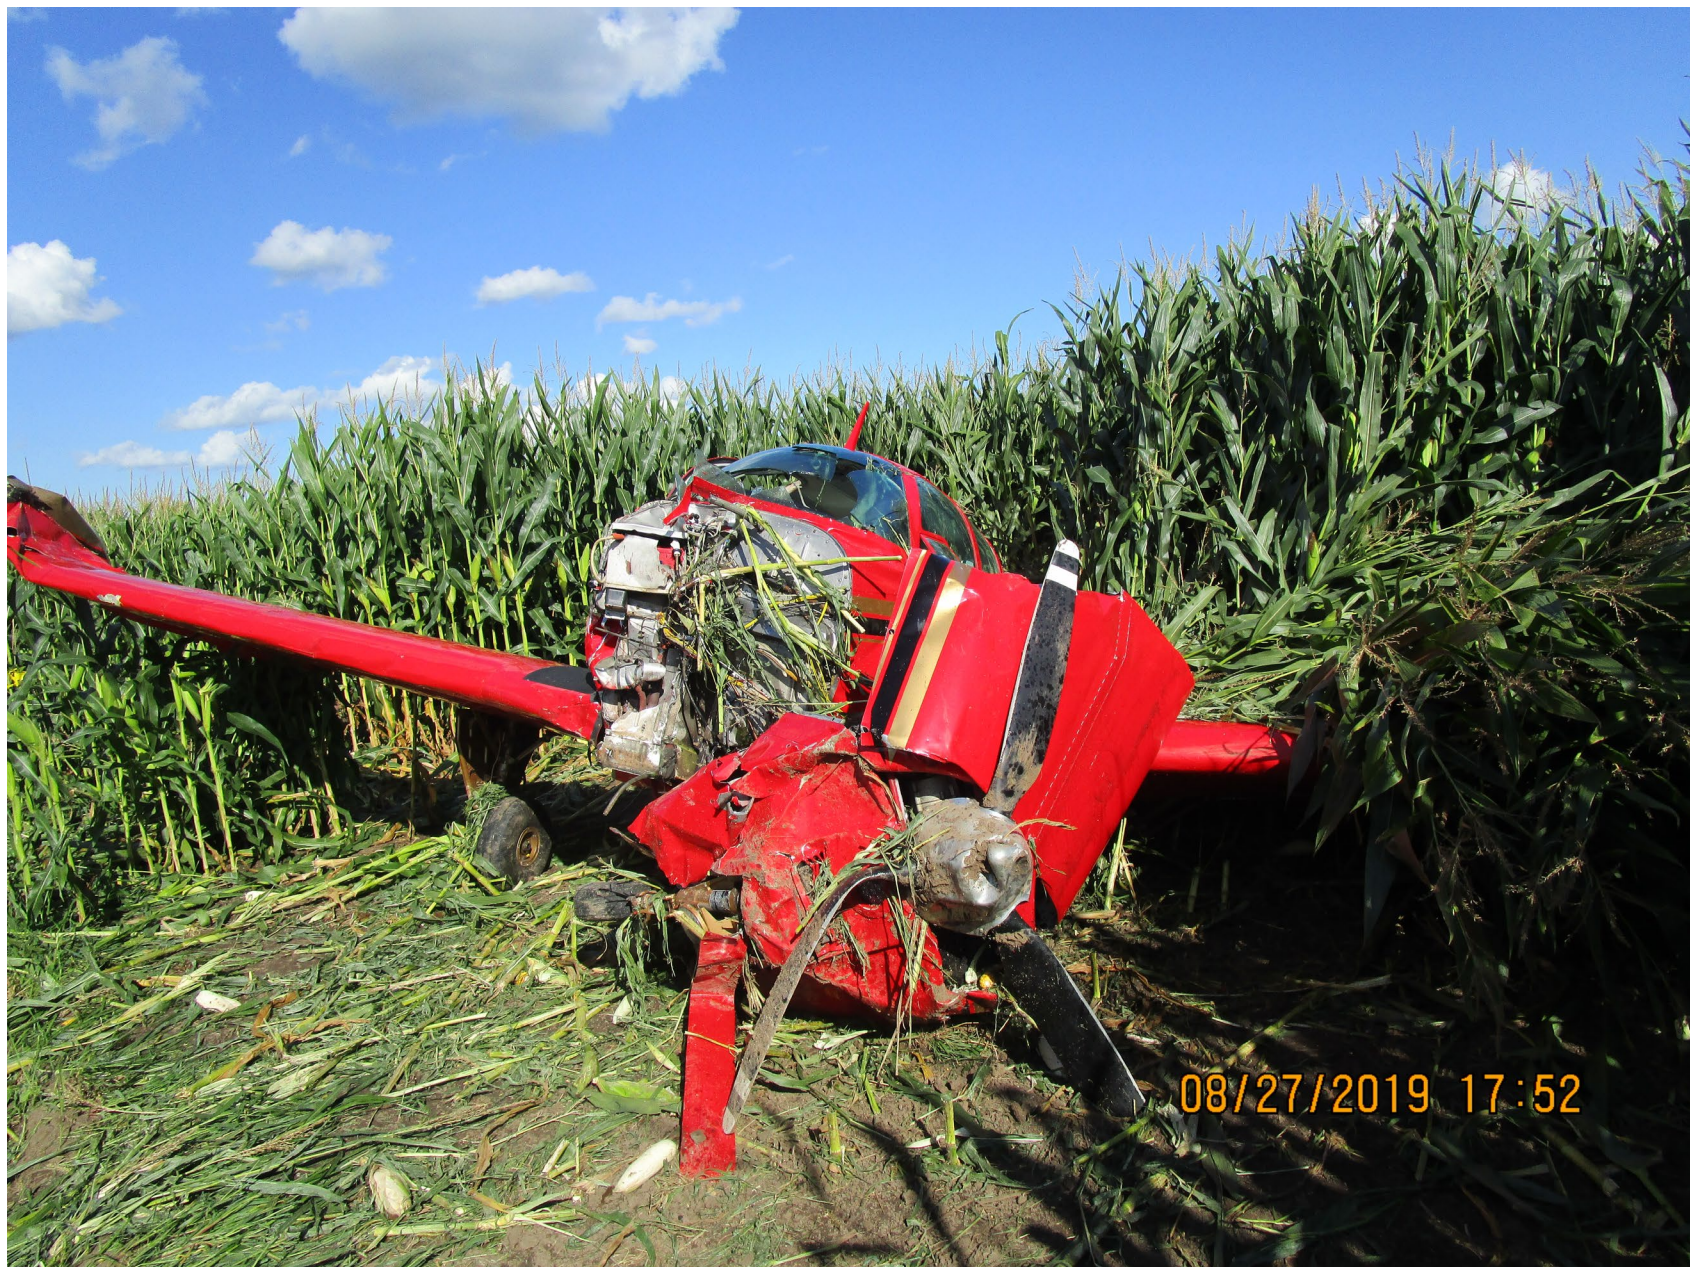
**Photo 3 – Front of airplane on scene**

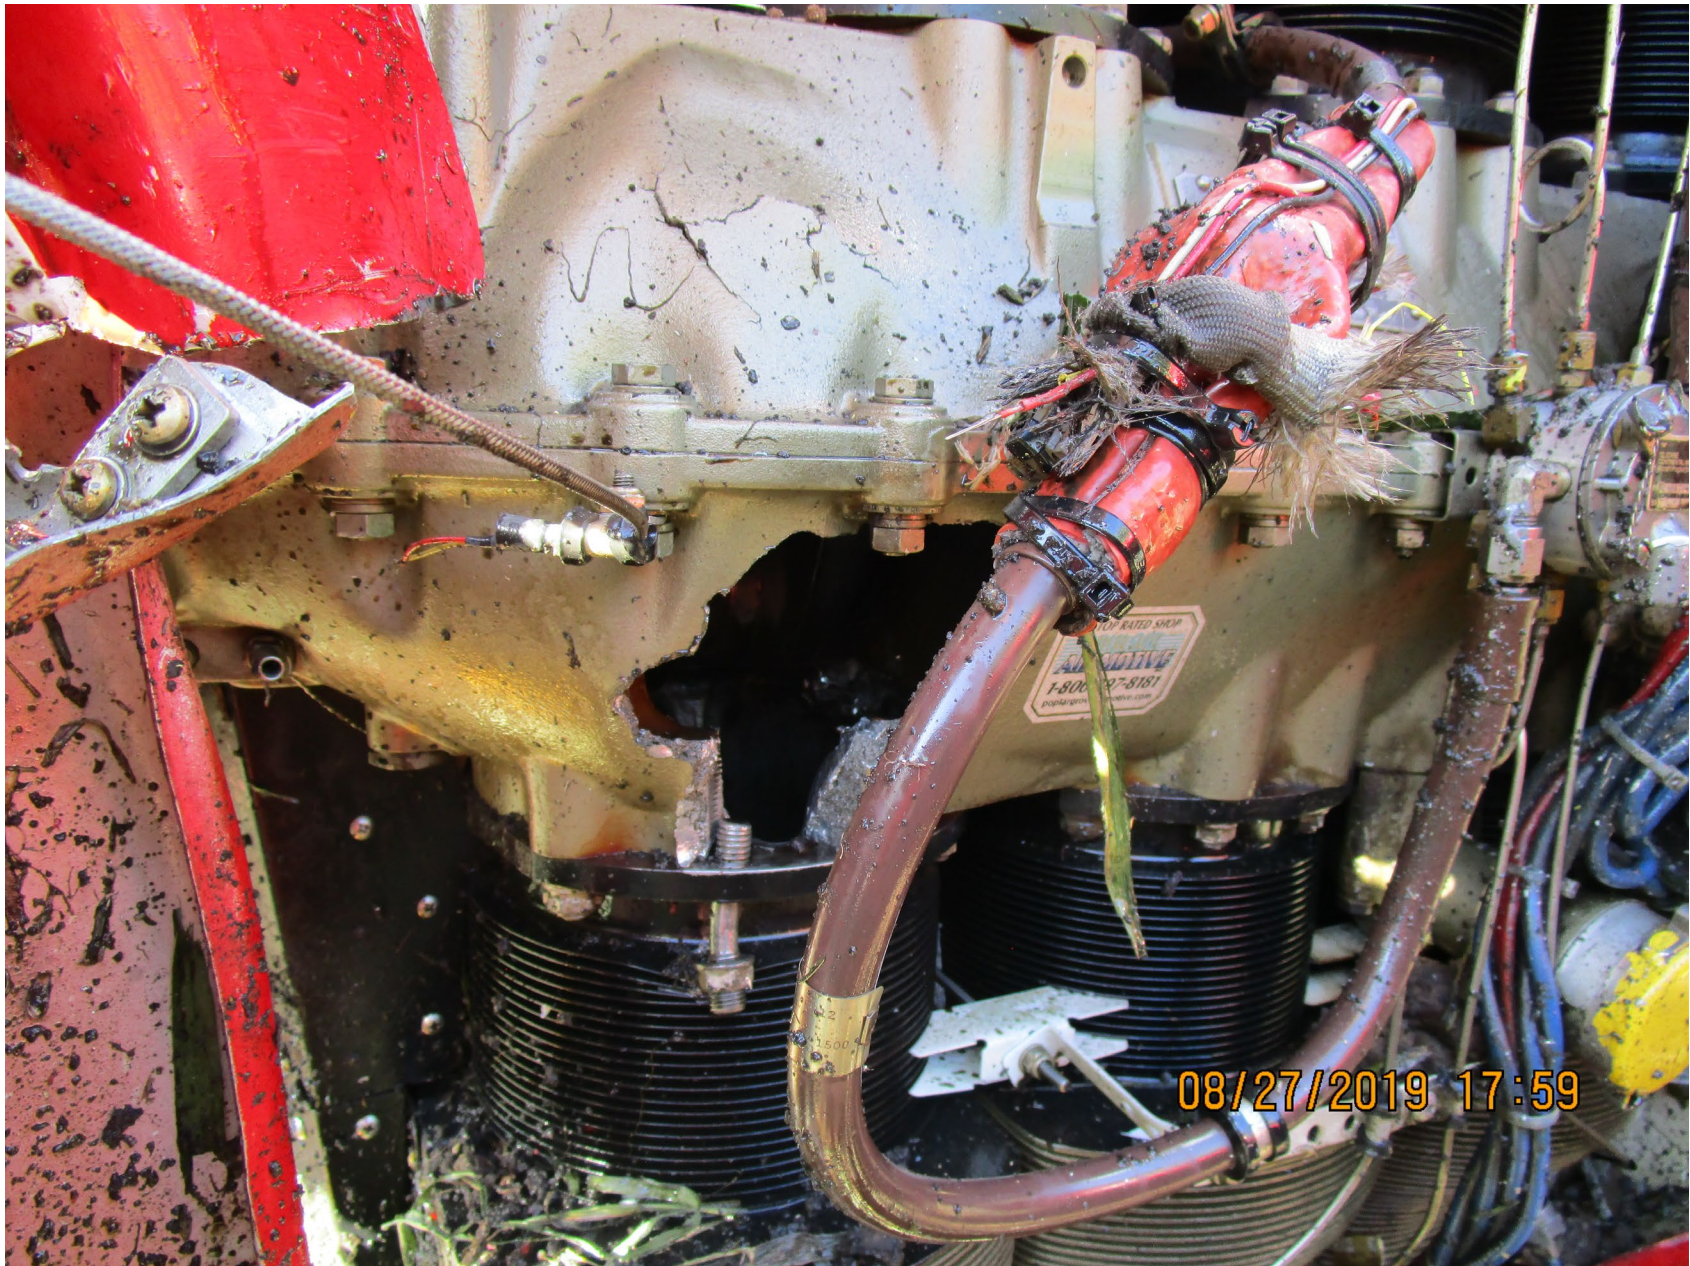
Photo 4 – Top of case on scene

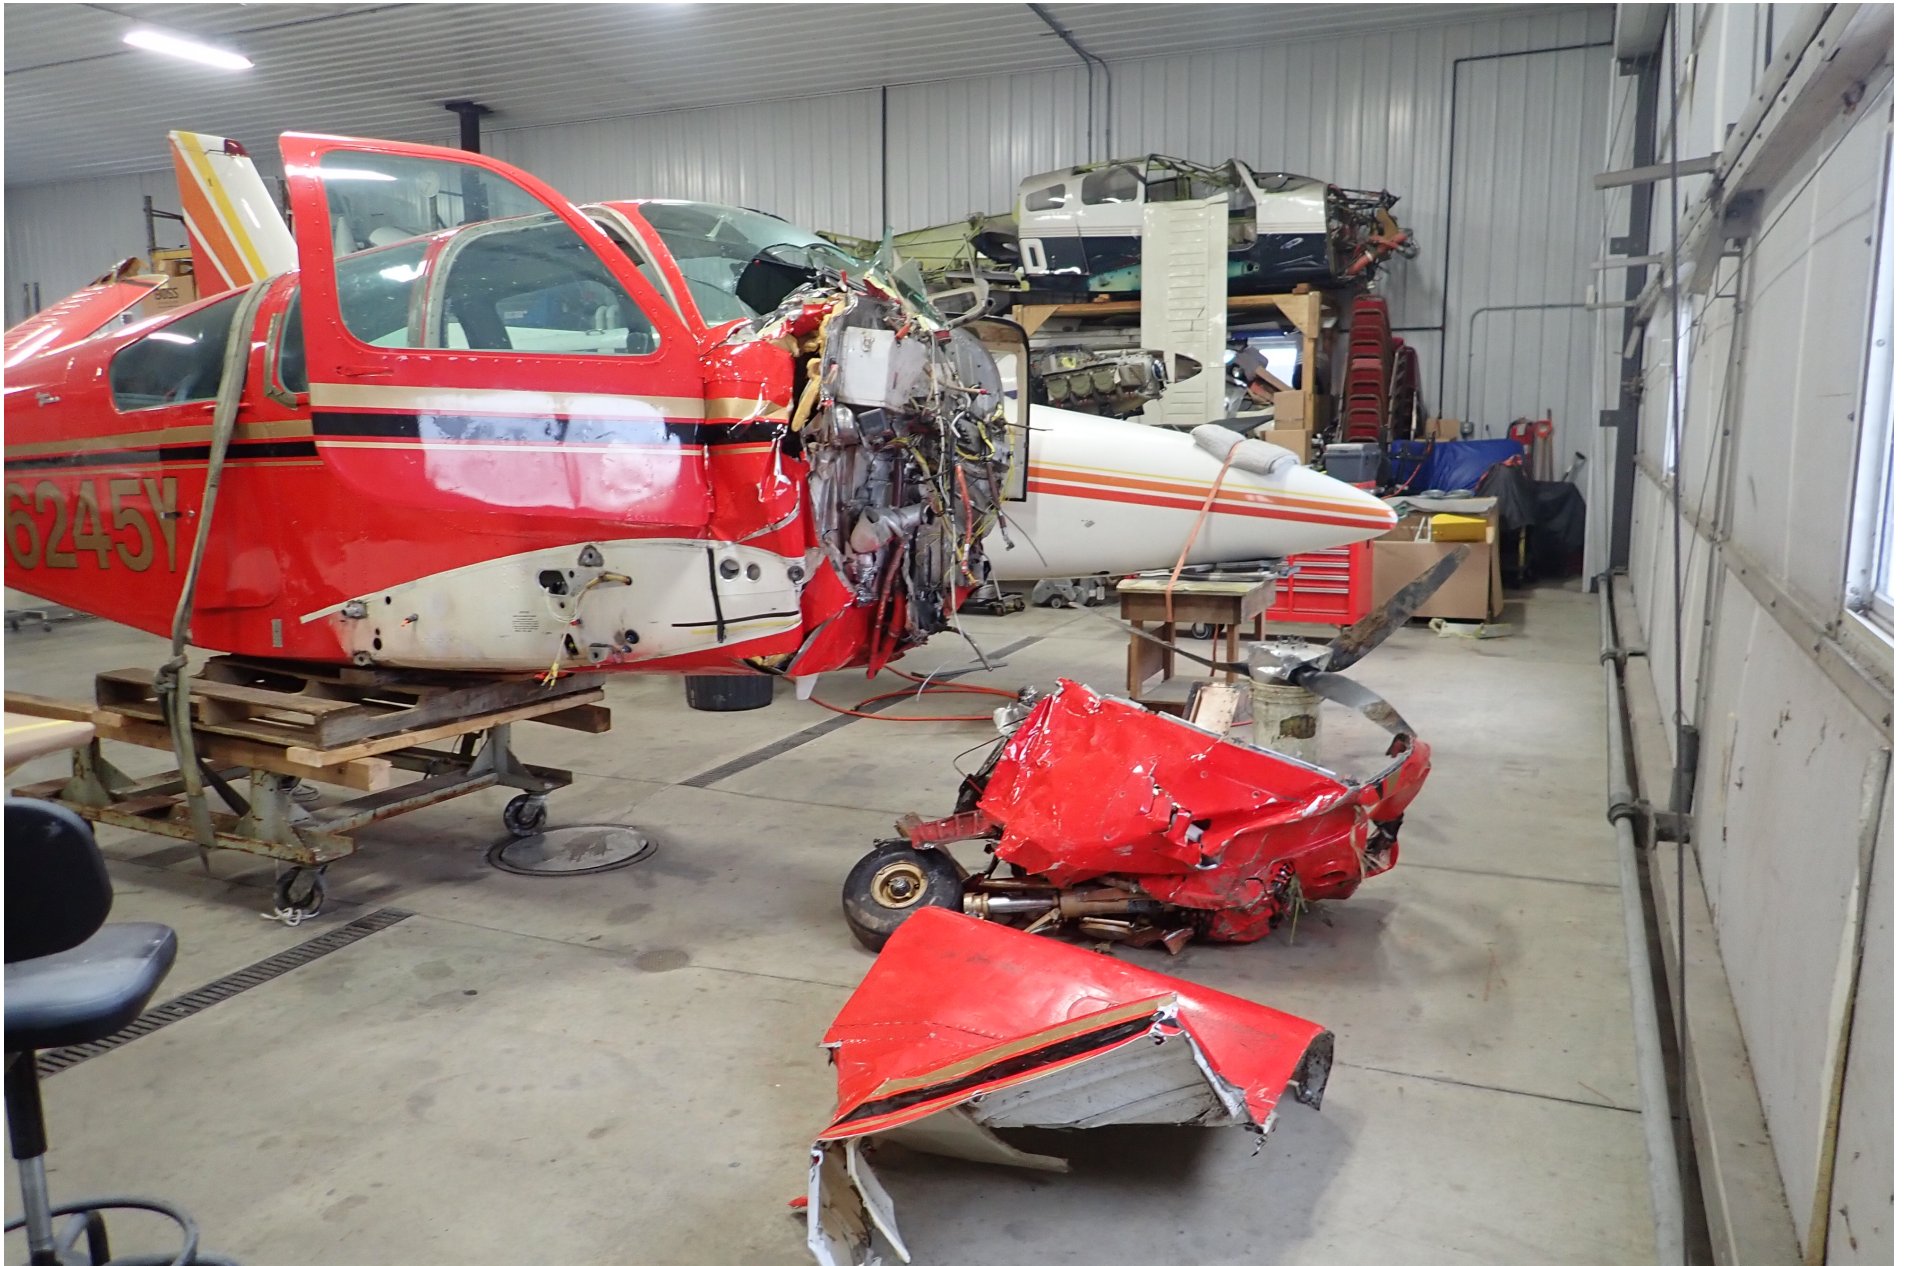
**Photo 5 – Right front of airplane after recovery**

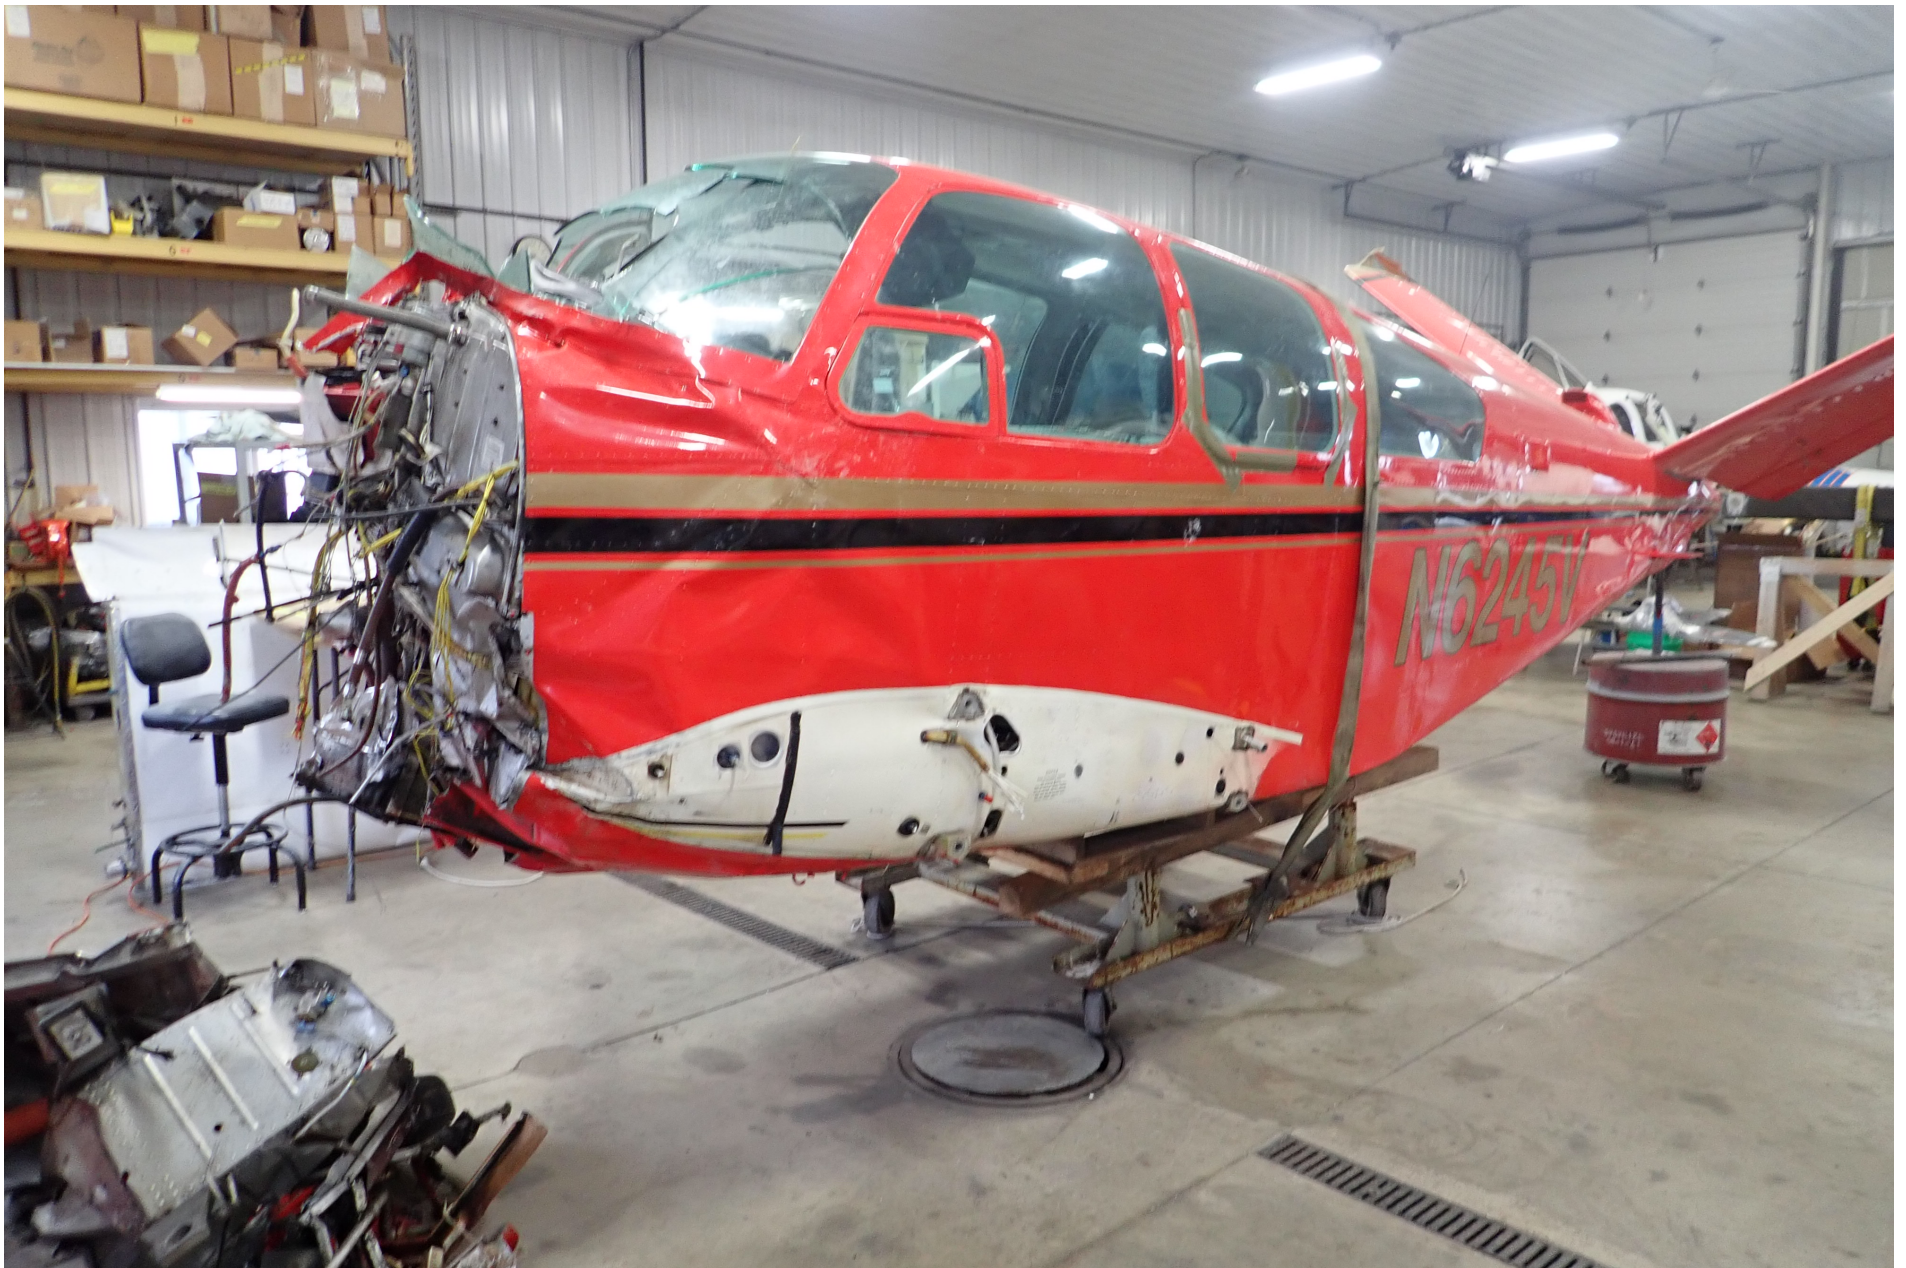
**Photo 6 – Left side of airplane after recovery**

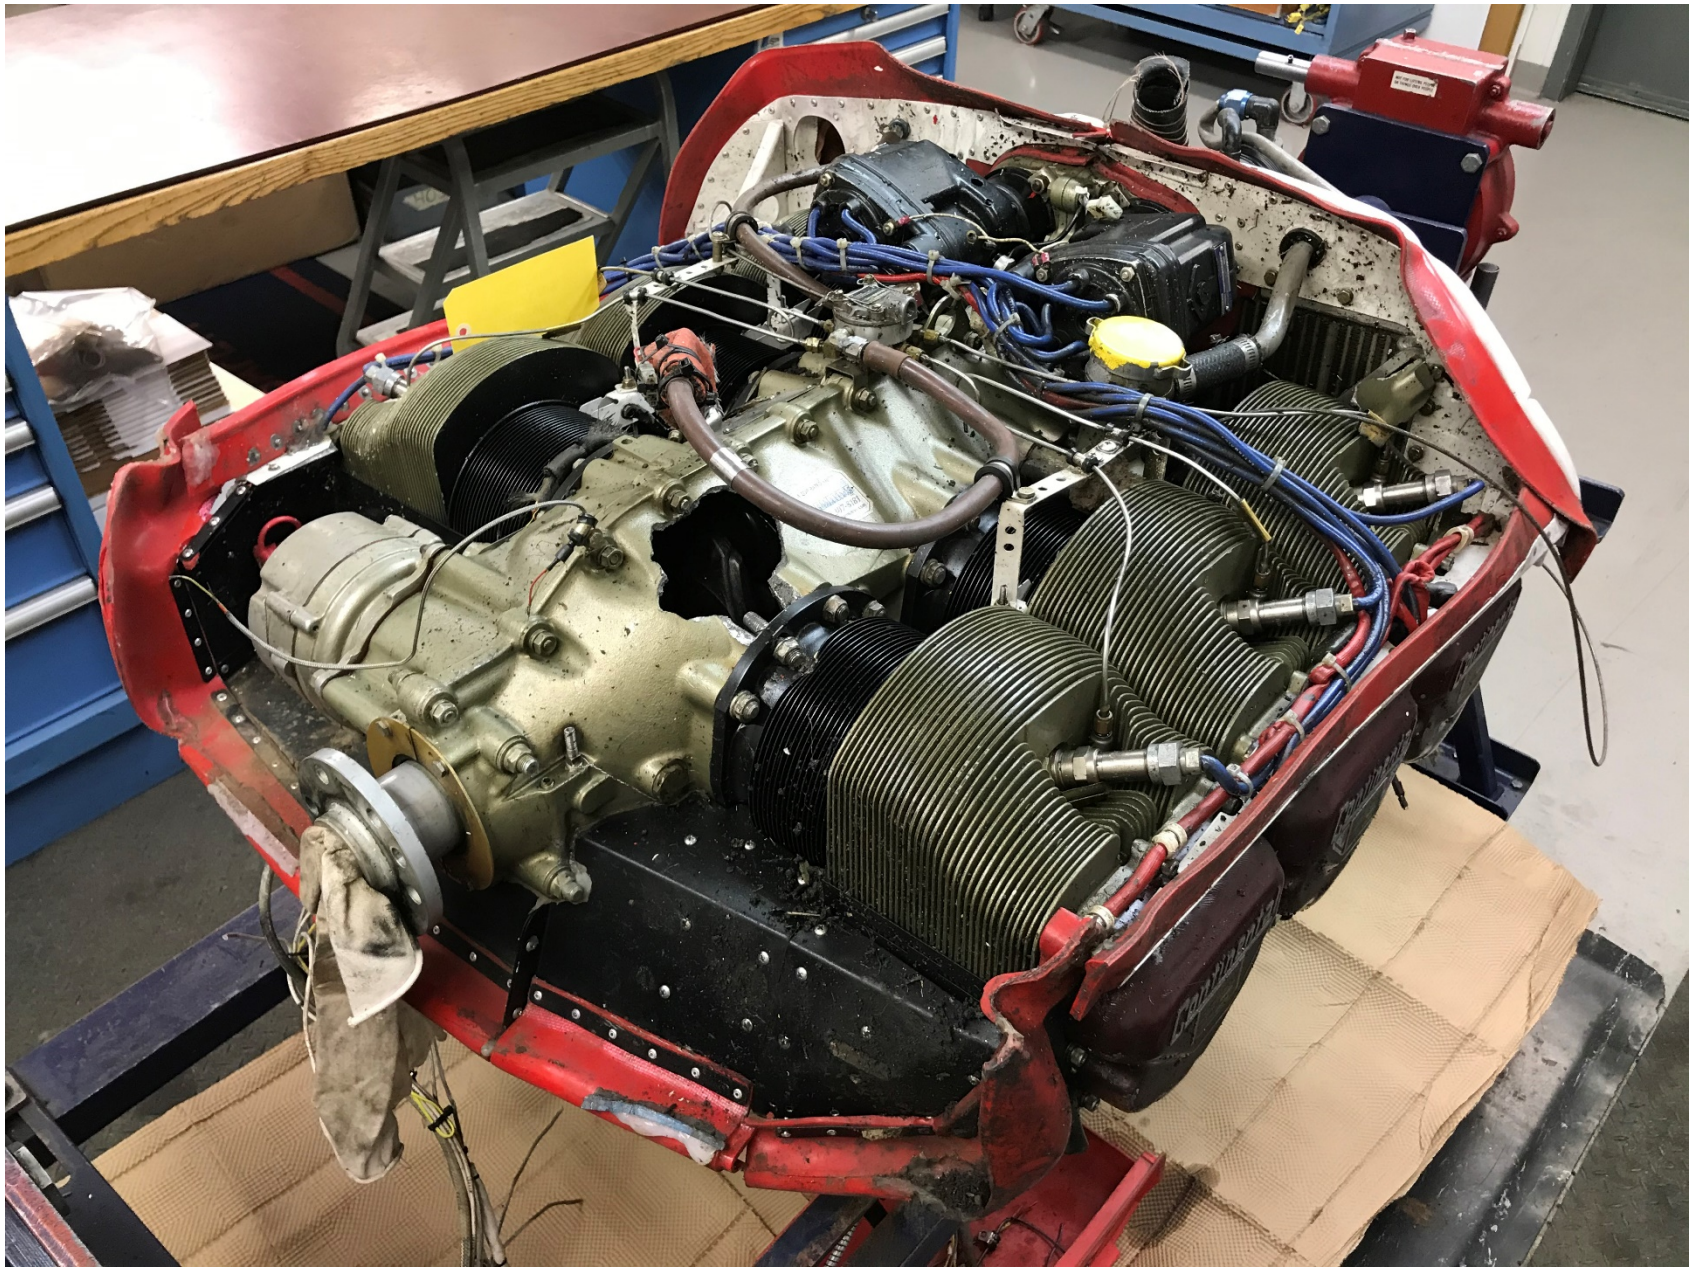
**Photo 7 – Hole in the case above No. 6 cylinder**

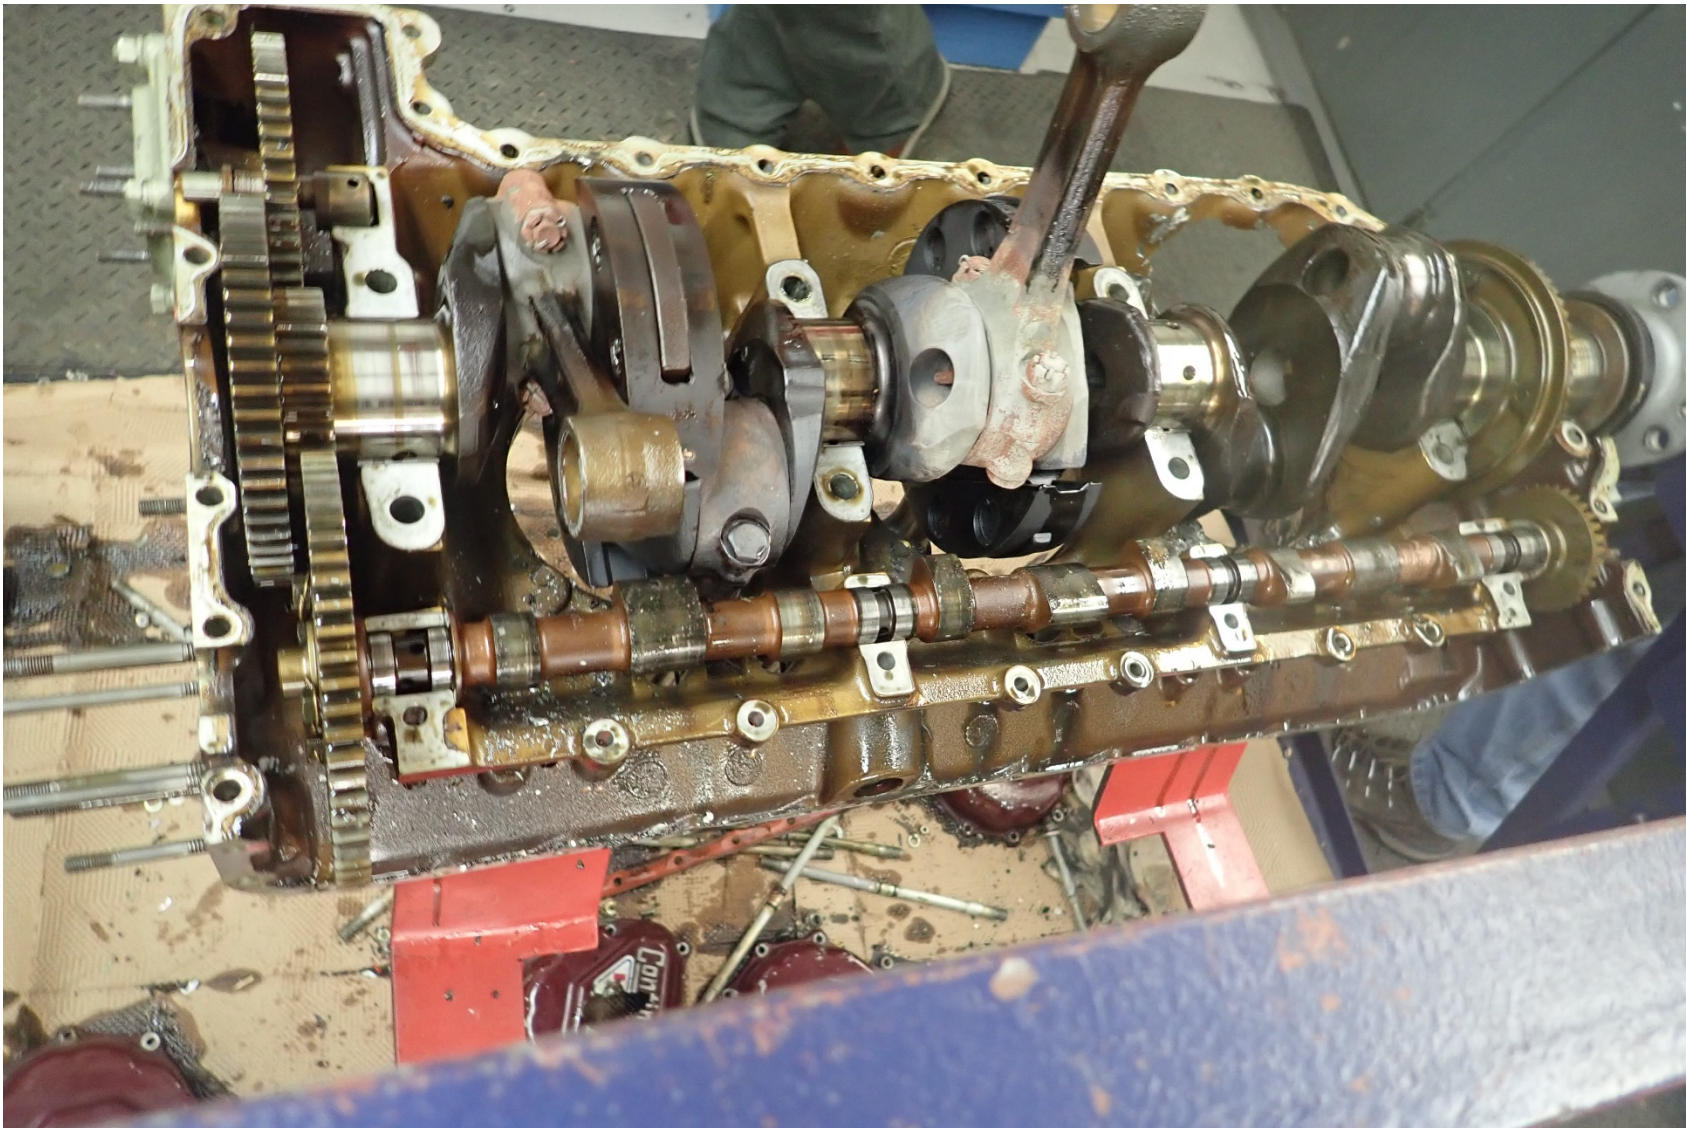
**Photo 8 – Left half of case with crankshaft and camshaft**

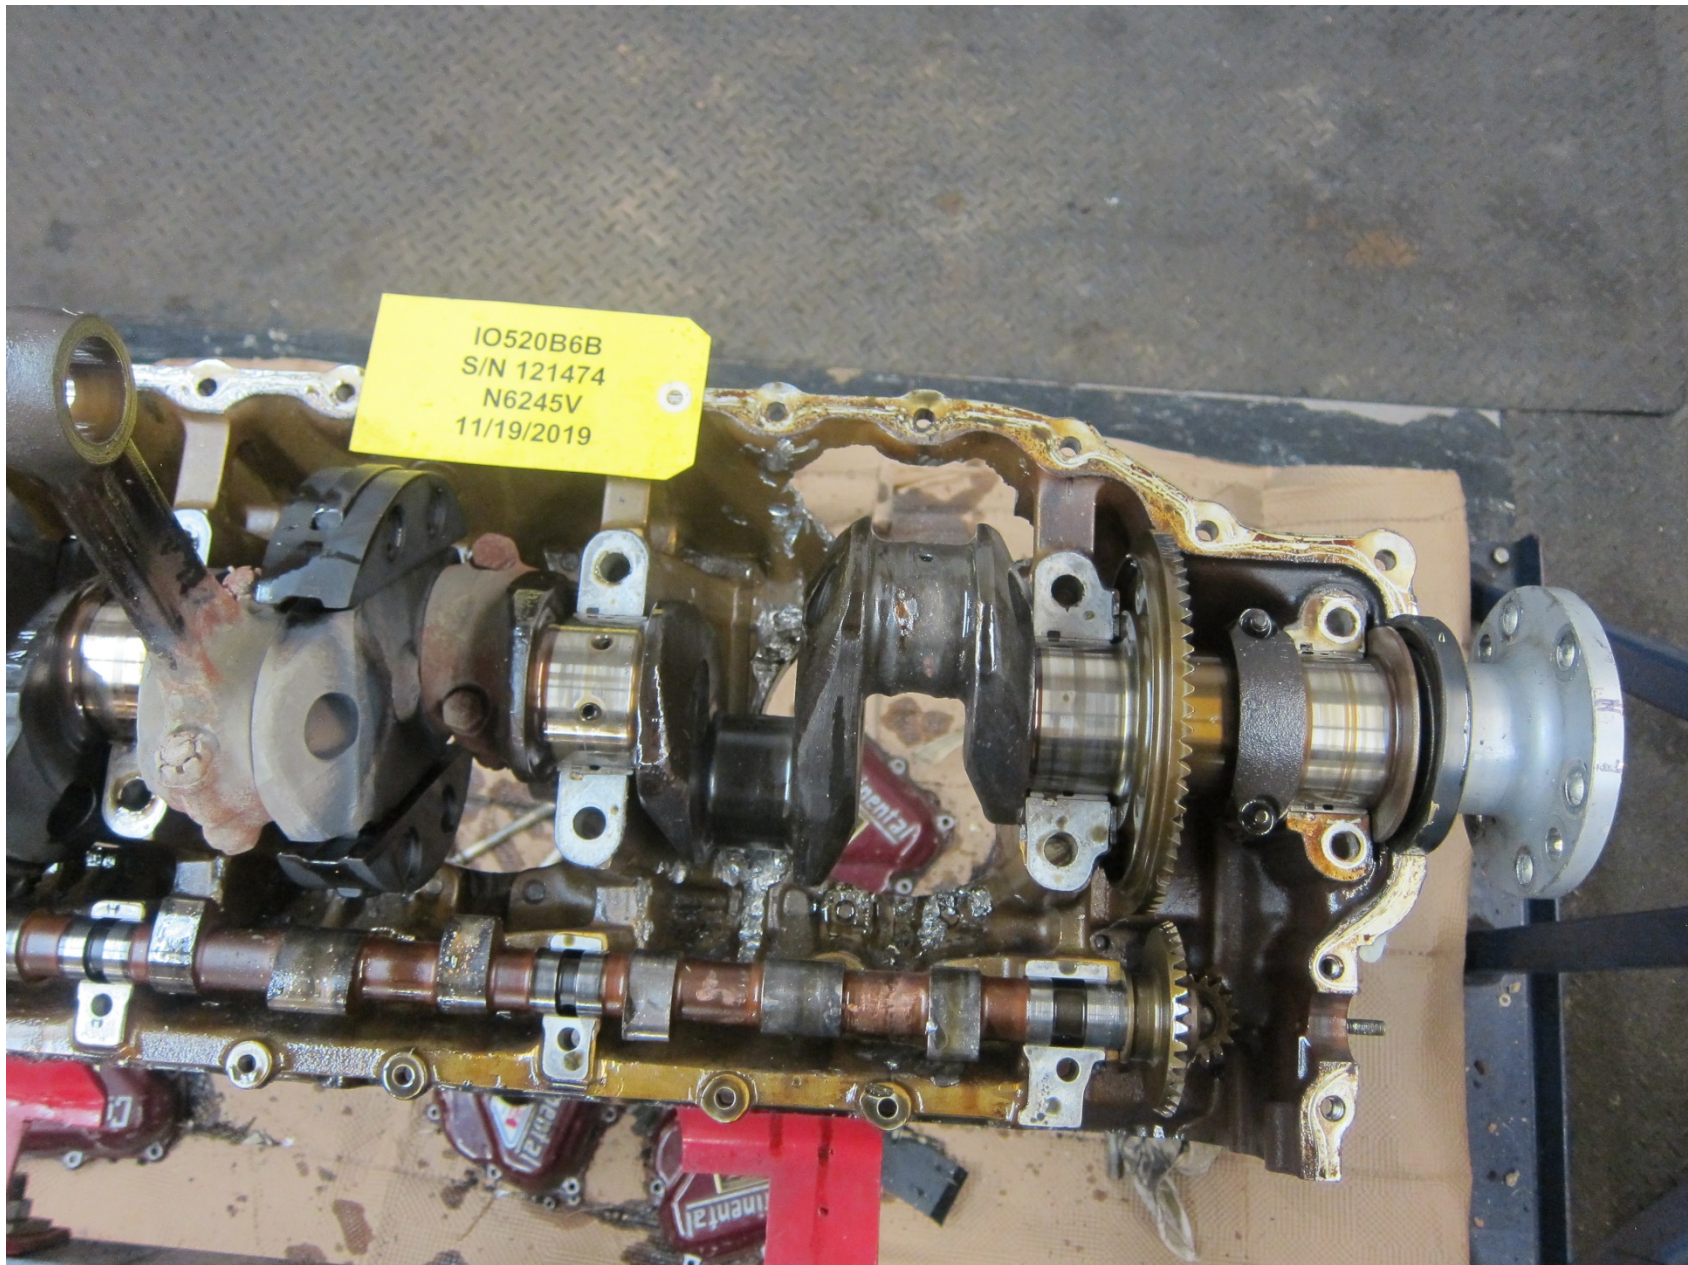
**Photo 9 – Front left half of case with crankshaft and camshaft**

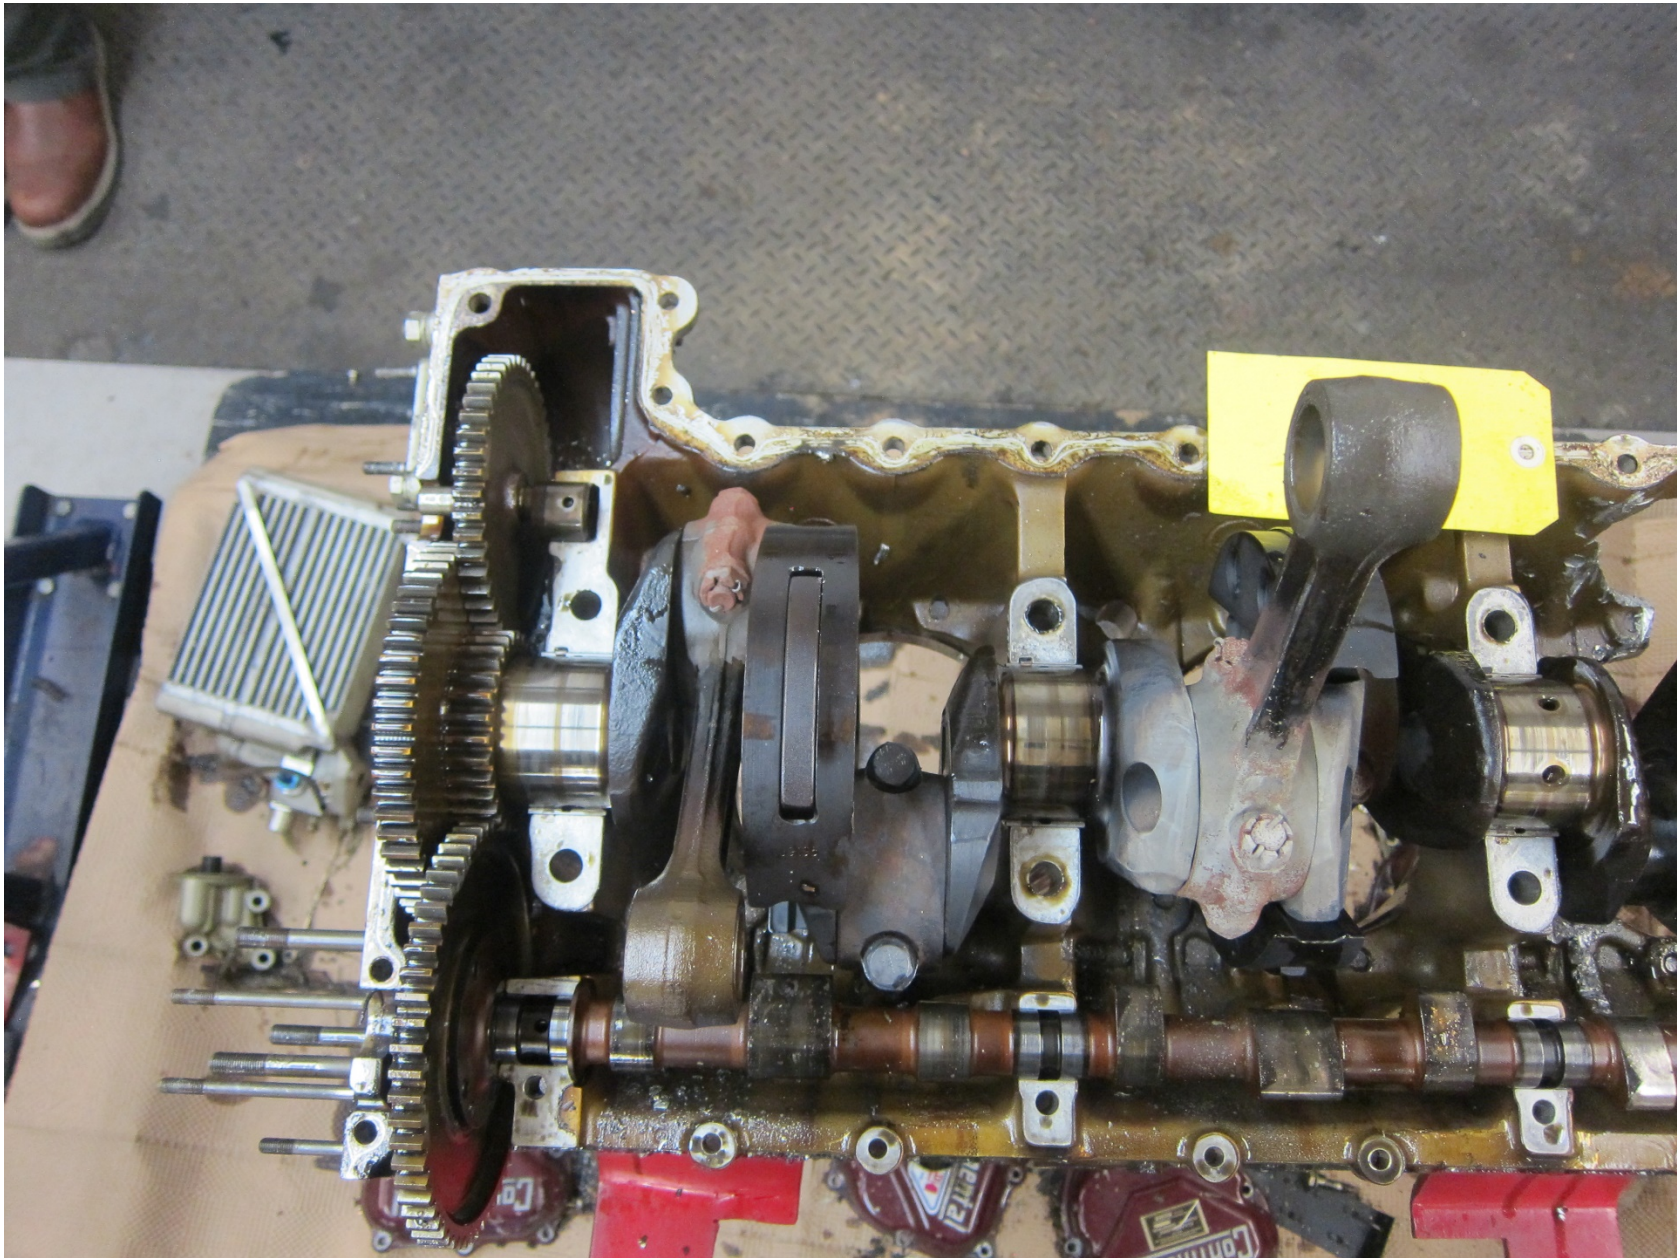
**Photo 10 – Rear left half of case with crankshaft and camshaft**

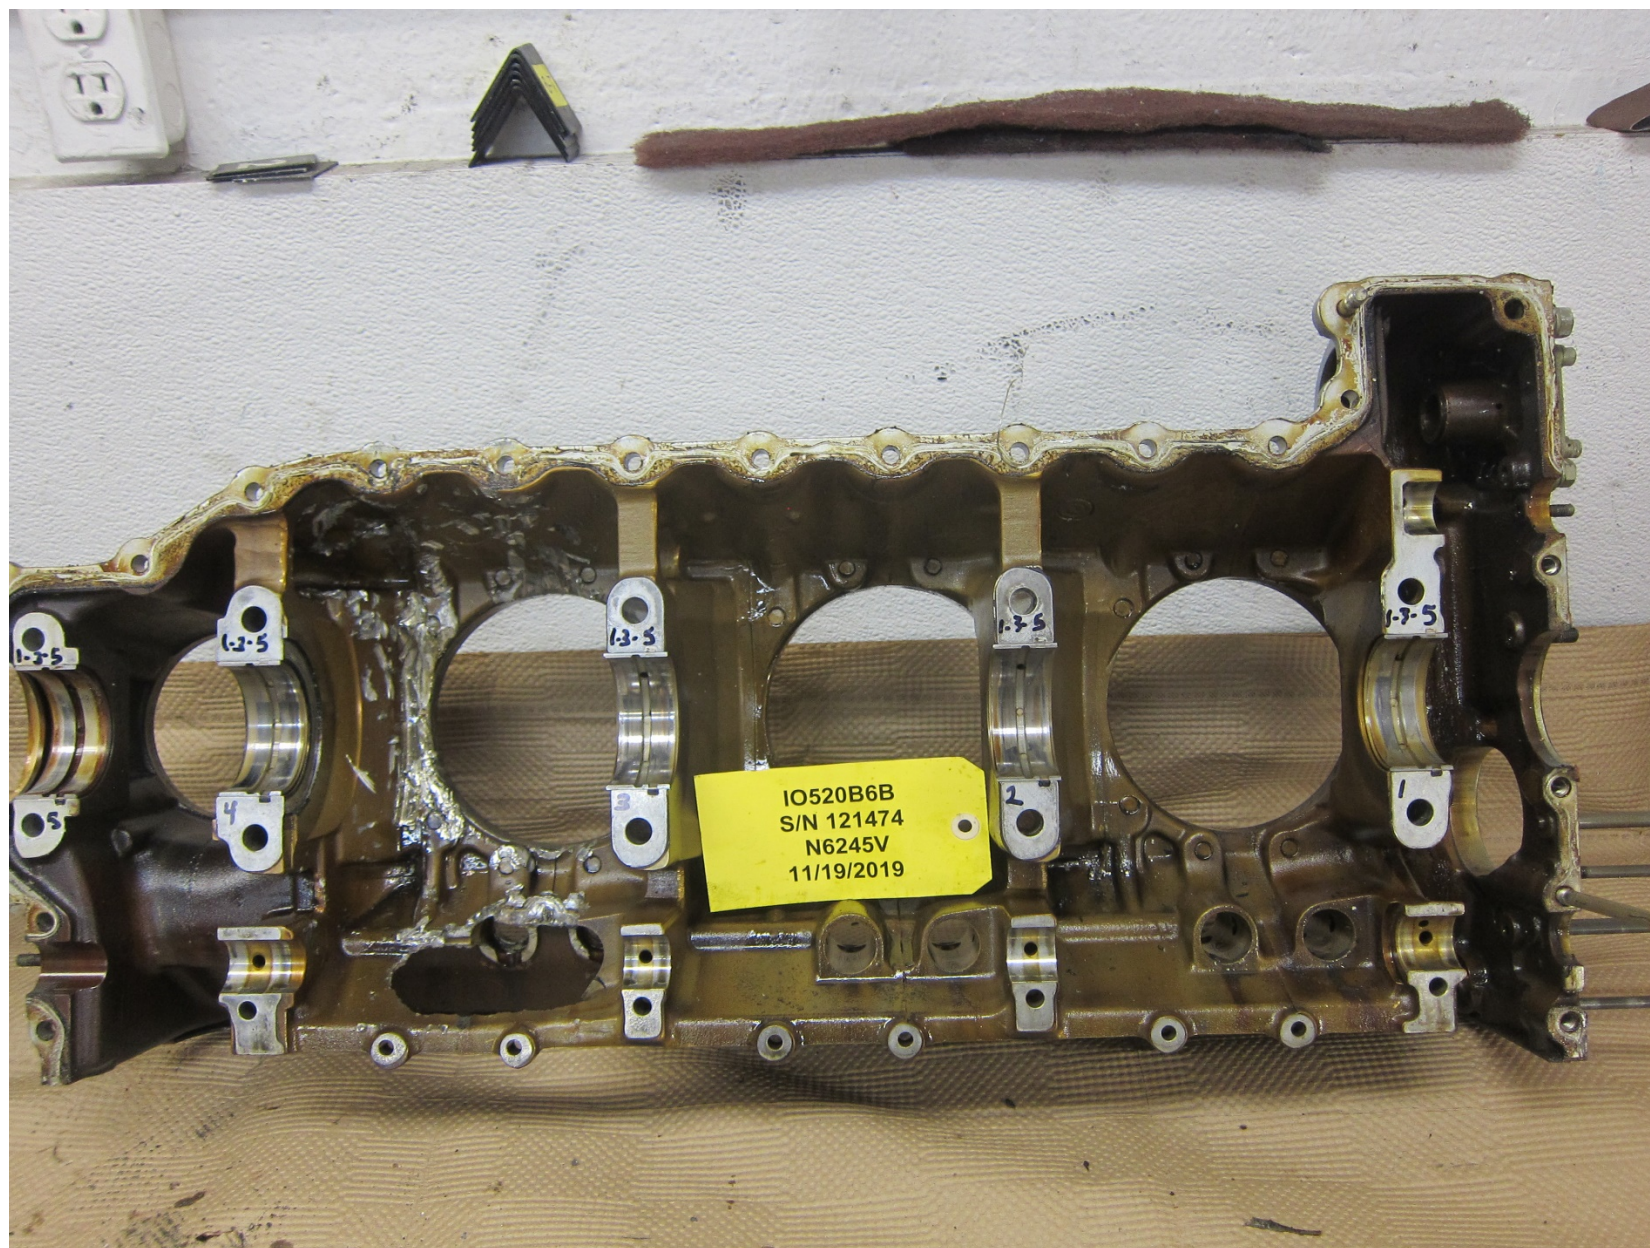
**Photo 11 – Right half of case, internal view**

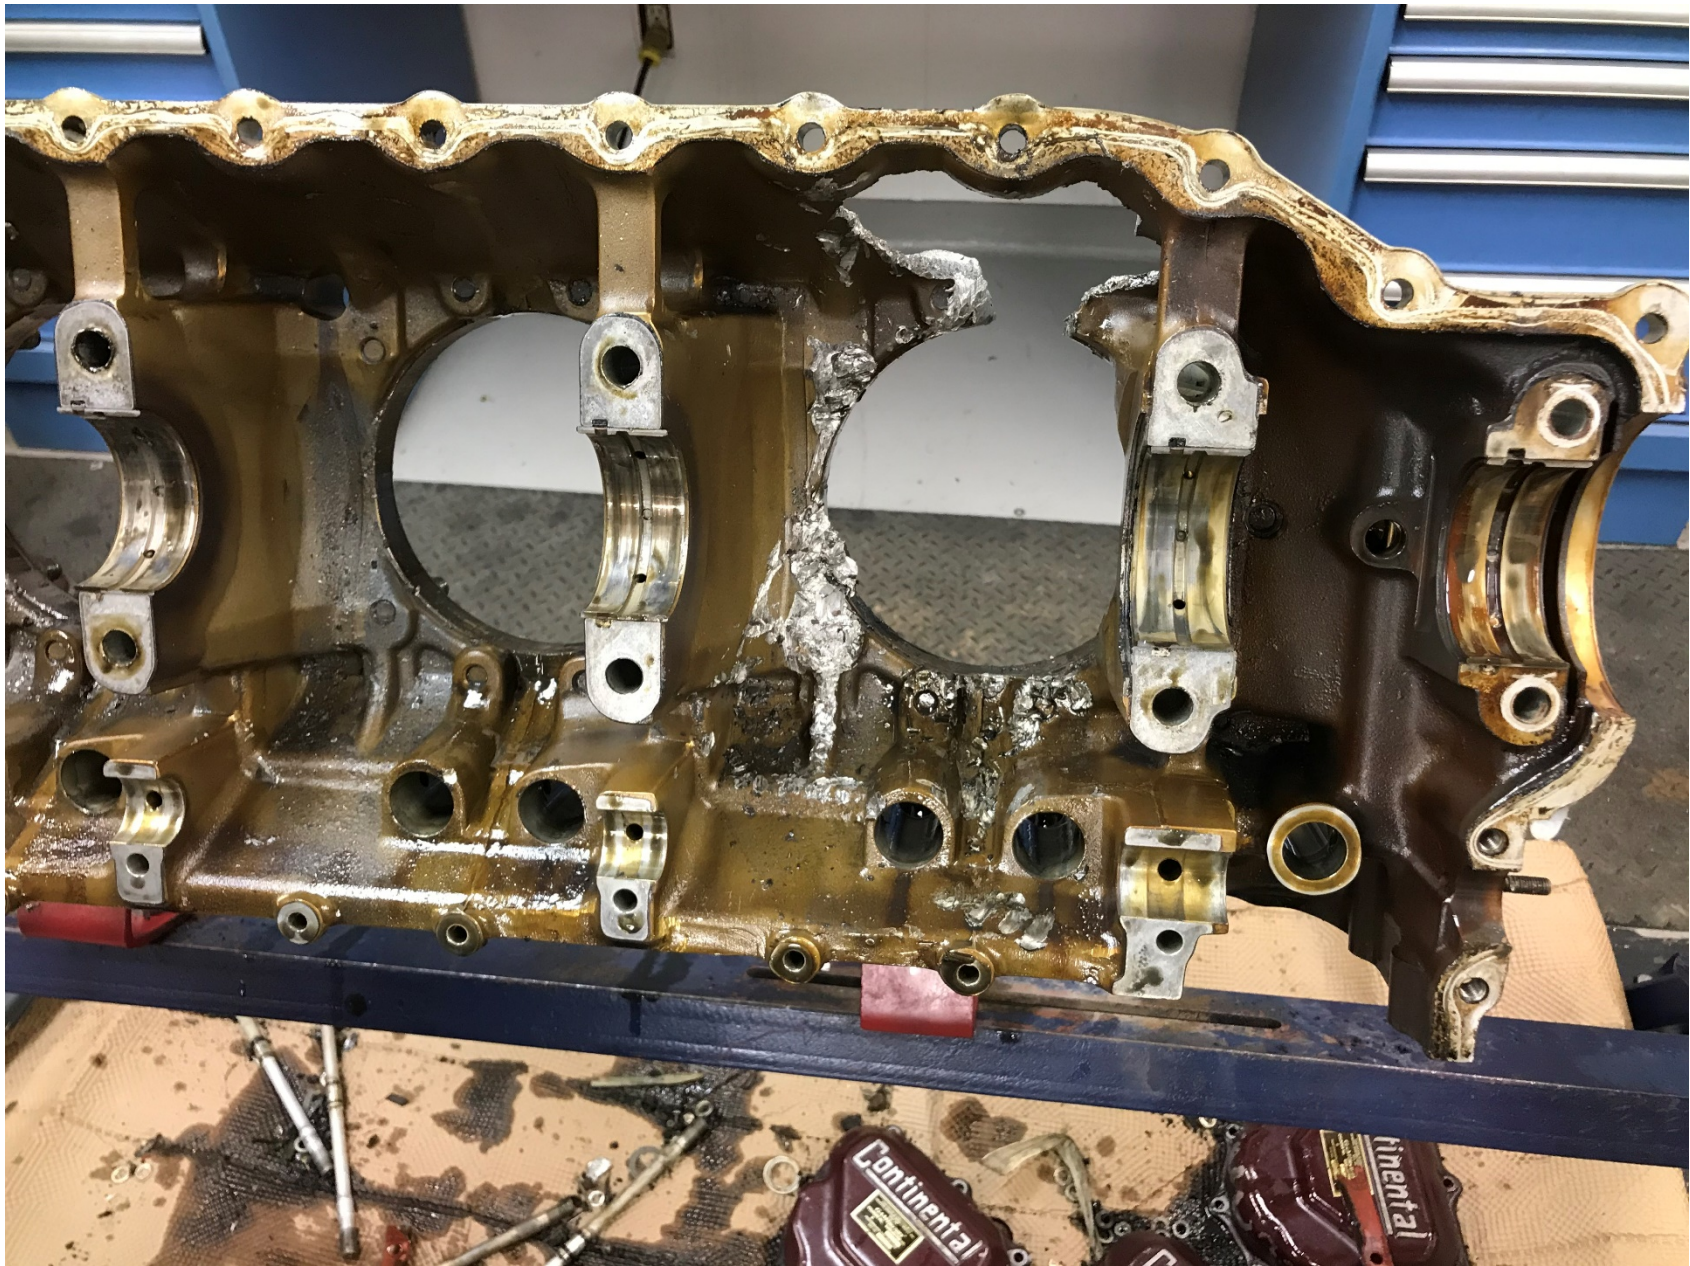
**Photo 12 – Front left half of case, internal view**
