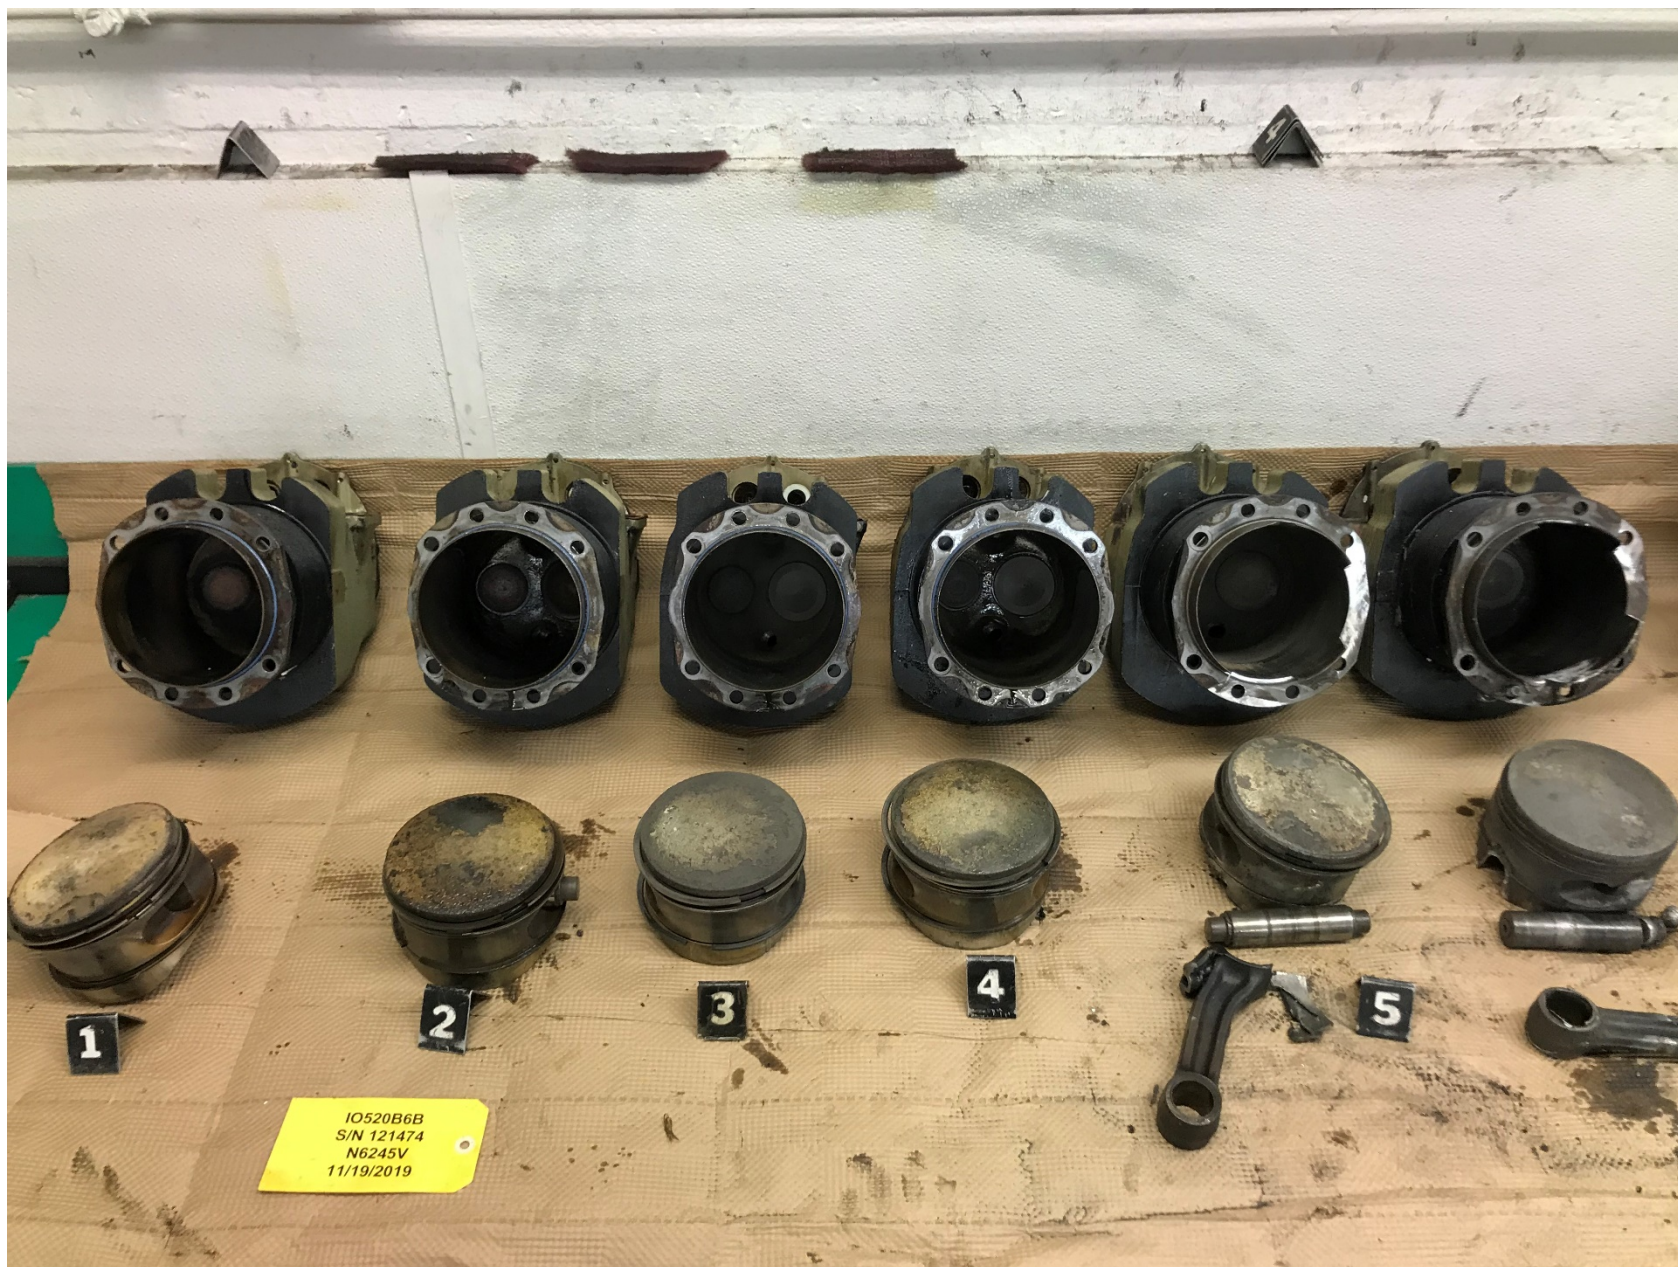
Photo 13 – All cylinders and piston heads

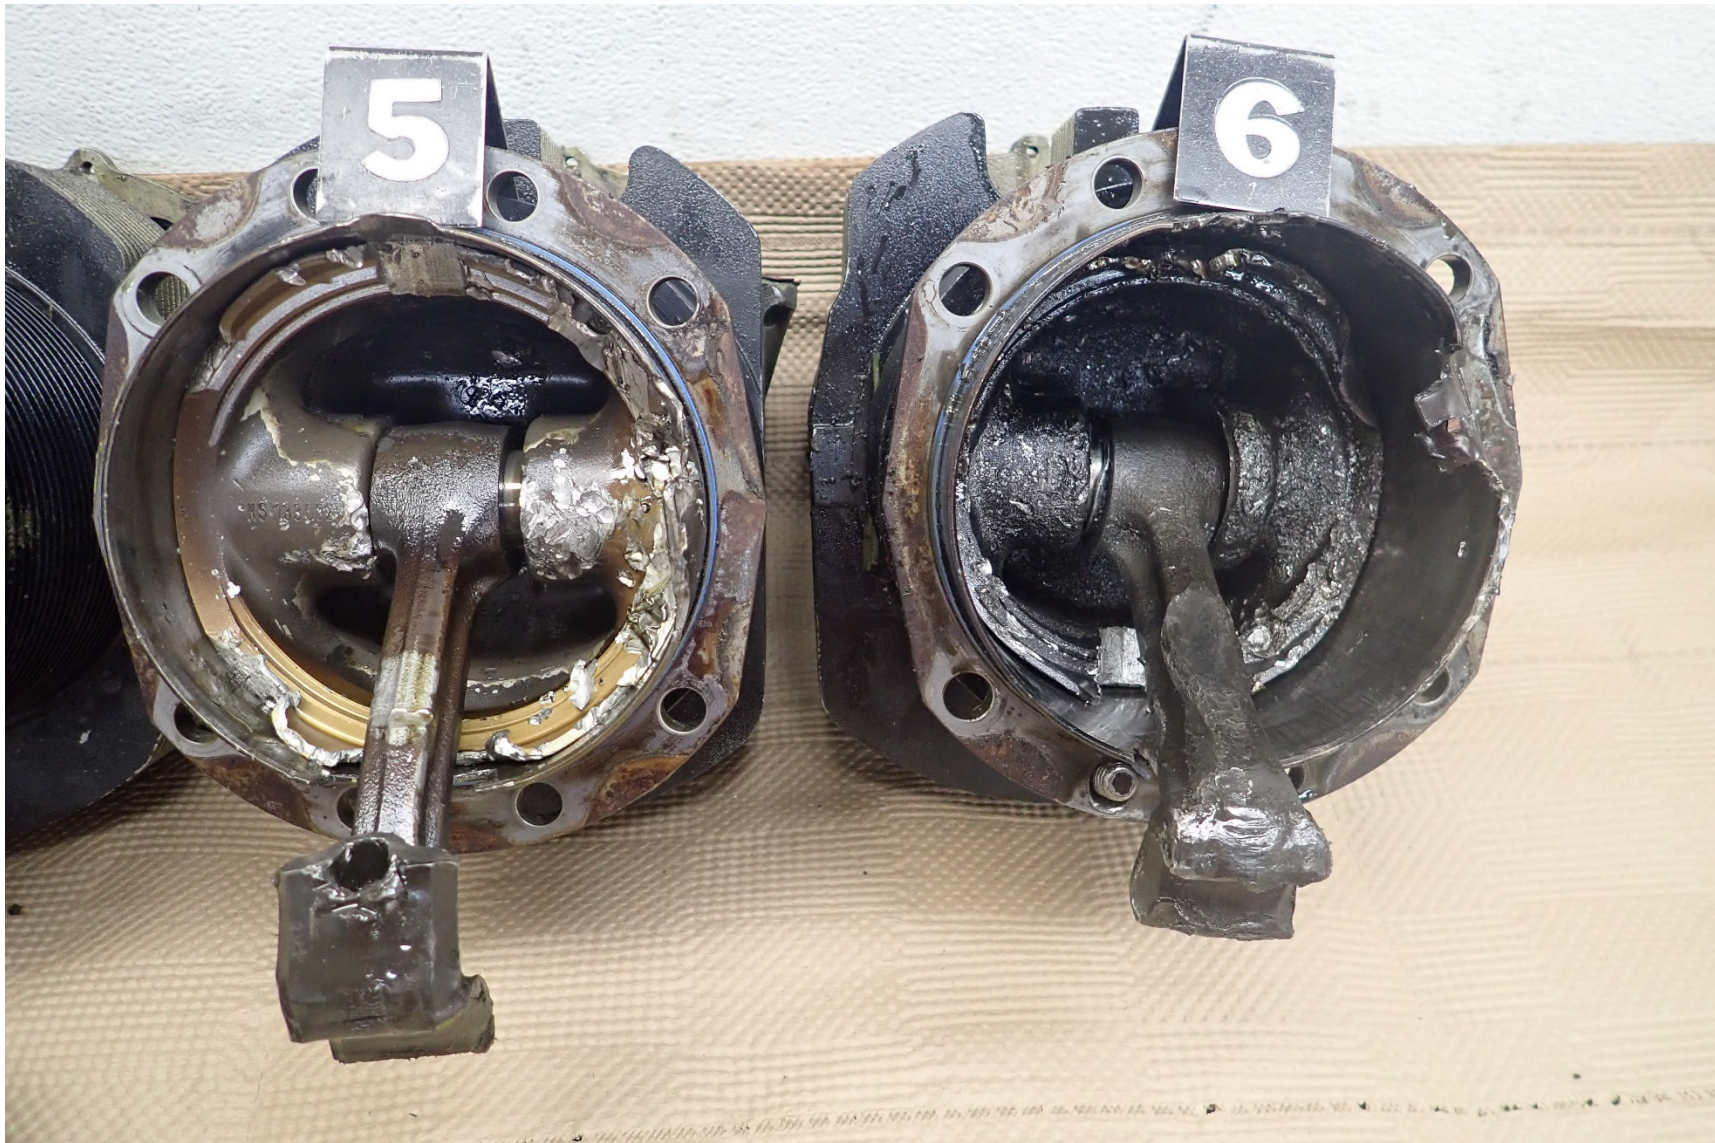
**Photo 14 – Nos. 5 and 6 cylinders with pistons and connecting rods installed**

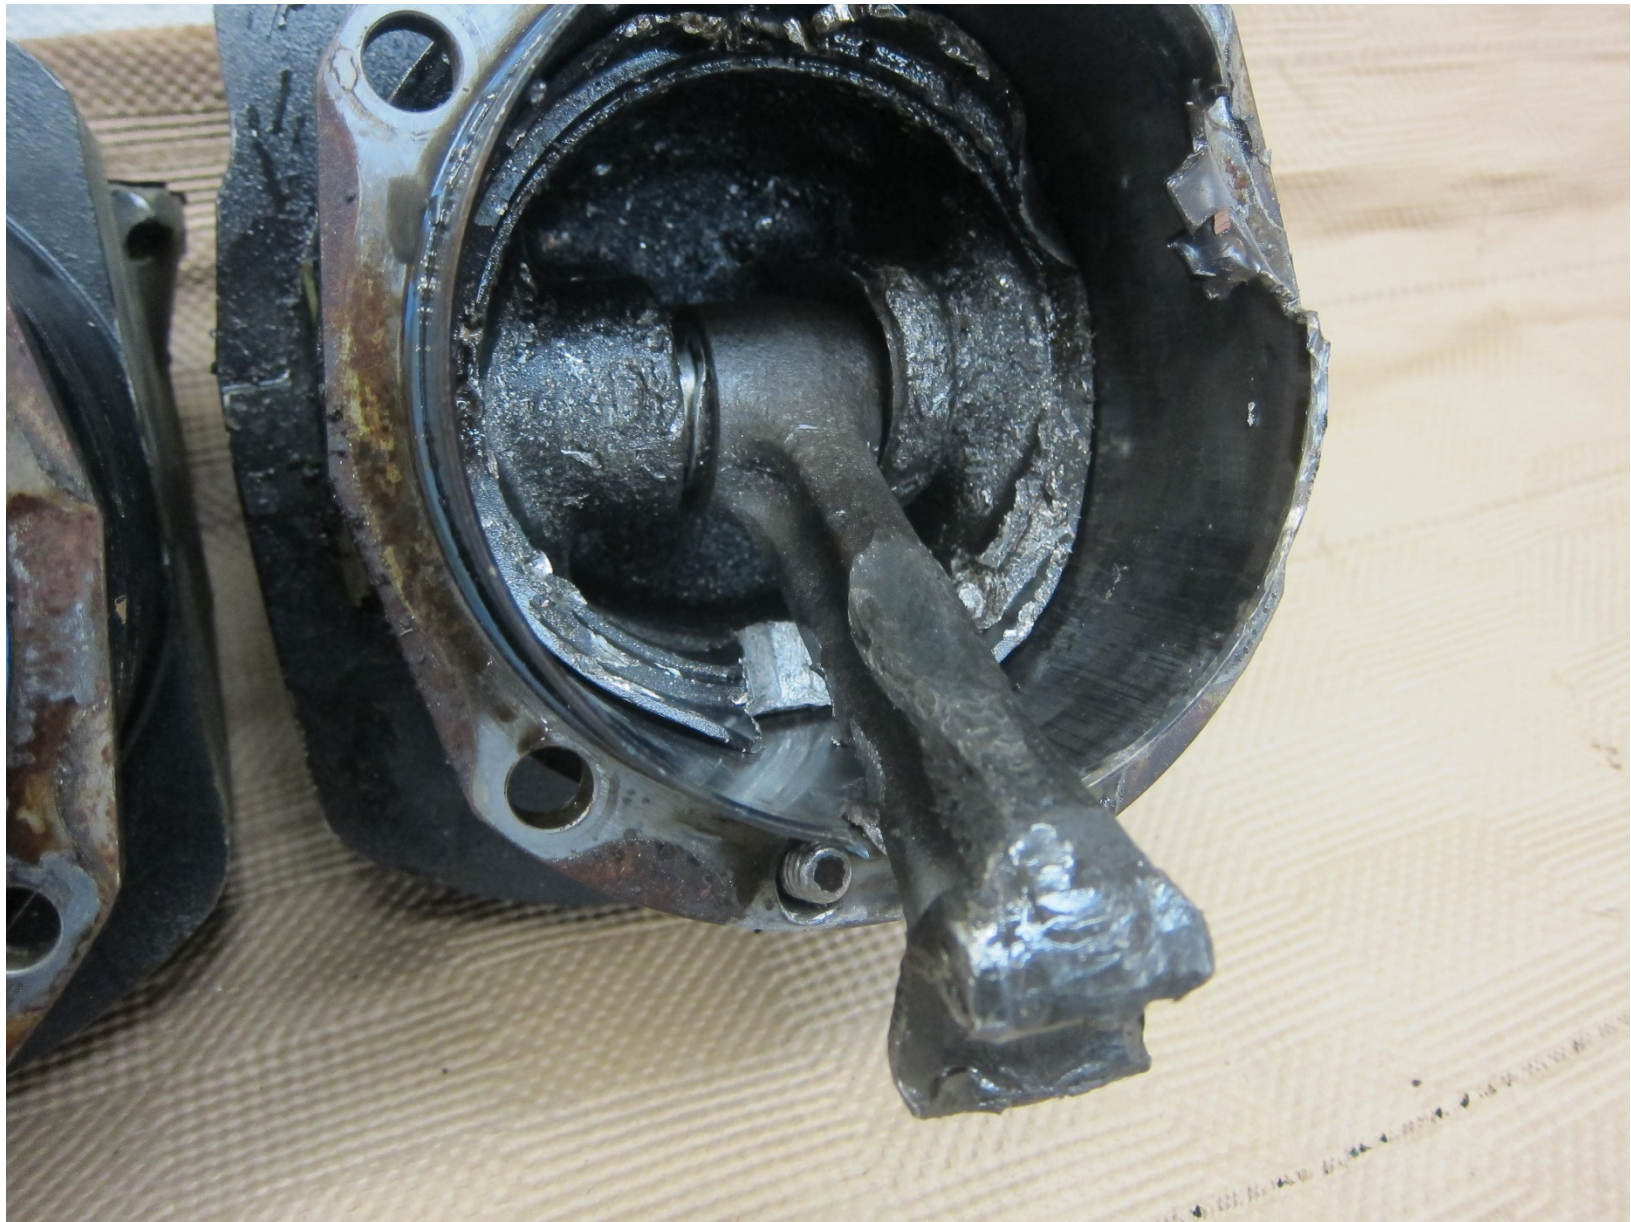
**Photo 15 – No. 6 cylinder with piston and connecting rod installed**

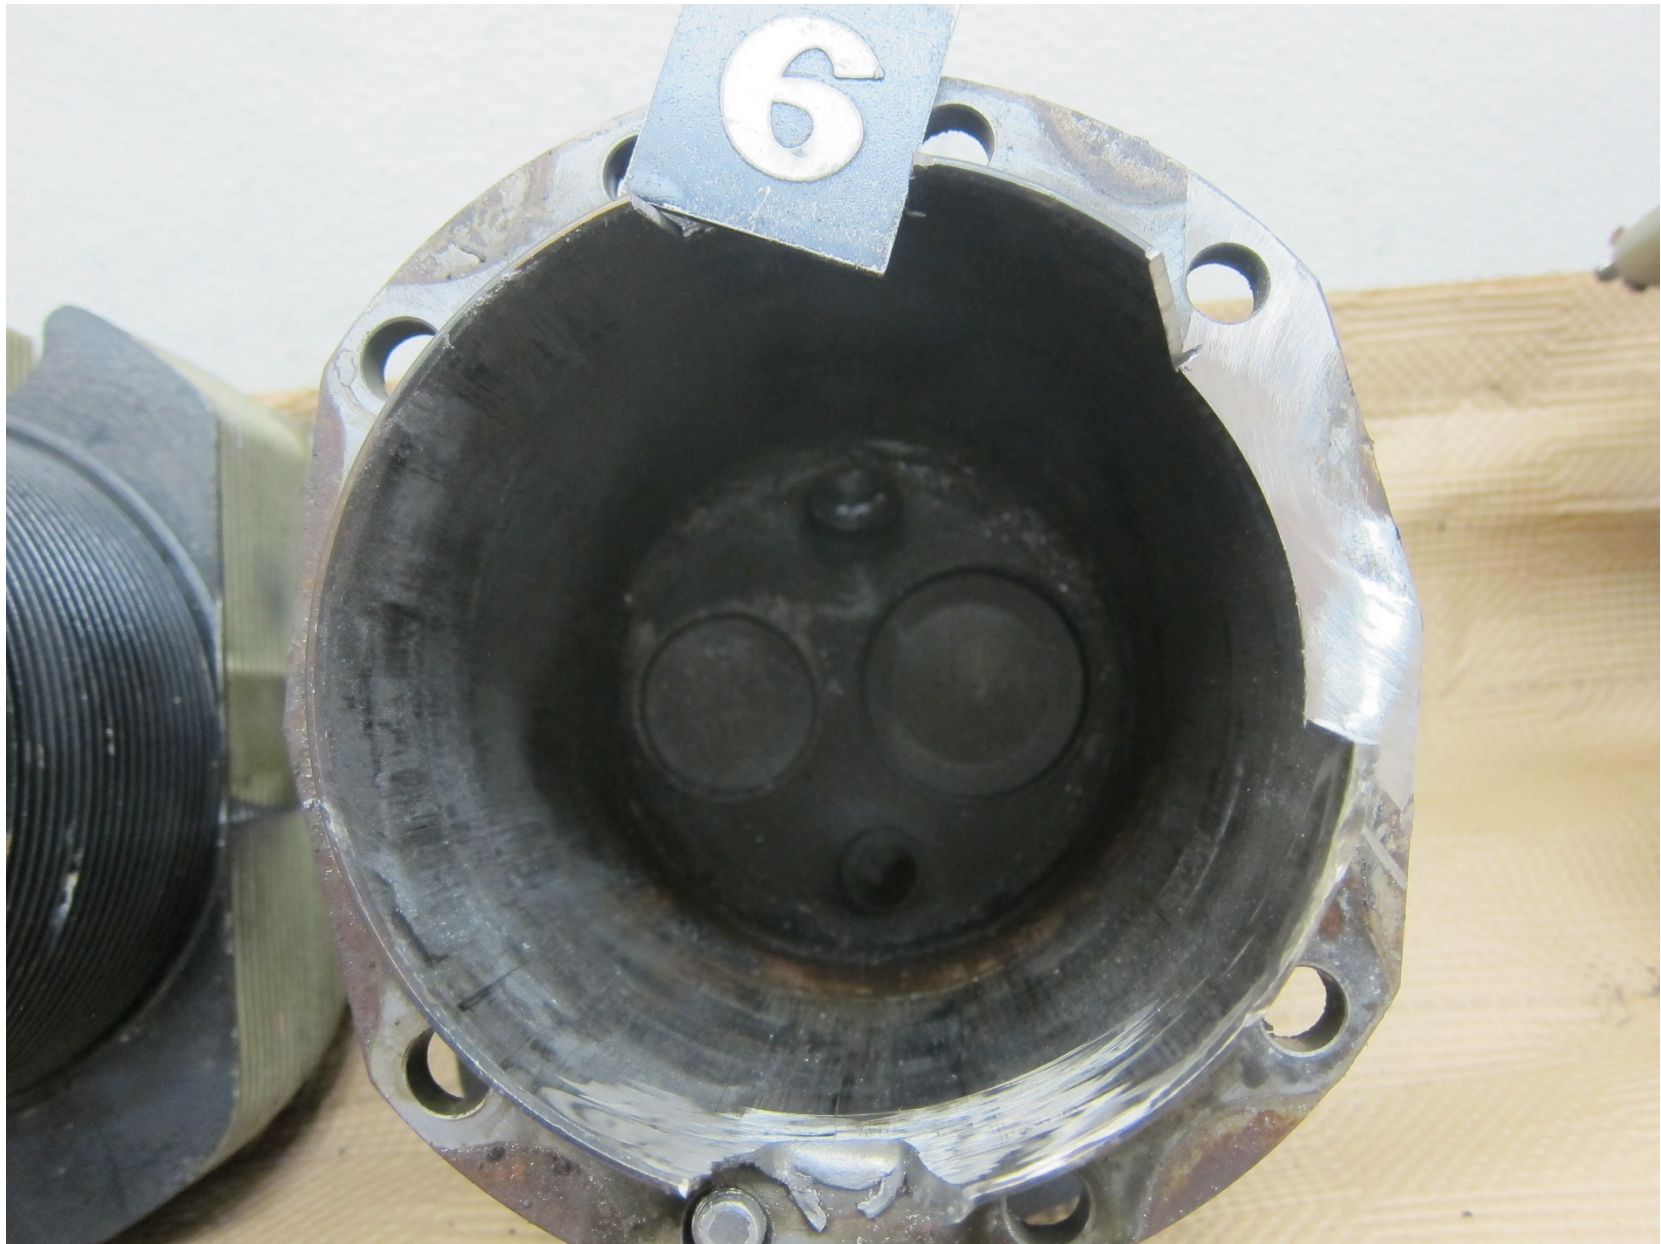
**Photo 16 – Inside No. 6 cylinder**

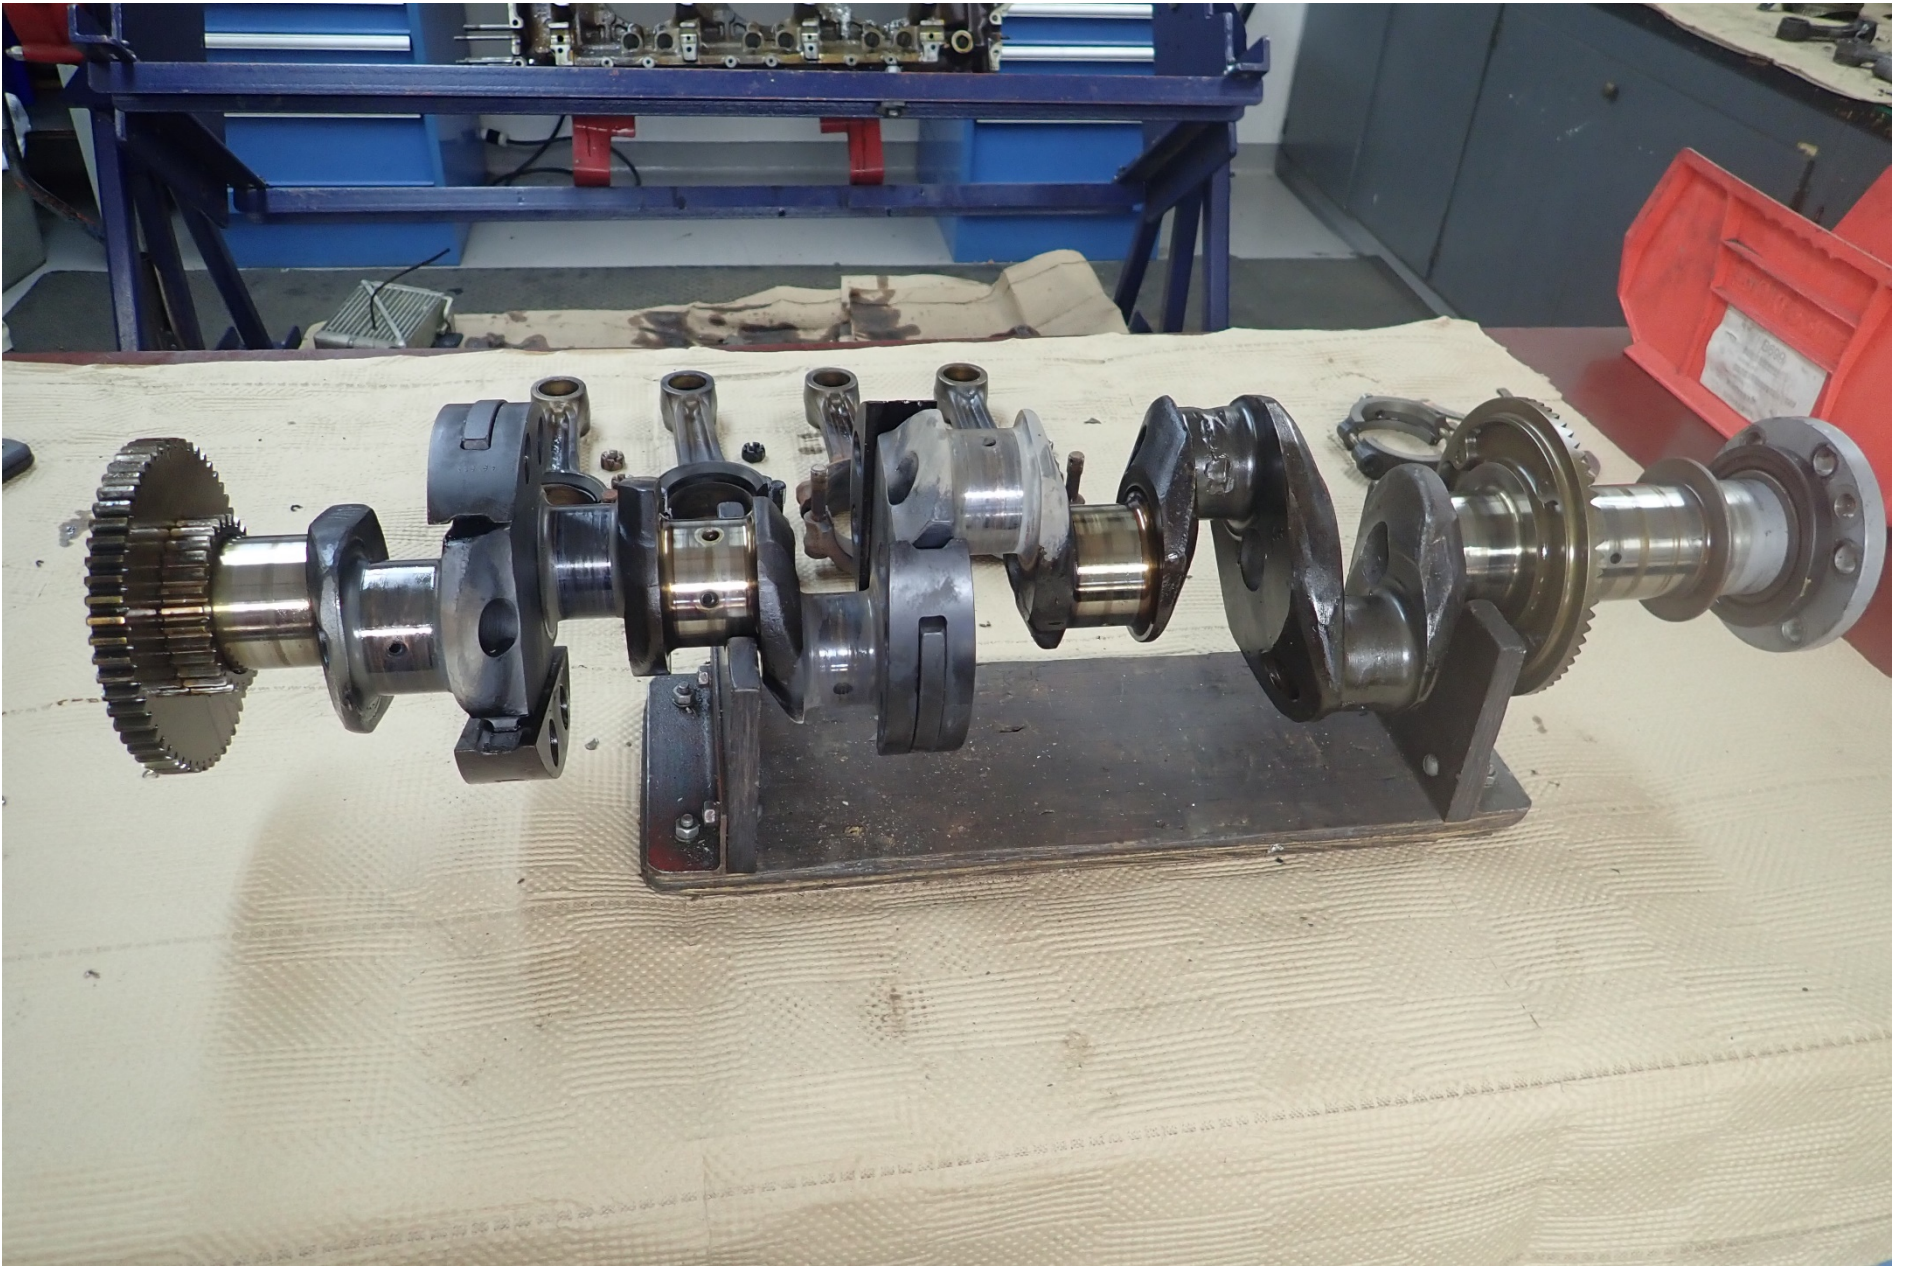
**Photo 17 – Crankshaft**

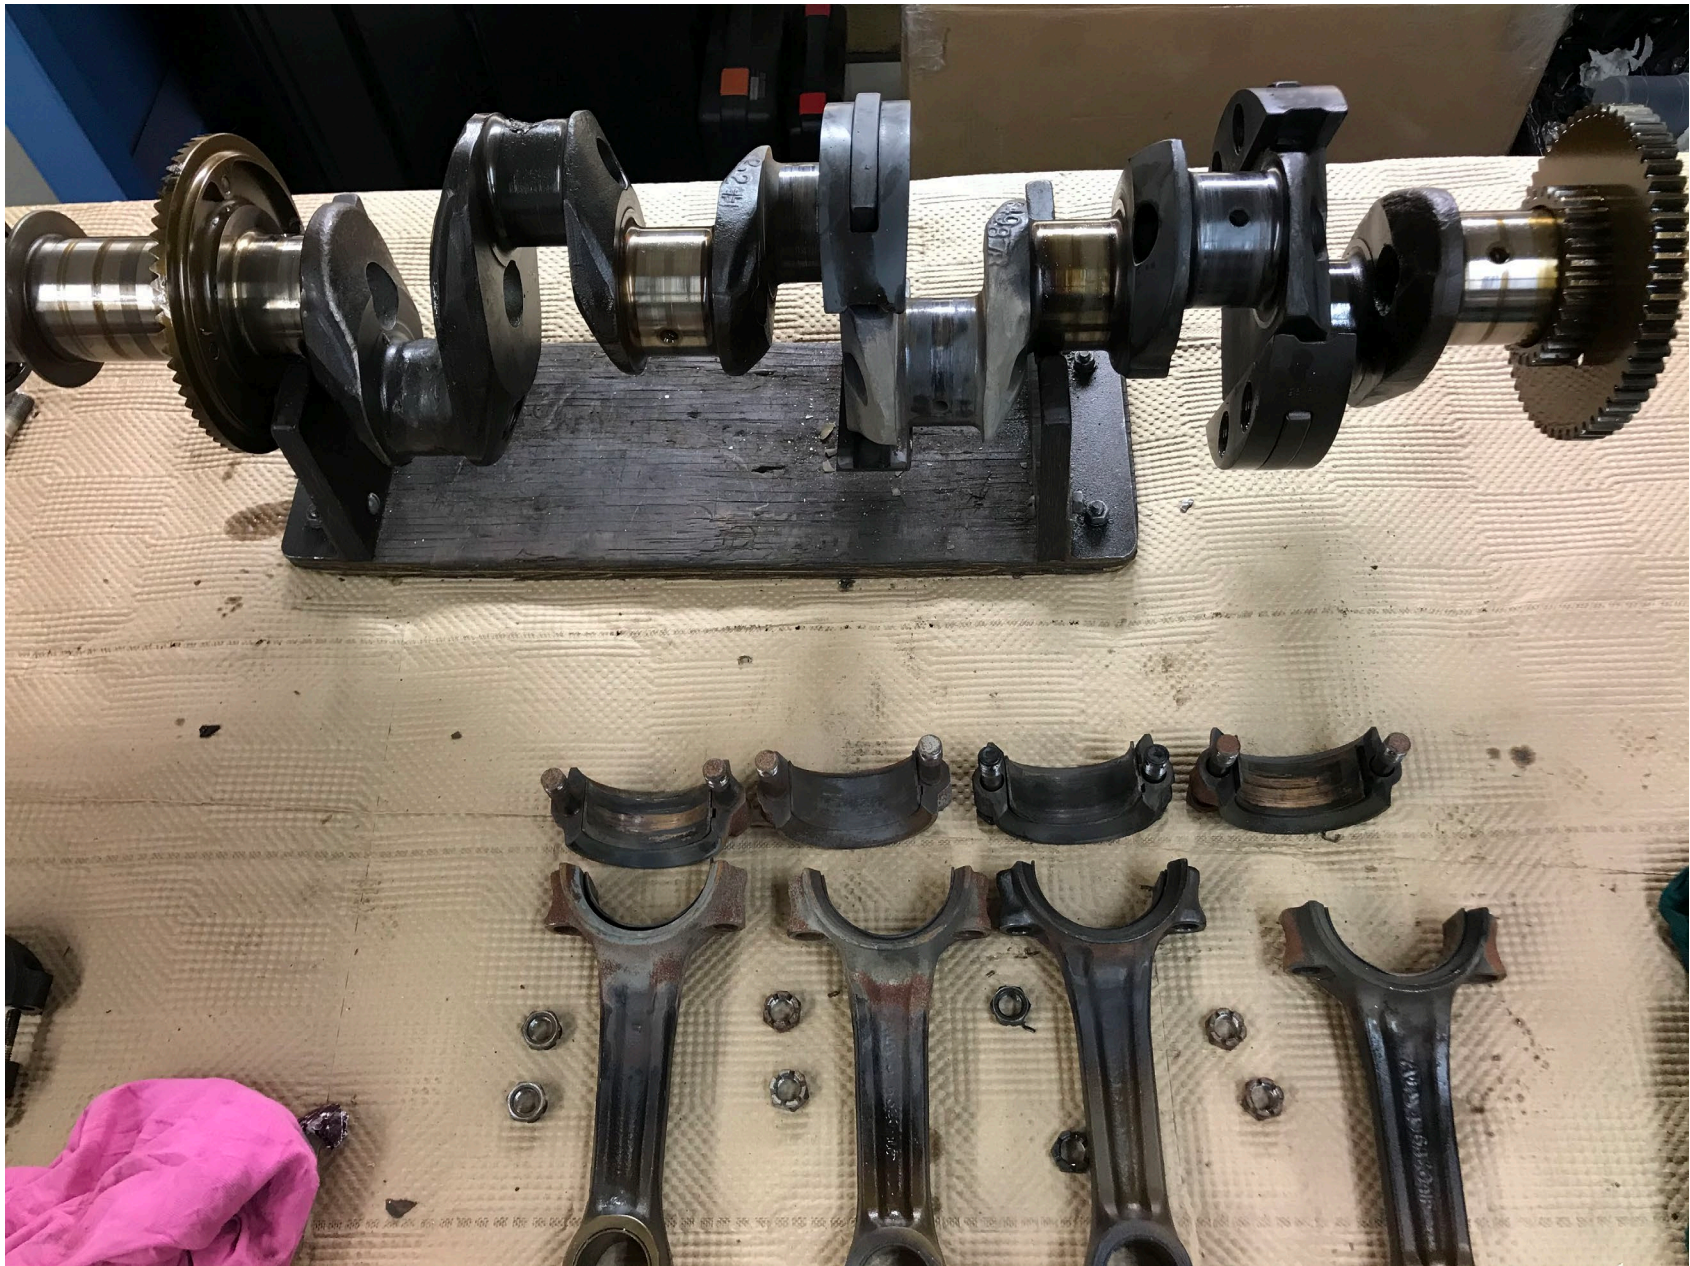
**Photo 18 – Crankshaft and Nos. 1, 2, 3 and 4 connecting rods**

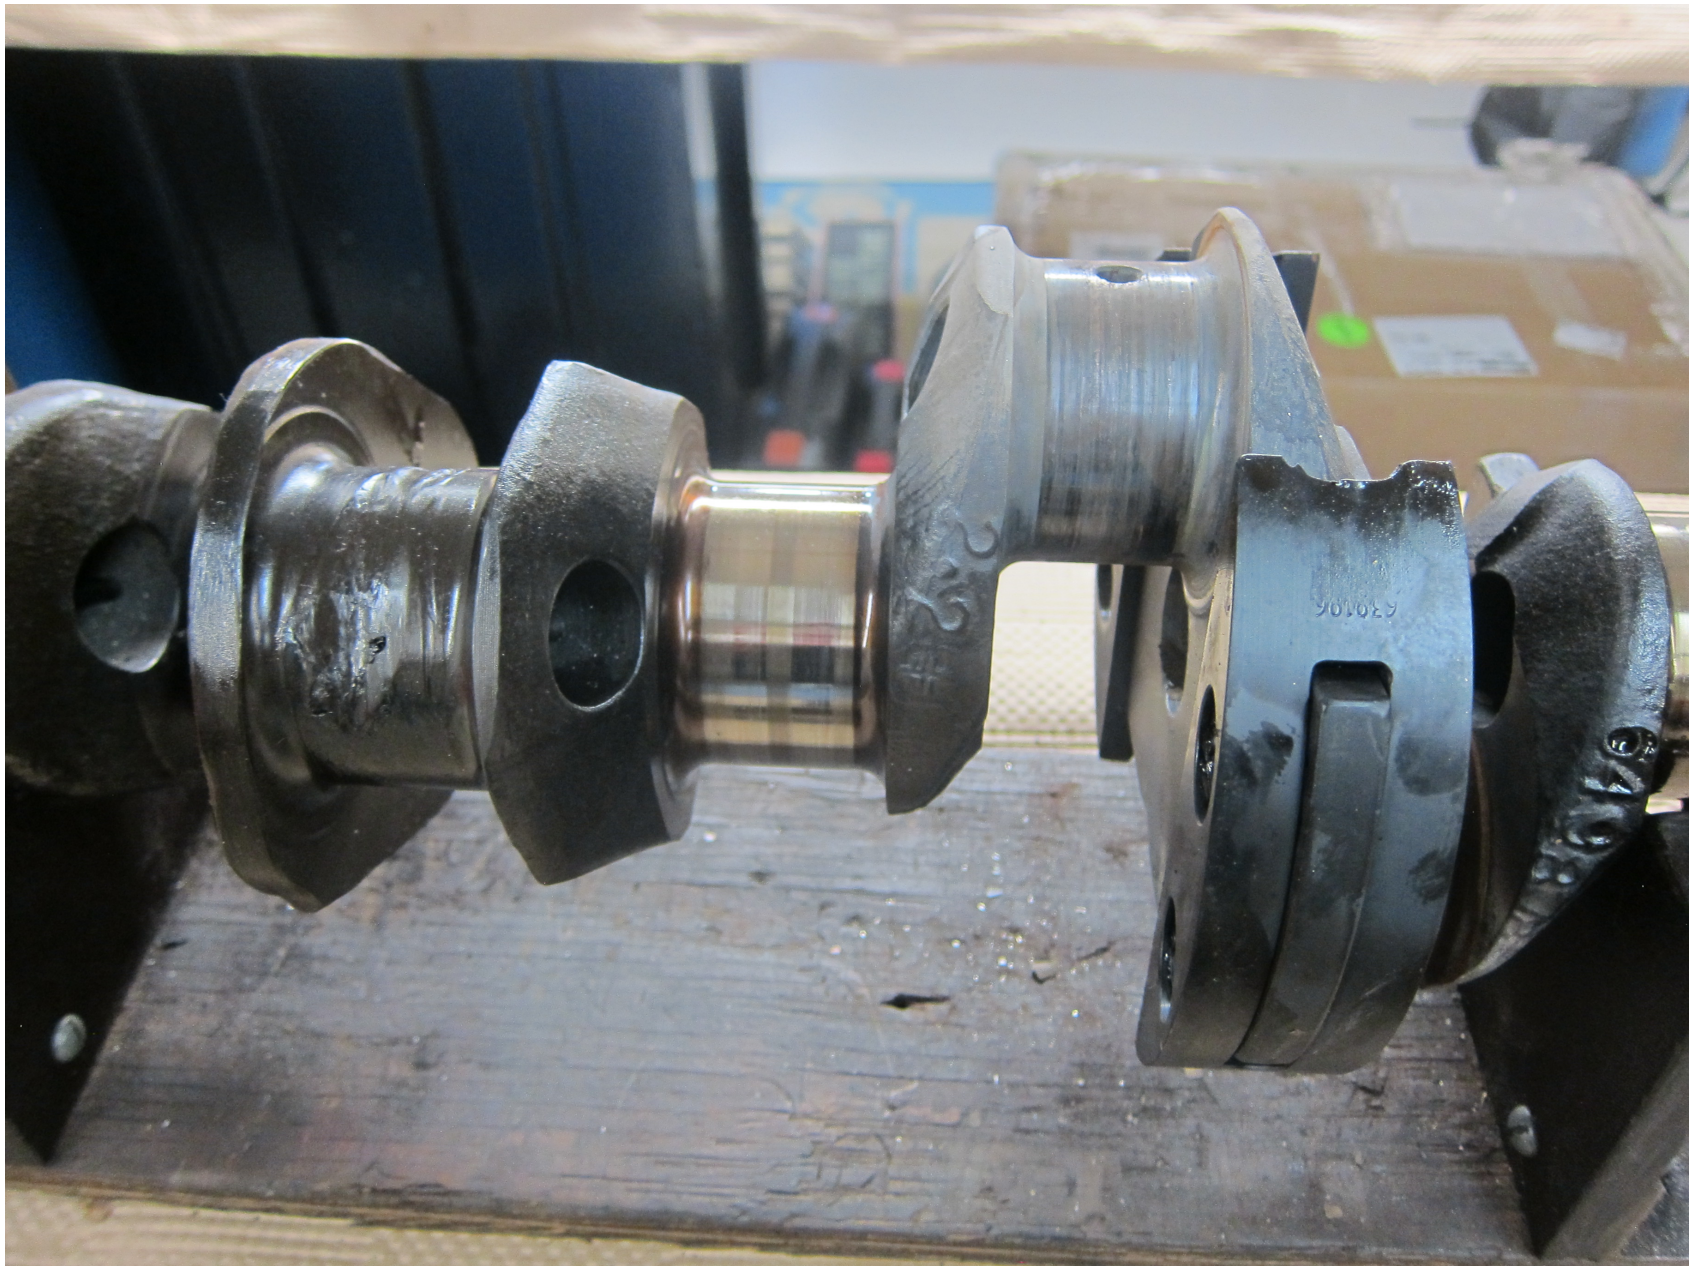
**Photo 19 – Nos. 4 and 5 rod journals**

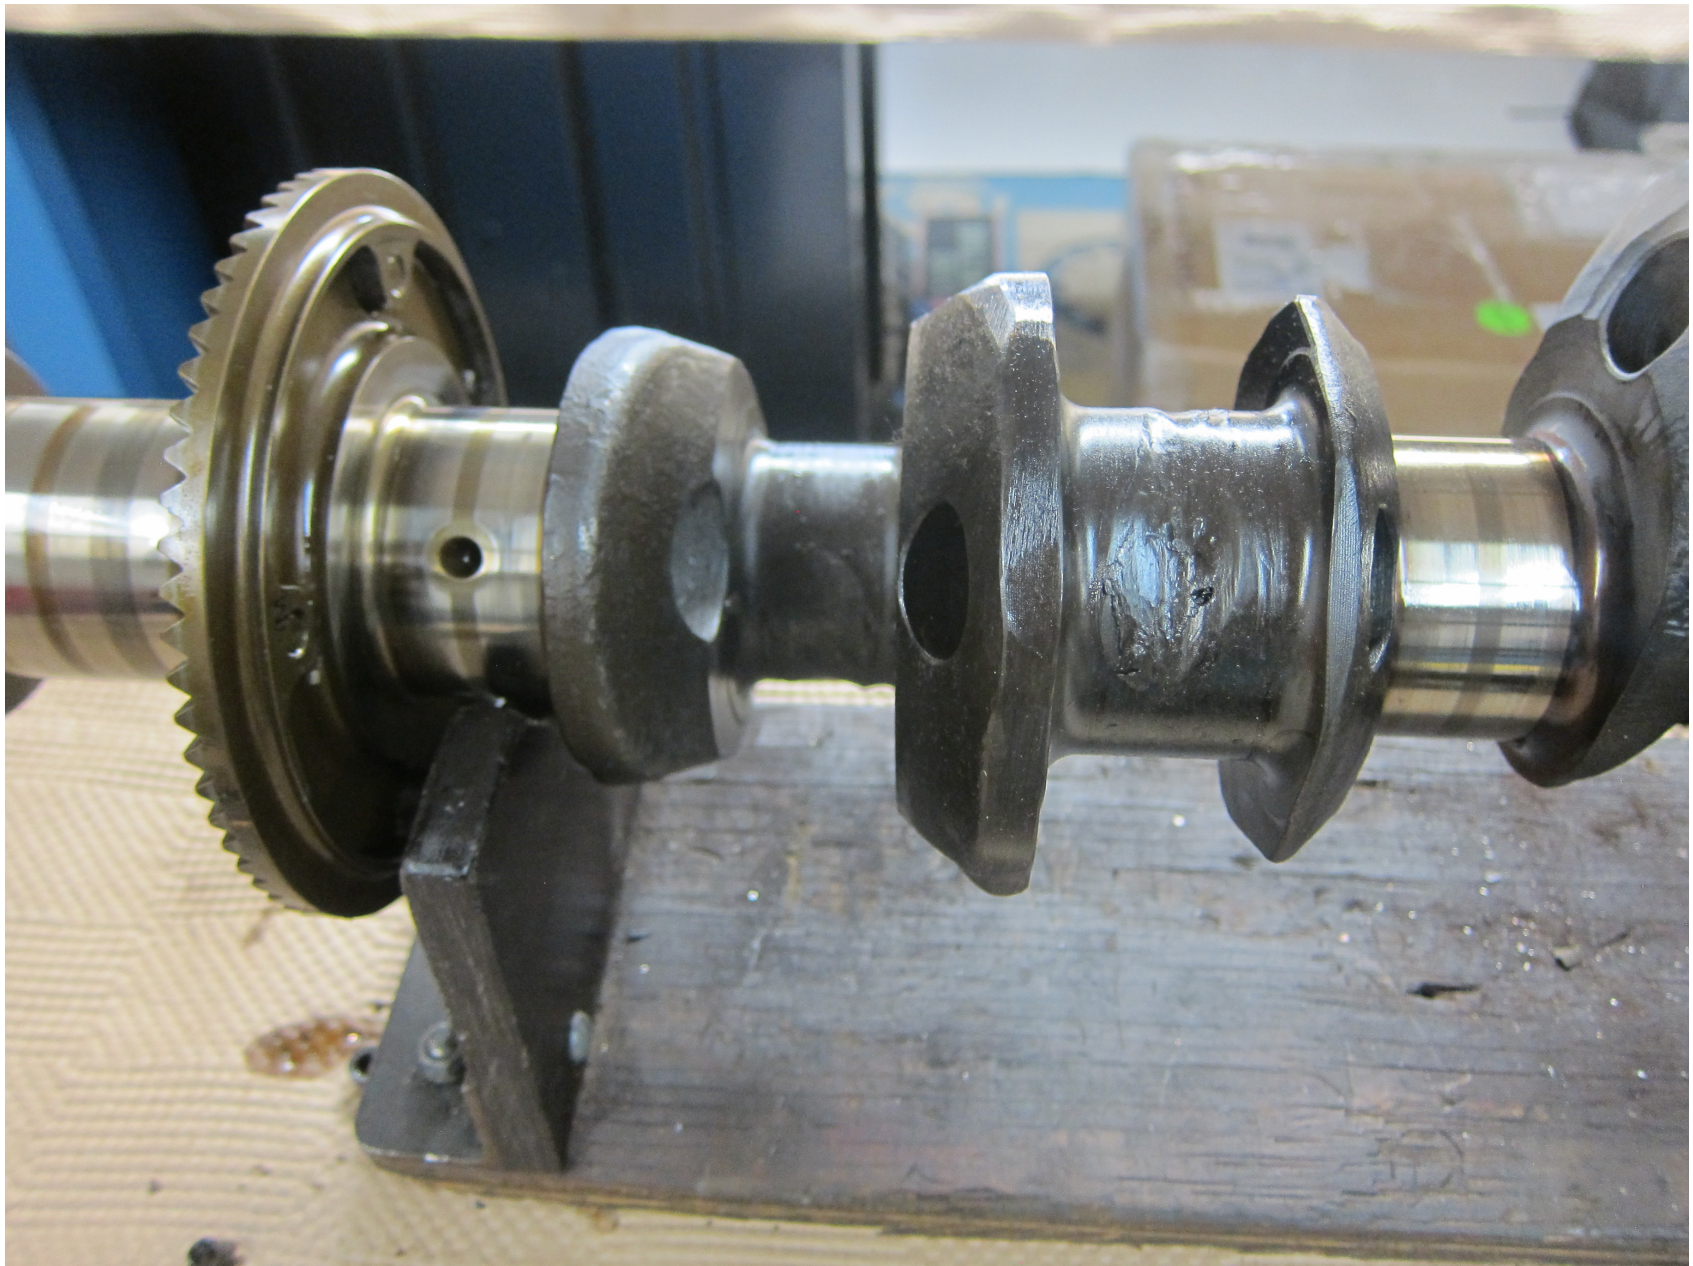
**Photo 20 – Nos. 5 and 6 rod journals**

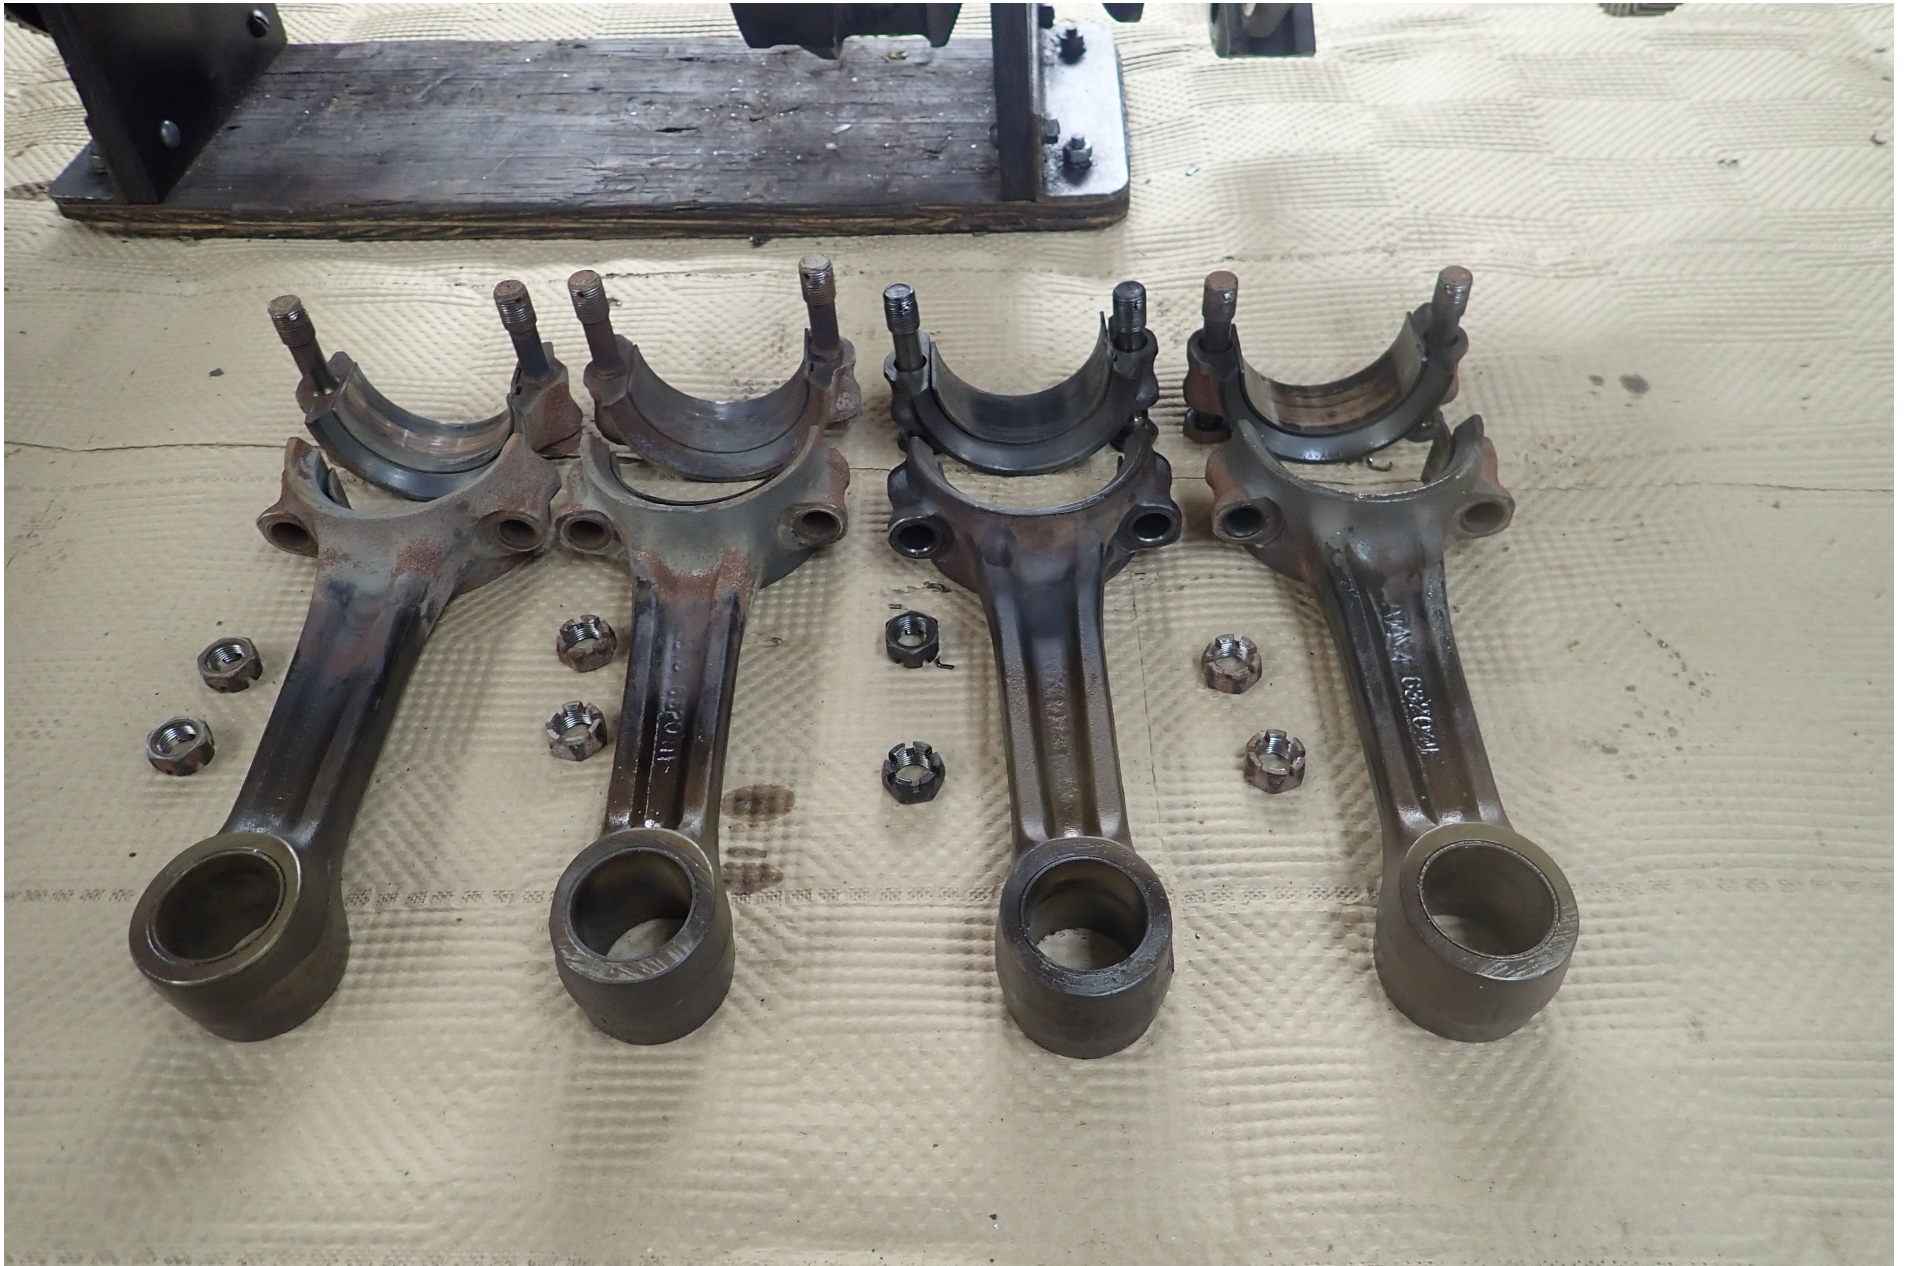
**Photo 21 – Nos. 1, 2, 3 and 4 connecting rods and bearings**

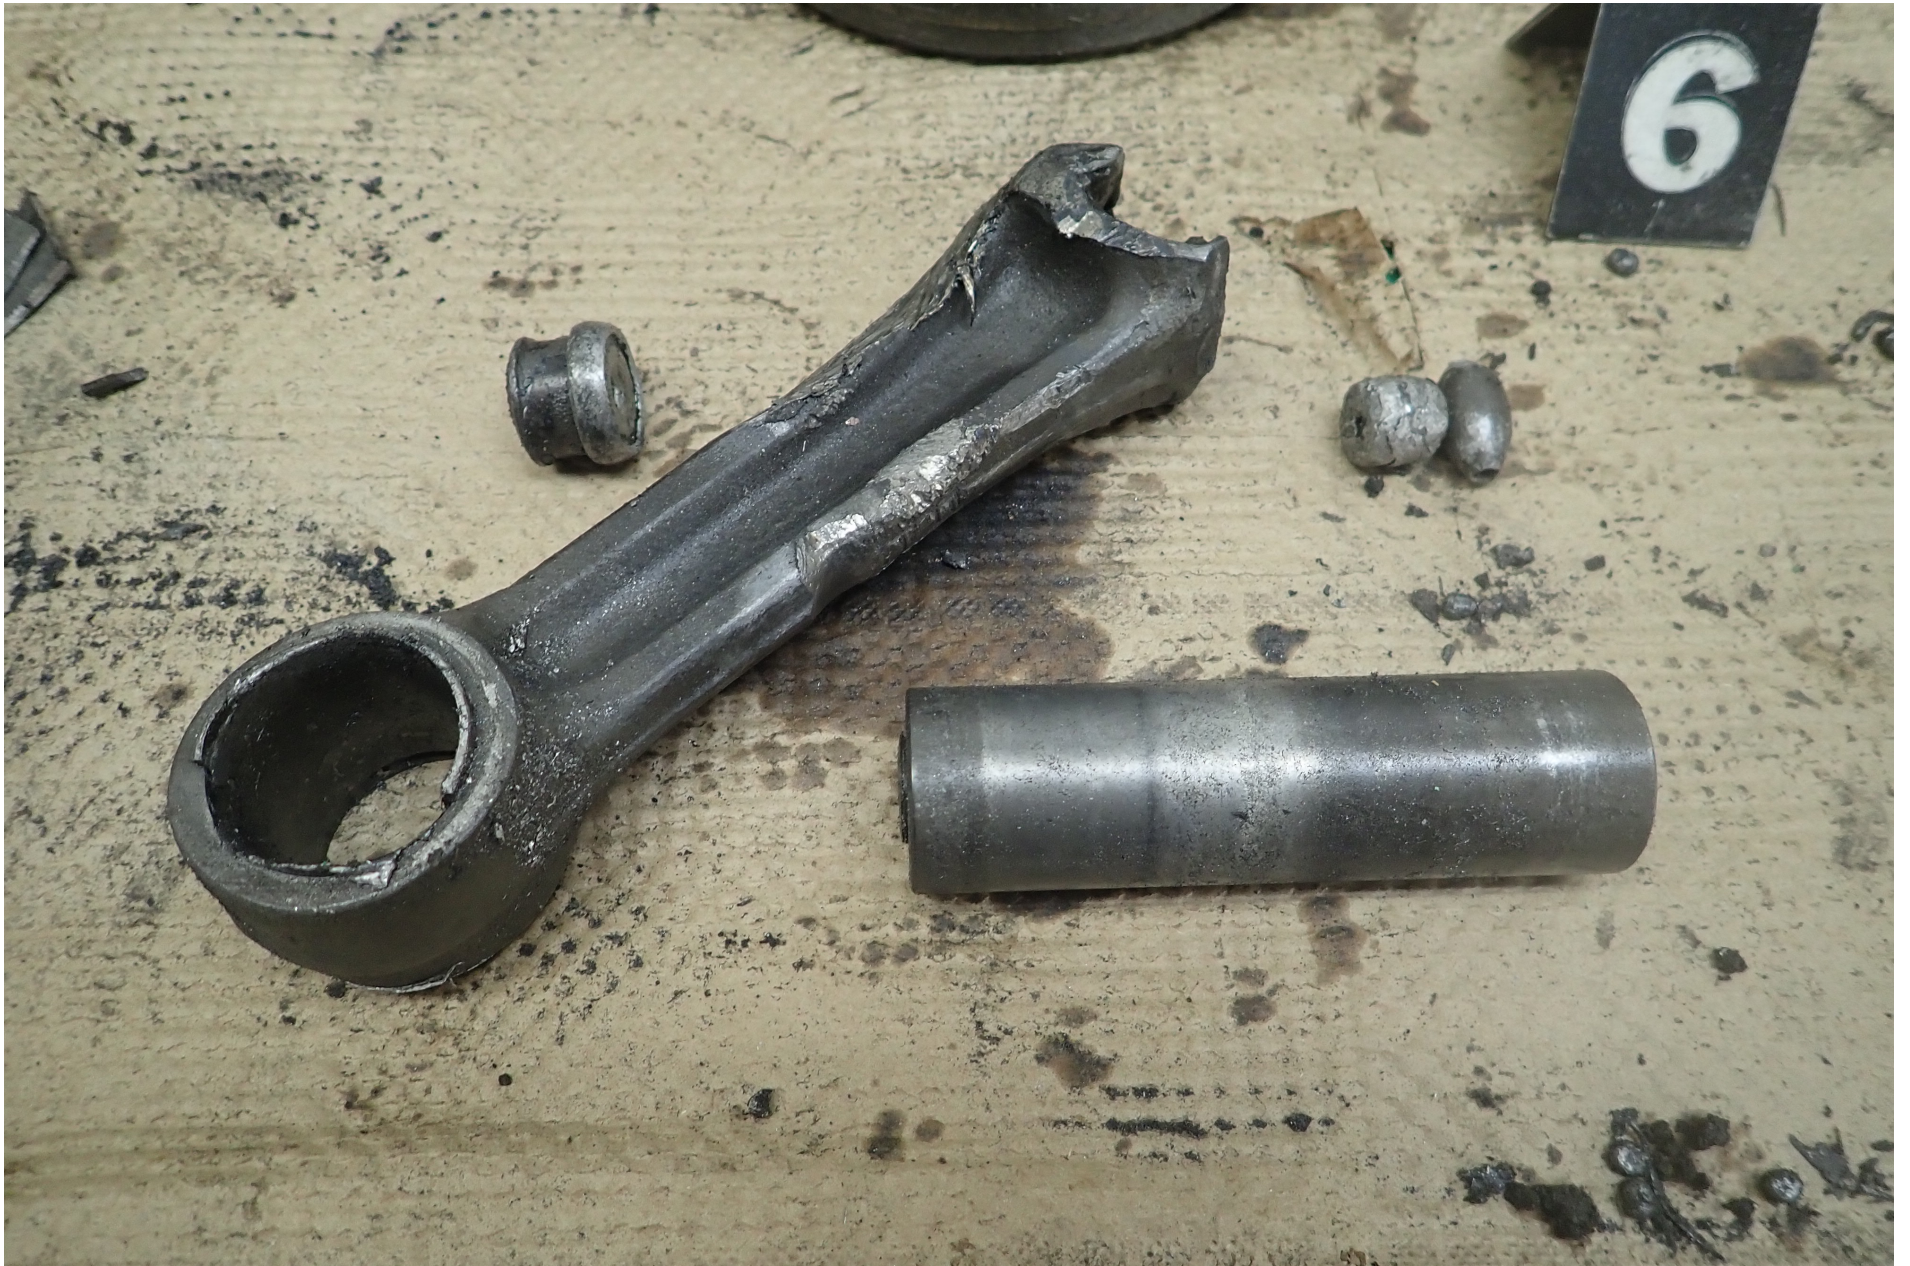
**Photo 22 – No. 6 connecting rod and piston pin**
