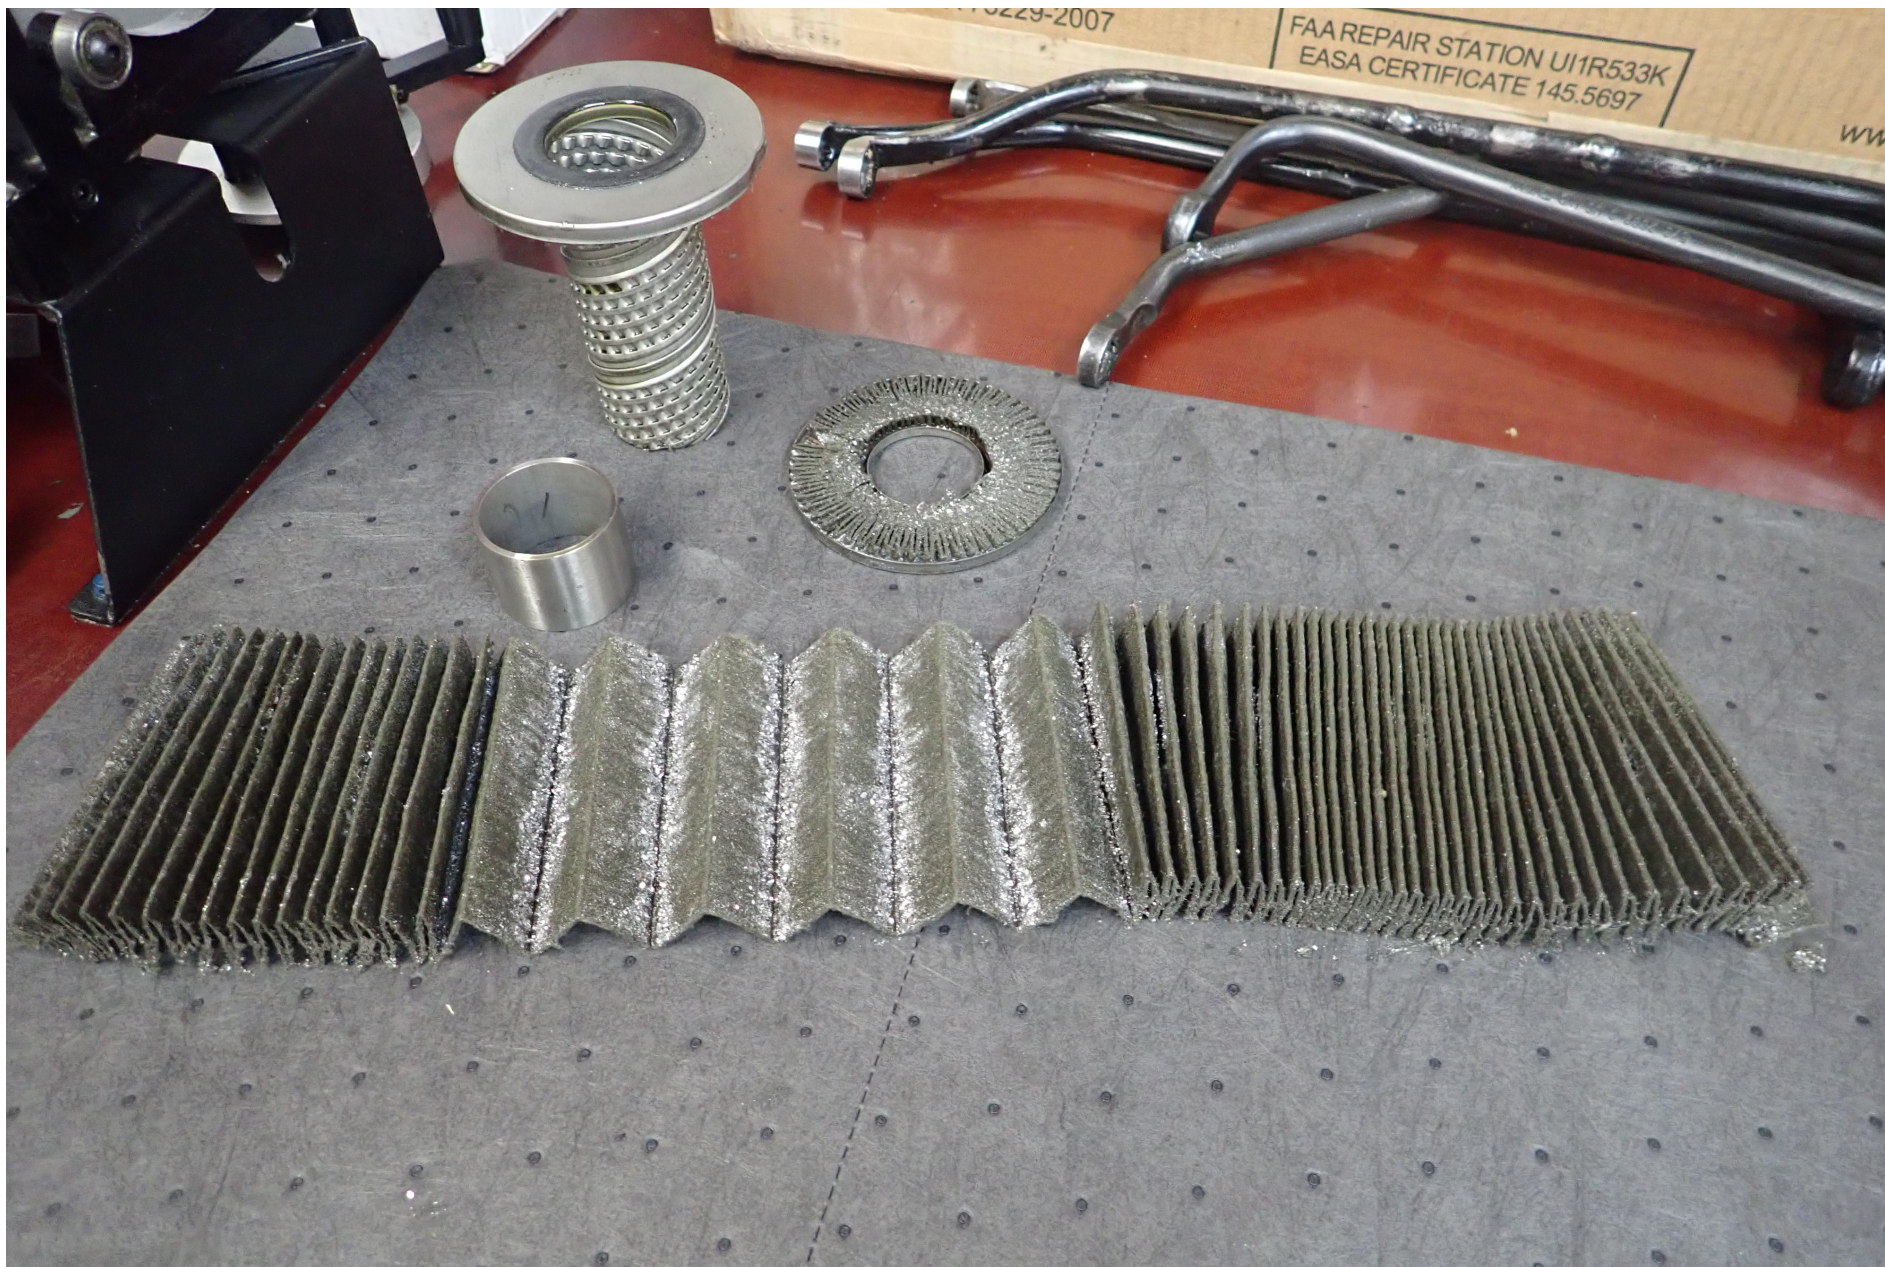
**Photo 23 – Oil filter element**

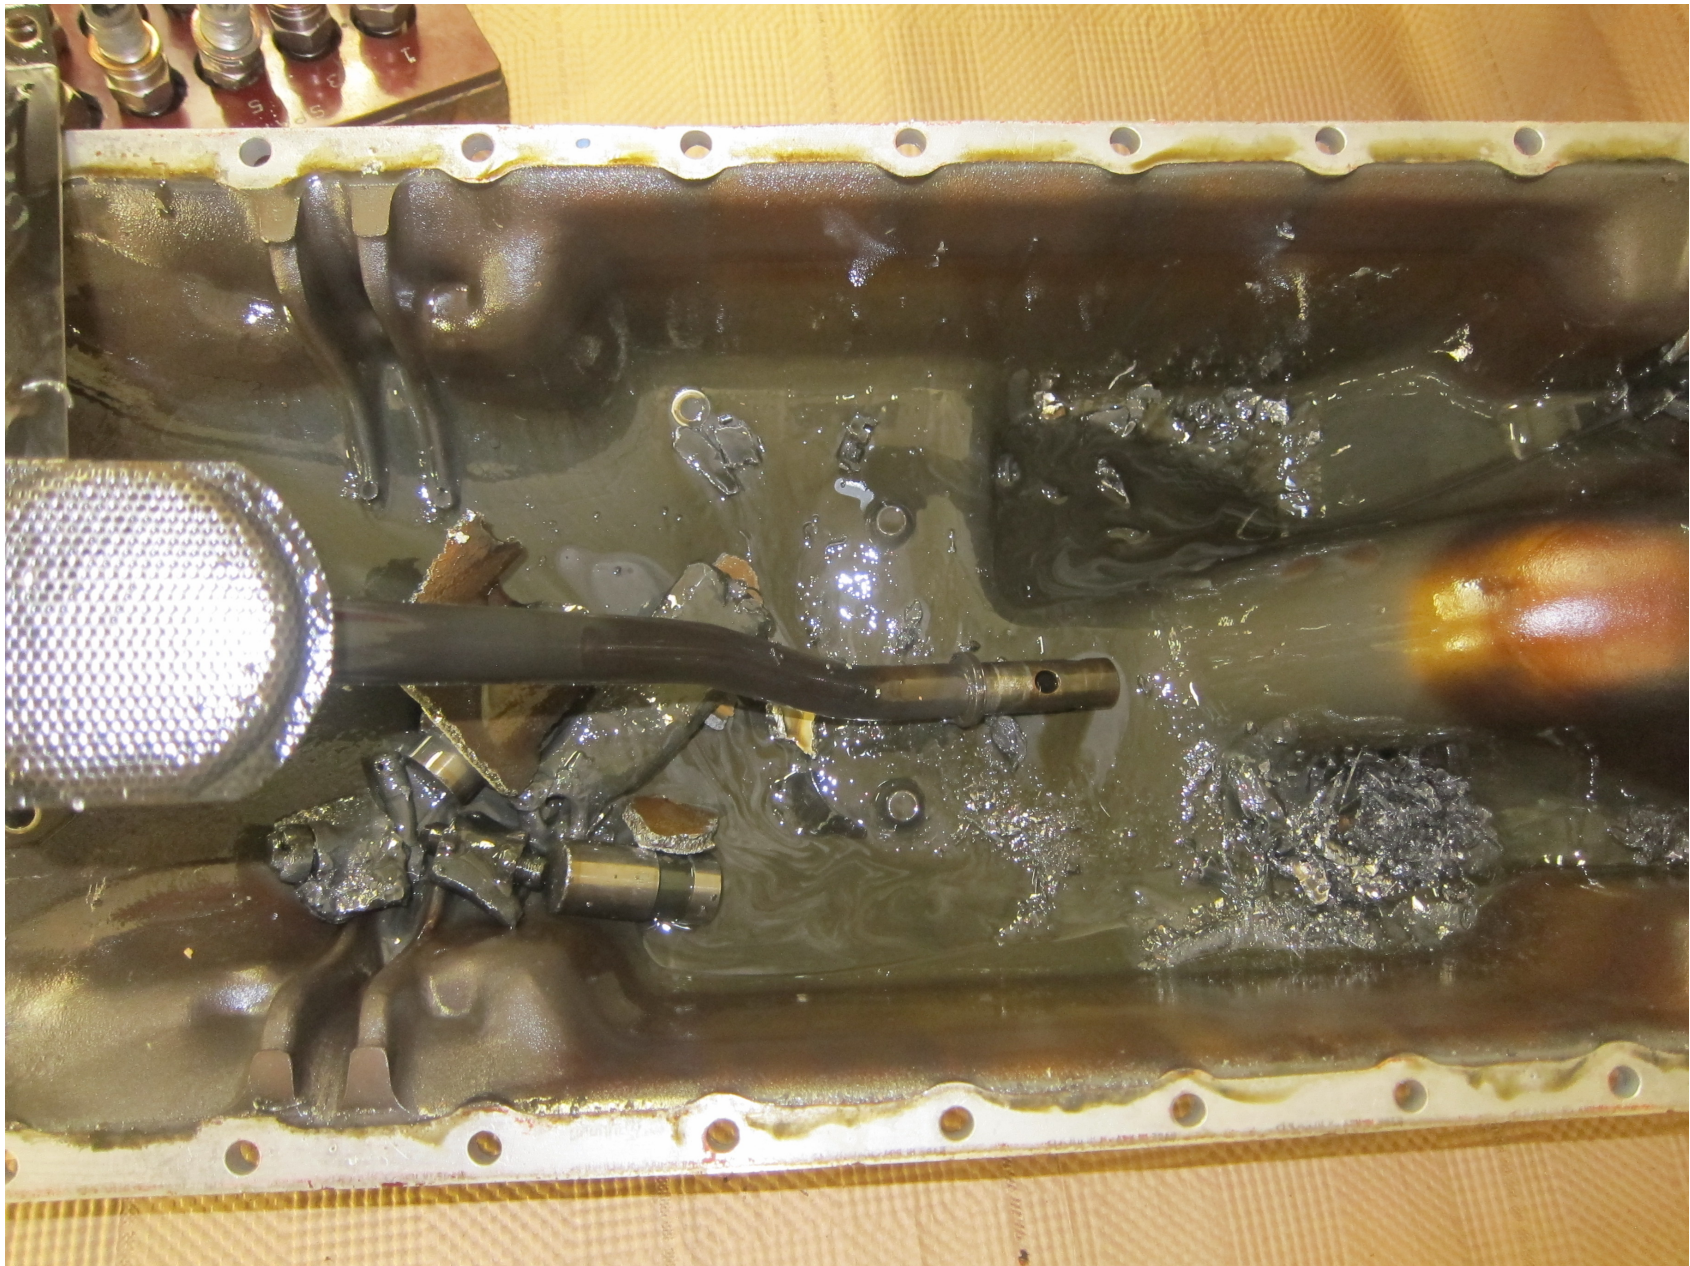
**Photo 24 – Debris in oil pan**
