**NATIONAL TRANSPORTATION SAFETY BOARD  
OFFICE OF AVIATION SAFETY  
WASHINGTON, D.C. 20594**

**POWERPLANTS GROUP CHAIRMAN'S FACTUAL REPORT**

**NTSB ID No.: CEN19LA295**

Location: Olney, Texas  
Date: August 29, 2019  
Time: 1100 central daylight time  
Aircraft: Air Tractor AT-502A, Registration: N8517Q

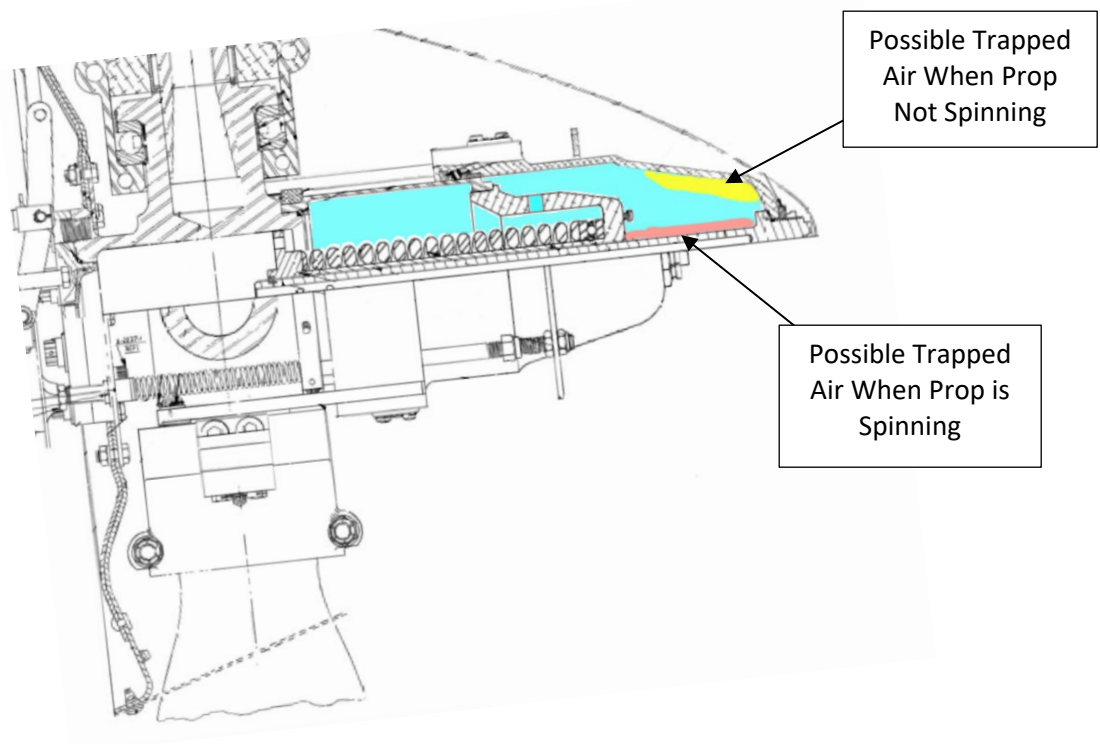
When newly assembled, the engine propeller shaft (Figure 5) and the propeller cavity (Figure 6 - depicted in blue) contain only air. Once the engine is started, oil is transferred from the prop governor via the propeller oil transfer sleeve in the RGB, through the oil transfer holes in the propeller shaft and into the propeller shaft hollow center. Oil flows forward, into the propeller cavity, filling the inner cavity of the cylinder and then passes through the transfer oil holes, filling the external piston cavity. The piston cavity is a closed dome with no bleed fitting, and any air and oil trapped in the piston must leave back through the oil transfer holes in the cylinder. The propeller begins spinning as soon as the engine started and the oil entering the piston is centrifuged outward, causing any trapped air (Figure 7 – depicted in pink) to be captured at the center of the external piston. Once shut down, it is possible that the remaining air may be captured in the forward upper portion of the external piston (Figure 7 - depicted in yellow). The chance that all the air will exit the transfer holes is low if the cycles are all made with the airplane at the nose-high ground angle.

Figure 7 - Propeller Cross Section - Possible Captured Air (Courtesy of Hartzell)

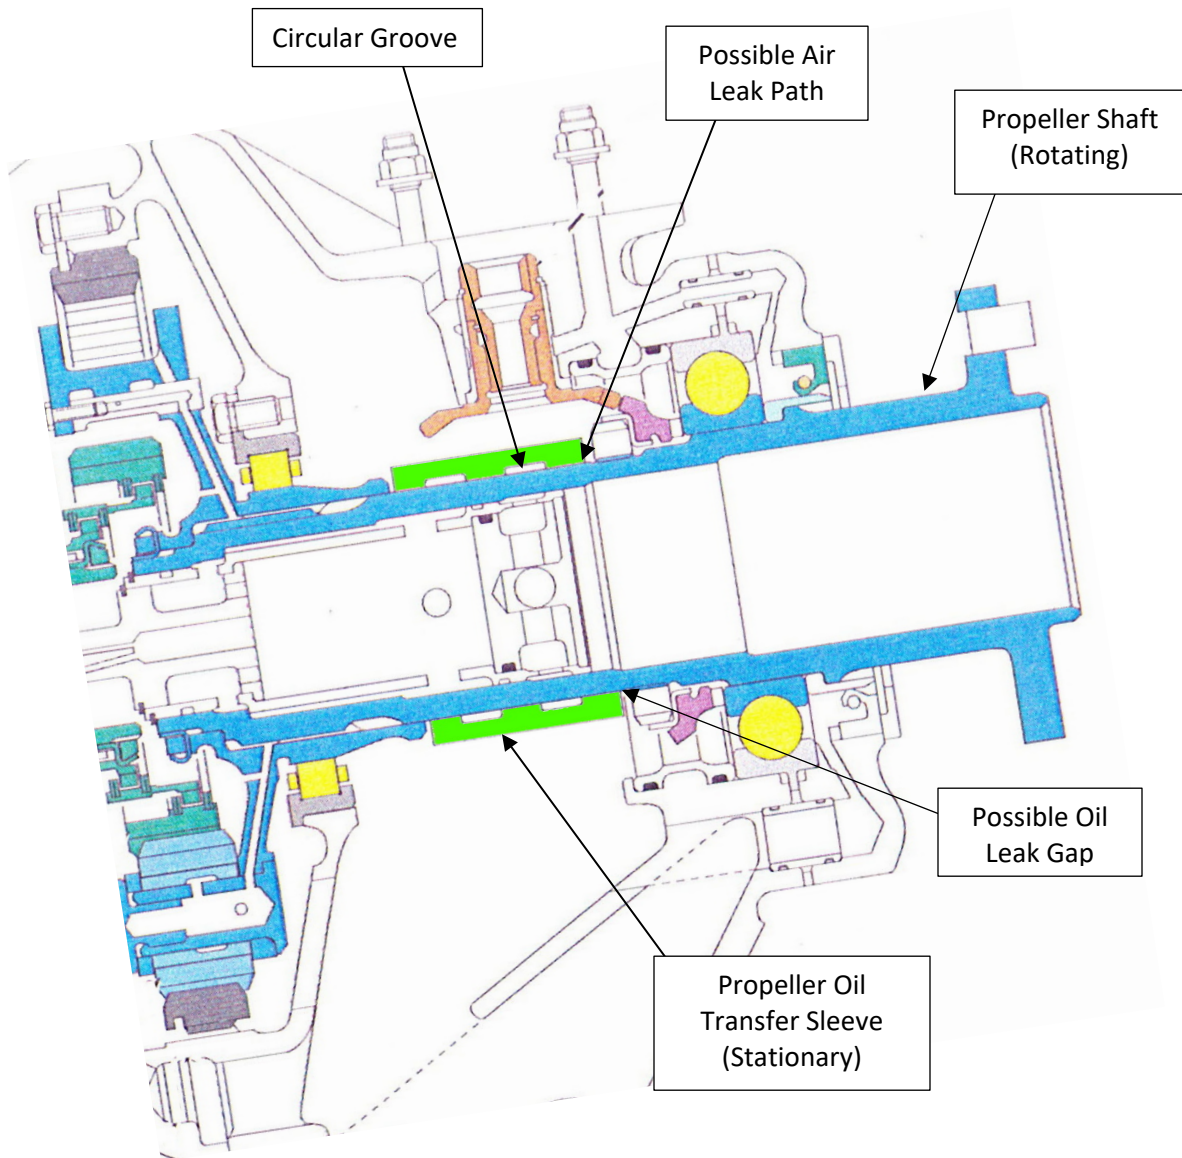
**Figure 8** - Reduction Gearbox & Oil Transfer Sleeve Detail (Courtesy of Pratt & Whitney Canada)

An examination of the propeller oil transfer sleeve (POTS) reveals a possible oil leak path during long term inactivity (See [Figure 8](#)). The purpose of the POTS is to allow the propeller governor to add or drain oil from the propeller shaft/cylinder/piston cavity from the stationary POTS to a rotating propeller shaft. The POTS is manufactured with a

very tight tolerance fit against the journals on the propeller shaft; however, there is still a gap between the POTS and the propeller shaft journal. During operation, the oil leakage of the running seal is negligible; however, when shut down, oil can leak through the gap. For a large amount of oil to leak; however, it must be displaced with air for the flow to continue. The source of the air can be the top section of the POTS (See [Figure 8](#)). The angle of the propeller allows the air that is usually captured in the POTS circular groove to be forced out of the gap on top, while oil leaks out of the bottom gap. Additionally, the angle of the installed engine makes the propeller piston to sit higher than the POTS, causing a small head of oil pressure at the running sleeve. The behavior does not occur on engines that are installed horizontally.

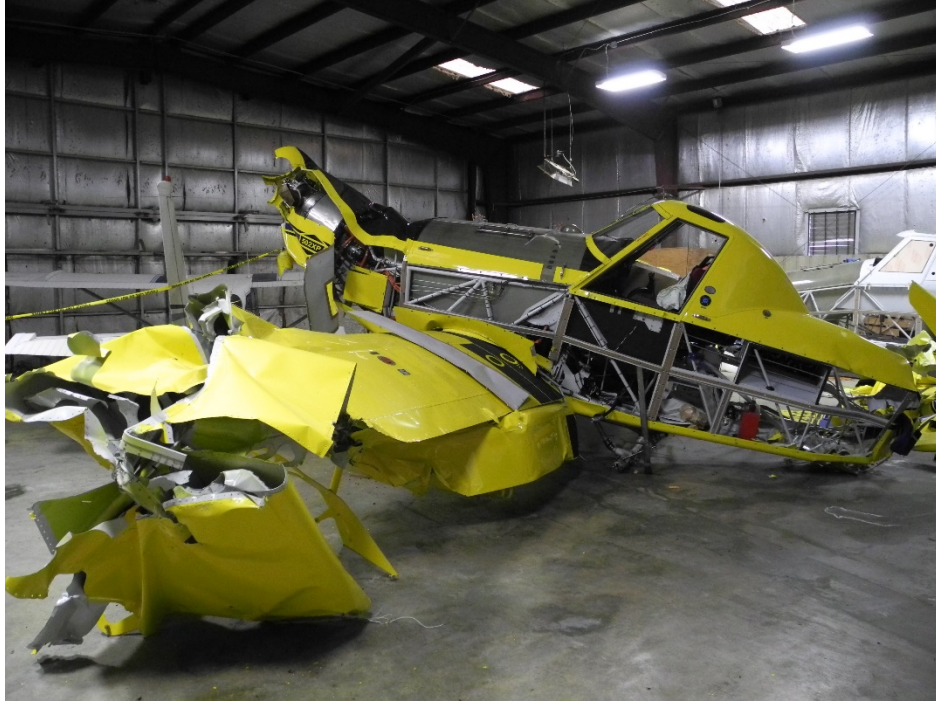
The wings were heavily damaged at the end of both tips with the outboard 5 feet of wing crumpled and fractured ([Photo 1](#)). Clumps of grass were still stuck in the fracture cracks of the skin. The aft approximately 10-foot section of the empennage was fractured and separate from the fuselage. The landing gear was buckled near the upper bend and the internal fuselage structure was buckled near the wing root. The cockpit was generally intact. The engine mount structure was bent upwards by approximately 2.5 feet and aft-wards approximately 1.5 feet ([Photo 2](#)).

Photo 1 – Air Tractor AT-502

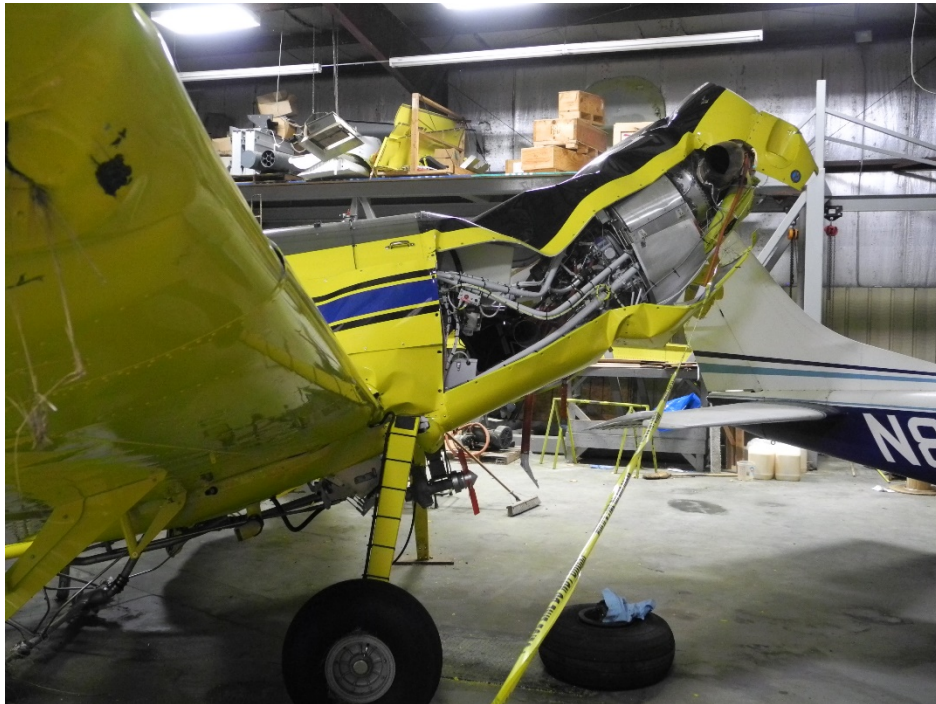
Photo 2 – AT-502 Engine Frame & Mount Damage

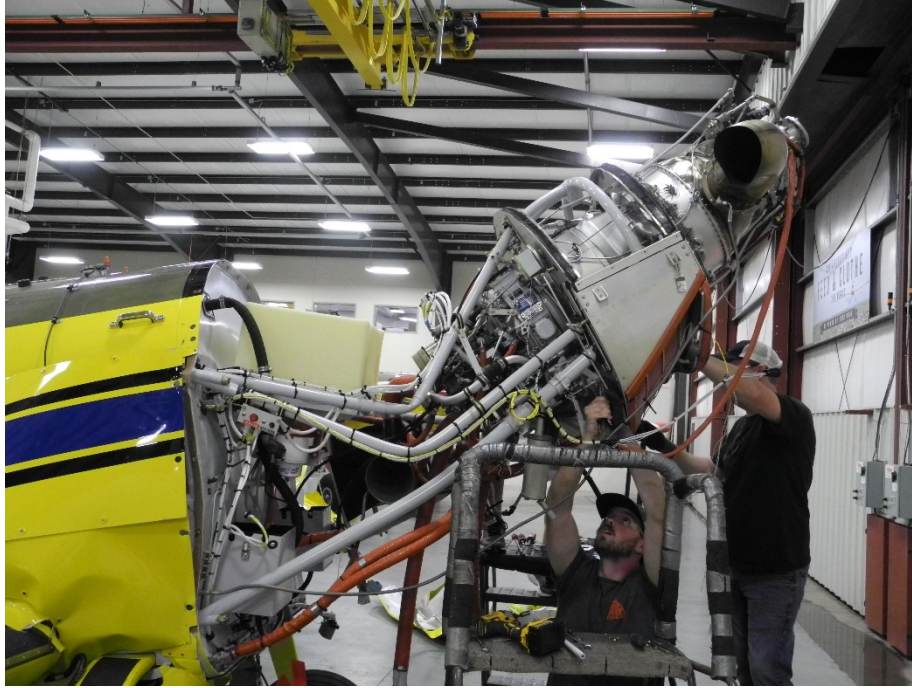
The engine was still attached to the airframe engine mount ring ([Photo 3](#)); however, the elastomeric mounts and attachment bolts were deformed. The propeller was separated from the engine propeller shaft. The 5-inch section of the propeller shaft flange was fractured and two propeller mounting bolts were still present in the flange holes ([Photo 4](#)). The starter generator was undamaged and still attached to the AGB.

Photo 3 – Engine Still Attached to Airframe Mount

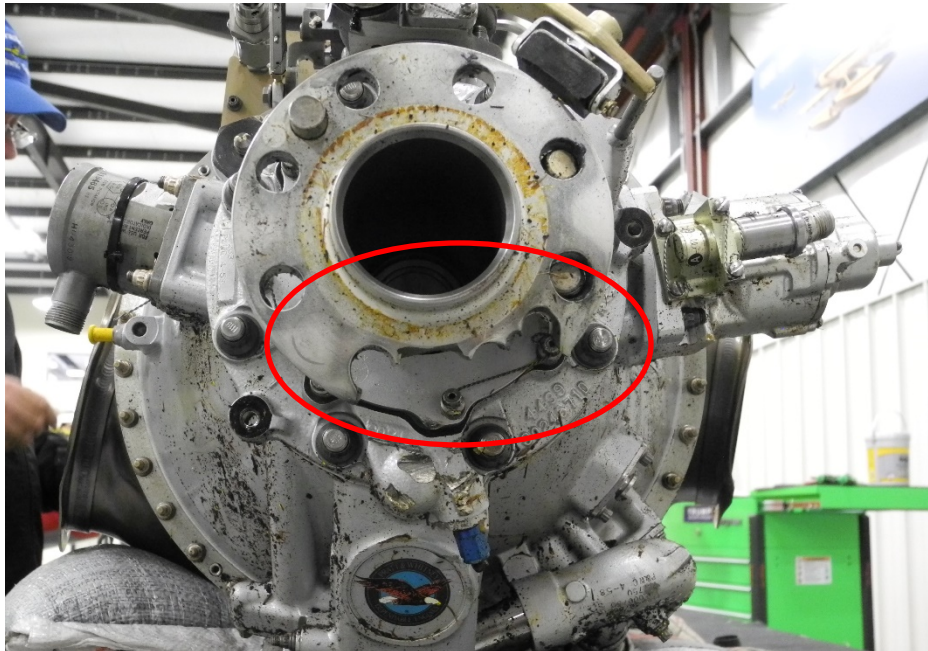
Photo 4 – Engine Propeller Flange – Partially Fractured

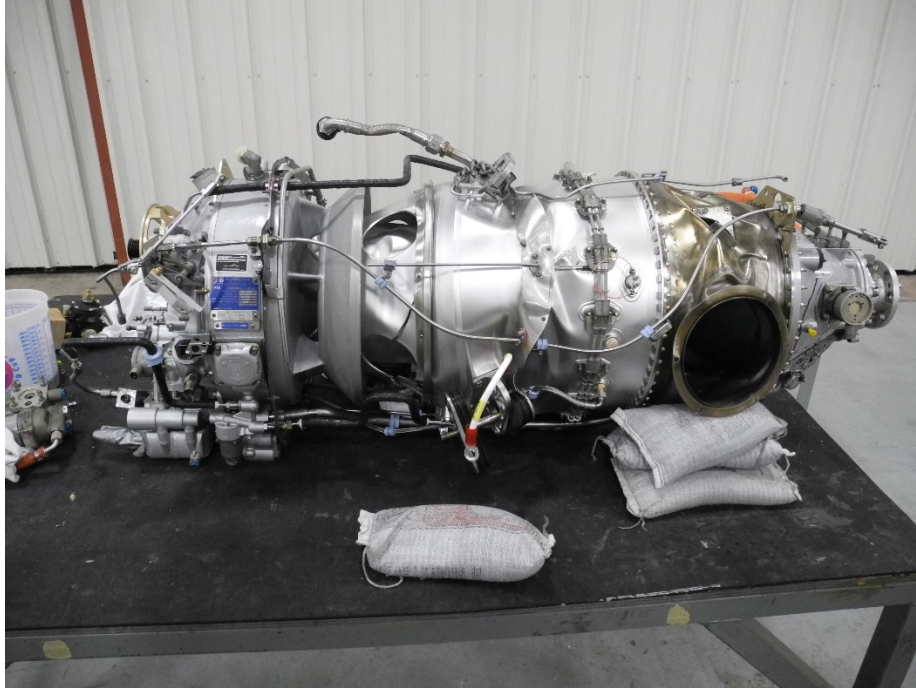
All the major engine modules were bent and/or fractured (Photo 5). The RGB was fractured circumferentially through 360 degrees (Photo 6). The exhaust housing was bent approximately 20 degrees upward and buckled. The combustor housing (Photo 7) was buckled at the upper flanges in the main mount plane and deformed into the housing. The external compressor housing was buckled, and the inner panels were deformed and fractured. The AGB was undamaged but slightly askew from the engine centerline.

Photo 5 – PT6A-140AG Engine – Deformed Modules

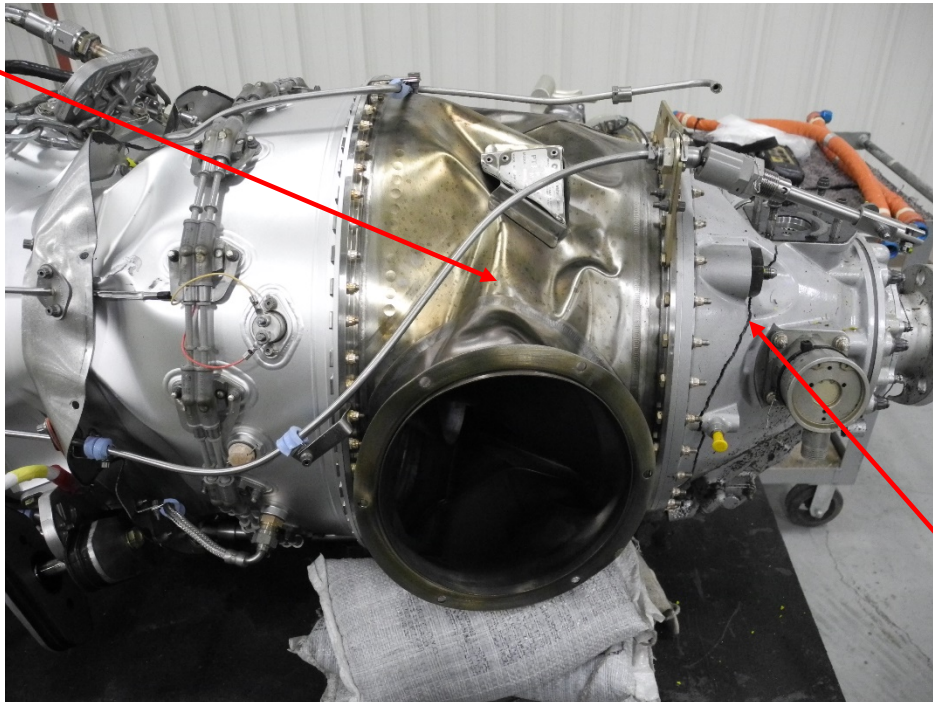
Photo 6 – RGB Fractured and Exhaust Housing Buckled

Exhaust  
Housing -  
Buckled

RGB  
Fractured

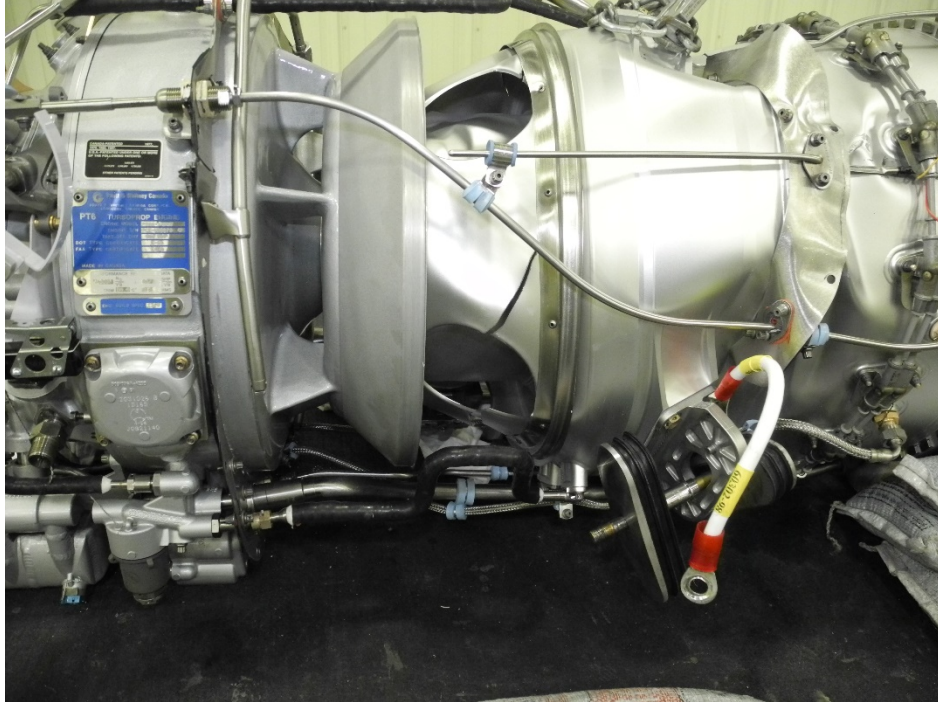
Photo 7 - Compressor Housing – Buckled and Torn

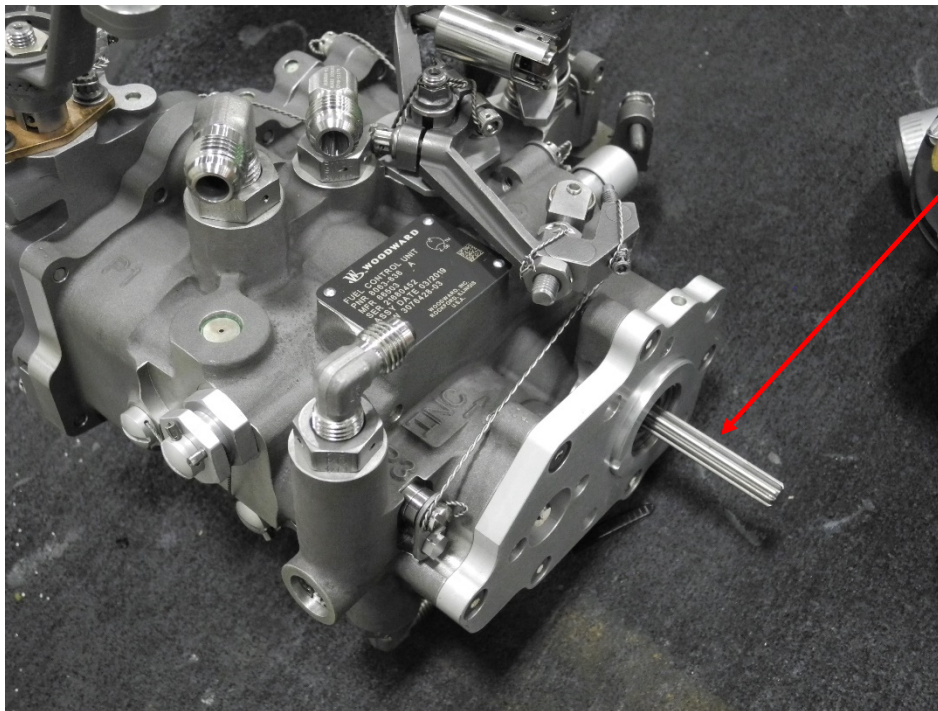
Photo 8 – FCU – Input Spline - Undamaged

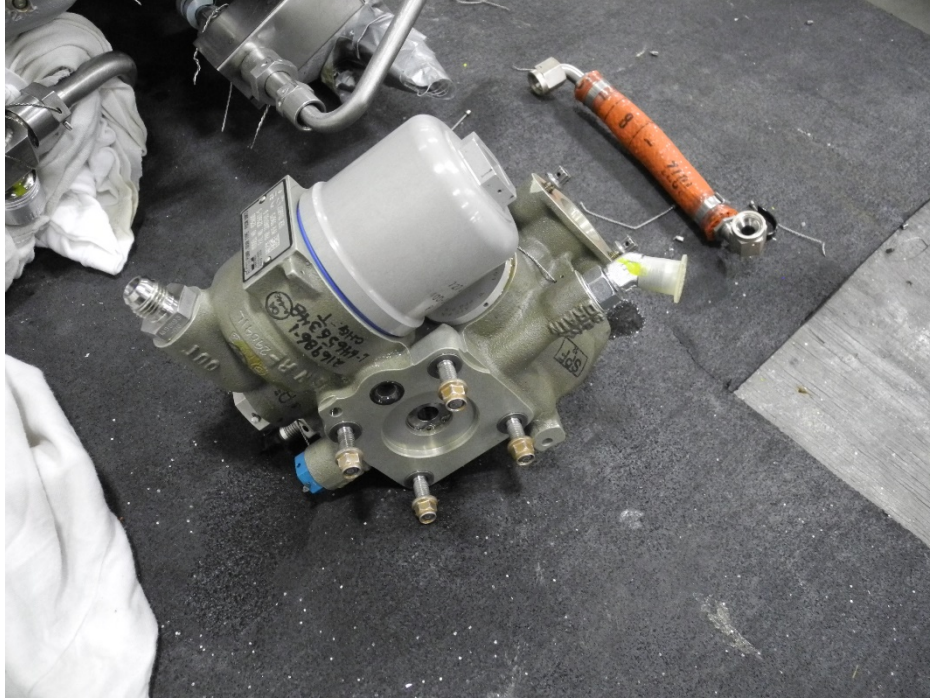
Photo 9 – Fuel Pump - Undamaged

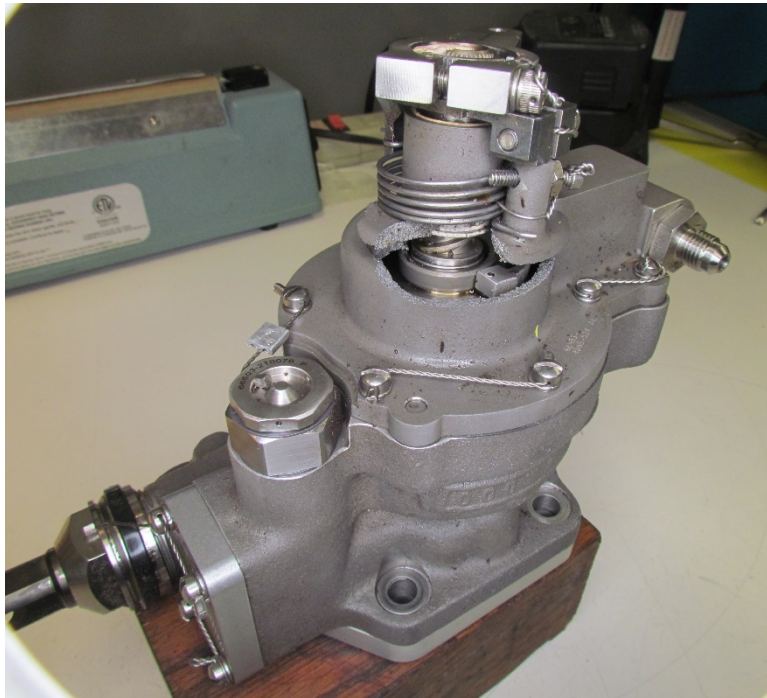
The CSU, P/N 3074154-01, S/N 21633198 housing was fractured, revealing the speeder spring and cam assembly (Photo 10). The beta valve was free to move. The beta valve lever was in location and still attached to the beta valve, the reversing cam push-pull cable and the carbon block. The carbon block, which was undamaged, was no longer

retained in the beta ring because the propeller was separated from the propeller shaft. The CSU was sent to the P&W Canada overhaul facility in St. Hubert, Quebec, Canada, where it was torn down, revealing no pre-accident damage that would have prevented normal operation.

Photo 10 – Propeller Governor (CSU) - Fractured

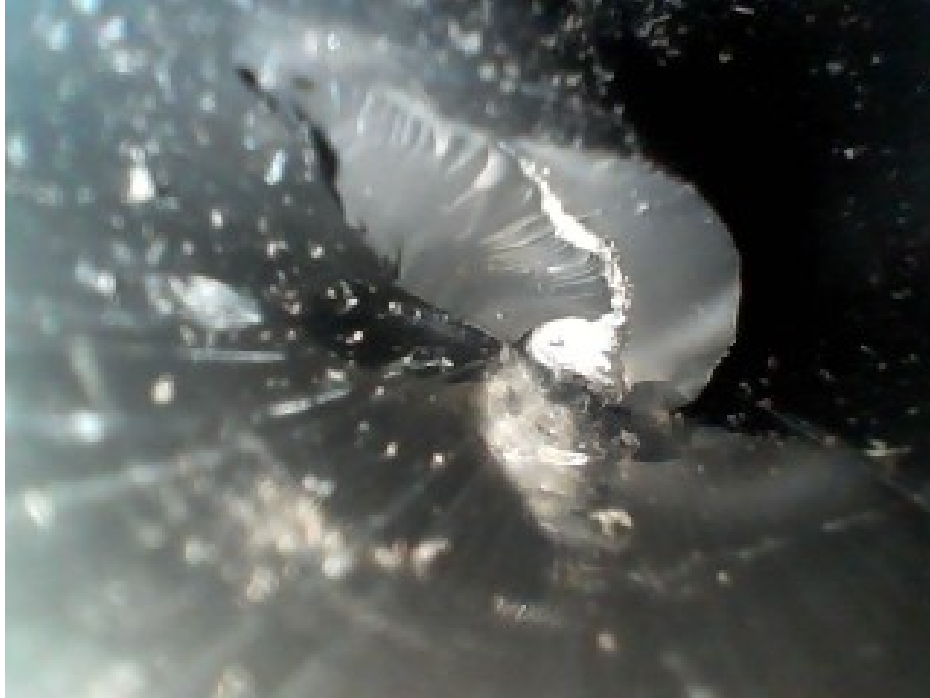
Examination of hose number 2, a Parker Stratoflex 111-12, MIL-DTL-8794-12 3Q18 OELG7 hose incorporated into an Air Tractor part number 51097-26 (05-30-2019), revealed an internal fracture in the rubber sleeve at approximately 20 inches from the fuel pump fitting ([Photo 11](#)). When examining the 30-inch-long hose location in the airframe, it was noted that the hose is in a looped condition when installed and that it is supported with a small tie-wrap against a small diameter structural airframe strut at the 20-inch location. It was additionally noted that the airframe strut was buckled near the tie-wrap location during the accident and may have contributed to the internal hose fracture. The hose was sent to Parker-Hannifin, the manufacturer, for further examination. It was determined that the internal tearing of the rubber was the result of a sharp bend that exceeded the minimum bend radius limit of the hose, consistent with having occurred after the initial impact.

Photo 11 – Fuel Hose #2 – Internal Rubber Fracture (via Borescope)

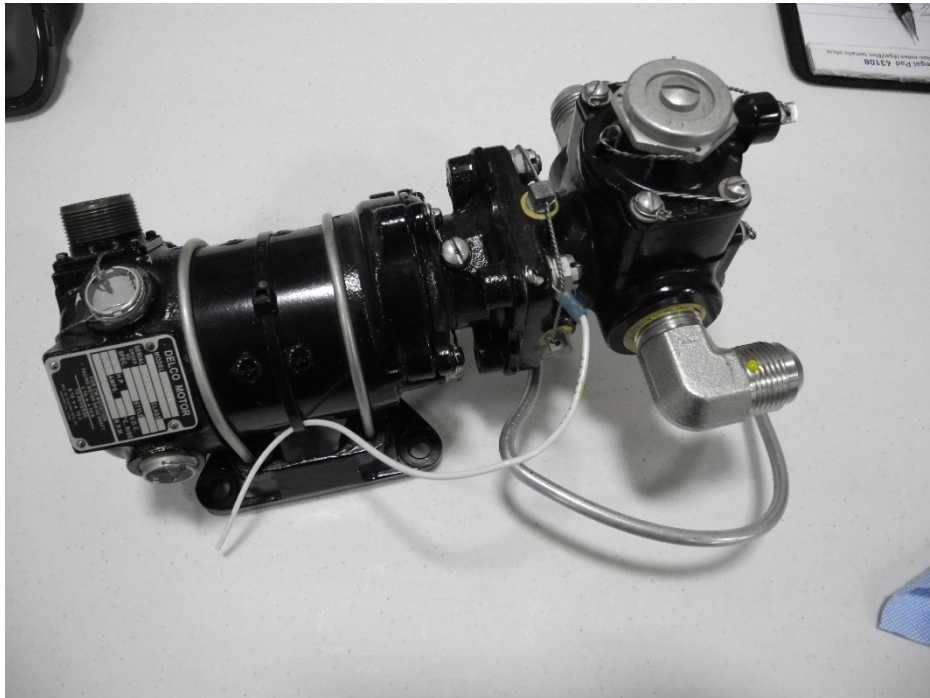
The low-pressure airframe electric fuel pump ([Photo 12](#)) is an assembly made by Sun-Air Parts and consists of a Chandler-Evans P/N CE9135, S/N E119888 pump and a Delco motor P/N A4949, S/N 27347. It was tested at the Sun-Air facilities in Valencia, CA, revealing a unit that was slightly out of calibration, but with no pre-existing mechanical or electrical damage. According to Air Tractor, the airframe electric fuel pump assembly is powered only during engine starting sequence, after which it is shut down, requiring only the engine driven pump (EDP) P/N 51076-7, S/N 01033 to supply low pressure fuel to the engine HP fuel pump. The EDP is an Air Tractor supplied component that is attached to the engine AGB and is about 4 feet above the fuel header tank, so the fuel supply hoses are always operating under a negative pressure. The EDP ([Photo 13](#)) was tested at the manufacturer's, Ontic facility in Chatsworth, CA. Despite the minor pressure variation and minor scoring observed in the rotor elements, no pre-existing damage was found in the mechanical fuel pump that would have precluded normal operation.

Photo 12 – Low-Pressure Airframe Electric Fuel Pump

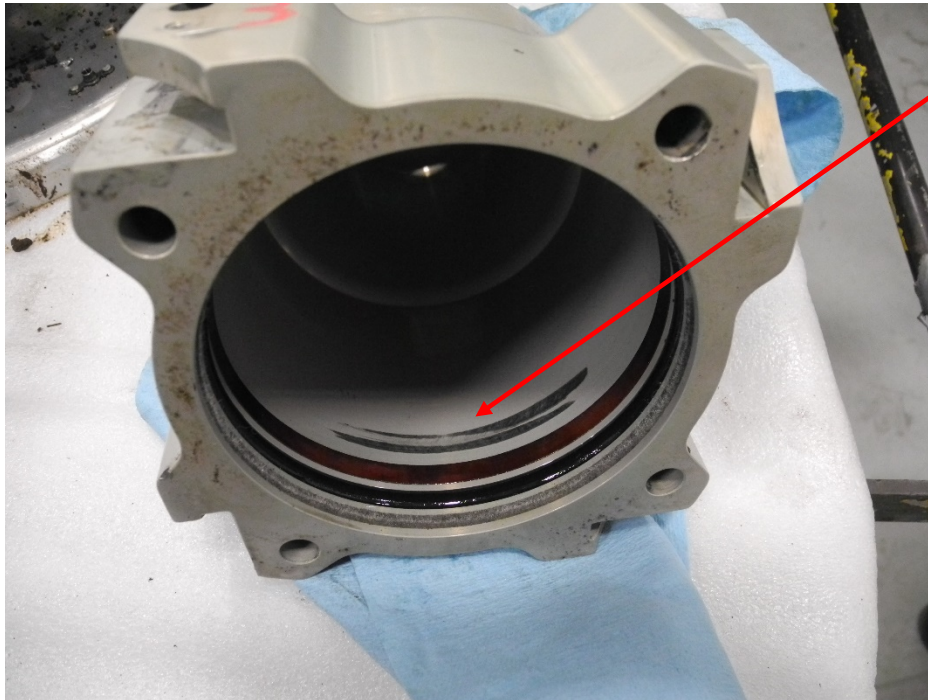
Photo 14 – Hartzell Propeller – External Piston with Impact Crease

Internal Impact  
Crease

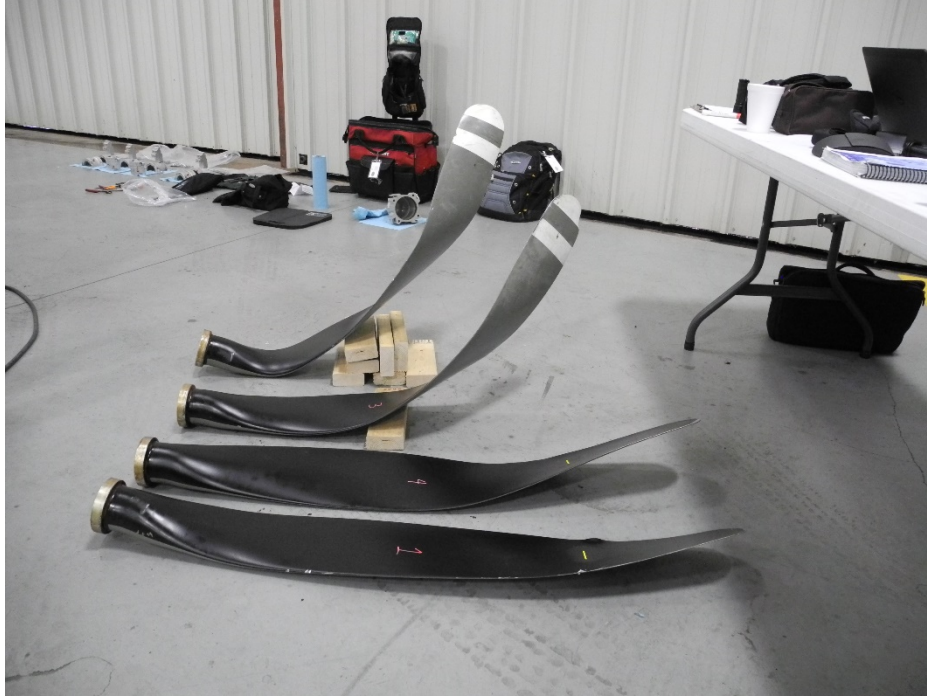
All four blades remained attached via the retention clamps, no pilot tubes were fractured and there were no blade fractures. All four blades exhibited aft bending, bending in the direction opposite rotation, and twisting towards low pitch in varying degrees. The four blades indicated a clear progressive bending and twisting in the sequence of rotation ([Photo 15](#)). All four blades exhibited chordwise/rotational abrasion predominantly on the camber side. Blades 1, 2, and 3 had leading edge gouges with material deformation towards low pitch. Blade 2 had a blade arm-to-blade butt signature in the low pitch range of operation. No manufacturing faults were found in the piston and cylinder or the piston ring. All the crank link bearings on the propeller blades and the links and piston were undamaged. All the propeller blade bearings were undamaged.

Photo 15 – Propeller Blades (in Progressive Order)

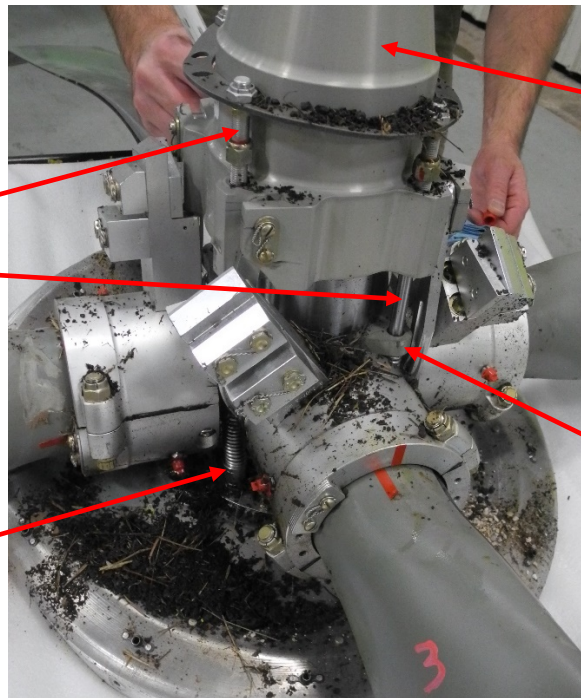
The investigation considered the impact of a sticky beta guide lug bushings ([Photo 16](#)) and their possible role in the erratic propeller behavior. The beta guide lug bushings were measured and found to be 0.0025 inches below the manufacturer's specification; however, according to Hartzell, it was unlikely that this would have affected the sliding performance of the beta rods. The inner diameters of the beta guide lug bushings were measured and found to be 0.001 inches below the manufacturer's specification; however, according to Hartzell, it was unlikely that this would have significantly affected the sliding performance of the beta rods. The sliding operation of the beta rods could not be tested because the beta rods were deformed during the accident. Swelling, caused by a chemical attack on the phenolic material of the beta guide lug bushings, causing sticking of the beta rod guides was not considered a contributing factor, since the propeller was new and not exposed to rain or crop-dusting chemicals. Additionally, after performing considerable lab tests, Hartzell stated that the guide lug bushings inner diameter is not affected by contact with turbine oil.

Photo 16 – Propeller Hub Details

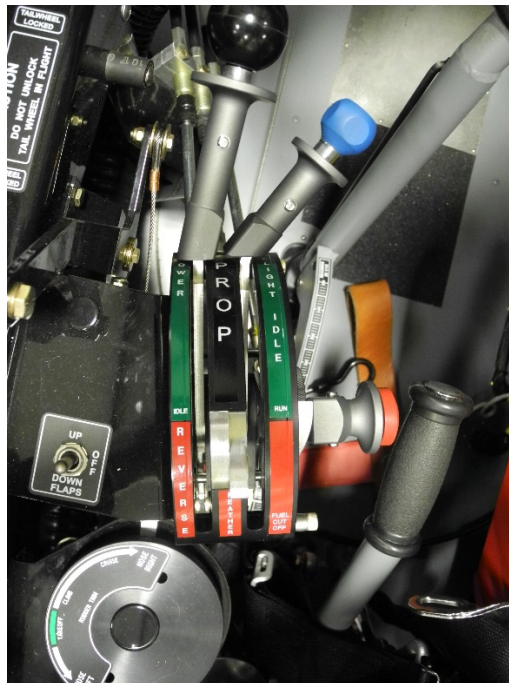
A review of the throttle lever quadrant revealed that it is not a standard Air Tractor part but rather a Kawak quadrant which can be factory installed at the request of customers. The Kawak quadrant ([Photo 18](#)) features small, compact levers (when compared to the Air Tractor quadrant) and a collar type of detent-defeat mechanism with a relatively low spring tension. It was noted that the collar can be grabbed and lifted quite easily and inadvertently compared to the Air Tractor ([Photo 19](#)) thumb operated button that requires a deliberate opposite-direction thumb motion to defeat the beta range detent. It is conceivable that the pilot, during a stressful situation, will grab the entire handle, thereby inadvertently raising the beta-detent collar, so that he would encounter no resistance at the idle detent location while retarding the power lever, allowing the lever to enter the beta range in flight.

and if there is an easily defeated beta detent, such as in the Kawak quadrant, then it is possible that the beta mode could be selected during flight, explaining the reported illuminated amber light. According to Hartzell, the propeller was not capable of being governed during this thrust fluctuation condition, it is unlikely that the beta mode selection during this flight would have made a difference in the propeller behavior.

Photo 18 – Kawak Quadrant – Integrated Detent Handles Close to Control Knob

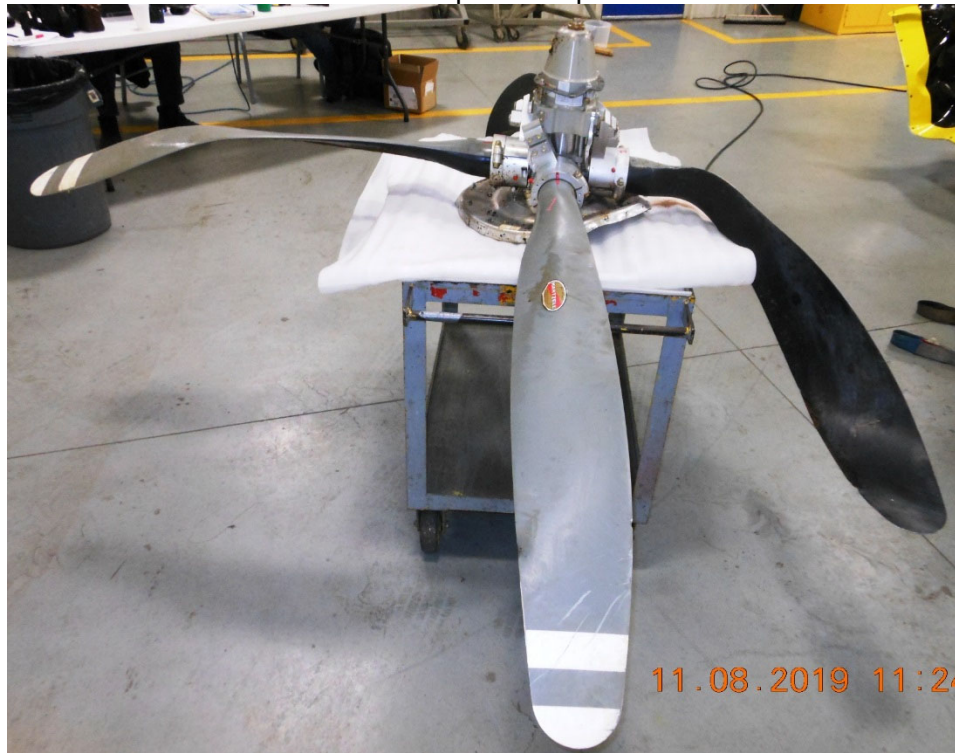
**“As Received” Condition:** The propeller fractured from the engine propeller shaft mounting flange during the impact sequence and was presented for examination as shown in Photo #1. The spinner dome was removed by Air Tractor personnel before this examination. The beta ring was bent and a portion of the aft flange – roughly the size of the beta carbon block – was fracture-separated. All four blades were bent aft and twisted leading edge down in varying degrees. The piston was extended approximately 2-2 1/16 inches from the beta rod guide collar. All four link arms appeared connected at both the link screw and link pins with the #2 link arm visibly bent in compression. The beta guide rod collar was gouged at the #1, #2 and #3 blade positions.

Photo #1 – Propeller as-presented

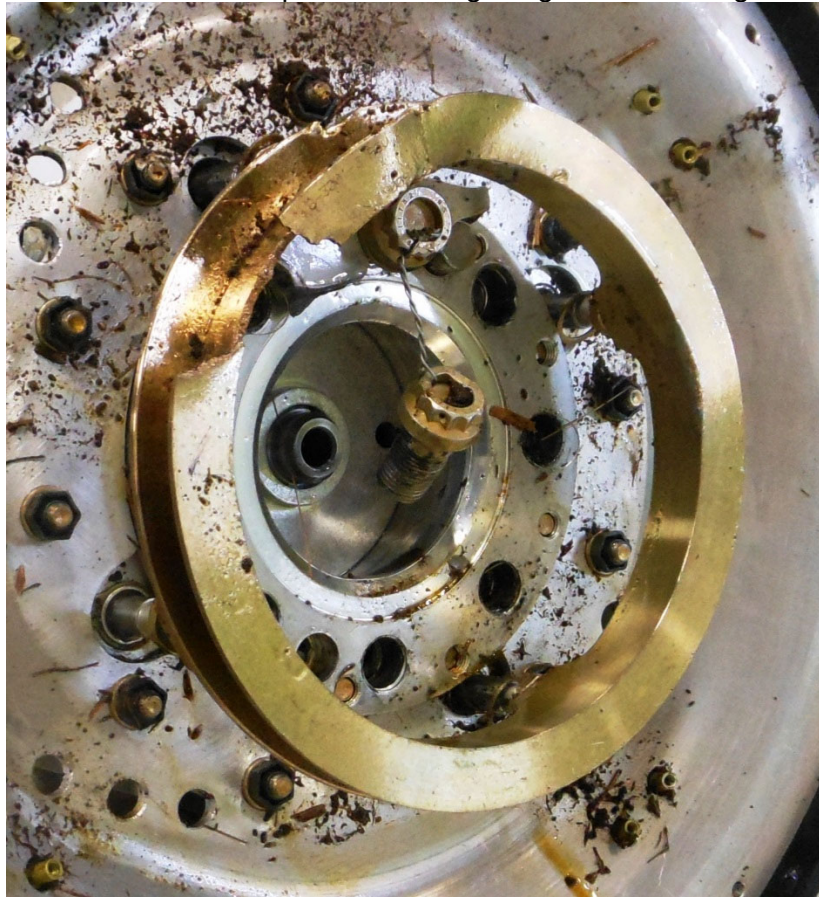
**Engine/Propeller Mounting:** (see Photo #3) A portion of the propeller mounting flange remained attached to the propeller hub with one mounting bolt still in position and one bolt loosely attached to it via safety wire. The shank of a third mounting bolt remained in the propeller hub but the head had fracture-separated. One drive dowel remained lodged into the propeller hub. Two propeller mounting bolts had pulled from the propeller hub and remained loosely connected to the engine propeller flange.

Photo #3 – Propeller mounting flange and beta ring

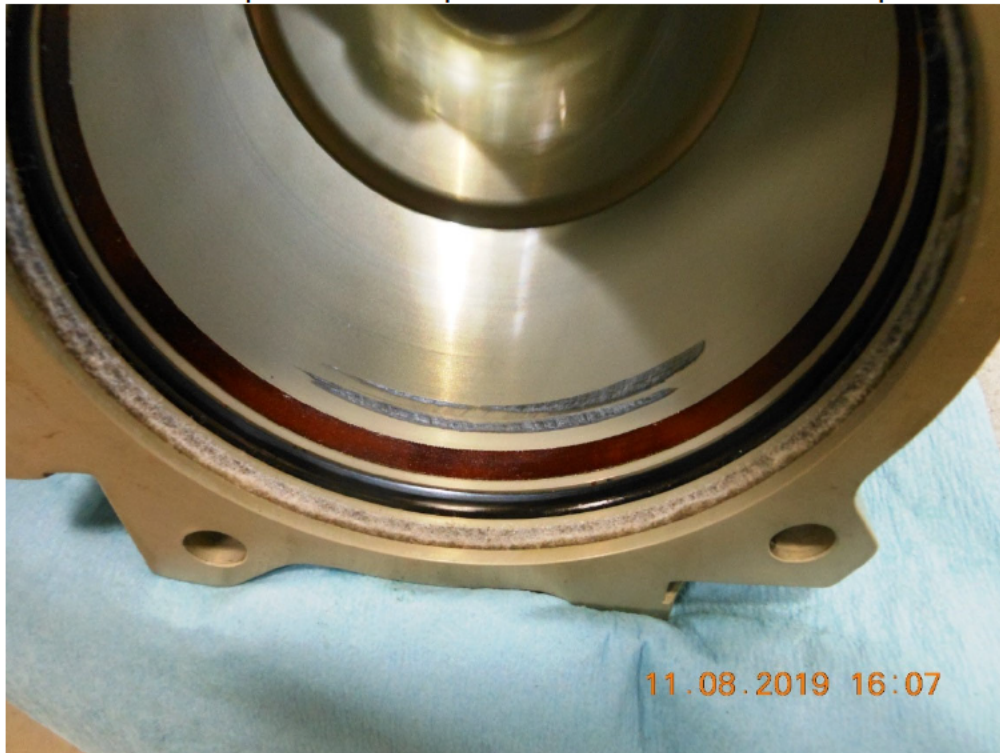
There were cylinder and piston impact marks that indicated the propeller was operating in the normal operating blade angle range at initial impact. There was no damage to indicate the propeller was feathered or in the beta/reverse range at the time of impact. All four blades remained attached via the retention clamps, no pilot tubes were fractured and there were no blade fractures. Blade damage that included camber side chordwise/rotational abrasion, bending aft, bending opposite rotation, leading edge gouging with material deformation towards low pitch and progressive compound bent/twisting towards low pitch was consistent with impact at a relatively shallow aircraft impact angle while rotating at a low power setting. Piston impact marks representing blade angle near the flight idle range are consistent with the blade damage, indicating rotation under low power and at slightly negative blade section impact angles.

Photo #5 – Representative impact marks on internal surface of piston

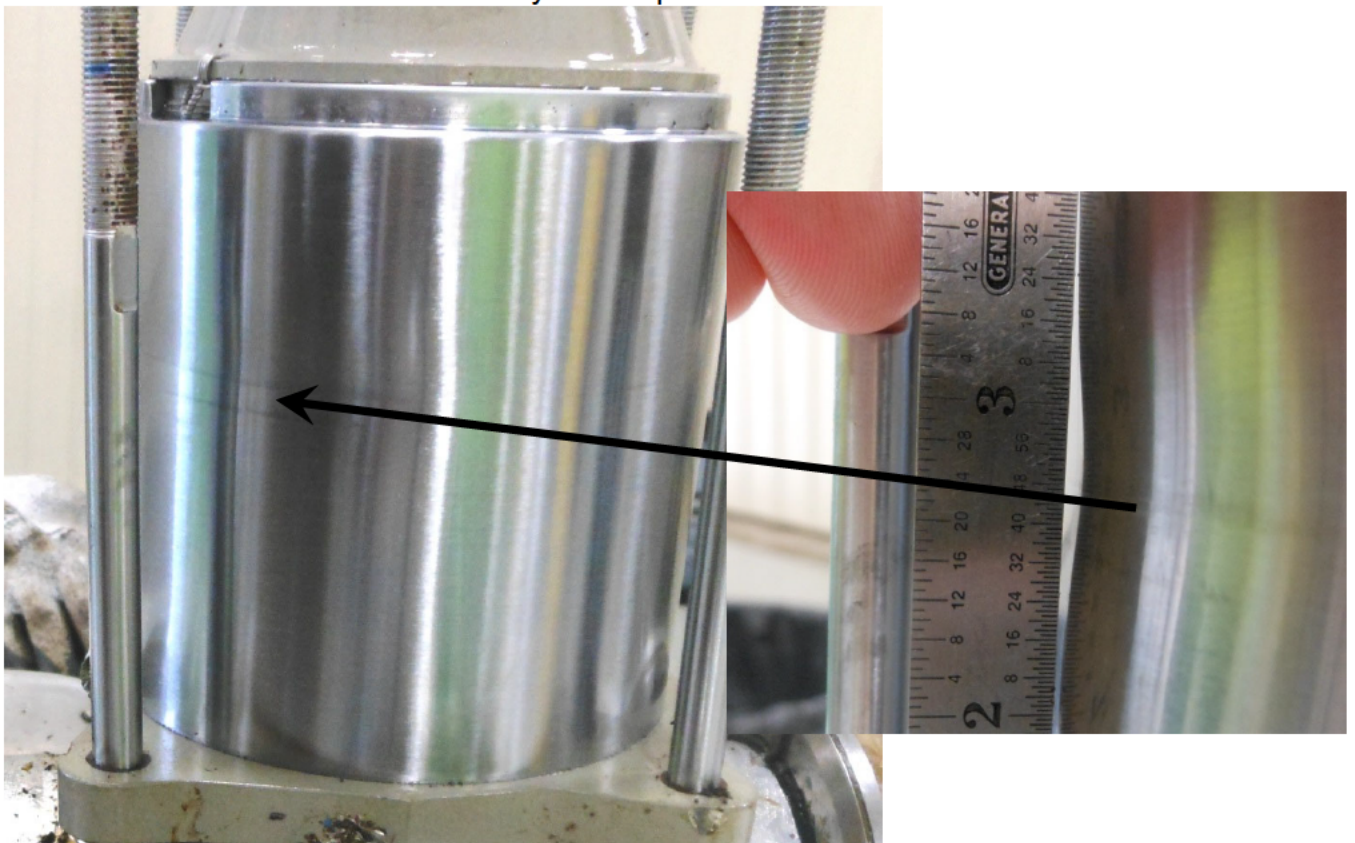
Photo #6 – Cylinder impact marks

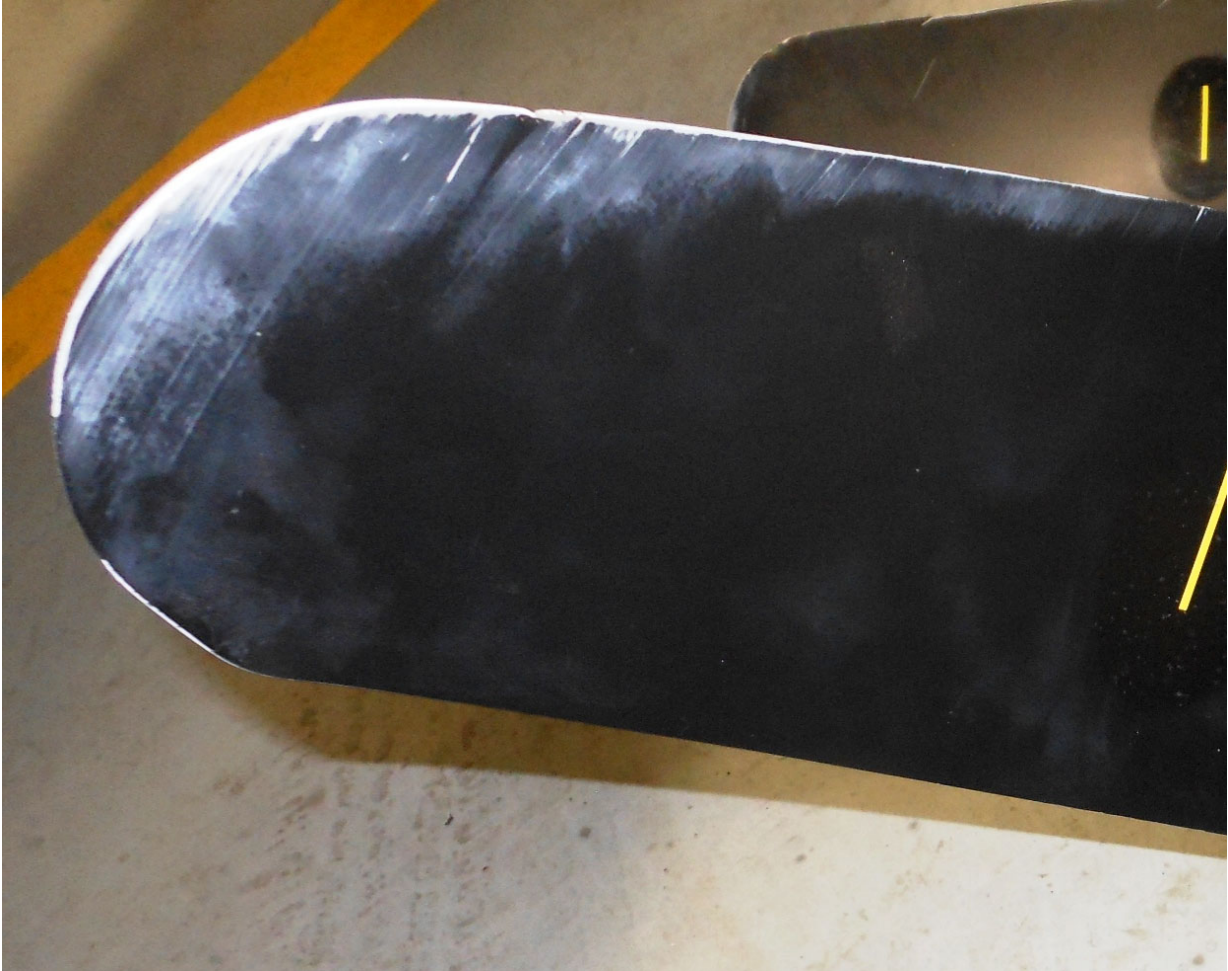
Photo #8 – Blade #3 face side – typical degree of chordwise/rotational abrasion

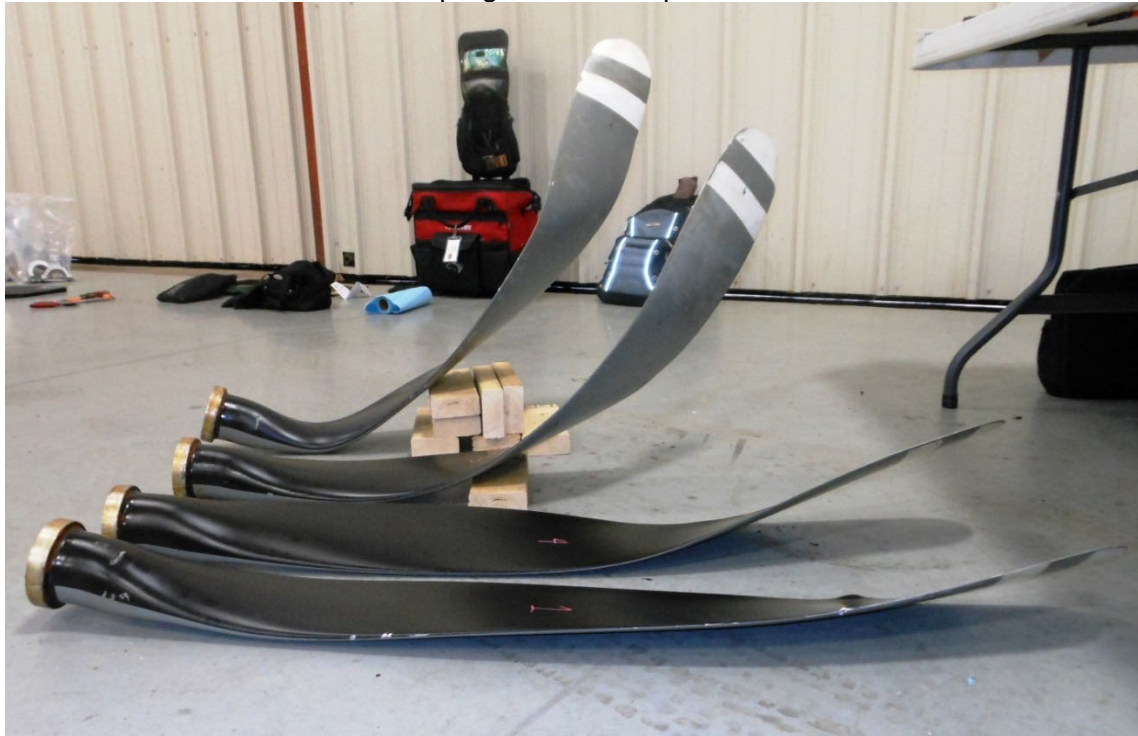
Photo #9 – Blade progressive, compound bend and twist

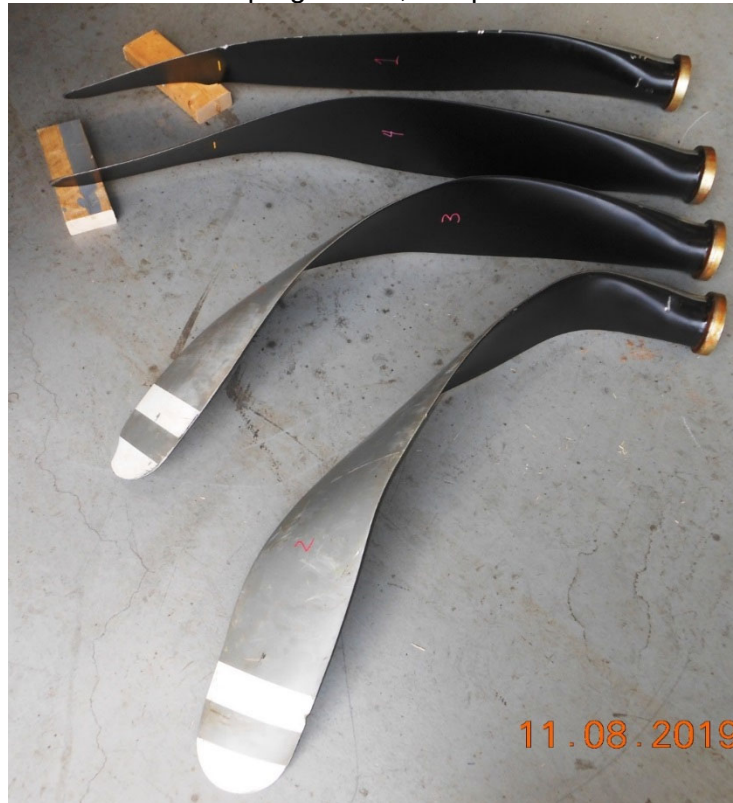
Photo #10 – Blade progressive, compound bend and twist

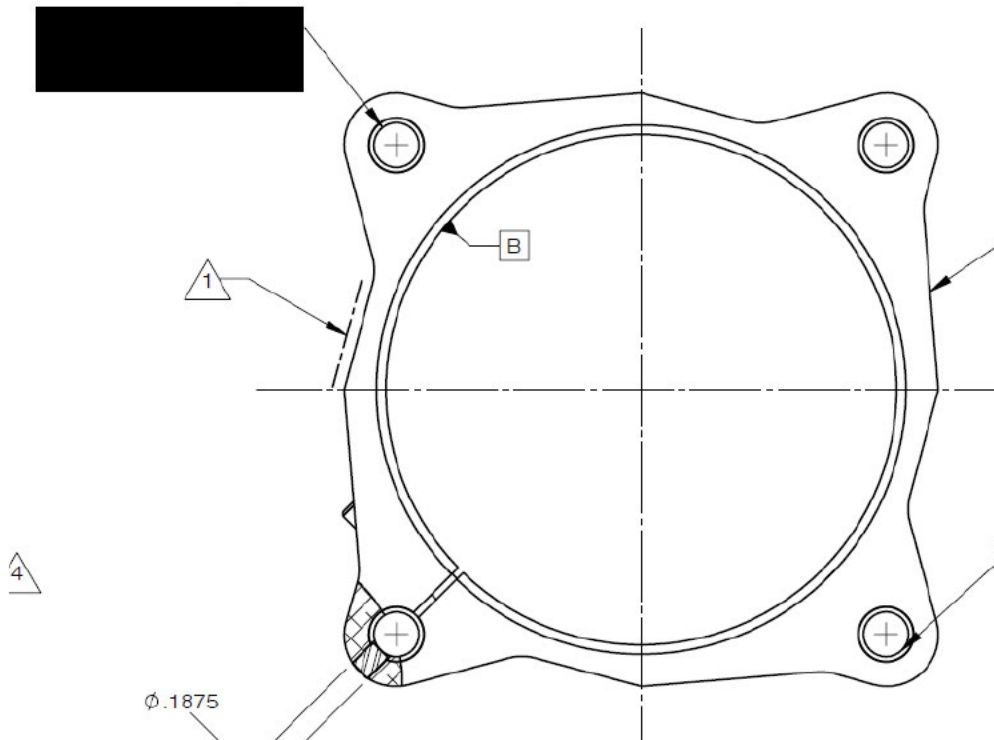
**Guide Collar P/N 834-13**

The guide collar bushings were measured using a pin gage of 0.380 and it fit snugly through all four approximately equally.

As shown in the drawing below, all were slightly below spec based on the pin gage fit.
