**NATIONAL TRANSPORTATION SAFETY BOARD  
OFFICE OF AVIATION SAFETY  
WASHINGTON, D.C. 20594**

**POWERPLANTS GROUP CHAIRMAN'S FACTUAL REPORT**

**NTSB ID No.: CEN19LA295**

Location: Olney, Texas  
Date: August 29, 2019  
Time: 1100 central daylight time  
Aircraft: Air Tractor AT-502A, Registration: N8517Q

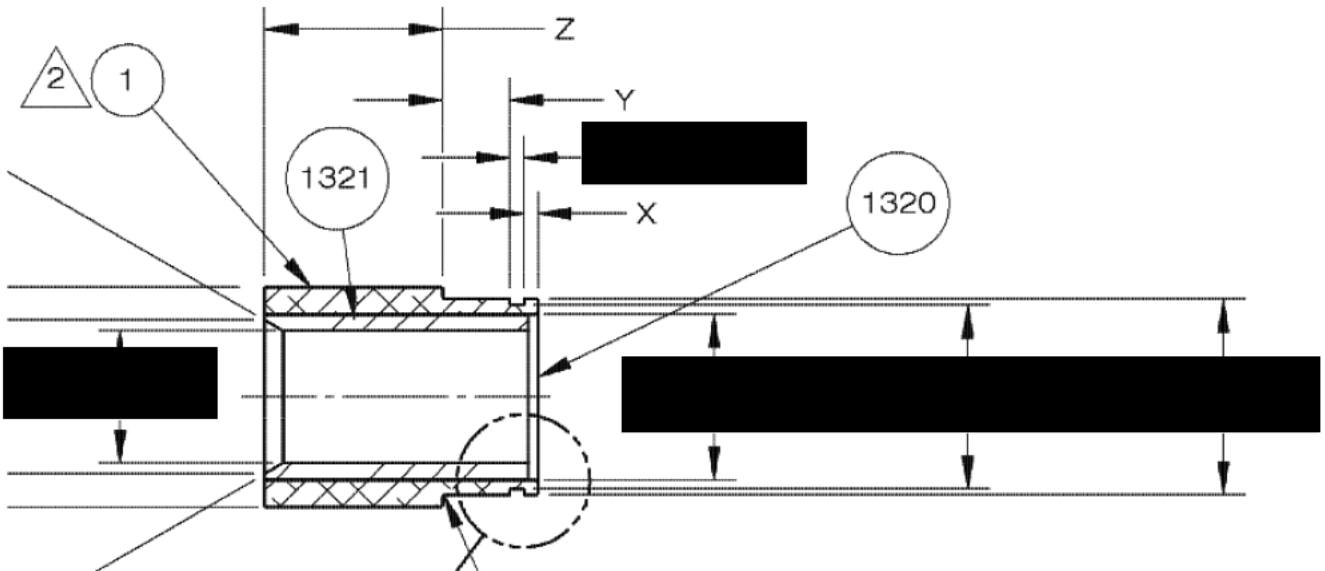
**Guide Lug P/N A-3067-2**

As shown in the drawing below, these bushings didn't meet spec based on using a pin gage method. Location #1 would likely meet spec but we didn't have a 0.376 pin gage.
