**Air Tractor, Inc.**  
**Accident Investigation**

**Airframe Report**

**CEN19LA295**

**8/29/19**  
**Olney, TX**

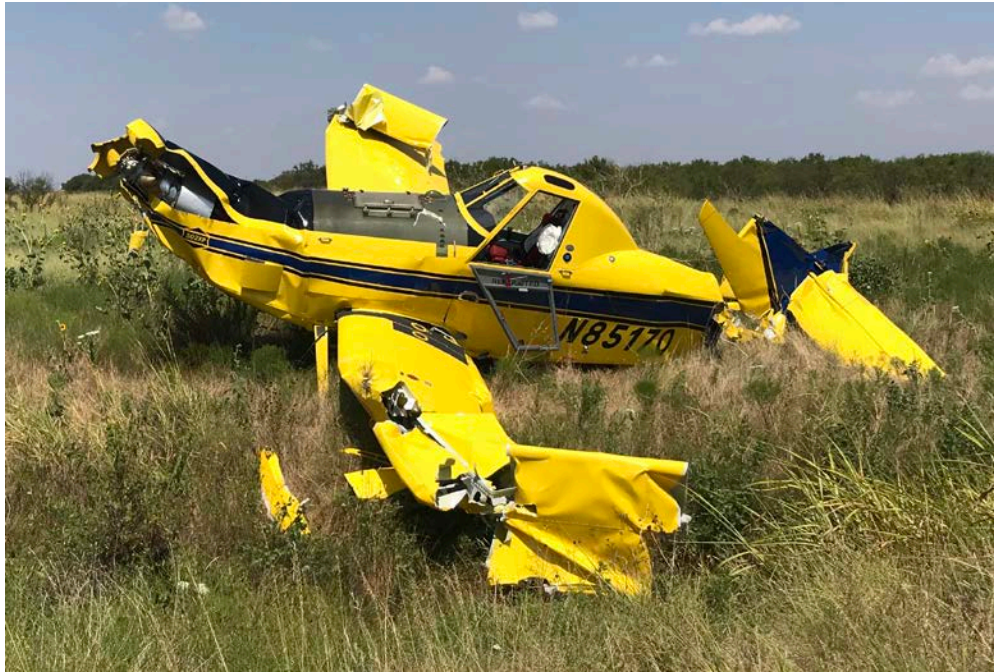
Arrival at the accident site was approximately 2:00 pm on 8/29/19. The aircraft wreckage was found in a pasture approximately 850 ft southeast of runway 31. The pasture contained a few scattered trees. A ditch oriented generally east to west, separated the southern 1/3 of the of the pasture from the north.

Debris and ground scarring at the scene indicated that the aircraft impacted the ground on an northeast heading, impacted a tree with the left wing, and crossed the ditch before coming to rest upright on the north side of the ditch, oriented on an western heading.

**Overview of Wreckage (Looking Northeast)**

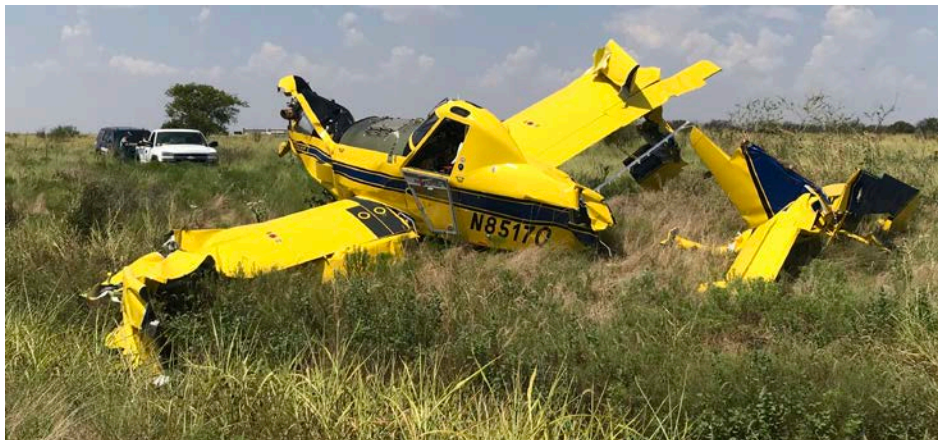
The fuselage was found upright with the aft fuselage completely separated. The engine and engine mount remained attached to the fuselage and were found bent upward. The aircraft was equipped with airbags which were found deployed. Each of the restraints were found intact, unbuckled.

**Fuselage Wreckage (Looking Northwest)**

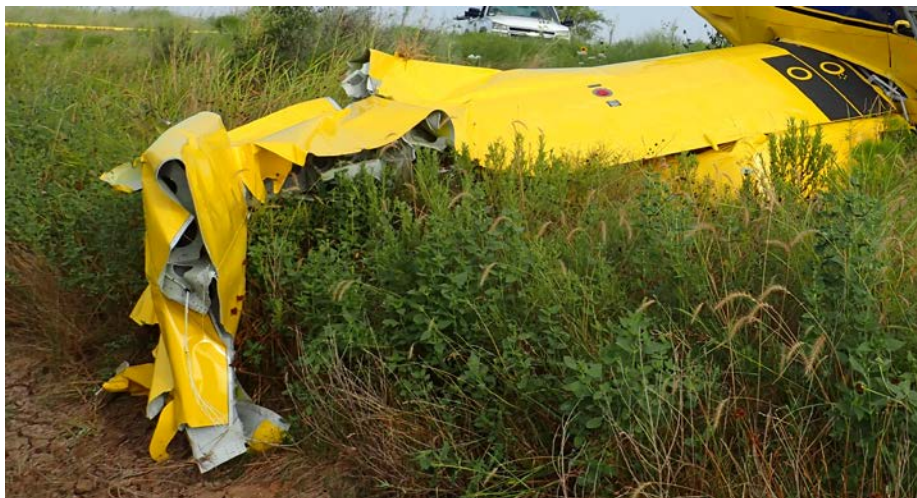
The outboard portion of the left wing was separated from the wing and found near a tree that had marks consistent with impact. The left flap remained attached to the wing. The left aileron was found separated from the wing near the wreckage.

**Left Wing Wreckage**

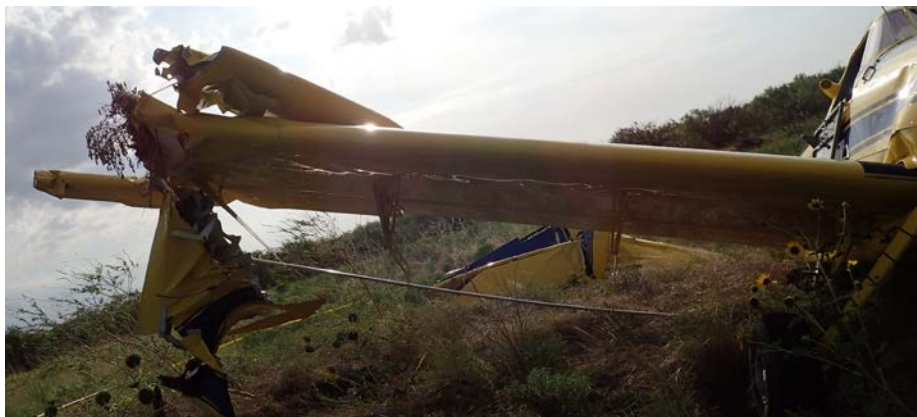
The right wing was found intact with outboard portion of the wing crushed inboard. The right flap and aileron were found in place on the wing.

## **Right Wing Wreckage**

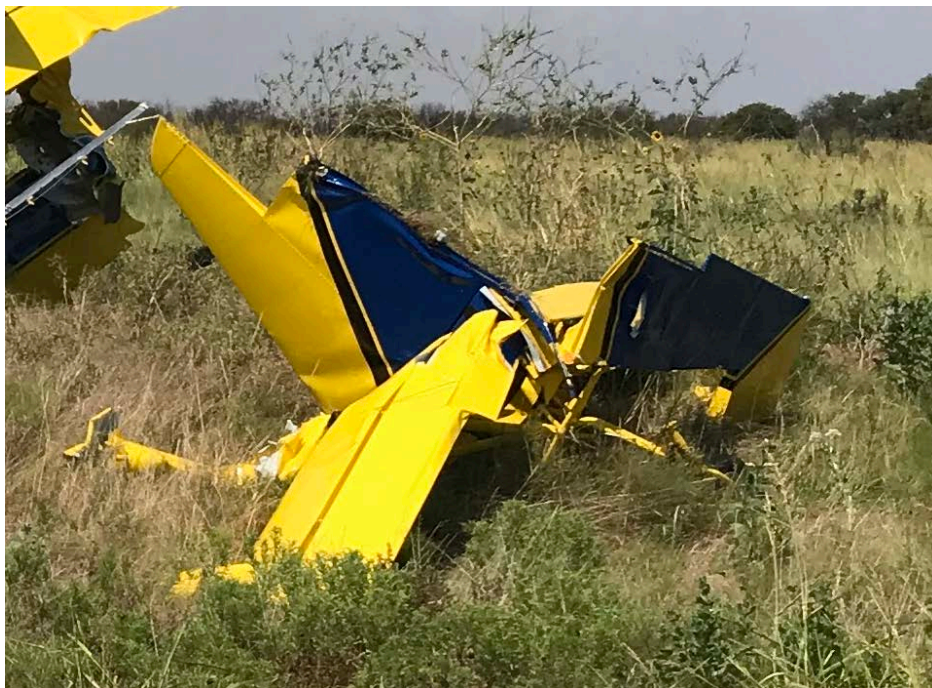
The empennage was found attached to the aft fuselage with significant crush damage.

**Empennage Wreckage**

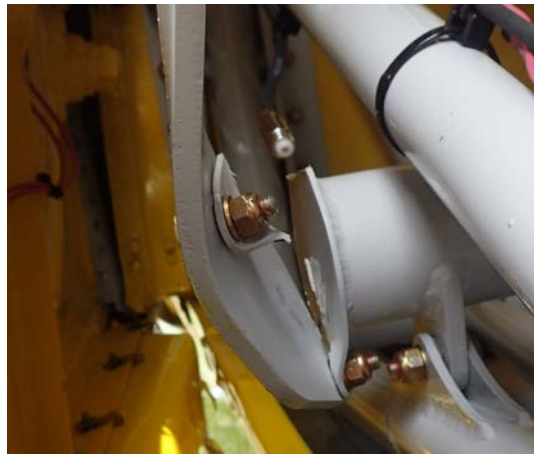
The flap actuator was found fully retracted. The flap control system was found to be continuous. The upper steel ear on the left side of the flap torque tube was found to have separated from the torque tube consistent with overstress.

**Left End of Flap Torque Tube**

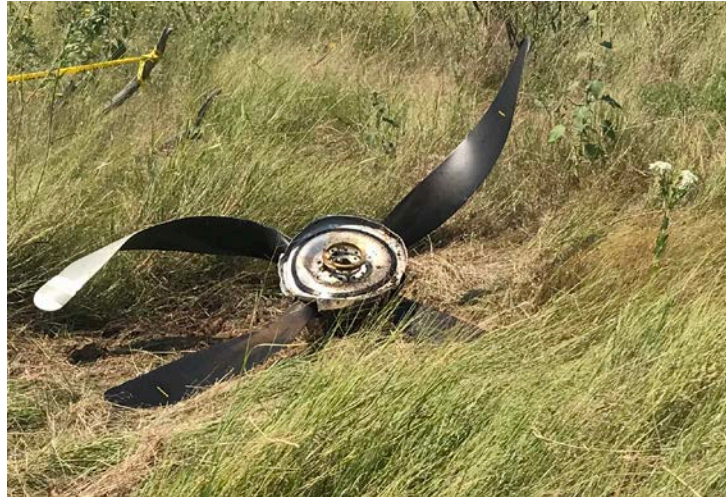
The engine was equipped with four-bladed constant speed, fully reversable, propeller. The propeller was found separated from the engine at the propeller flange.

**Propeller Wreckage**

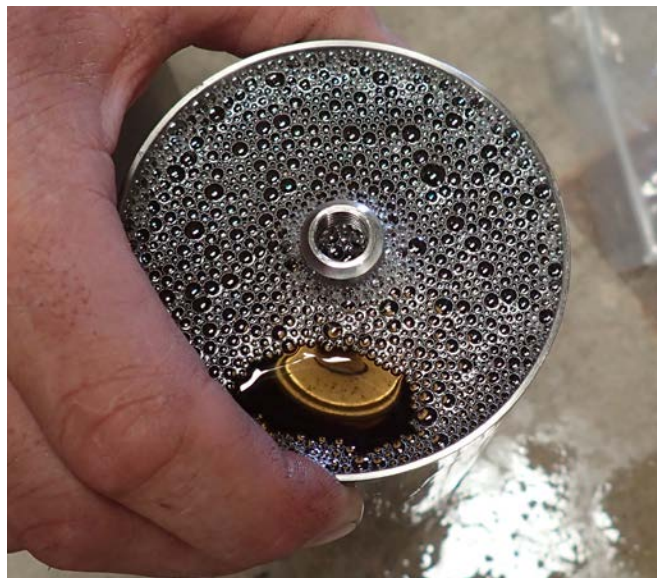
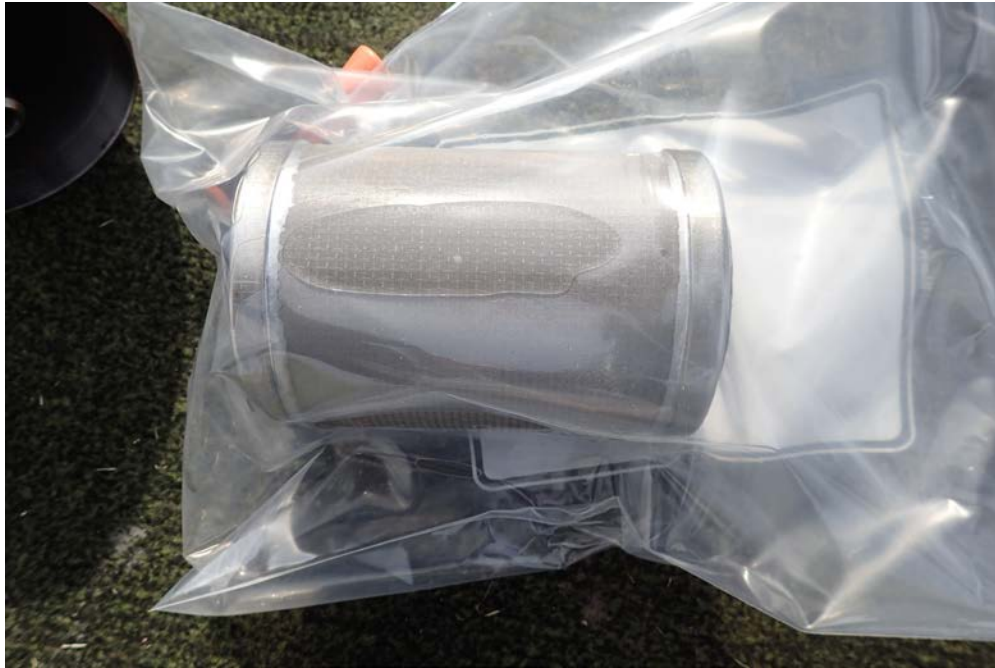
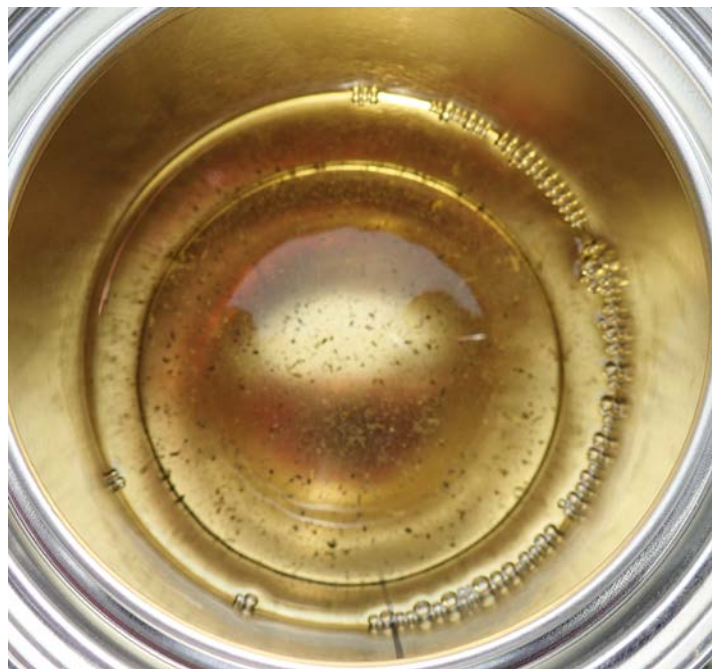
The fuselage fuel filter was removed, and the fuel was drained into a clean can. The fuel removed from the housing was found to completely fill the housing without the filter element installed. The filter element was found free of any substantial blockage. The fuel drained from the fuel filter housing was found to contain small dark grey particles. Samples of the fuel containing the particles were retained but, at the time of writing this report, were not analyzed.

**Airframe Fuel Filter Housing (Without Filter Element)**

**Airframe Fuel Filter Element**

**Fuel from Airframe Fuel Filter (Containing Particles)**

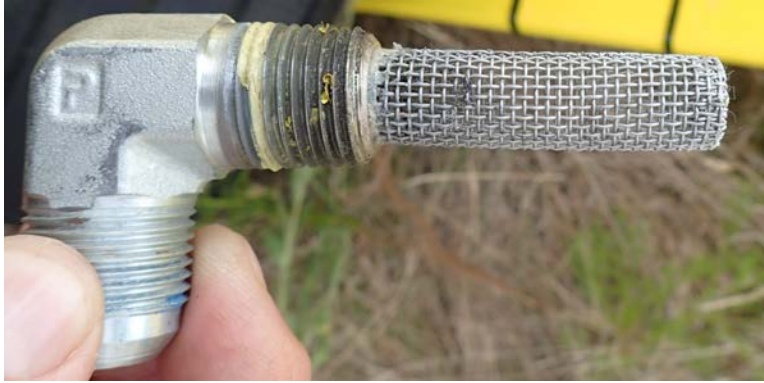
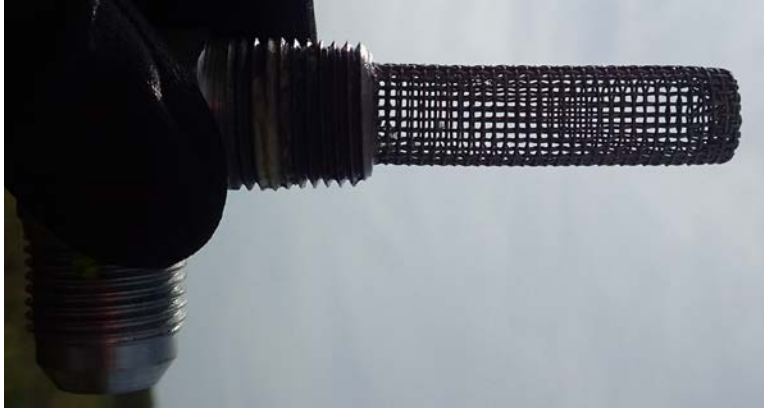
The finger strainers at the wing fuel tank outlets were removed and found without any substantial blockage.

**Left Fuel Tank Finger Strainer**

**Right Fuel Tank Finger Strainer**

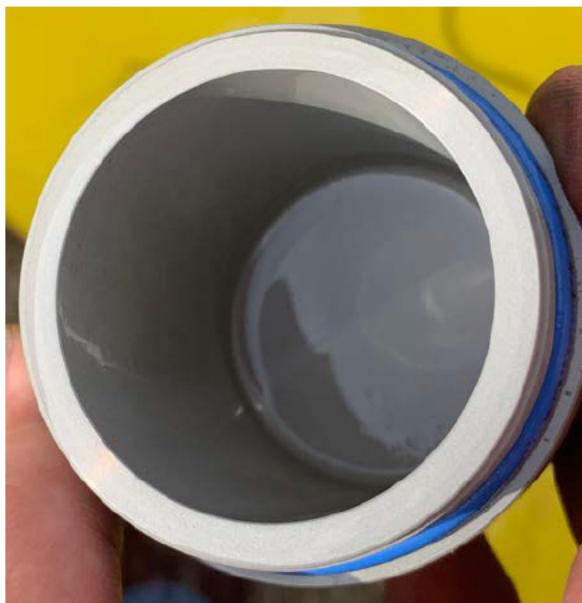
The FCU filter bowl was removed and found wetted, with less than a teaspoon of fuel remaining. The FCU filter was found without any noticeable blockage.

**FCU Bowl**

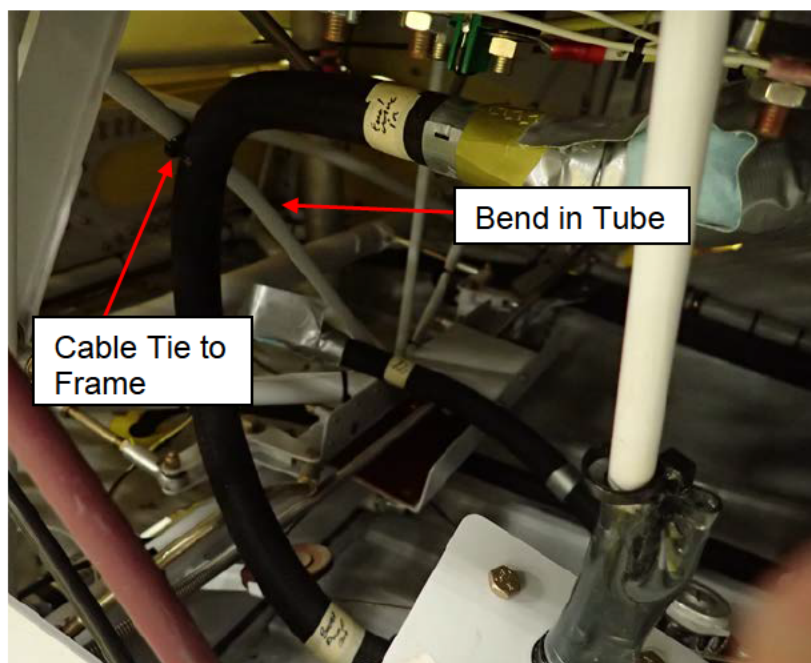
The airframe fuel hoses were removed from the airplane and internally inspected using a borescope. A tear was found on the inside of the hose that connected the boost pump to the fuel selector valve. The tear was approximately 20 inches from the boost pump end of the hose which is the approximate location where the hose is attached to the frame with cable ties. The frame tube that the hose was attached to was found with an upward bend. The hose was sent to Parker Hannifin Corp. for further review.

**Hose Secured to Fuselage Frame**

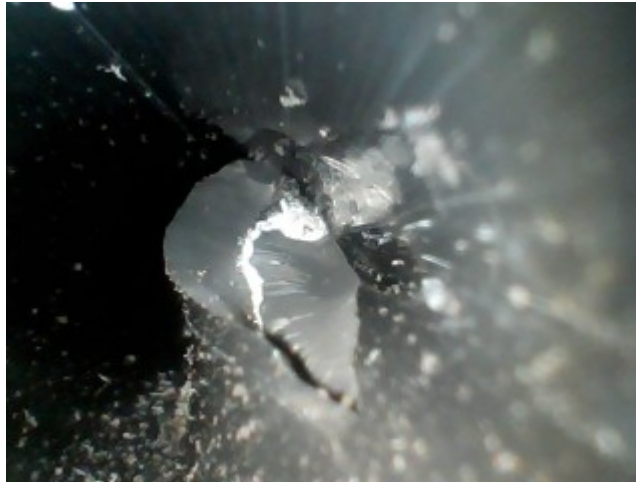
**Tear in Boost Pump to Fuel Selector  
Valve Hose**

The hose was examined by FAA Aviation Safety Inspector Darryl Shaw, Parker Air Safety Officer Jeremy Katt, and Parker Product Engineering Manager Shadrach Nanney at Parker Stratoflex in Fort Worth on February 5, 2020. Per the examination report provided by Parker Hannifin Corp., the tear in the hose was most likely caused by a sharp sudden bend that exceeded the bend radius of the hose. The tear, being primarily on one side of the hose, was reportedly consistent with a sharp sudden kink in that location.
