Note: Except for the empennage, the aircraft was submerged on water for several hours prior its recovery and relocation to CXO airport, where an examination was performed on September 5, 2019.

On September 5, 2019, accompanied by two other airworthiness inspectors an examination performed of aircraft N55633.

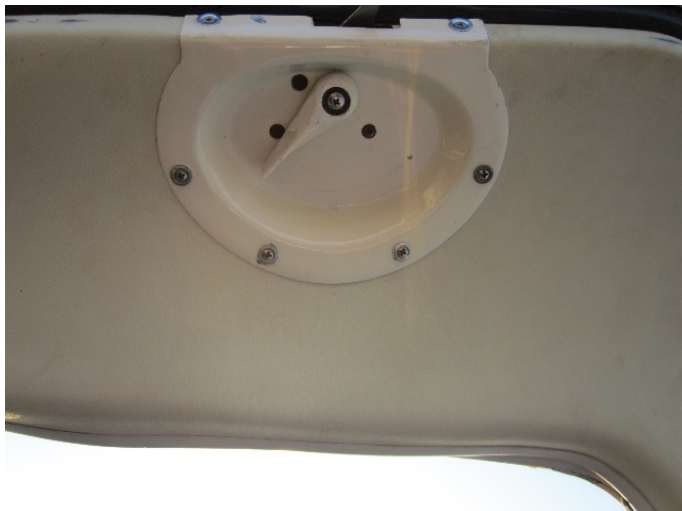
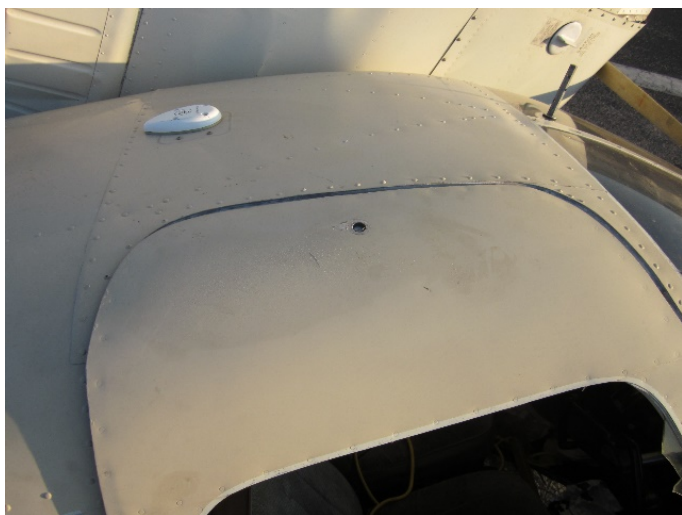
Cabin door both interior handles worked properly. Outside top door handle broke and missing. Outside lower door handle worked properly. No operation instructions placards inside or outside.

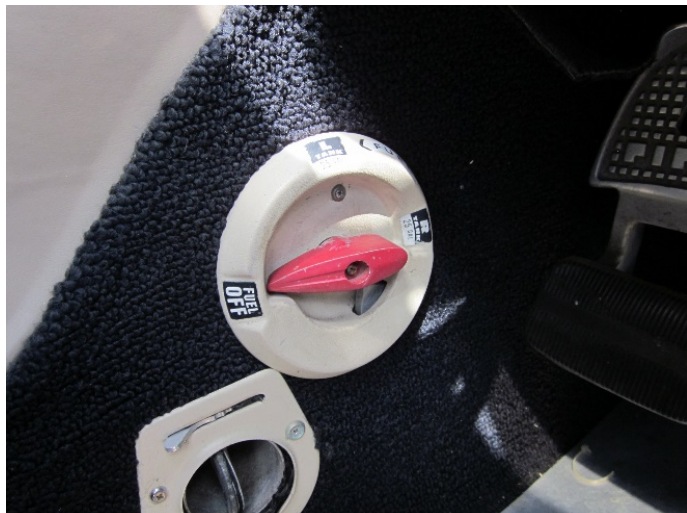
Fuel control valve labeled clearly and appropriately. Handle lock mechanism that prevents shutting off the fuel, and the left and right tanks positions detents worked properly.

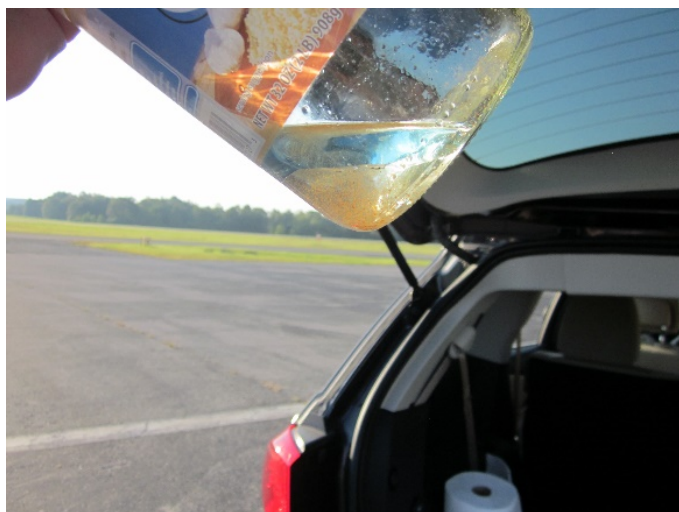
Carburetor bowl drained. Approximately 4 oz. of fuel collected and about the same amount of a clear liquid, (presumably water) with yellow sediment also collected.

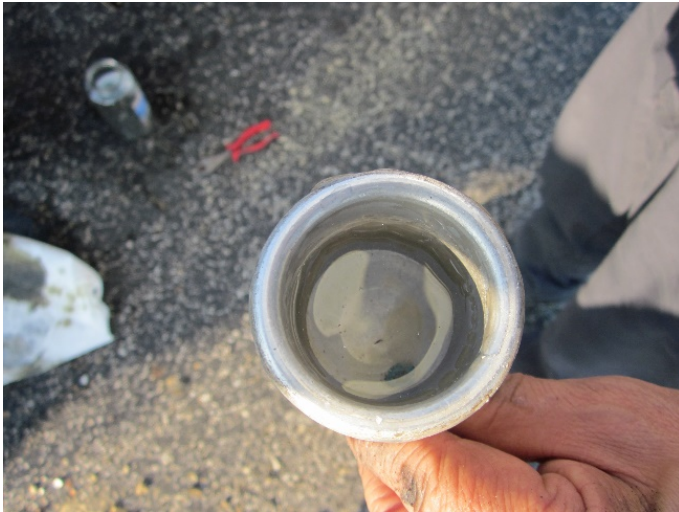
Fuel gascolator removed and was almost full of a clear liquid, (presumably water). No fuel found.

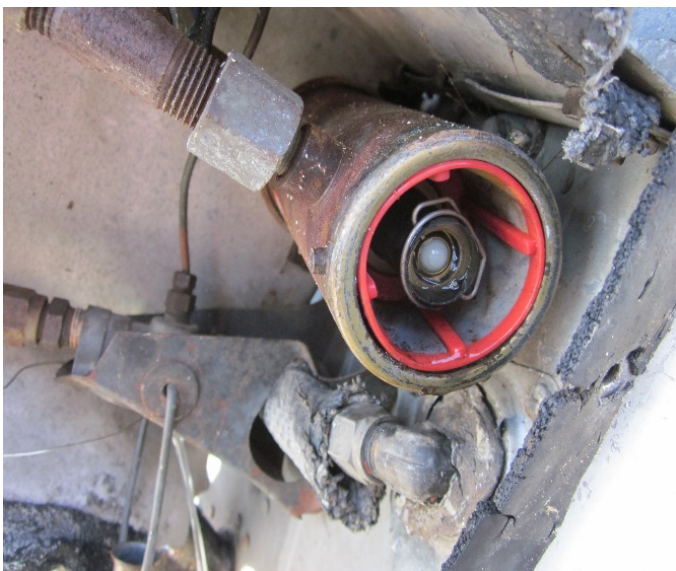
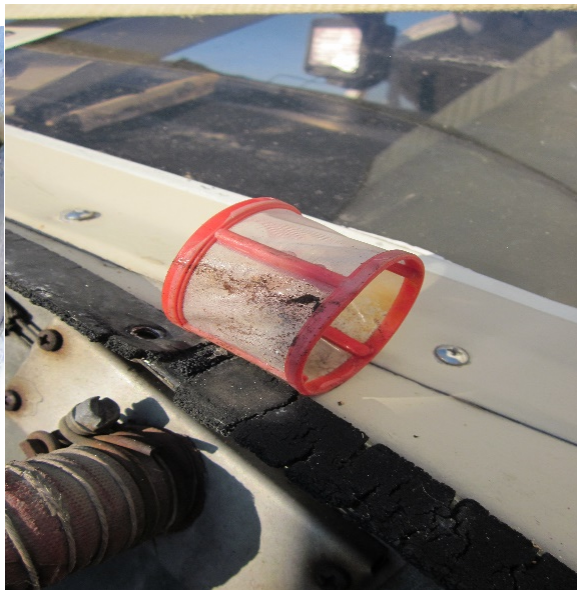
Electric fuel pump filter inspected. About an ounce of fuel present. No other liquid found. Filter had a small amount of sediment.

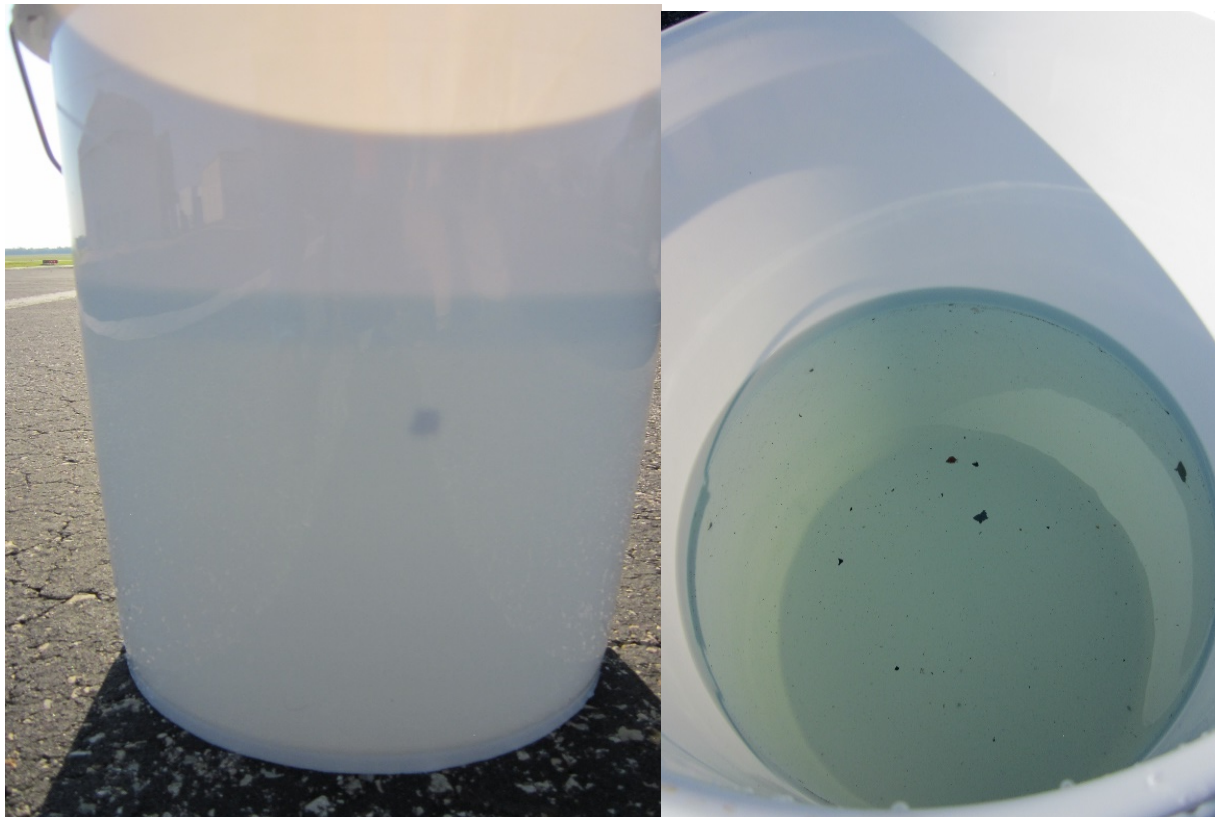
Right wing fuel tank completely drained through the gascolator. Around three gallons of a clear liquid (presumably water) collected and around 1 pint of fuel.

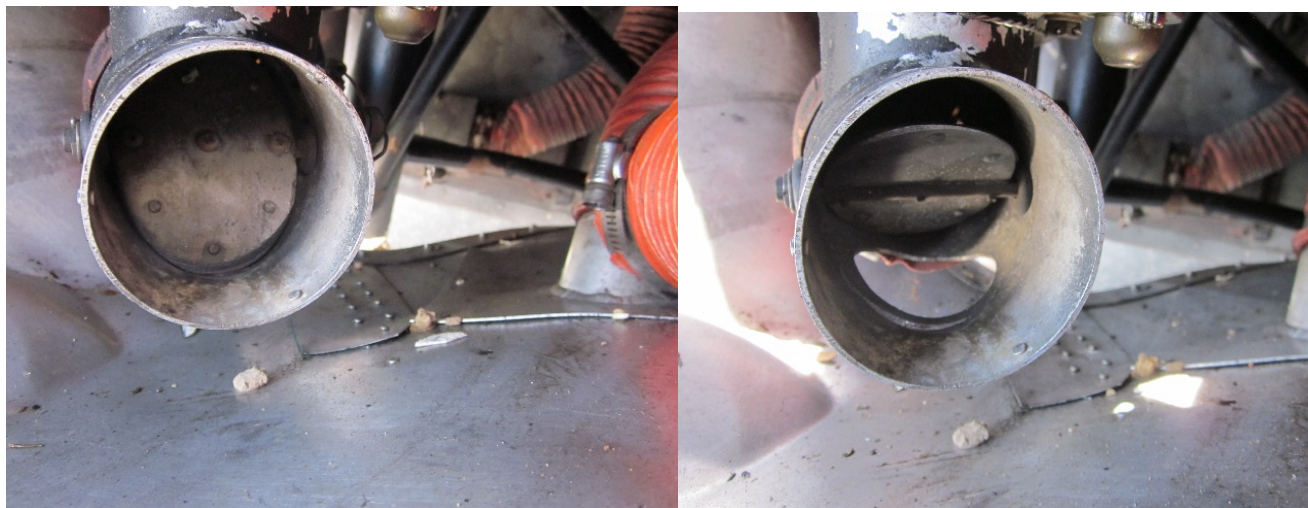
Carburetor heat control cable connected to the carburetor heat box. Carburetor heat valve reacts properly to the position selected on the handle at the control panel; however, the valve did not travel to the full close position when heat selected. No defects found on the carburetor heat box hoses.

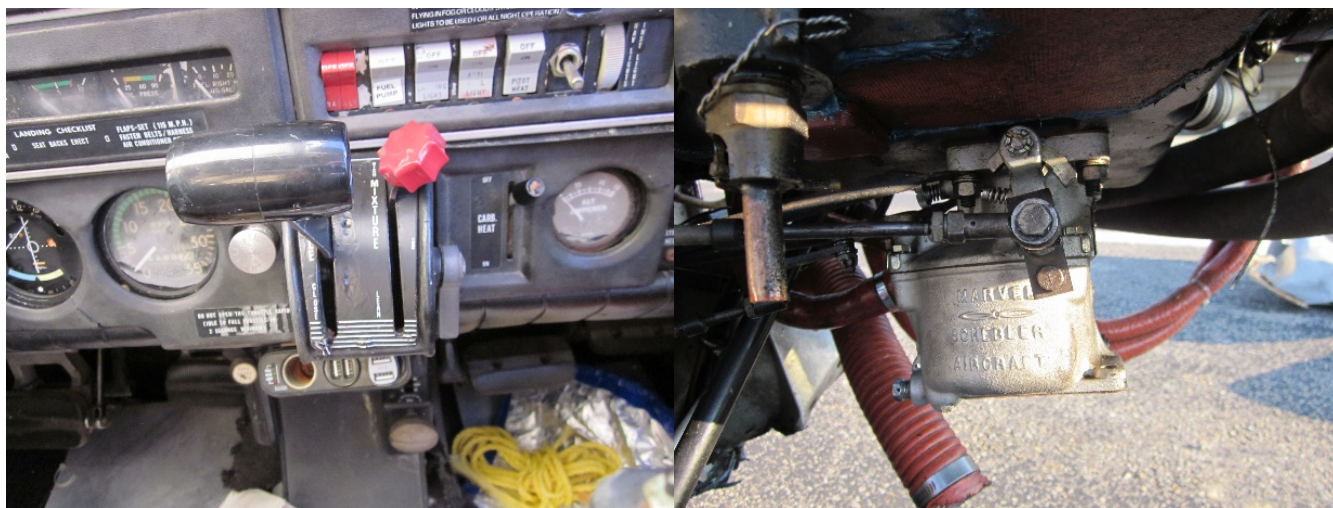
Throttle cable connected to the carburetor throttle link and reacted to the command to the lever at the control panel, however, the lever hit the stop before the link on the carburetor for the full throttle position. Mixture control cable connected to the carburetor mixture link and reacted to the command to the lever at the control panel.
