**Photo 1 – N6595J, a Piper PA-28D-180, at the accident site. (FAA photo).**

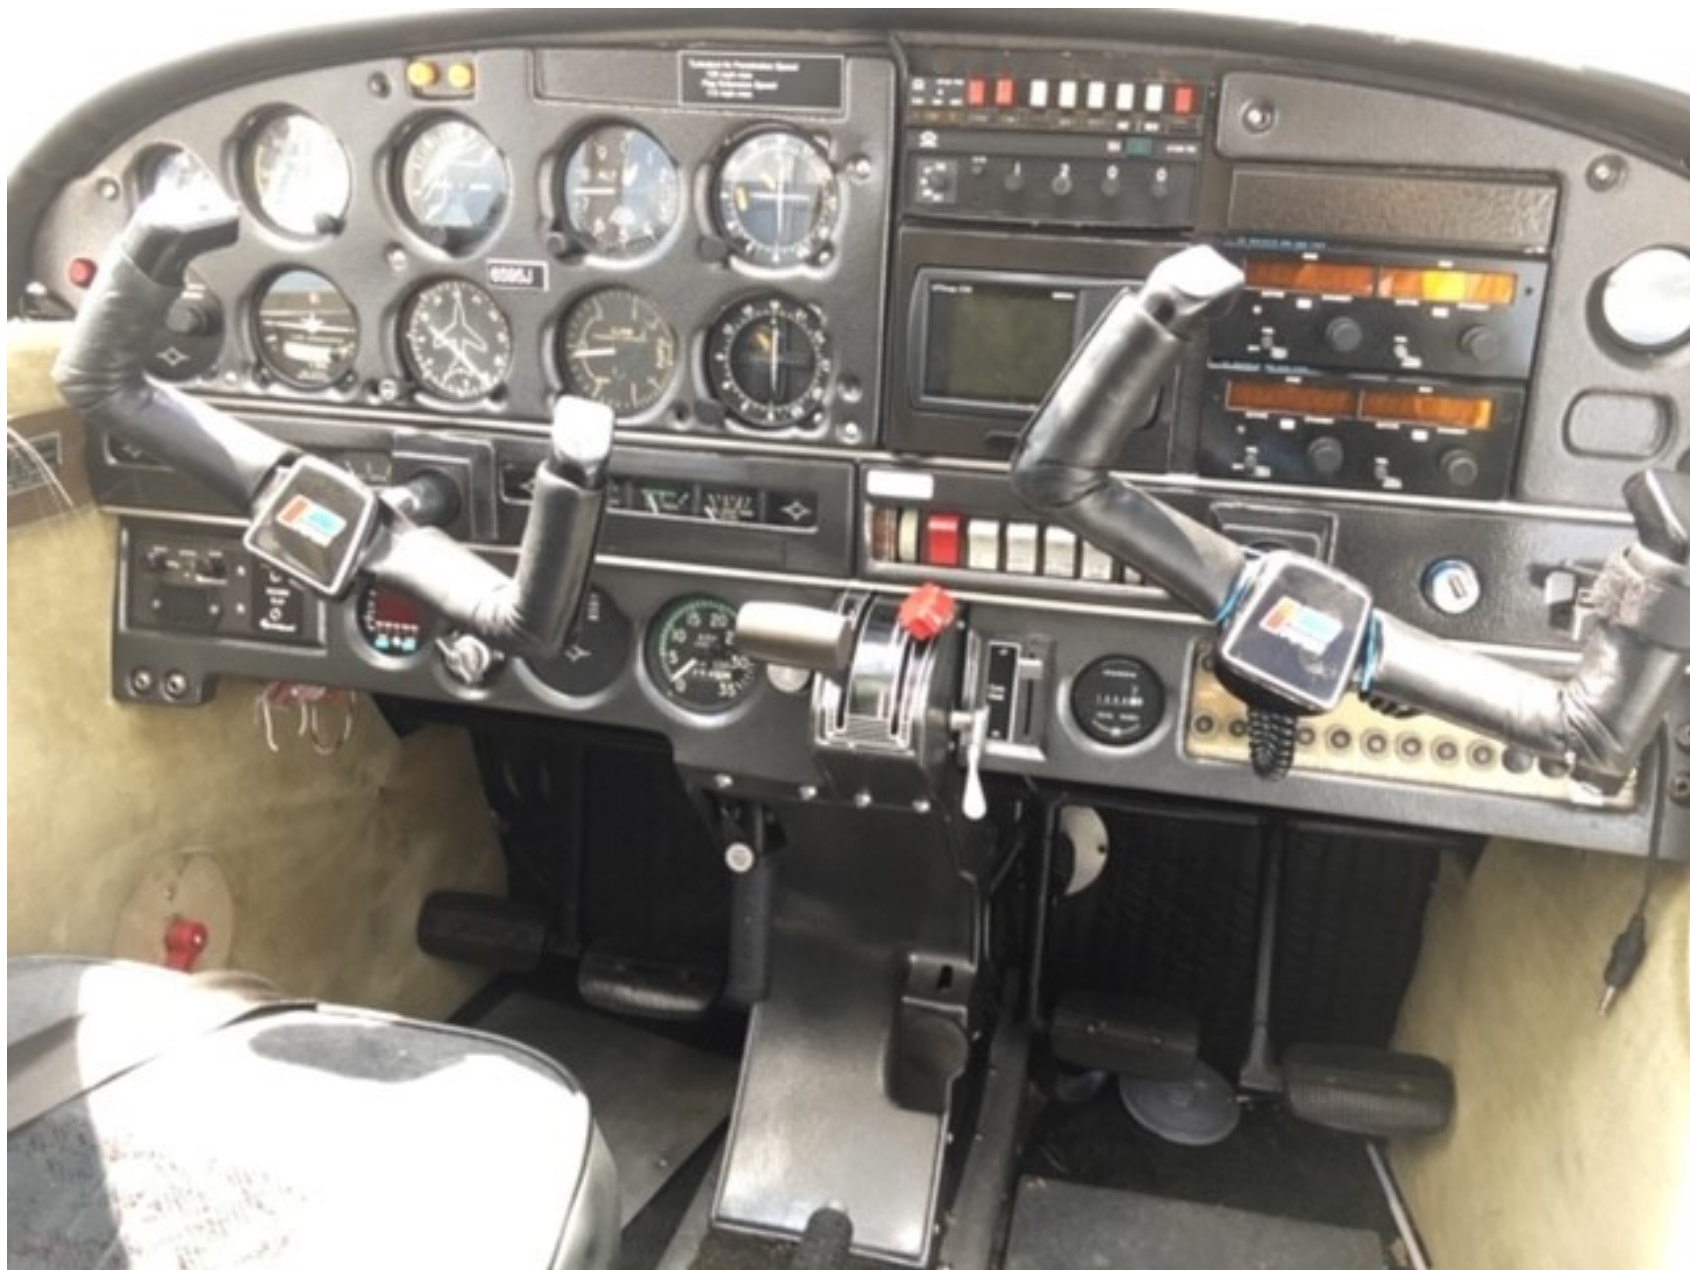
**Photo 2 - The cockpit. Note the fuel selector (red handle, bottom left) is positioned on the right fuel tank. (FAA photo).**

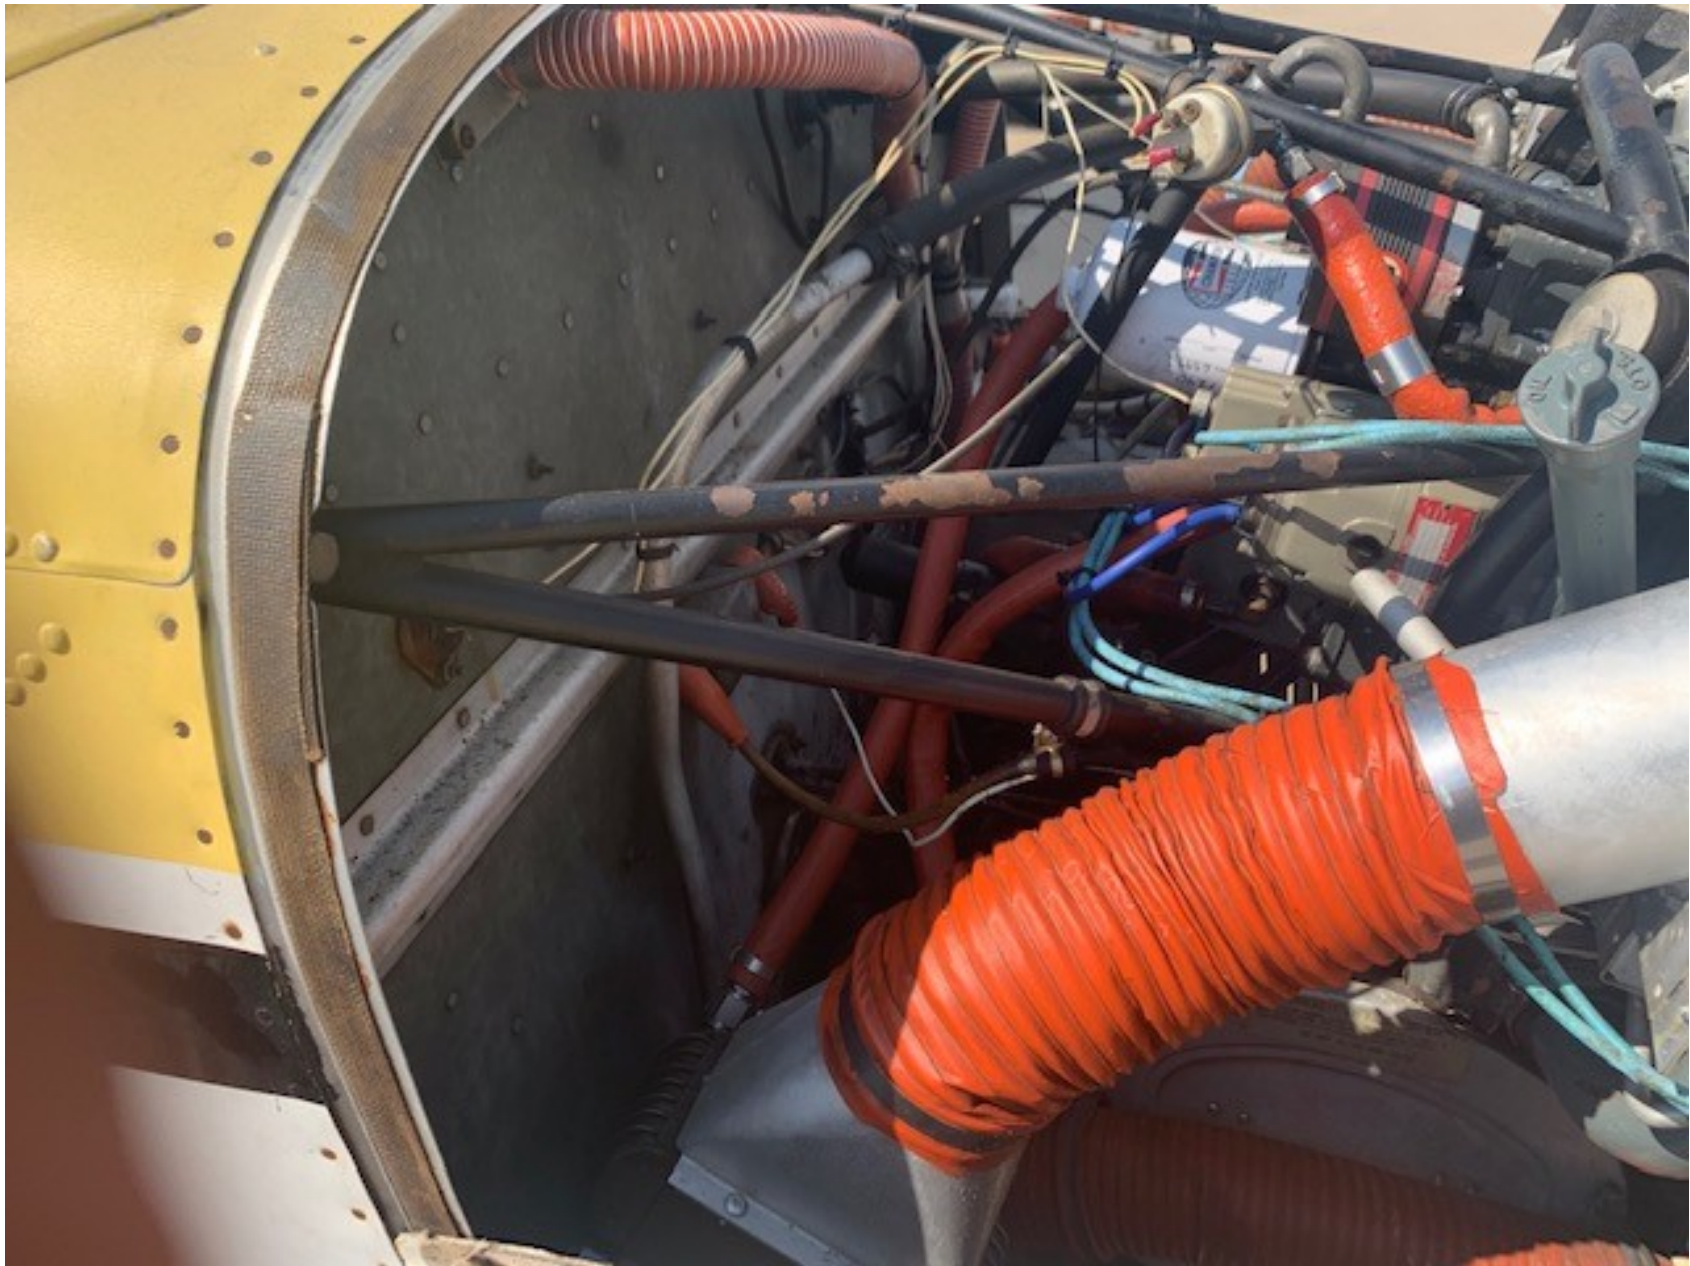
**Photo 3 – The engine was unremarkable. (FAA photo).**

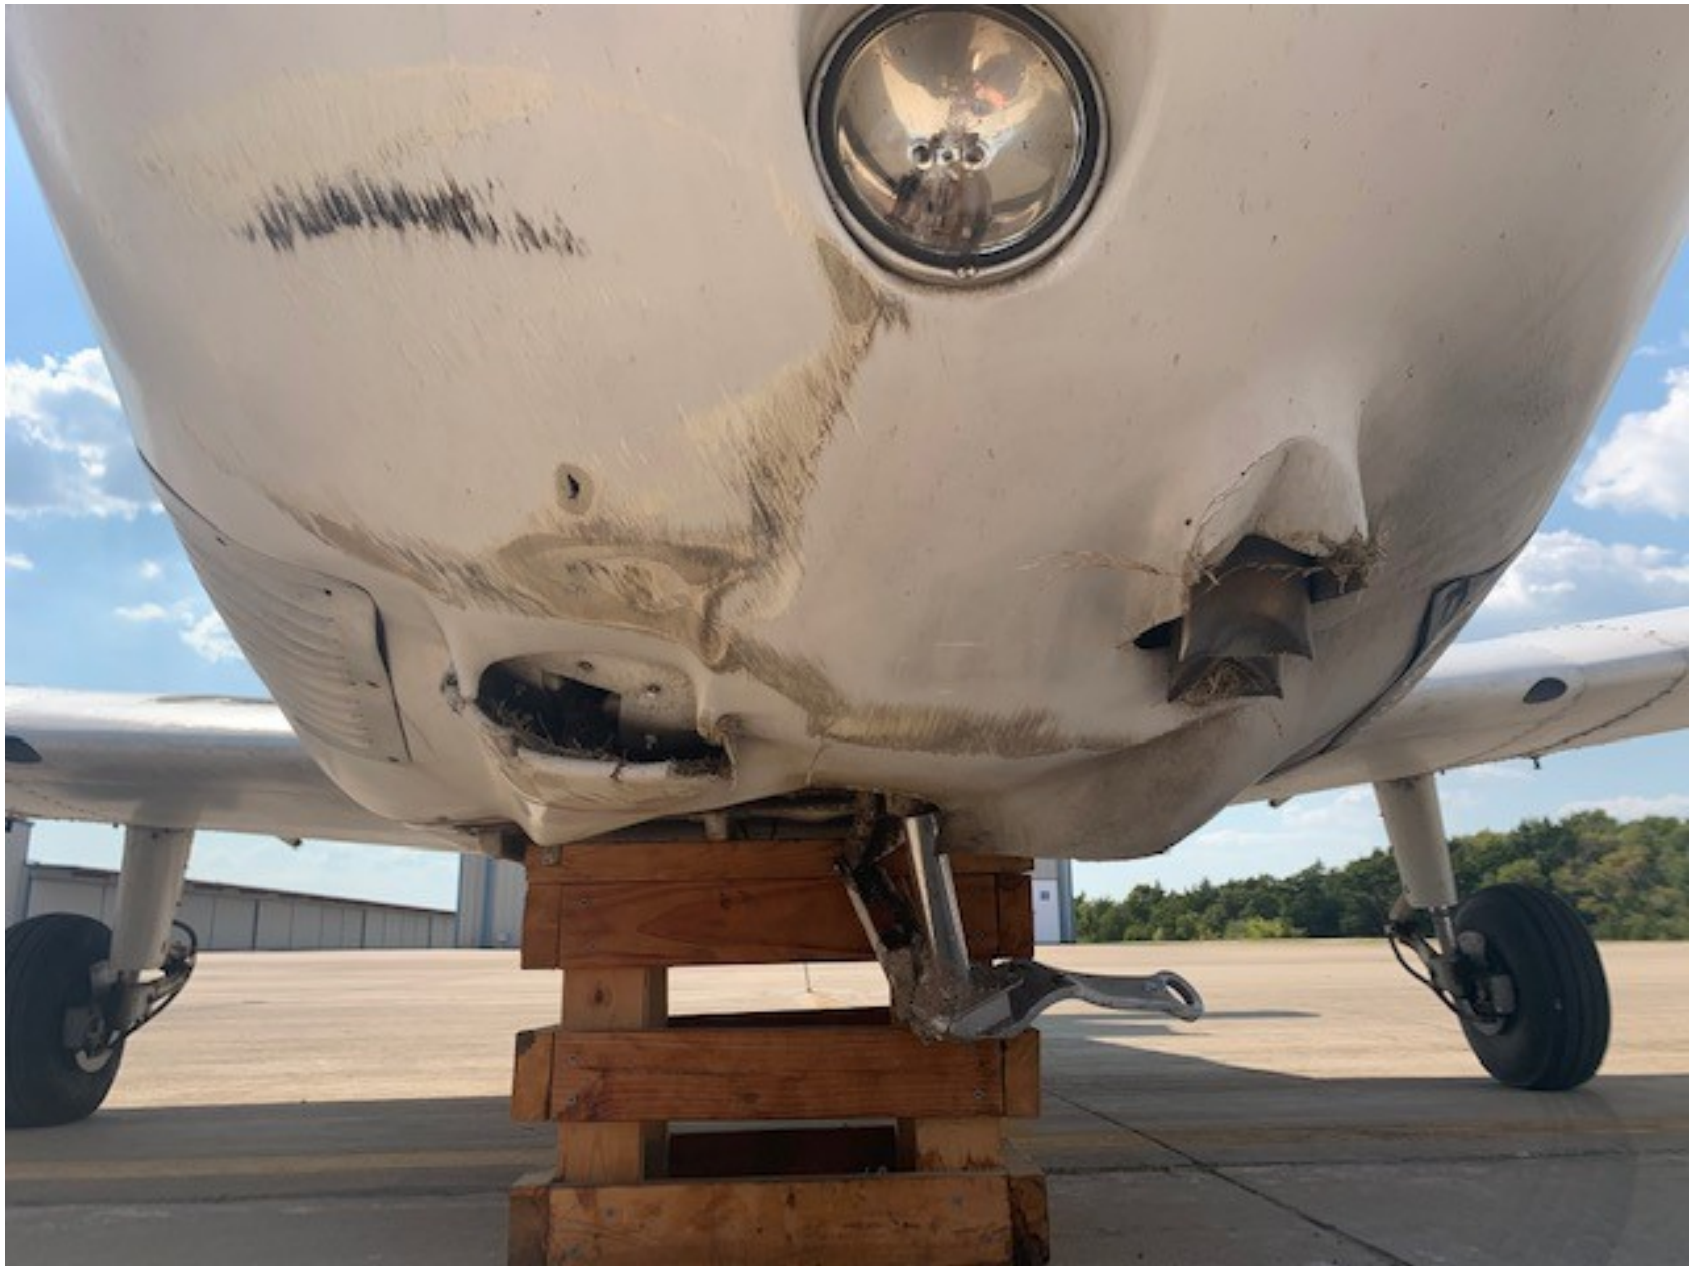
**Photo 4 - Damage to the cowling after the nose gear separated. (FAA photo).**

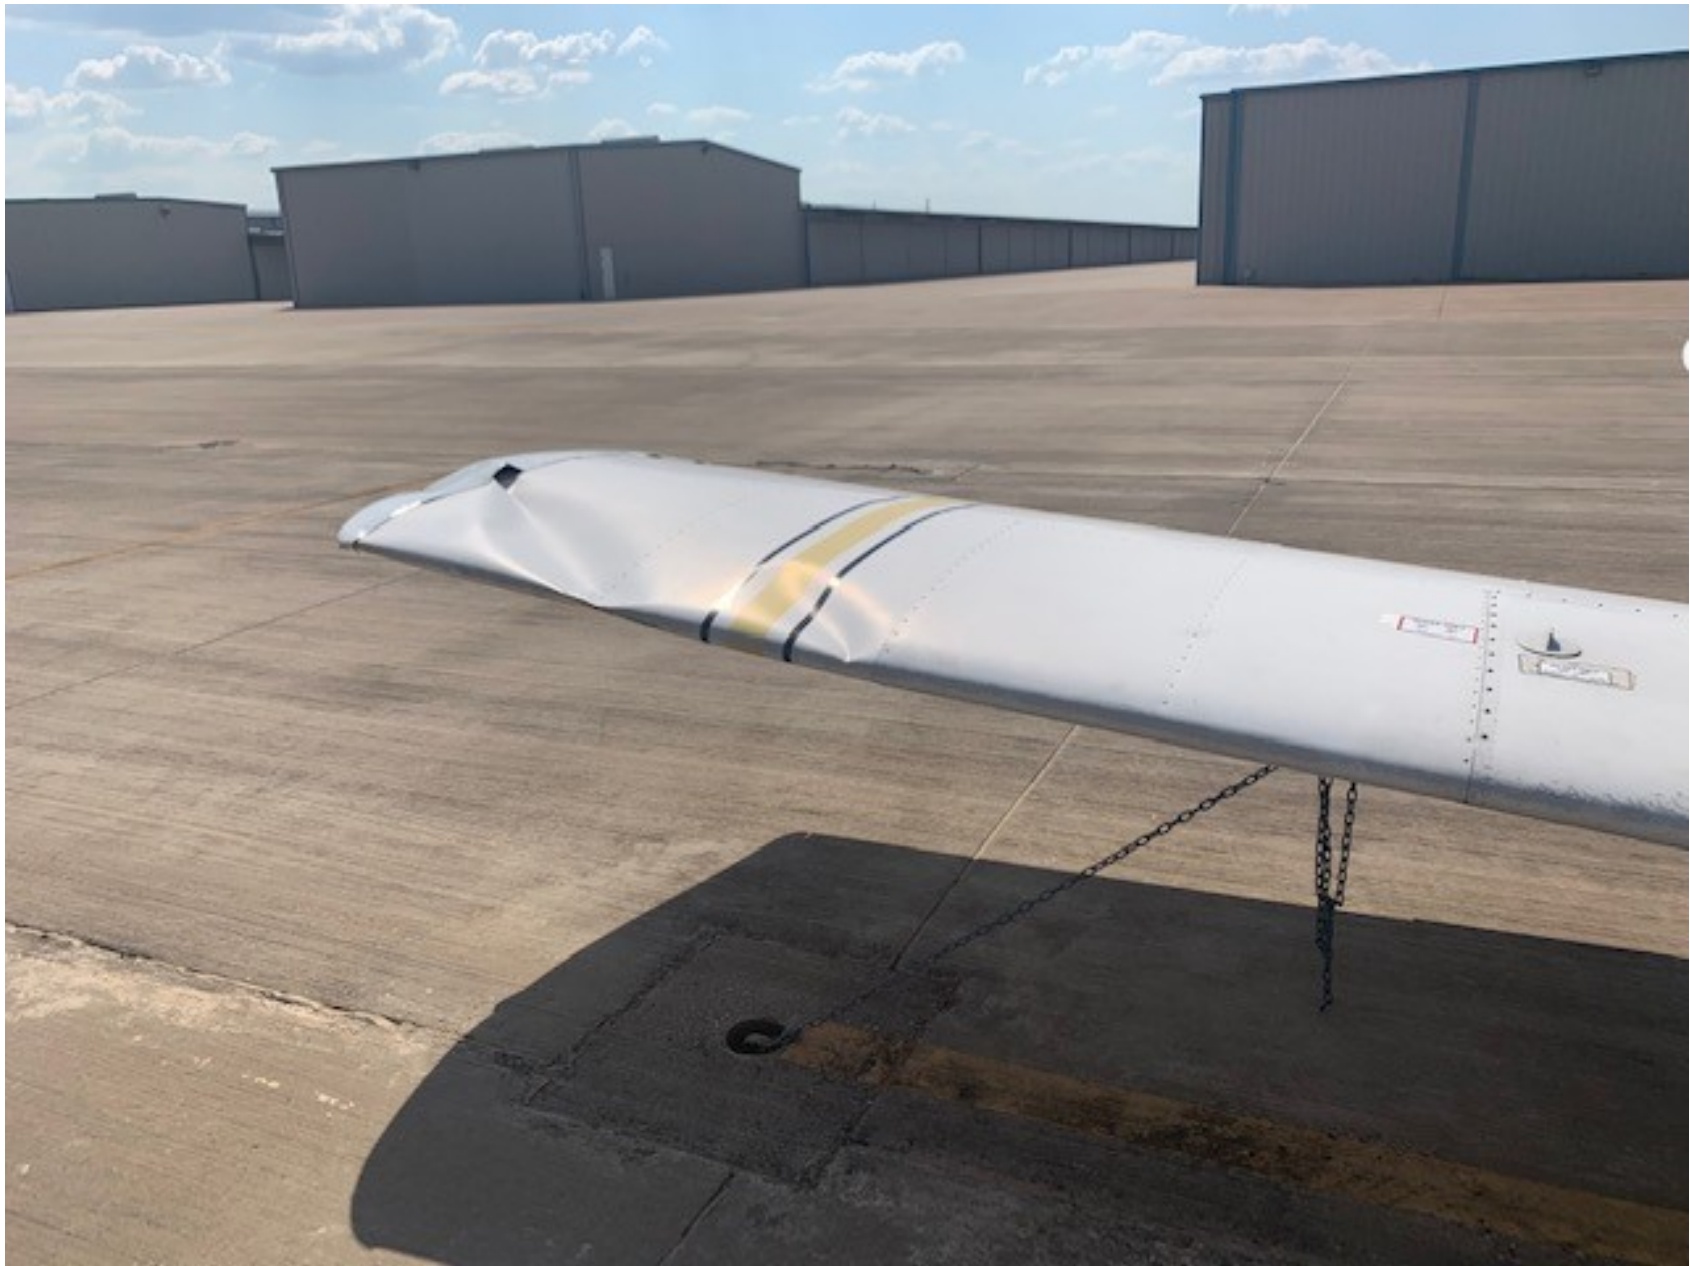
**Photo 5 – Right wing damage. (FAA photo).**

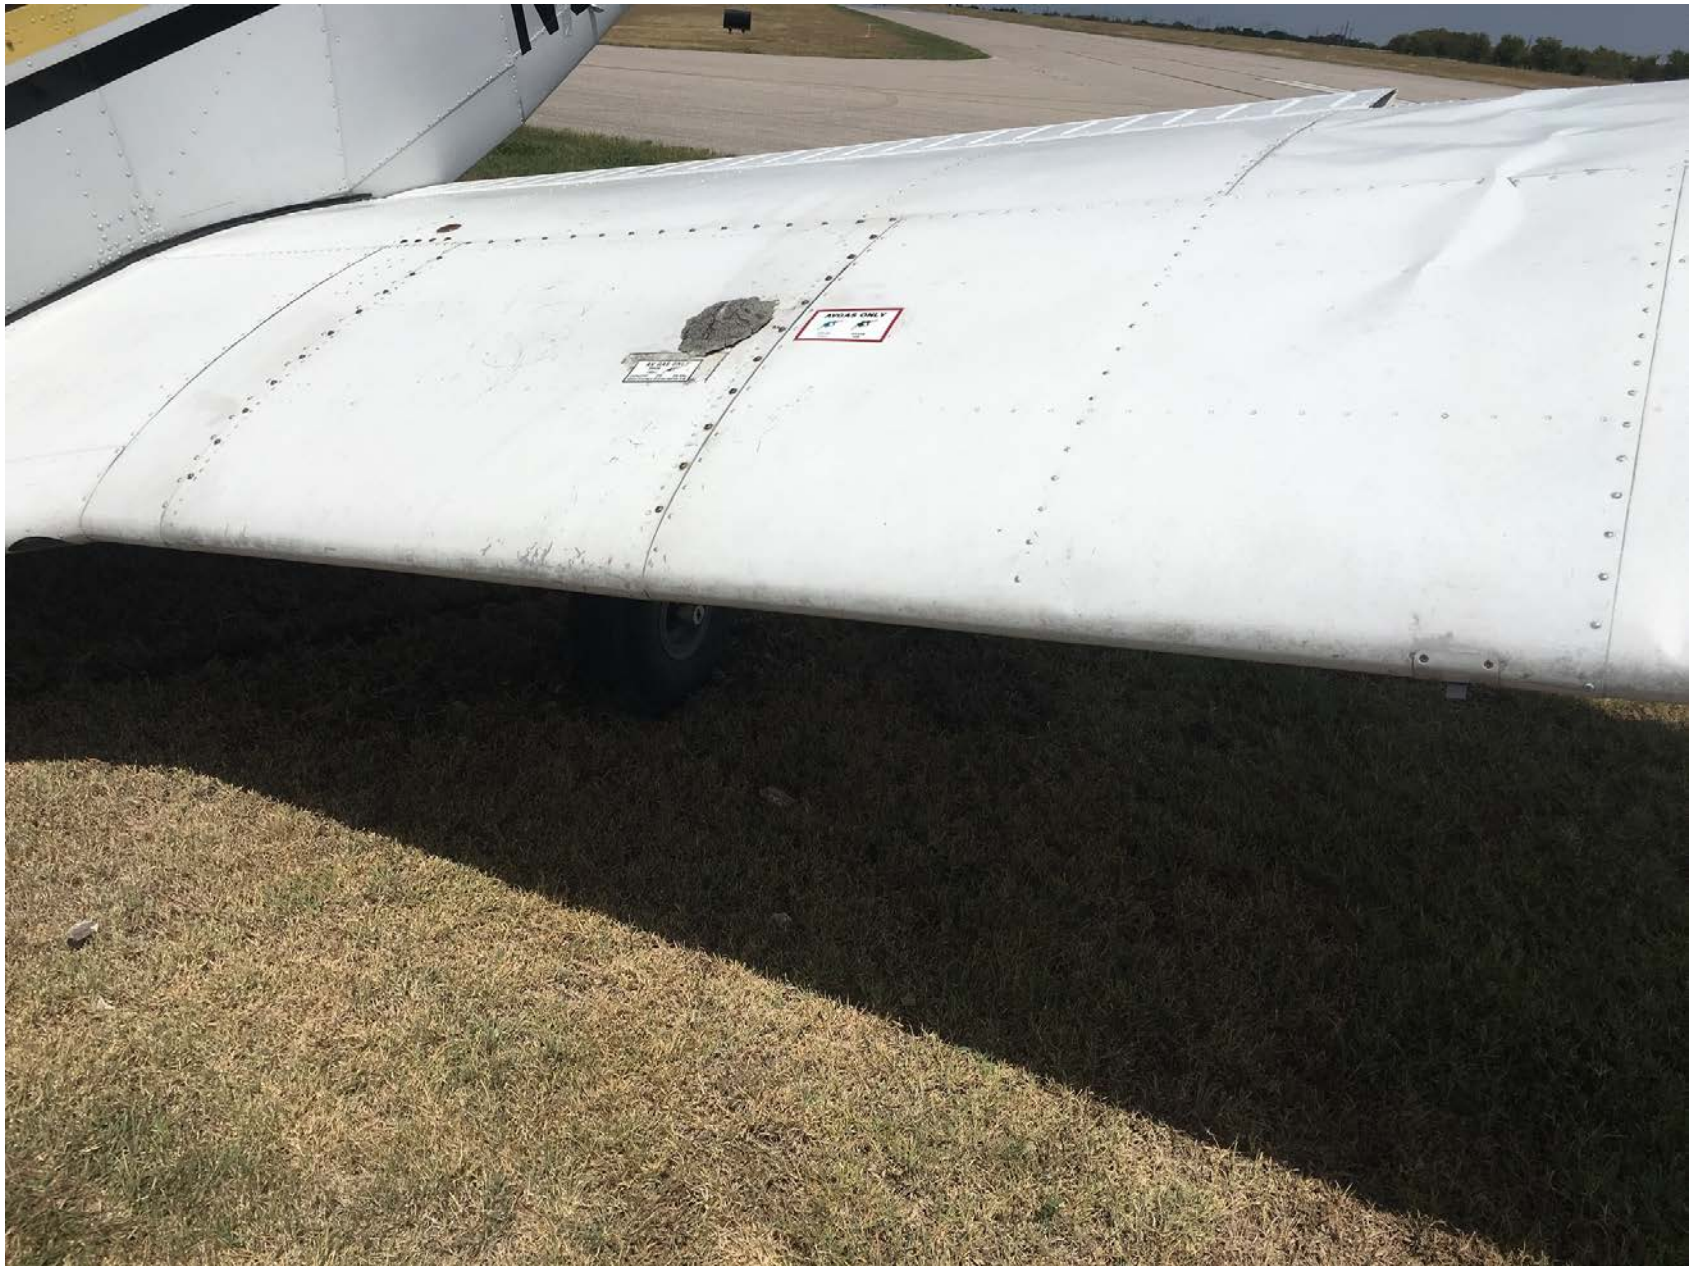
**Photo 6 – Left wing damage. (FAA photo).**
