**From:** Bob Jackson [REDACTED]  
**Sent:** Thursday, September 12, 2019 7:49 AM  
**To:** Scott Arnold; 'Ritter, Stan A (FAA)'  
**Cc:** [REDACTED]  
**Subject:** Velocity N2XF Incident -- Summary Statement

### Summary of Incident

Velocity XL/RG  
N2XF

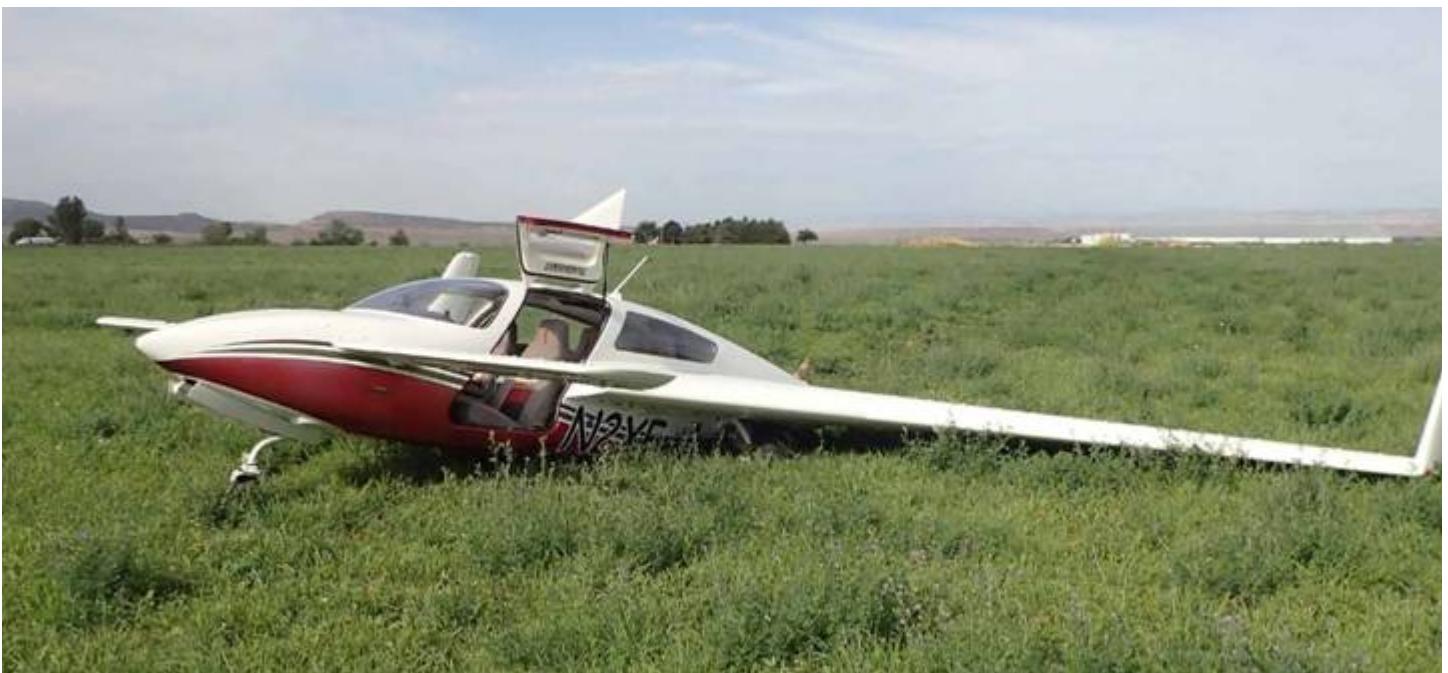
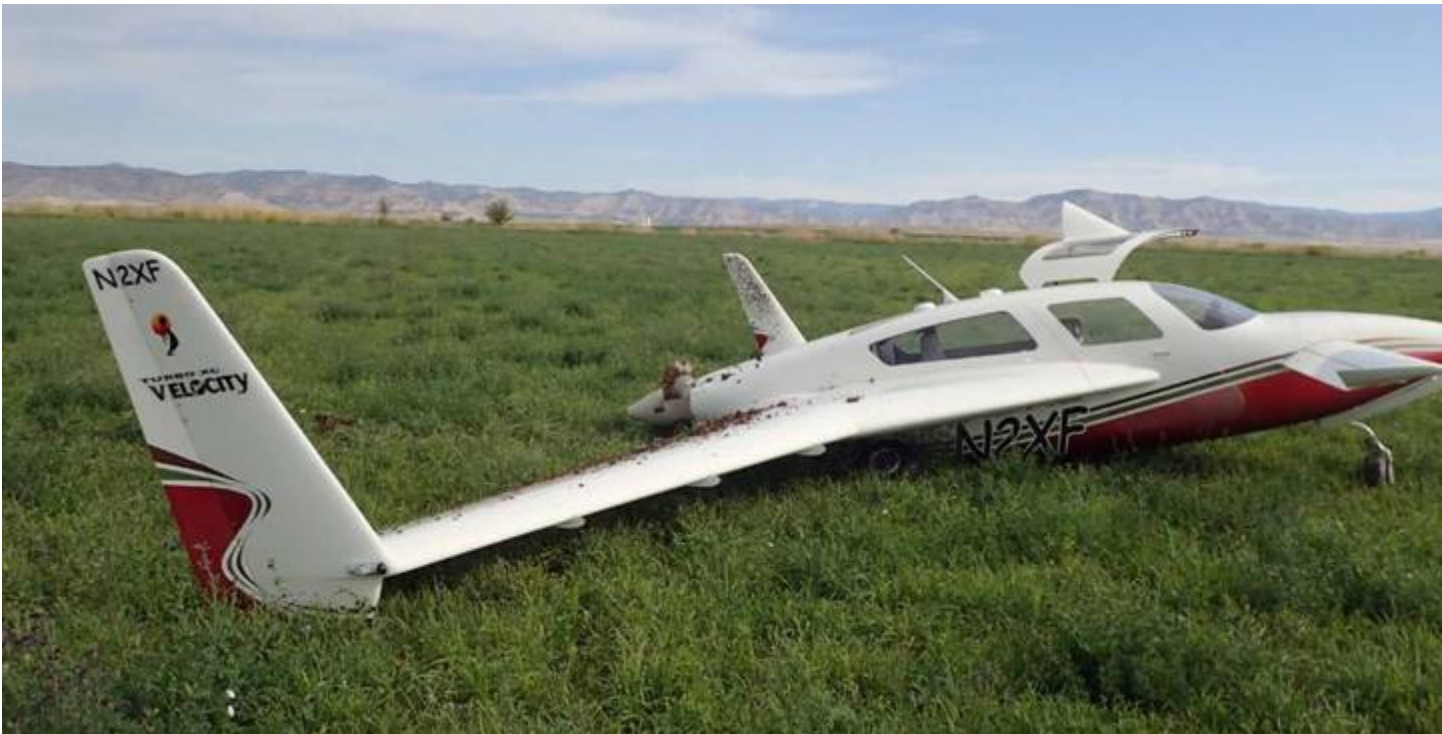
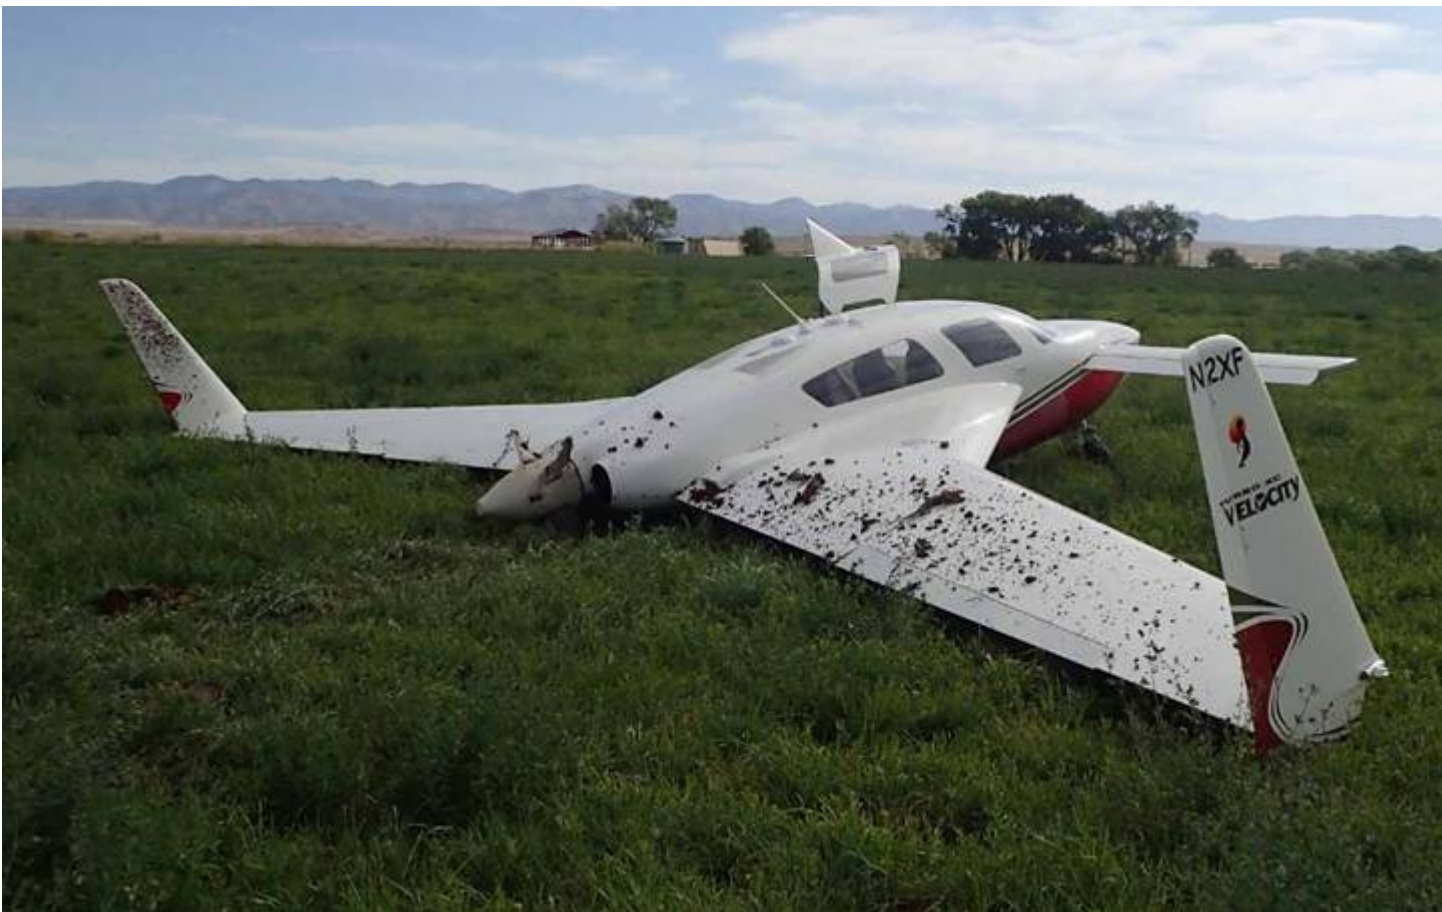
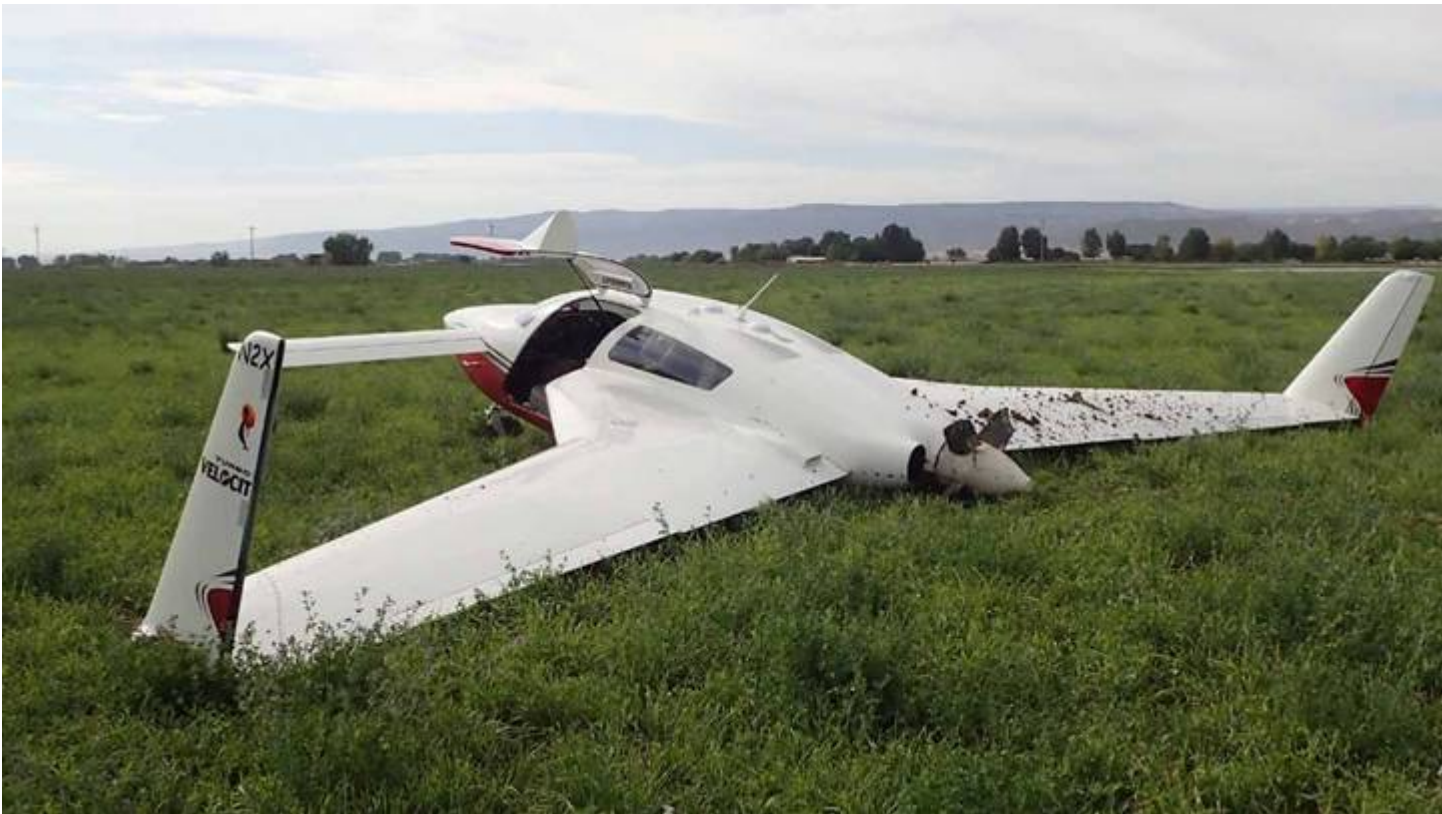
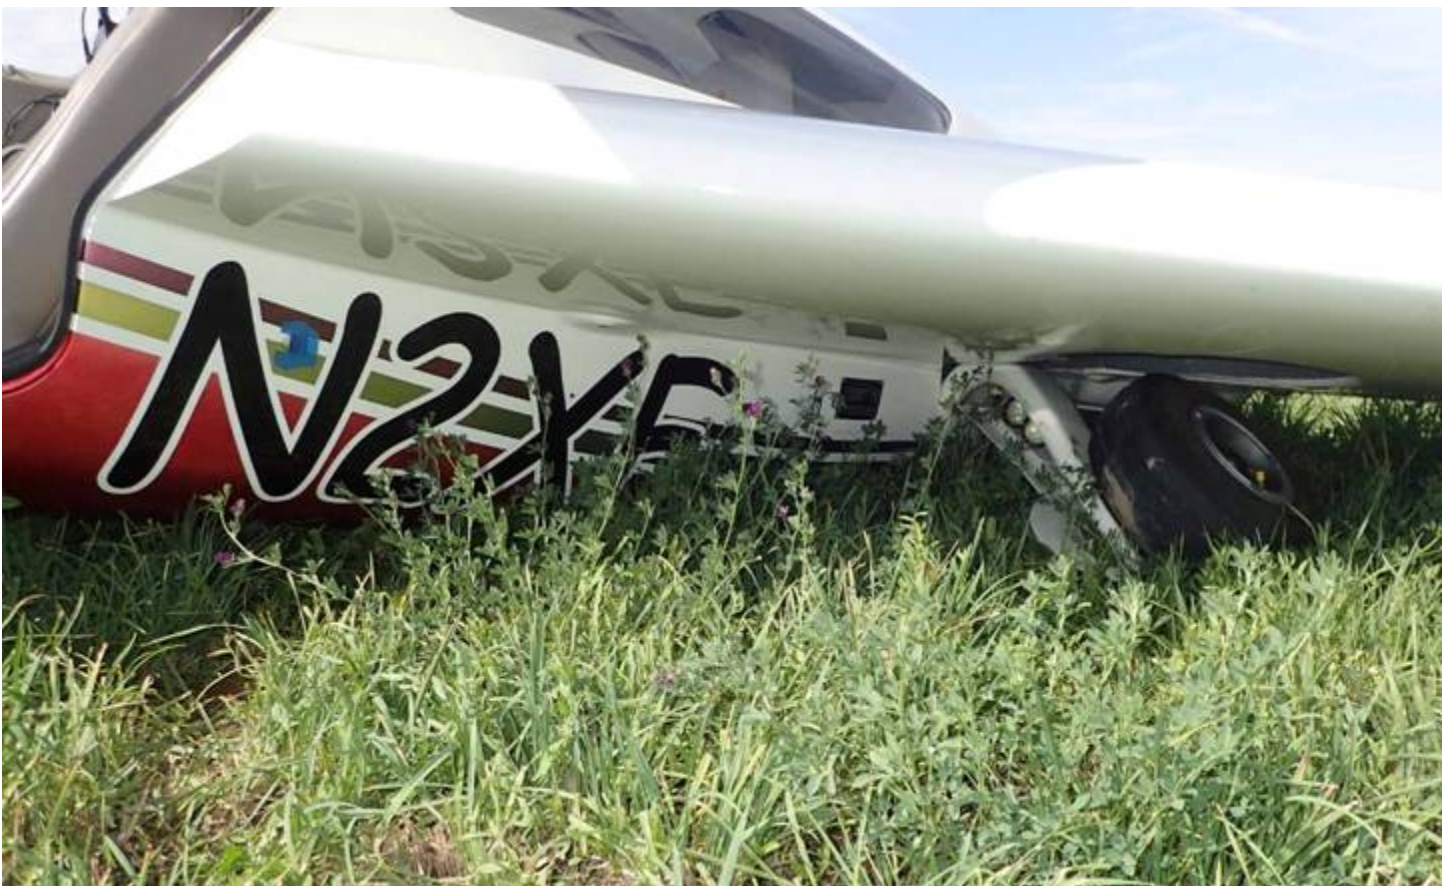
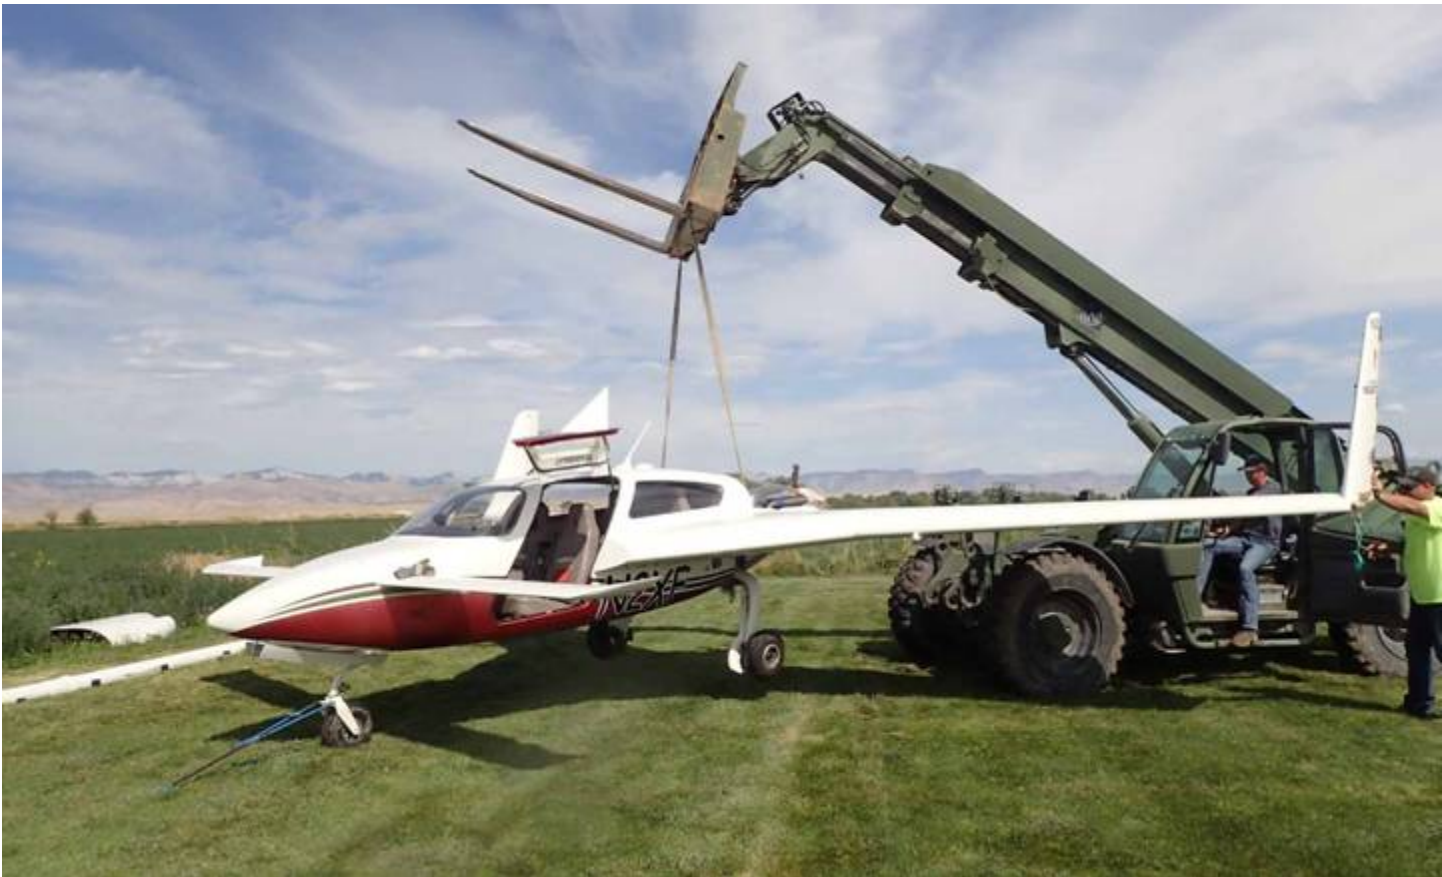
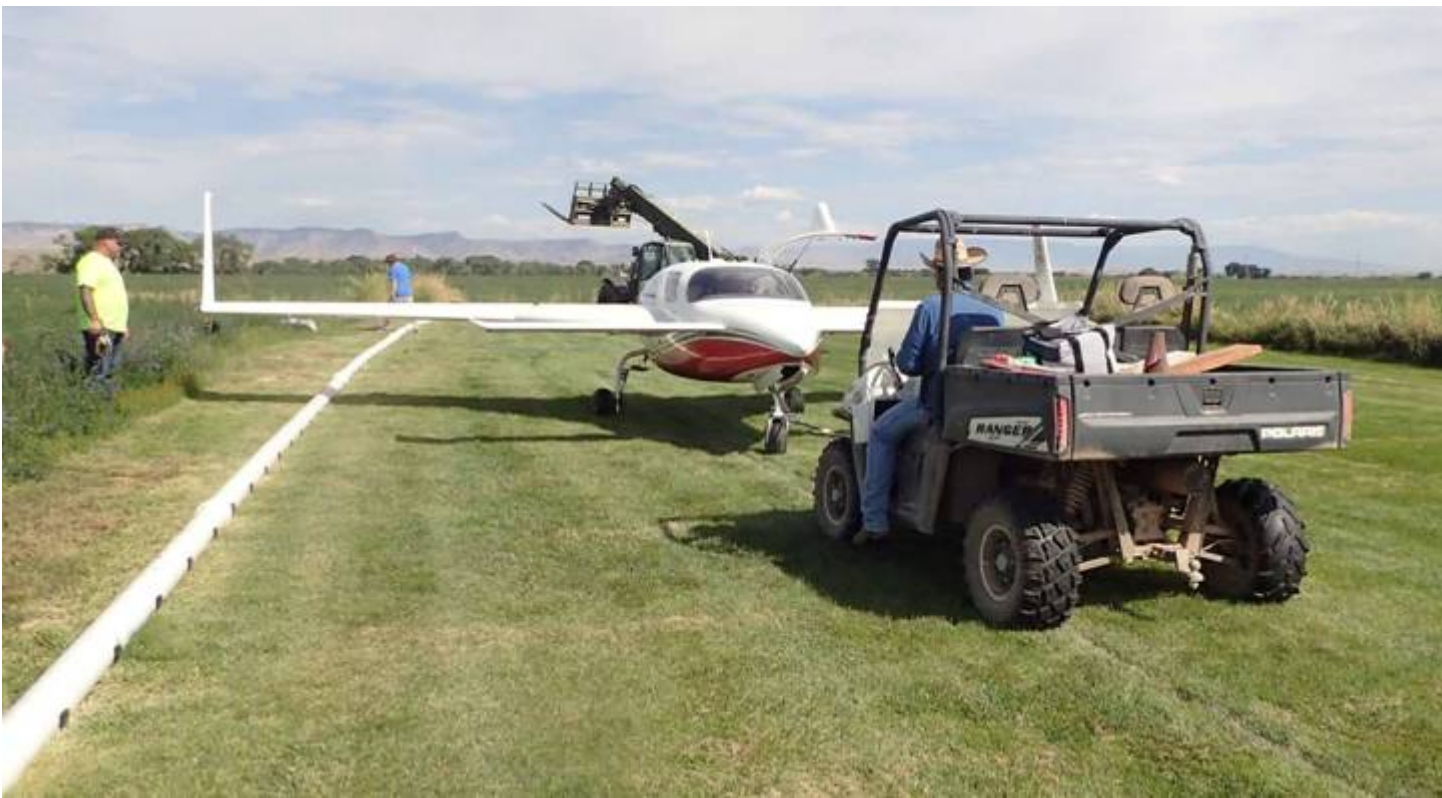
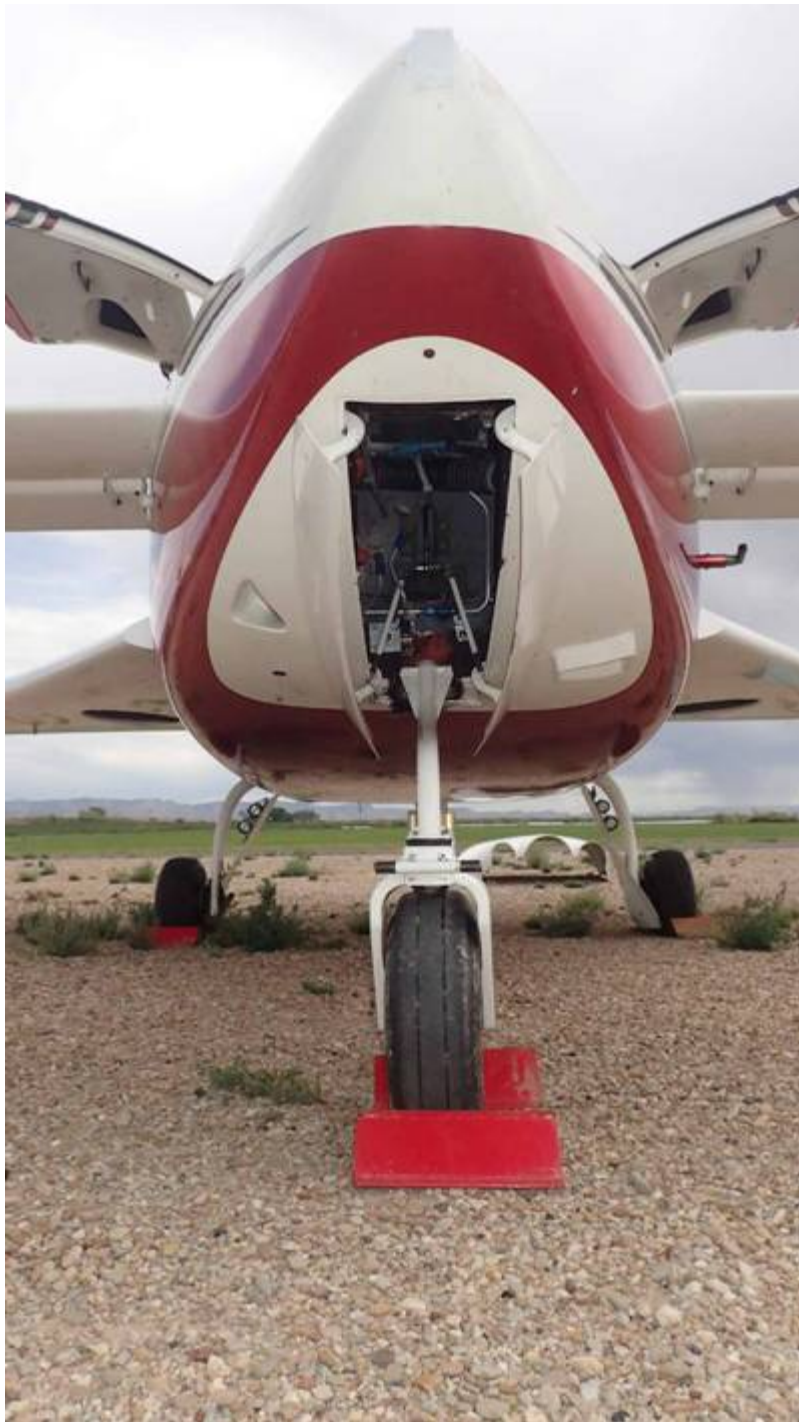
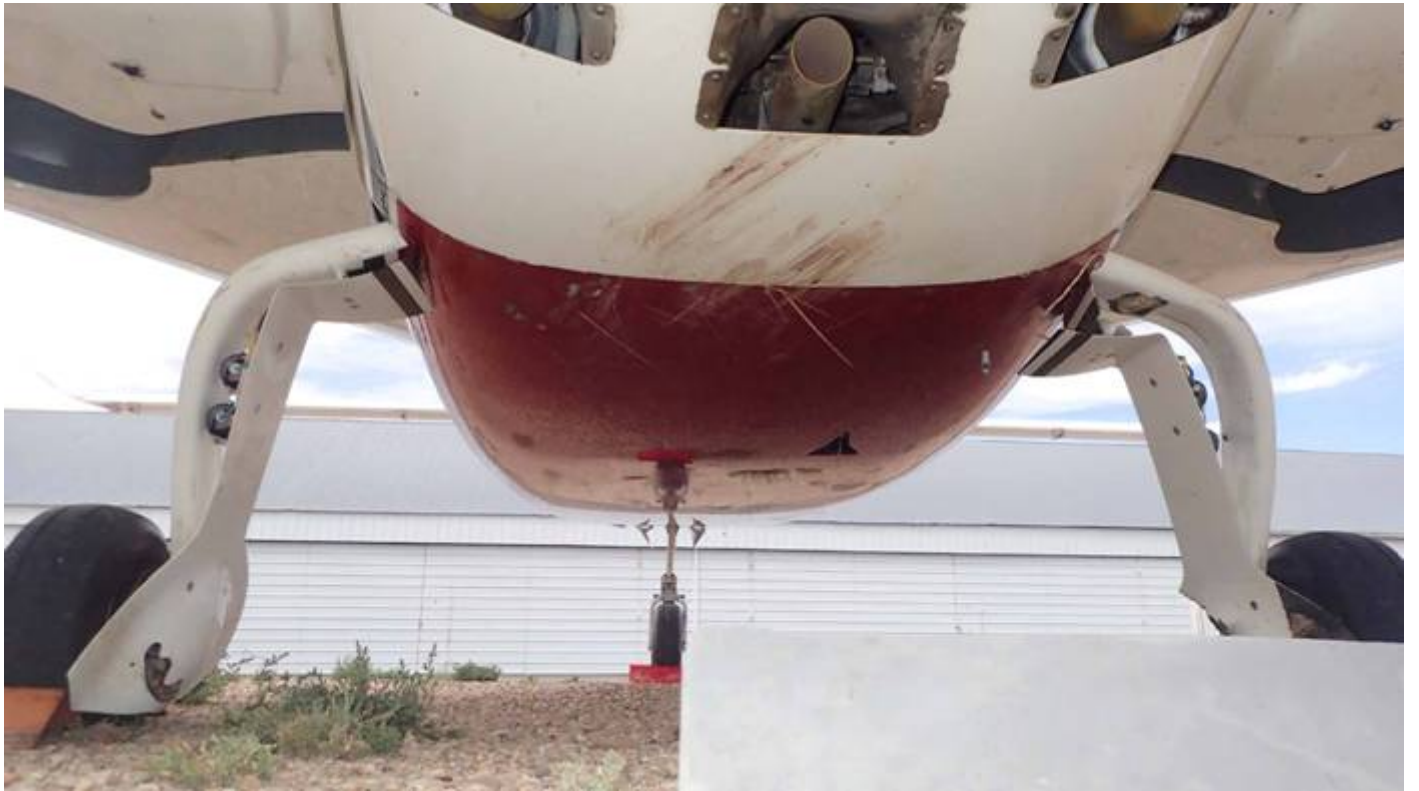
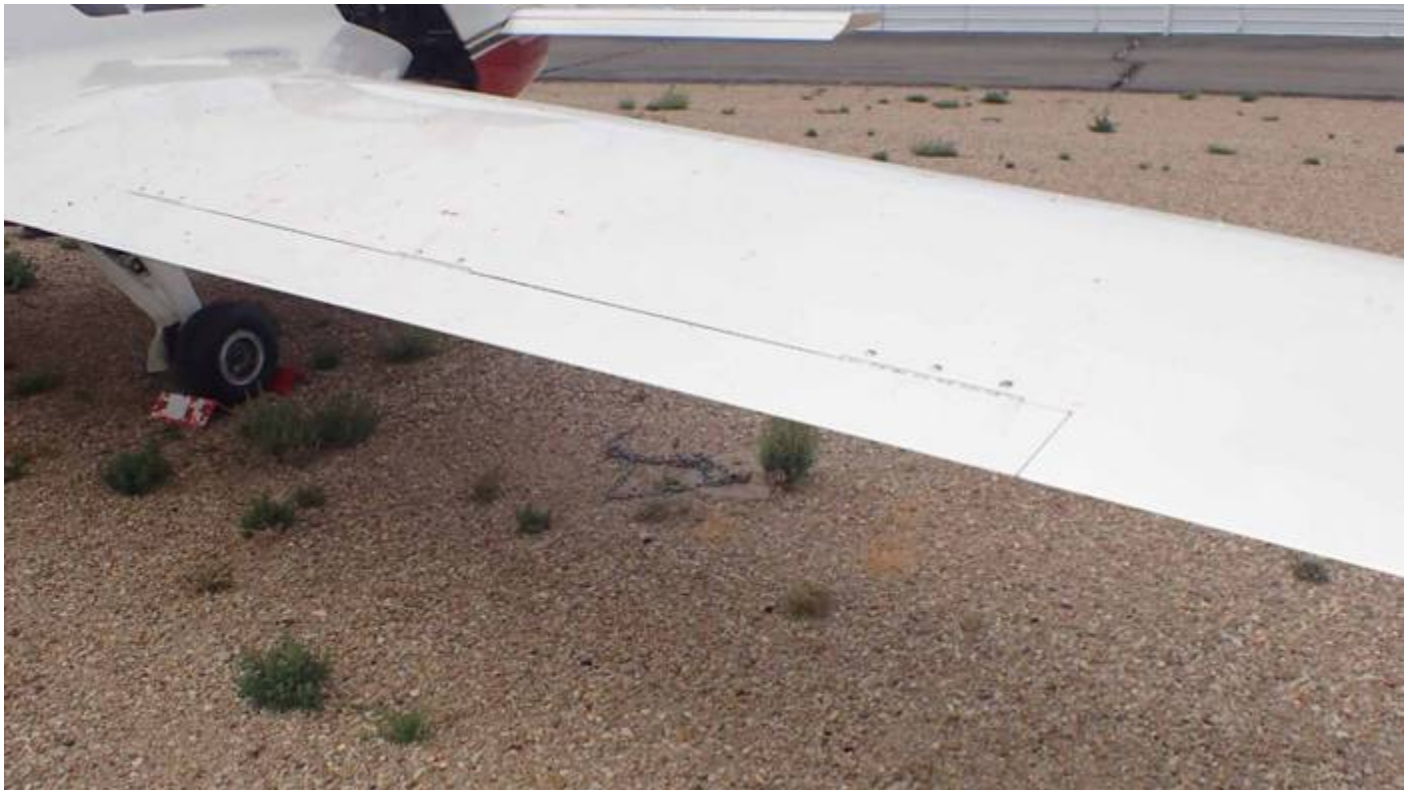
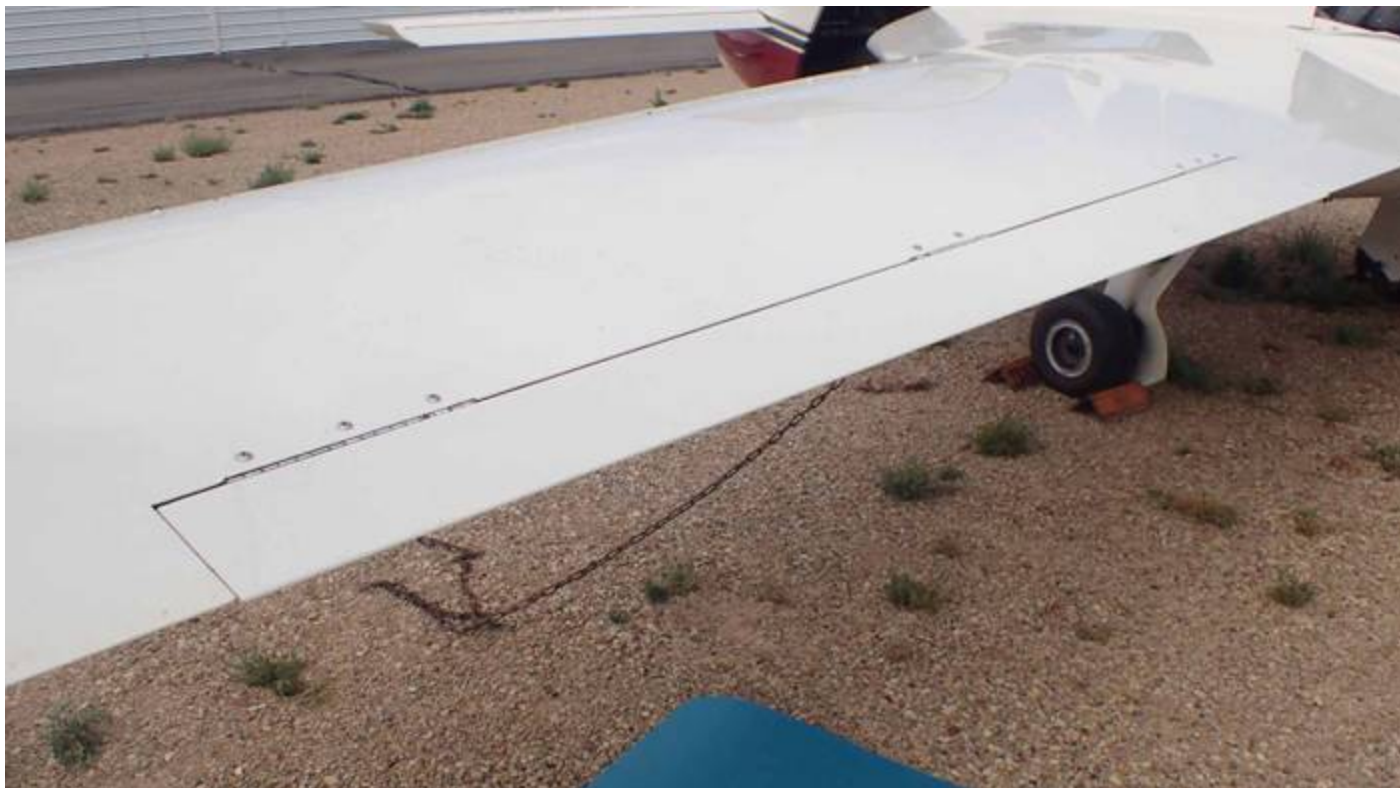
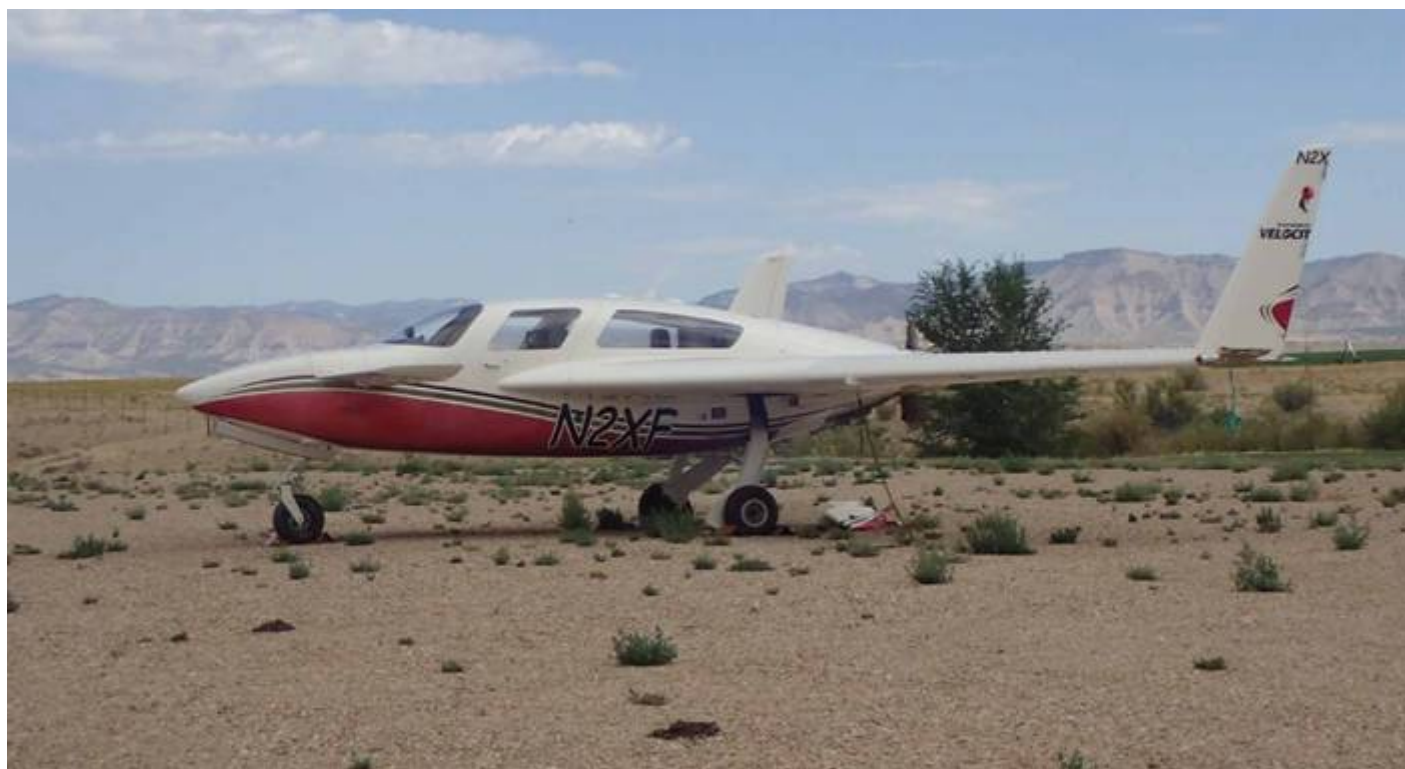
Aircraft photos taken after the emergency landing of N2XF at the Mack Mesa airport (10CO) are included below. Someone said that damage to flight controls was a consideration in the incident/accident determination. You will notice from the pictures that all the flight controls are intact and still fully functional except for the rudder on the left winglet. This left rudder was not damaged as a result of the landing, but instead in the last few feet of the roll out on the overrun when it caught the edge of a large irrigation pipe (similar to the large white pipes visible in several of the pictures included below) that traverses the end of the overrun.
