**From:** Bob Jackson [REDACTED]  
**Sent:** Thursday, January 9, 2020 10:46 AM  
**To:** Scott Arnold  
**Cc:** [REDACTED]  
**Subject:** N2XF Overspeed Incident - Root Cause Analysis  
**Attachments:** N2XF Governor/Prop Testing Report

### Overspeed Root Cause Analysis

N2XF  
Experimental Velocity TXL/RG/XC

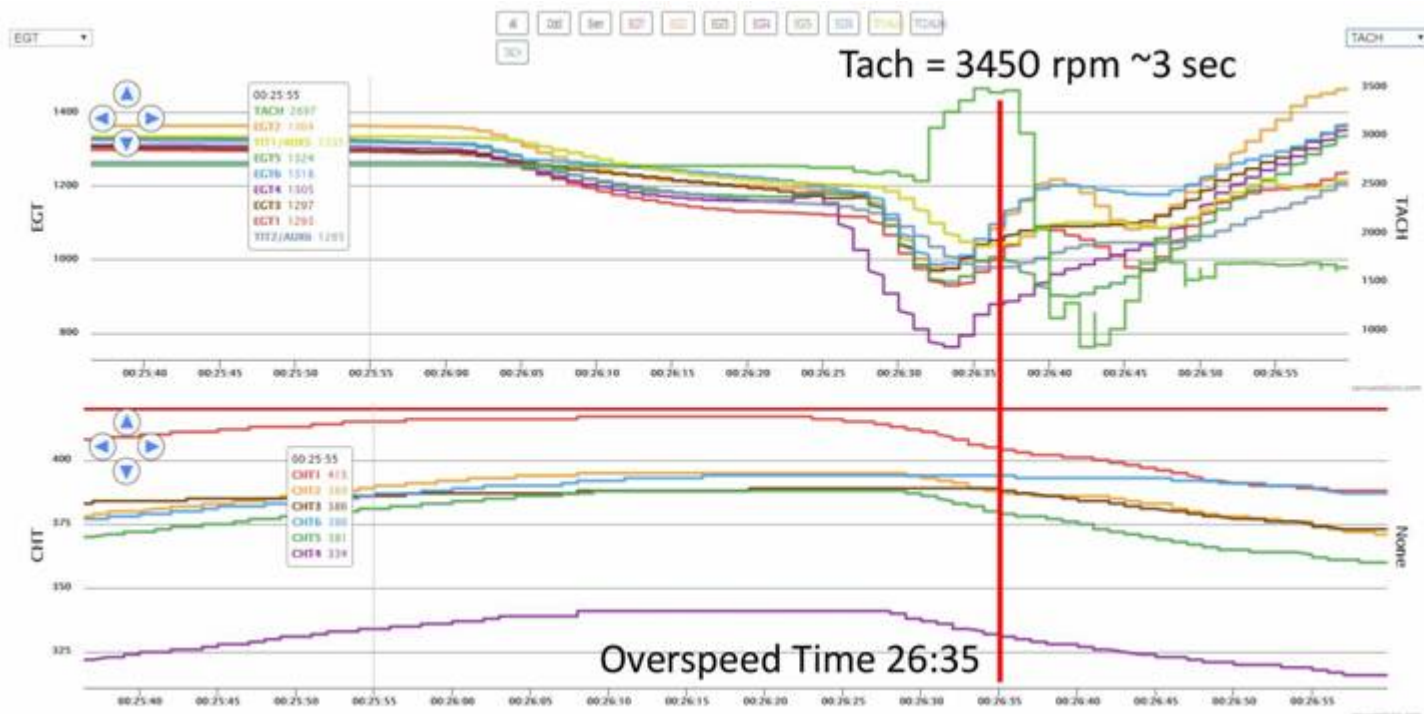
Close analysis of the engine monitoring data traces (like the one included below) indicates that the damage to the electronic ignition timing disk and timing sensors discovered on post flight most likely occurred just prior to the overspeed, and not as a result of the overspeed or of the landing rollout.

From close examination of the supporting engine data traces like the one above, as well as the physically damaged electronic ignition timing components, it is believed that the overspeed was caused by the prop governor's normal reaction to the slight slow down of engine speed (from climbout steady 2700 rpm shown by the green trace on the chart above down to ~2550 rpm – the slight 'droop' in the green trace evident on the chart) that occurred during the ten seconds prior to the overspeed.

It is believed that during the ten seconds prior to the overspeed the slow down was caused by the timing ring attachment screws backing out and striking and severely damaging the electronic ignition timing sensors. The interference to rotation and damage caused by the loose screws striking the Hall Effect senders caused the slowdown from ~2700 rpm to ~2550 rpm.

During this ten second slowdown, a normally operating propeller governor would decrease propeller pitch in an effort to bring the propeller rotation back up to speed. Once the obstruction of the ingested screws cleared away, the friction was released, and now the blades with way too little pitch allowed the prop to suddenly overspeed as shown in the trace. It can be seen from the rapidly falling EGT traces that the engine had quit firing correctly, even during the ten seconds prior to the overspeed, and was likely not producing any significant power during the overspeed.

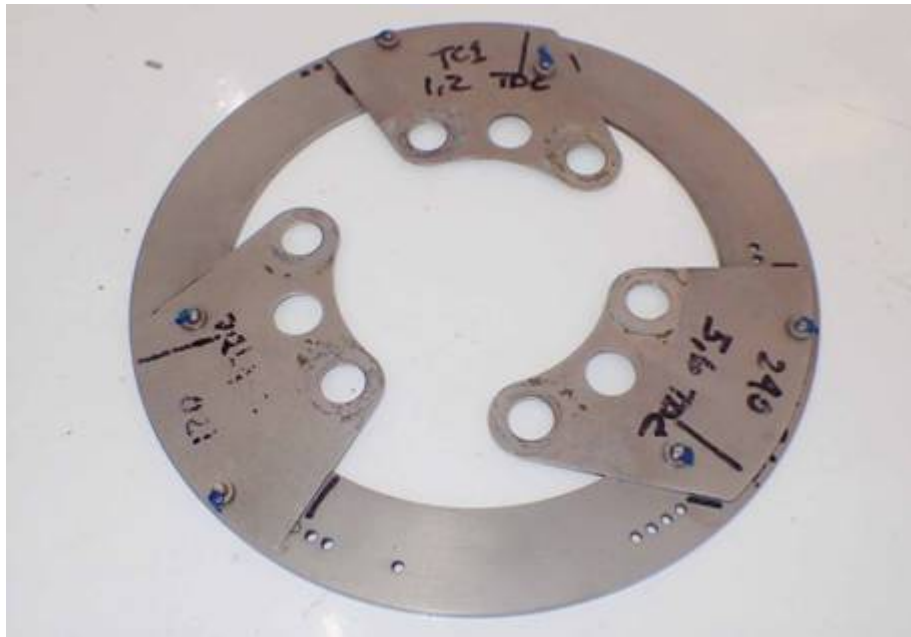
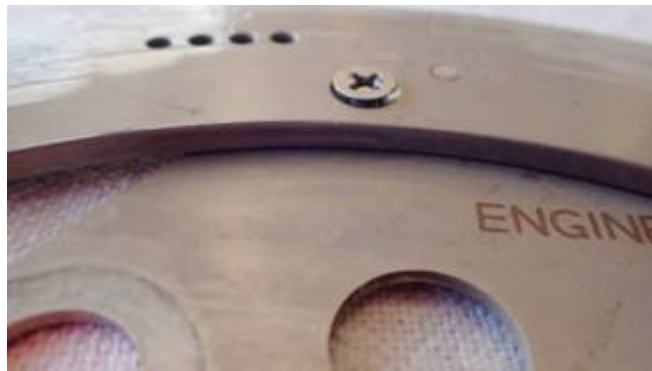
Careful analysis of the timing ring and the Hall Effect timing sensors after the flight revealed that of the six total 6-32 flush head screws that attach the timing ring to the three standoff brackets, (2) had backed out and were missing, (2) were sheared off with the thread ends still in the threaded bracket inserts, and (2) were loose and backed out, but still captured in the threaded inserts of the third standoff bracket.

(2) timing ring attachment screws were missing, (2) were sheared off, and (2) were loose and partially backed out

The four missing screws caused significant damage to the Mini Sensor timing pickups of both electronic ignition systems as they came out.

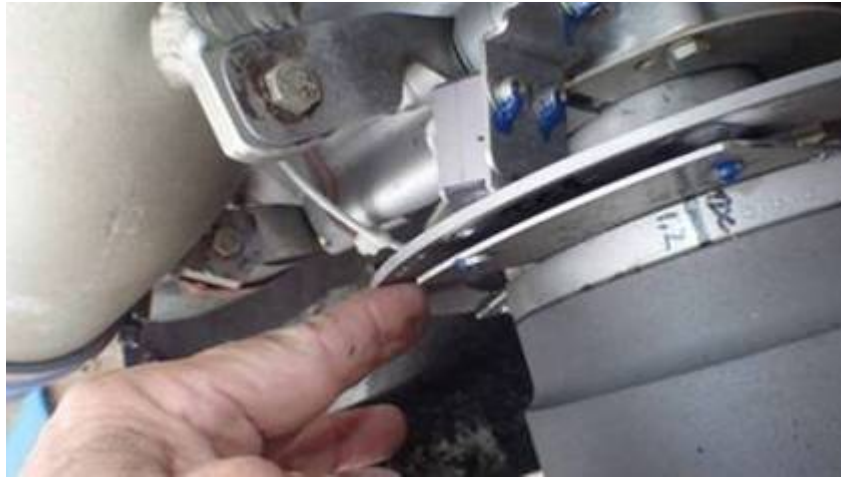
Timing ring loose and separated from bracket

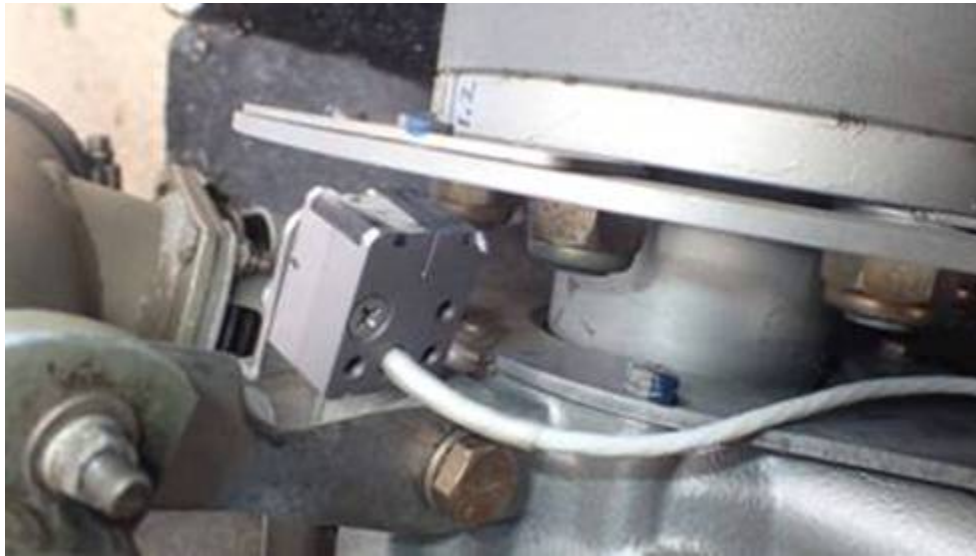
Bent CDI-1 bracket and damaged Hall Effect

sender

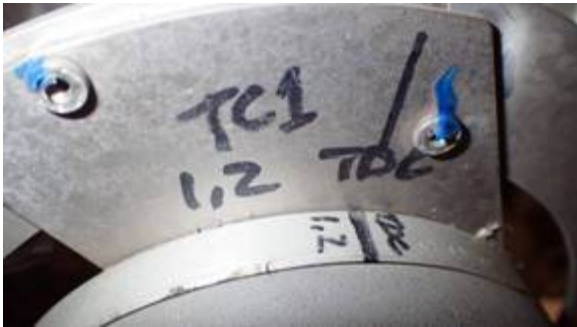
Threaded inserts for screws on back of bracket

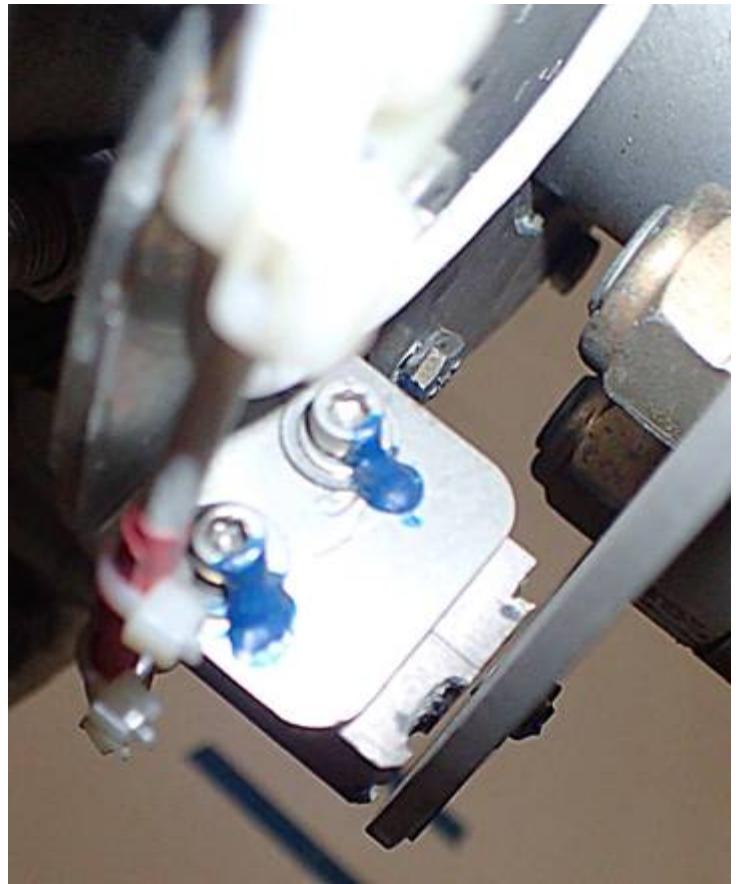
Damaged CDI-2 Hall Effect senders

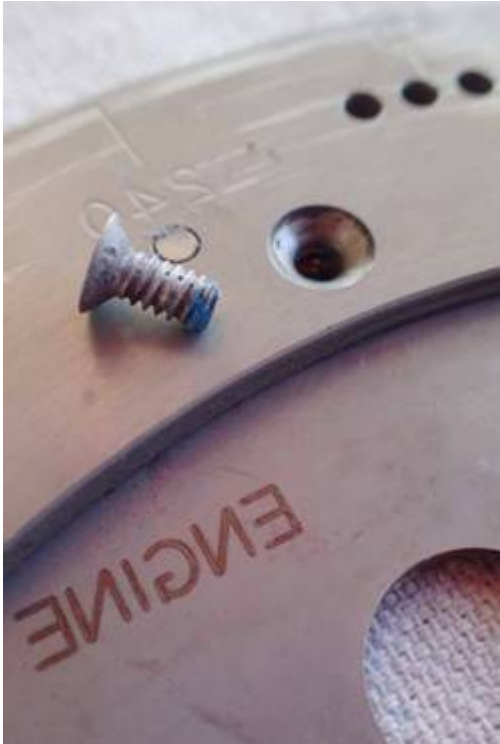
Flush head 6-32 attach screw

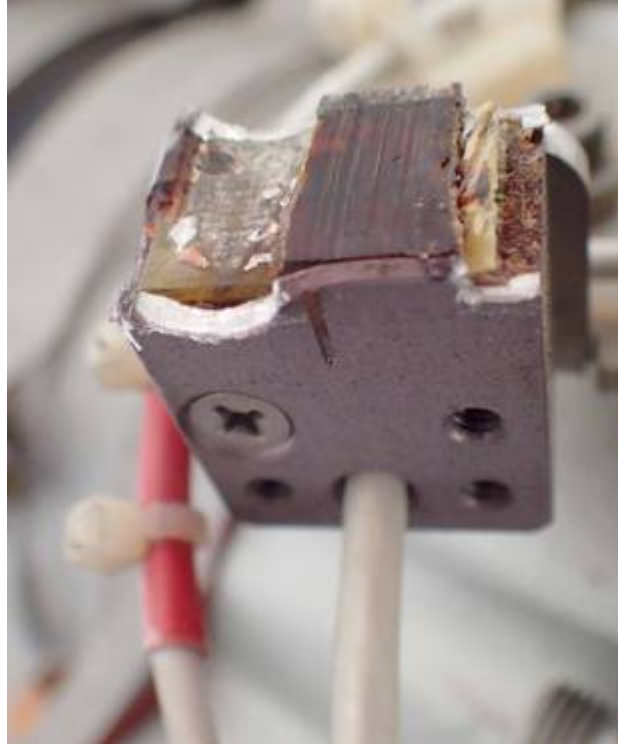
Damaged CDI Mini Sensor #2
