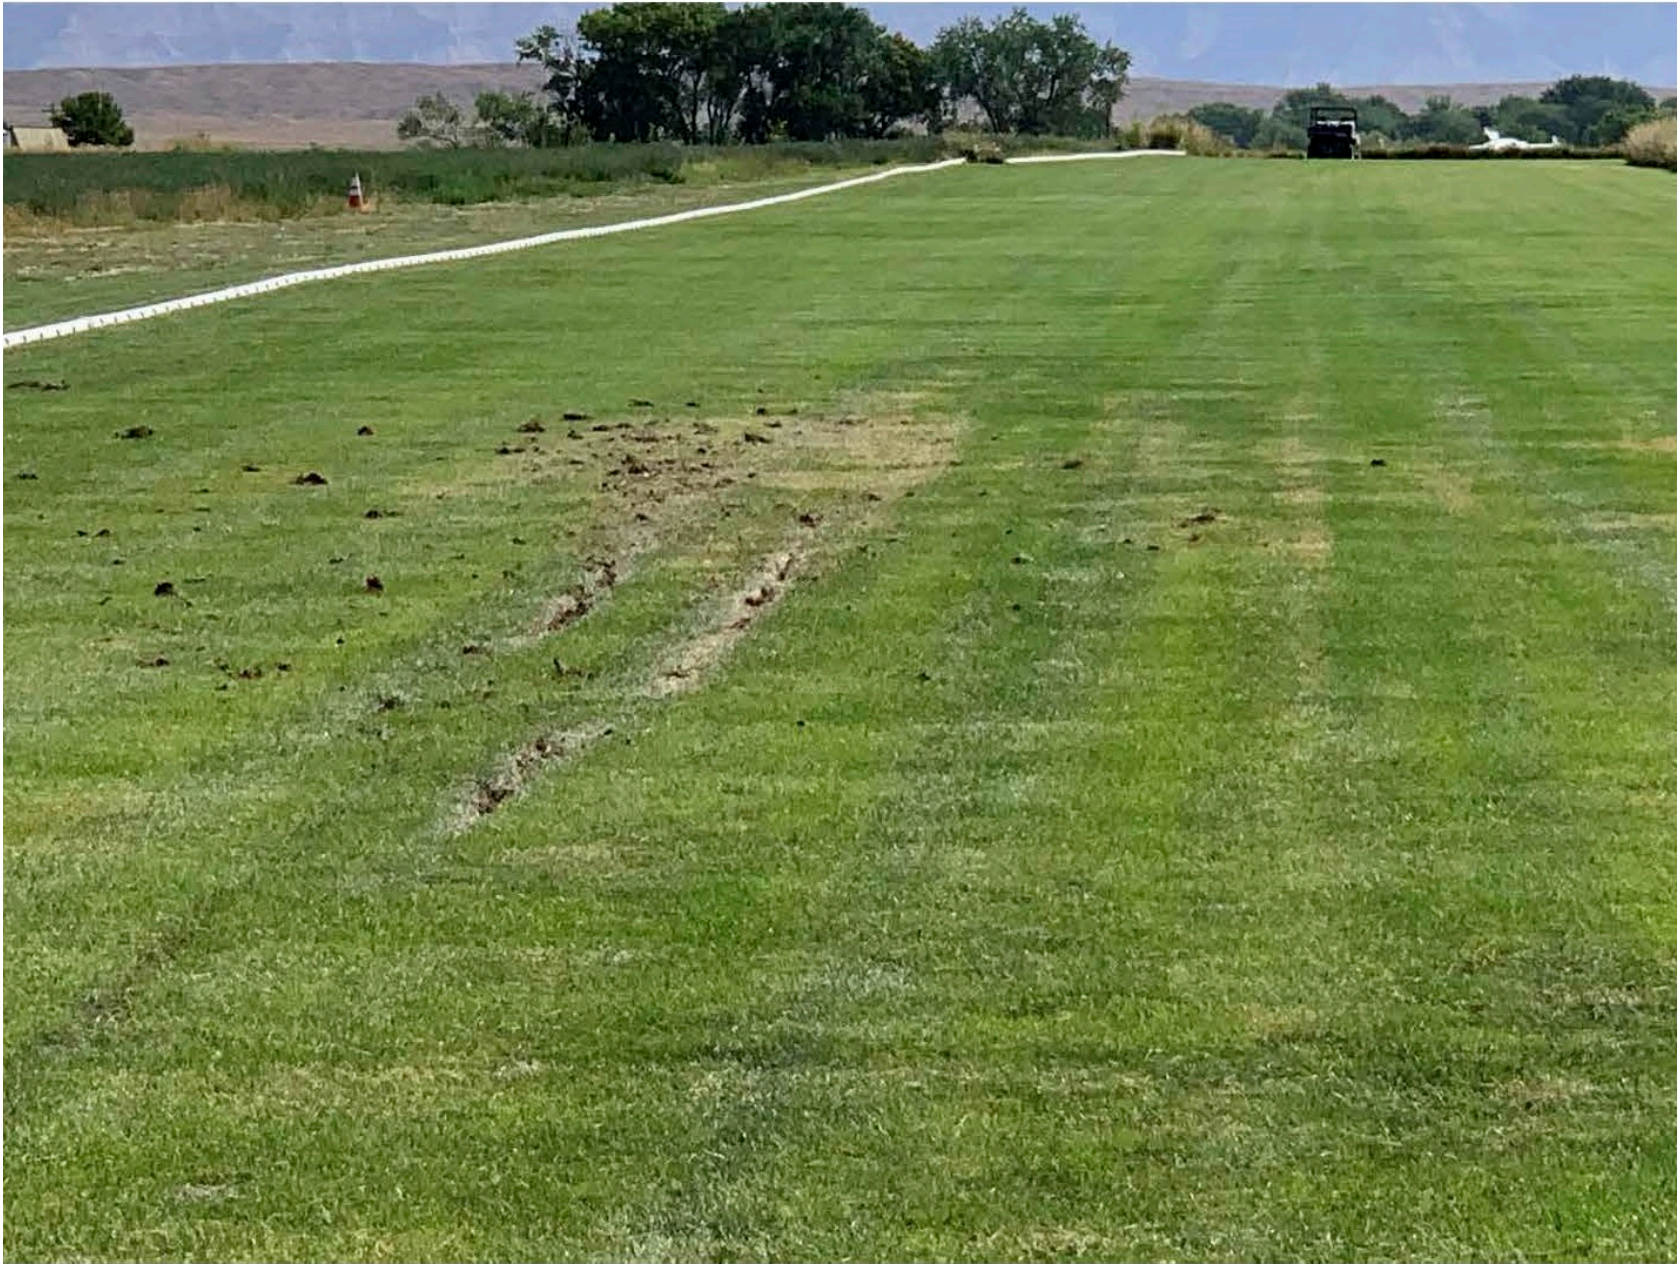
**Photo 1 – When N2XF made its forced landing, it went off the end of runway 7. Gouges in the ground were caused by the partially extended main landing gear. Irrigation pipe is at left and aircraft is in background**

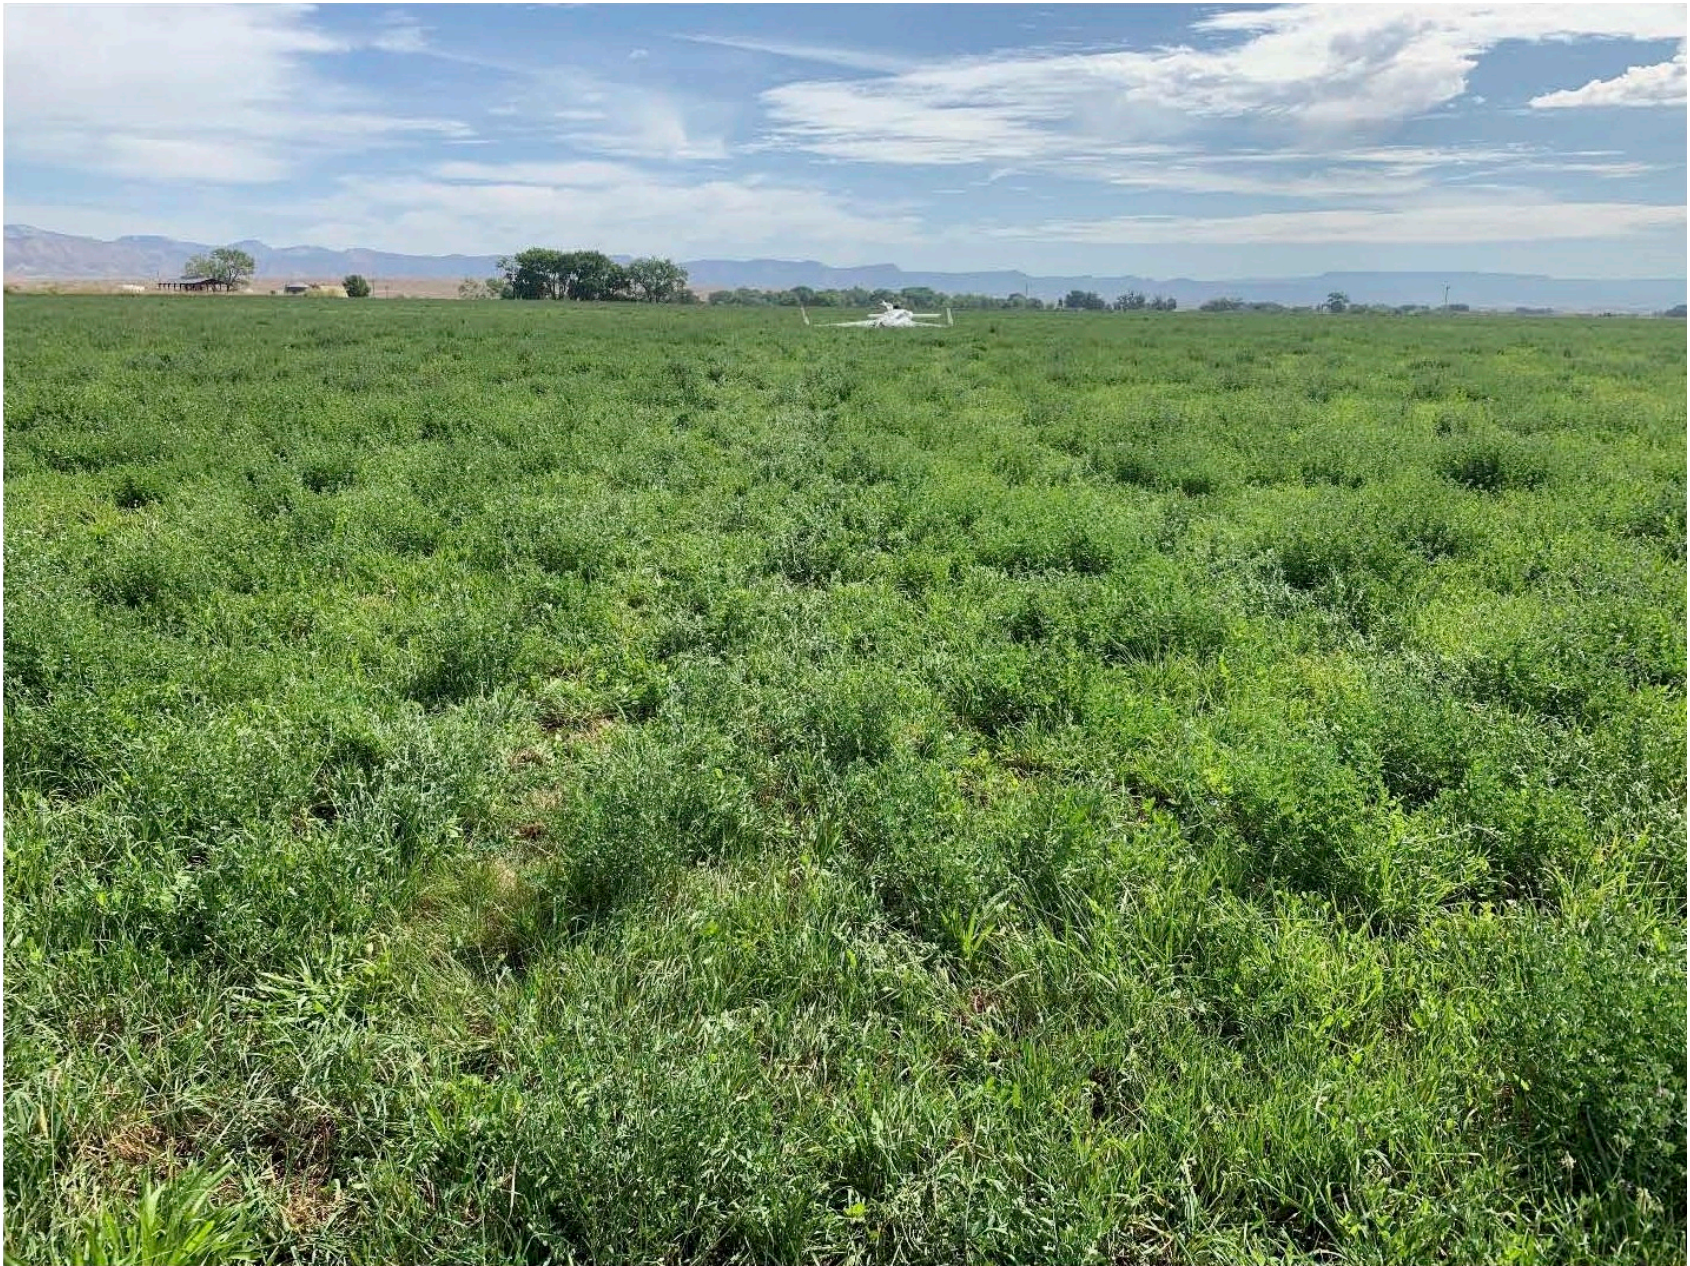
**Photo 2 – N2XF rests in a clover field**

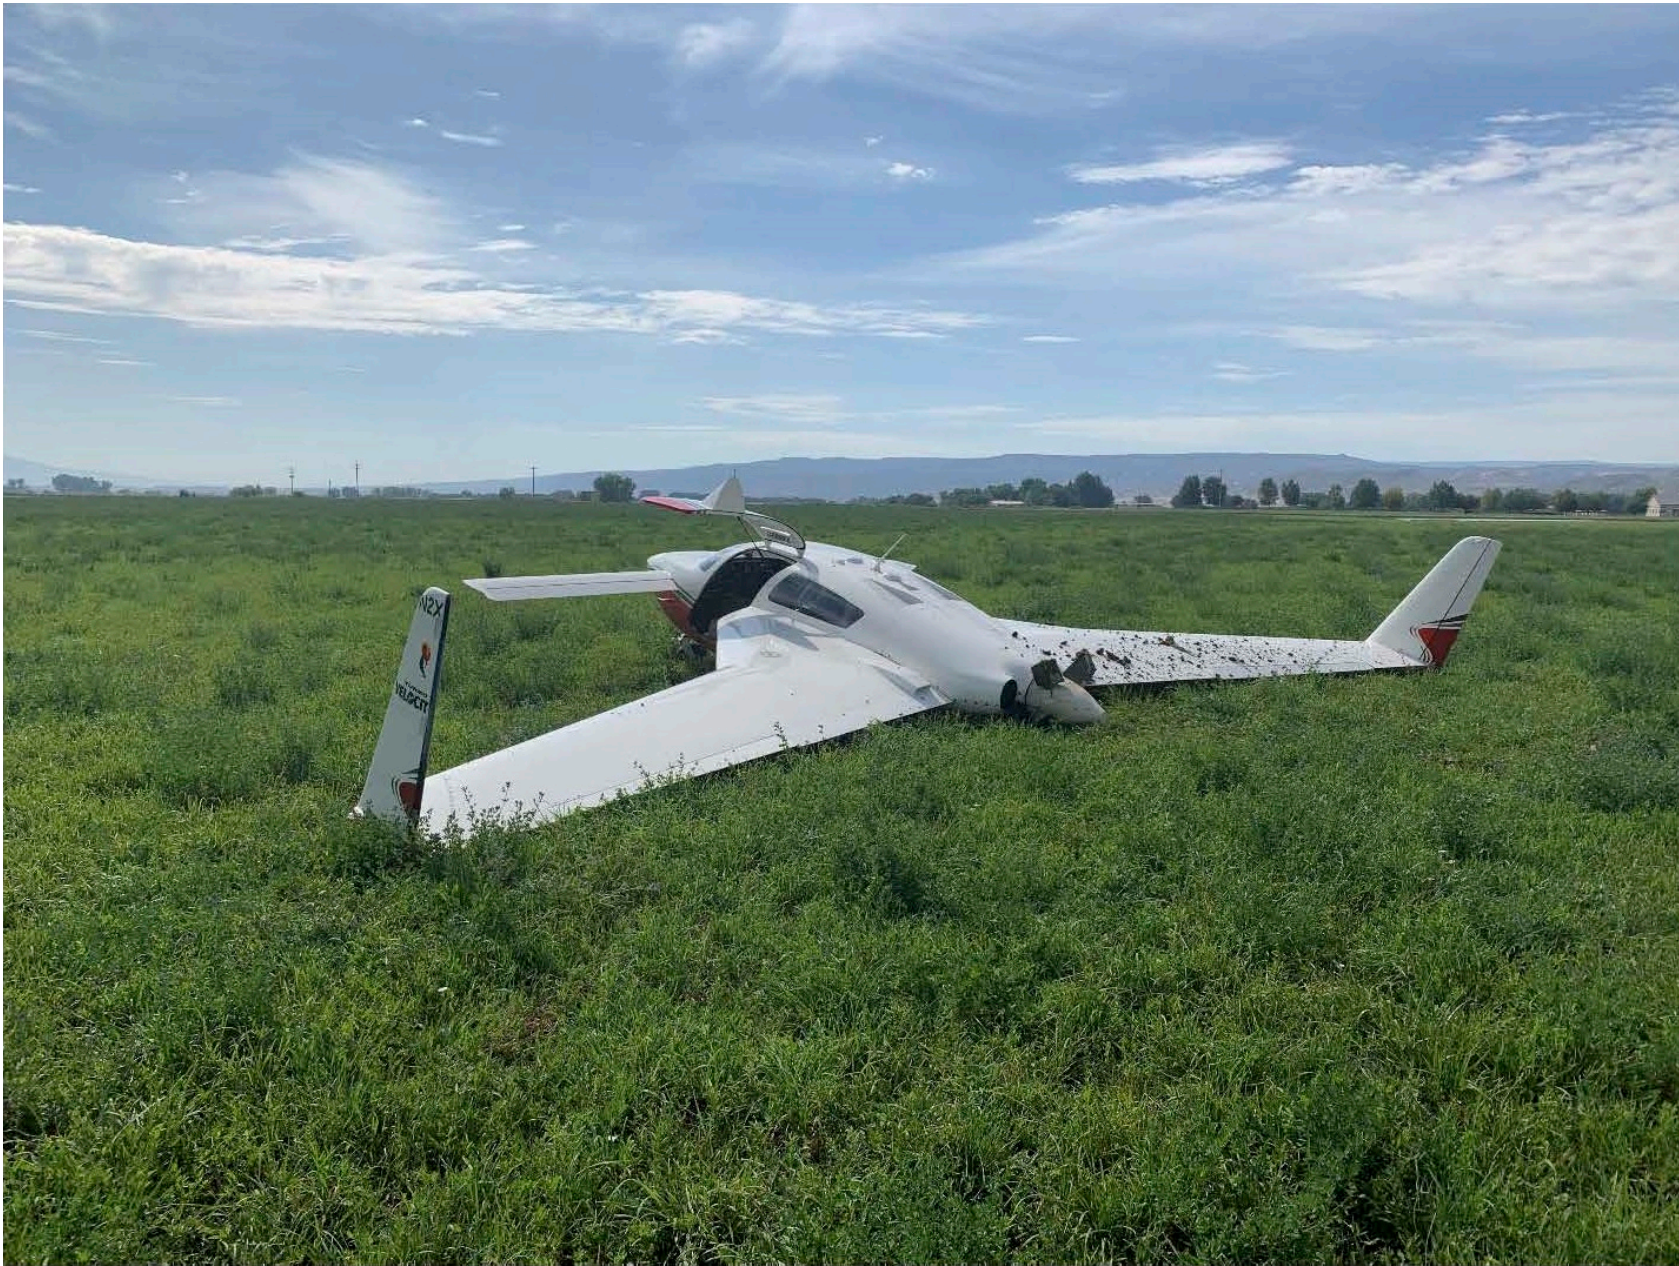
**Photo 3 – Close-up view of N2XF. Note the left rudder was knocked off when the airplane struck the irrigation pipe during its forced landing**
