## ENGINE EXAMINATION REPORT

| ENGINE MODEL | TSIO-360-FB |
| AIRCRAFT REGISTRATION | N2890T |
| FILE NUMBER | 19-095 |

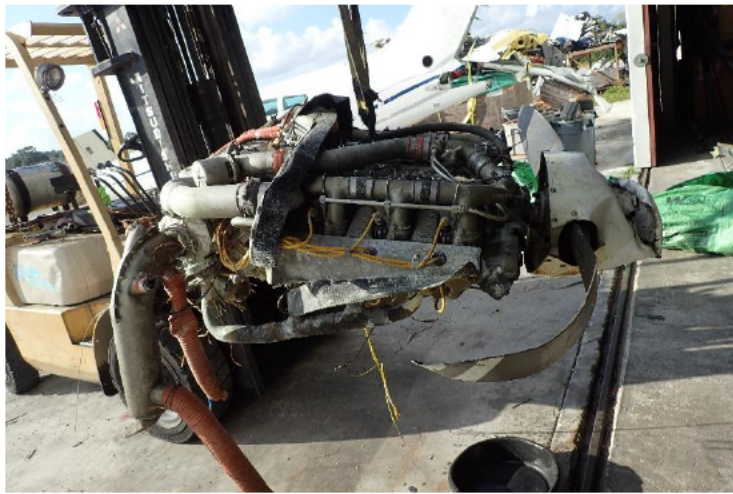
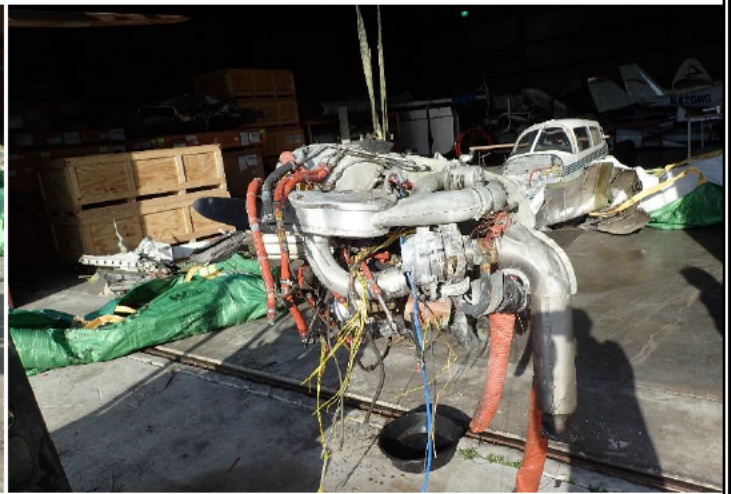
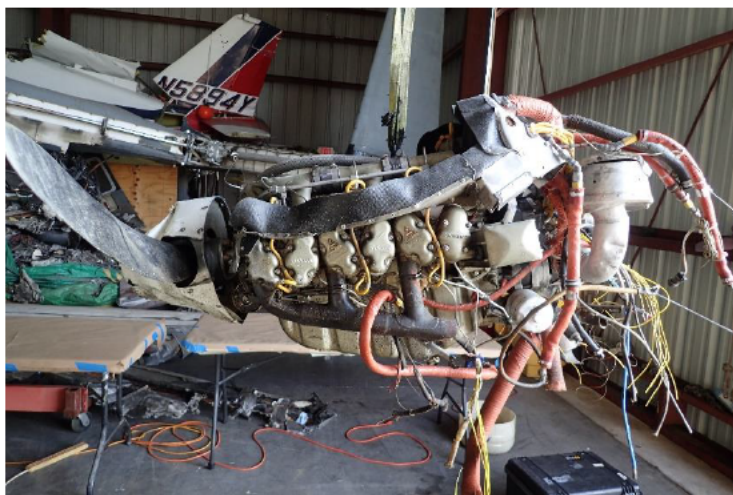
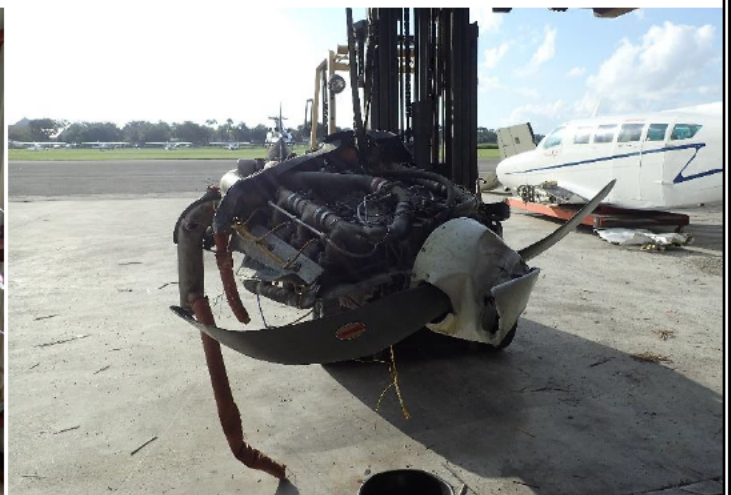
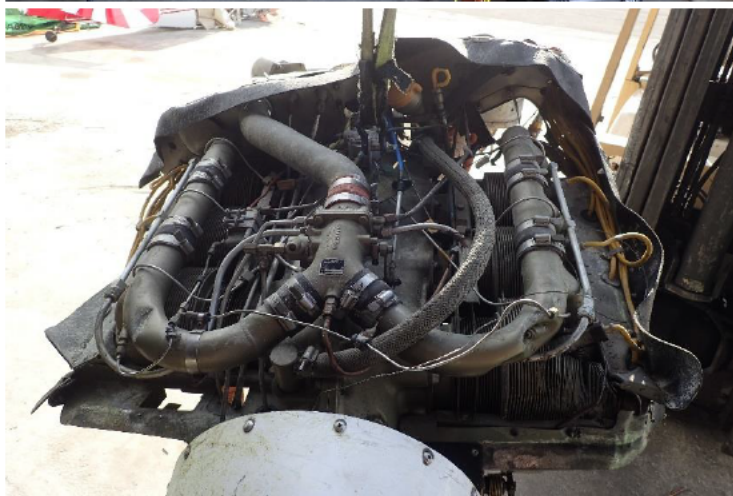
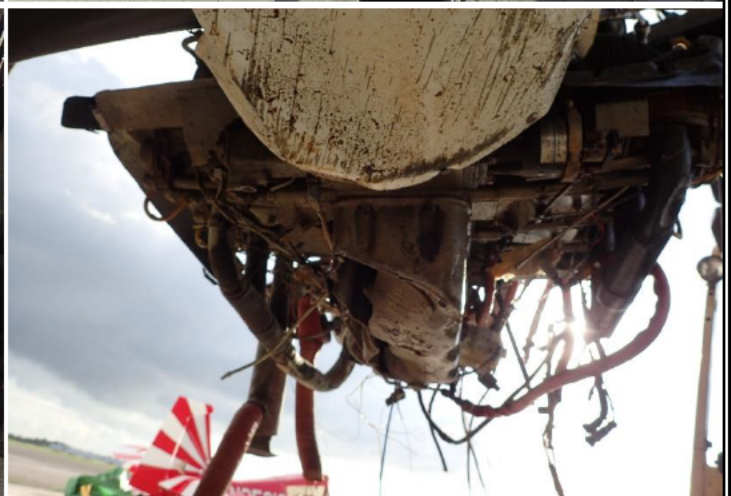
The engine was separated from the airframe at the time of the examination. The engine displayed impact damage signatures with most of the damage occurring to the bottom of the engine; the engine also displayed corrosion consistent with fire suppression activity. The crankcase remained intact and there were no holes in the crankcase that would indicate a catastrophic internal engine failure. The propeller flange remained attached to the rest of the crankshaft and there were no signs of cracks in the propeller shaft. All six cylinders remained attached to their cylinder bays and displayed minor impact damage as well as some corrosion consistent with fire suppression activity. The two-blade, constant speed propeller remained attached to the propeller flange and displayed impact damage signatures.

Both magnetos remained attached to their installation points and displayed corrosion consistent with fire suppression activity. The ignition harness displayed impact damage signatures and several of the ignition leads were torn and severed. The spark plugs remained installed in their cylinders and were undamaged.

The fuel pump remained attached to its installation point and displayed impact damage signatures as well as some corrosion. The throttle and metering assembly and the fuel manifold valve remained attached to their installation points and were undamaged. There were no signs of fuel leaks observed around the fuel components.

The exhaust system displayed impact damage signatures in the forms of bending and crushing. There were no signs of exhaust leaks observed. The induction system displayed impact damage signatures to some of the induction tubes. There were no signs of induction leaks observed.

The turbocharger remained attached to the engine and displayed minor impact damage as well as some corrosion consistent with fire suppression activity. It was observed that the fixed wastegate had been removed and an STC was used to install a Merlyn Products, Inc. automatic wastegate.

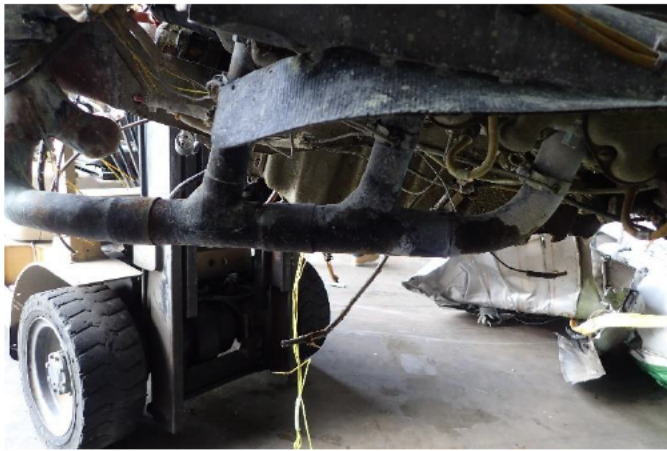
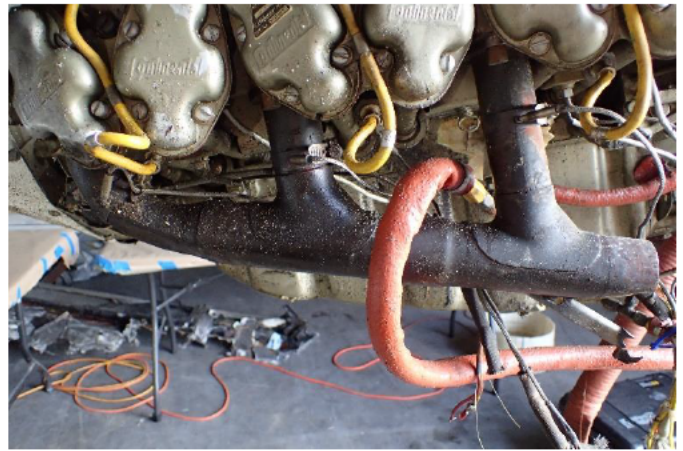
### EXHAUST SYSTEM

The exhaust system remained attached to the engine and displayed impact damage signatures as well as significant corrosion consistent with exposure to fire suppressant chemicals. The V-band clamp remained secured to the turbocharger and there were no exhaust leaks noted around the exhaust tubes and risers. It was noted that the exhaust had been modified to remove the fixed wastegate and to install an automatic wastegate via an STC by Merlyn Products, Inc.

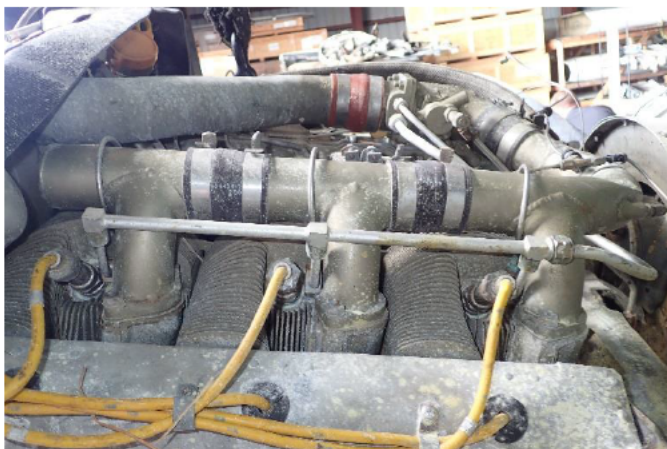
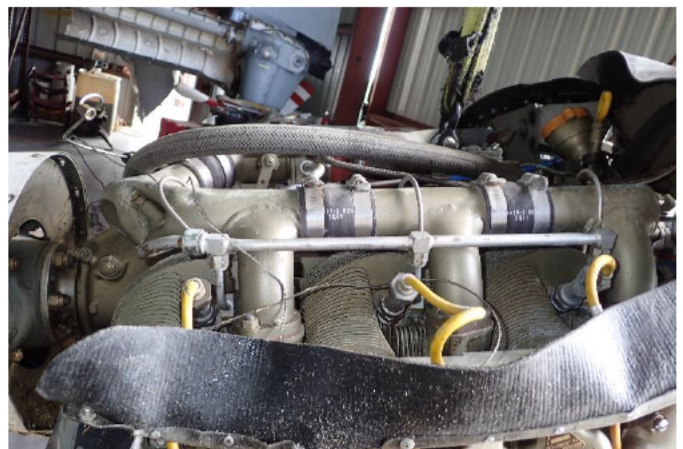
### INDUCTION SYSTEM

The induction system displayed impact damage signatures to some of the induction tubes as well as the airbox. There were no signs of induction leaks and the inlet air filter was clear of obstructions.

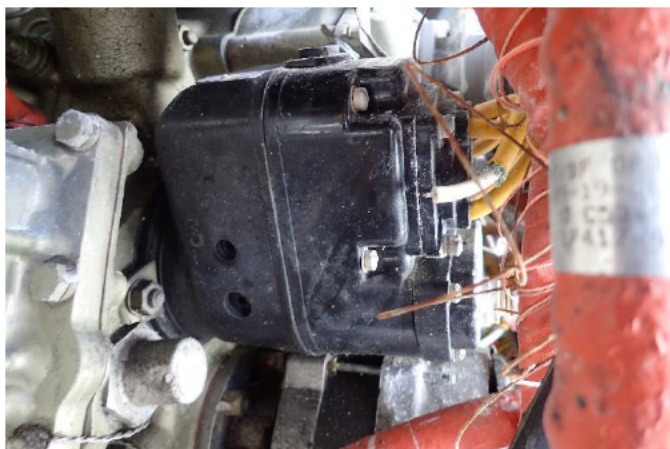
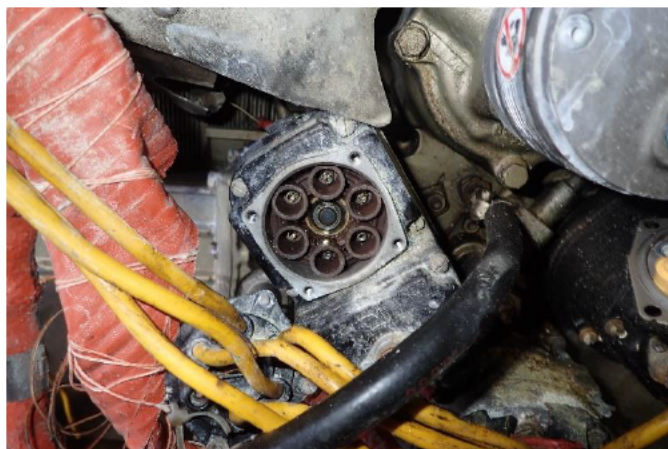
## LEFT MAGNETO

The magneto remained attached to its installation point and displayed corrosion consistent with exposure to fire suppressant chemicals. The magneto impulse coupling was noted to operate during crankshaft rotation and the magneto was capable of producing a spark on all six posts, in the correct firing order, and was in sync with the right magneto.

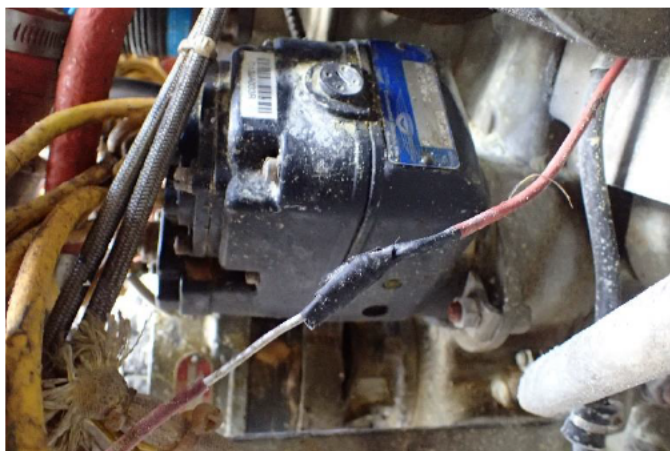
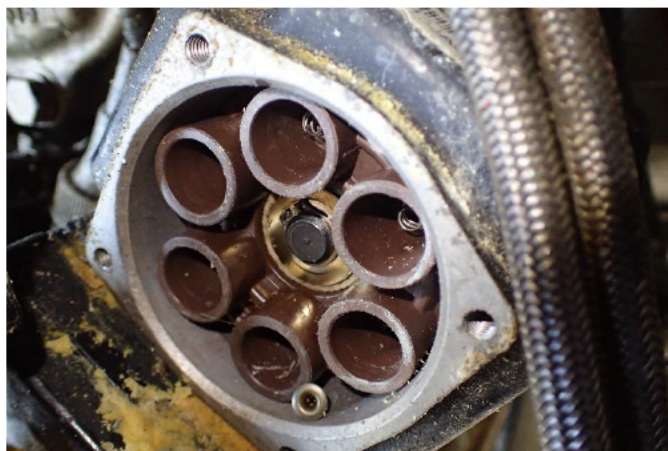
RIGHT  
MAGNETO

The magneto remained attached to its installation point and displayed corrosion consistent with exposure to fire suppressant chemicals. The magneto impulse coupling was noted to operate during crankshaft rotation and the magneto was capable of producing a spark on all six posts, in the correct firing order, and was in sync with the left magneto.

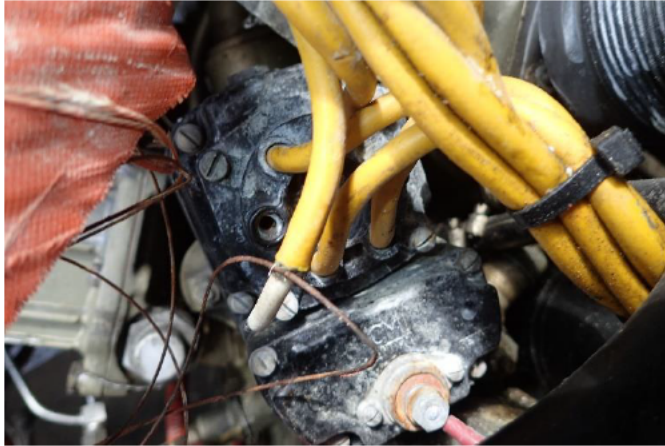
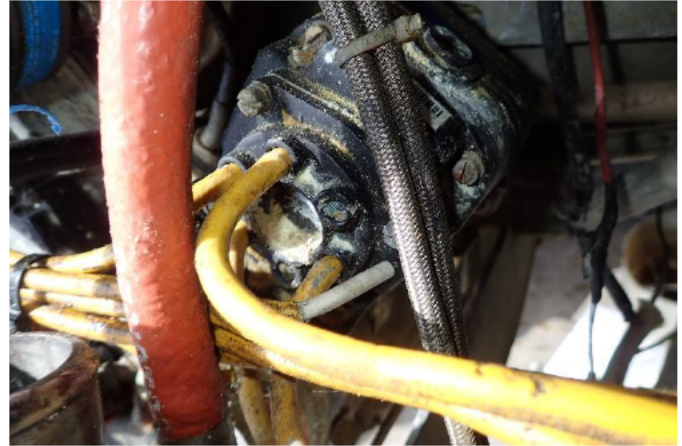
## IGNITION HARNESS

The ignition harness remained attached to the engine and displayed impact damage signatures; three of the ignition leads had pulled out from the magneto caps. It was observed that during magneto impulse coupling operation all of the intact ignition leads were capable of conducting a spark from the magneto to the ignition lead end; the 3 ignition leads that had pulled out displayed normal operating signatures.

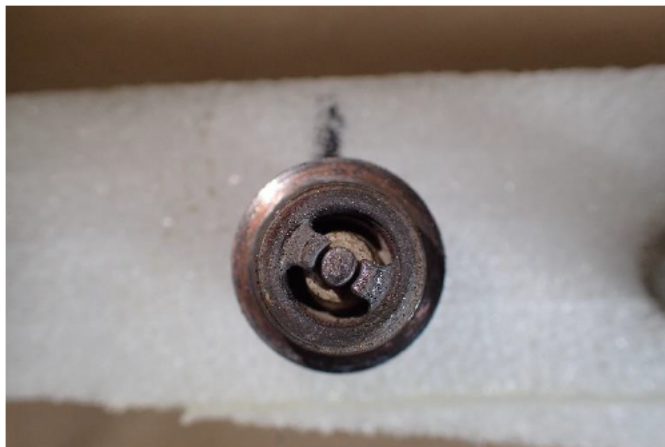
#1 Top Spark Plug

The spark plugs remained installed in their cylinders and were undamaged. The top spark plugs were removed for examination and the bottom spark plug electrodes were examined using a lighted borescope. The electrodes displayed normal operating and all of the spark plugs were in a normal worn-out condition.

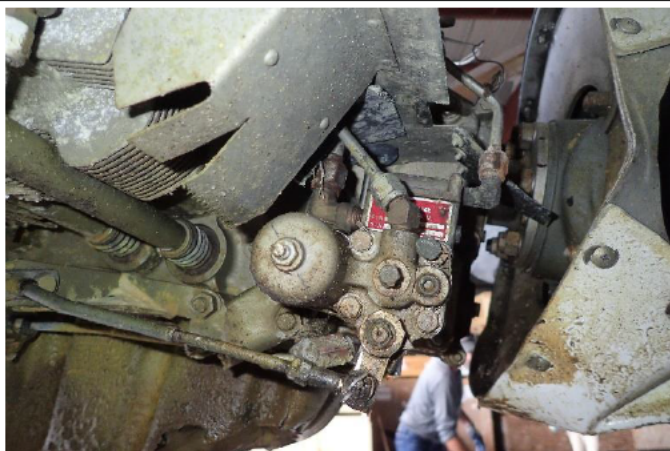
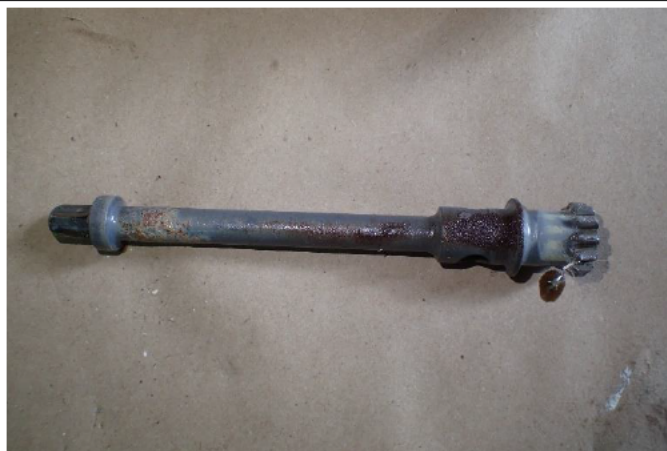
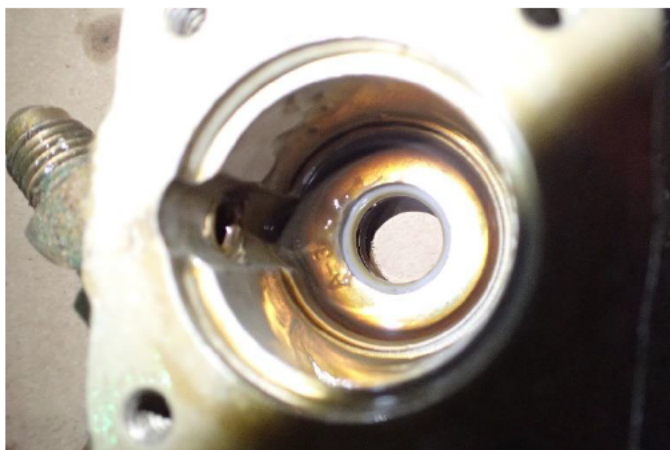
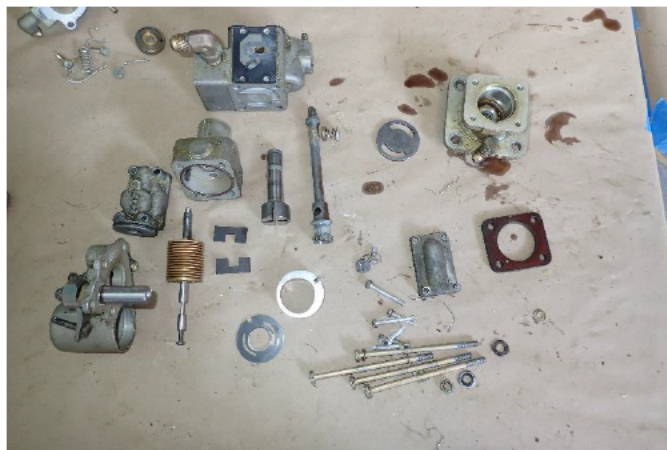
## FUEL PUMP

The fuel pump remained attached to its installation point and displayed impact damage signatures to several of the AN fittings. The fuel pump was removed and it was observed that the drive coupling remained intact. The fuel pump was disassembled and the internal components were examined. The housing was noted to contain some oil consistent with oil leaking past the seal; the oil drain vent was noted to be unobstructed. The rest of the internal components displayed normal operating signatures.

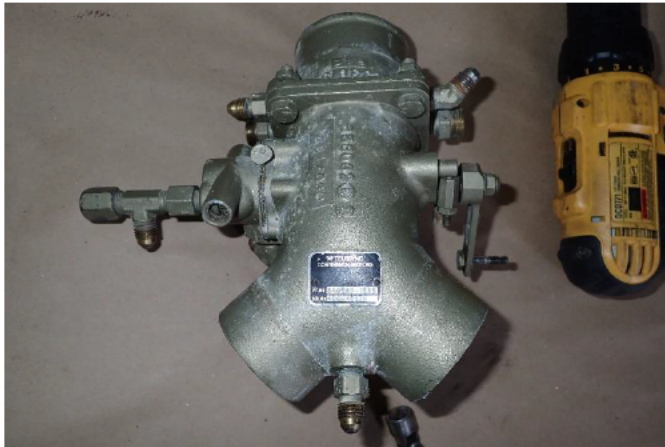
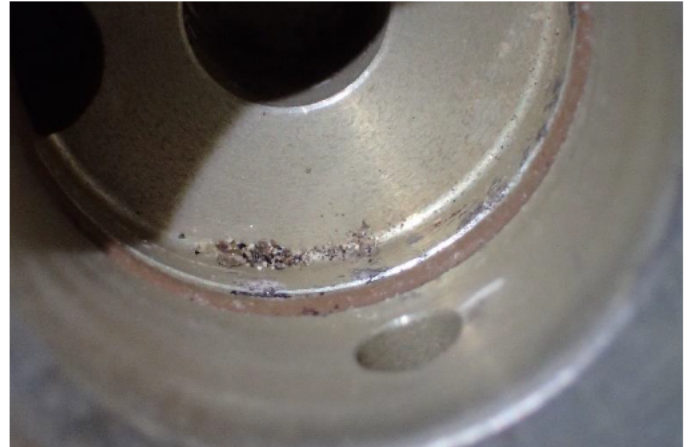
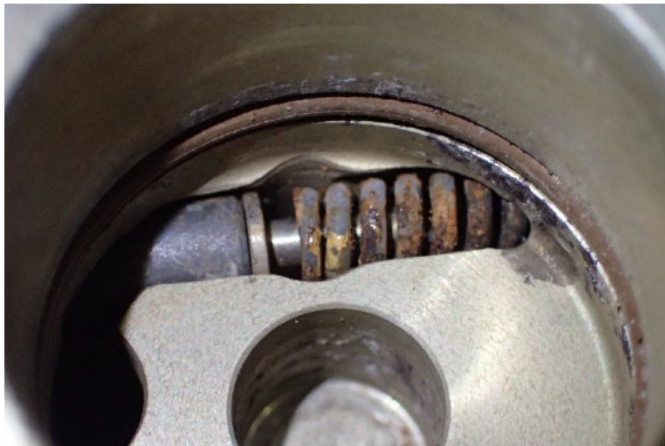
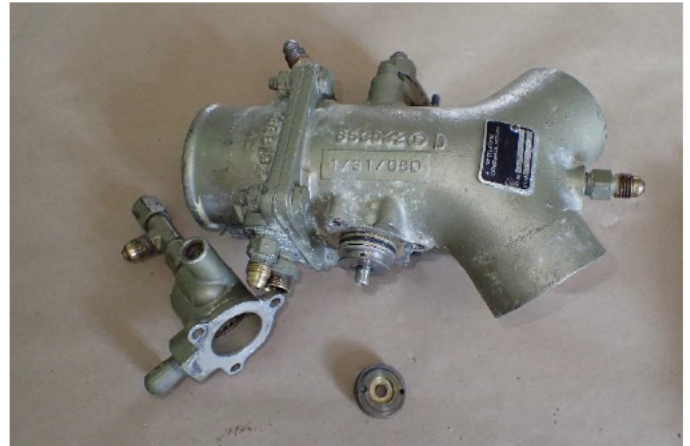
THROTTLE BODY  
METERING UNIT

The throttle and metering assembly contained a small amount of debris within the assembly. There were no further anomalies observed with the engine that would have prevented normal operation or production of rated horsepower. The engine had an STC installed for an automatic wastegate by Merlyn Products Inc. The automatic wastegate and the throttle and metering assembly were retained by the NTSB for further examination

The throttle and metering assembly remained attached to its installation point and was undamaged. The throttle control rod end remained secure to the throttle control arm and the control arm was secured to the shaft. The throttle and metering assembly was disassembled and the internal components were visually examined; it was observed that there was some small particle debris within the fuel metering assembly and the screw for the mixture adjustment was corroded. The debris and the throttle and metering assembly were retained by the NTSB for further examination and testing.

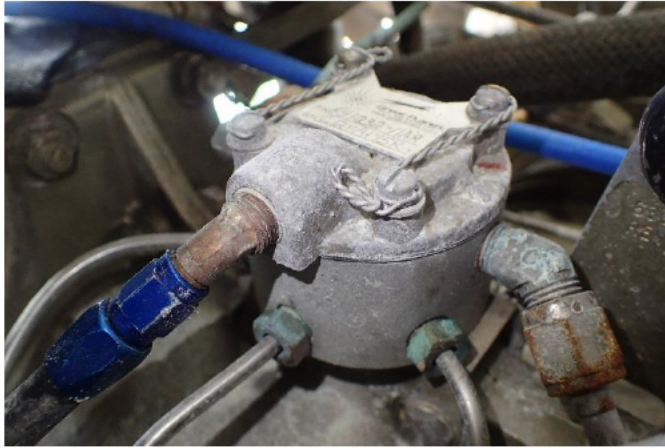
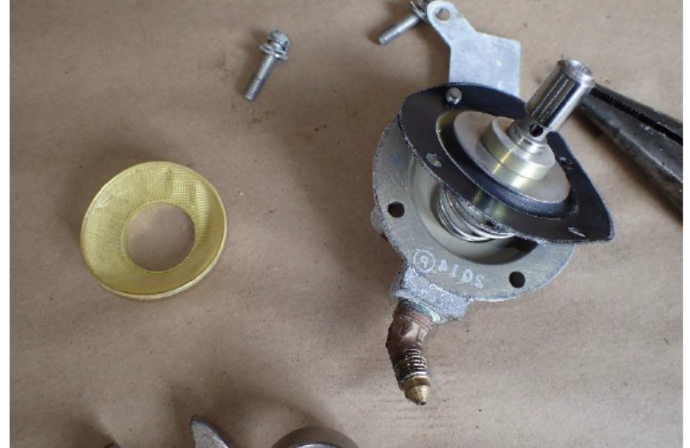
## FUEL MANIFOLD VALVE

The fuel manifold valve remained attached to its installation point and was undamaged. The valve was disassembled, and the internal components were visually examined; there was a small amount of debris noted on the unfiltered side of the manifold valve. The rest of the components displayed normal operating signatures and the screen was clear of debris.

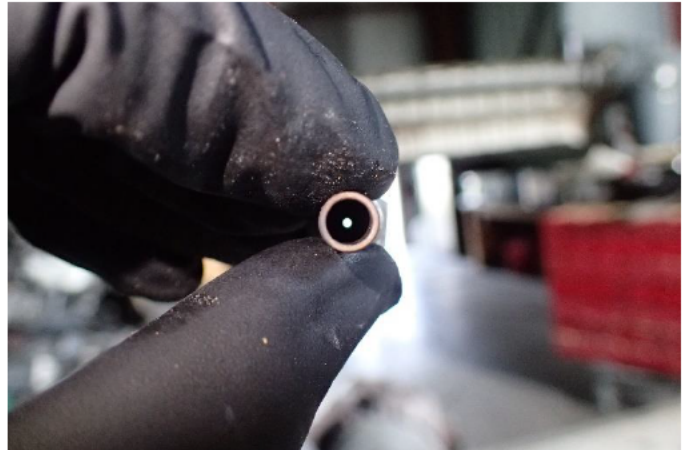
#3 Nozzle

The nozzles remained installed in their cylinders and displayed corrosion consistent with exposure to fire suppressant chemicals. The nozzles were removed and checked for obstructions. It was observed that the #1 nozzle was visually obstructed; air was blown into the inlet side of the nozzle and the debris was able to be easily blown out. The rest of the nozzles were unobstructed.

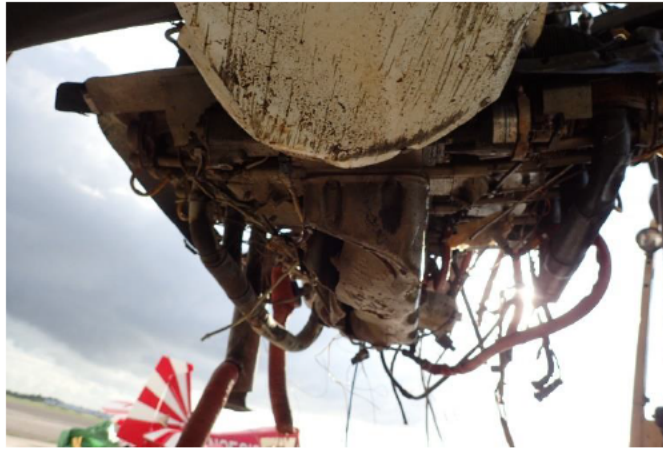
## OIL SUMP

The oil sump remained attached to its installation point and displayed impact damage signatures; the oil sump was breached and the quick drain had broken free. There were no anomalies observed with the oil sump.

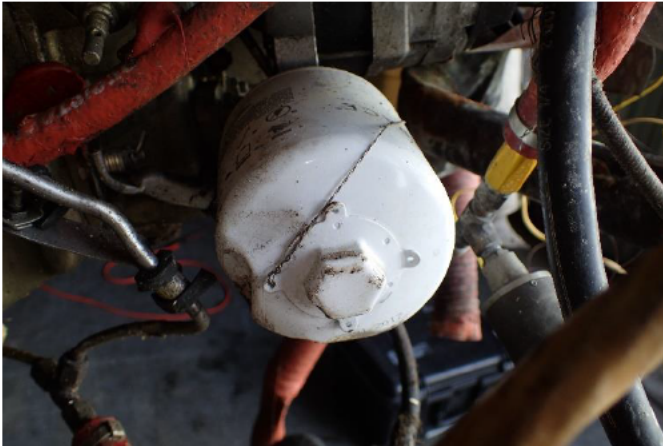
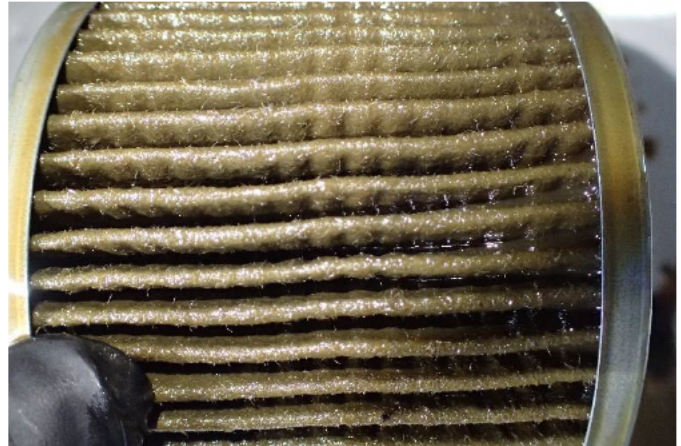
## OIL FILTER

The oil filter remained attached to the oil filter adapter and displayed impact damage signatures. The oil filter was removed, and the filter housing was cut open. There was no metallic material noted within the filter pleats.

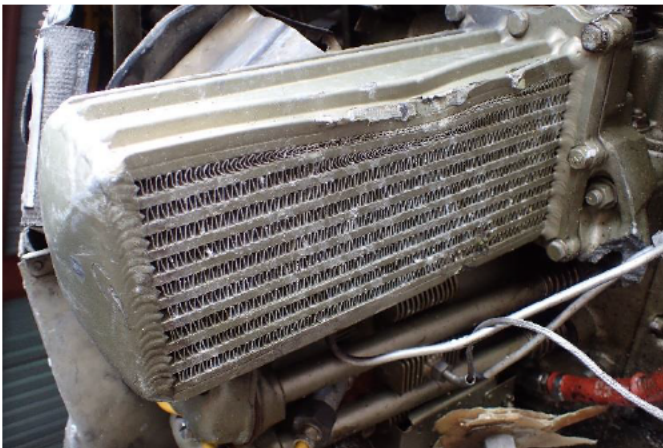
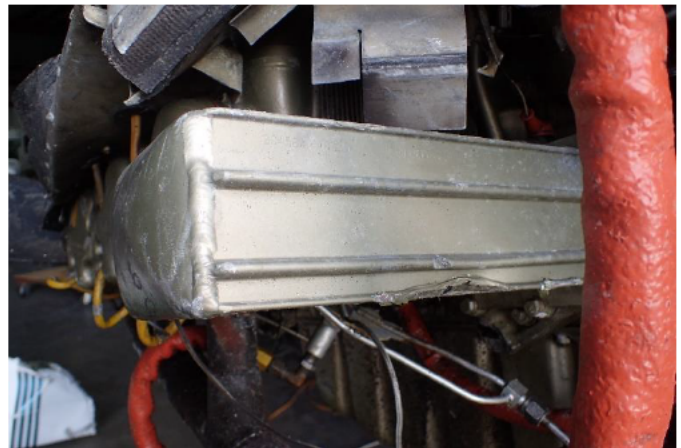
## OIL COOLER

The oil cooler remained attached to its installation point and displayed impact damage signatures. There were no oil leaks or other anomalies observed with the oil cooler.

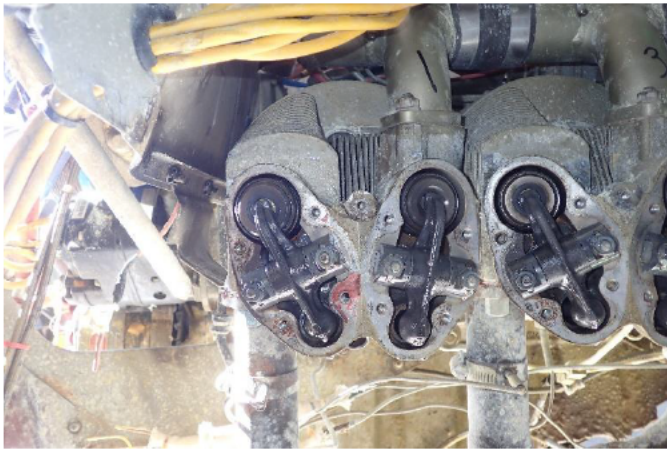
#1 Cylinder Overhead

The cylinders displayed varying amounts of impact damage and displayed corrosion consistent with exposure to fire suppressant chemicals. The cylinders were inspected using a lighted borescope; the cylinder bores displayed surface corrosion as well as normal operating signatures. The valve heads and piston faces displayed normal operating and combustion signatures. During crankshaft rotation all of the cylinders displayed good thumb compression and suction and all of the overhead components (springs, valves, and rocker arms) operated normally. The overhead components displayed normal operating and lubrication signatures.

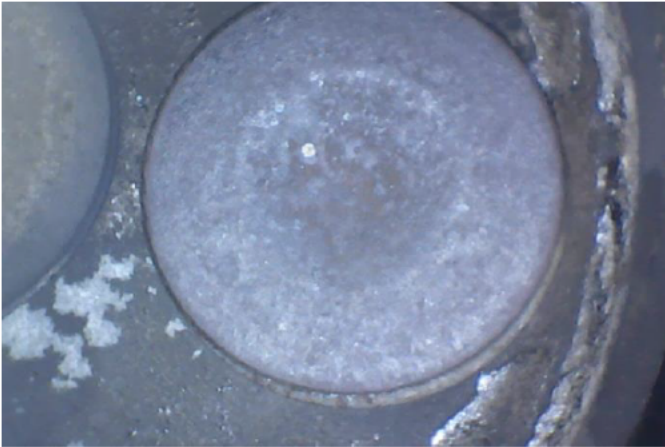
#1 Exhaust Valve

The valve heads were inspected using a lighted borescope. The valve heads displayed normal operating and combustion signatures. During crankshaft rotation all of the valves operated normally.

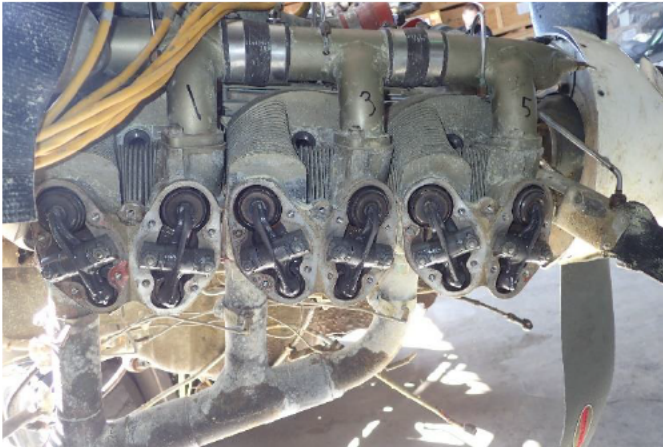
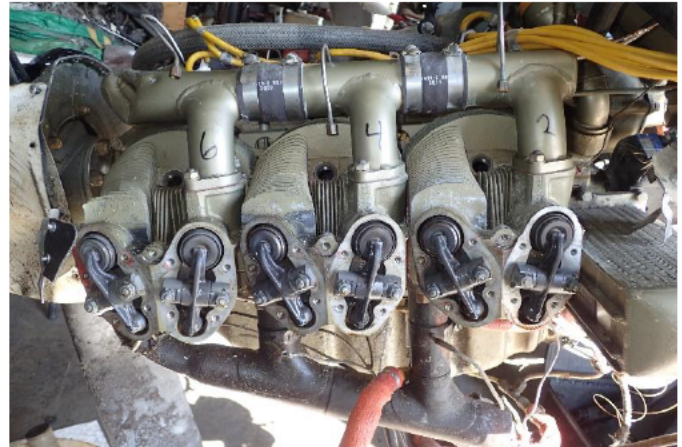
## ROCKER ARMS AND SHAFTS

The rocker arms remained attached to their installation points and were undamaged. The rocker arms displayed normal operating and lubrication signatures and the rocker arms operated normally during crankshaft rotation.

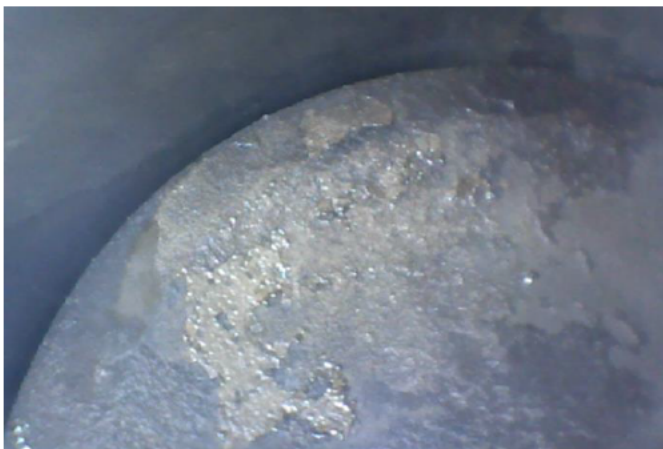
#1 Piston

The piston faces were inspected using a lighted borescope. The piston faces displayed normal operating and combustion signatures. During crankshaft rotation all six pistons operated normally.

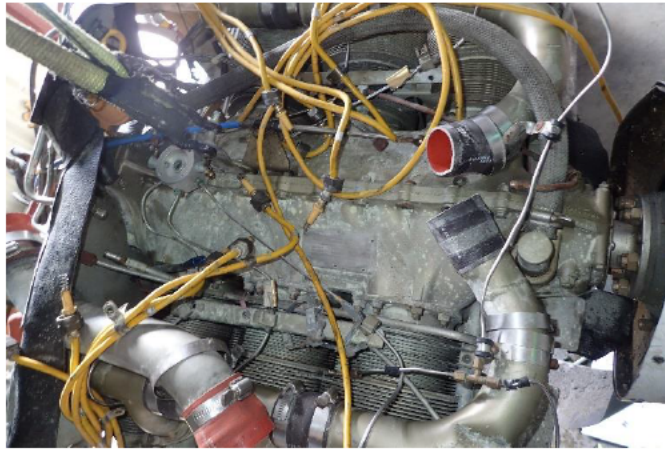
## CRANKCASE ASSEMBLY

| Condition: | The crankcase remained intact and displayed discoloration consistent with exposure to fire suppressant chemicals. There were no holes in the case that would indicate a catastrophic internal engine failure. | | | |

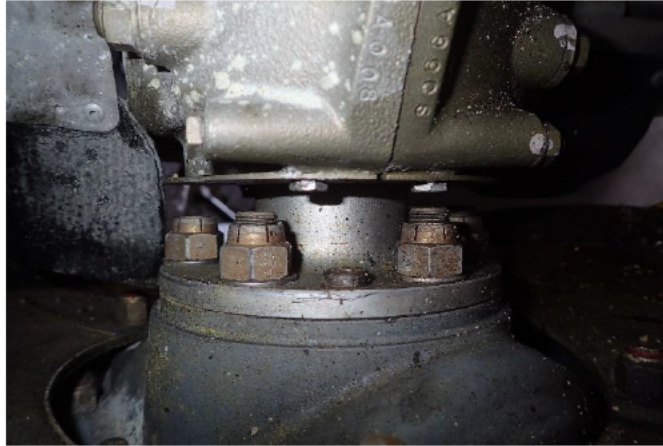
## CRANKSHAFT ASSEMBLY

| Condition: | The propeller flange remained attached to the rest of the crankshaft and there was no visible damage to the crankshaft. The crankshaft was rotated by hand and continuity was established between the crankshaft, camshaft, connecting rods and associated components. There were no anomalies observed. | | |

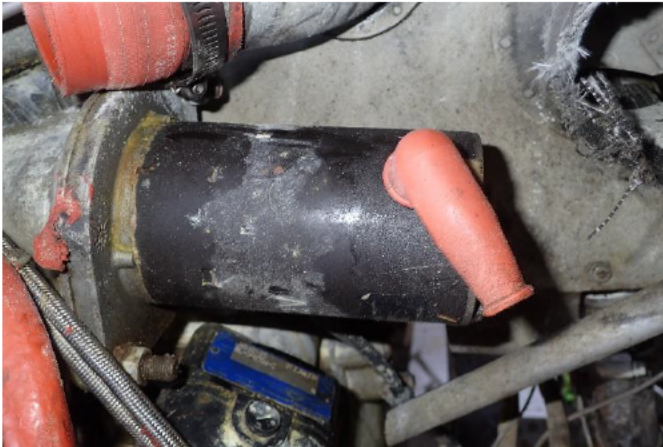
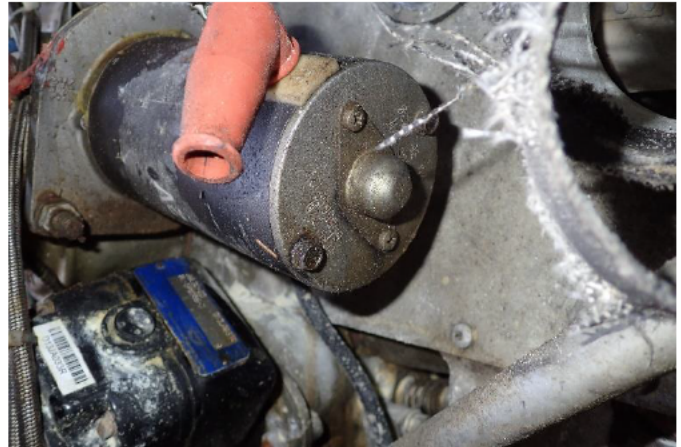
## STARTER

The starter remained attached to the starter adapter and displayed corrosion consistent with exposure to fire suppressant chemicals.

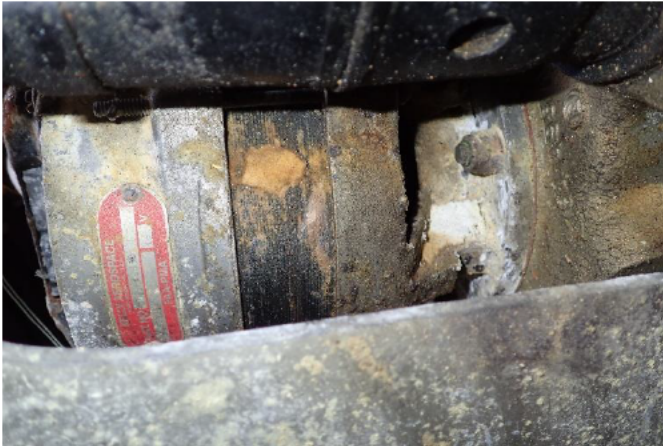
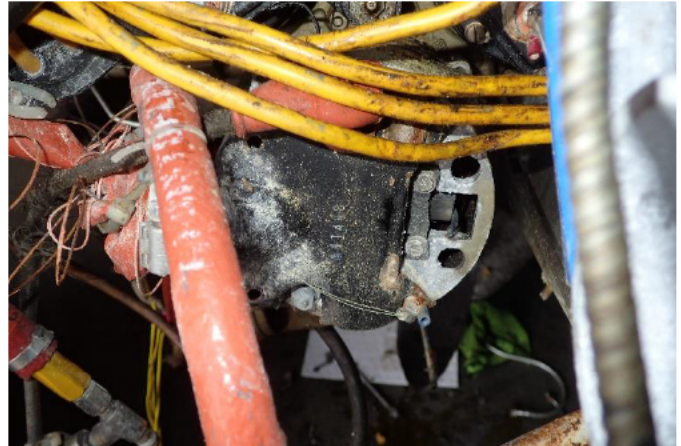
## ALTERNATOR

The alternator remained attached to its installation point and displayed impact damage signatures as well as corrosion consistent with exposure to fire suppressant chemicals. There were no anomalies observed.

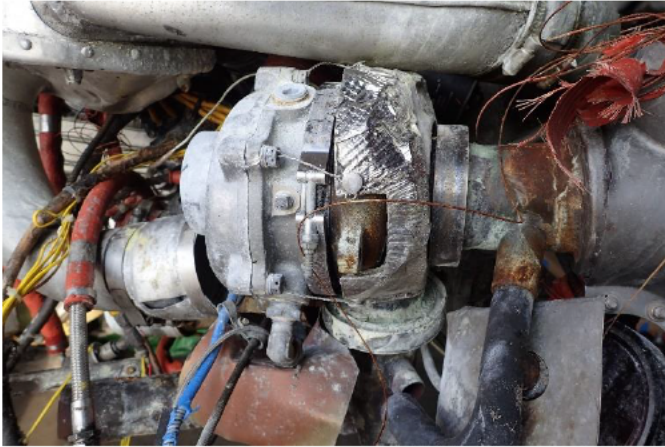
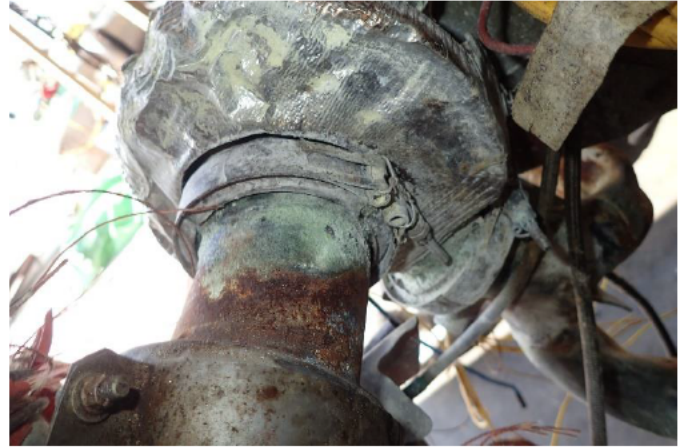
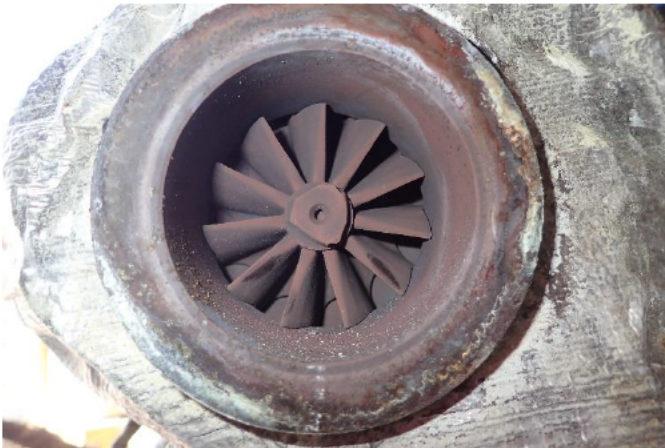
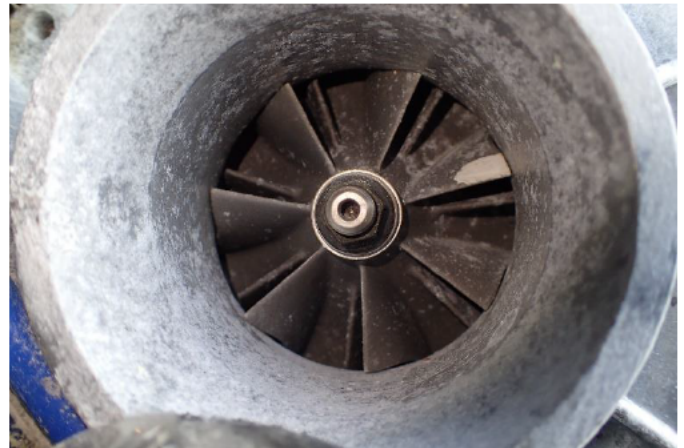
## TURBO

The turbocharger remained attached and displayed impact damage as well as corrosion consistent with exposure to fire suppressant chemicals. The turbine and compressor blades displayed normal operating signatures and were capable of rotation.

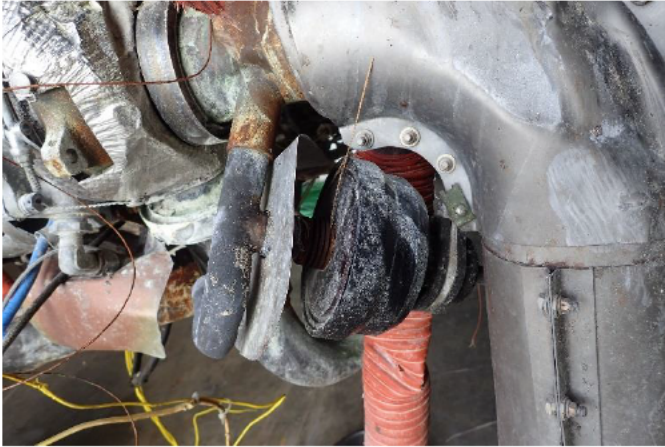
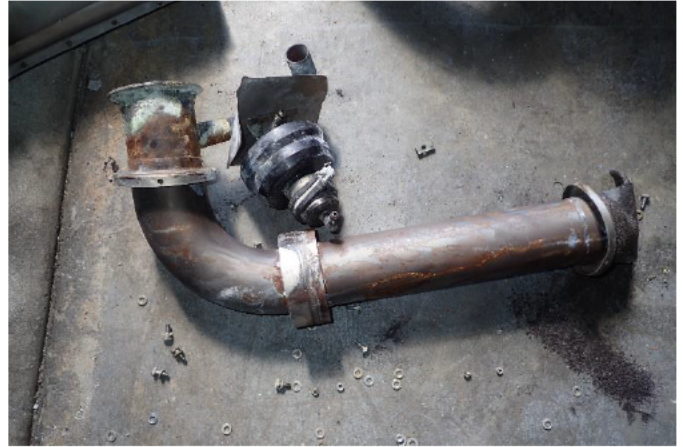
## WASTEGATE

The fixed wastegate was replaced with an automatic wastegate via an STC by Merlyn Product, Inc. The wastegate remained attached to its installation point and both AN fittings were secure. The wastegate was retained by the NTSB for additional testing.

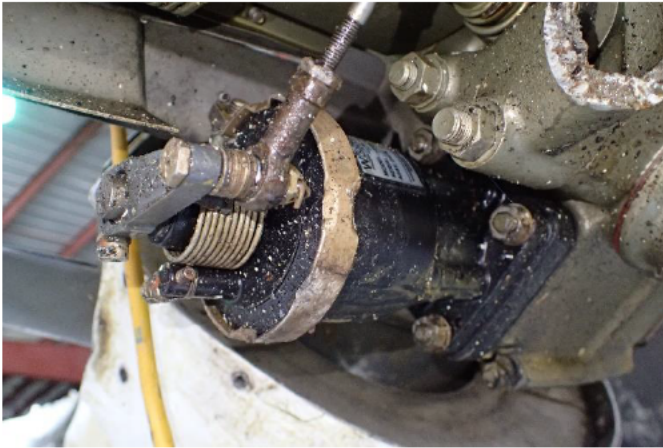
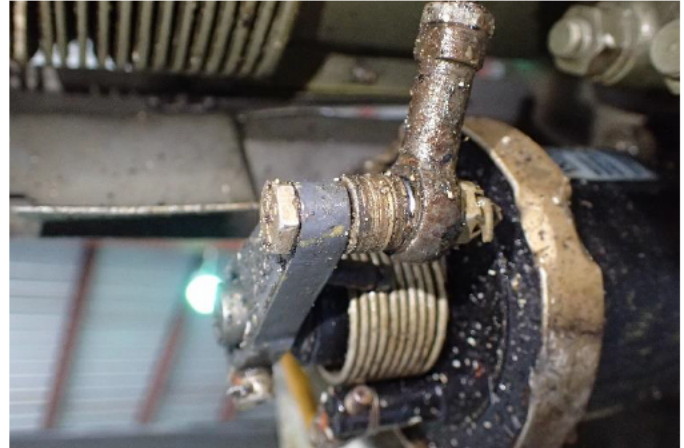
PROPELLER  
GOVERNOR

The propeller governor remained attached to its installation point and was undamaged. The propeller control rod end remained attached to the control arm; it was observed that the propeller control arm spring had detached from its installation point.

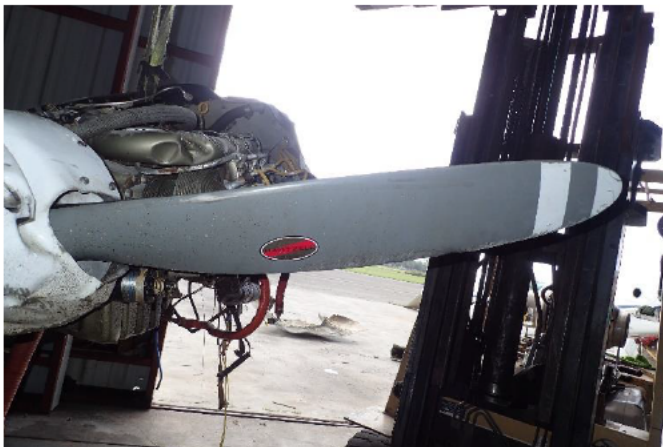
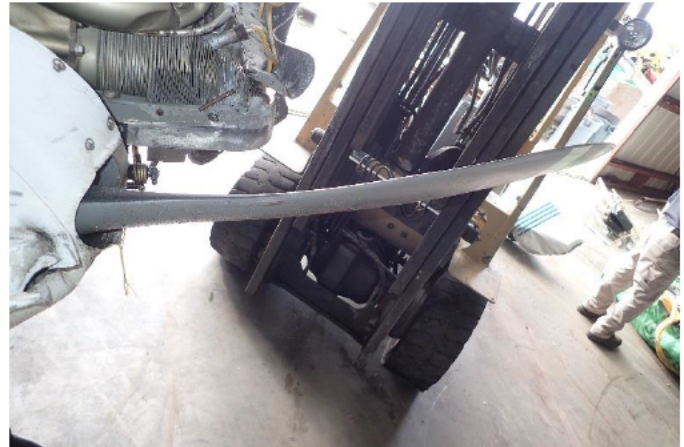
Propeller Blade "A"

The two-blade, constant speed propeller remained attached to the crankshaft and both propeller blades remained within the propeller hub. Both propeller blades displayed impact damage signatures. One of the propeller blades (blade "A") displayed minor aft bending deformation and minor chordwise scratches at the trailing edge of the blade. The other propeller blade (blade "B") displayed aft bending deformation, minor twisting deformation, and minor chordwise scratches at the leading edge of the blade.
