## Memorandum of Record

**Date: 10/22/20**  
**Subject: CEN19LA317, N2890T, Boca Raton FL**  
**Fuel Metering Unit/Throttle Examination**

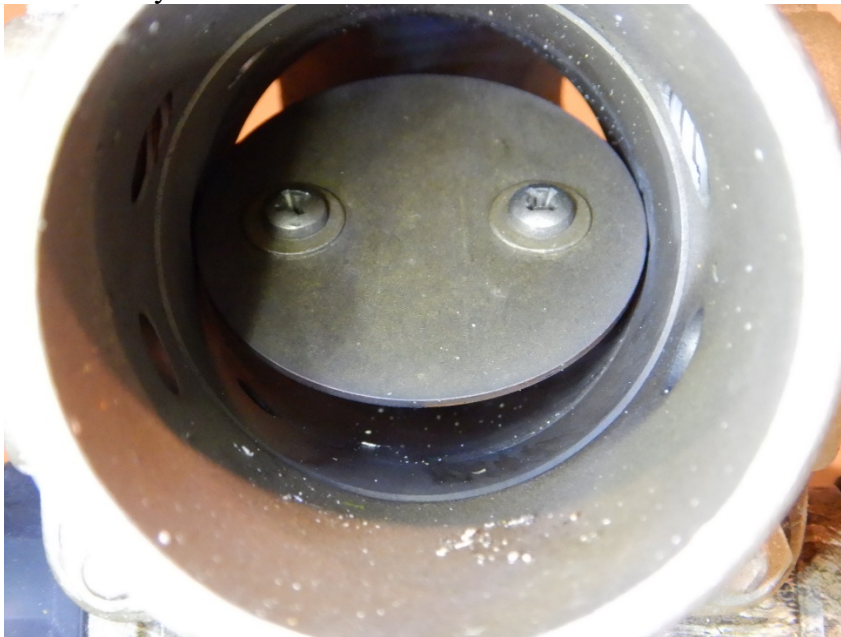
Figure 1.

The throttle control lever remained attached to the fuel metering assembly and moved freely when manipulated. The fuel metering butterfly valve moved freely in direct response to movement of the throttle lever. Small white particles similar in size to sand were found scattered within the assembly tube walls (figure 1). All orifices were visually checked and no obstructions or debris were noted. No anomalies were noted that would have precluded normal operation of the assembly.
