## **NATIONAL TRANSPORTATION SAFETY BOARD**

### **AIRFRAME & ENGINE EXAMINATION SUMMARY**

**CEN19LA318**

Location: Hill City, South Dakota  
Date: September 12, 2019  
Aircraft: Bell 206B, N100CK  
NTSB Investigator-in-Charge: Jason Aguilera

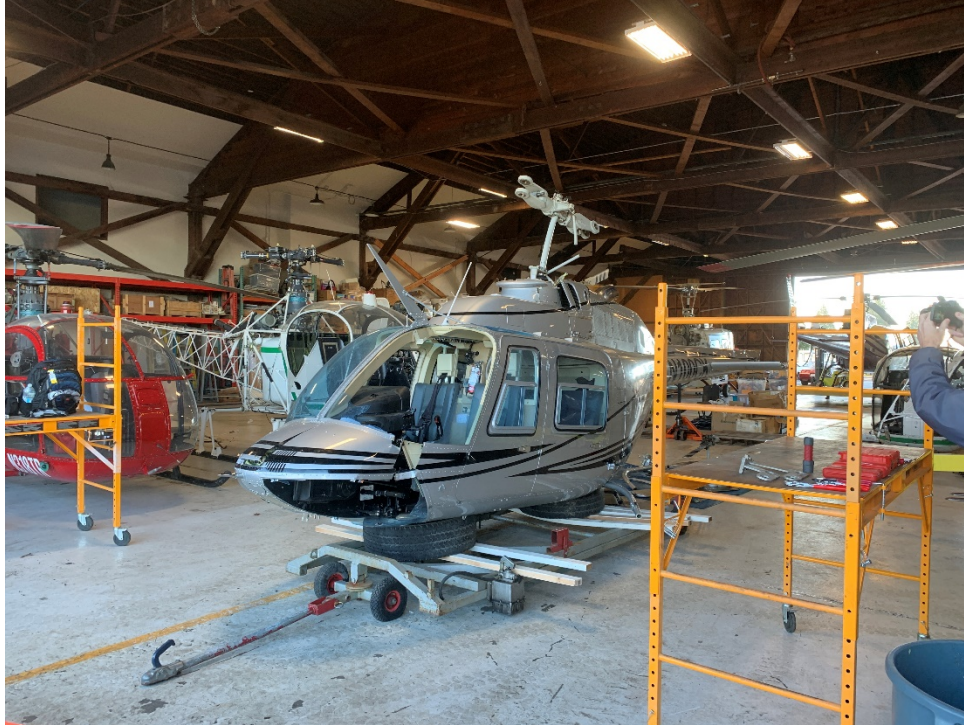
Figure 1: View of the helicopter as found for the examination.

The recovered airframe was mostly intact, with the skids, main rotor blades, and aft section of the tailboom, which included the tailrotor, tailrotor gearbox, vertical stabilizer, was separated, consistent with tailrotor strike to the left side of the tailboom during an accident sequence. The left windscreen and lower left chin bubble were damaged, which was found consistent with main rotor blade contact to the left windscreen and chin bubble area during the accident sequence.

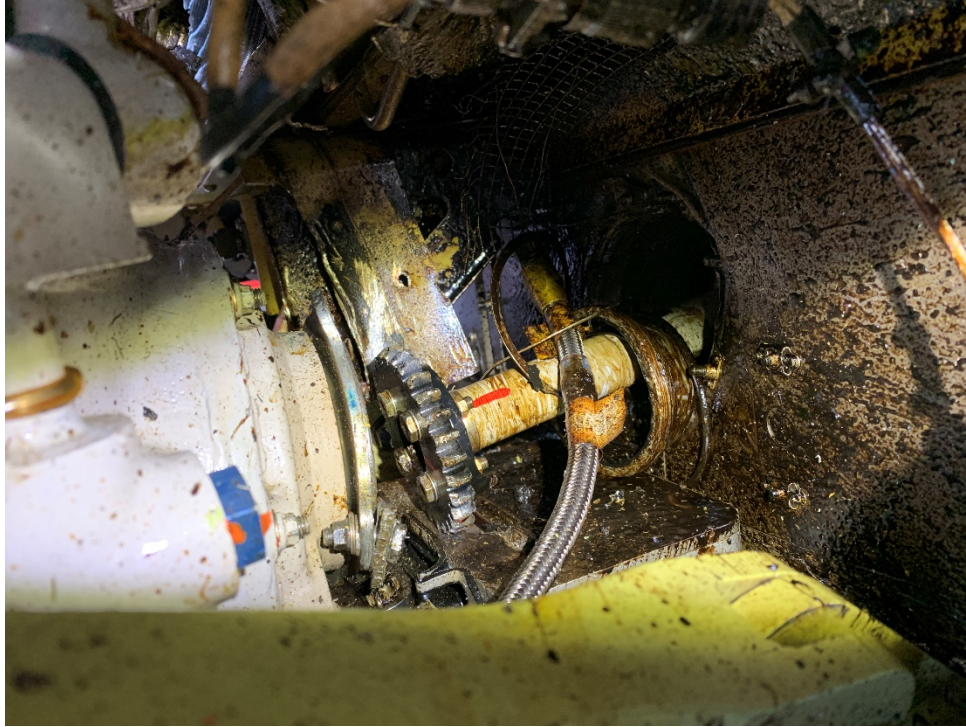
The engine to transmission driveshaft was separated from the transmission, however, remained attached to the engine gearbox. The temperature indication strips were “white” in color, consistent with no evidence of overheating at the engine side. Grease splatter was observed throughout the internal areas of the forward cowling surrounding the separation area of the shaft coupling. The forward coupling was fractured into four pieces. The separation of the engine to transmission driveshaft was found consistent with impact.

**Figure 2: View of the engine to transmission driveshaft.**

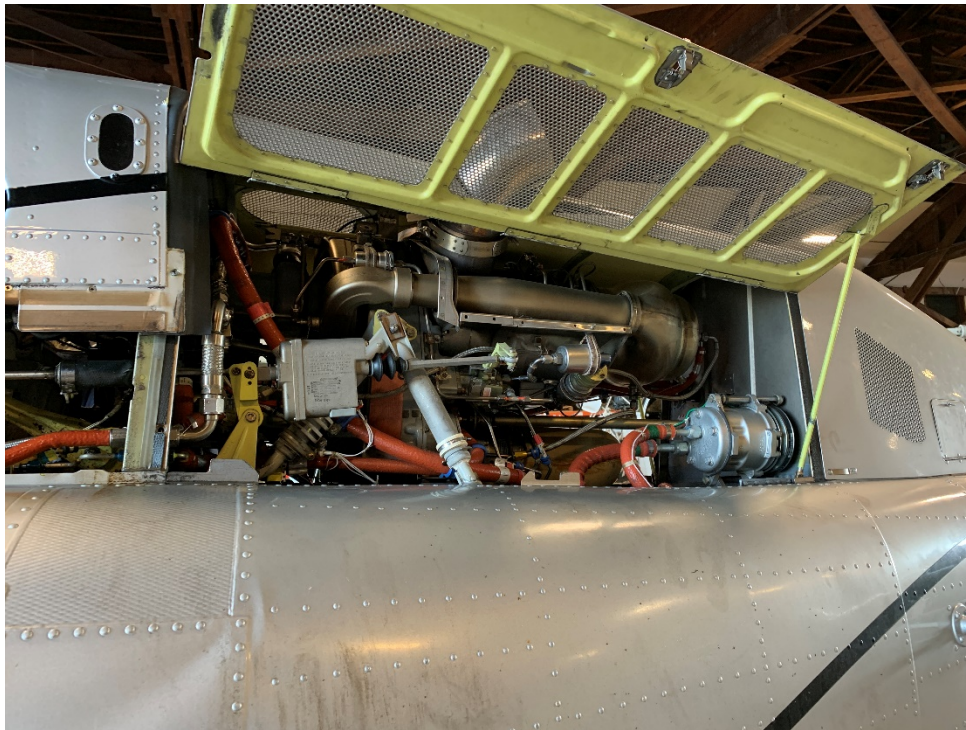
The Rolls Royce 250-C20J engine, serial number CAE-271006, remained attached to the airframe via its mounts. All accessories remained attached and secure to the engine. No evidence of any mechanical damage was observed to the engine, nor was there any evidence of

fire damage. No evidence of any loose “B” nuts was observed, and all “B” nuts exhibited “torque stripes.” All pneumatic, oil, and fuel lines remained attached. N1 and N2 rotated freely by hand, with smooth rotation noted with no mechanical noise heard. Control continuity was established from the throttle twist grip to the fuel control unit. Control continuity to the power turbine governor via the collective pitch lever was established visually, and a fractured bellcrank was observed on the upper engine deck near the pitch control link and hydraulic servos. The damaged bellcrank was found to be consistent with impact damage.

**Figure 3: View of the engine.**

The compressor inlet and first stage blades were damaged, consistent with foreign object debris (FOD) ingestion.

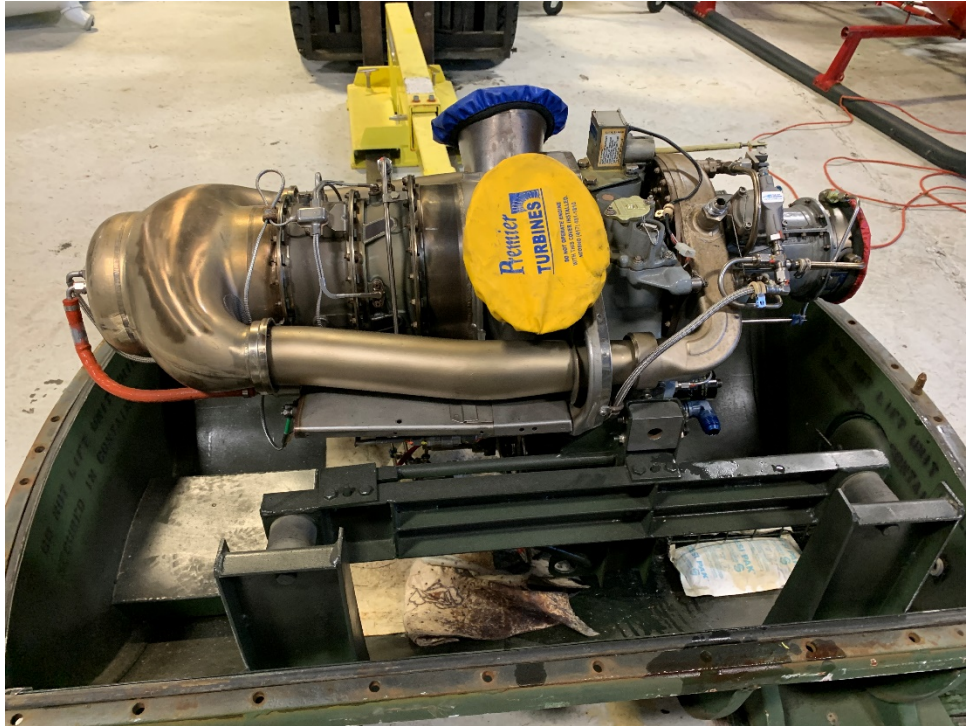
The engine was removed from the airframe and placed in a shipping container for shipment for further examination.

**Figure 4: View of the engine installed in the engine shipping container.**
