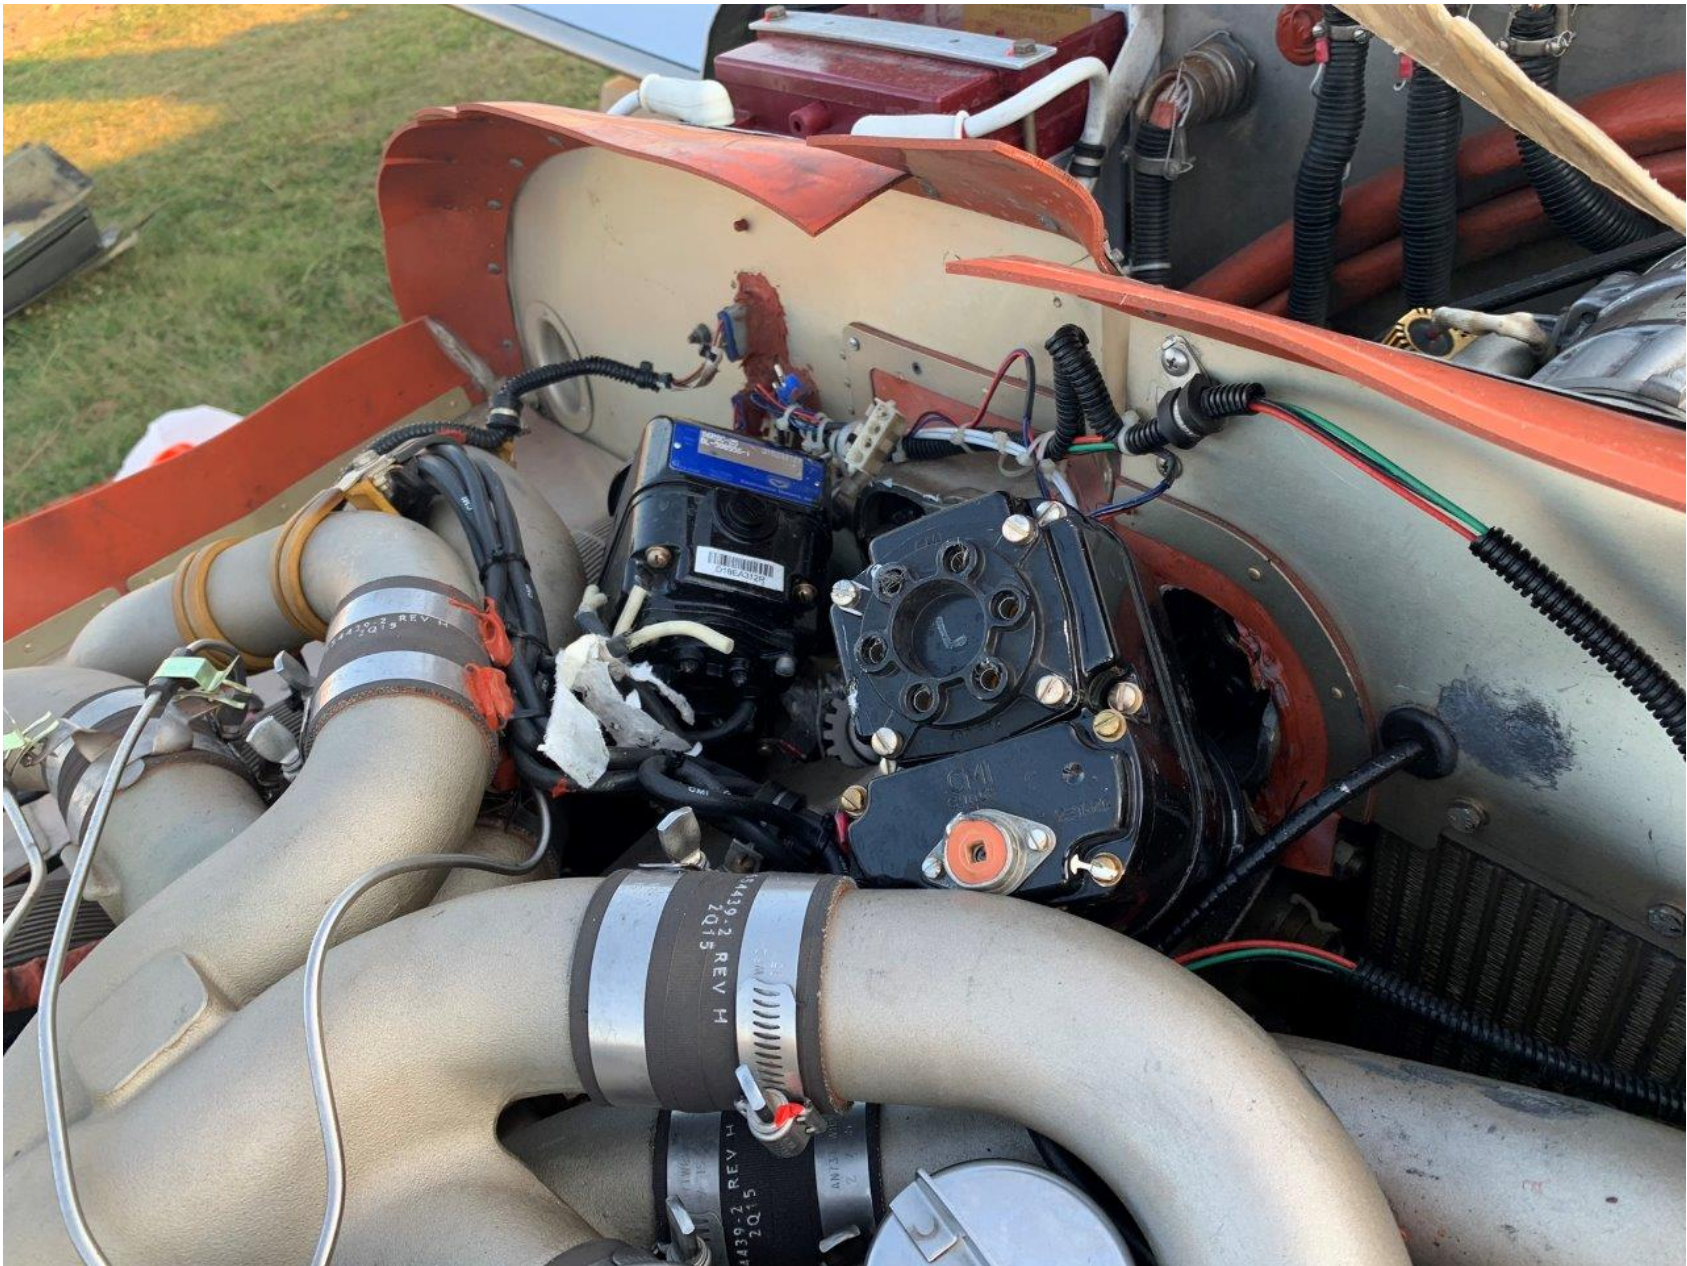
**Photo 1 – View of the top of the engine at the accident site. Both magnetos are displaced from their designated locations.**

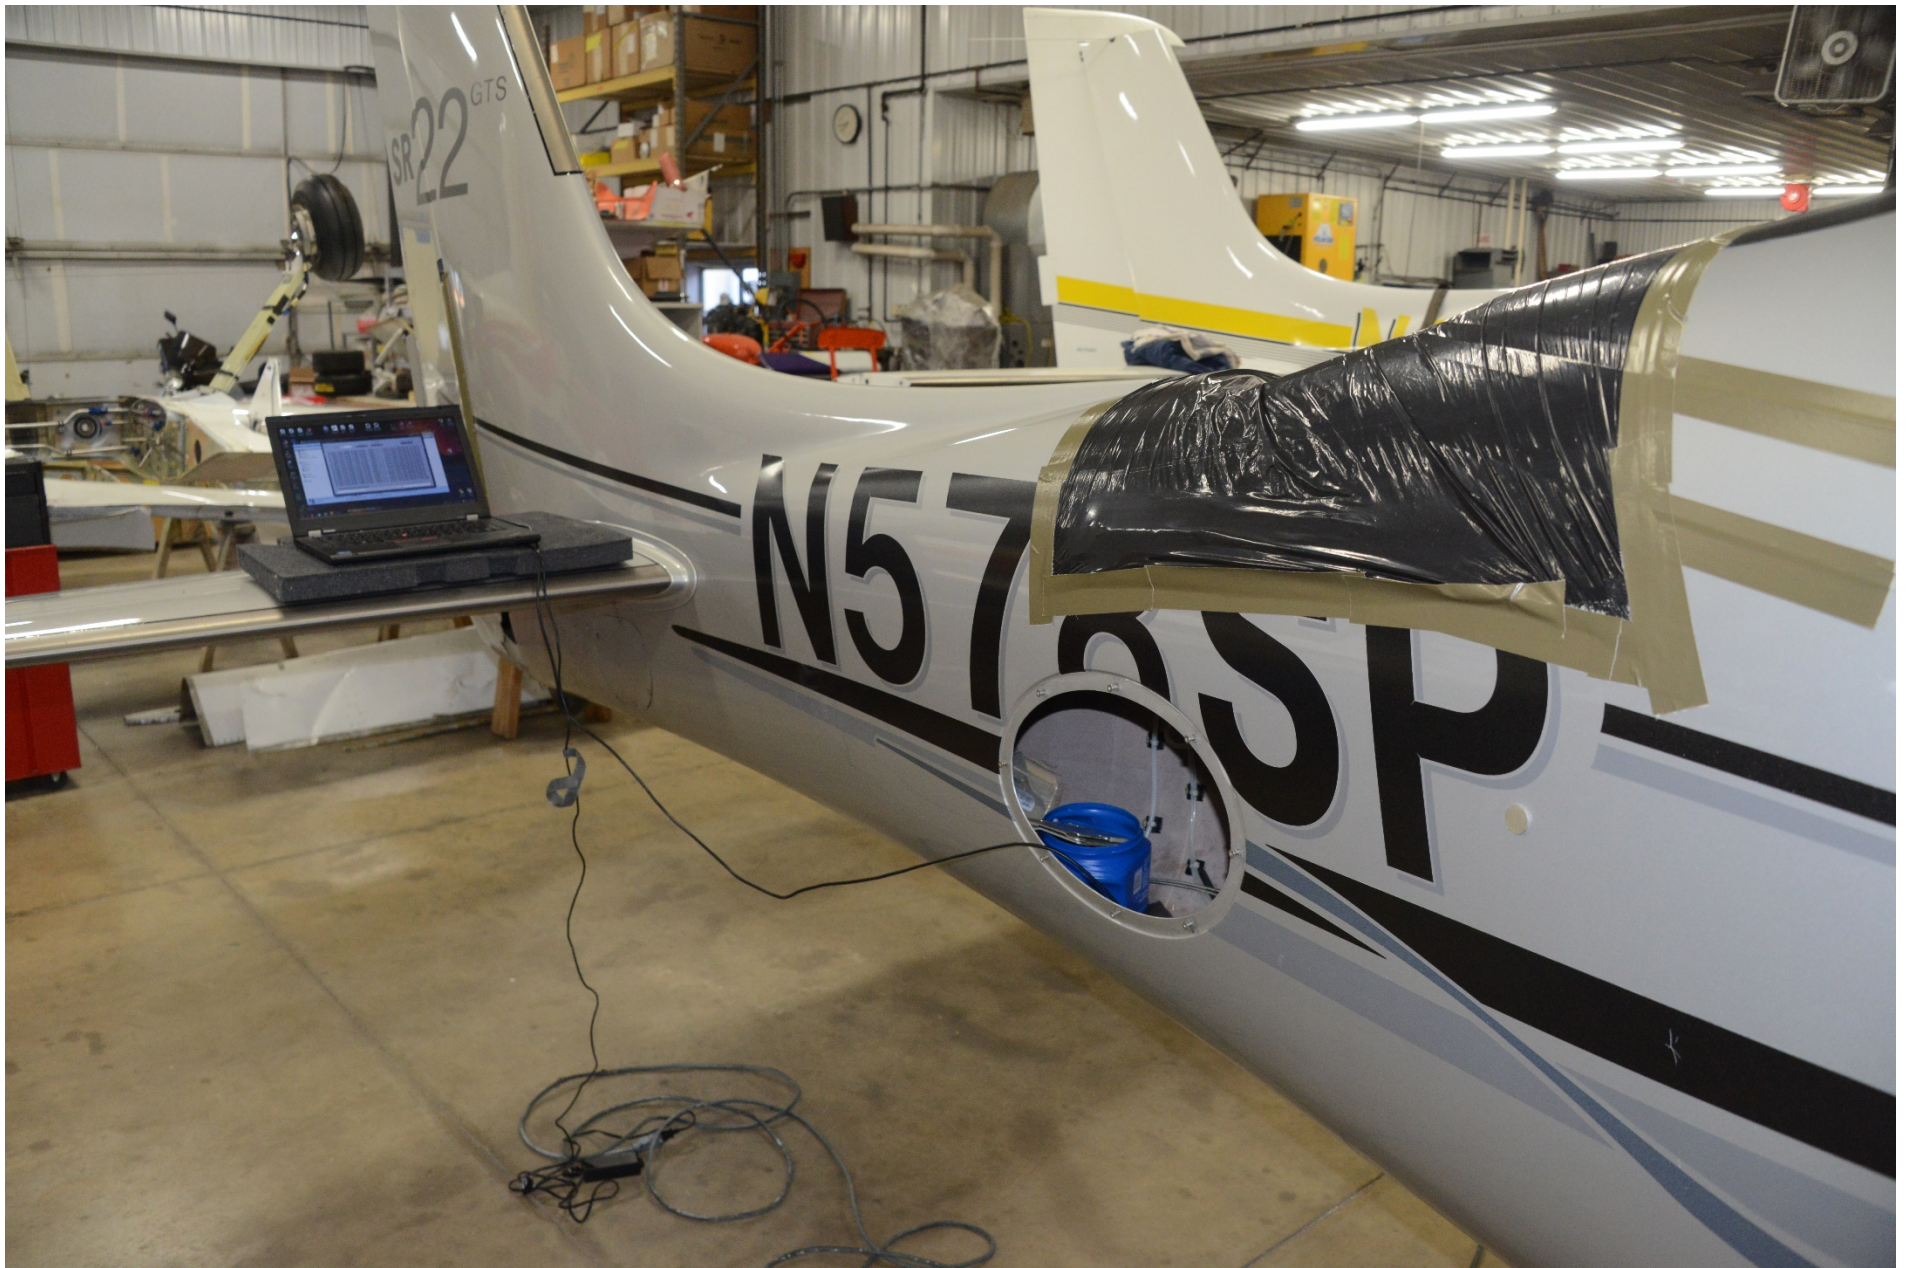
**Photo 2 - View of the right side of the empennage in a recovery facility. A computer is viewed performing an RDM download.**

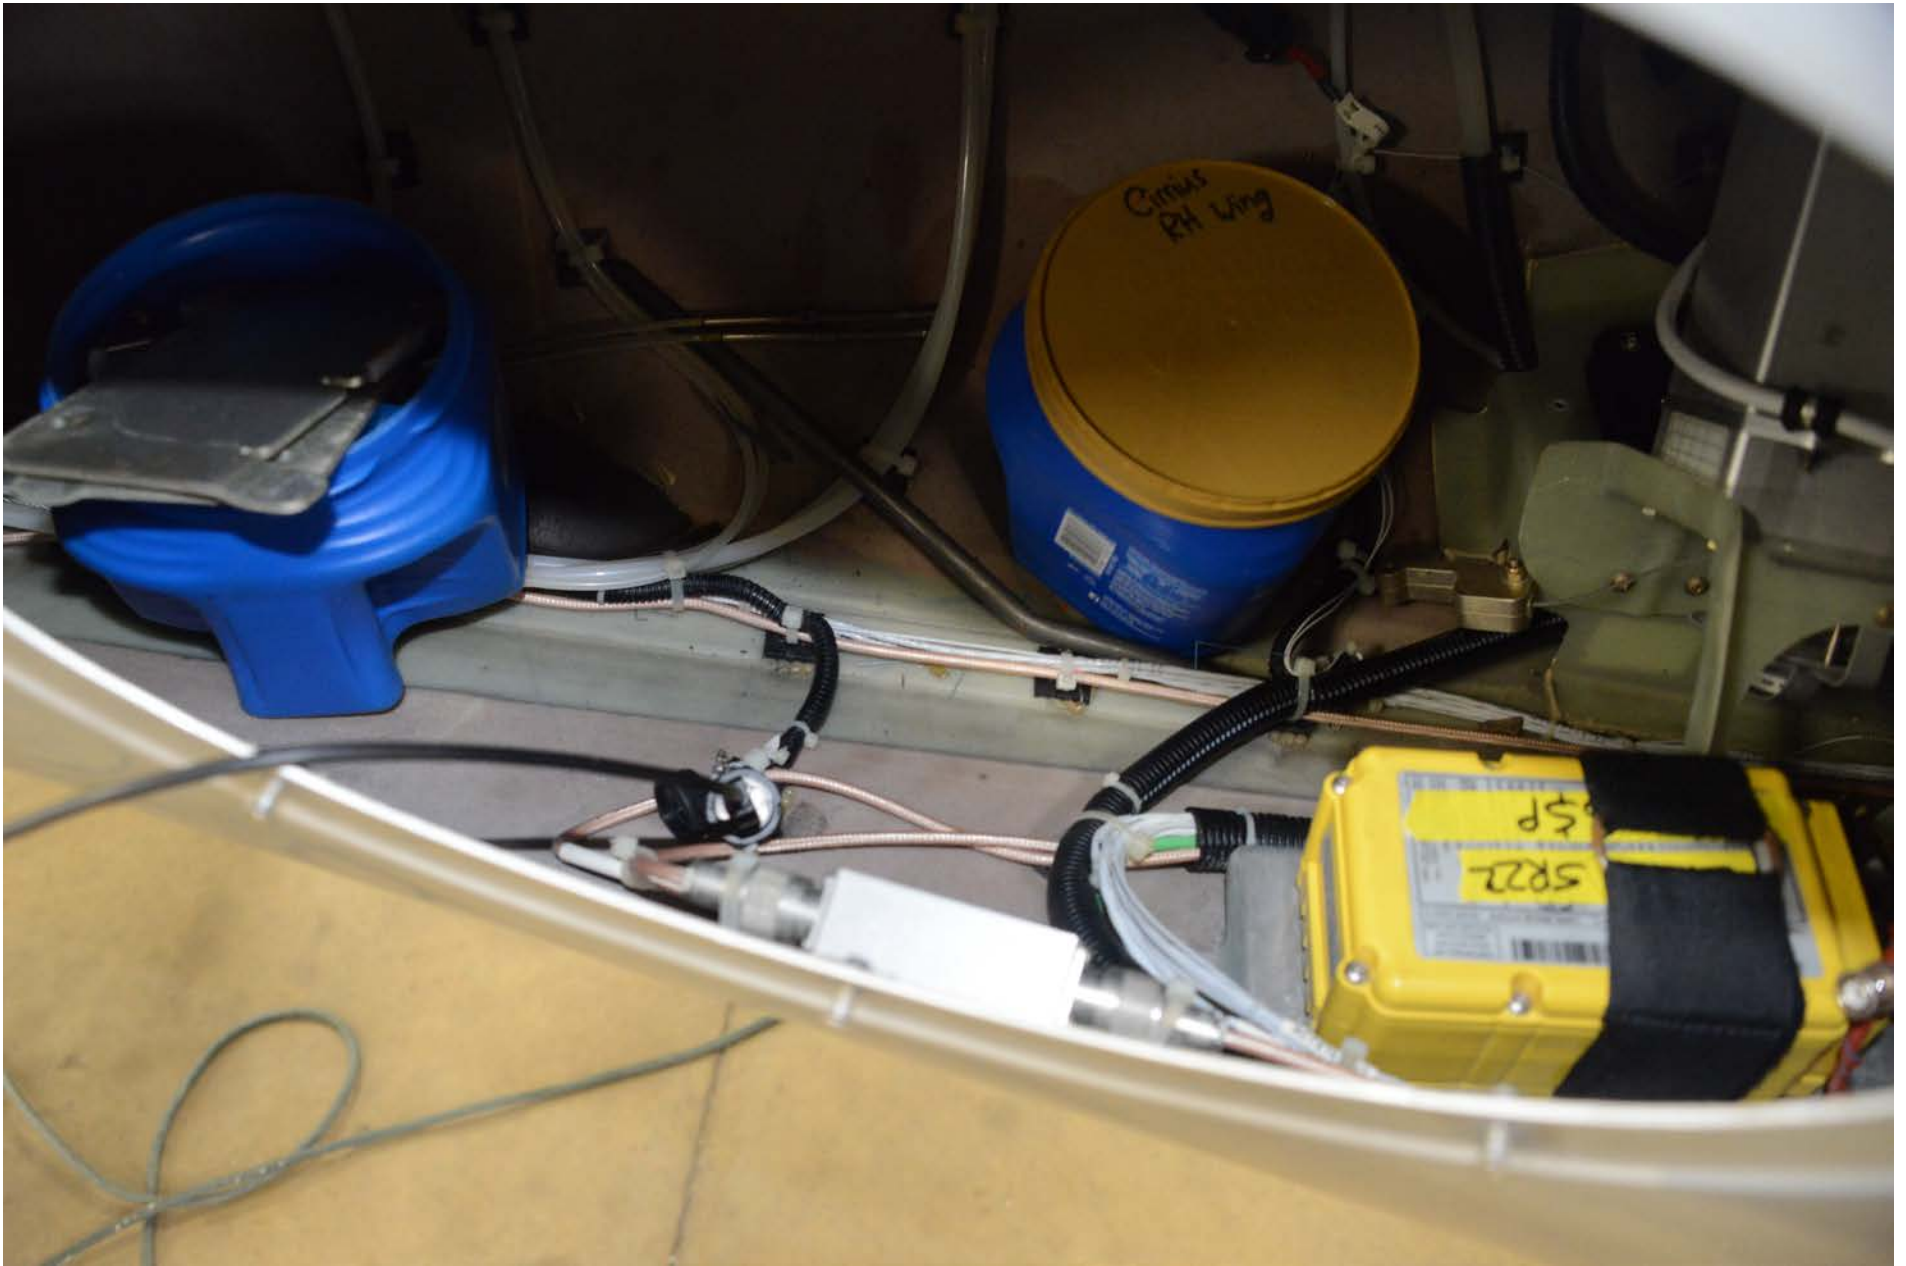
**Photo 3 - View inside of the right side of the empennage. A port is viewed through which an RDM download is being conducted.**

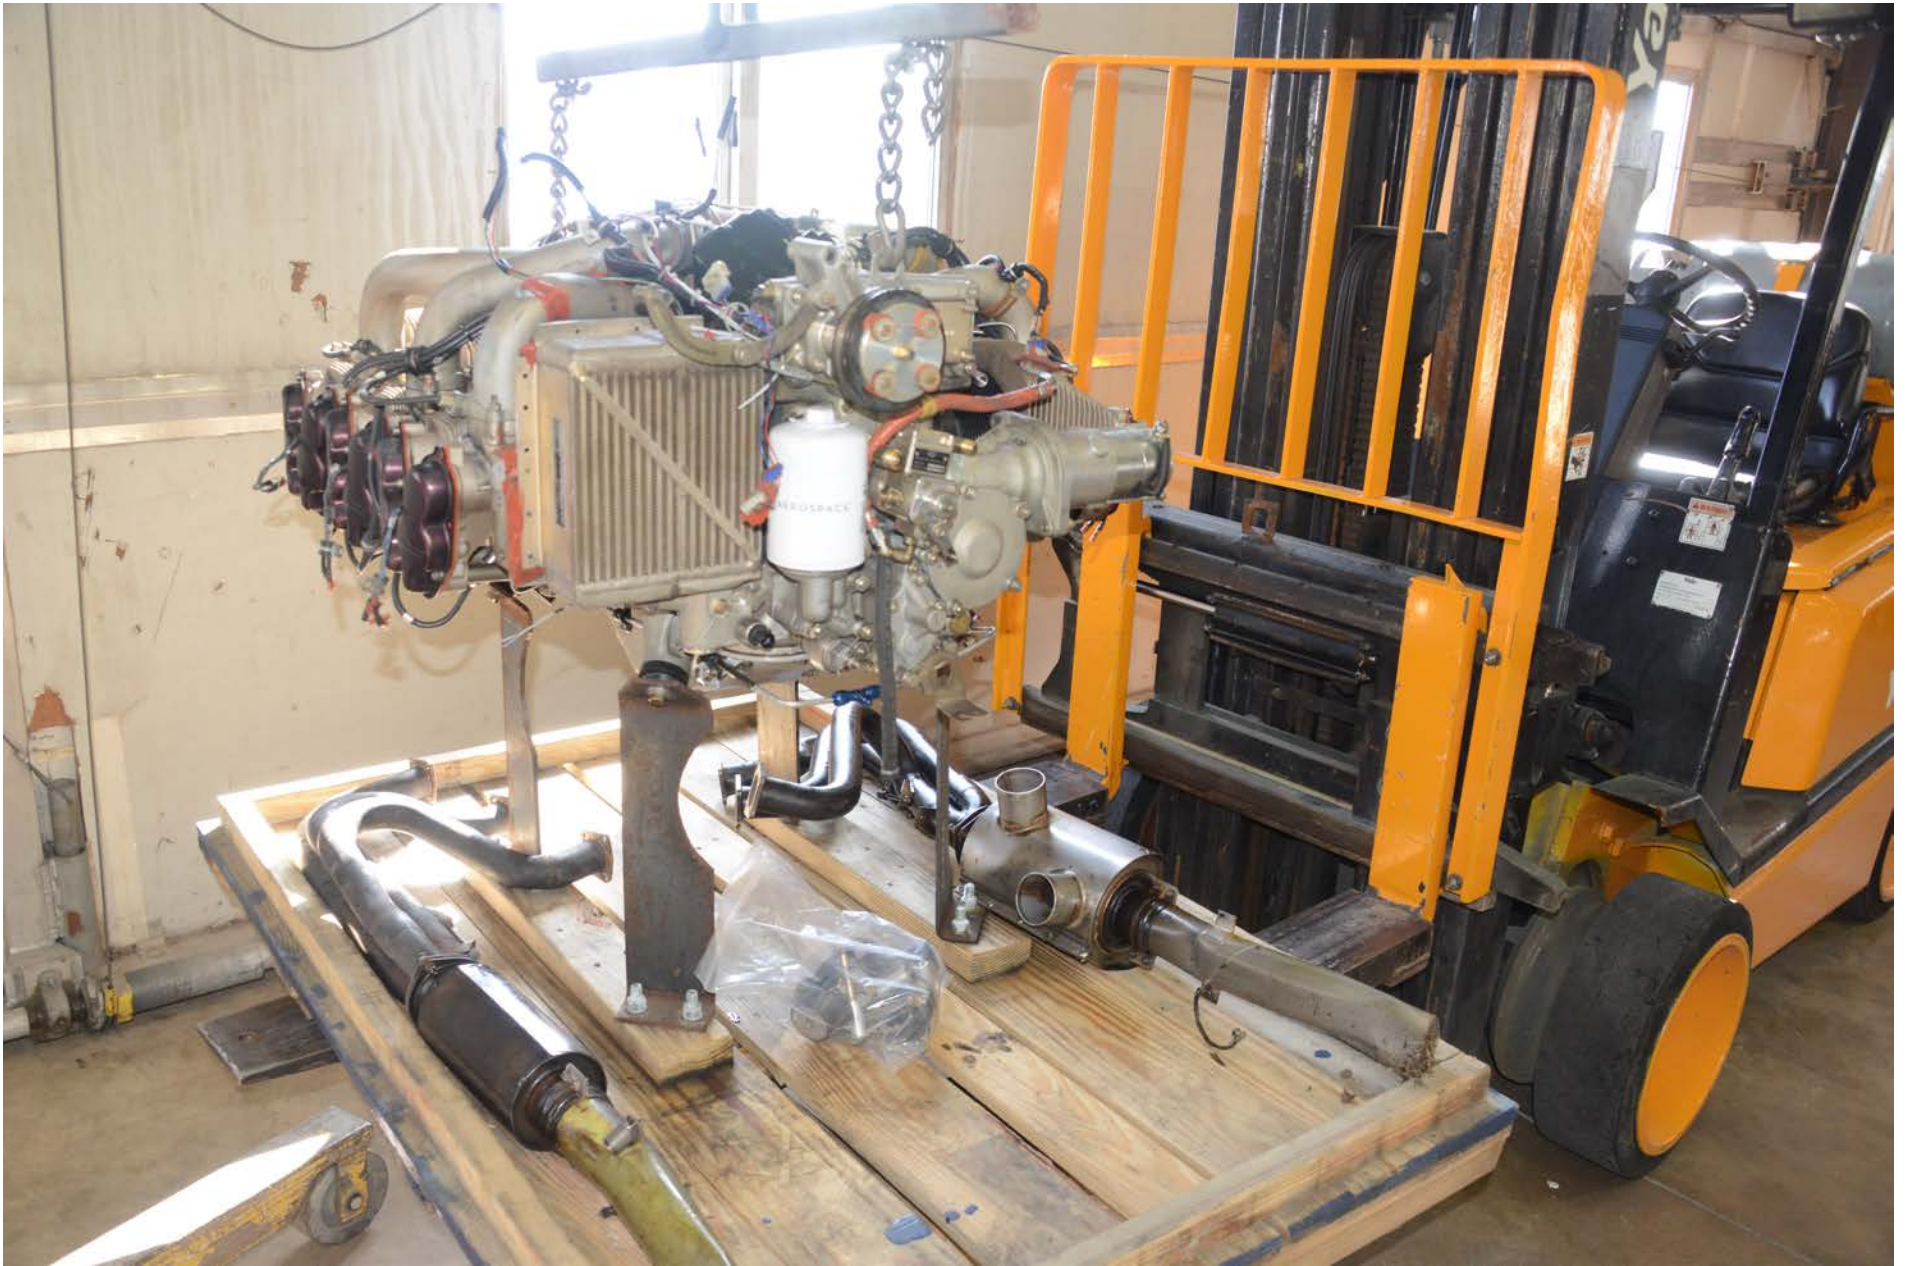
**Photo 4 - View of the engine mounted on a crate for shipment for a disassembly examination.**

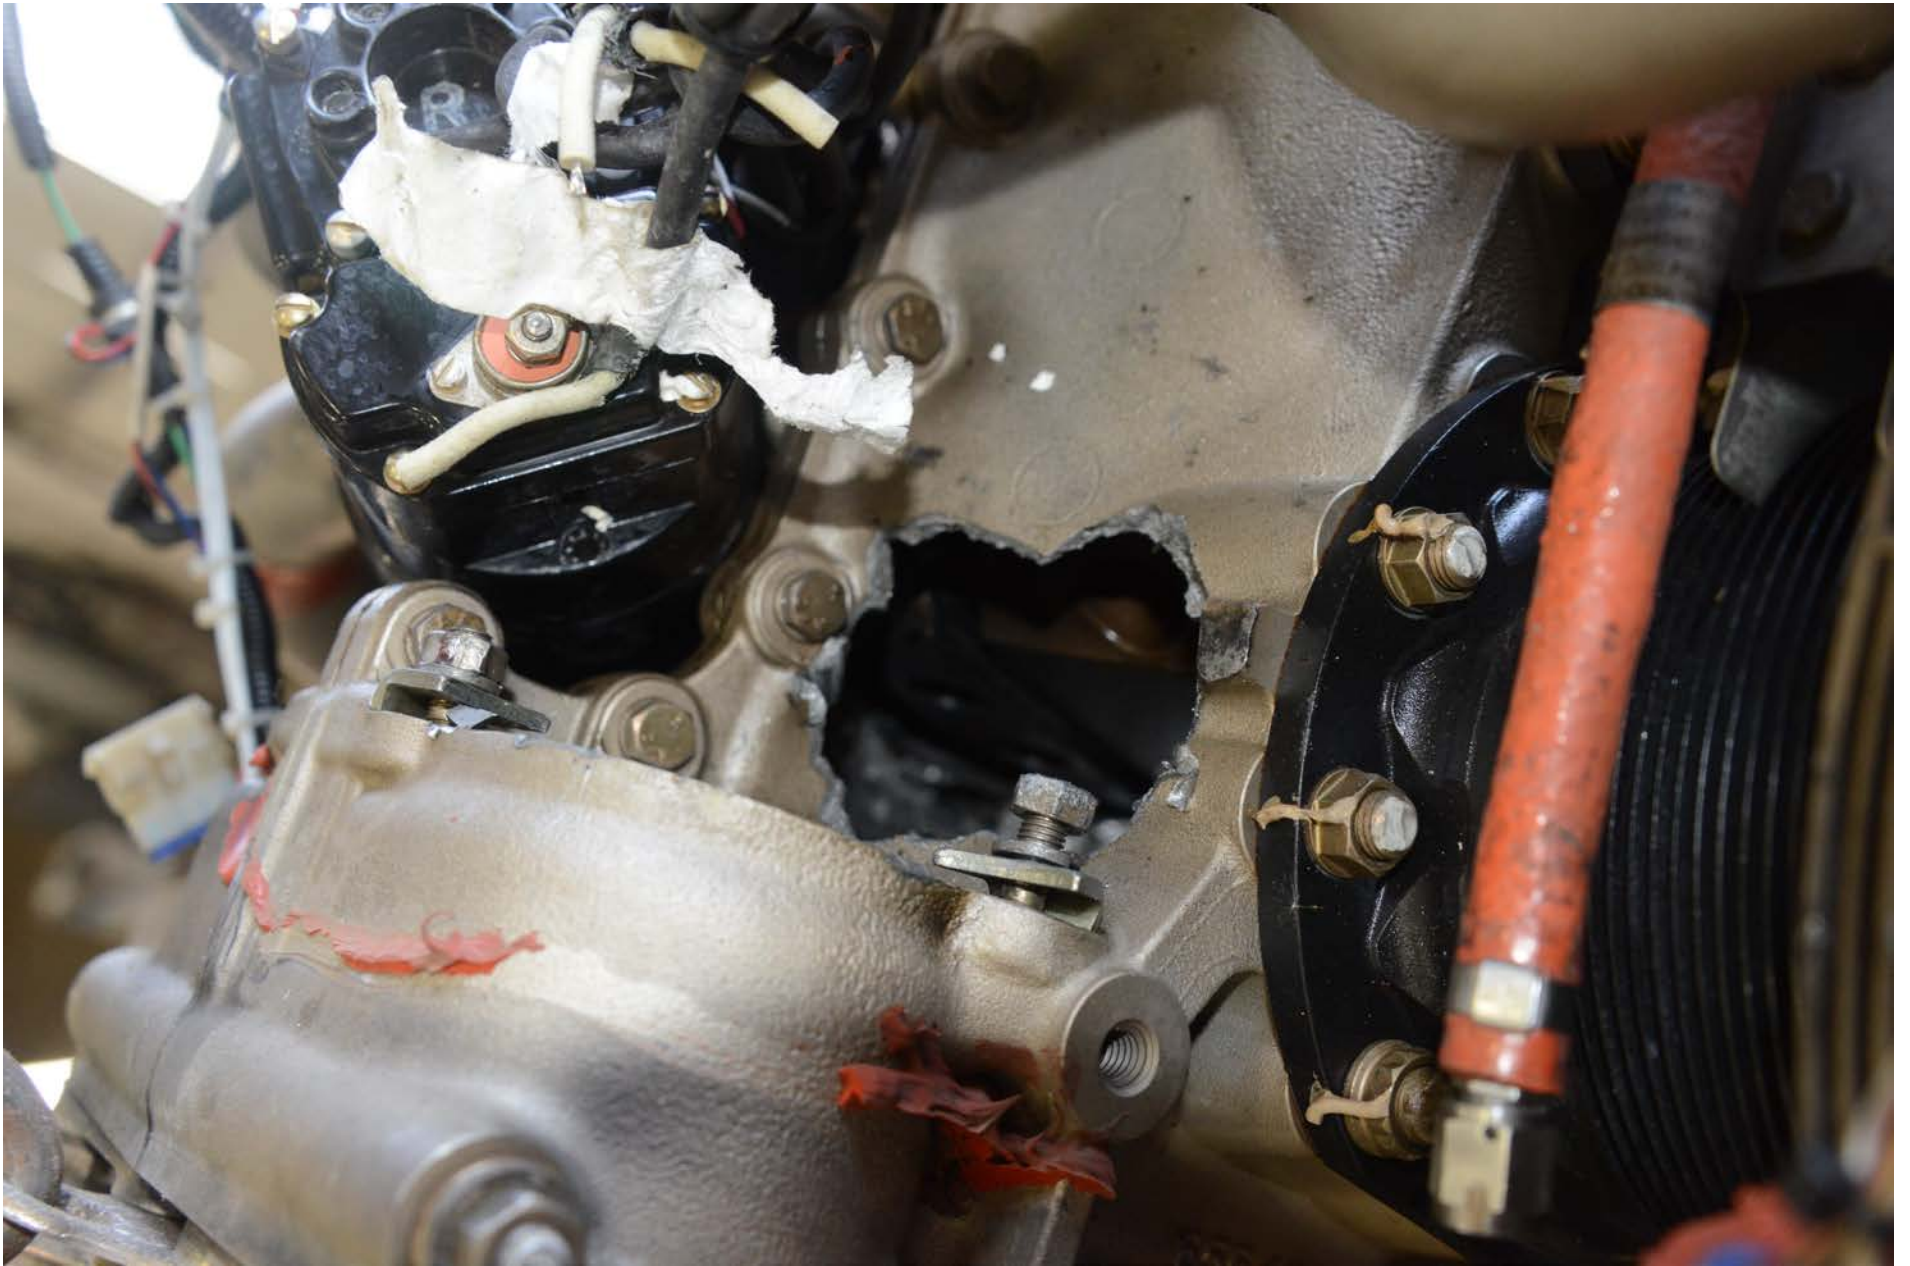
**Photo 5 - Close up view of a hole in the crankcase above the No. 1 cylinder.**

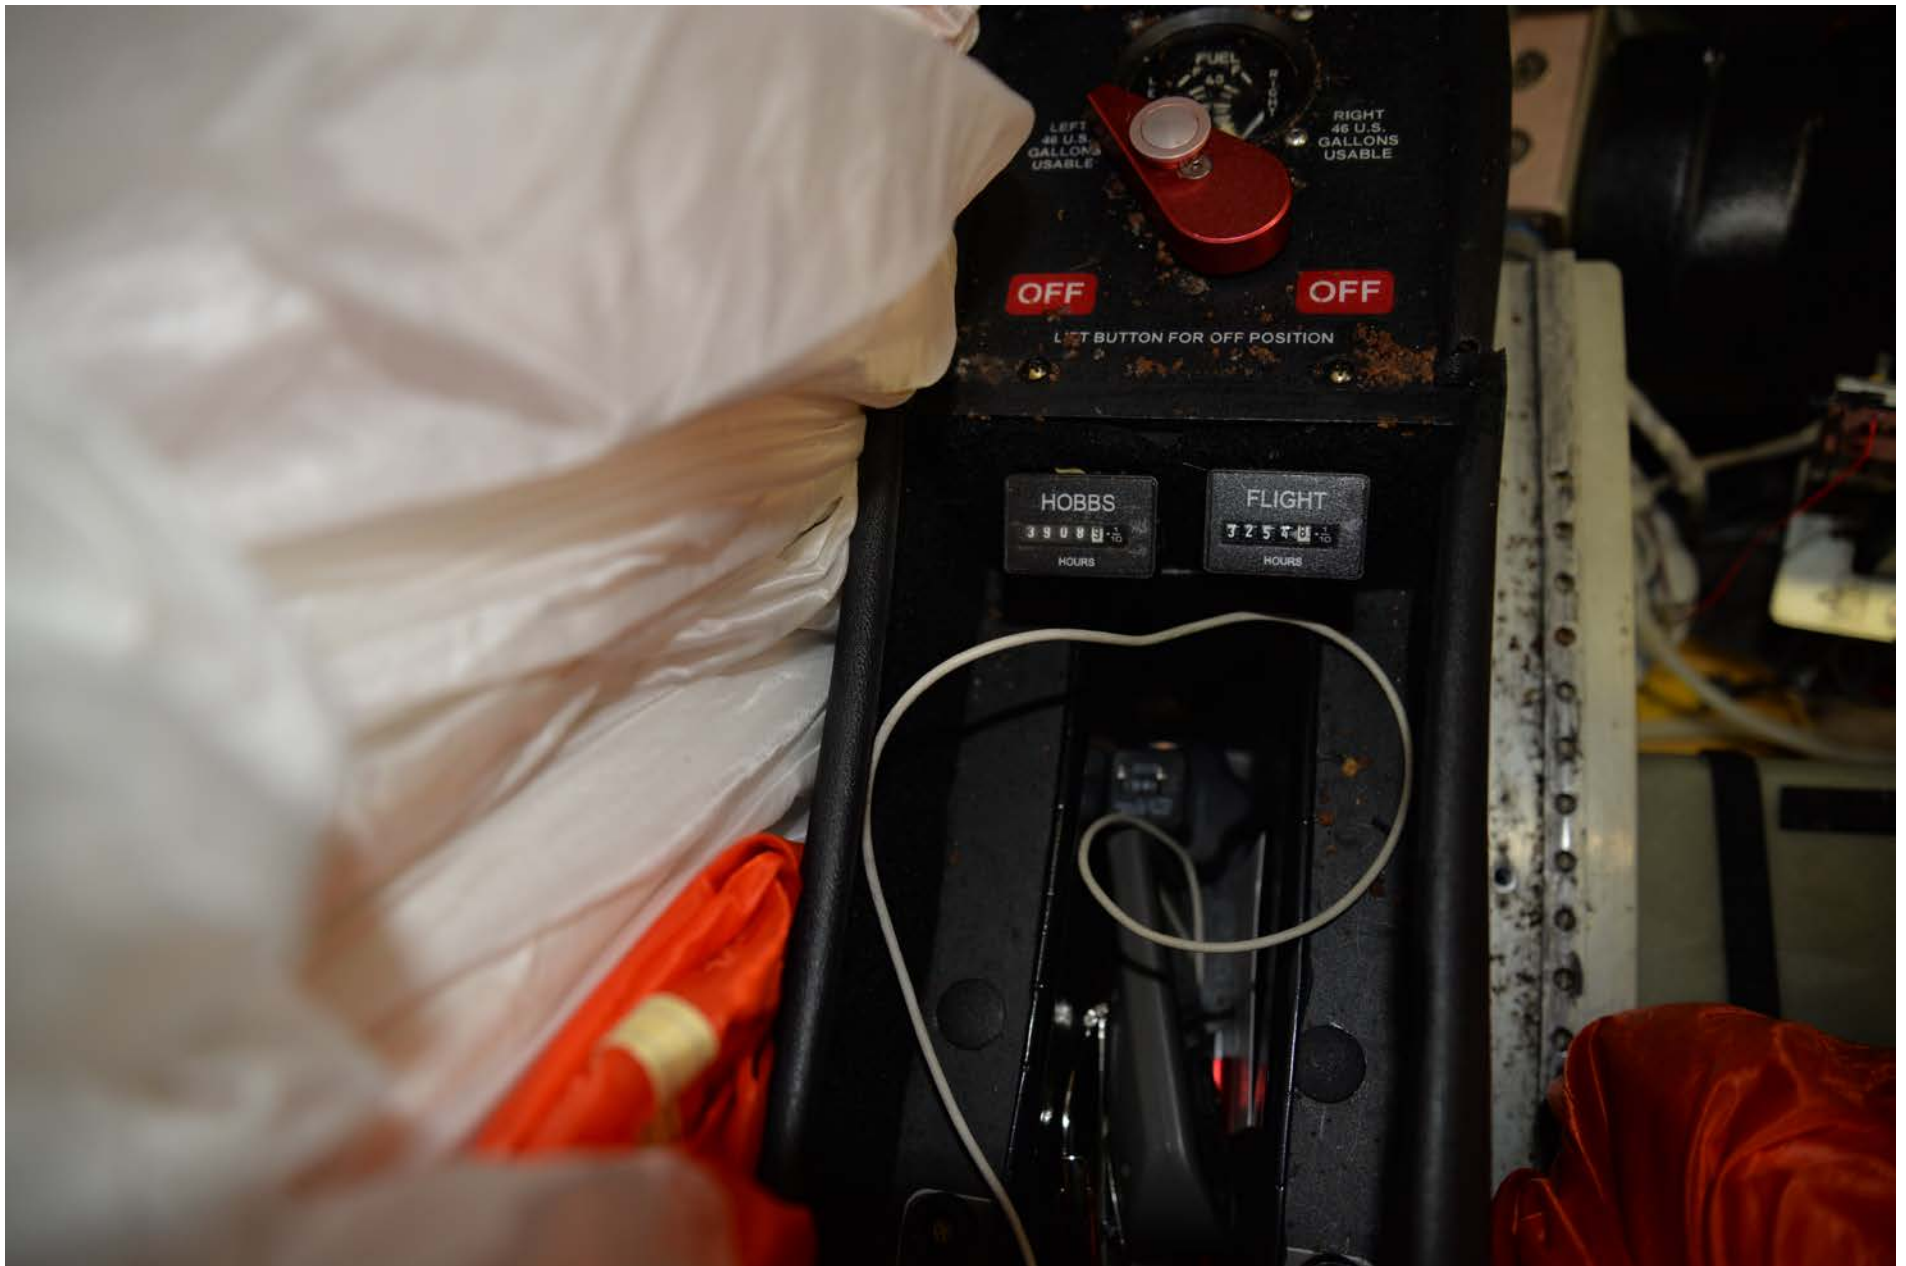
**Photo 6 - View of the Hobbs and flight time meters. The Hobbs indicates 3,908.9 hours and the flight indicates 3,254.8 hours.**

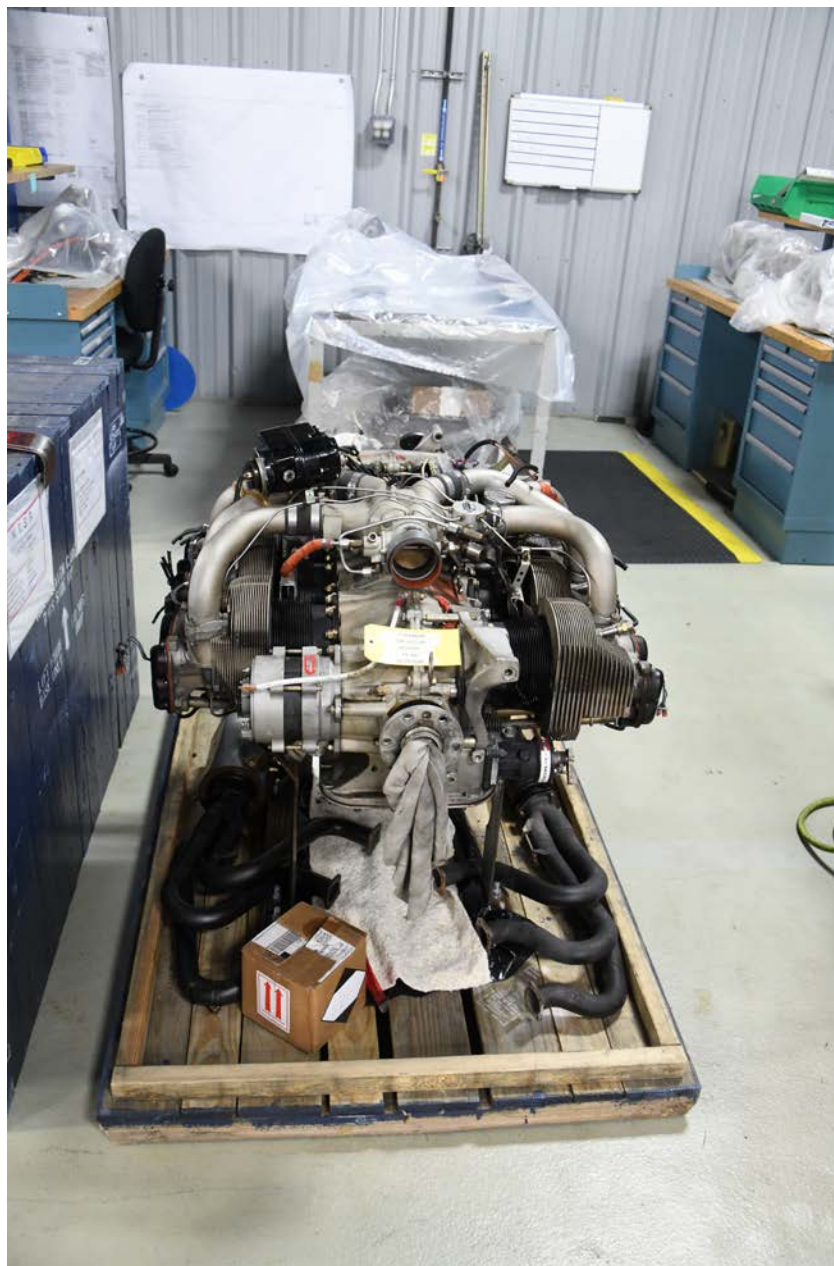
**Photo 7 - View of the engine as received for the disassembly examination.**

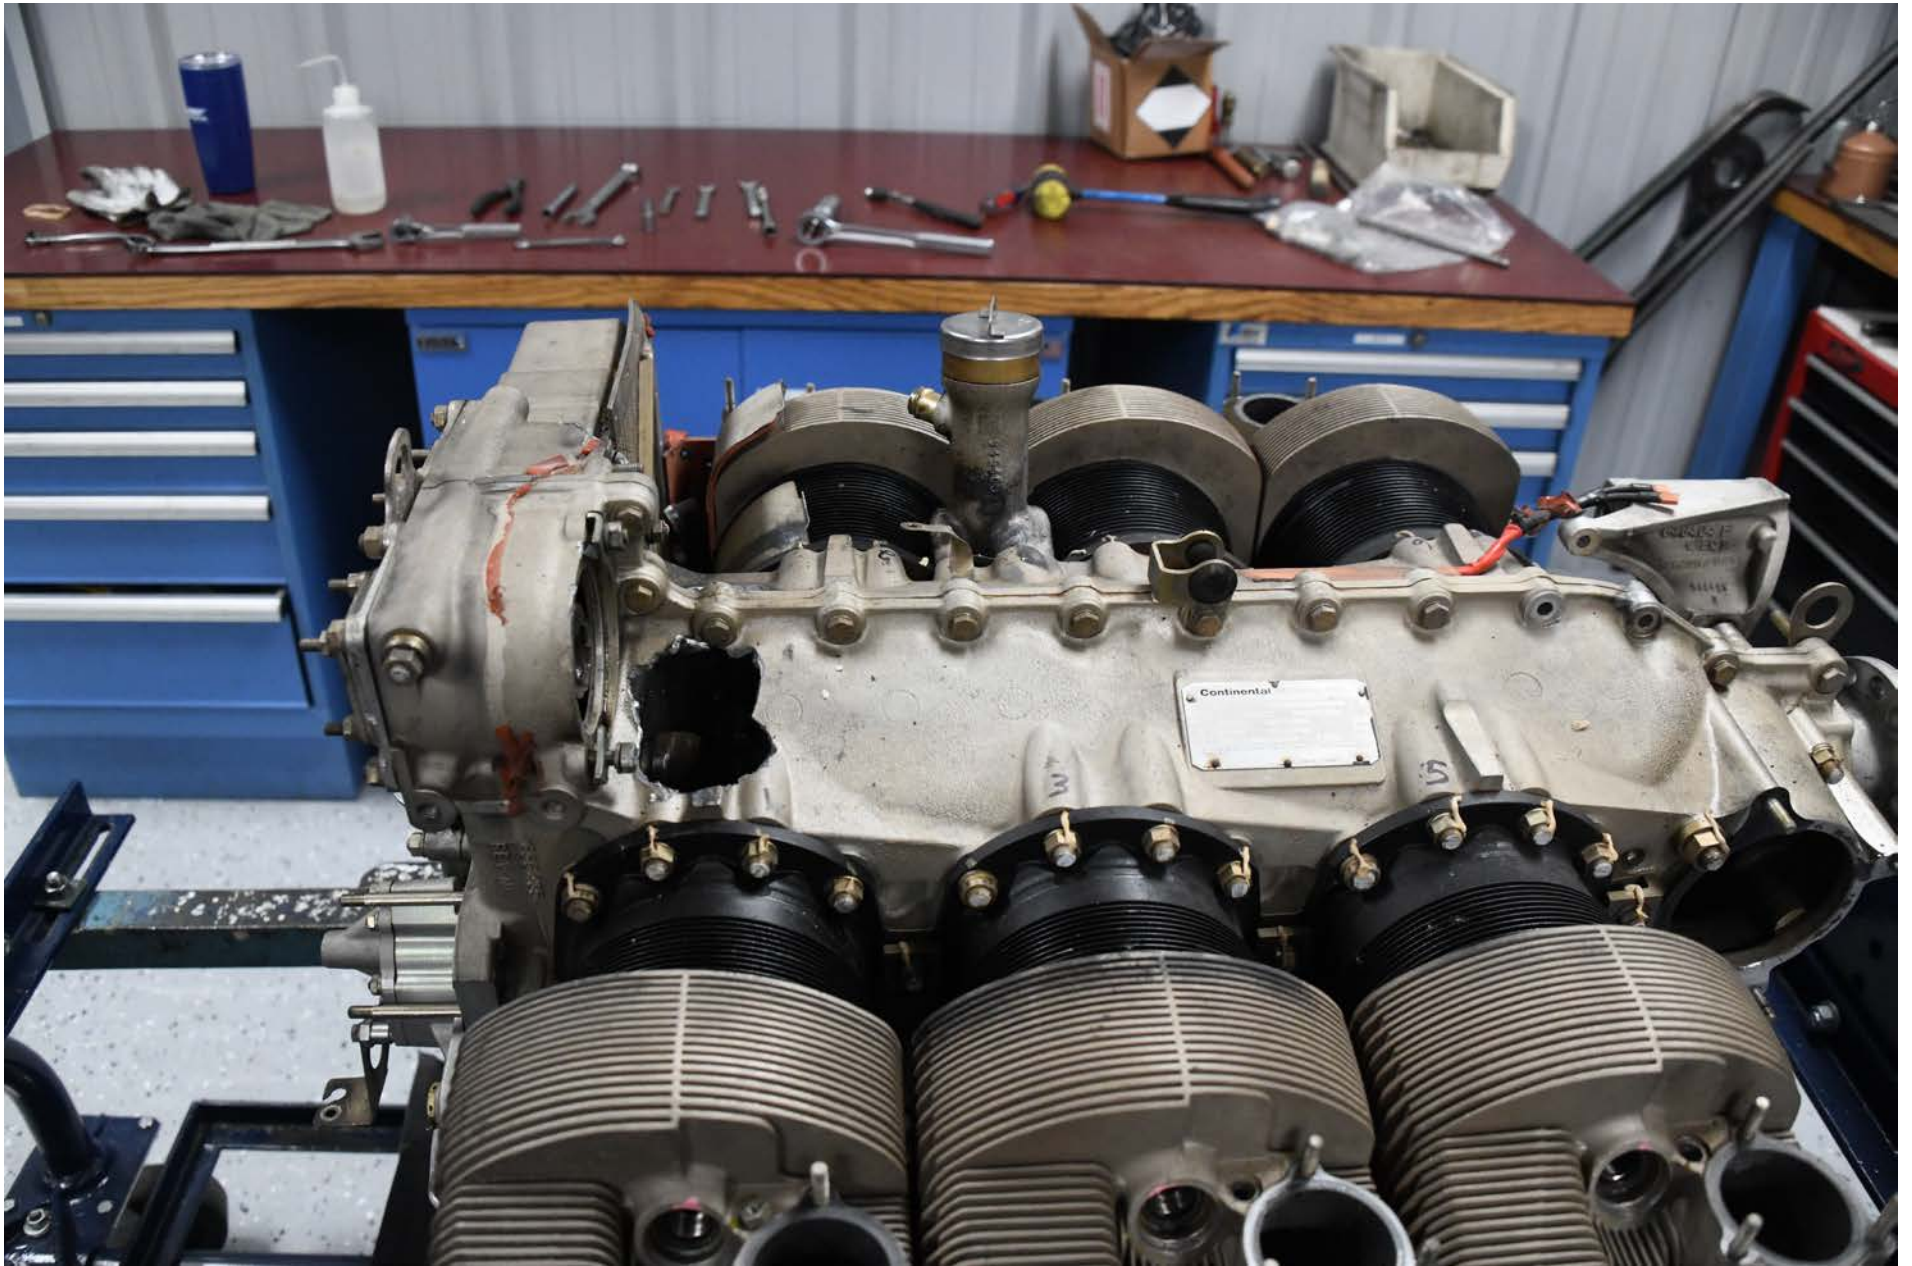
**Photo 8 - View of the partially disassembled engine on a motor stand.**

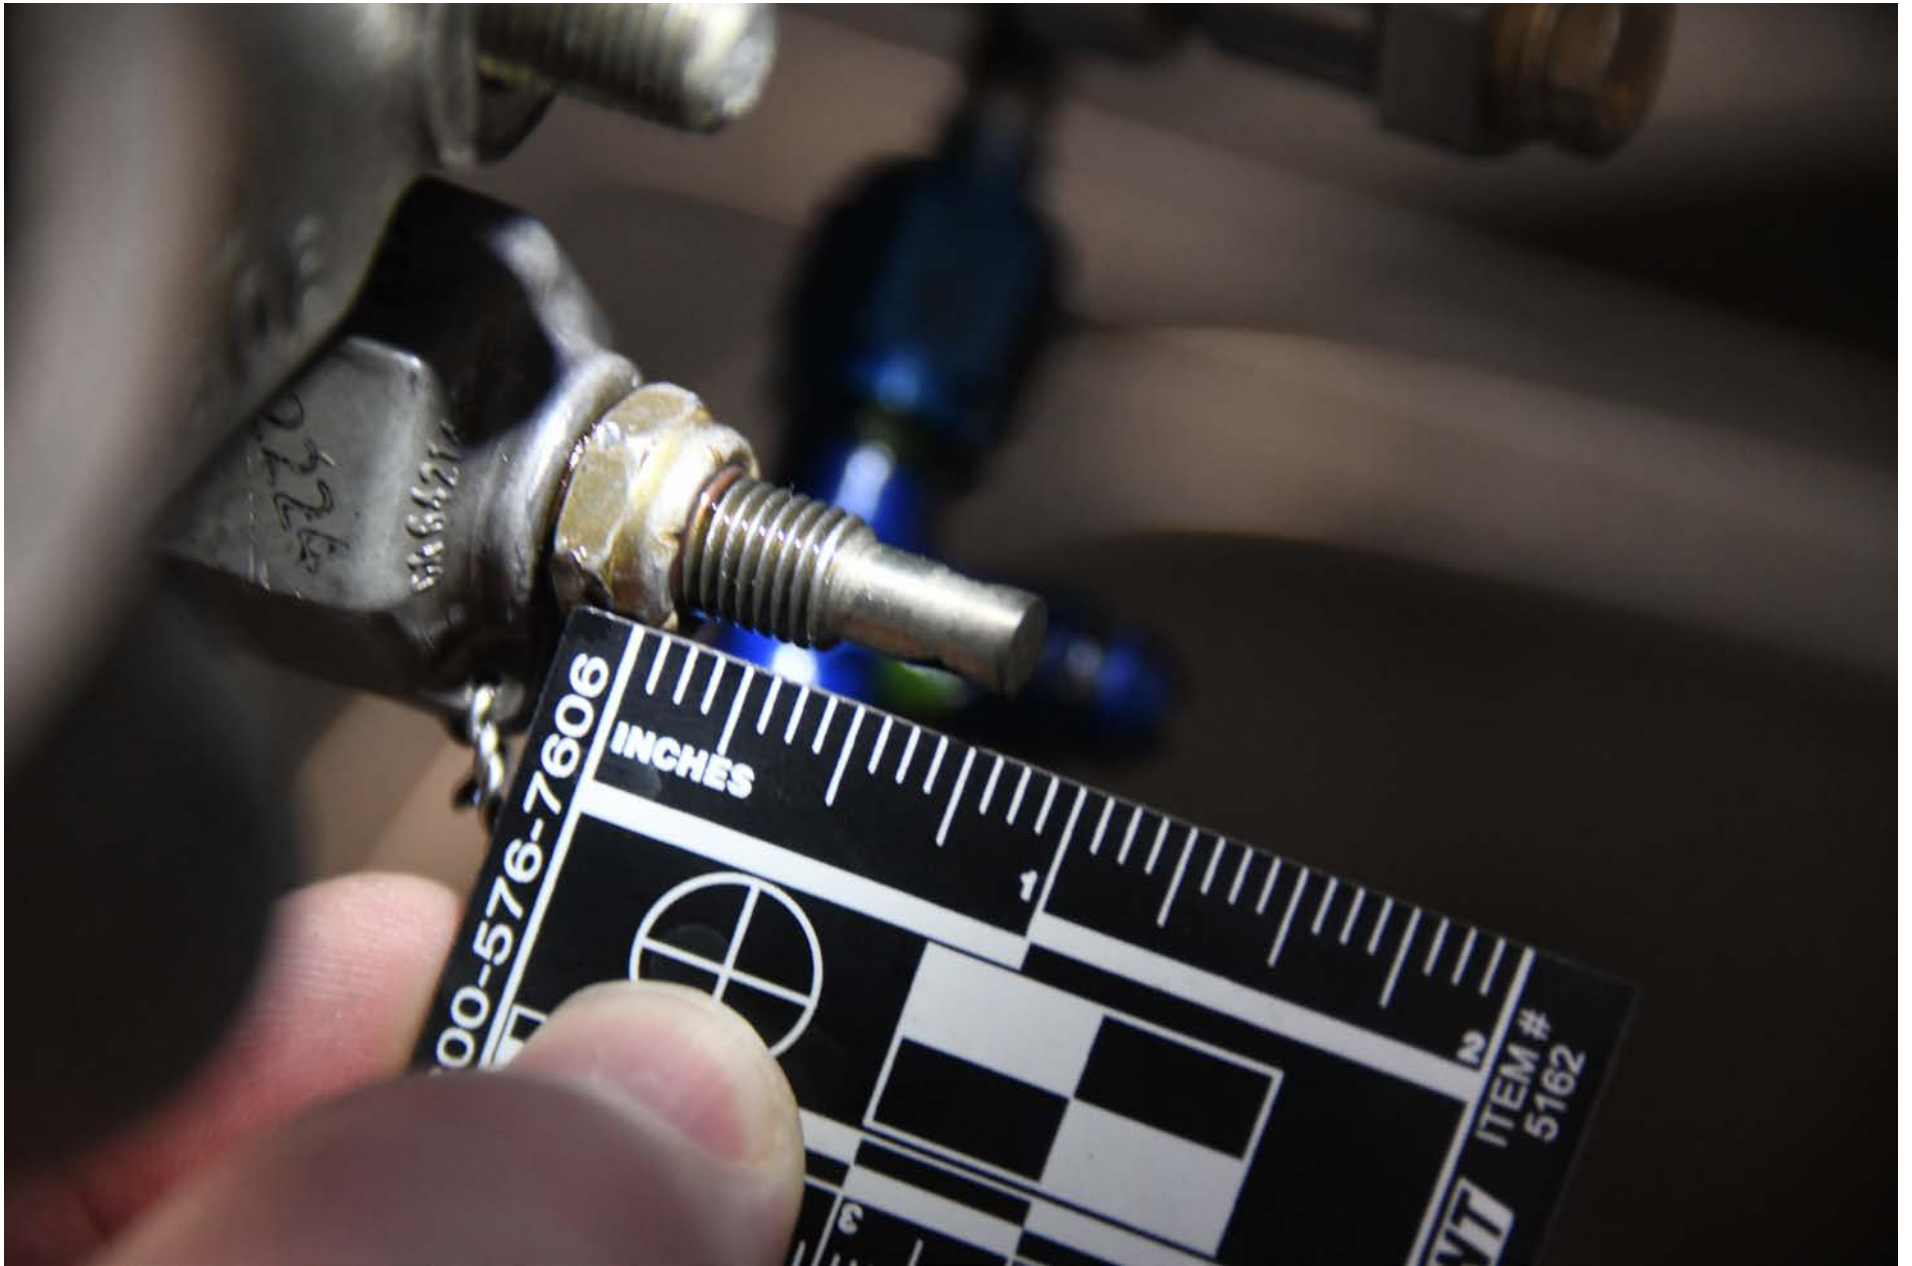
Photo 9 - Close up view of the oil pressure adjustment.

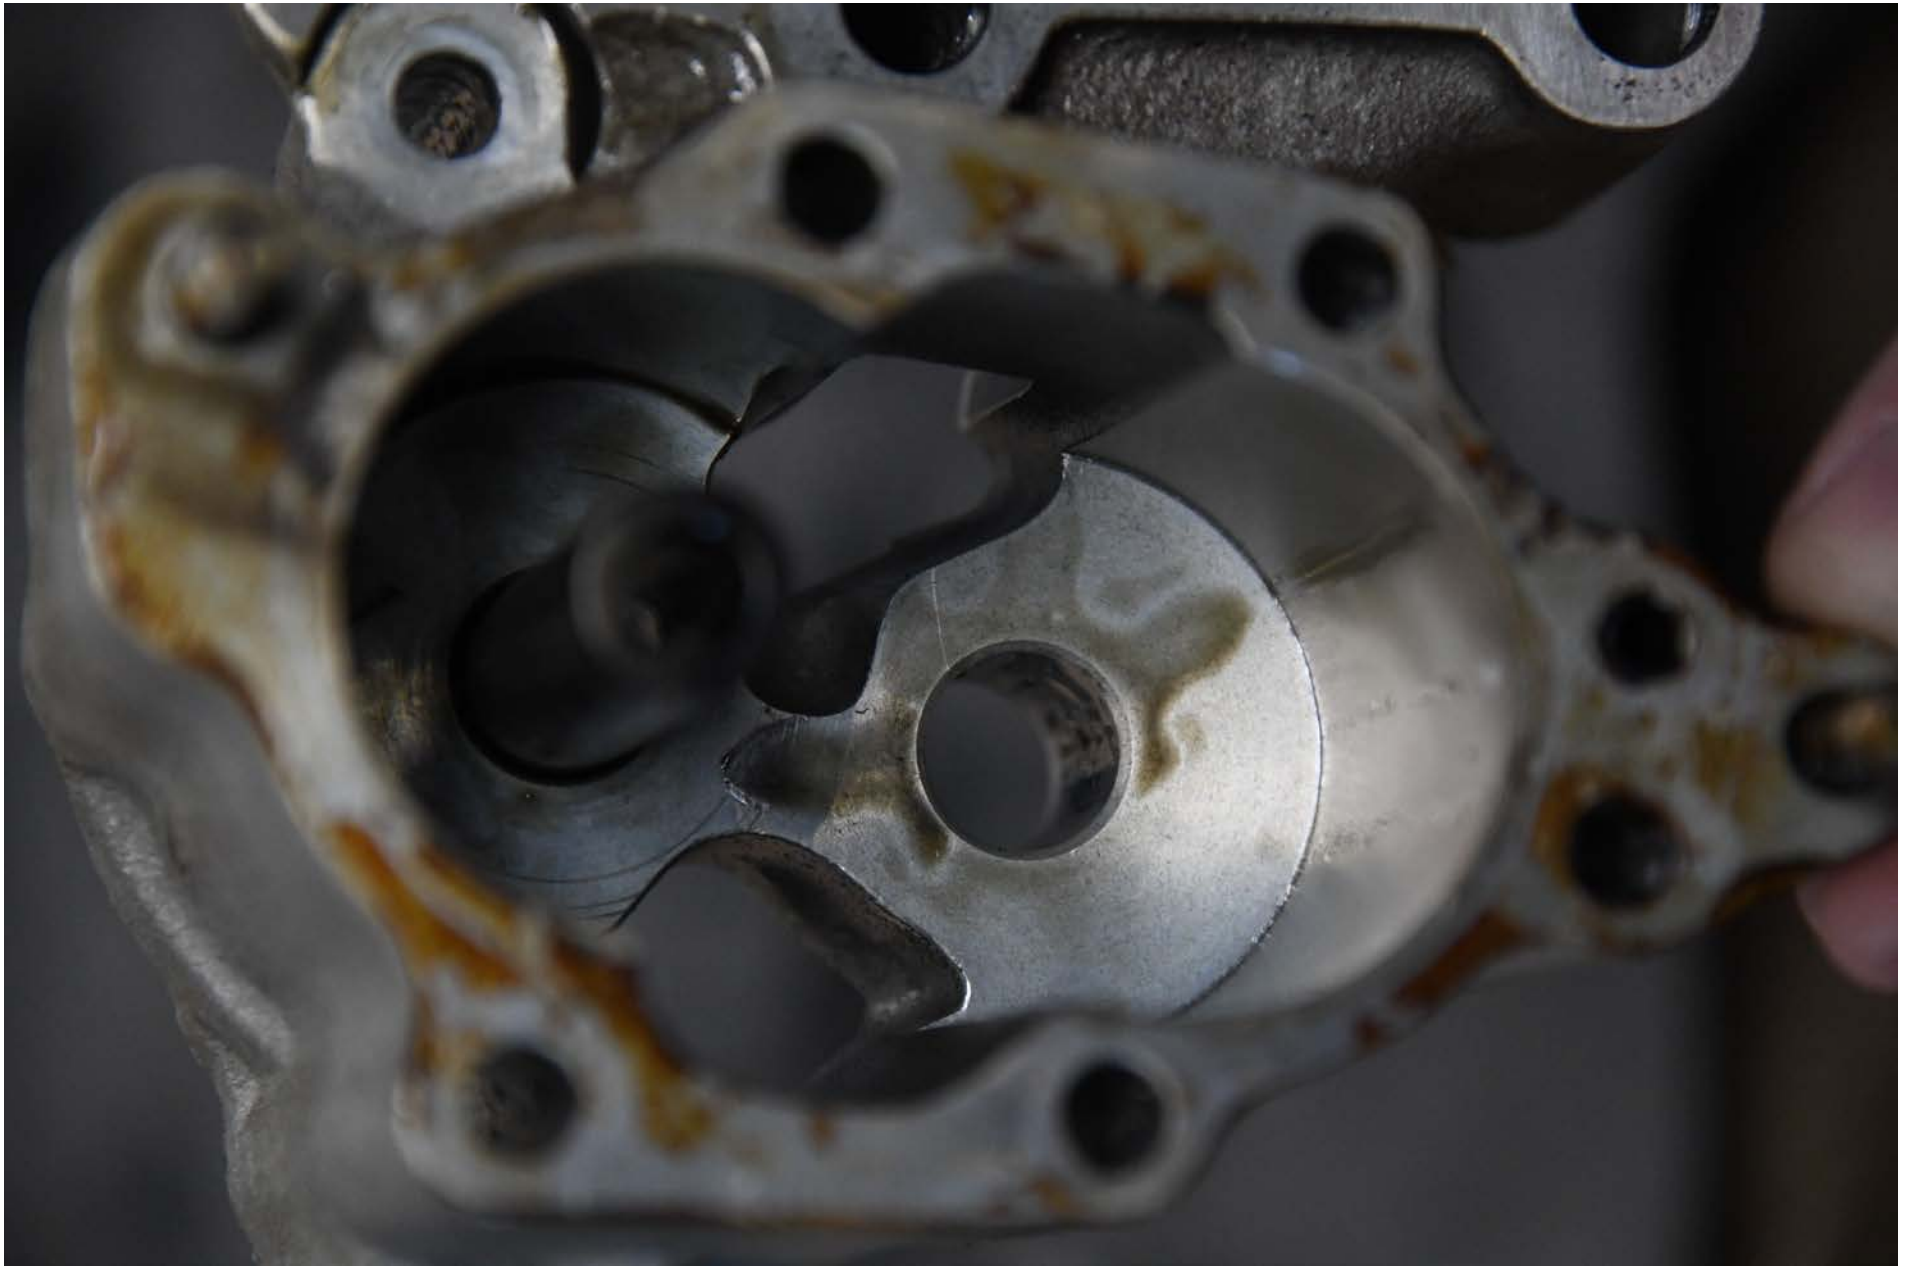
**Photo 10 - Close up view of the oil pump cavity. No marks consistent with passage of hard particles are observed on the cavity's walls.**
