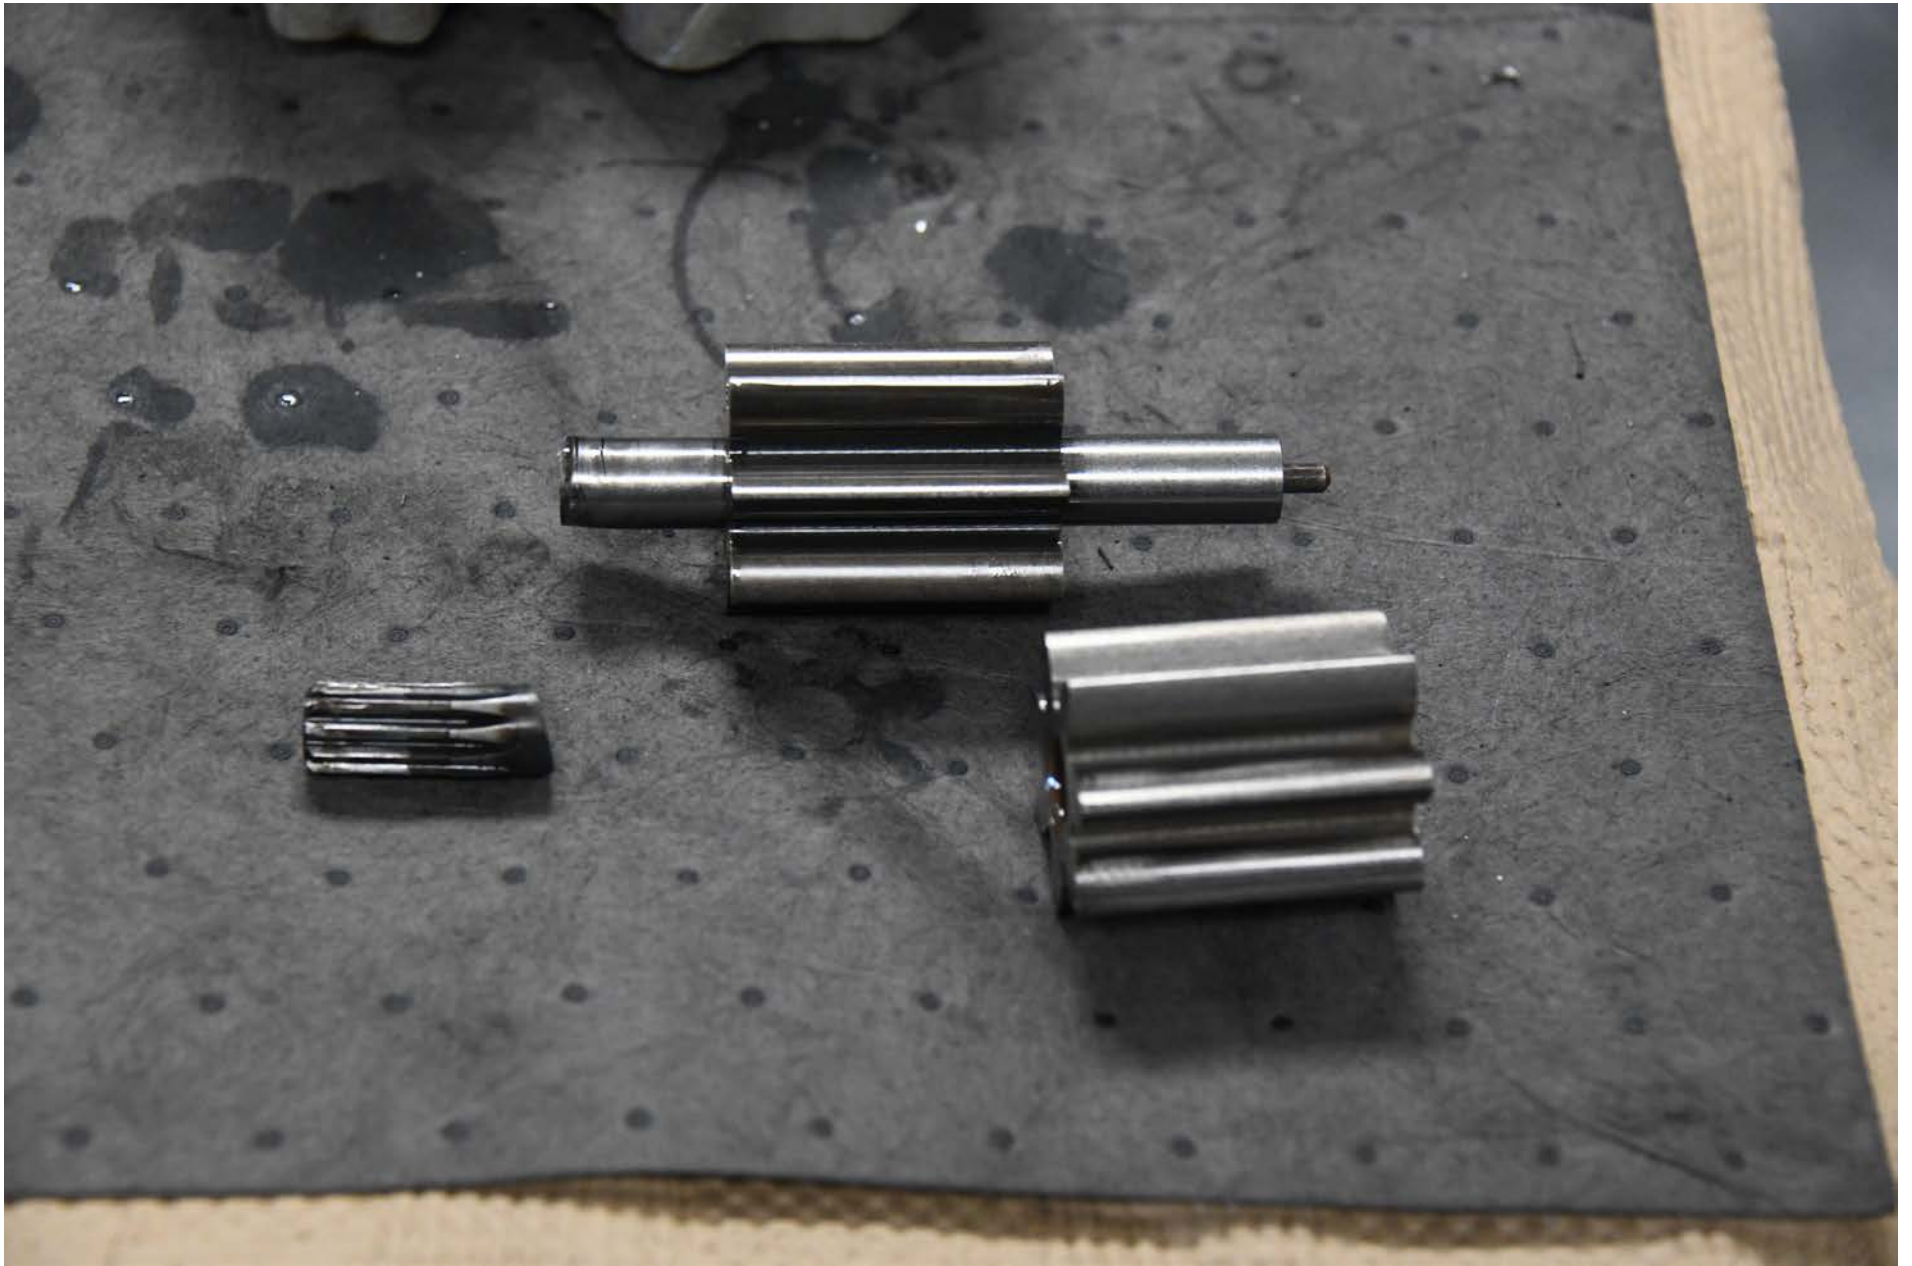
**Photo 11 - Close up view of the oil pump's drive and driven gears. No marks are observed on the gear's surfaces.**

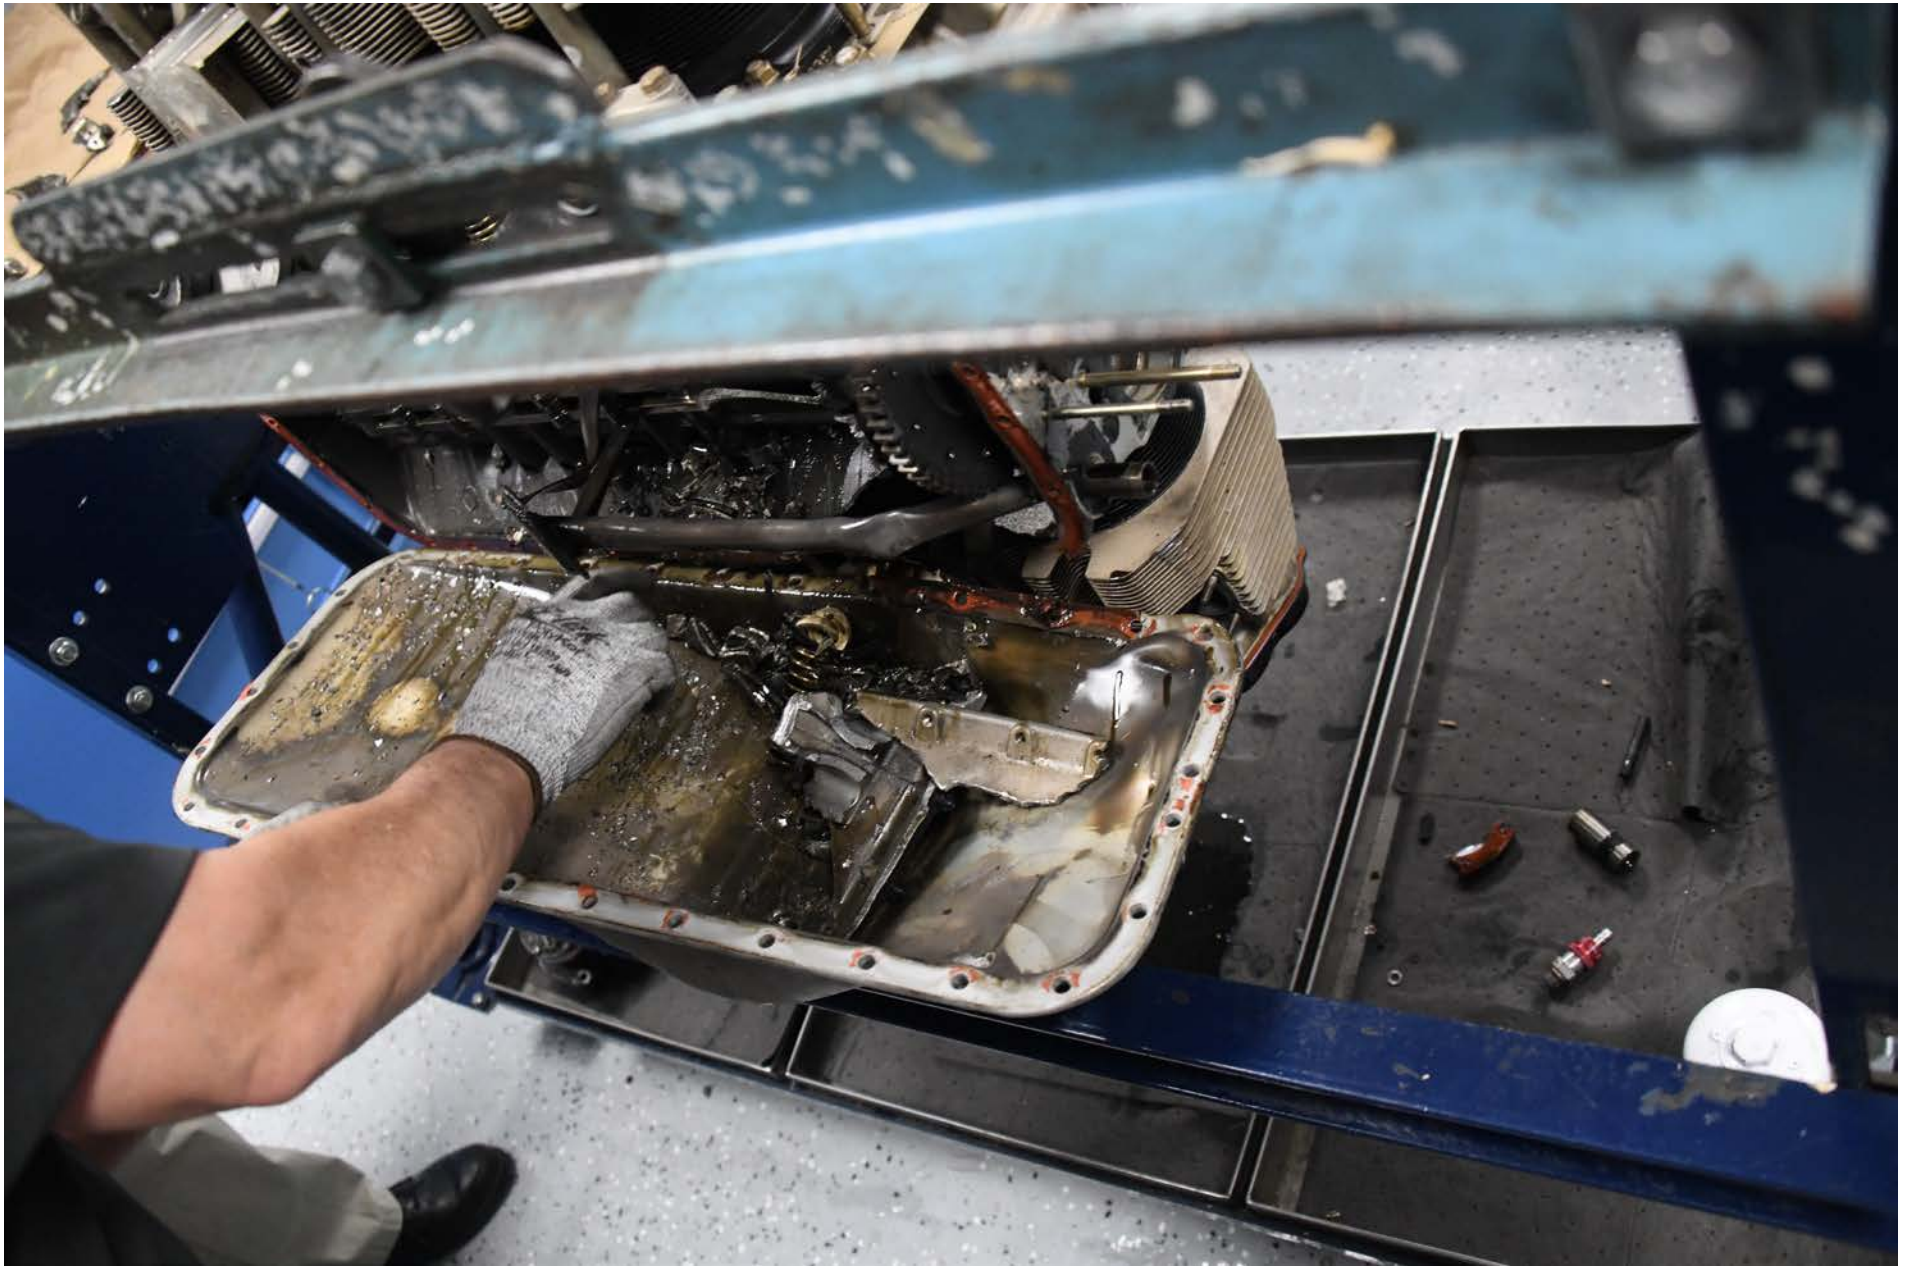
**Photo 12 - View of the oil sump pan as it is being removed.**

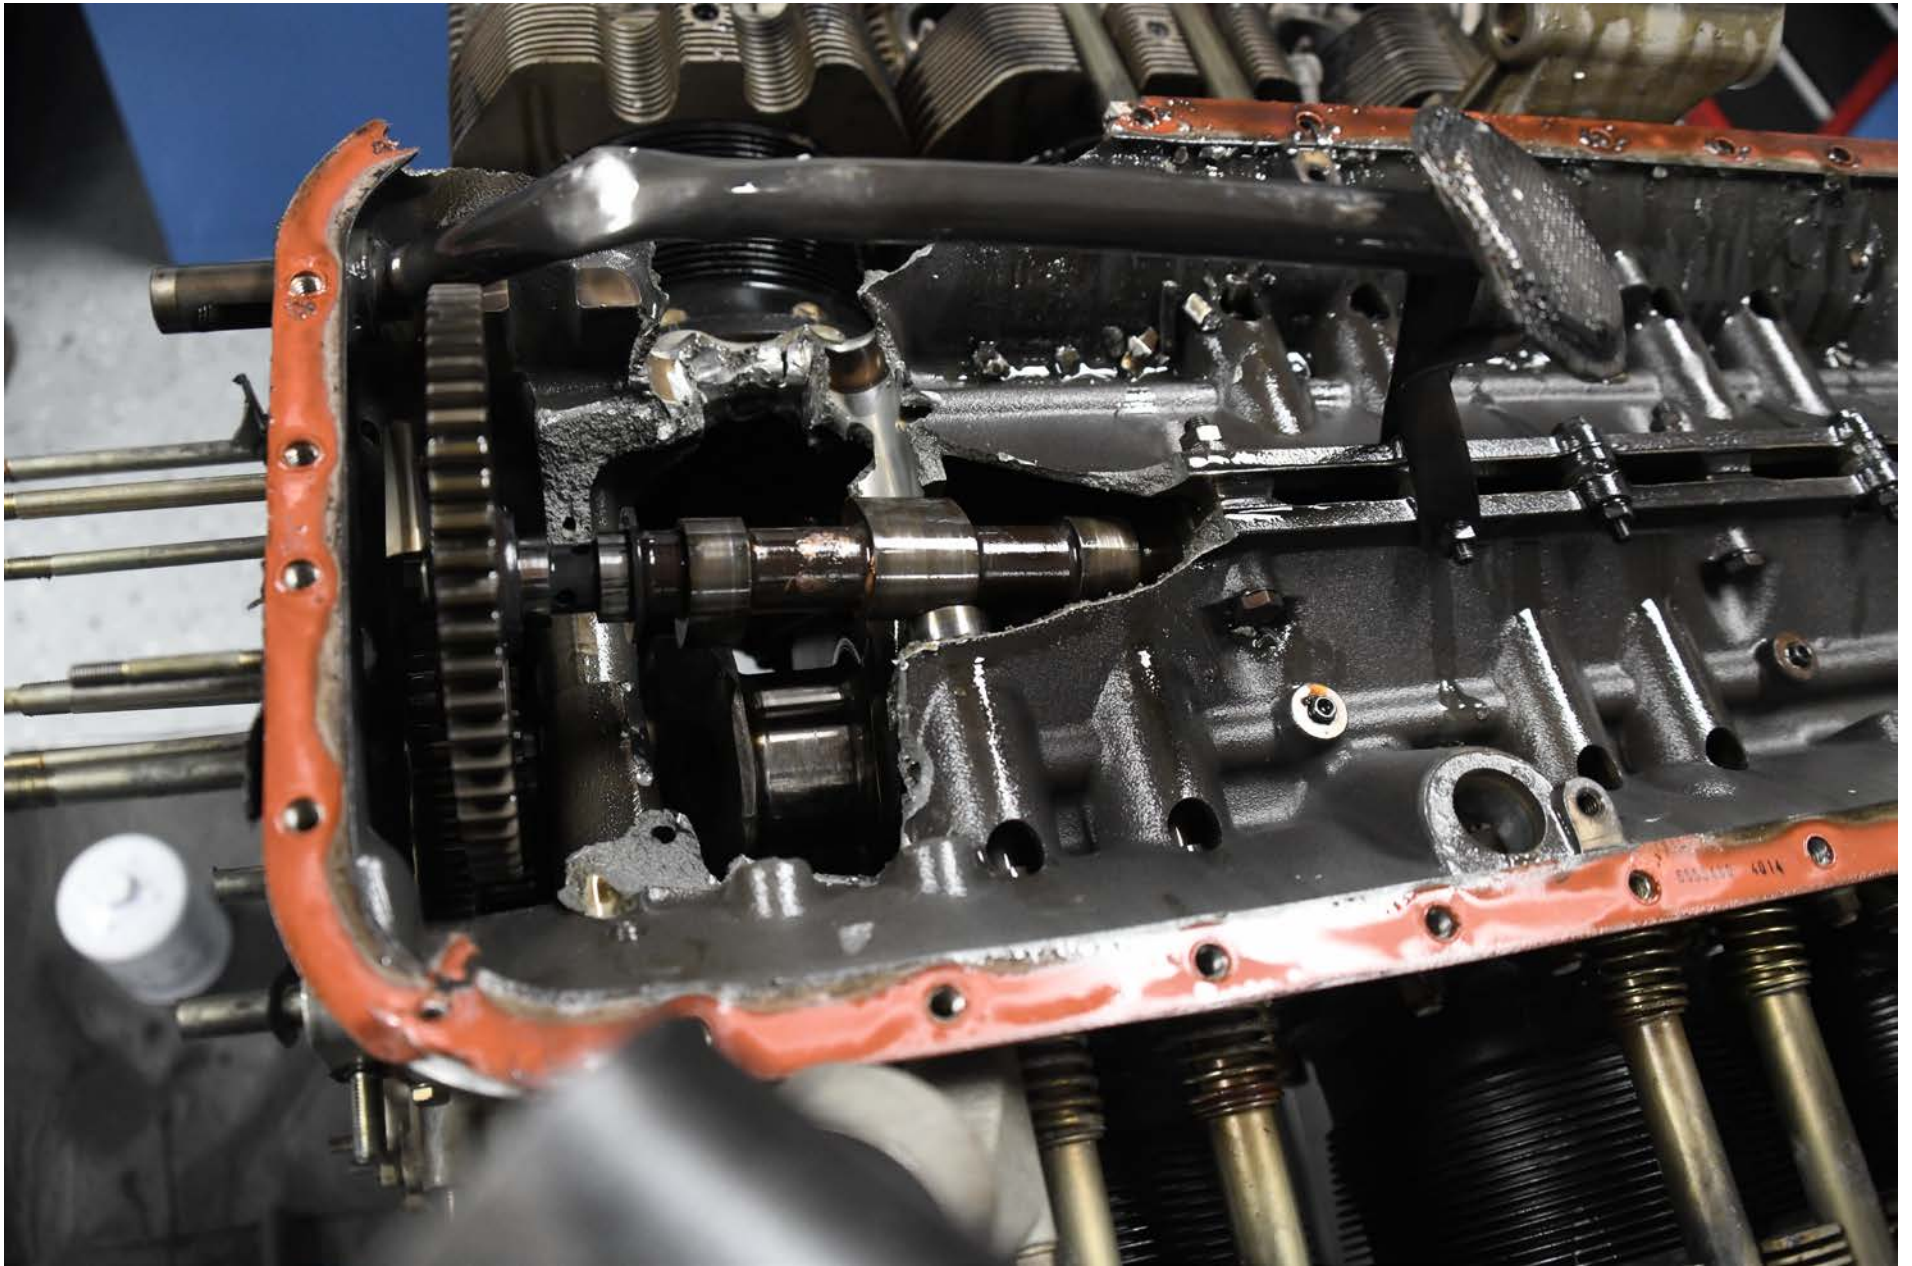
**Photo 13 - View of the crankcase area below the No. 1 and 2 cylinders. Sections of the crankcase structure there are displaced, and the camshaft is bent.**

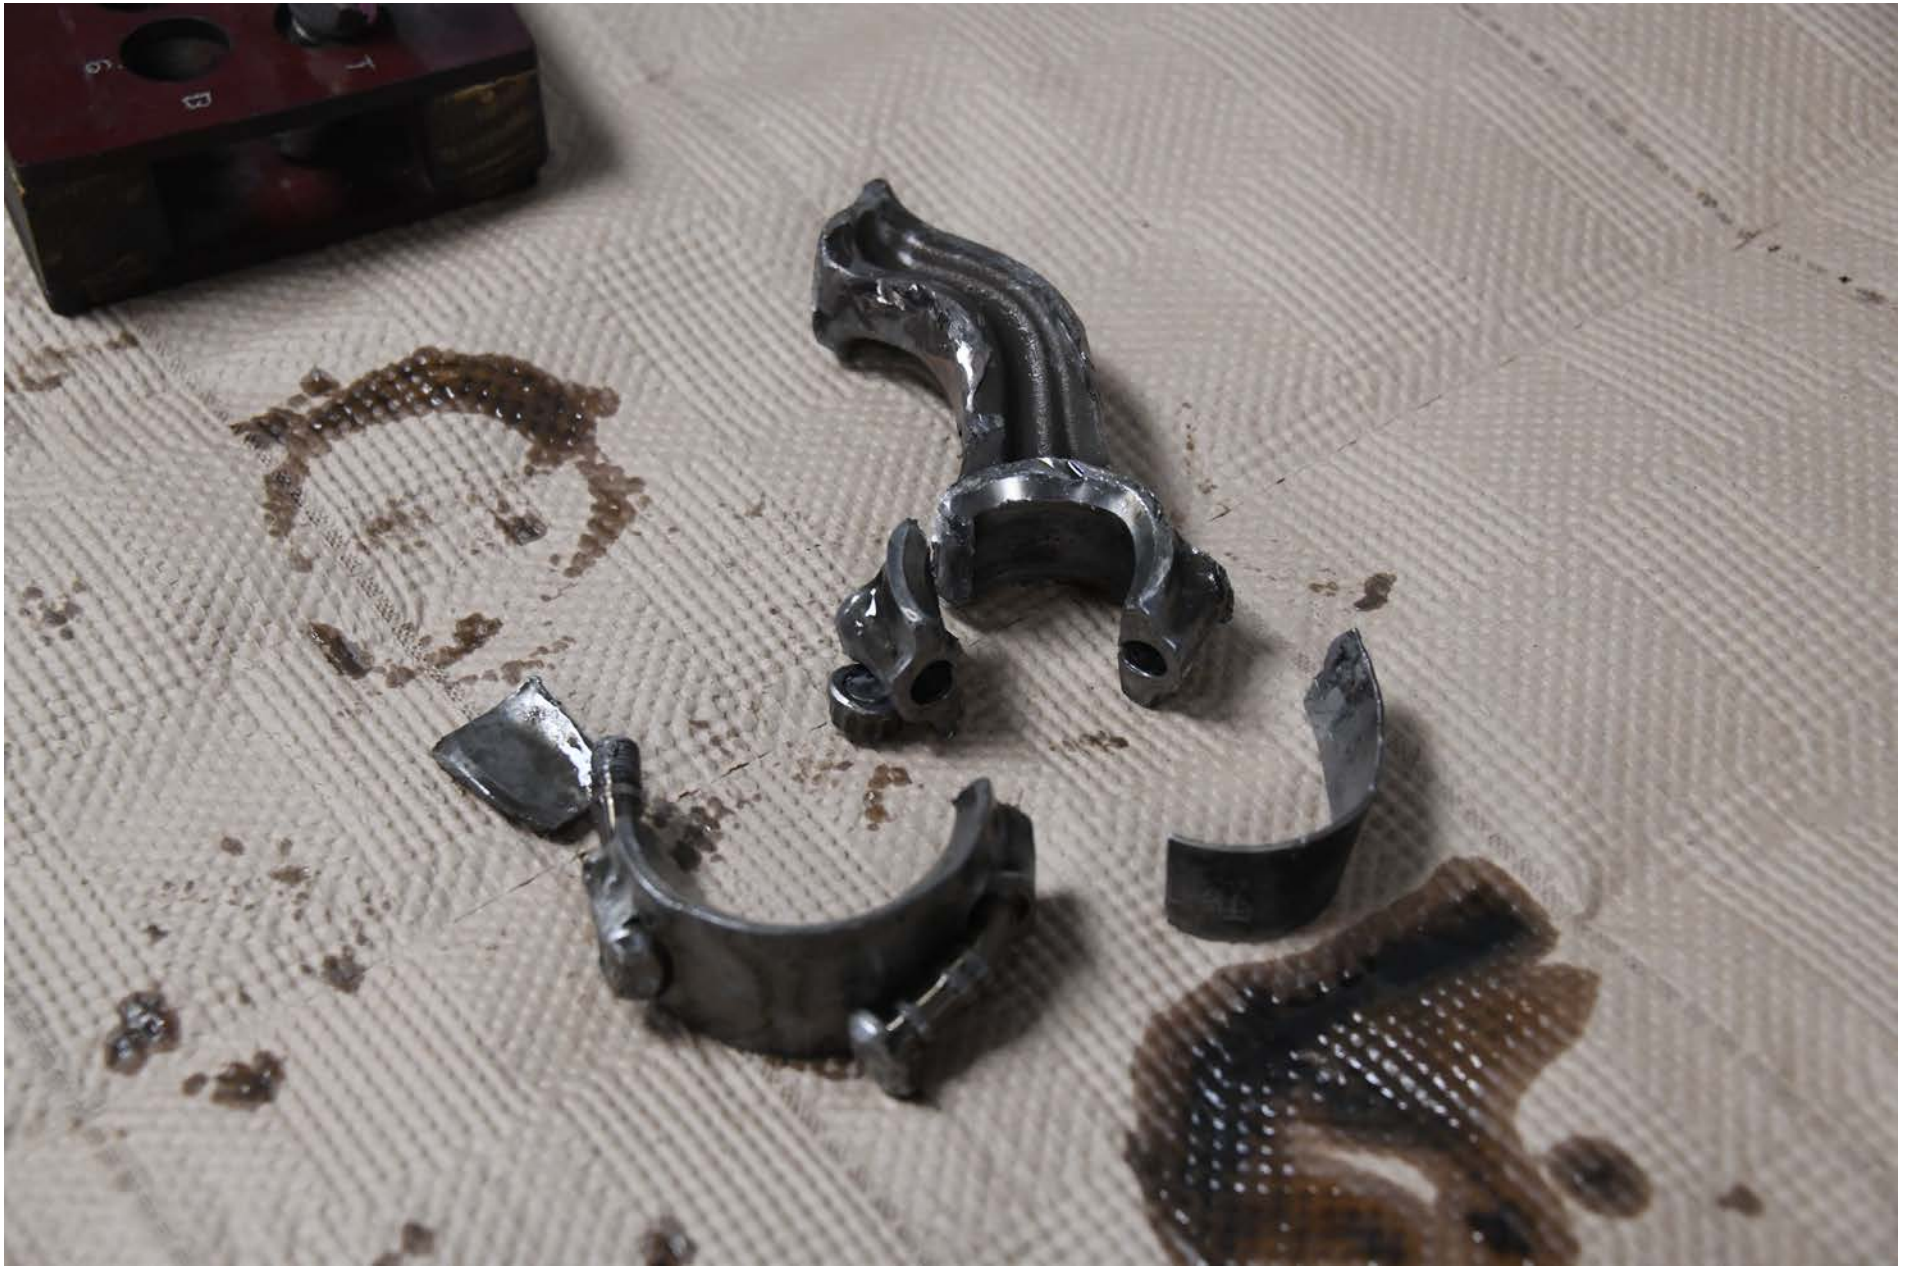
**Photo 14 - Close up view of the connecting rod from the No. 1 cylinder.**

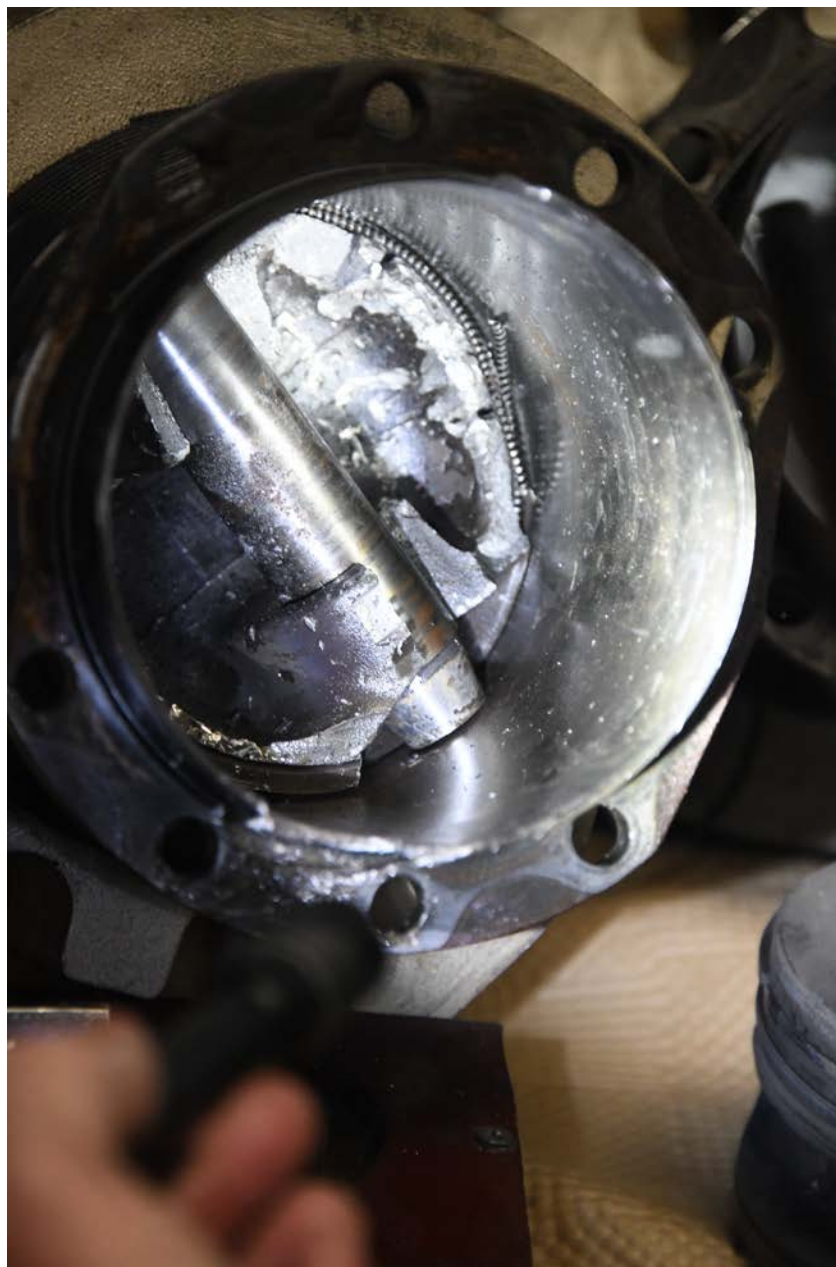
**Photo 15 - View of the piston inside the No. 1 cylinder.**

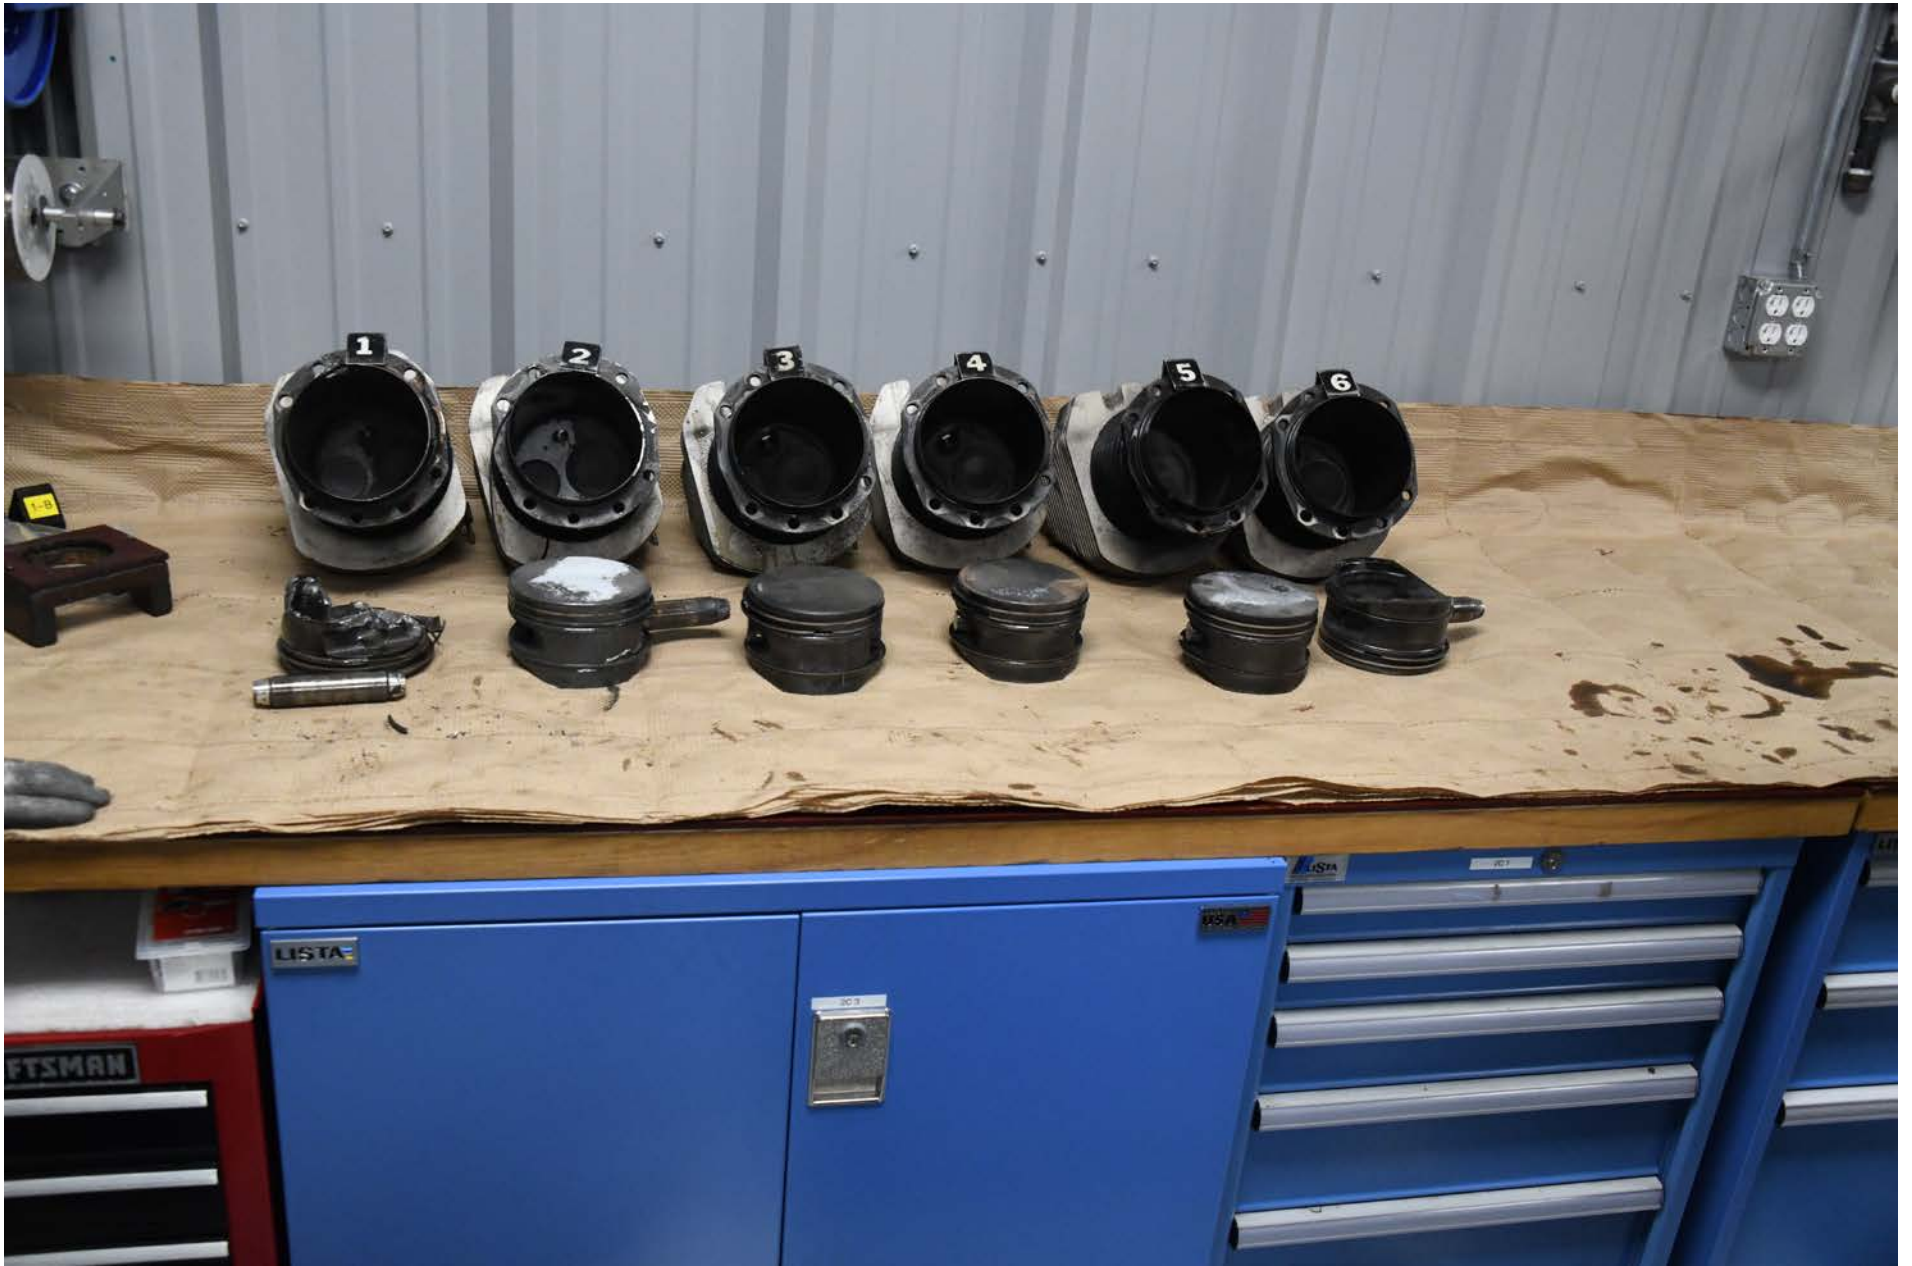
**Photo 16 - View of the removed cylinders.**

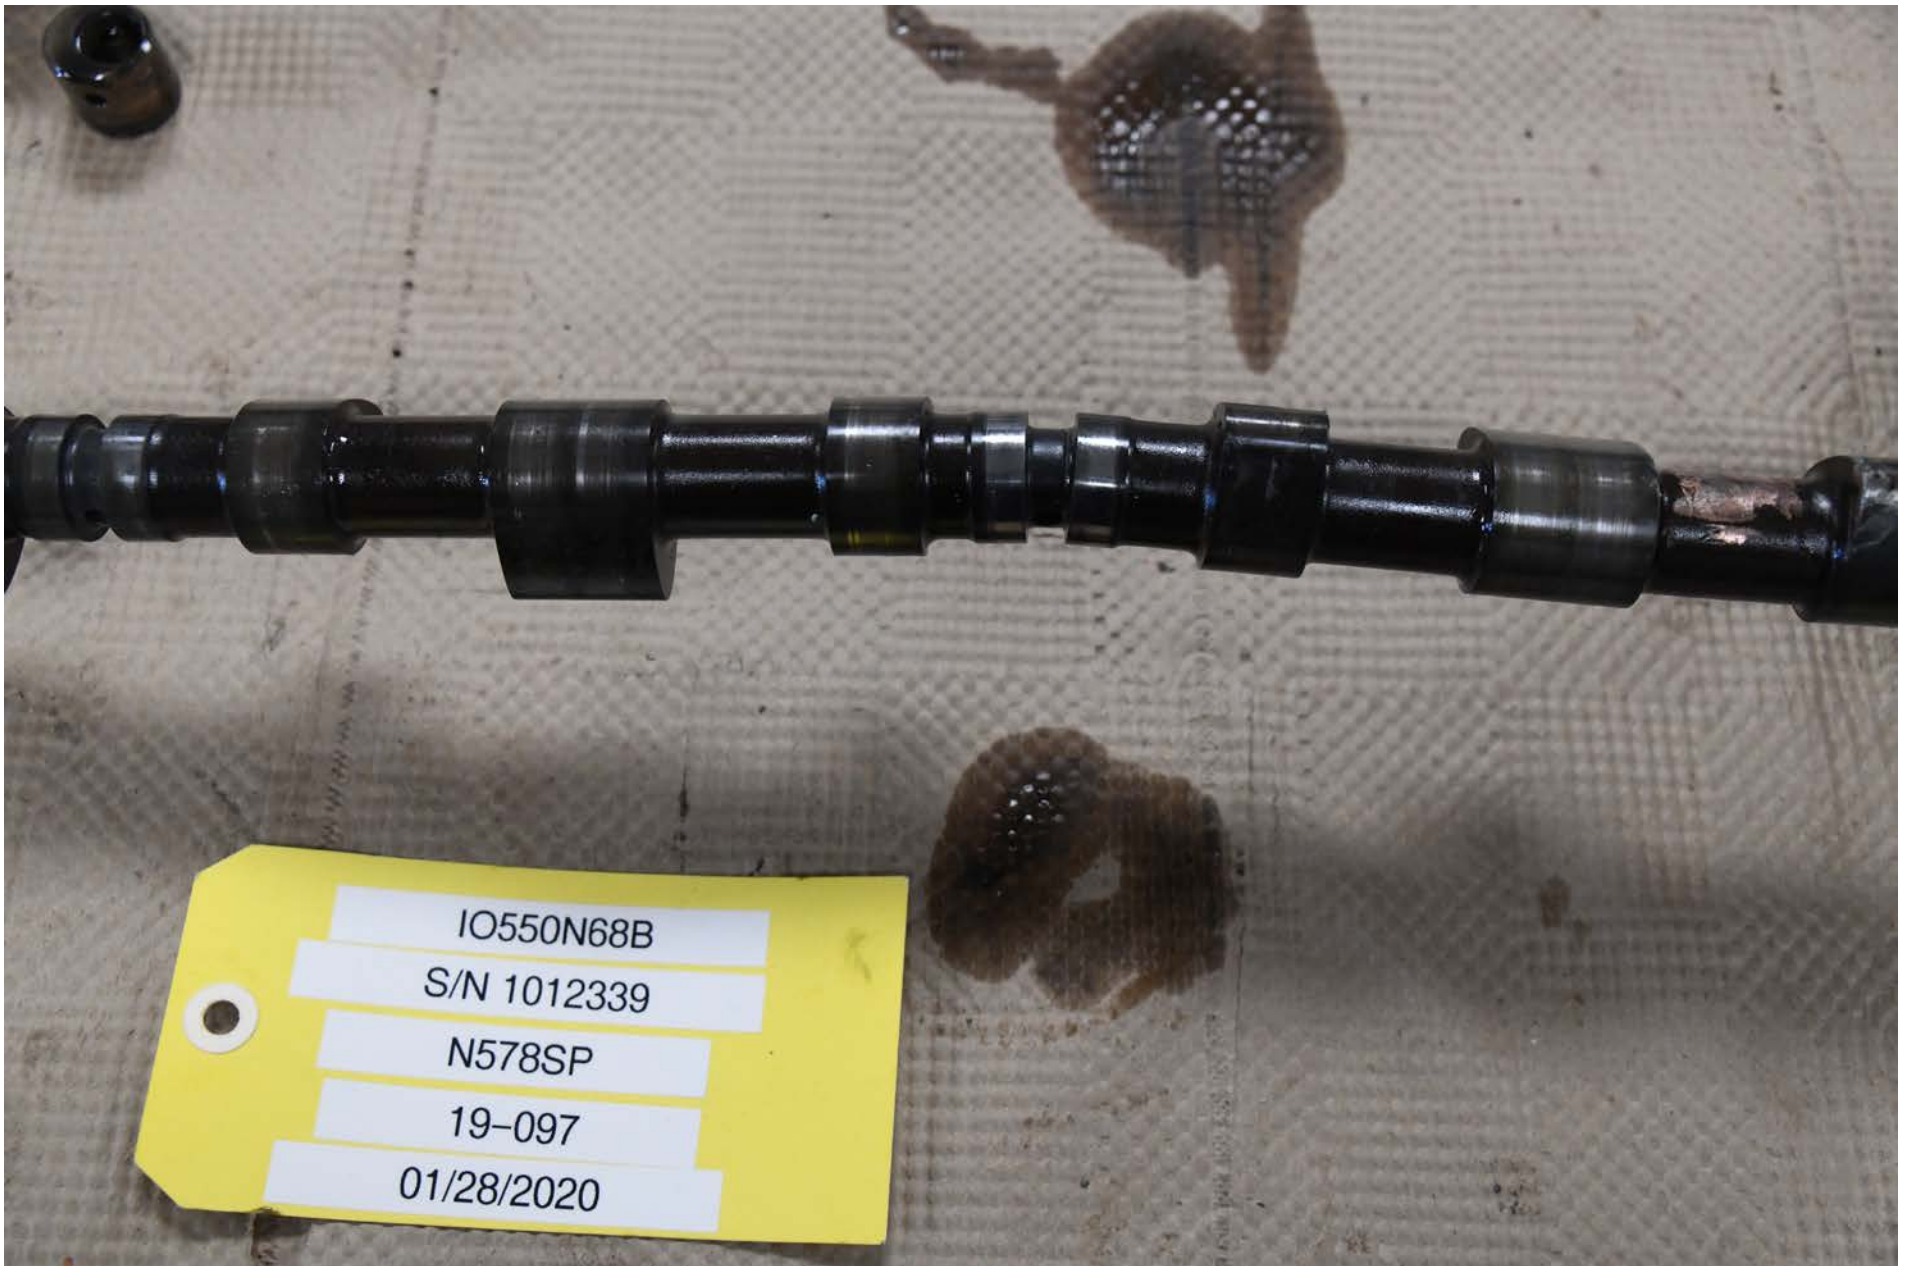
**Photo 17 - Close up view of the bent camshaft.**

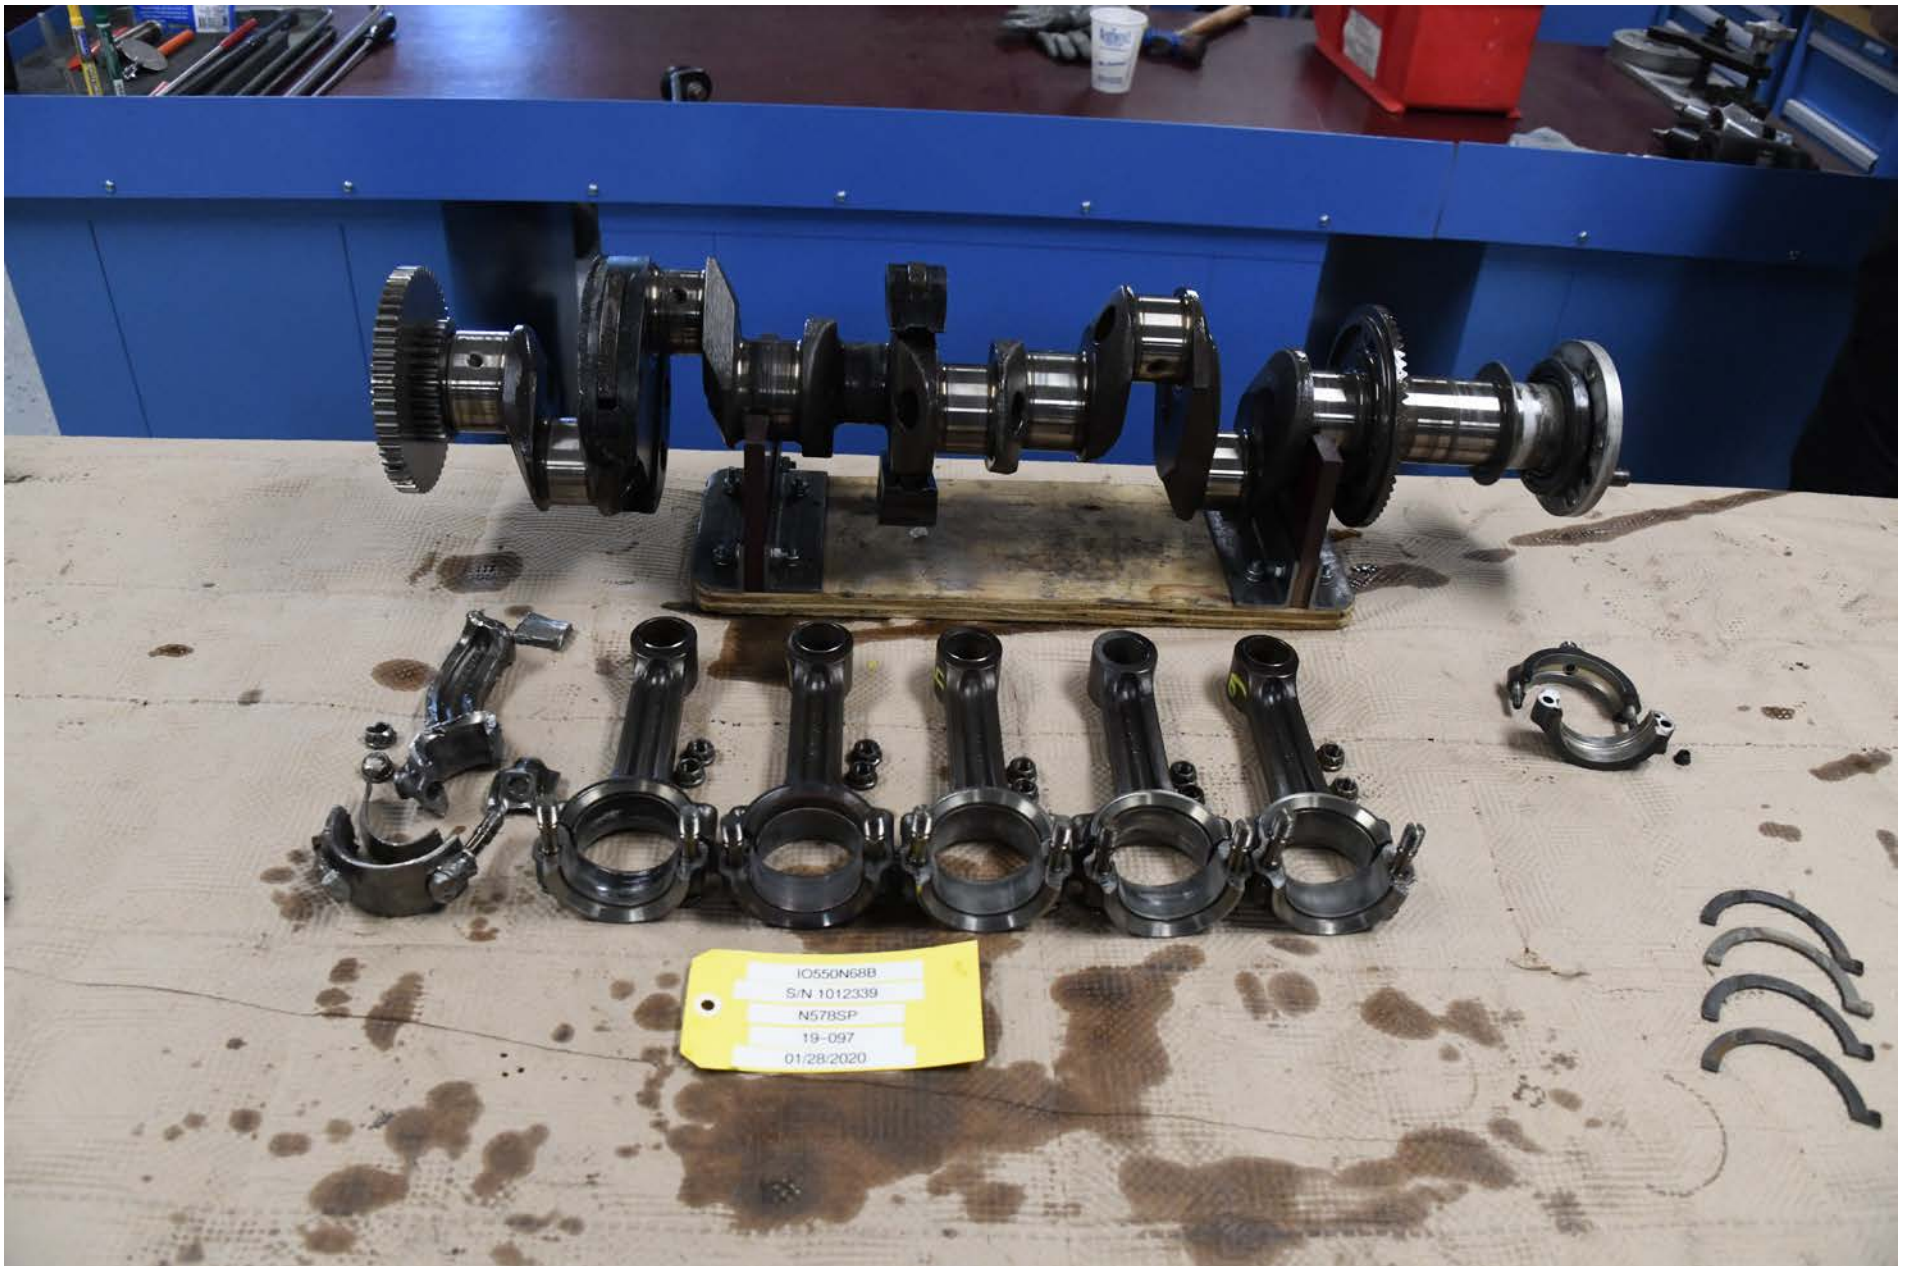
**Photo 18 - View of the removed crankshaft and connecting rods.**

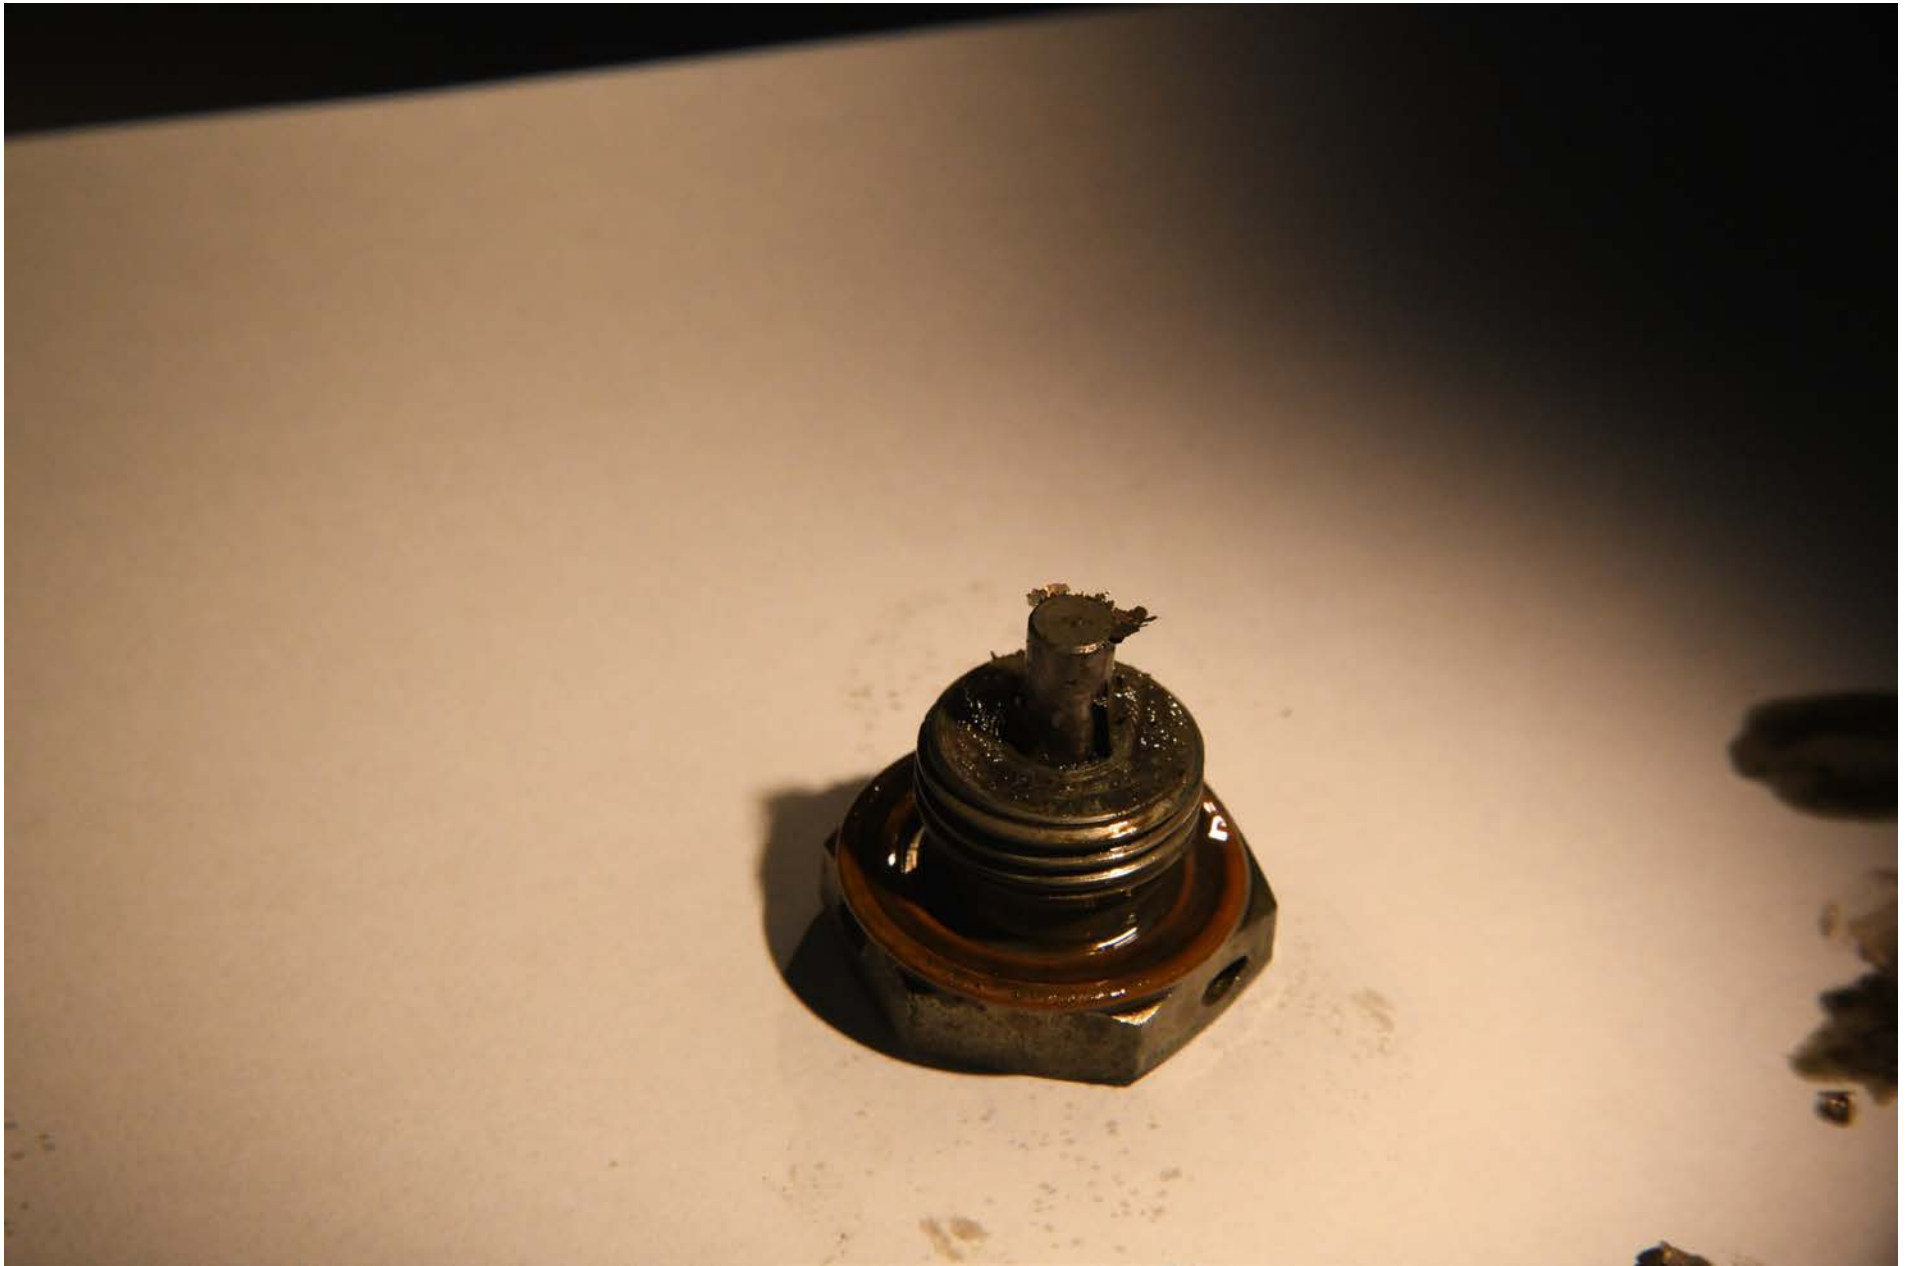
**Photo 19 - Close up view of the magnetic plug from the oil sump pan.**

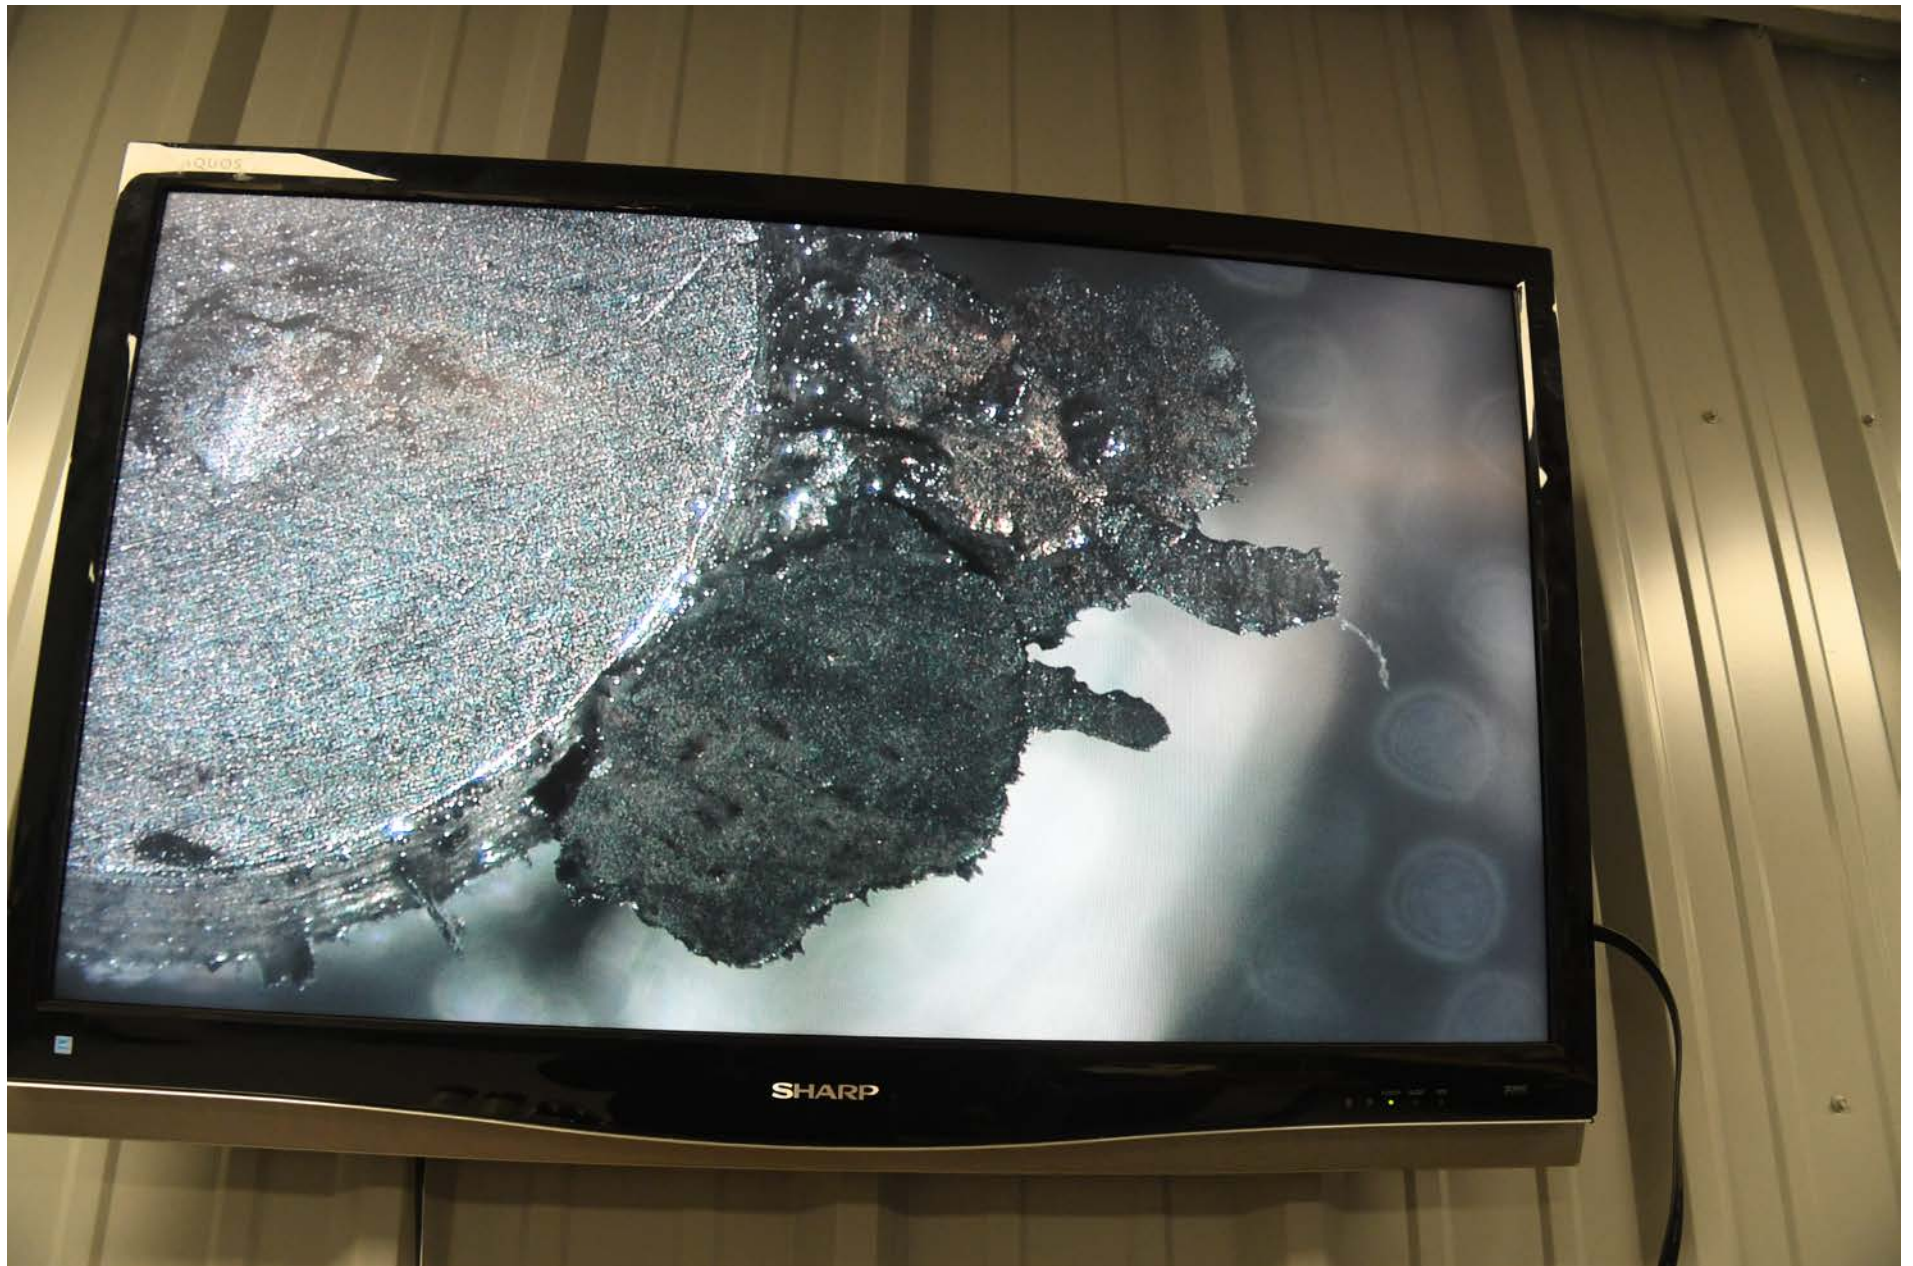
**Photo 20 - Magnified view of particles attached to the magnetic plug from the oil sump pan.**
