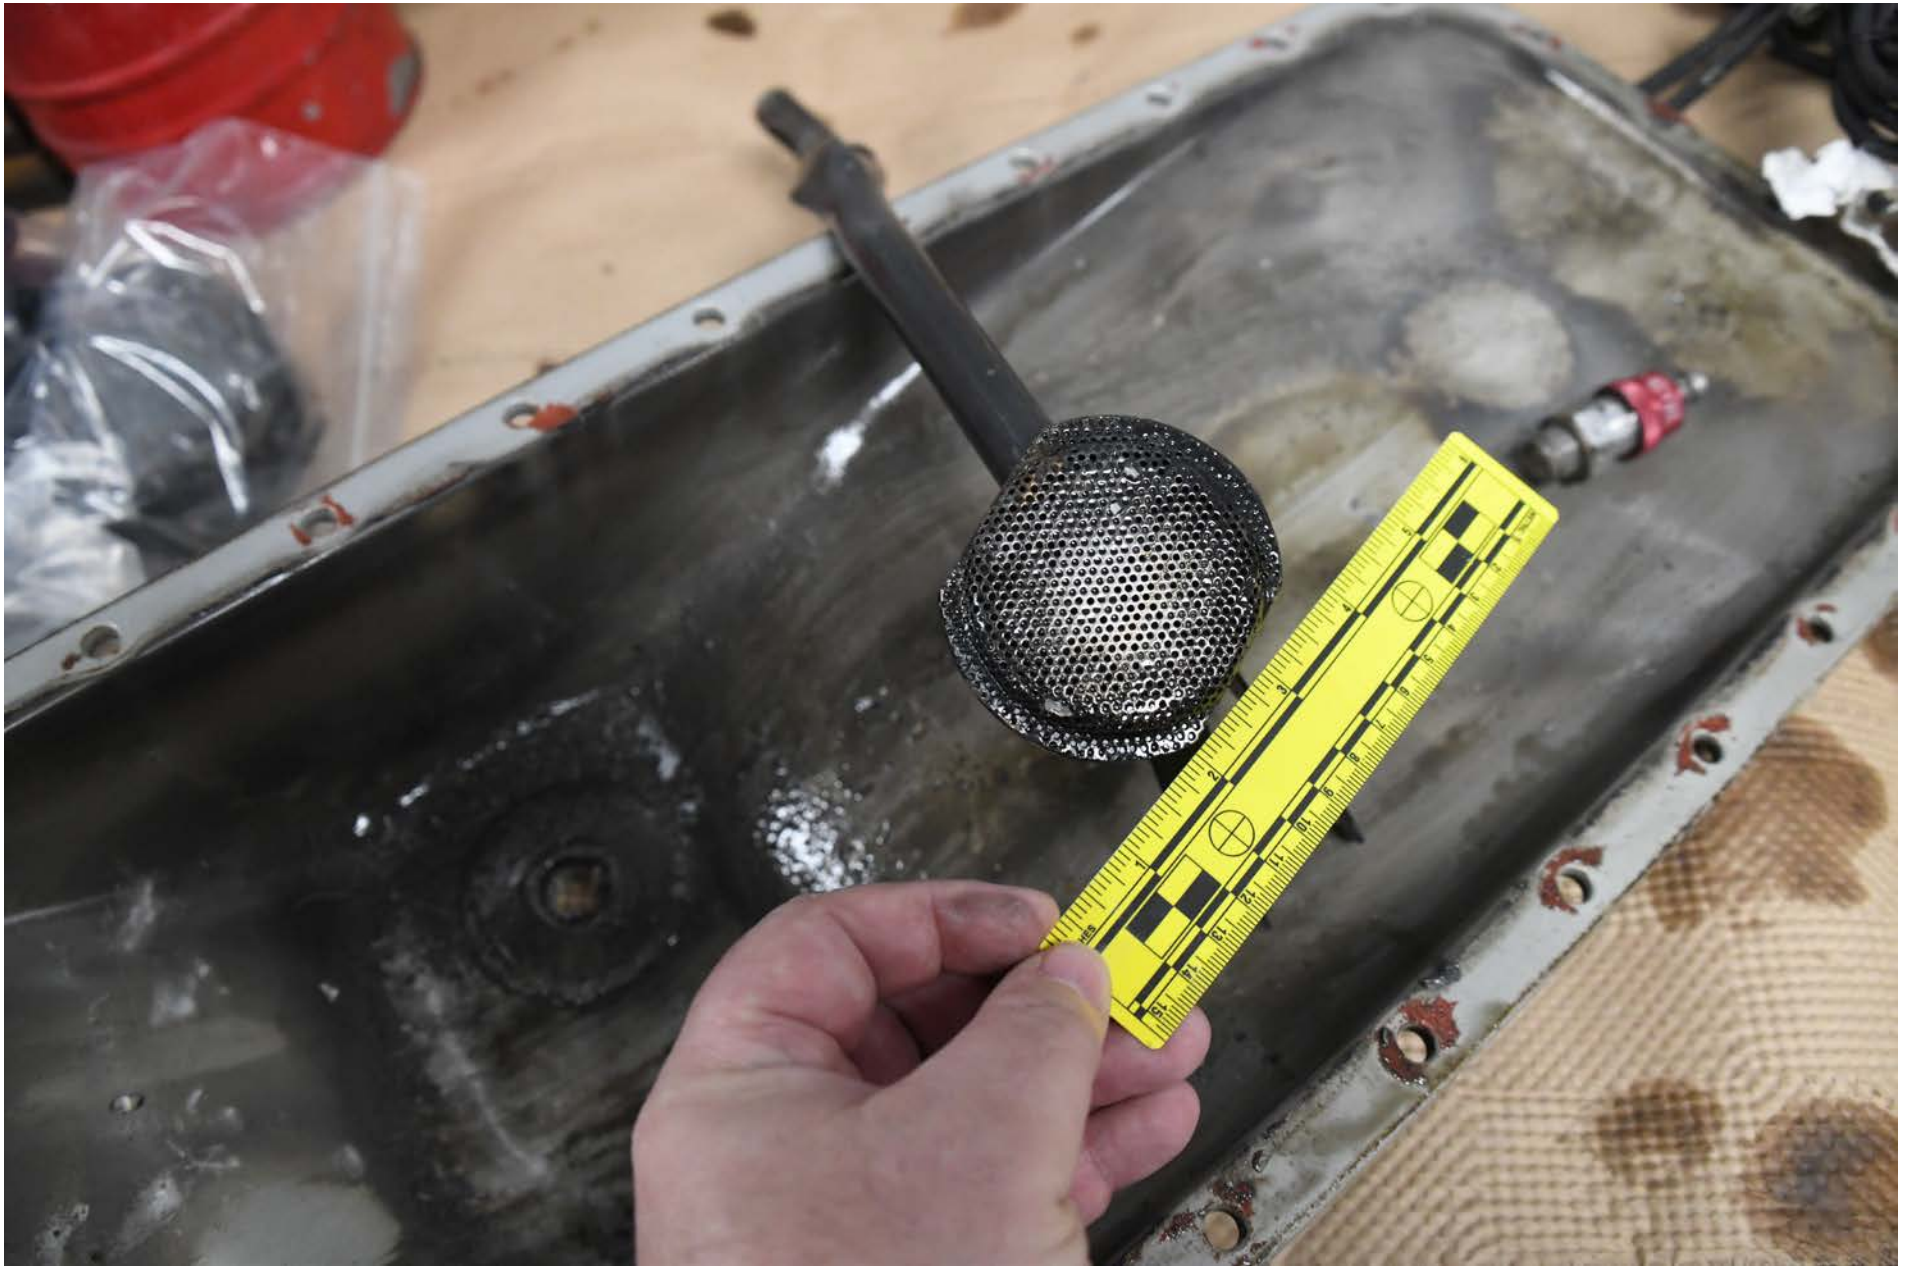
**Photo 21 – View of the pickup tube from the oil sump area.**

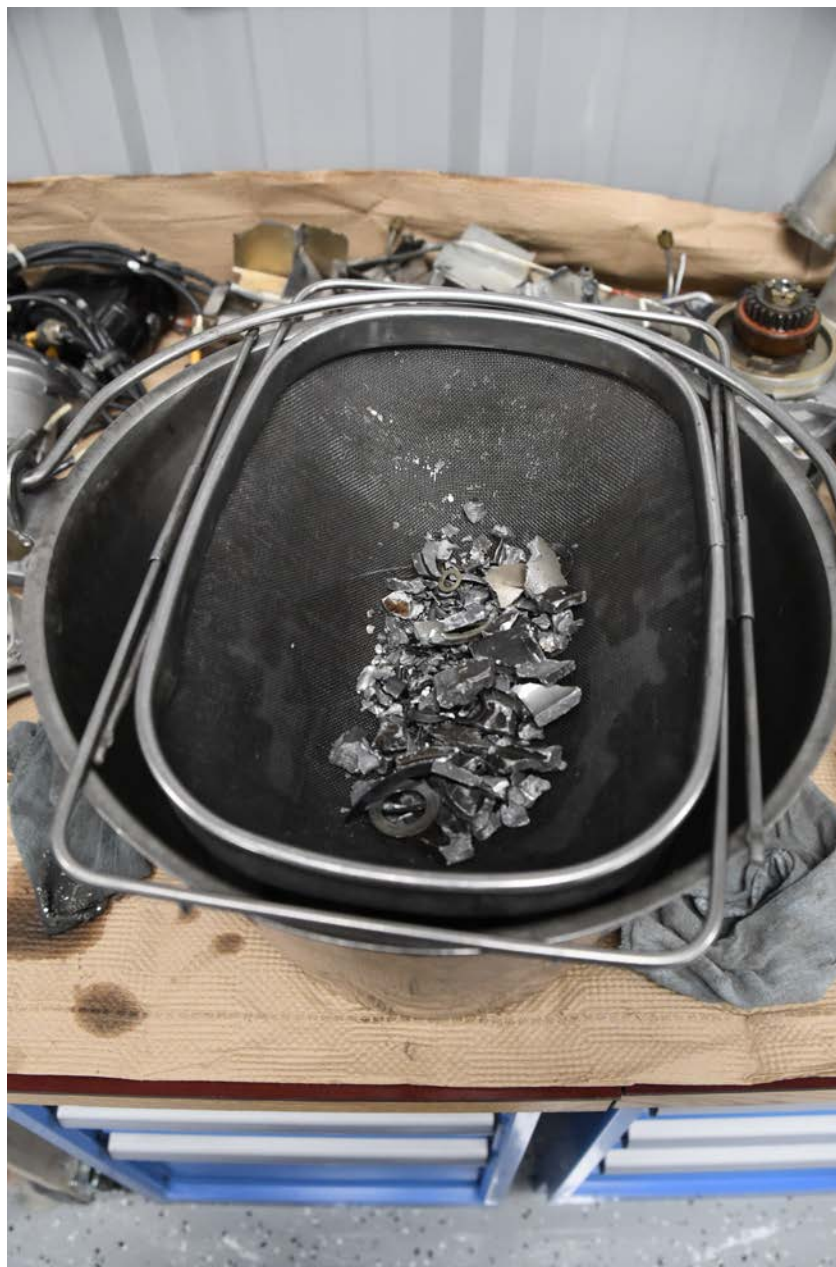
**Photo 22 - View of media from the oil sump pan.**

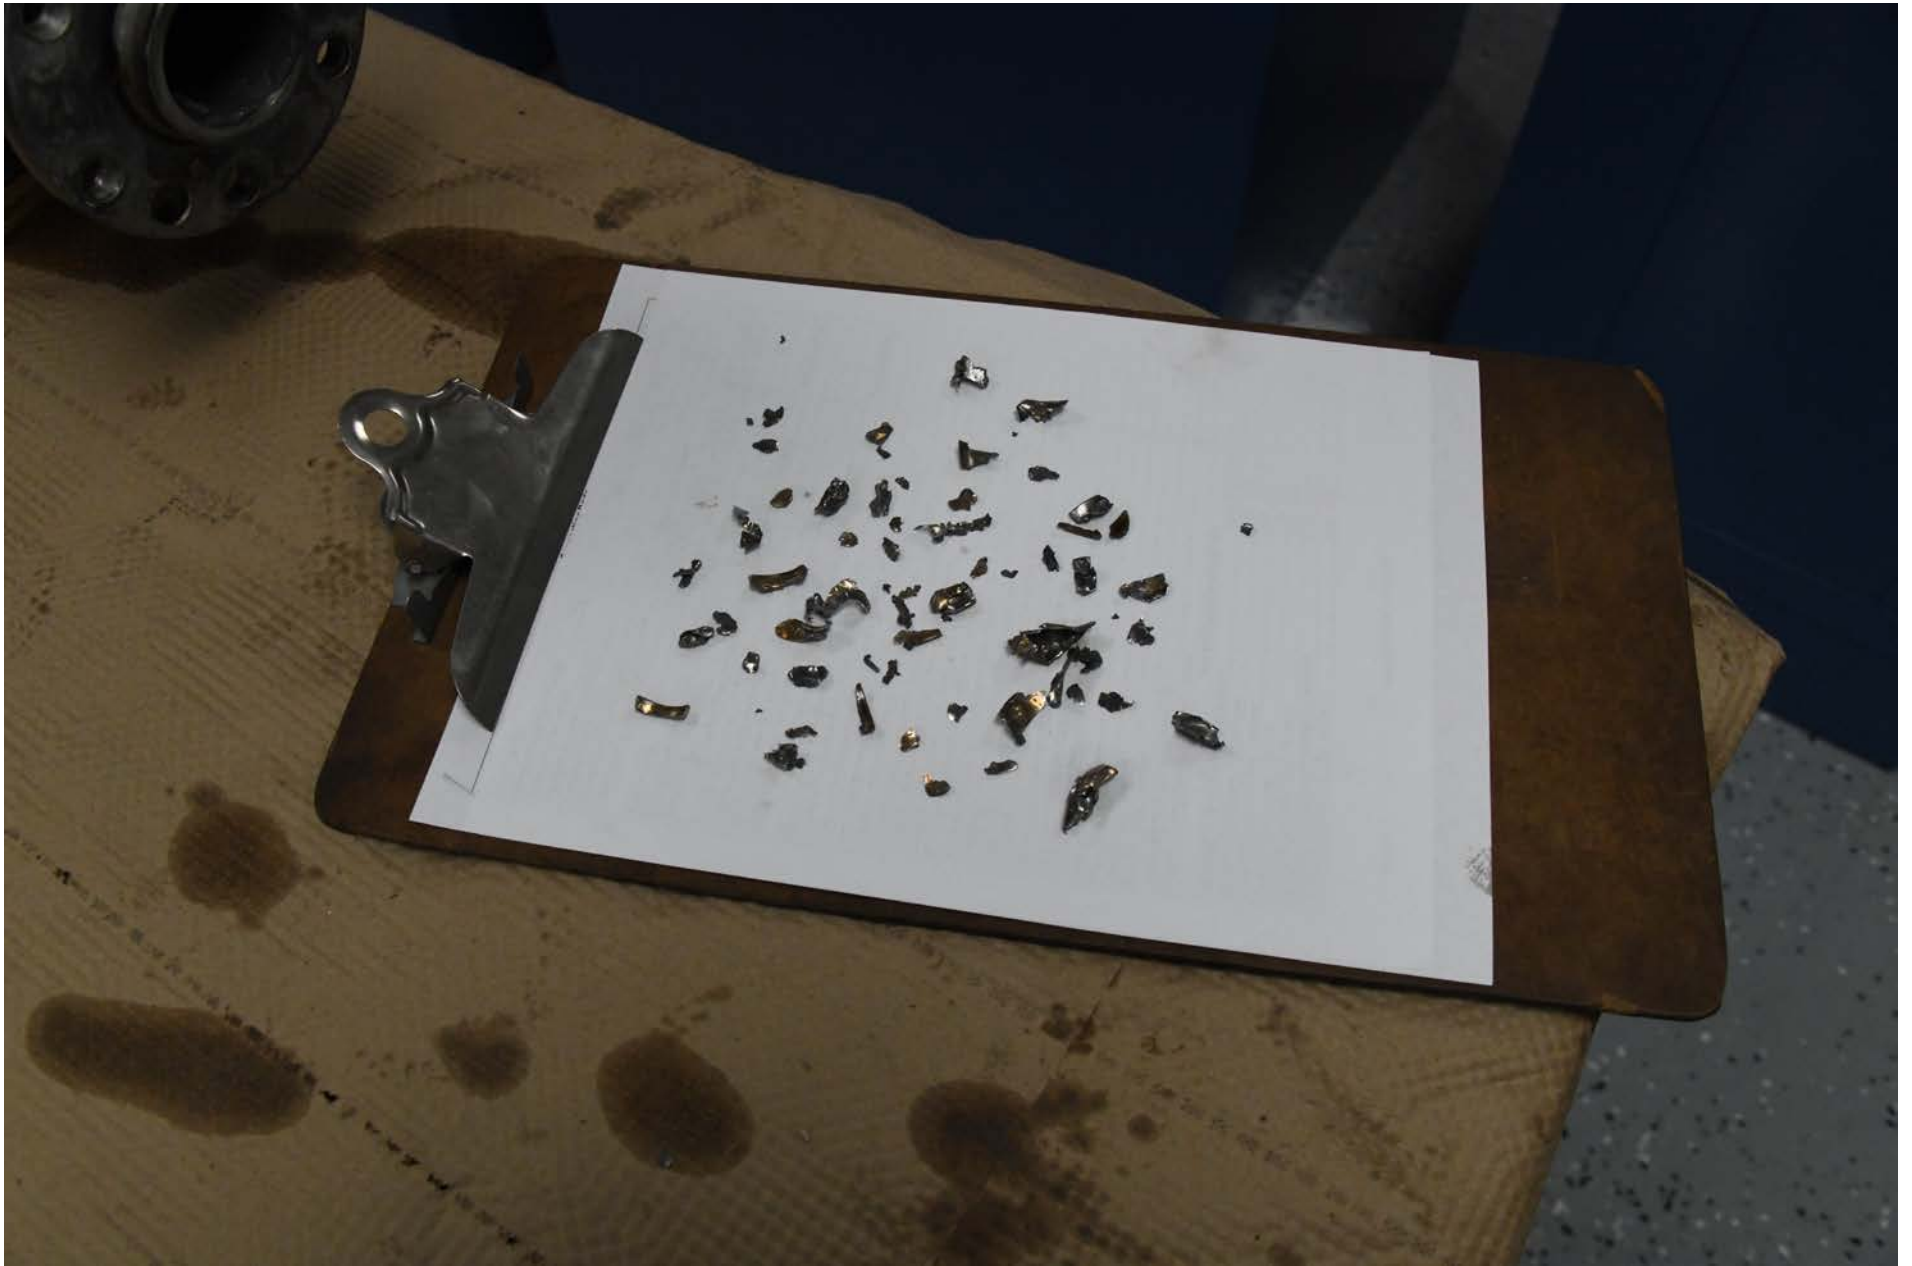
**Photo 23 - View of media removed from the sump pan using a magnet.**

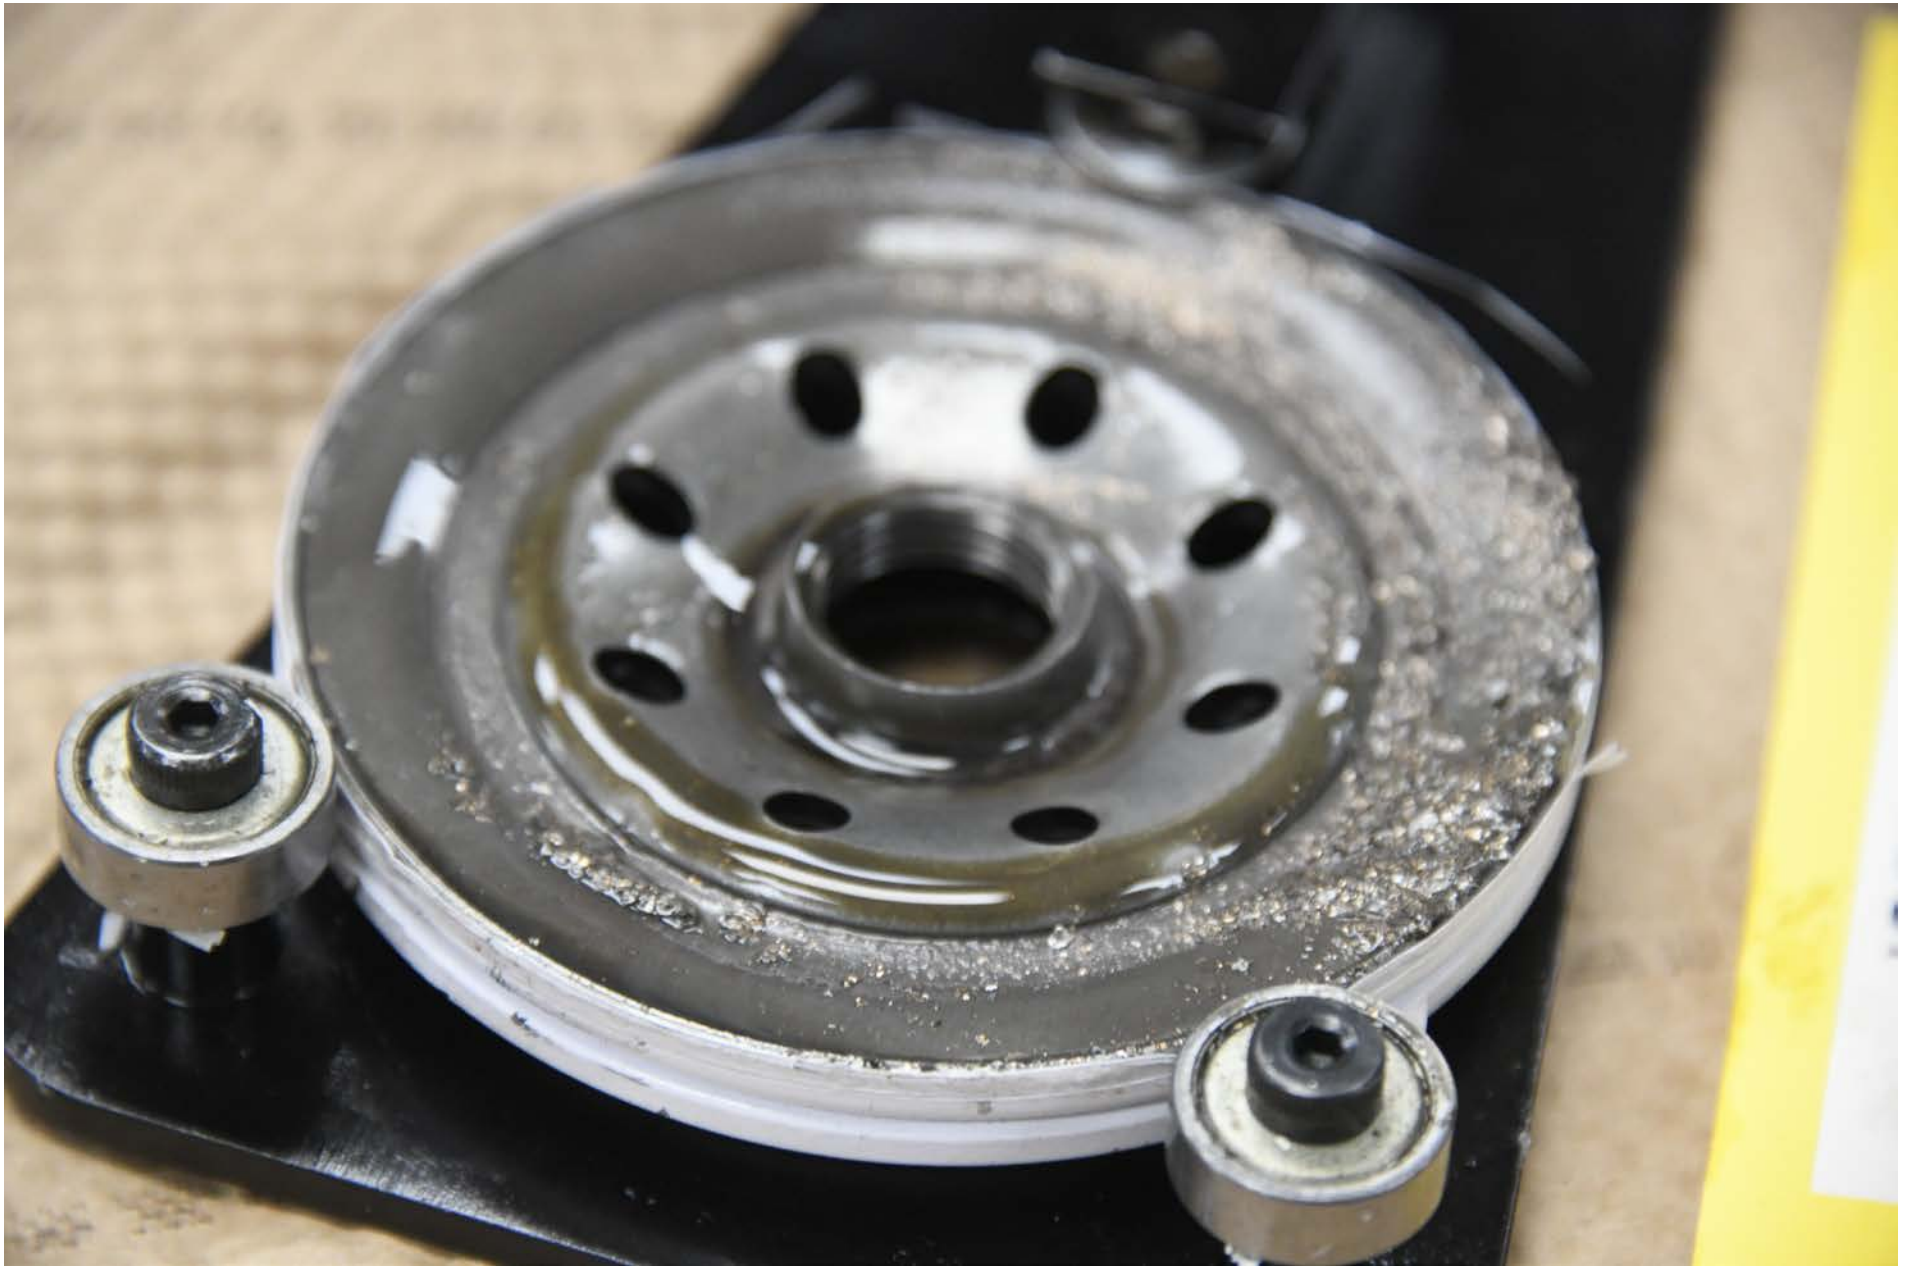
**Photo 24 - View of the cut open oil filter. Particles are observed on the internal side of the filter base.**

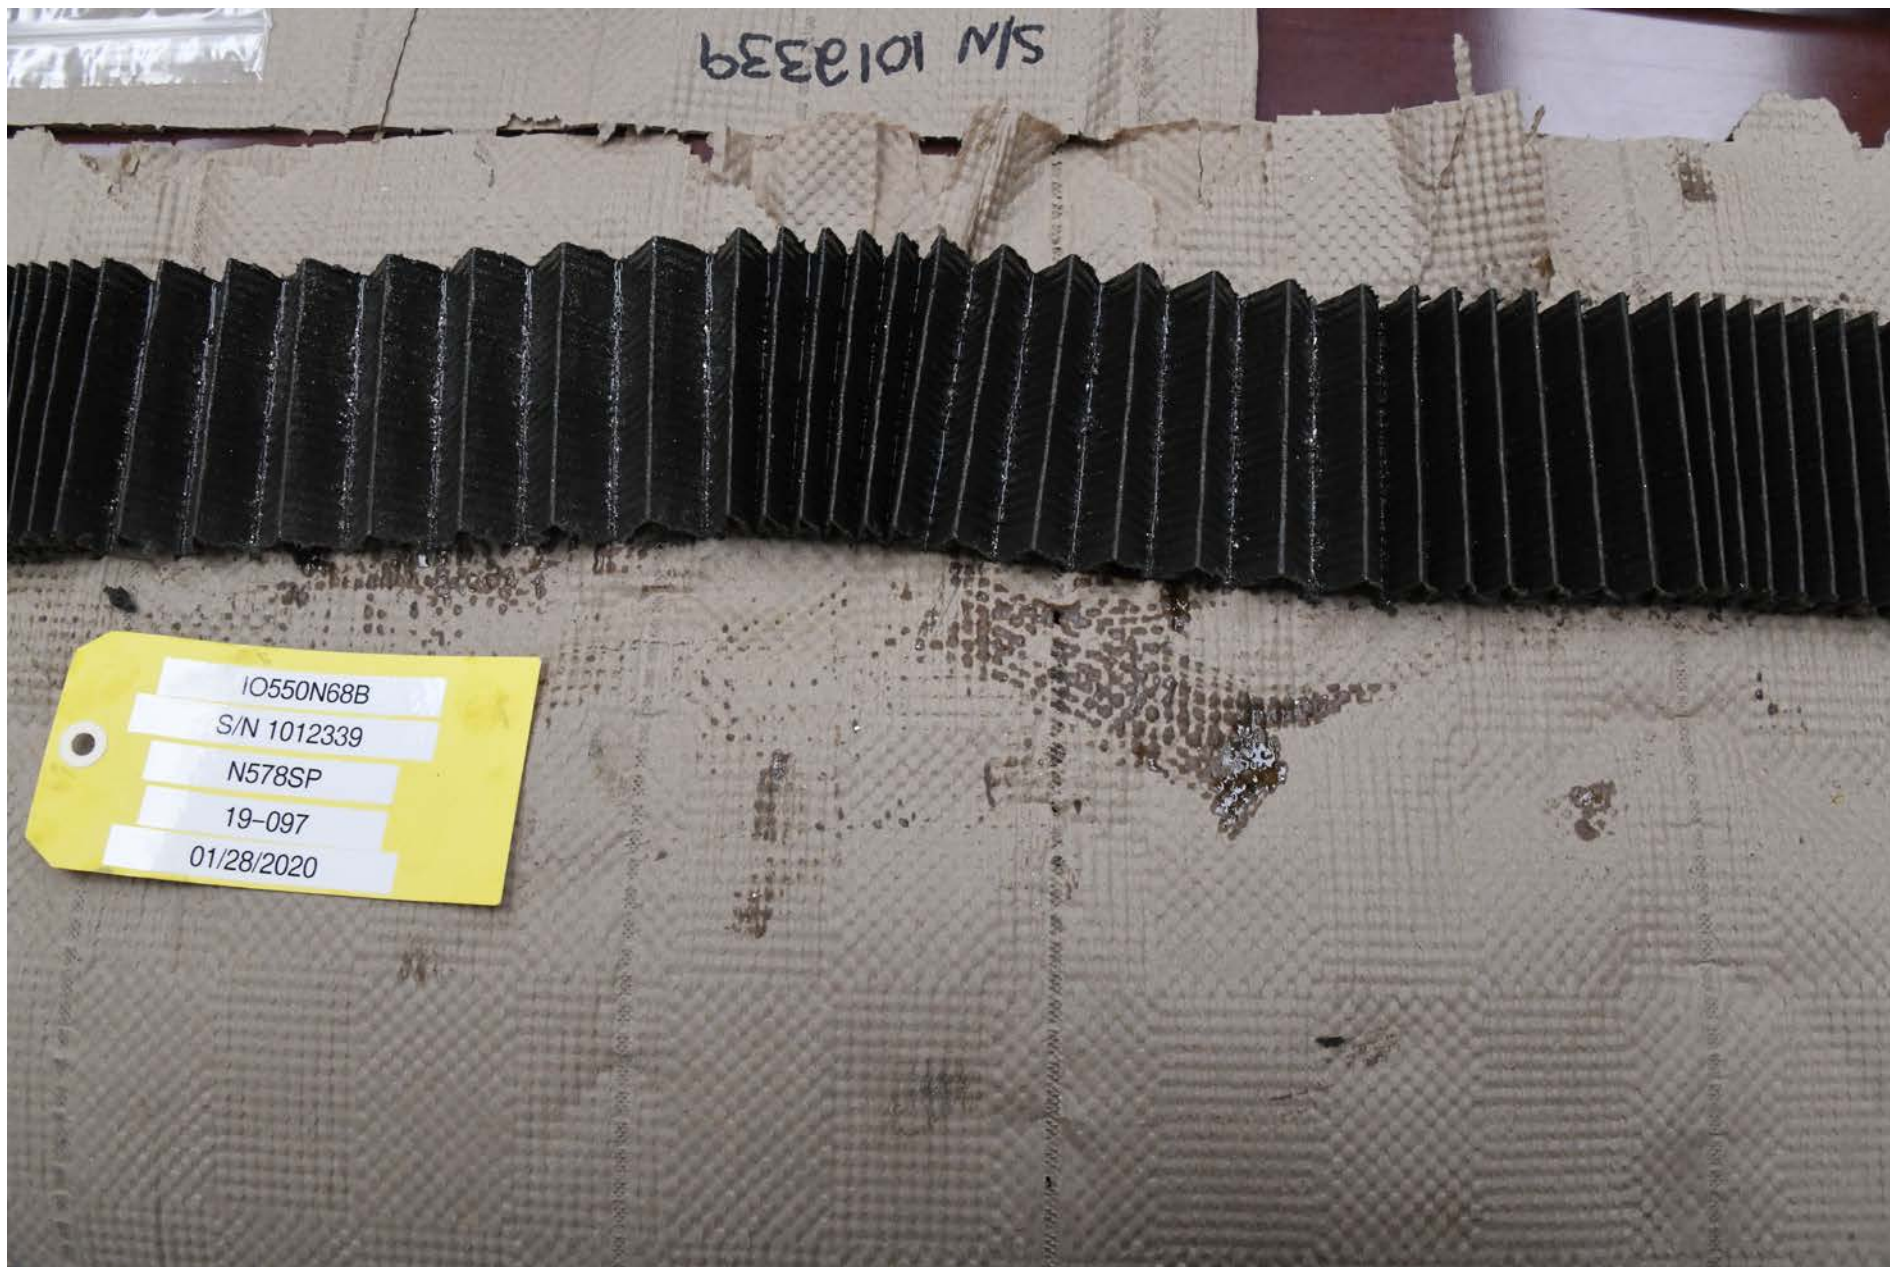
**Photo 25 - View of the removed filter element from the oil filter. Particles are observed on the pleats within the element.**

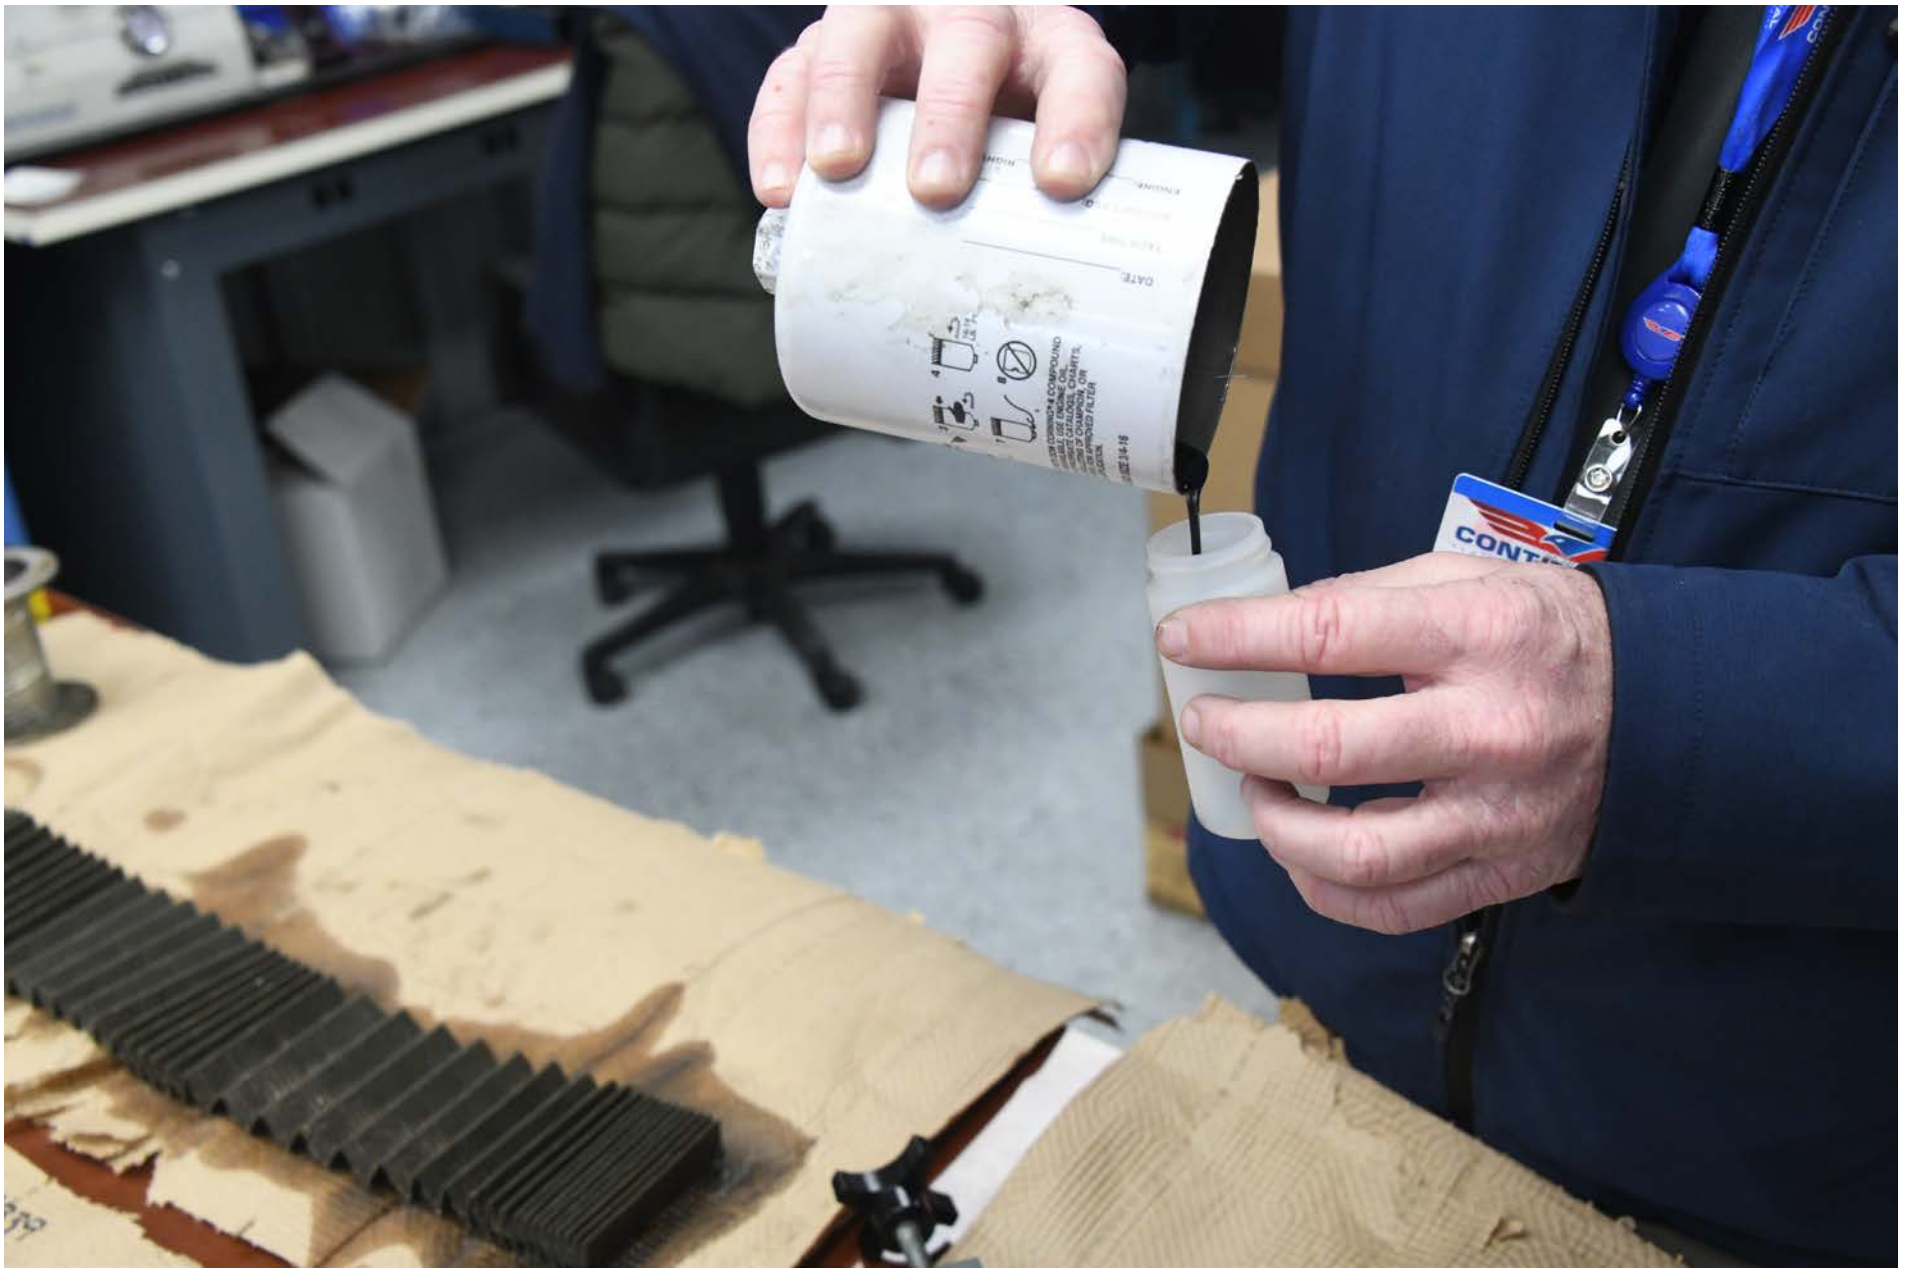
**Photo 26 - View of the oil filter contents being poured into a sample container.**

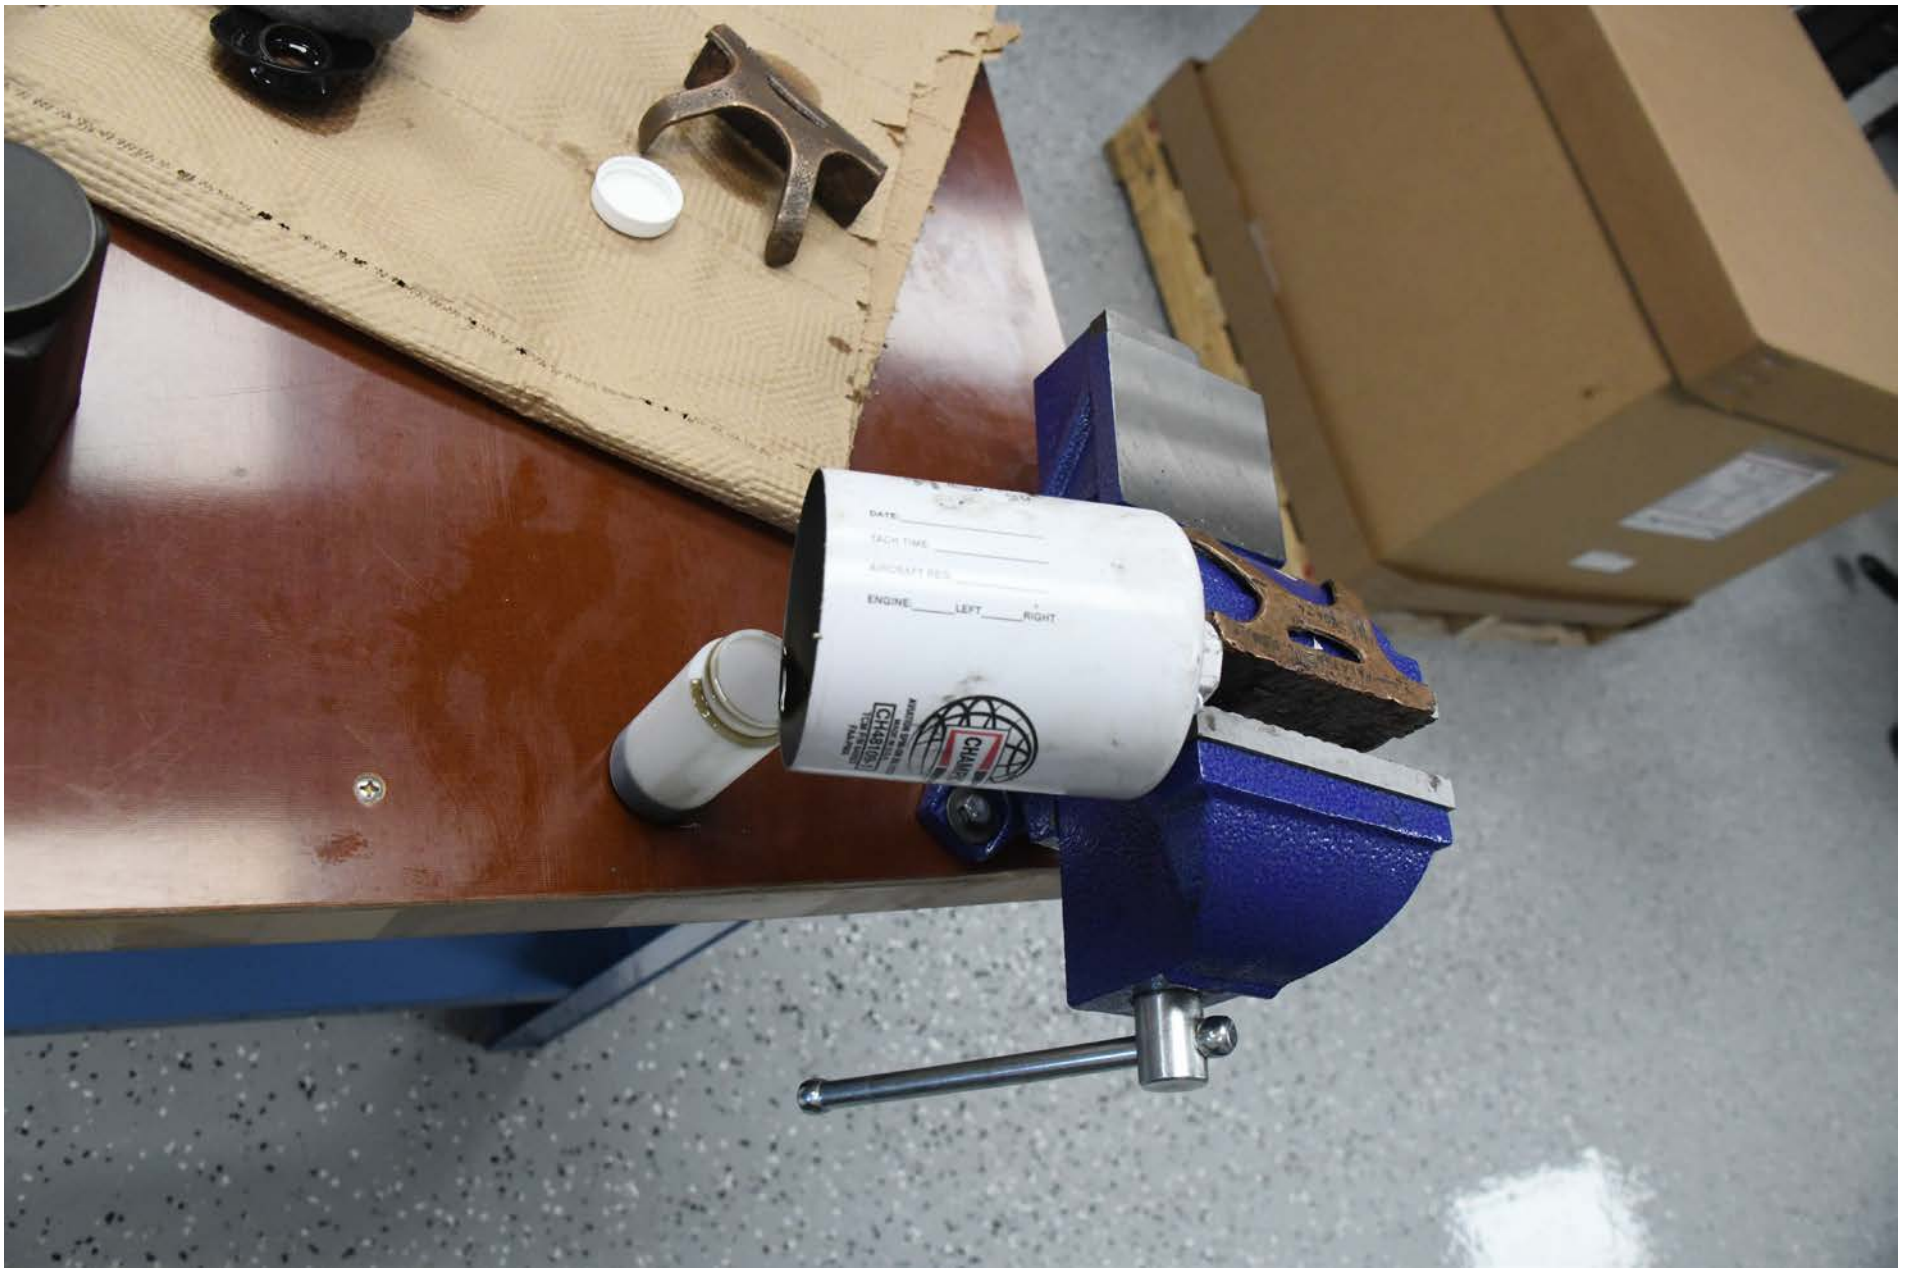
**Photo 27 - View of the contents of the oil filter being drained in to the sample container.**

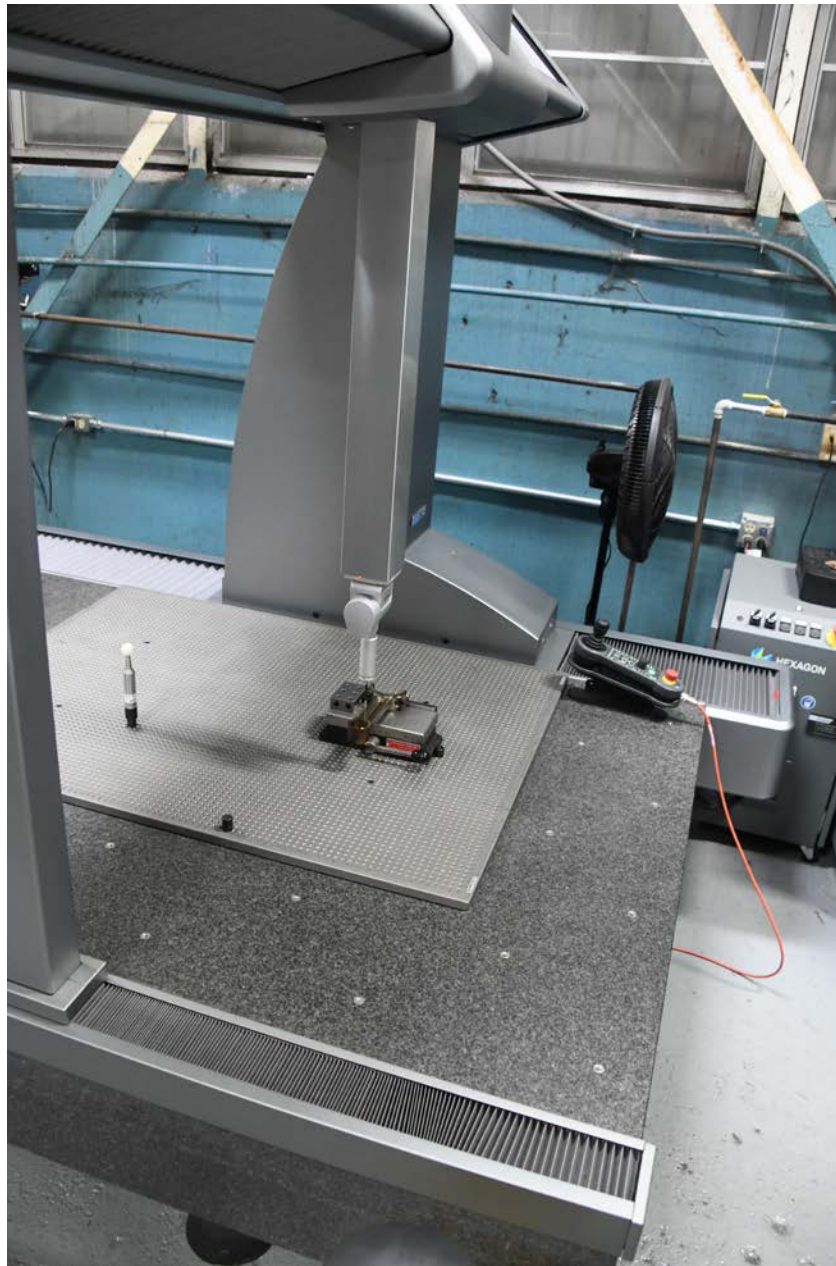
**Photo 28 - View of a connecting rod being measured.**

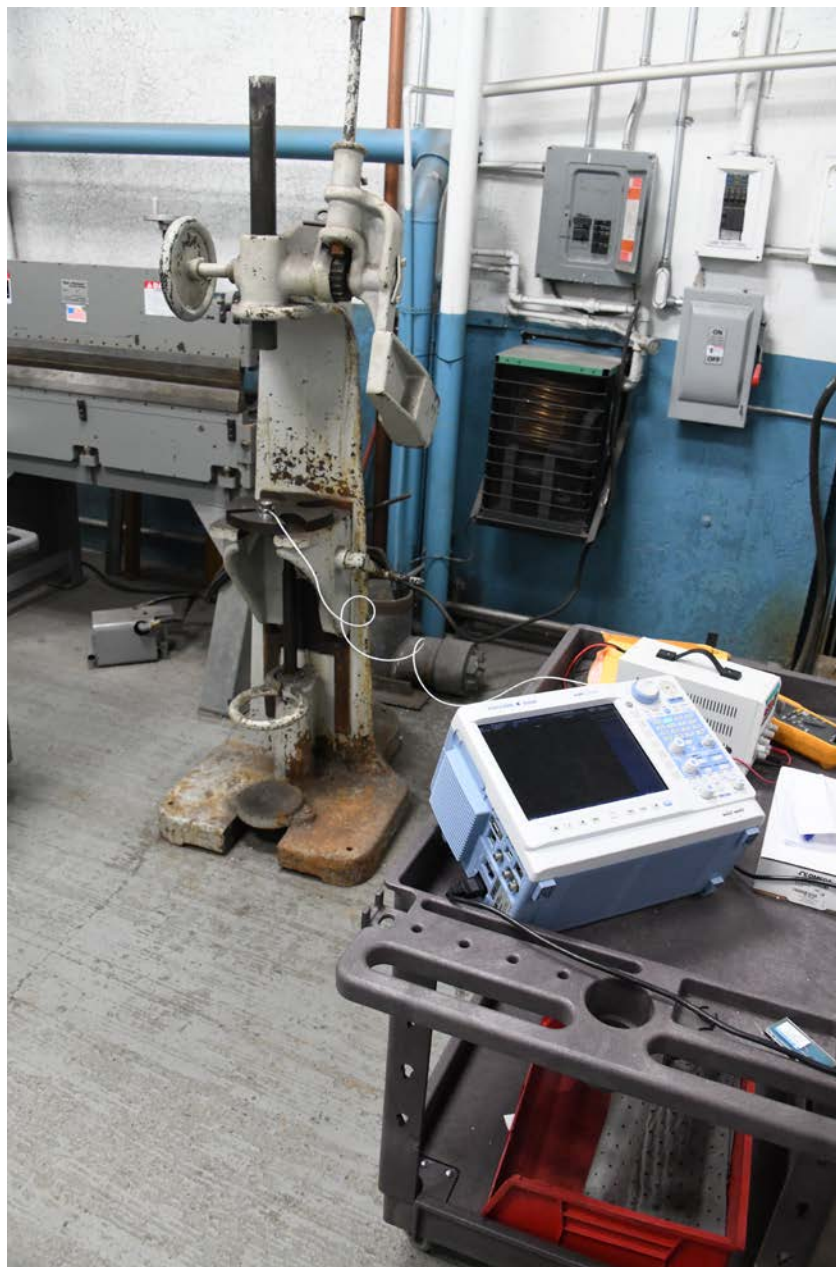
**Photo 29 - View of a setup to measure the pressure required to displace connecting rod bushings.**

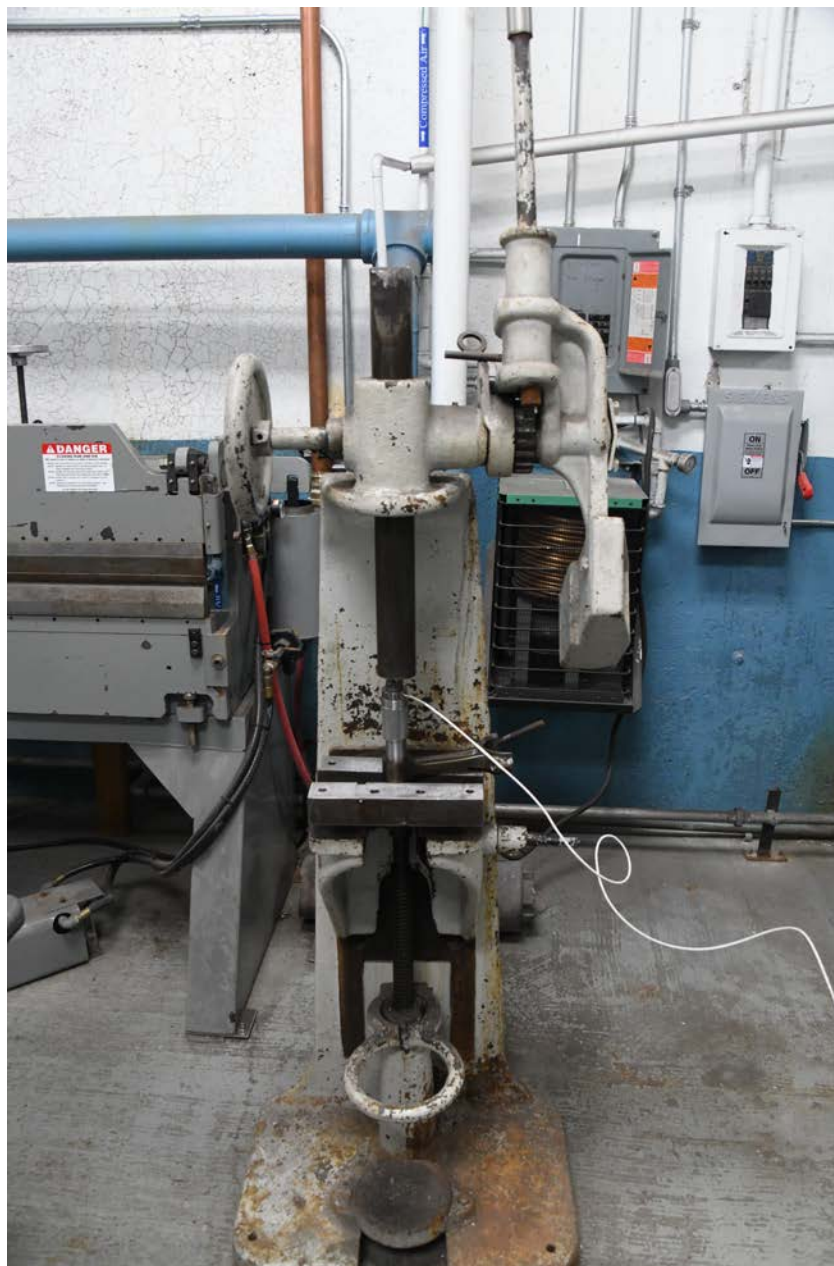
**Photo 30 - View of a setup to measure the pressure required to displace connecting rod bushings.**

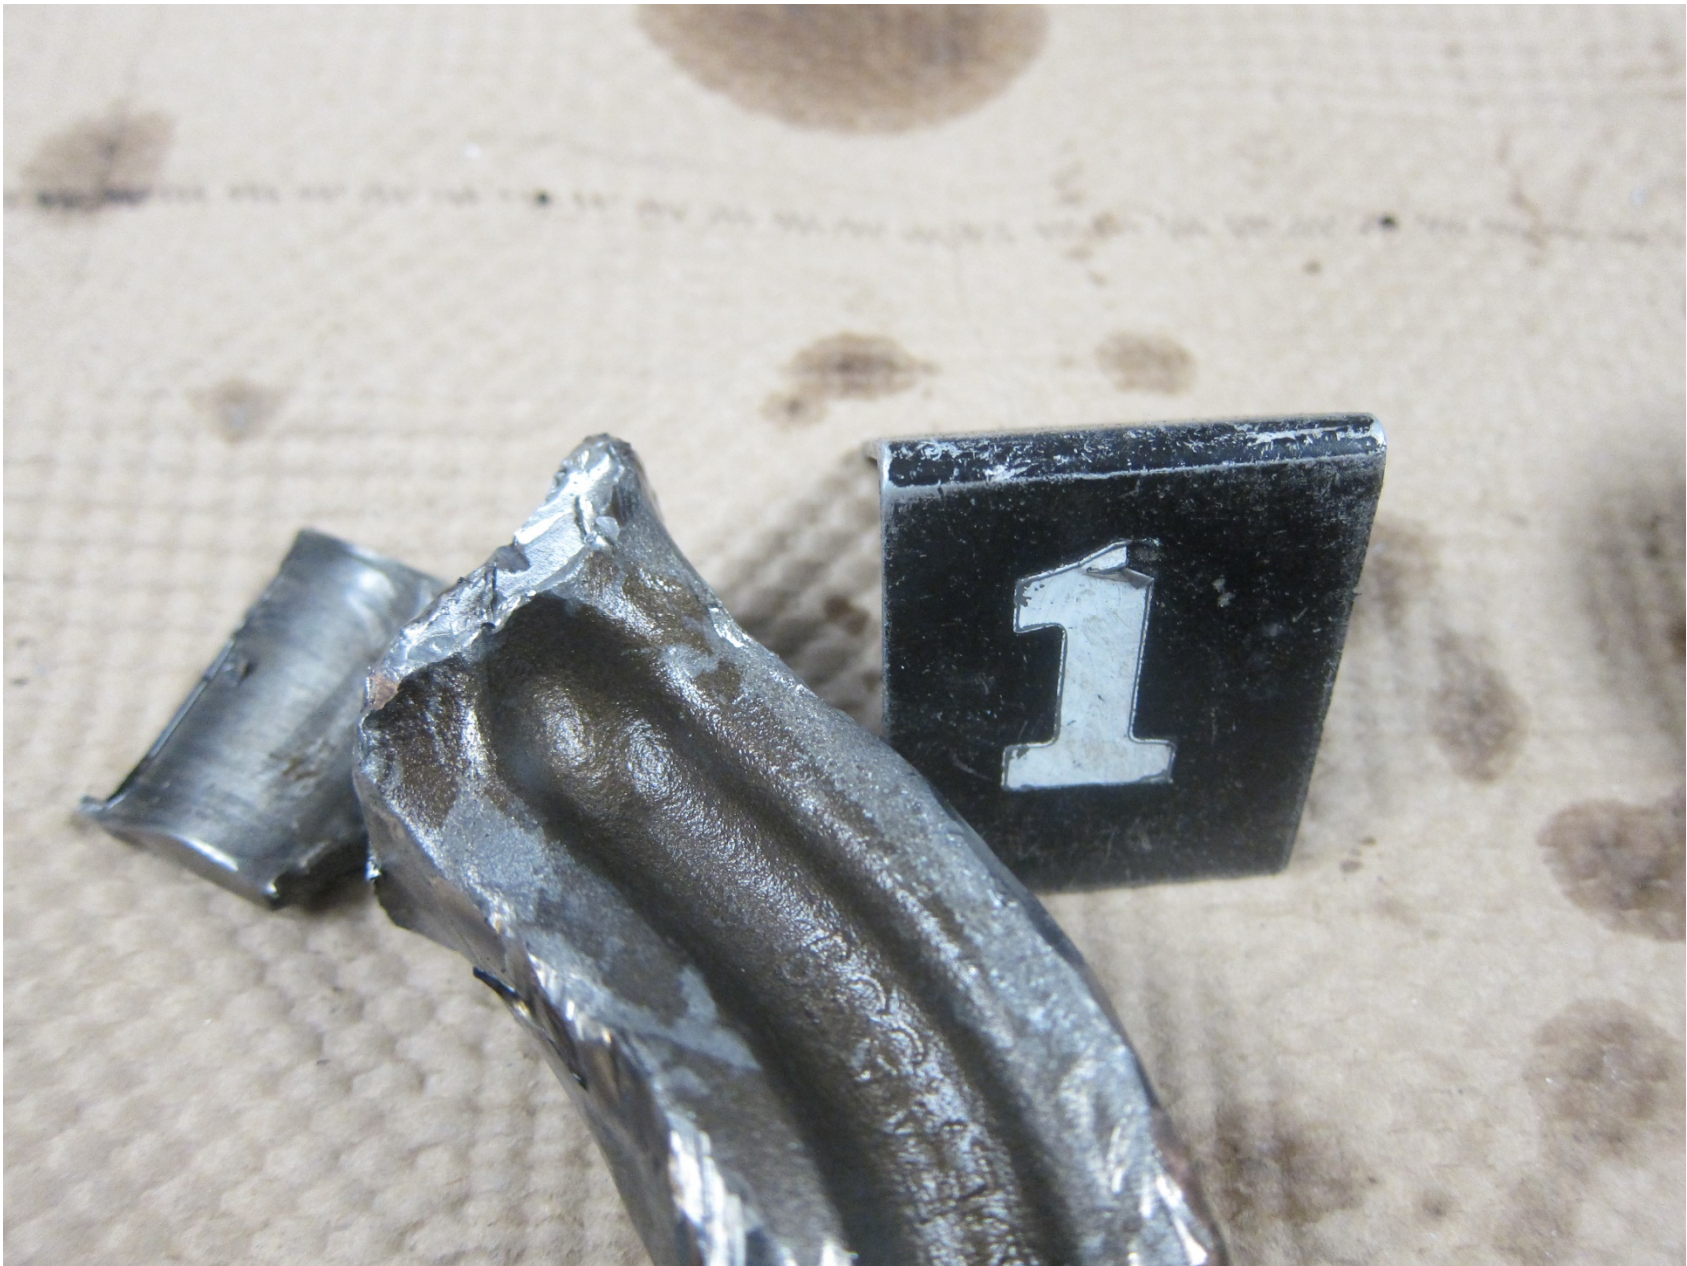
**Photo 31 – Supplied close up view of the No. 1 connecting rod and a separated section of its rod end.**
