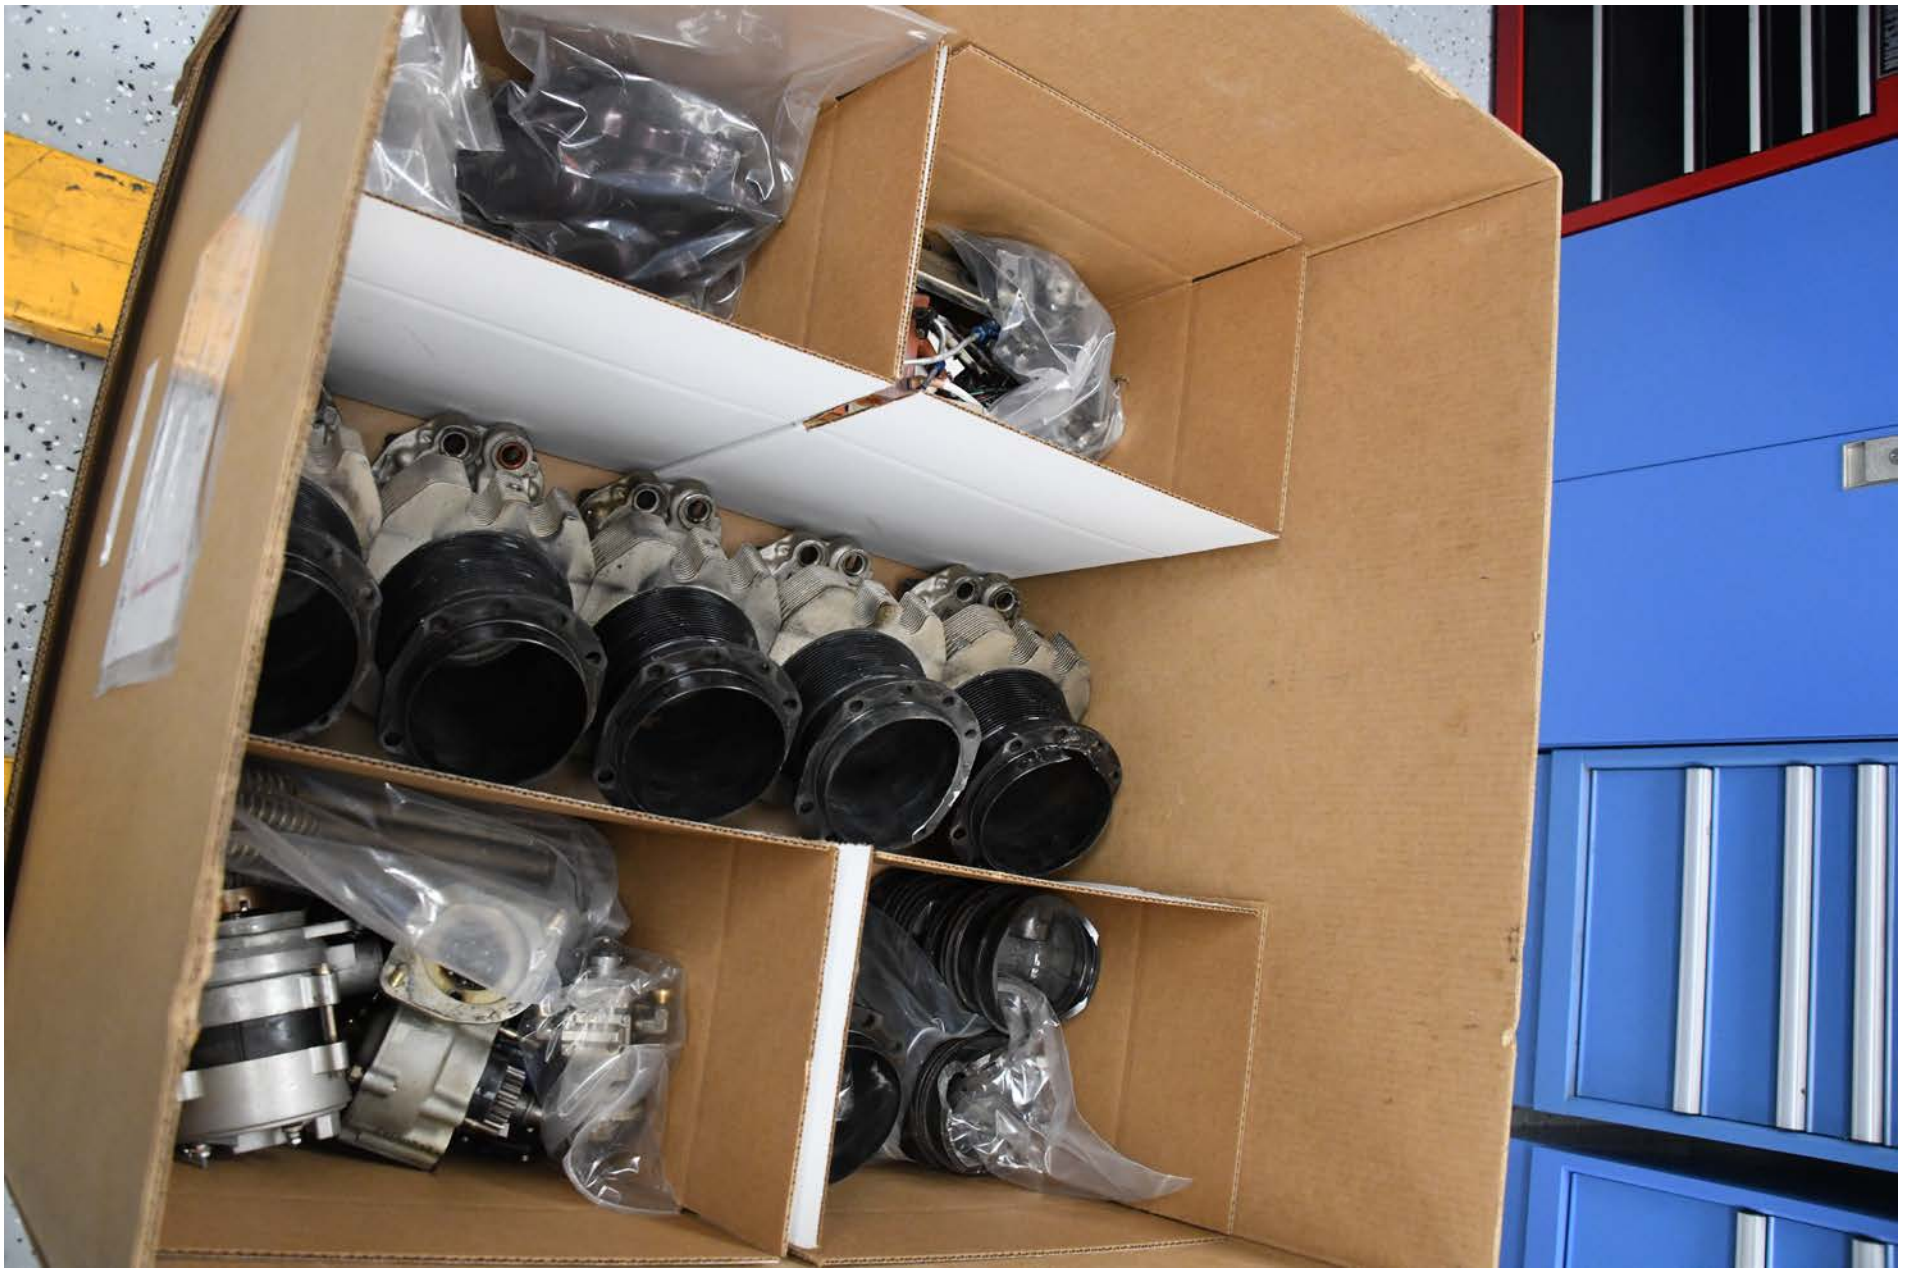
**Photo 32 - View of the disassembled engine being crated for return shipment.**

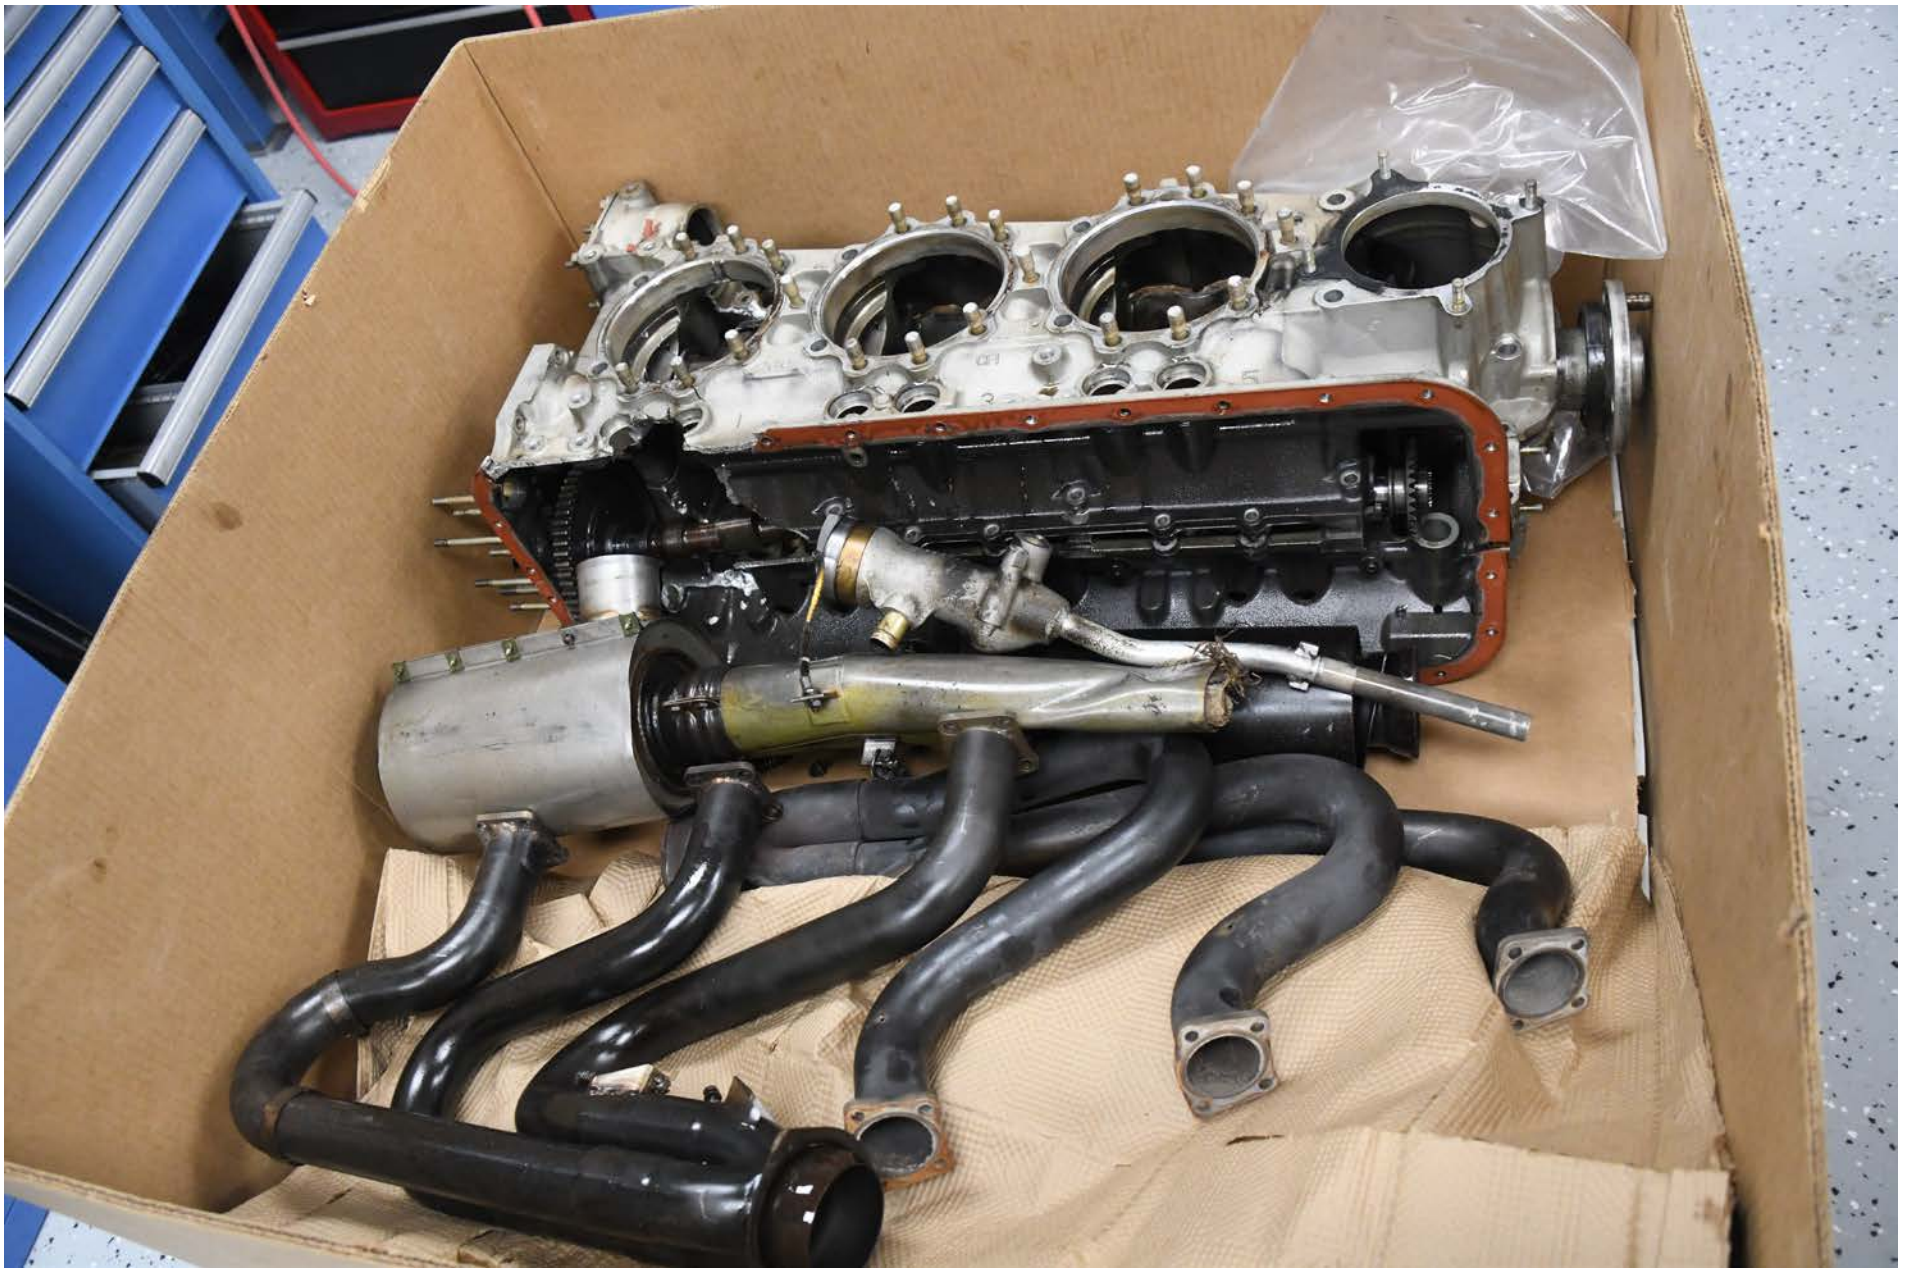
**Photo 33 - View of the disassembled engine being crated for return shipment.**

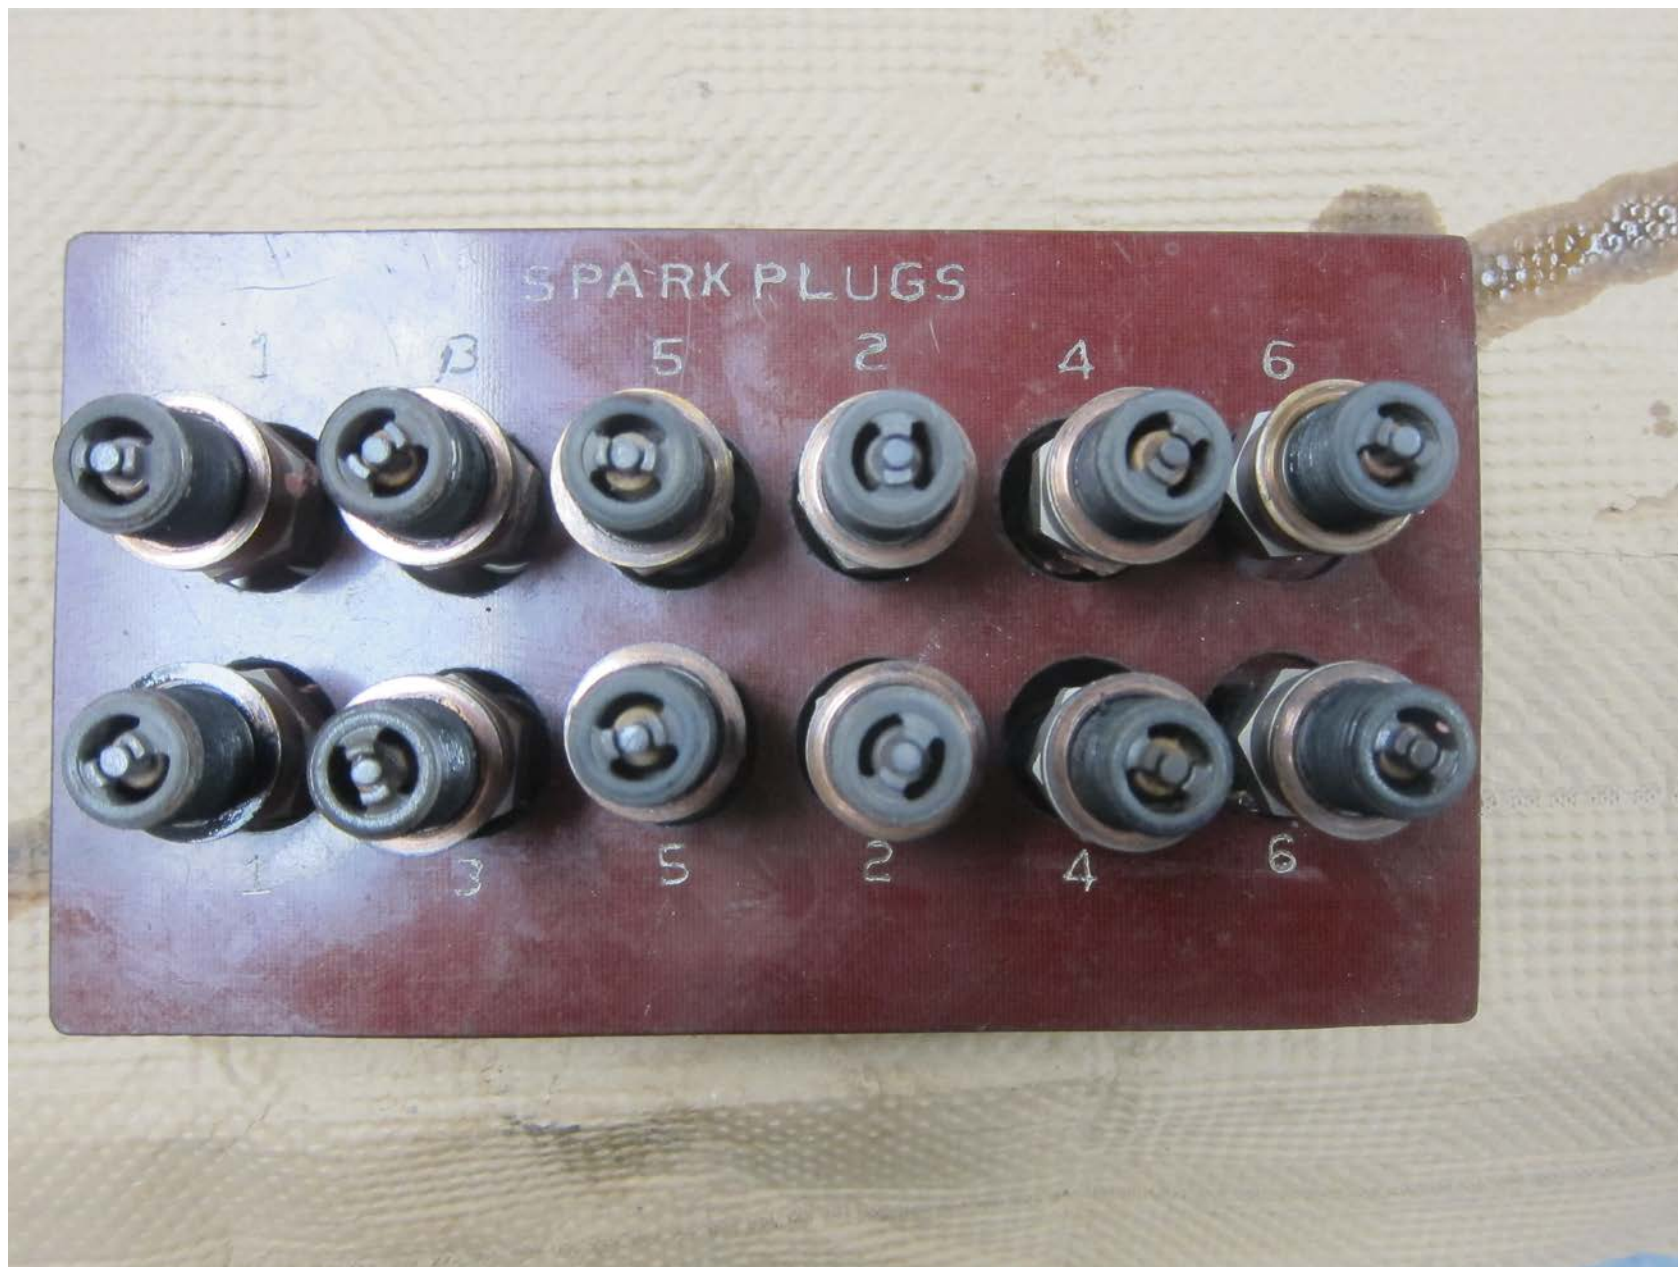
**Photo 34 – Supplied close up view of removed sparkplugs.**

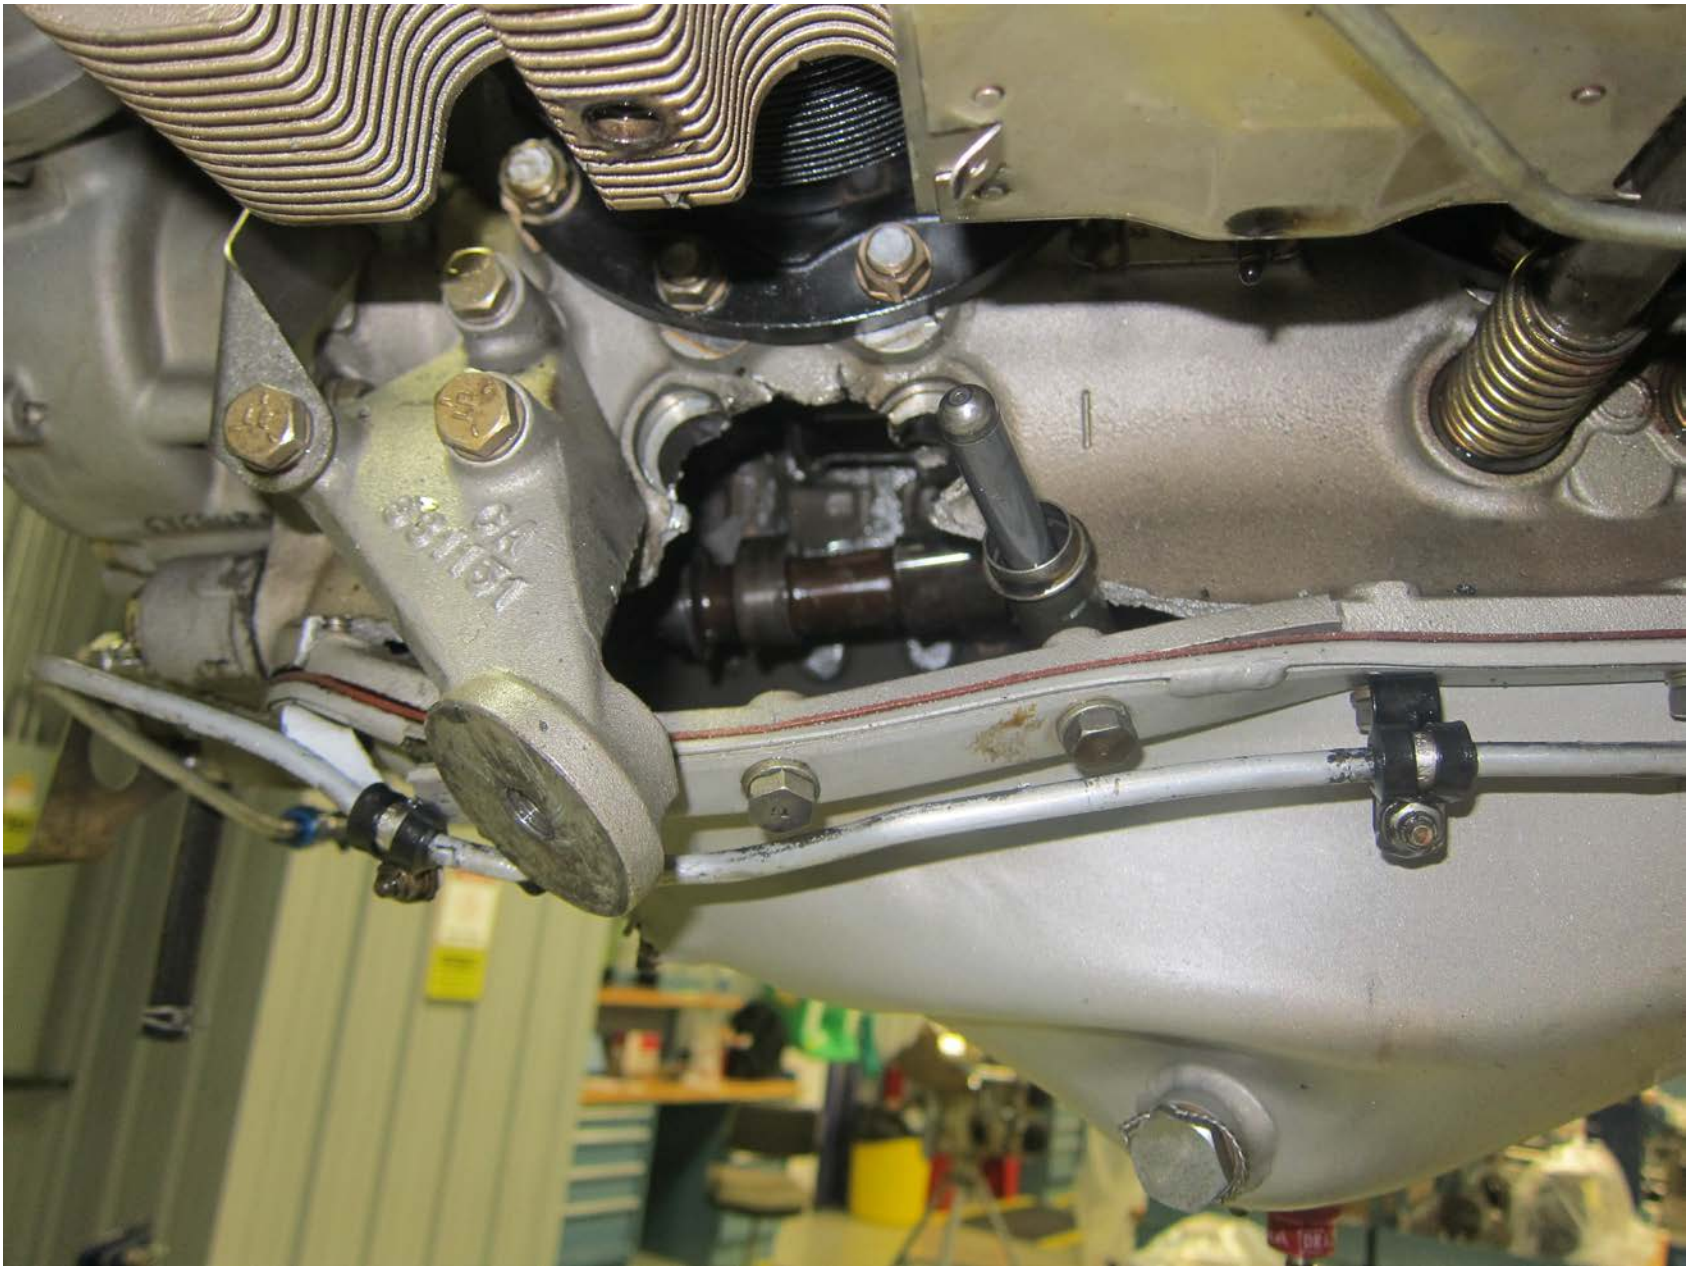
**Photo 35 – Supplied close up view of the crankcase under the No. 1 cylinder.**

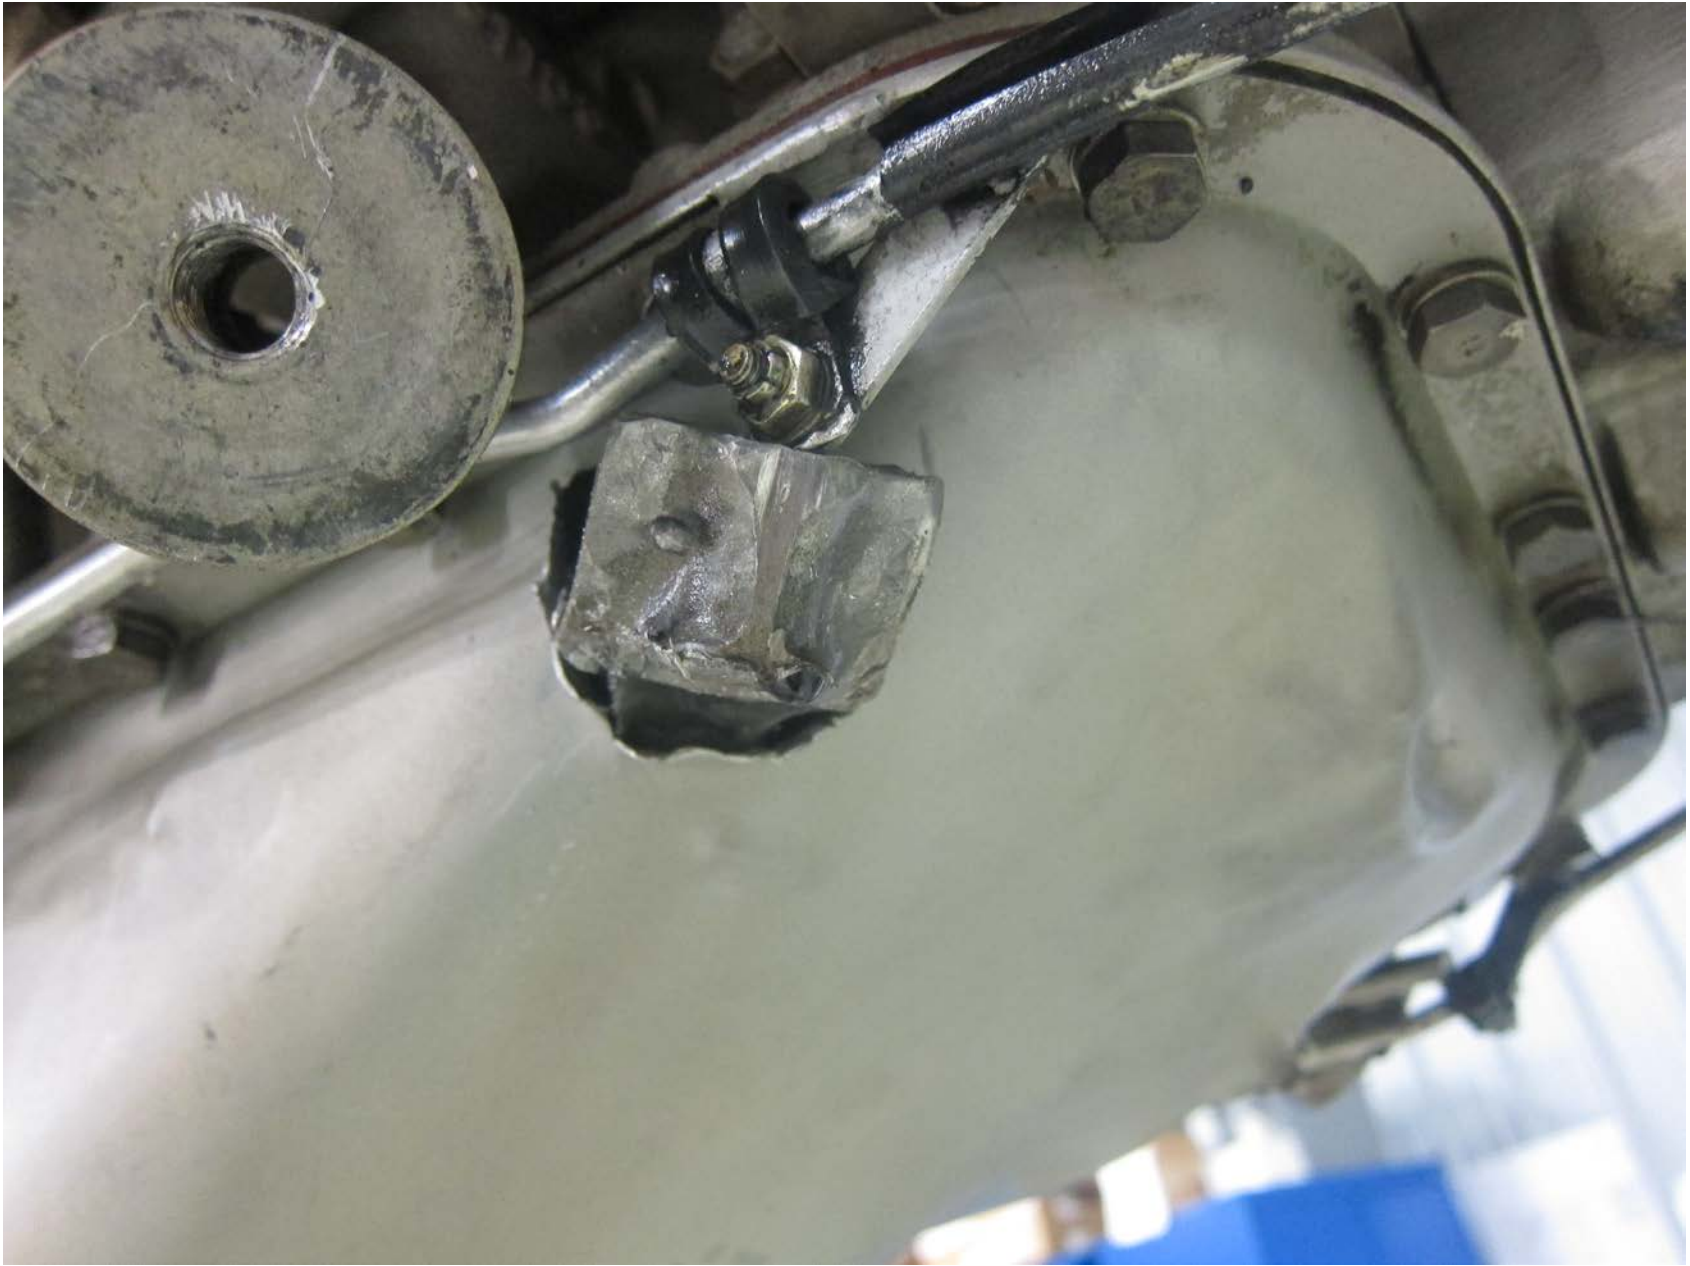
**Photo 36 – Supplied view of the oil sump pan. An end of a connecting rod is observed in a hole in the pan.**

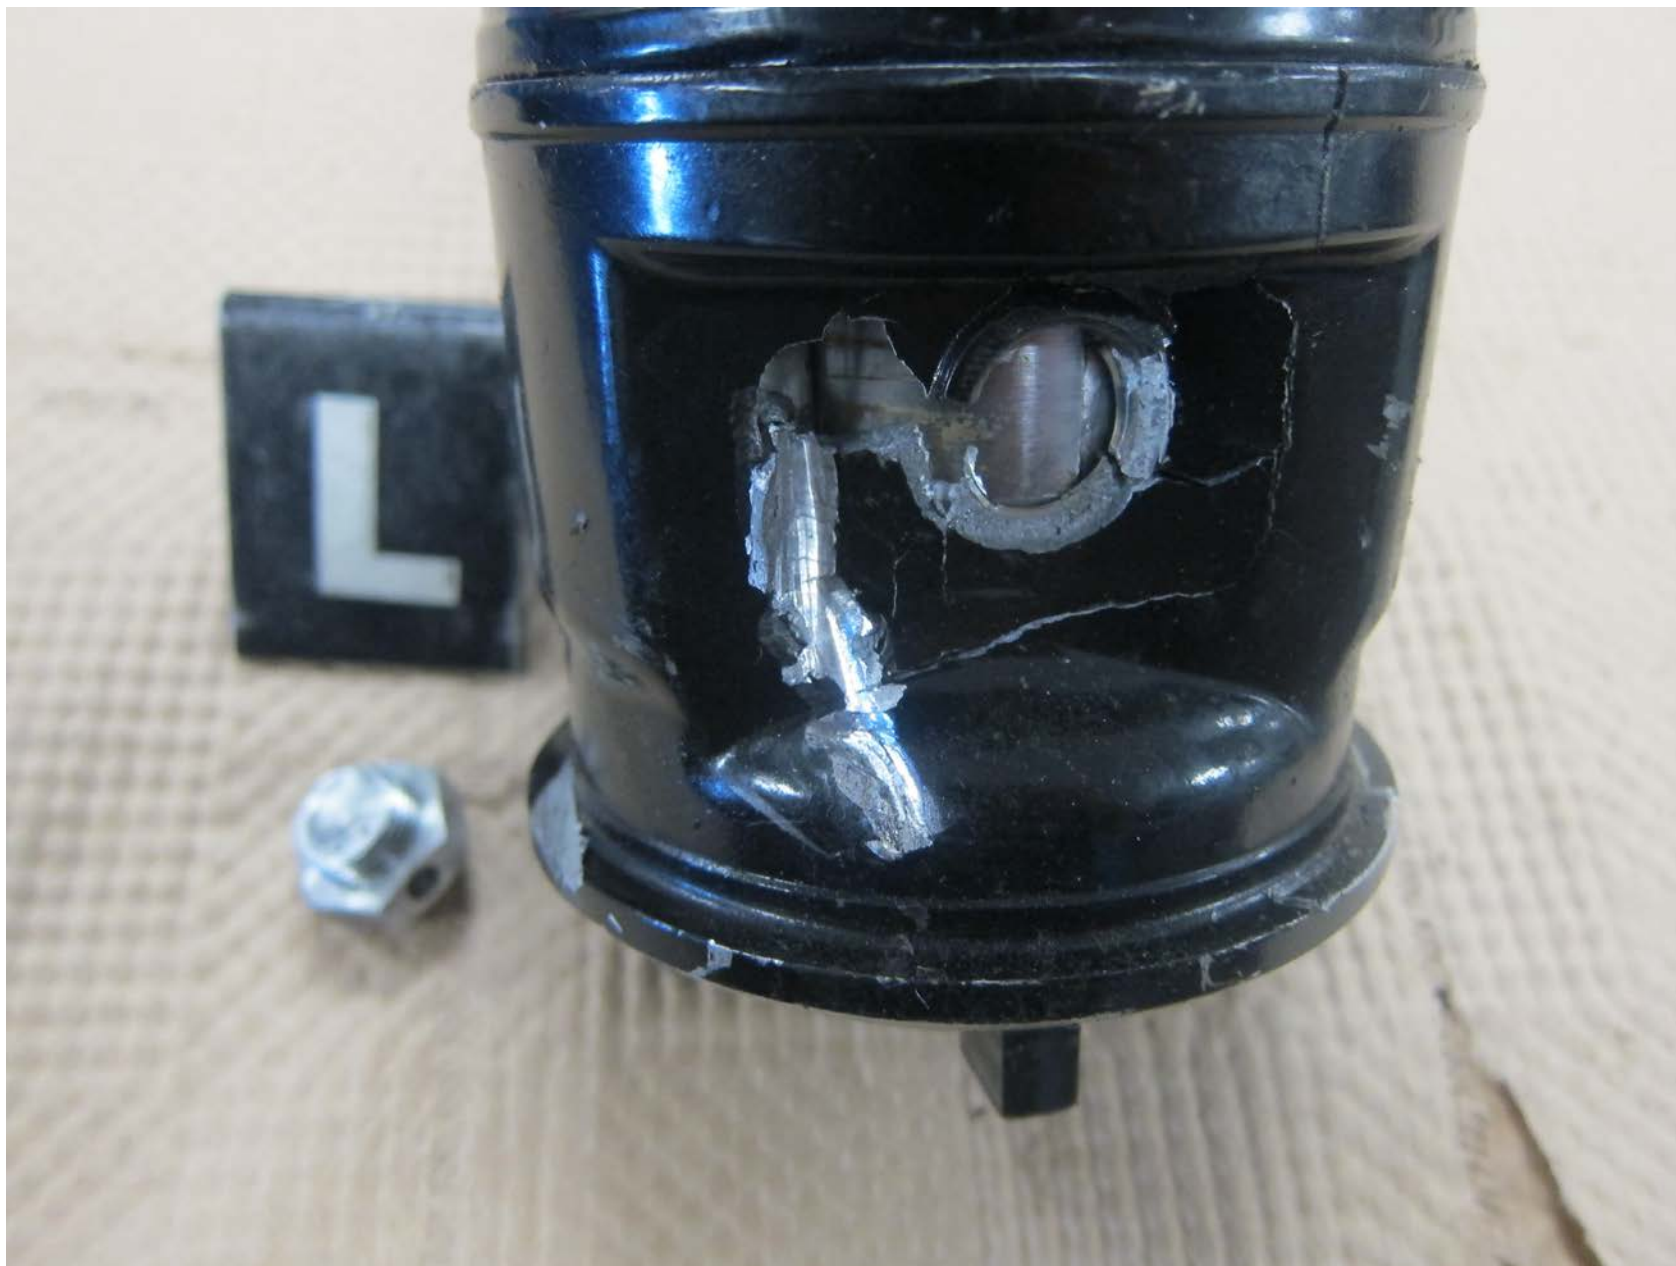
**Photo 37 – Supplied view of the left magneto. The magneto exhibits damage witness marks.**

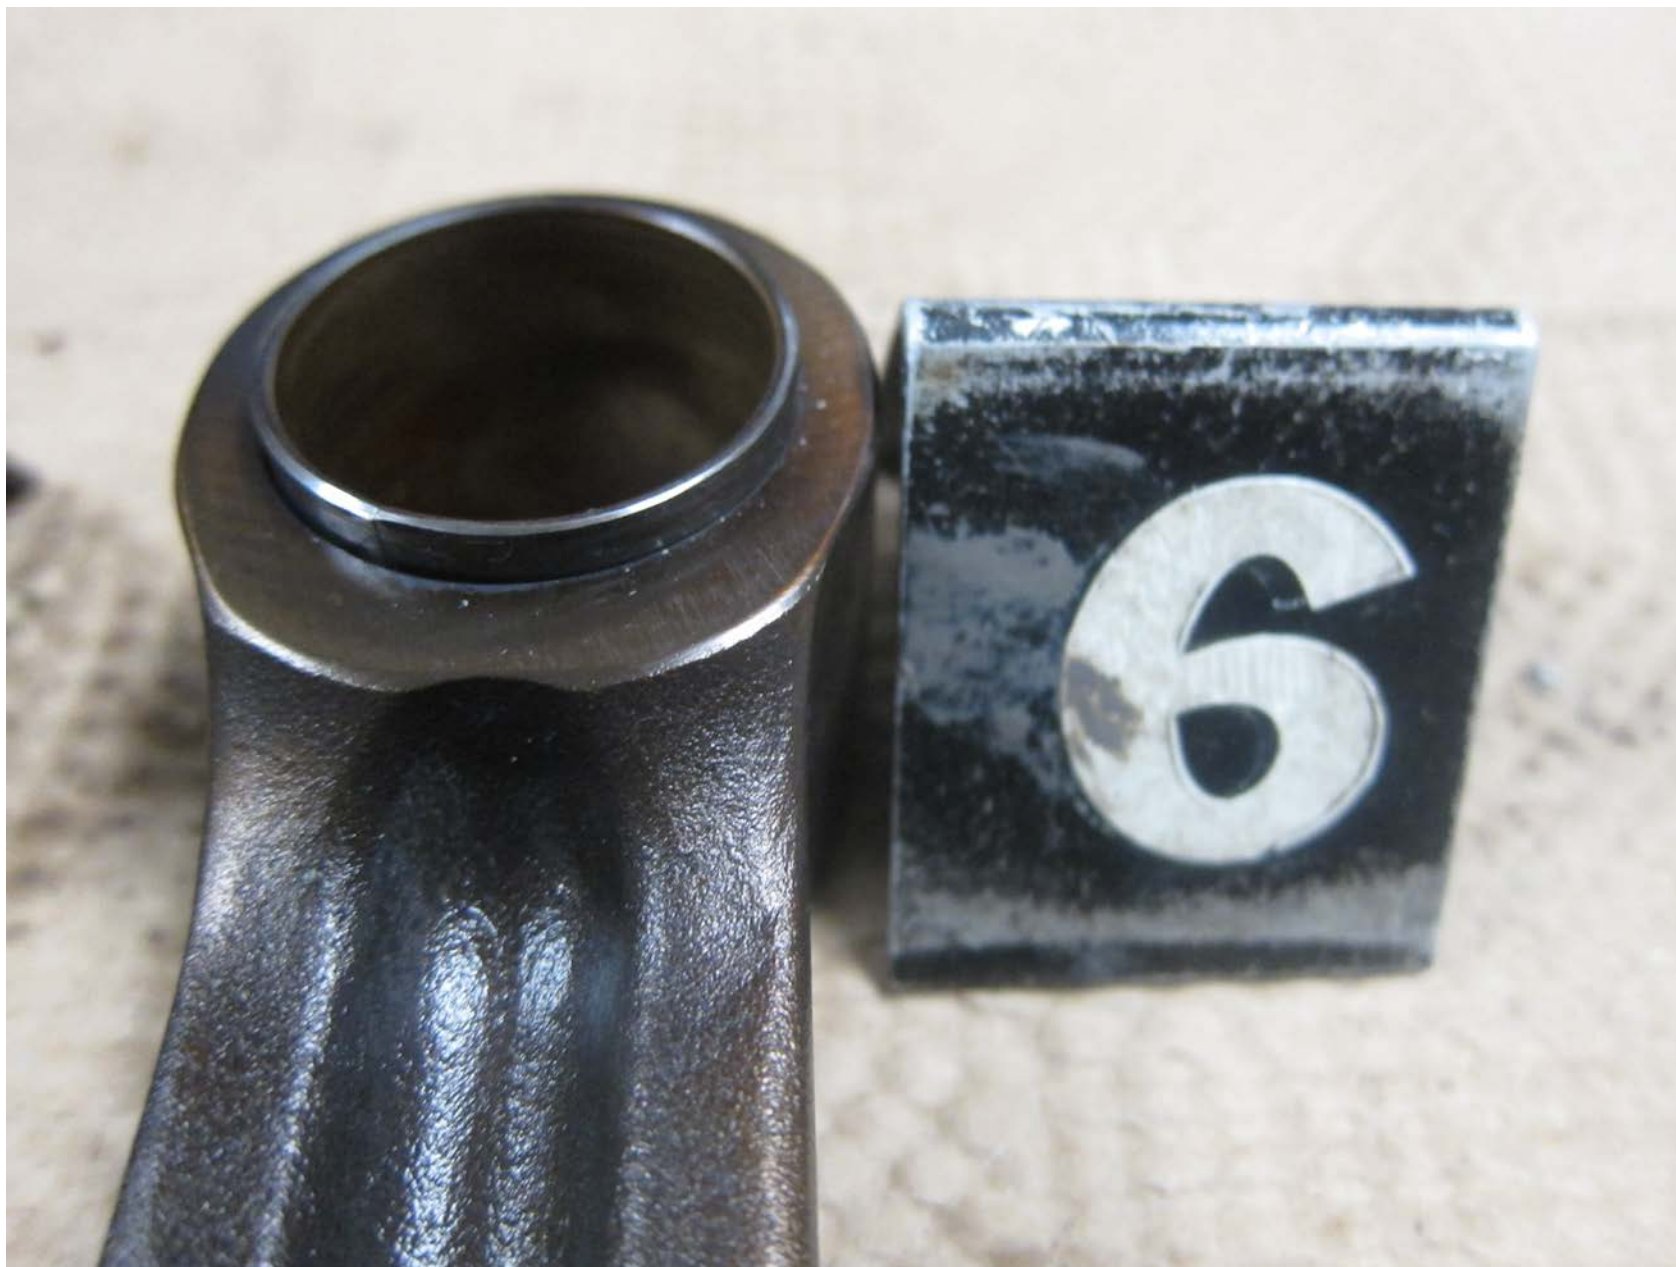
**Photo 38 – Supplied close up view of the No. 6 connecting rod. Its bushing is displaced.**

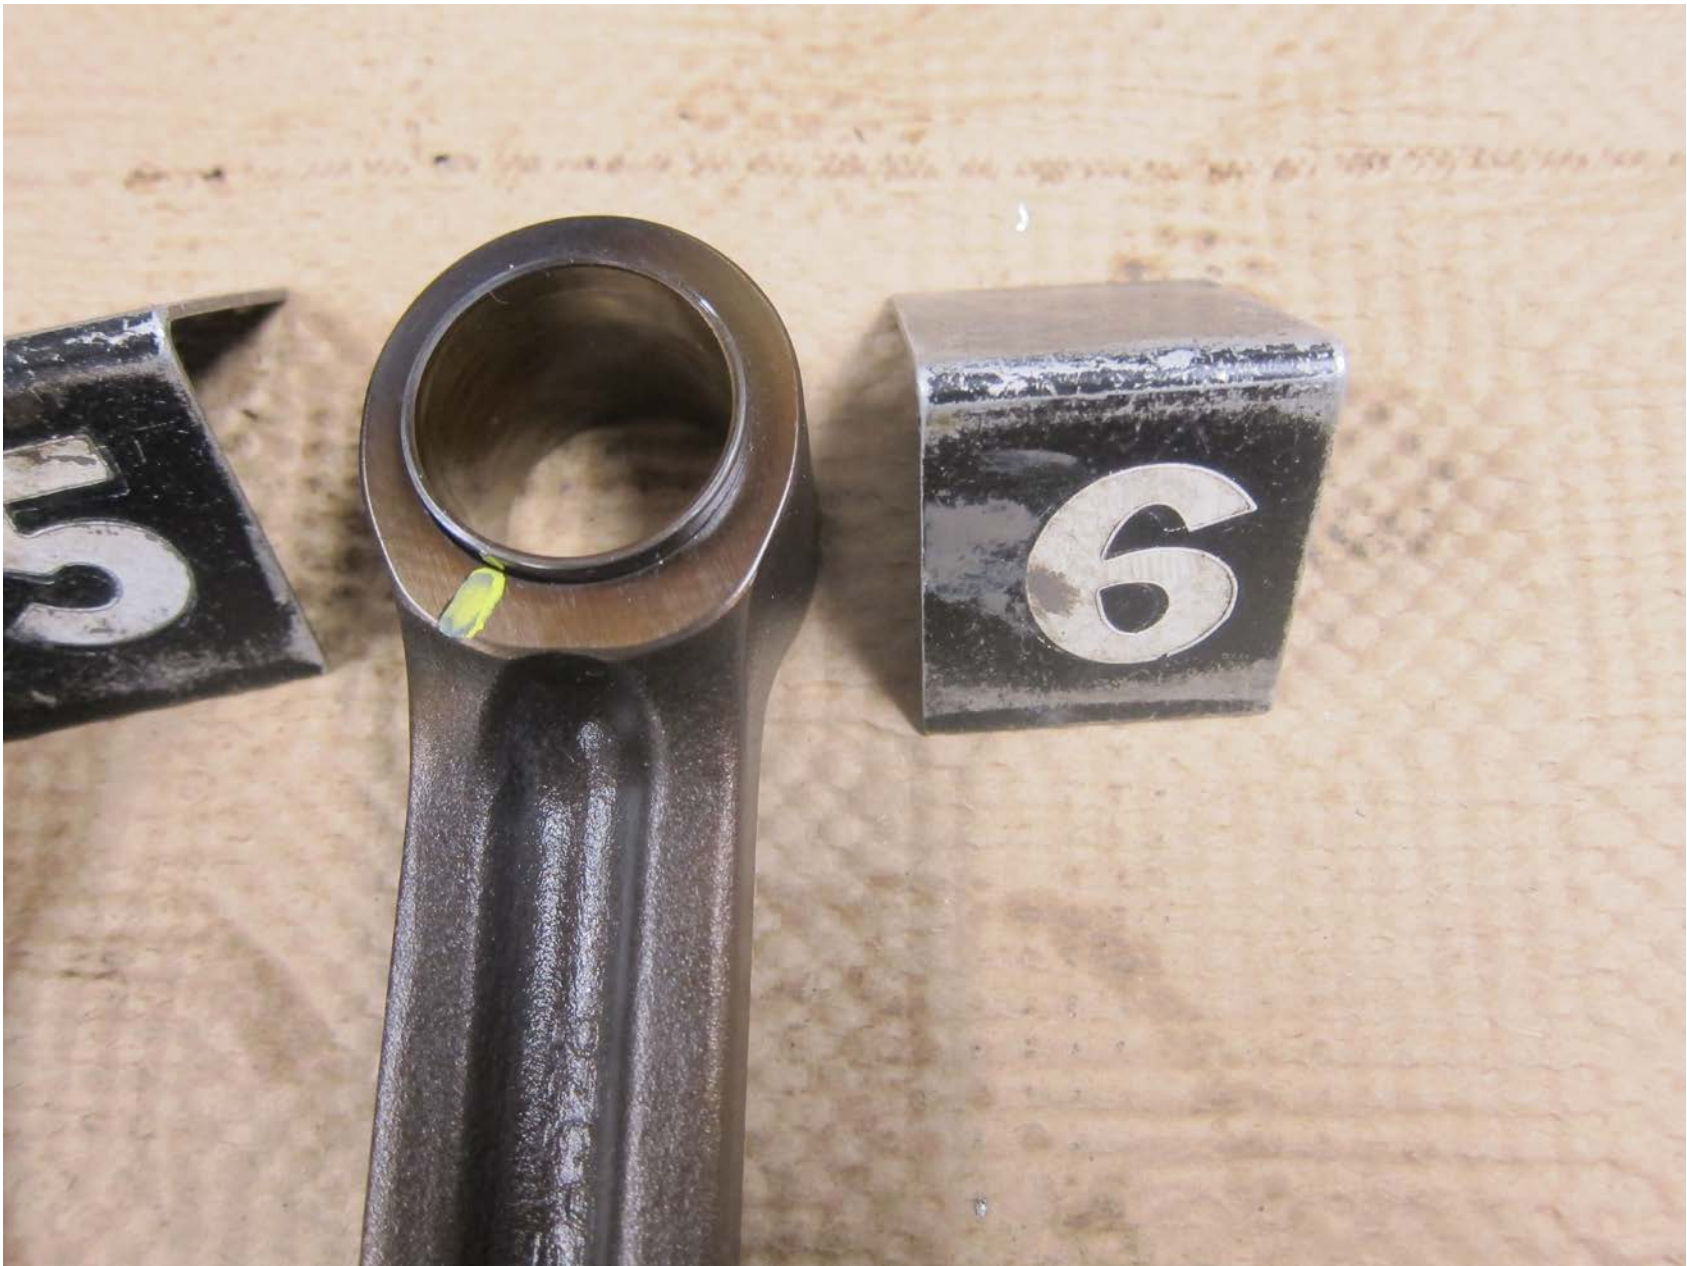
**Photo 39 – Supplied close up view of the No. 6 connecting rod. Its bushing split is marked.**

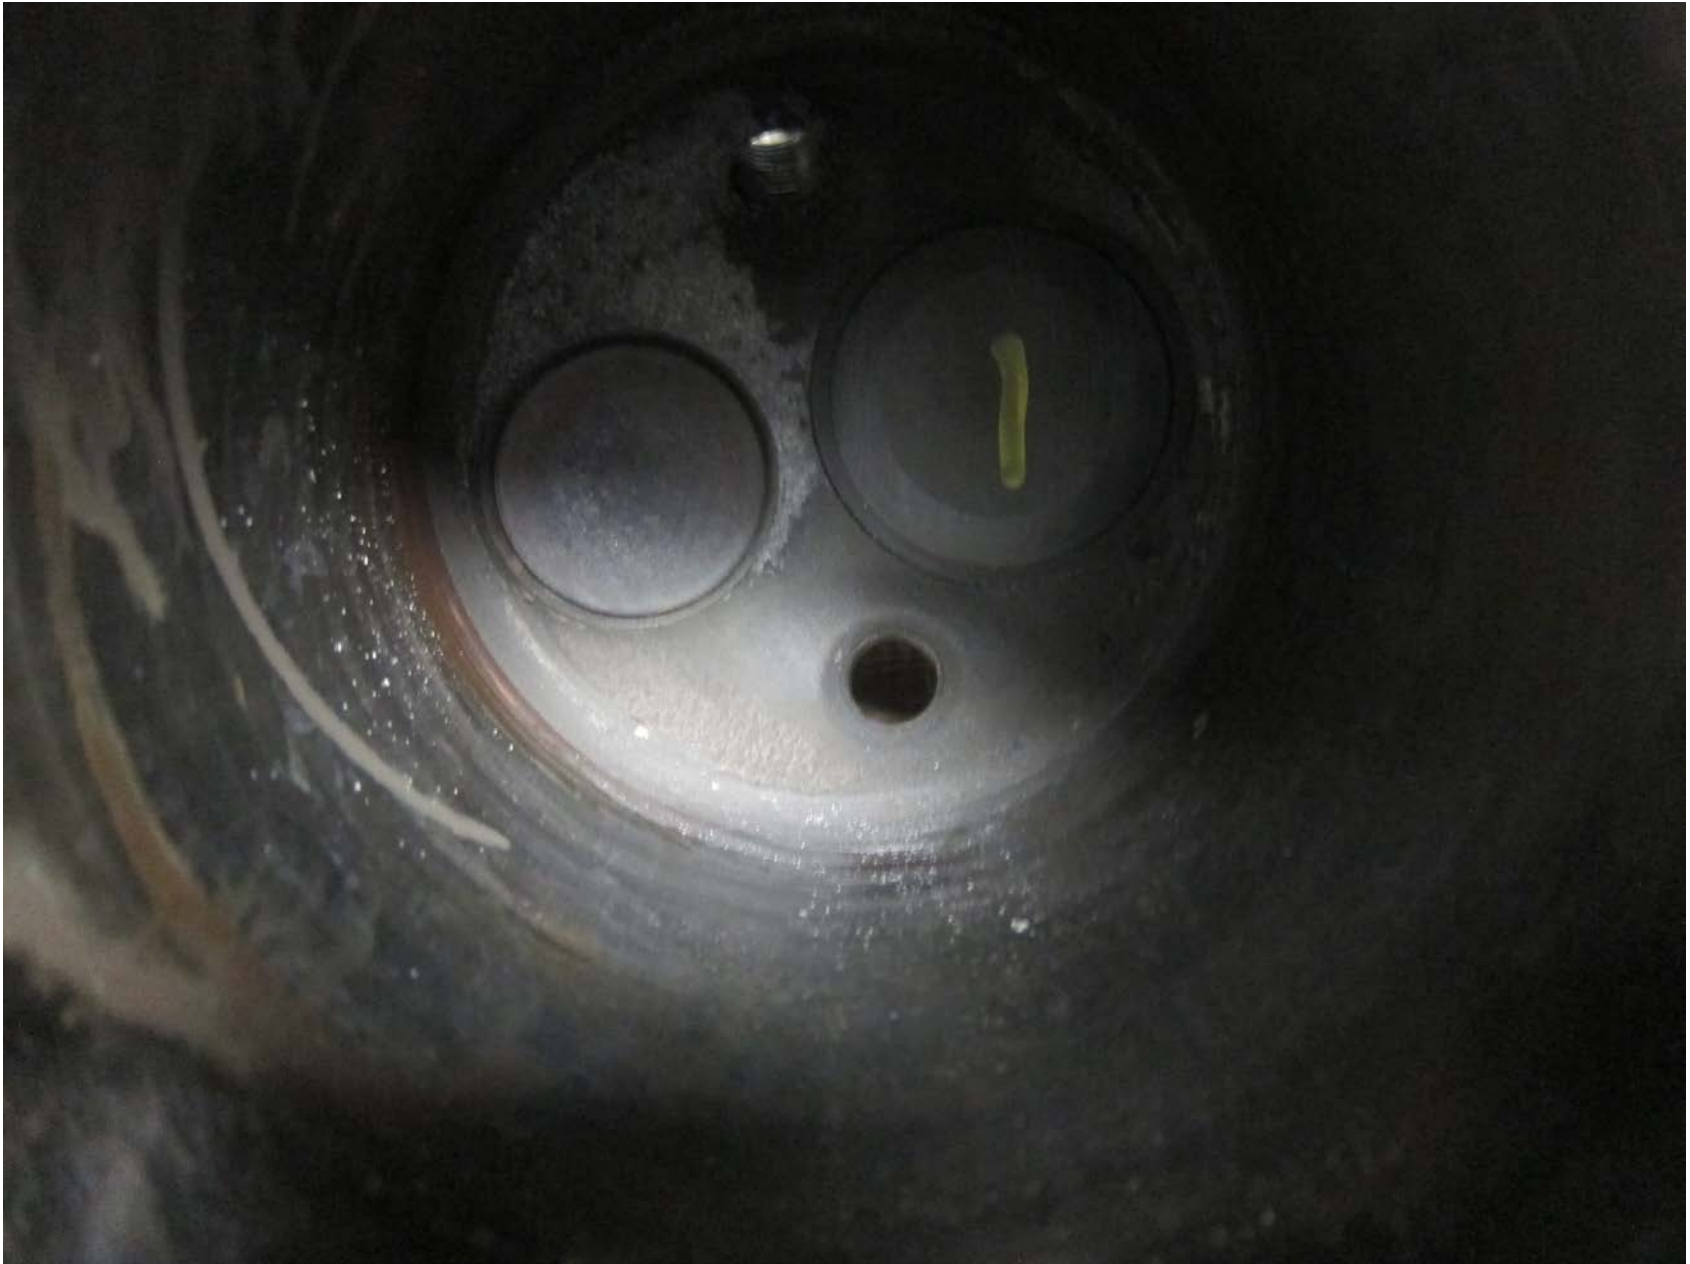
**Photo 40 – Supplied view inside the No. 1 cylinder.**
