# NATIONAL TRANSPORTATION SAFETY BOARD

## MATERIALS LABORATORY FACTUAL REPORT

Report No. 20-024

Place : Pocahontas, Iowa  
Date : September 6, 2019  
Vehicle : Cessna 195A, N9895A  
NTSB No. : CEN19LA322  
Investigator : Mitchell Gallo, AS-CEN

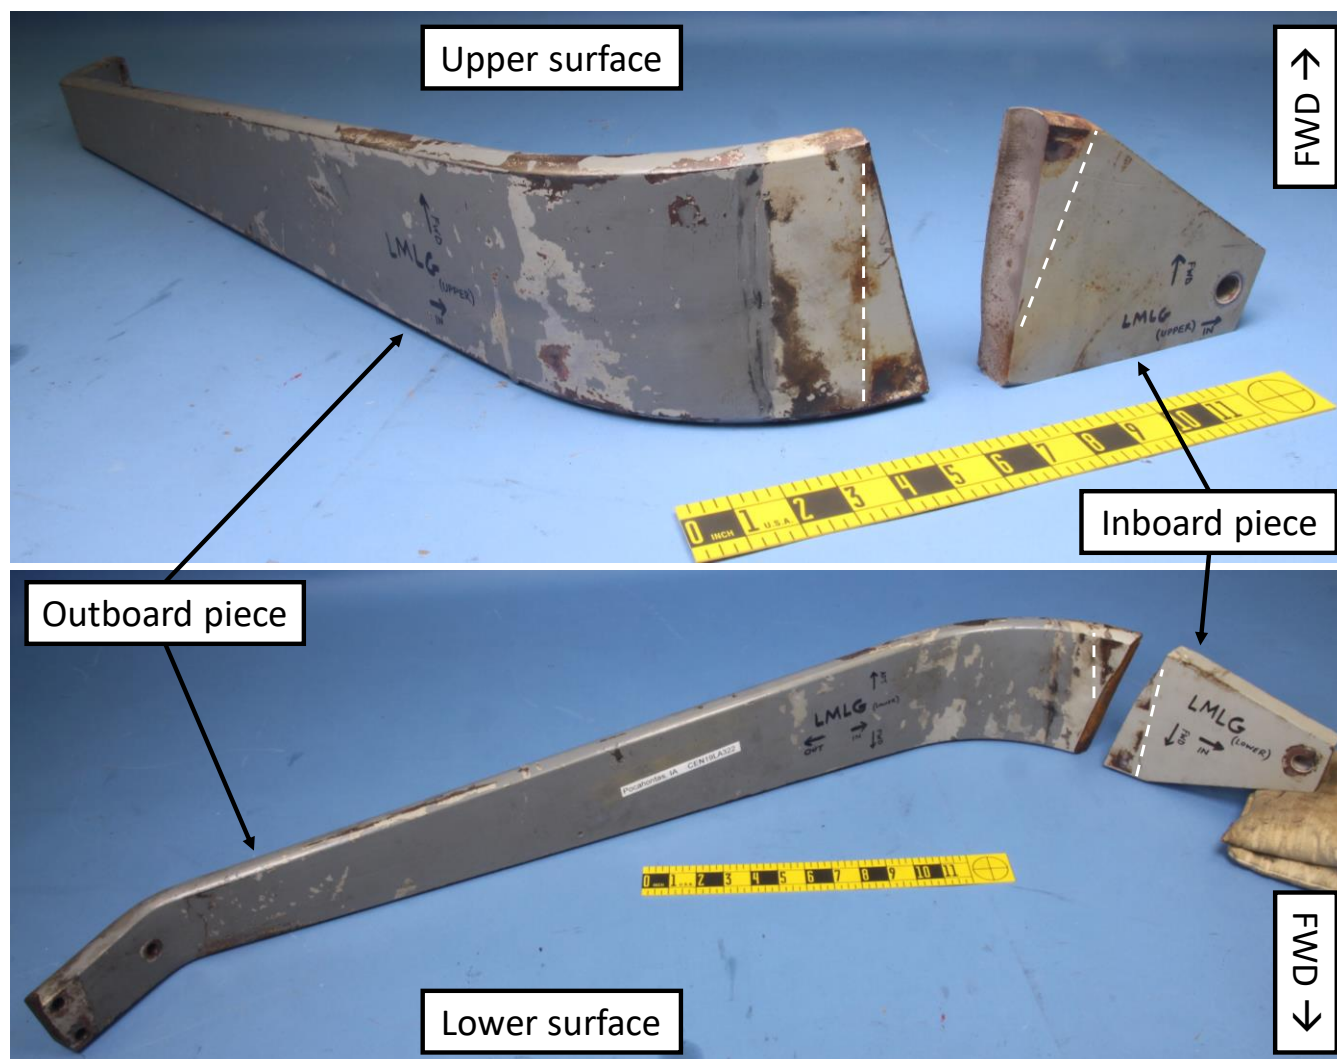
Figure 1 shows photographs of the fractured left main landing gear spring strut as received. The spring strut fractured at approximately 7 $\frac{1}{8}$  inches from the inboard edge at the forward side and approximately 6 $\frac{1}{8}$  inches from the inboard edge at the aft side. A light gray paint coating appeared over the entire part surface and a darker gray paint coating was only present on the outboard piece with a clearly delineated inboard boundary. Both gray coatings were chipped and absent from numerous locations over the part surface thereby exposing areas of the underlying light gray coating as well as areas of brownish-red oxidized metal. A visibly distinct band of brighter light-gray coating and exposed oxidized metal was apparent on the upper and lower surfaces of the spring strut on both sides of the fracture as indicated between the white dashed lines. The upper surface of the spring strut was visibly smoother than the lower surface, which exhibited a dimpled texture.

Figure 1: Photographs of the fractured left main landing gear spring strut as received. The top photograph shows a view of the upper surface of the component and the bottom photograph shows a view of the lower surface of the component. A light gray coating was apparent over most of the part surface which was covered by a darker gray coating outboard of the fracture. A distinct band of coating wear was evident between the dashed white lines on each side of the fracture surface. More random areas of chipped and worn coating was observed over the rest of the part surface.

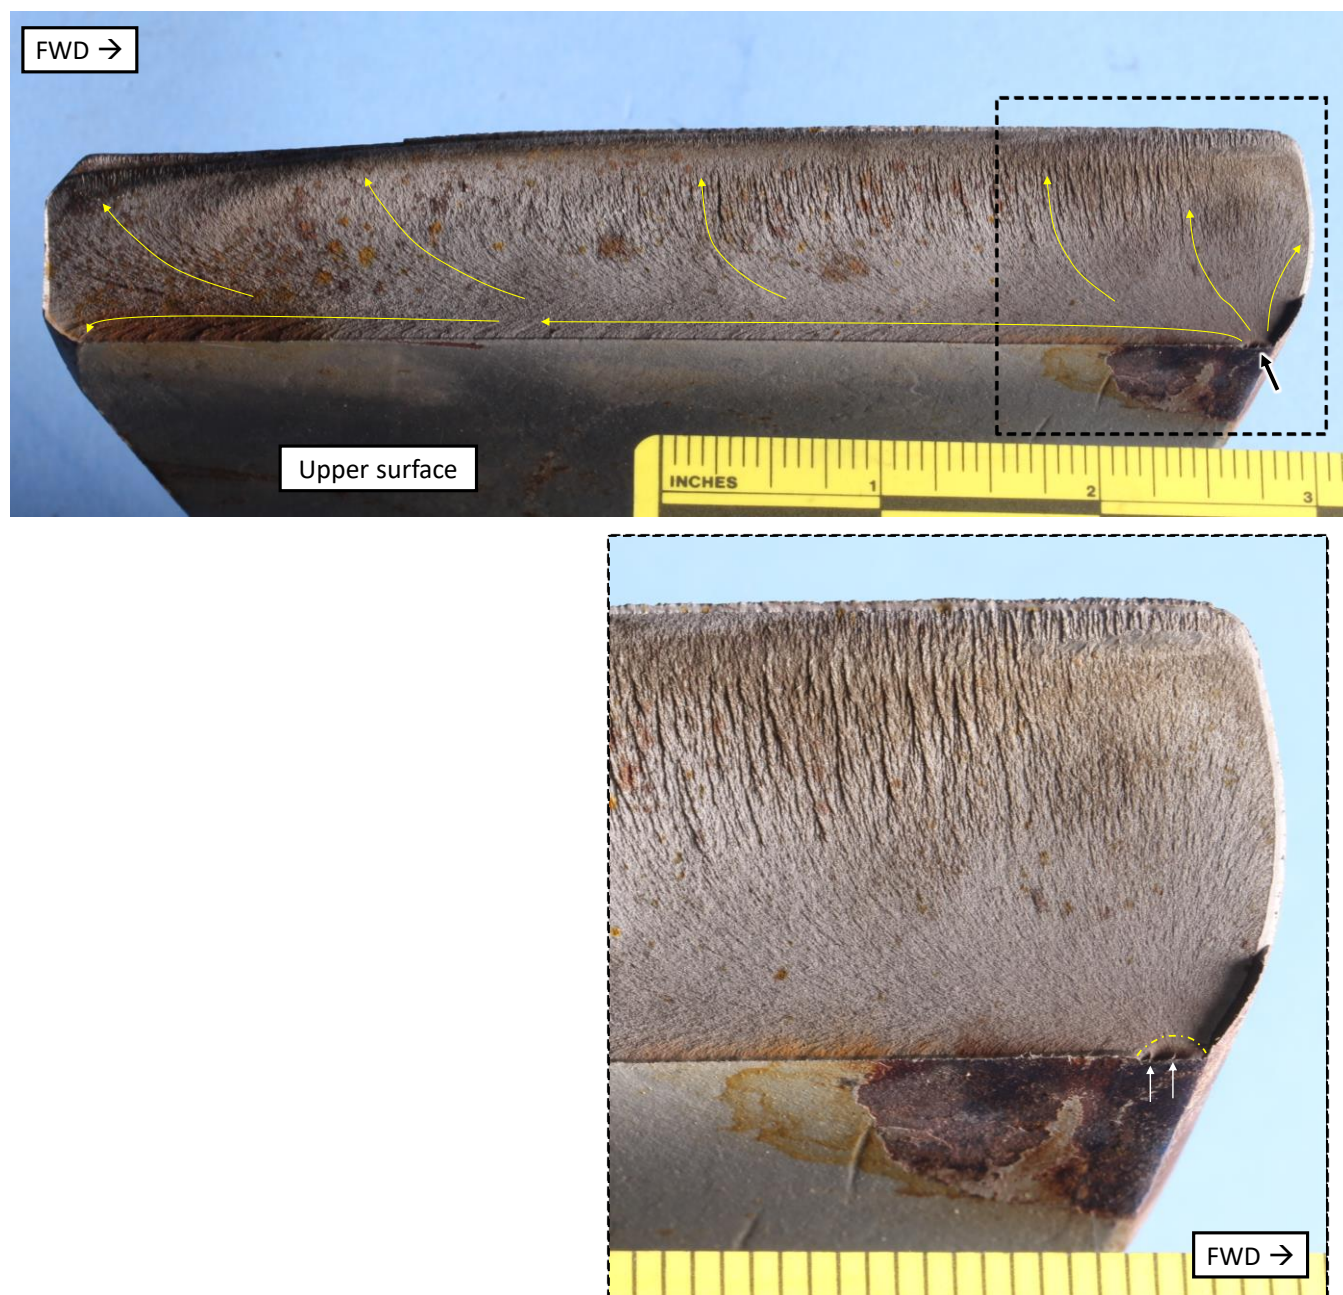
Figure 2 shows a photograph of the inboard fracture surface. The mating outboard fracture surface exhibited significant post-fracture mechanical damage and oxidation which obscured some of the finer fracture details. The fracture origin was located on the upper

surface at the forward edge of the spring strut. Chevron marks<sup>1</sup> radiated outward from this location along the upper surface and toward the lower surface consistent with an aft and downward crack propagation direction as indicated with yellow arrows. Shear lip<sup>2</sup> features were present around the perimeter of the fracture surface. Closer examination of the origin area revealed a small discolored thumbnail shaped crack and ratchet mark<sup>3</sup> features which were consistent with fatigue cracking<sup>4</sup> from multiple origins. The upper surface of the spring strut adjacent to the thumbnail shaped crack at the fracture origin was absent of gray coating and had exposed oxidized metal over an area approximately 1 inch inboard of the fracture surface and approximately 0.75 inch aft of the forward edge. This area was pitted and rougher than the surrounding upper surface where gray coating was intact. Reddish-orange staining was also observed near the fracture origin on the surrounding gray coating.

Figure 2: A photograph of the inboard fracture surface is shown above. Chevron patterns pinpointed the fracture origin at the corner of the upper surface and forward edge, indicated by the unlabeled black arrow. From the origin, the crack propagated aft and downward as indicated by the yellow arrows. A closer view of the origin is shown below from the area within the dashed black box, scale markings are 1/16 inch. A relatively flat and smooth thumbnail shaped crack, outlined by the yellow dashed line, and ratchet mark features, indicated by white arrows, were present at the fracture origin, consistent with fatigue initiation from multiple origins. Paint was chipped and absent from the surface adjacent to the origin and brownish-red oxidized metal was visible. Intact paint surrounding this area exhibited a light orange staining pattern.

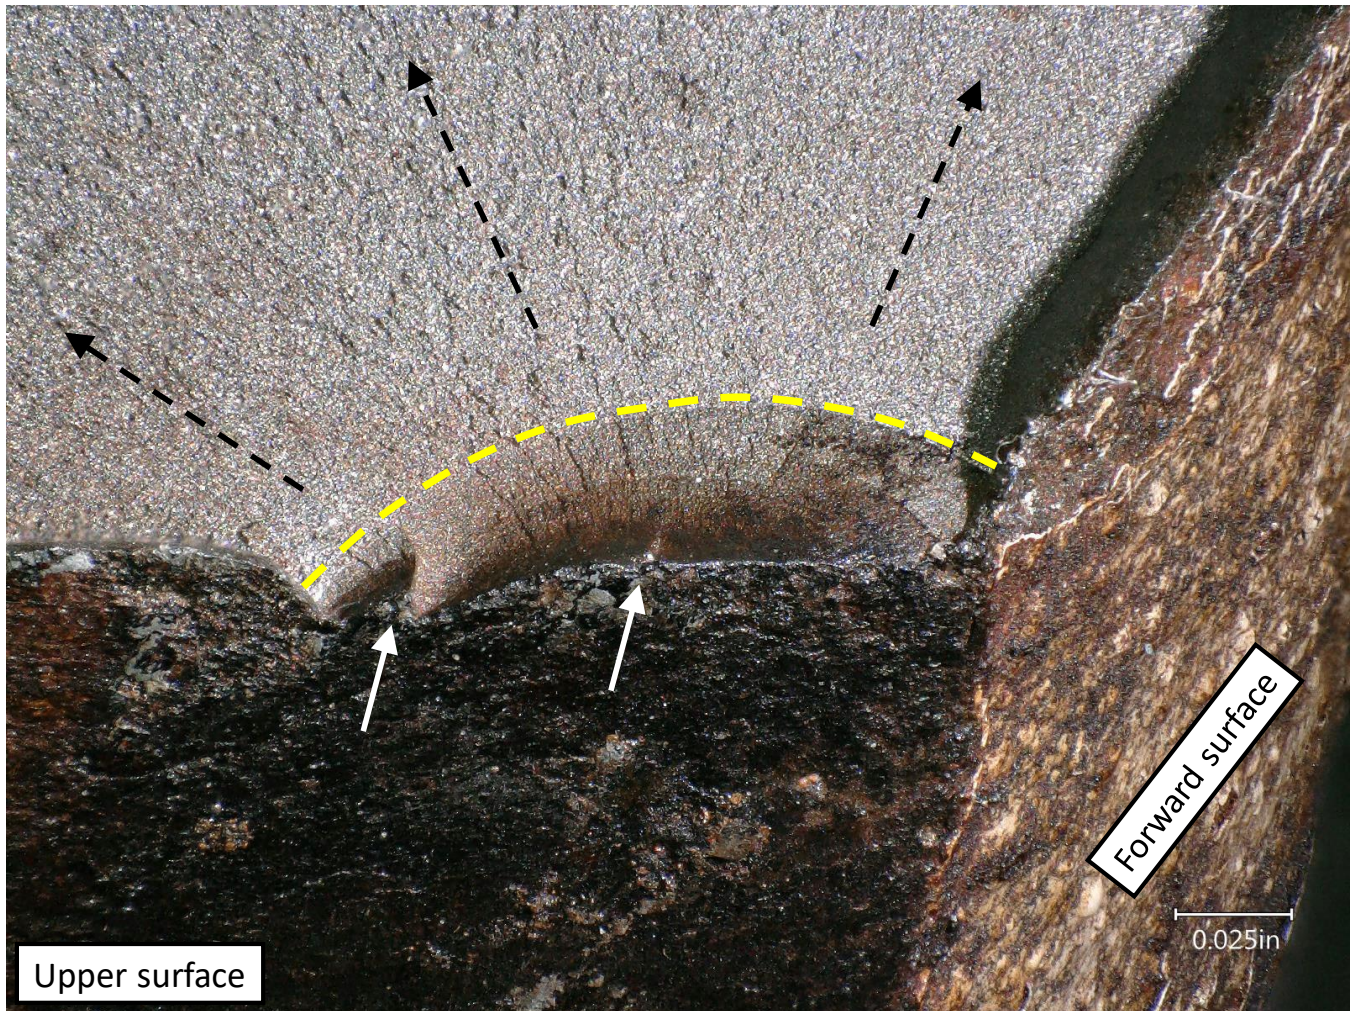
A closer digital microscope image of the fracture origin area and adjacent upper surface of the spring strut is shown in figure 3. The thumbnail shaped pre-existing crack region highlighted with the yellow dashed line was relatively flat and smooth compared to the rest of the fracture surface. Crack arrest lines were evident progressing from at least three origins separated by two visible ratchet marks identified by white arrows. Smaller, semi-elliptical sections bounded by crack arrest lines within the thumbnail crack were brownish-red in color, and progressively lighter in color away from the origins. The pre-existing crack measured approximately 0.131 inch along the upper surface of the spring strut and extended approximately 0.058 inch into the part. The fracture surface morphology outside of the thumbnail shaped pre-existing crack was dull and rough in appearance, consistent with overstress separation.

Figure 3: A digital microscope image of the fracture origin and adjacent surface. The yellow dashed line indicates the boundary of the thumb-nail shaped fatigue crack. White arrows highlight ratchet marks consistent with multiple crack origins on the upper surface within an area exhibiting corrosion. Black dashed arrows indicate crack propagation direction in the overstress region and shear lips were observed immediately after the fatigue crack boundary on the part periphery.
