| Report number: <b>ML12162021</b> | |
| <p><b>METALLURGICAL REPORT</b></p> | <p><u>Distribution</u></p> <p>1] Phillip Grice</p> |
| Subject: Fuel Line P/N 649101 | |

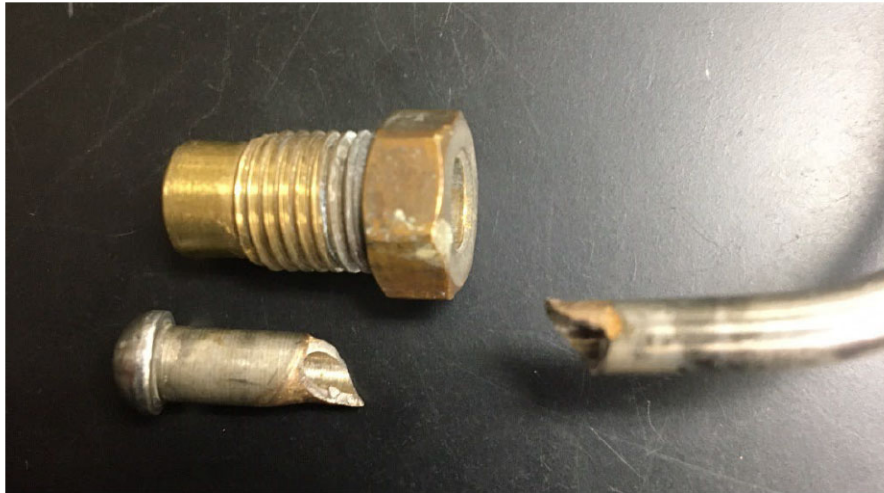
A fractured fuel line assembly presented for inspection included a broken line and associated assembly components. The fractured area and mating components are shown in figure 1. The fracture initiated near the intersection of the brazed components and propagated around the tube in fatigue, as shown in figures 2-4. The initiation area is smoother in appearance than the termination, which is jagged and has a deformed edge. The braze joint appears sound, and the fracture occurred in the steel.

*Figure 1 Fractured fuel line assembly with flared end (left) and tube (right)*

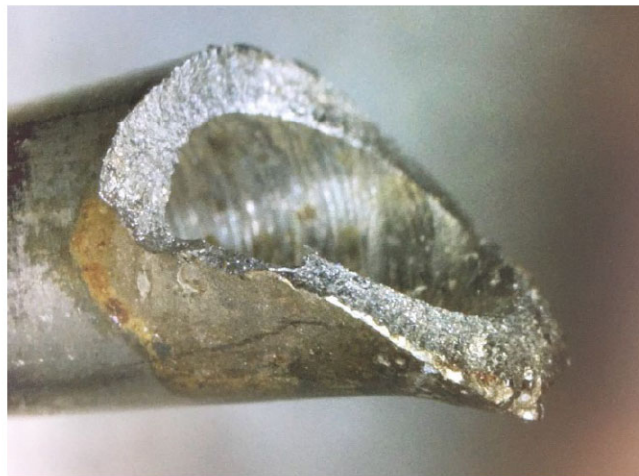
*Figure 2 Side view of tube end of fracture*

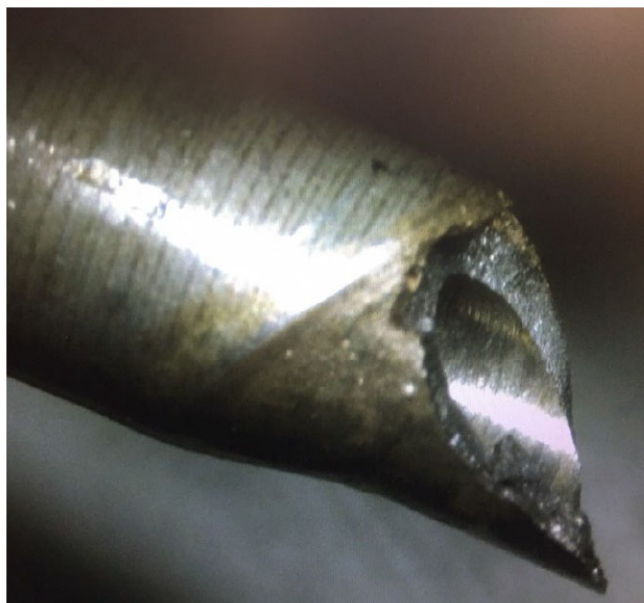
*Figure 3 Side view of fitting end of fracture*

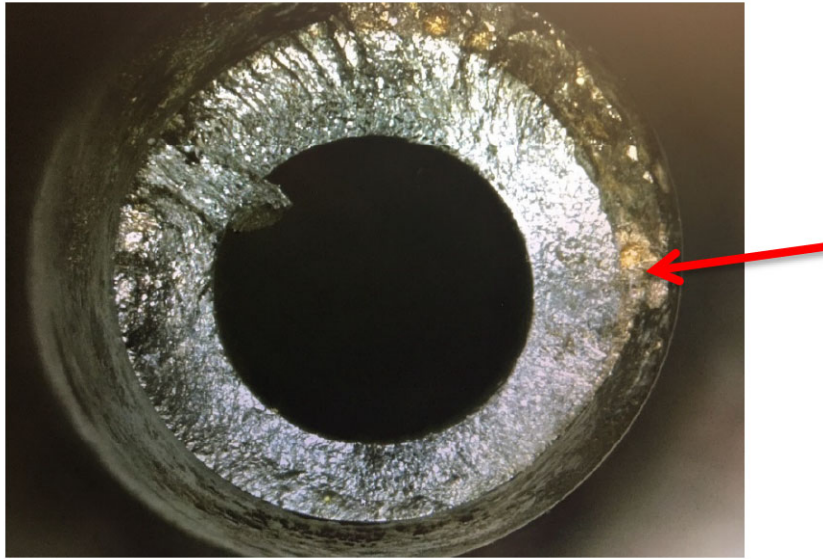
- 1] The fracture occurred in fatigue, initiating in the heat affected zone of the brazed joint. The joint itself was not affected by the fracture.
- 2] No material anomalies were observed.

*Figure 4 Fitting end fracture with initiation area marked*

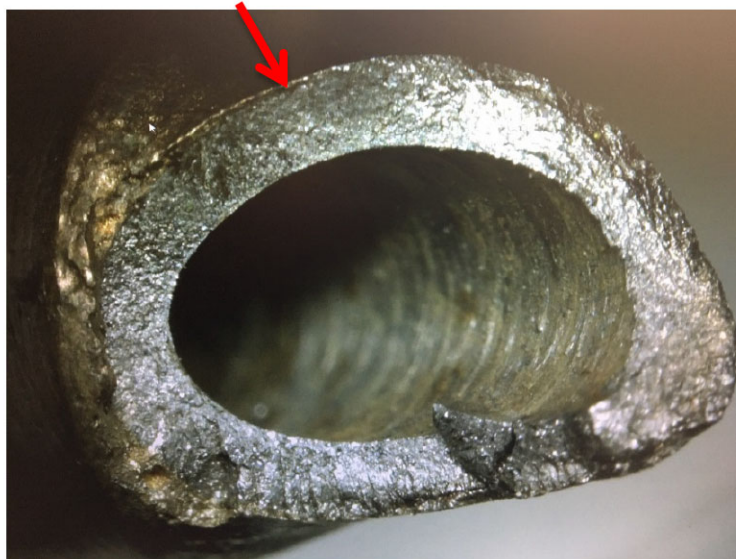
*Figure 5 Side view of fitting end fracture with initiation area marked*
