**NATIONAL TRANSPORTATION SAFETY BOARD**  
**Office of Aviation Safety**  
**Washington, D.C. 20594**

**POWERPLANT GROUP CHAIRMAN'S FACTUAL REPORT**  
**NTSB No: CEN19MA312**

Location: Monclova, Ohio

Aircraft: Convair 440, Registration Number N24DR

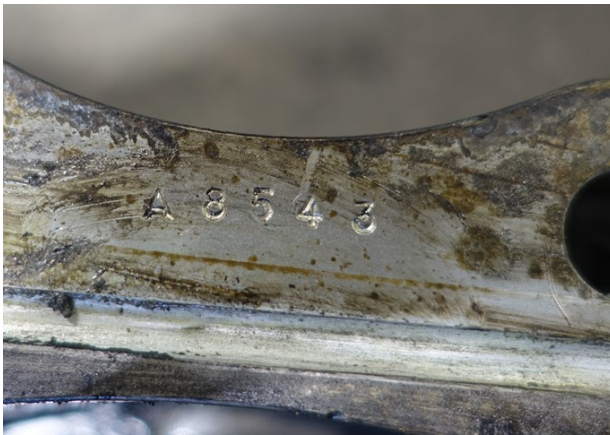
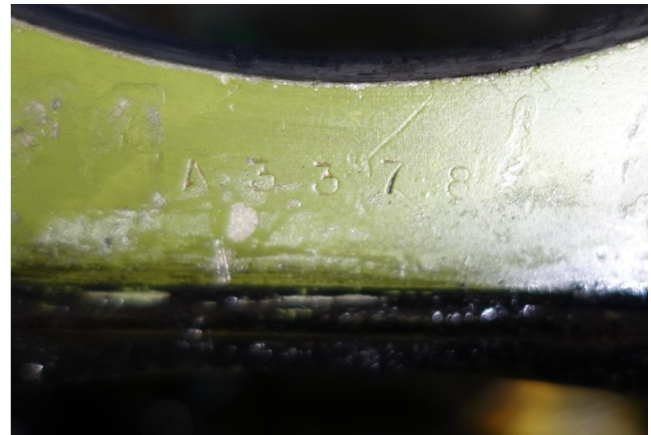
During the propeller examination, a number was visible on the left propeller hub mating flange that matched the left propeller serial number documented in the aircraft component listing. The right propeller serial number marking was not located. According to Aviation Propeller, assembly serial numbers for the Hamilton Standard 43E60 propellers historically begin with a letter. Markings A8543 and A3378 were identified on the left and right propeller hub flanges (**Photo 1**).

**Photo 1- Propeller Assembly Serial Numbers on Hub Mating Flange (L) Left Propeller, (R) Right Propeller**

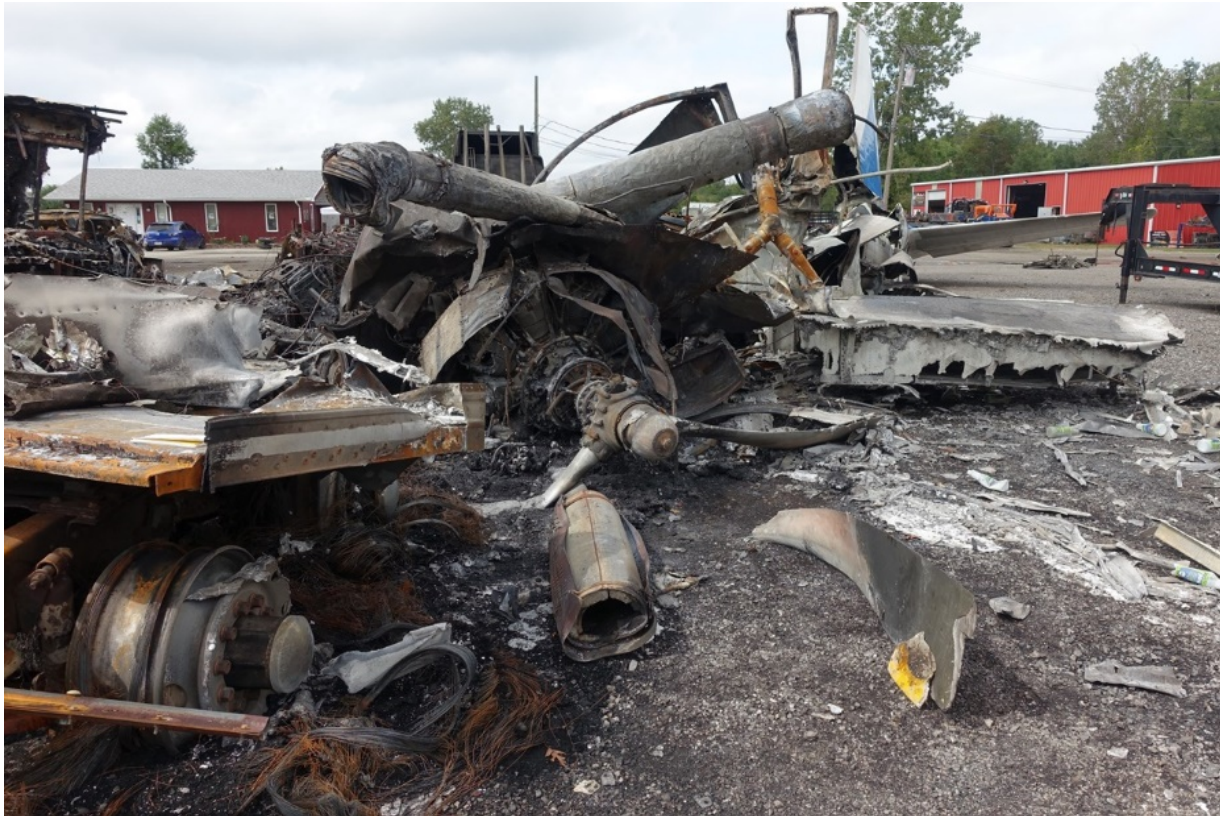
The No. 1 engine and propeller assembly came to rest on the ground against the aft side of a semi-trailer. The engine was laying on its right side, (3 o'clock position) facing approximately 150° relative to the flight path (**Photos 2 and 3**). Both the engine and propeller were thermally damaged by the post-crash fire. The Global Position System (GPS) positions and location within the debris field were documented with an unmanned aircraft system (UAS) and are available in the UAS Aerial Imagery report in the investigation docket. Investigation party members from Pratt & Whitney, the FAA, and the NTSB documented the accident site between September 12-15, 2019.

**Photo 2- No. 1 Engine and Propeller in Wreckage**

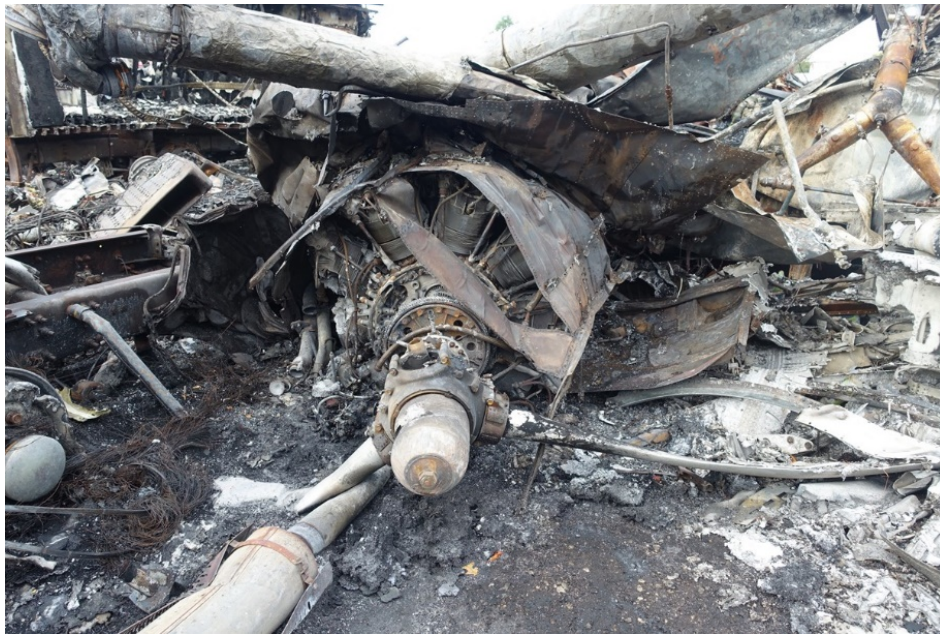
**Photo 3- No. 1 Engine and Propeller**

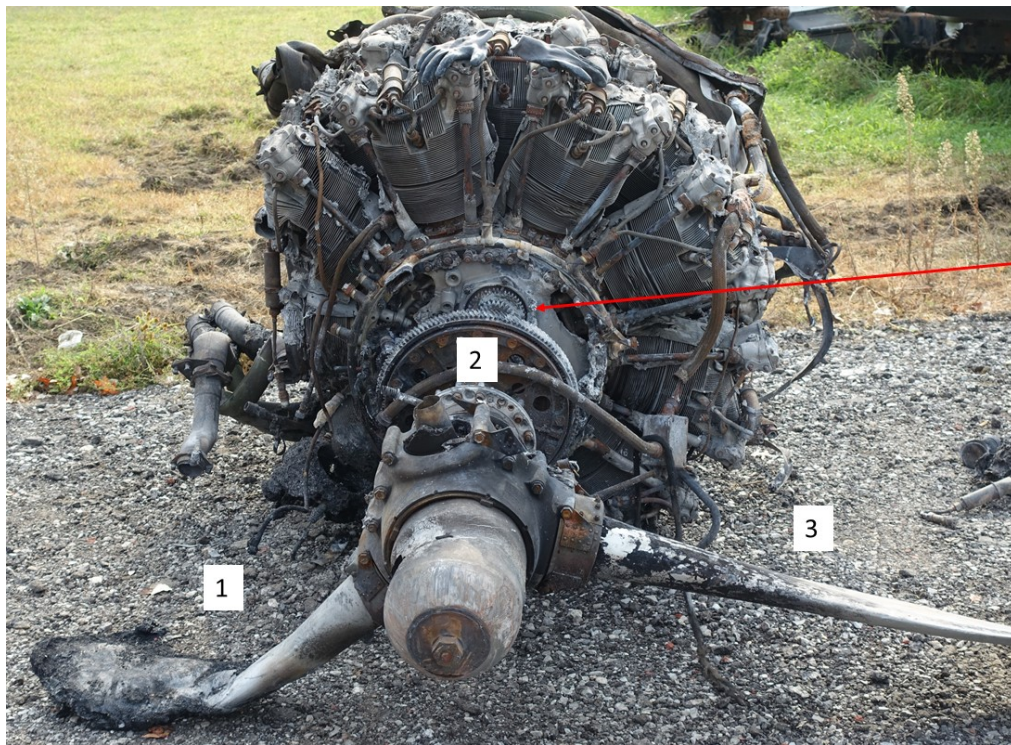
**Photo 4- No. 1 Engine, Front**

The No. 1 engine was lifted out of the wreckage with a tow truck and a visual examination was performed to document the external condition (**Photos 4, 5, and 6**). The front case and front accessory case were thermally consumed exposing the internal gear assemblies. All visible gears had dark discoloration and were coated in soot. Resolidified metal slag was adhered to the top half of the gear surfaces relative to the resting position of the engine. All 18 cylinder heads had varying levels of impact and thermal damage. The cylinder damage was most concentrated between the 12 and 5 o'clock positions. Cylinder heads 1, 2, 3, 4, 5, 7, and 18 were either fully or partially consumed exposing the piston heads. The cylinder heads between the 5 and 12 o'clock positions were complete but exhibited thermal deformation of the cooling fins and rocker head covers.

Front Case  
and Front  
Accessory  
Case  
Consumed

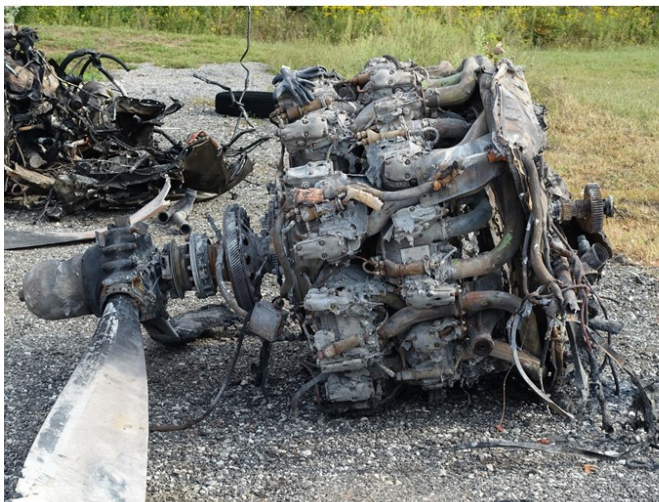
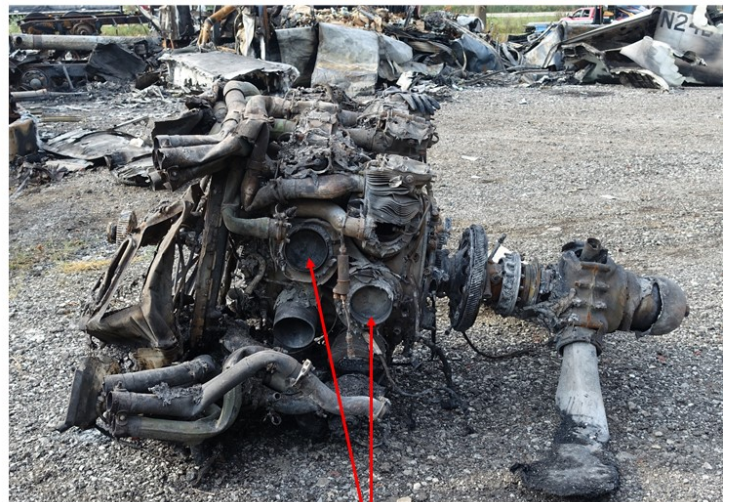
Piston Heads  
Visible

**Photo 5- (L) No. 1 Engine, 6 o'clock Position, (R) No. 1 Engine, 12 o'clock Position**

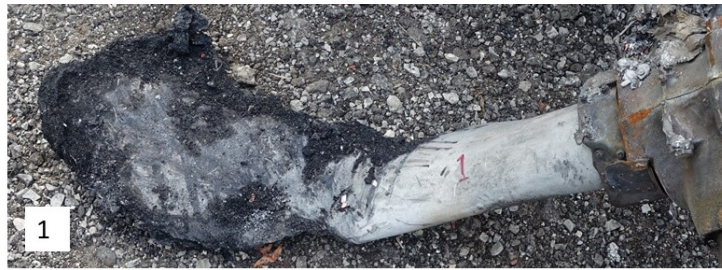
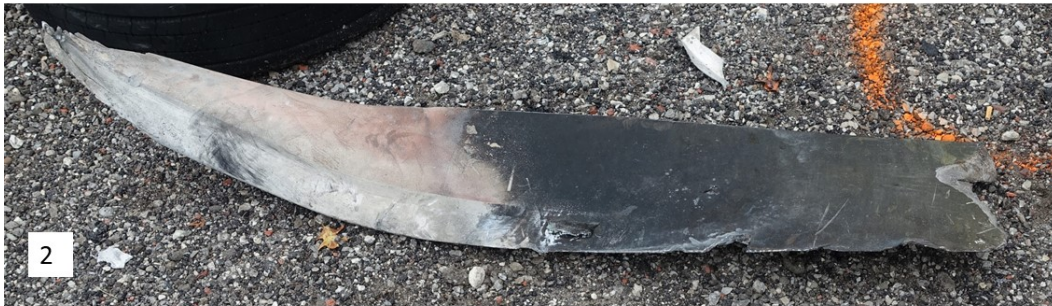
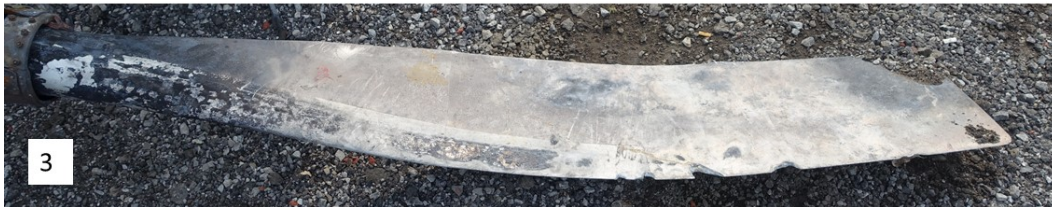
The left propeller assembly and blades were thermally damaged and heavily sooted consistent with exposure to a post-crash fire. The right facing propeller blade (blade 1) was melted approximately 13 inches from the blade collar, outward along the rest of the span. What remained of the propeller blade measured 34 inches from the blade collar to the resolidified blade tip.

The propeller blade that came to rest facing upward (blade 2) was fractured at the blade root and the fracture surface appeared rough and jagged. The separated blade section was recovered near the engine against a semi-trailer frame. The length of the recovered propeller blade section was approximately 68 inches and exhibited bending in the clockwise direction and had leading edge impact strikes.

The left facing propeller blade (blade 3) was complete and measured approximately 71 inches. The blade exhibited bending in the clockwise direction and had leading edge impact gouges over the outer 30 inches of the blade span. The leading edge gouges were at approximately the same spanwise location as the separated section of propeller blade 2. The propeller dome was thermally consumed from the 12 to 5 o'clock positions, coincident with the area of most severe thermal damage on the engine cylinders and external engine components (**Photo 7**).

**Photo 7- Left Propeller Blades**

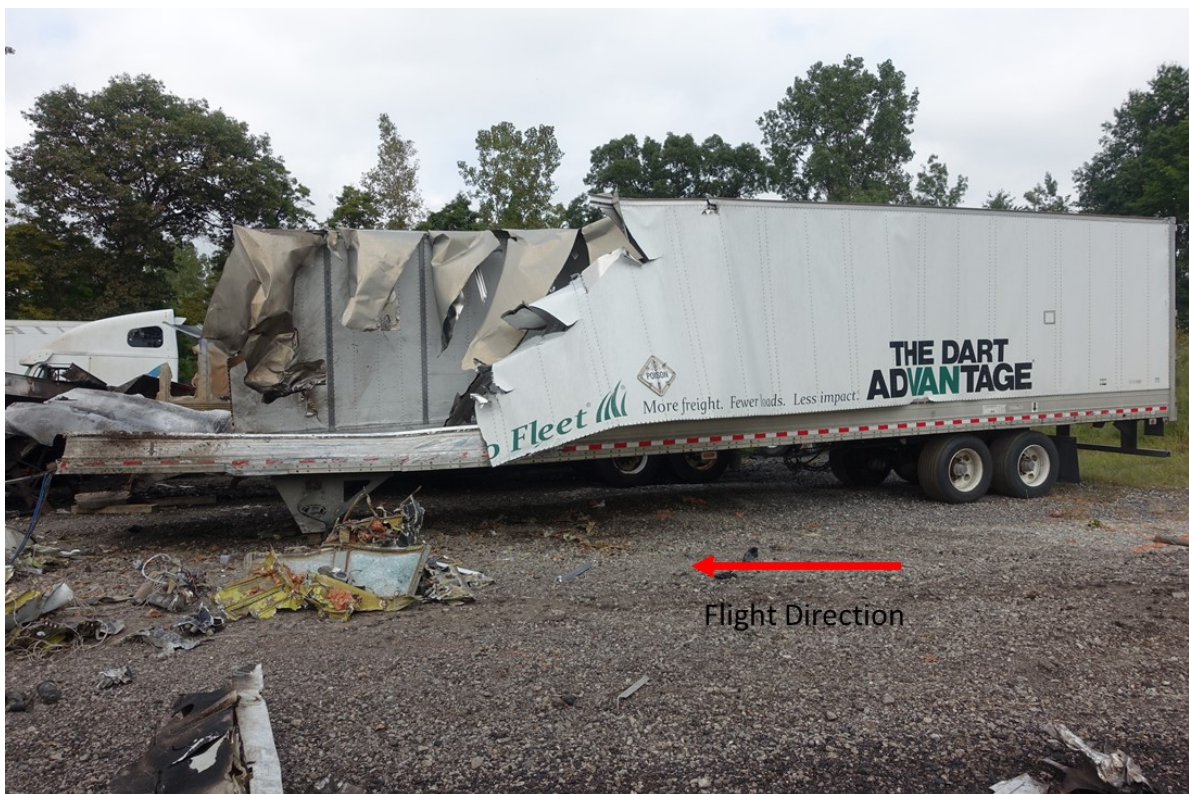
A semi-trailer parked on the right side of the flight path had a series of propeller strikes that sliced through the roof and left side of the trailer<sup>1</sup>. Two additional propeller strikes were also observed on the wood floor/deck of the trailer. The propeller strikes on the left side the trailer were spaced approximately 38 inches apart and the two slices in the wood floor were approximately 42 inches apart (**Photos 8 and 9**). Propeller blade fragments that appeared to be the blade tips were recovered loose on the trailer floor (**Photo 10**). The position of the trailer appeared to have shifted during the impact sequence.

**Photo 8- Trailer Propeller Strikes**

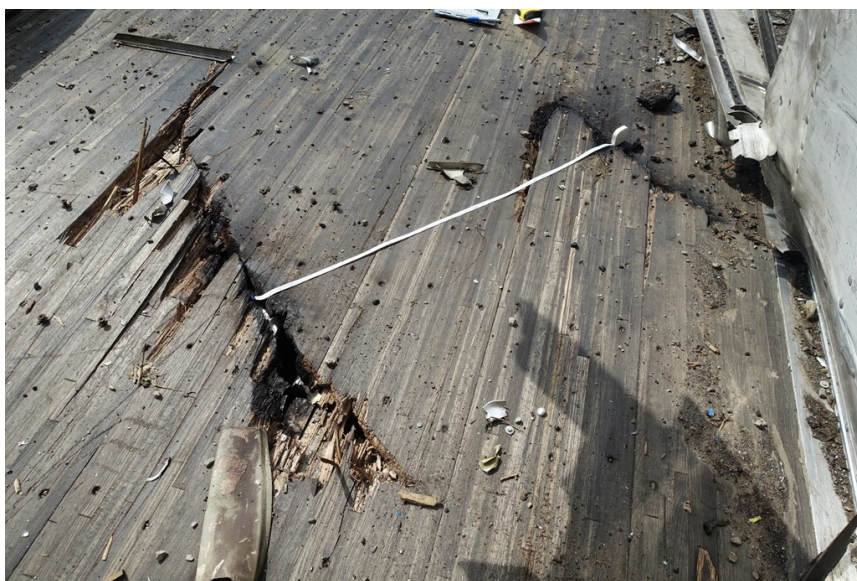
**Photo 9- Trailer Floor Propeller Strikes**

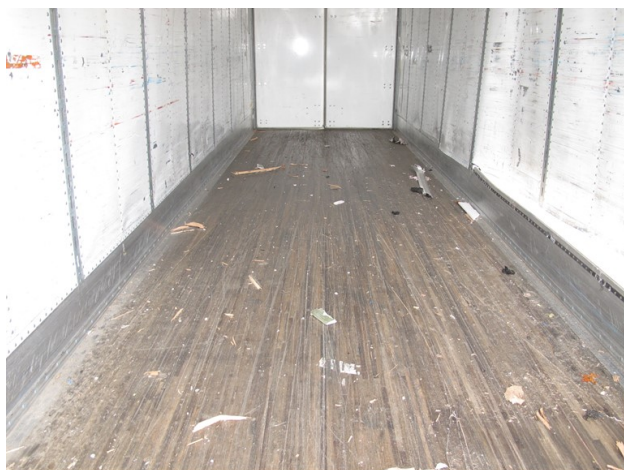
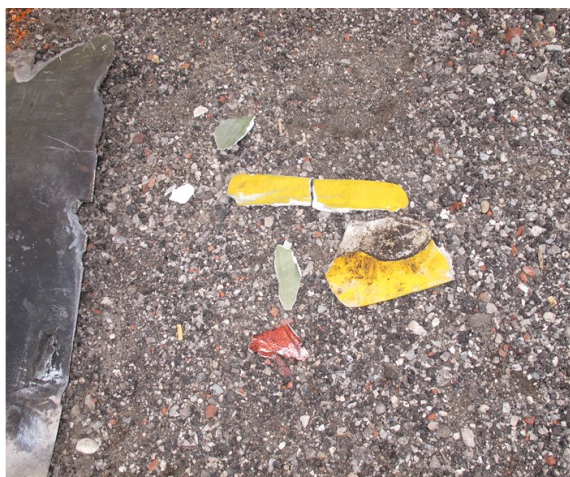
**Photo 10- Propeller Blade Tip Fragments (L) In Trailer**

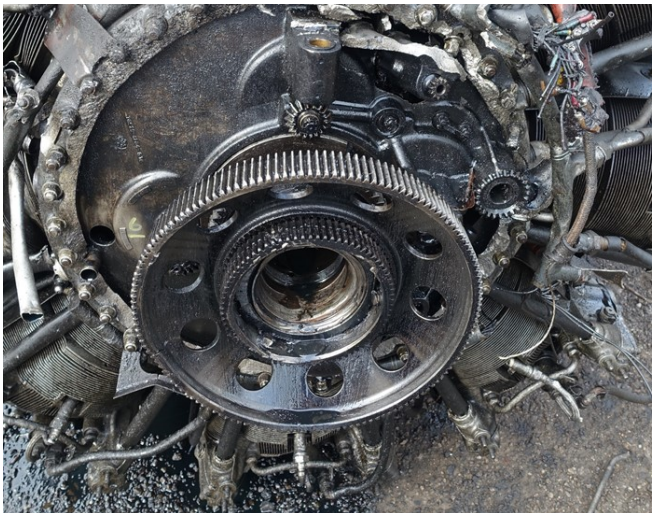
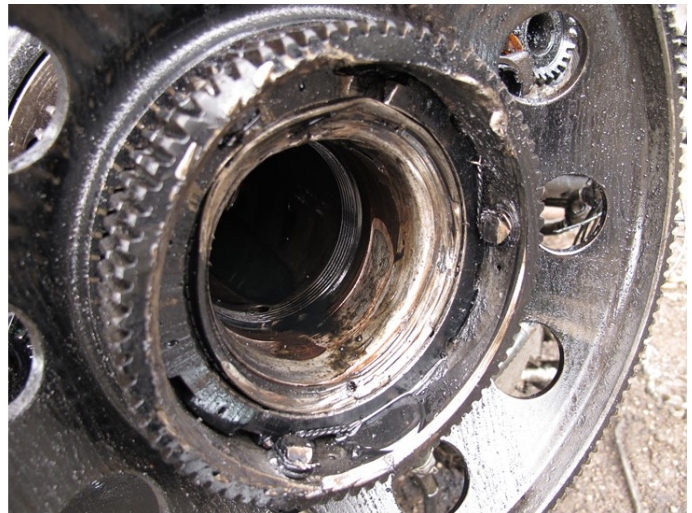
The engine front and front accessory cases were fractured and separated forward of the crankcase. The fracture surfaces appeared rough and jagged. Exposed engine surfaces were oil wetted, and oil was pooled beneath the engine. The oil color appeared normal and did not smell acrid. The exposed reduction drive gear was deformed consistent with impact damage. The reduction drive gear had a crack that ran from the outer diameter into the gear web. The engine propeller shaft journal had 360° rotational scoring in plane with the reduction drive gear (**Photo 13**).

**Photo 13- Reduction Drive Gear Deformation and Propeller Shaft Journal Scoring**

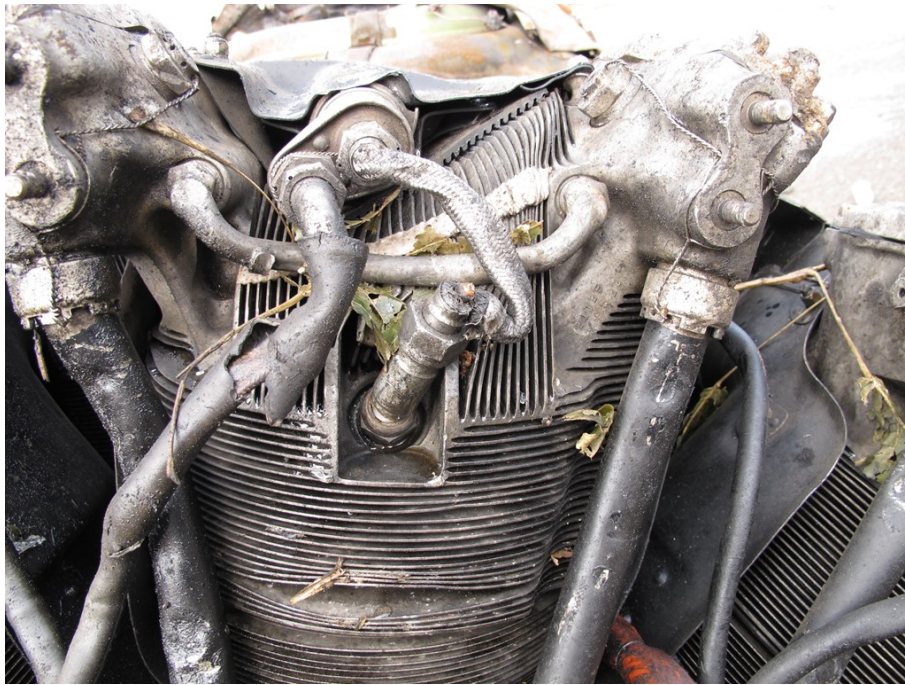
All 18 cylinders were present and complete. Branches, leaves, and dirt debris were collected in the front cylinder head cooling fins between the 12 and 5 o'clock positions (**Photo 14**). The exhaust rocker cover on cylinder 2 and the intake rocker cover on cylinder 18, both located near the 12 o'clock position were separated and the surfaces around the separated covers had impact/rub damage in the axial direction. The exhaust manifold plumbing was all present, but some crushing deformation was observed at about the 1 o'clock position. There was a small area of localized thermal damage at approximately the 12 o'clock position (left side as the engine was resting), immediately aft of the cylinder

**Photo 14- Tree and Leaf Debris Lodged into Cylinder Heads**

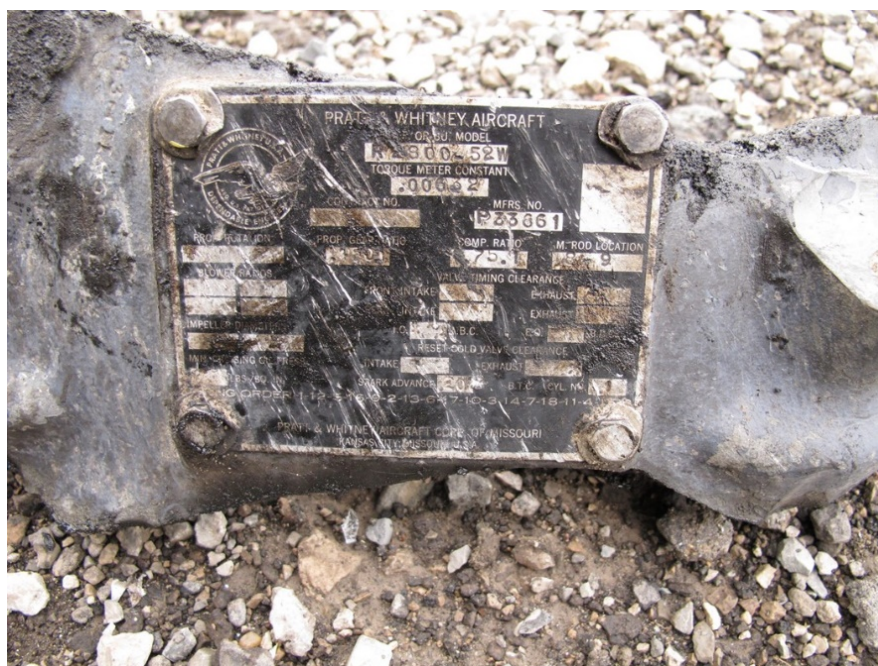
Two front accessory case fragments, including one with an engine data plate, were recovered along the debris path. The fracture surfaces of the recovered case fragments matched the fracture surfaces on the right engine front accessory case (**Photo 15**).

**Photo 15- Front Case Fragment and Engine Data Plate**

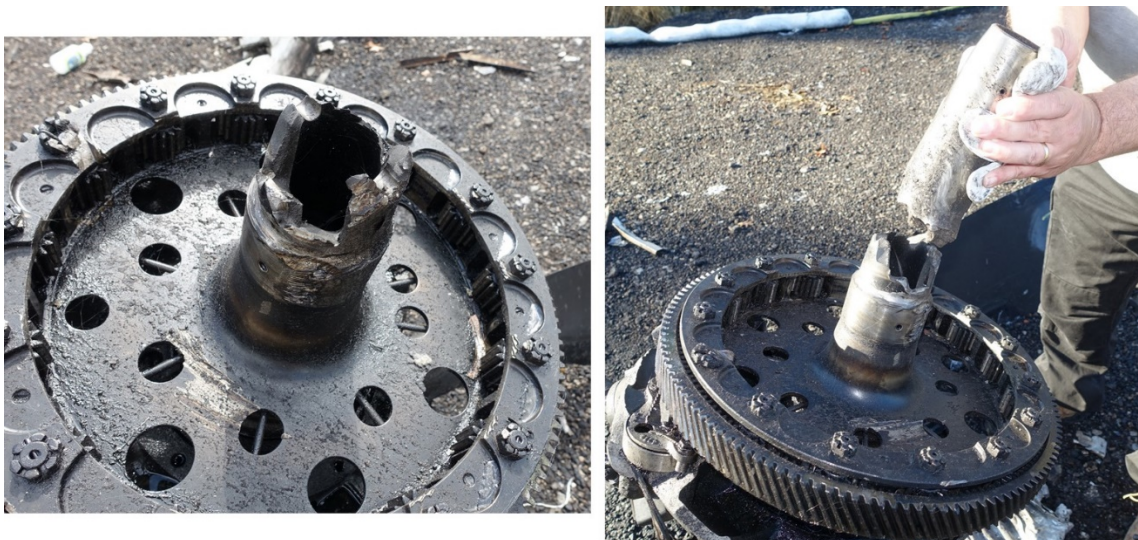
The aft end of the propeller shaft was separated during the impact sequence. The separated section of the shaft was recovered near the propeller (**Photo 16**). On both sides of the shaft fracture there was circumferential scoring. The scoring was coincident with the scoring documented in the engine propeller shaft journal. The propeller came to rest with the propeller dome and two of the blades against the ground (**Photo 17**). All three propeller blades were full span, approximately 71 inches from blade collar to tip. One propeller blade (blade 2) was rotated 180° relative to the other two. The blades labeled 1 and 2 both exhibited bending in the clockwise direction. The anti-icing boot on all three blades was thermally damaged. The as-recovered blade angles did not appear consistent with the deformation on the blade collars.

**Photo 16- Right Propeller Shaft Separation**

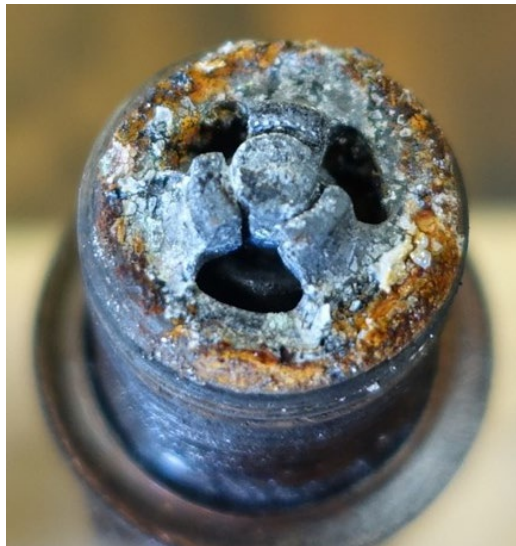
<sup>4</sup> According to Vintage Radials, ashy or light colored spark plug electrodes are commonly seen when the engine is operated with a lean fuel mixture.

**Photo 23- Cylinder 11 Front Spark Plug Electrode**

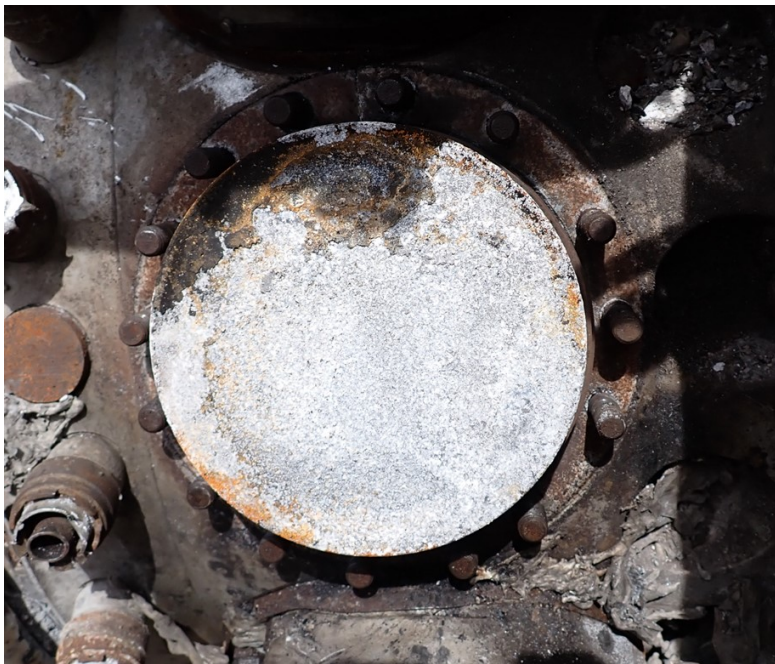
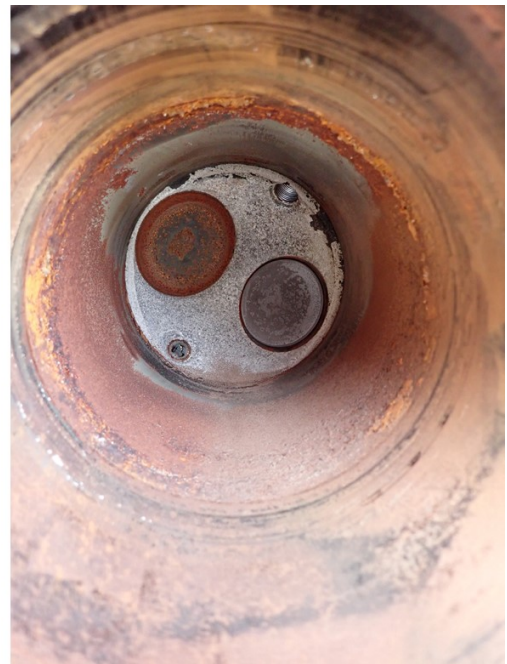
<sup>5</sup> Signs of detonation include uneven wear, material loss, and/or discoloration on the top surface of the piston head.

**Photo 24- Cylinder 16, (L) Piston Head, (R) Cylinder Interior and Valves**

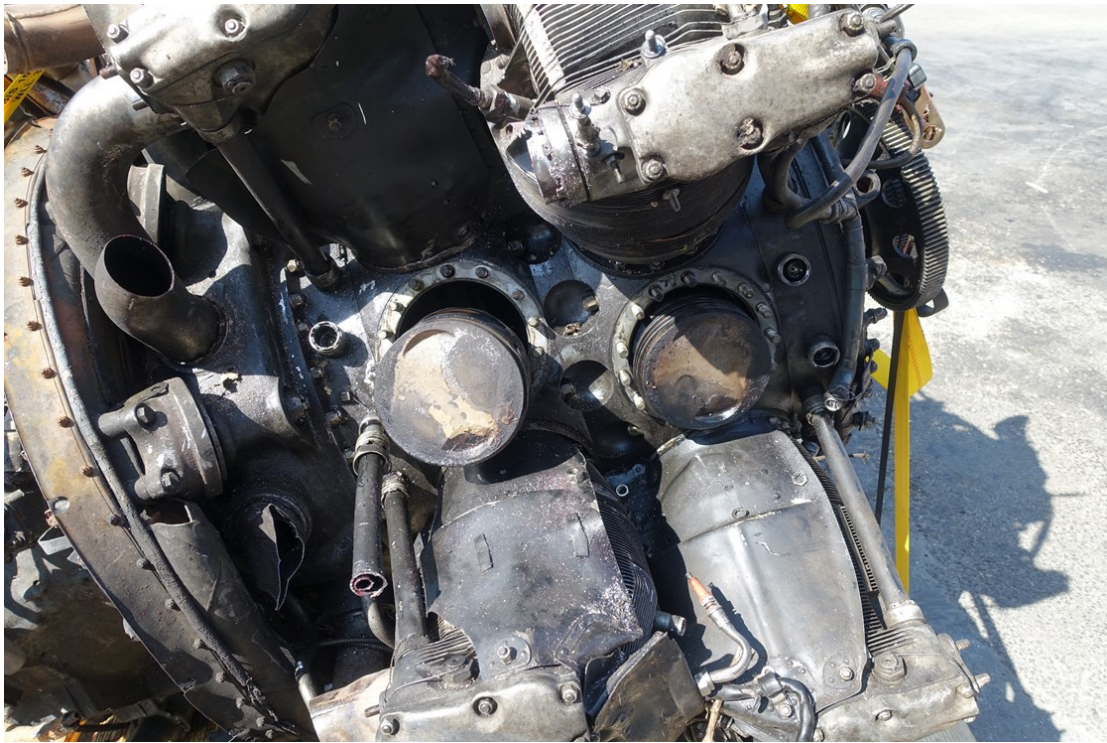
cylinders and the exposed piston heads were in good condition with no evidence of detonation or other anomalies (**Photos 29 and 30**). The forward and aft sections of the crankcase were inspected visually and with a borescope. The internal components were oil wetted and in good condition.

**Photo 29- No. 2 Engine Piston Heads, Cylinders 5 and 6**

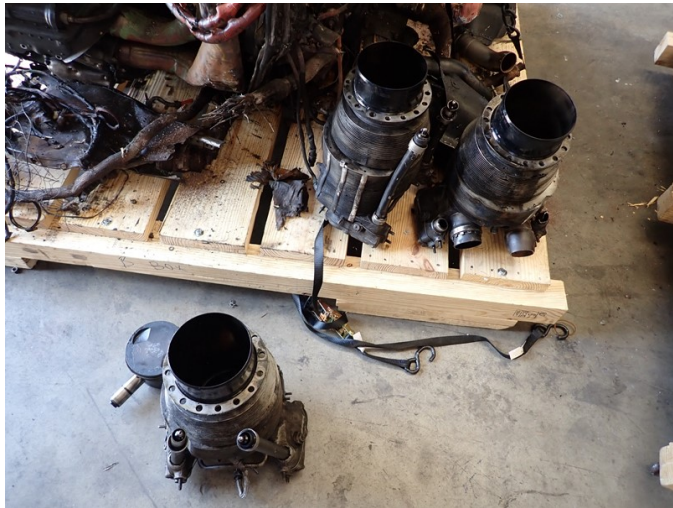
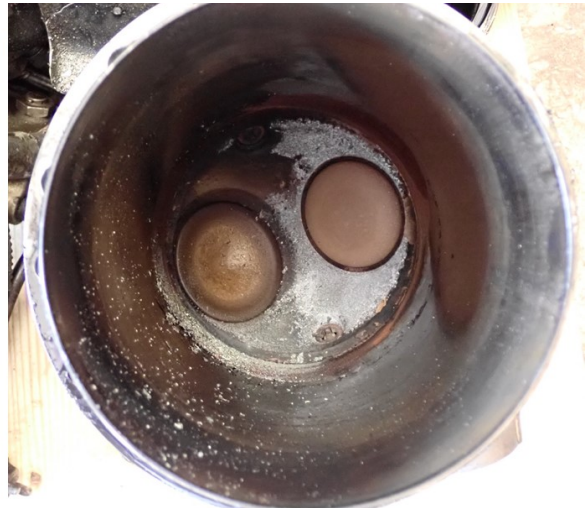
**Photo 30- No. 2 Engine, (L) Cylinder Heads/Sleeves 5, 6, and 16, (R) Inside of Cylinder 16**

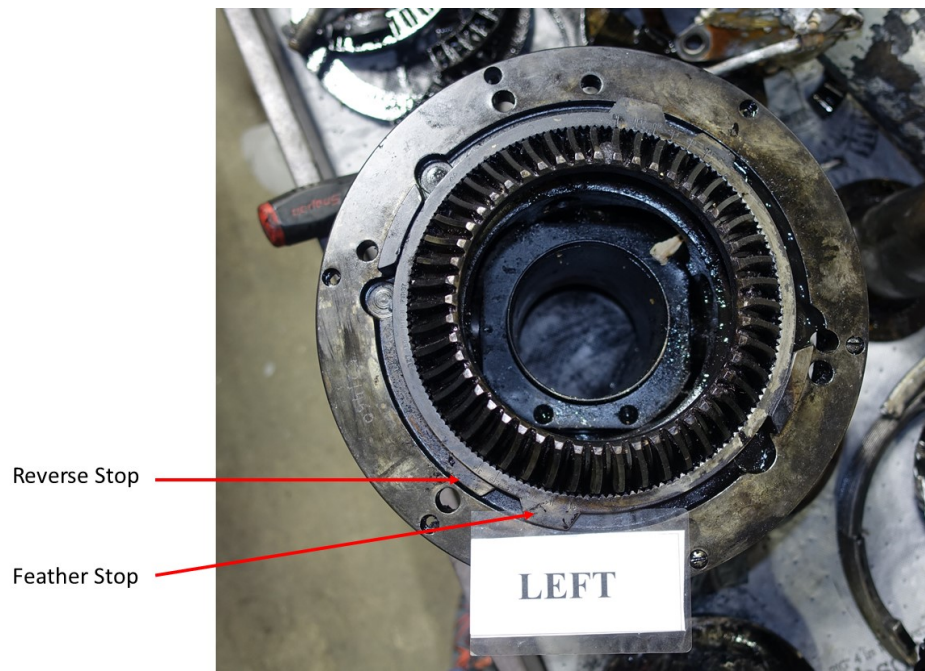
The left propeller dome was thermally damaged and missing material. Prior to disassembly, an index mark was created to identify the as-received piston position. The dome nut was seized and could not be removed with standard tooling. The nut was cut in three places with a pneumatic cutting wheel and then a hammer was used to unthread the nut and separate the dome. The dome oil transfer tube and transfer housing were intact. The dome stop ring position<sup>6</sup> was measured with a Collins Aerospace protractor template and revealed an angle of 40° (**Photos 33**).

**Photo 33- Left Propeller Dome Assembly**

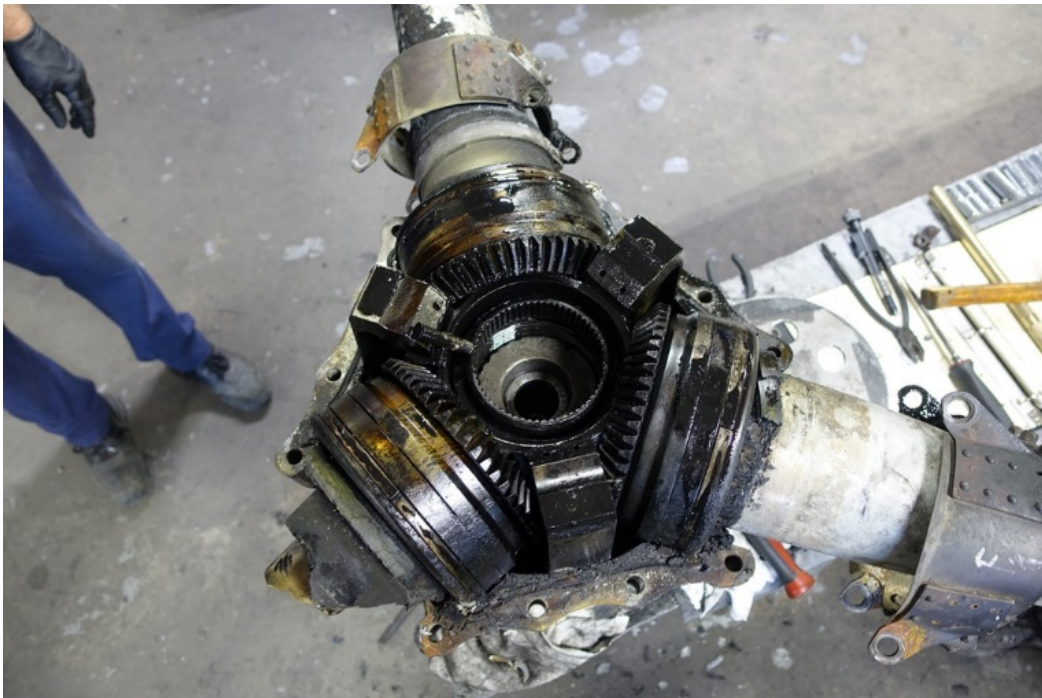
The left propeller hub and propeller blade thermal and impact damage resulted in deformation that made propeller blade removal difficult (**Photo 34**). Small metal fragments were recovered inside the propeller hub cavity. The hub flanges exhibited metal adhesion and wear outboard of the gasket seal (**Photo 35**). The shims on blades 2 and 3 were fractured and all three shims had an area of uniform discoloration consistent with thermal exposure and impact witness marks (spider impact marks). The shim discoloration and spider impact mark angles were measured with a protractor template to approximate blade angle (**Photo 36, 37, and 38**) and summarized in **Table 2**. The bushing retaining pins and screws located on the blade butts were fractured on blades 2 and 3 (**Photo 39**).

**Photo 34- Left Propeller Hub Cavity**

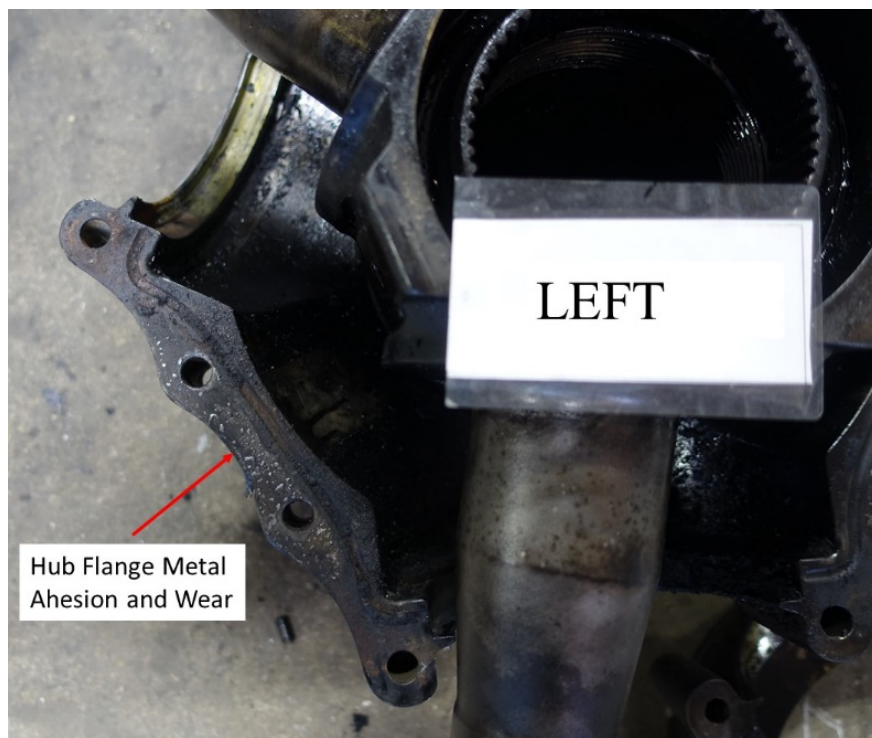
**Photo 35- Left Propeller Hub Flange, Metal Adhesion and Wear**

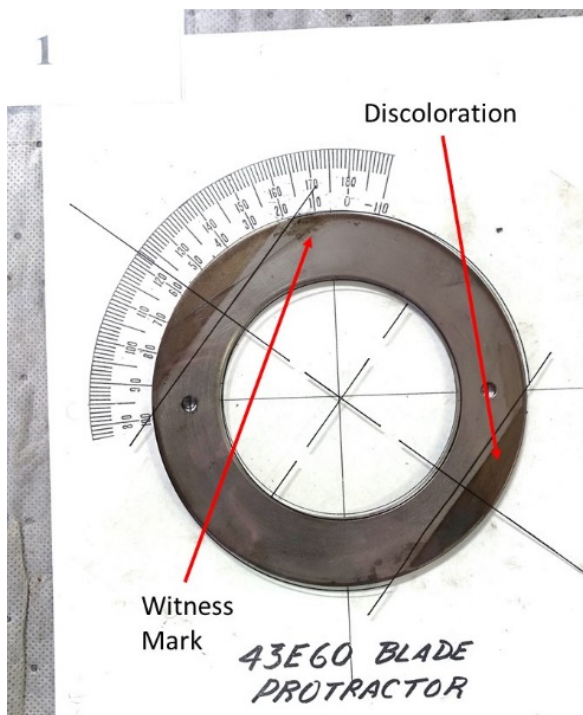
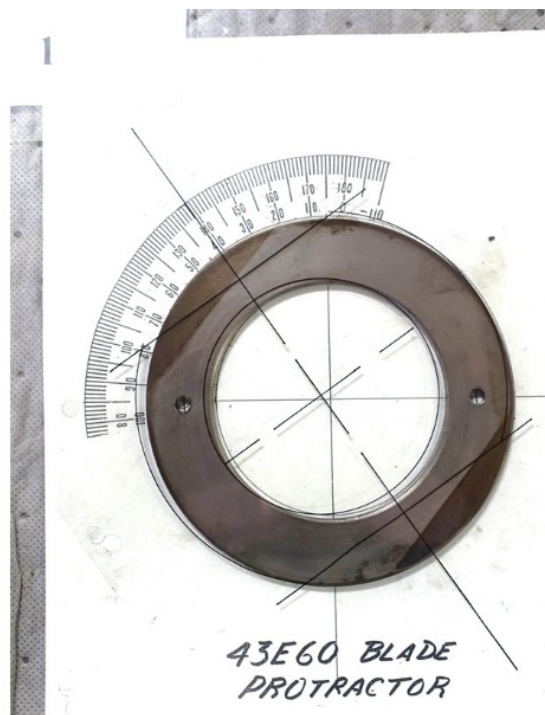
Photo 36- Left Propeller, Blade 1 (L) Discoloration Angle, (R) Witness Mark Angle

| Blade Shim | Discoloration Angle (degrees) | Spider Impact Mark Angle (degrees) |
|---|---|---|
| 1 | 55 | 41 |

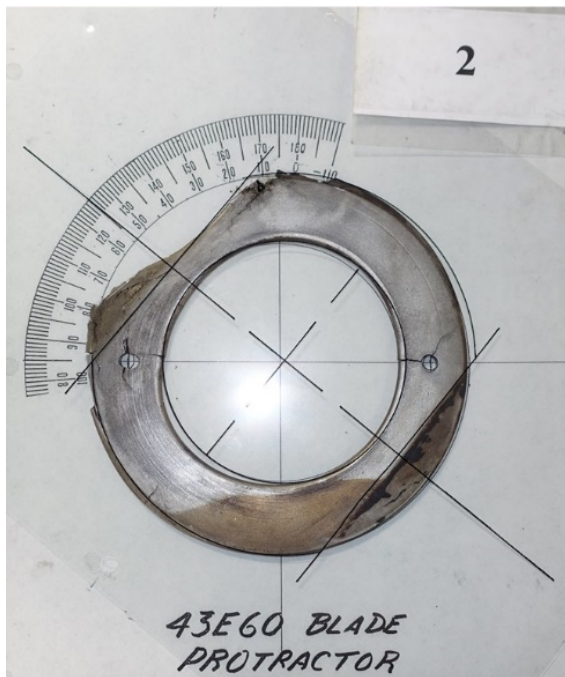
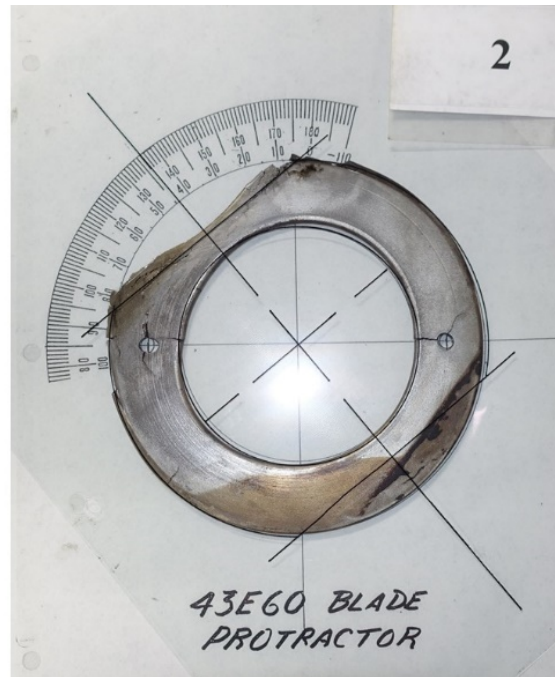
Photo 37- Left Propeller, Blade 2 (L) Discoloration Angle, (R) Witness Mark Angle

| Blade Shim | Discoloration Angle (degrees) | Spider Impact Mark Angle (degrees) |
|---|---|---|
| 2 | 55 | 44 |

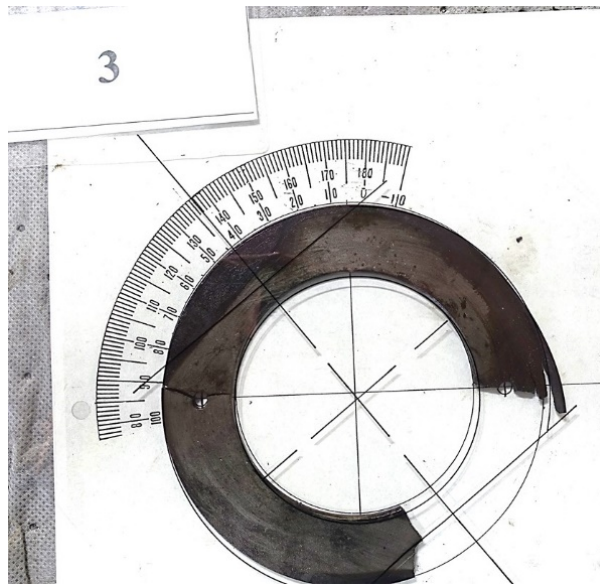
**Photo 38- Left Propeller, Blade 3 Witness Mark Blade Angle**

| Blade Shim | Discoloration Angle (degrees) | Spider Impact Mark Angle (degrees) |
|---|---|---|
| 3 | 55 | 43 |

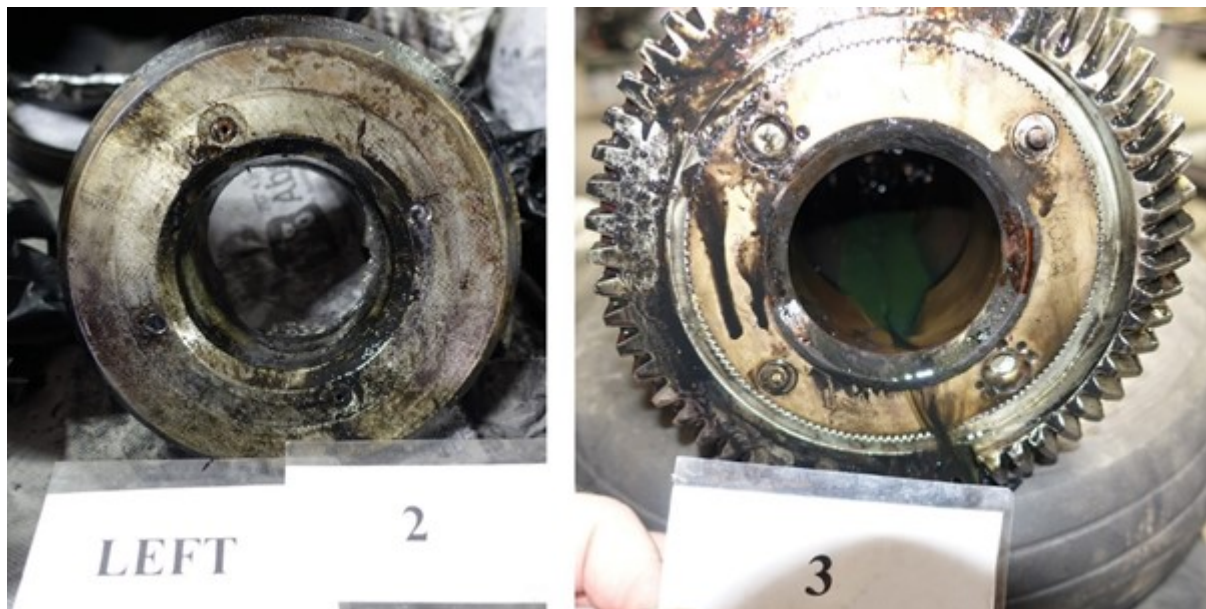
**Photo 39- Left Propeller Blades 2 and 3 Bushing Drive Pins and Retention Screws Broken**

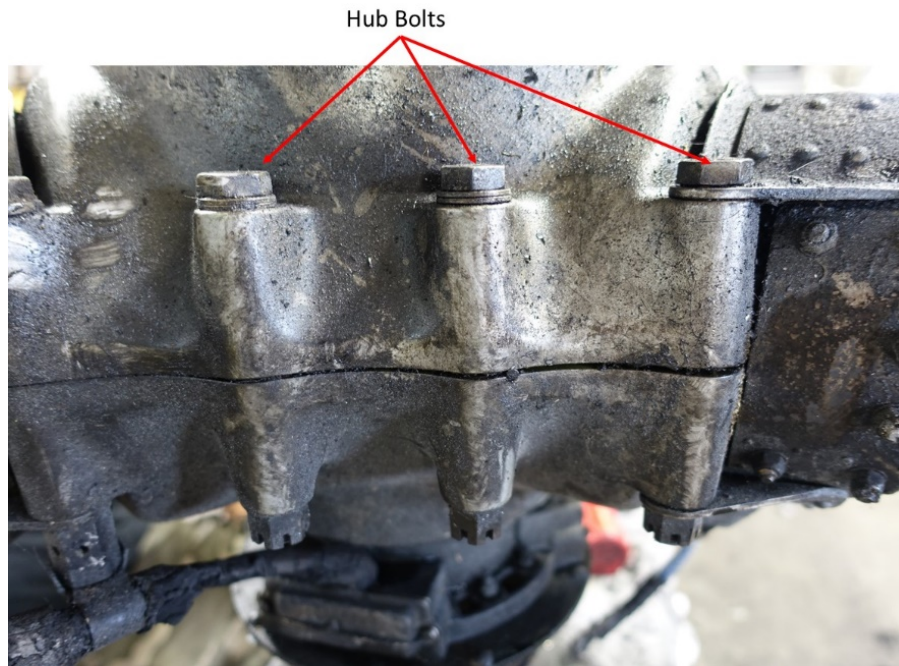
The propeller hub had multiple small metal fragments that were recovered loose inside the hub cavity. The hub bolts all had minimal torque and a gap was visible between the hub halves with o-ring material protruding from the gap (**Photo 41**). Blade 2 had rotated about 180° relative to the other two blades.

**Photo 41- Right Propeller Hub Gap**

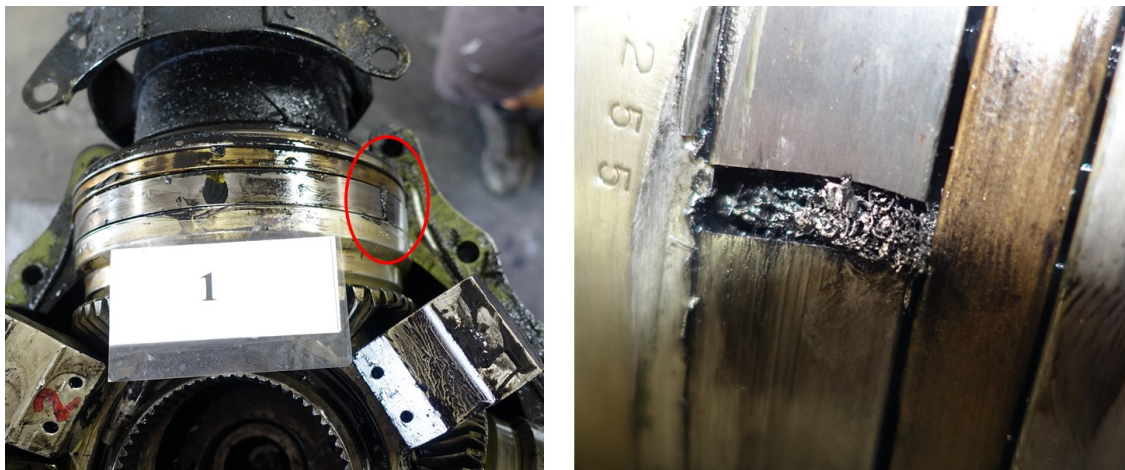
The blade 1 bevel washer was split and partially separated. Metal shavings had accumulated between the split halves (**Photo 42**). A coincident rub with material loss was observed on the arm bore. A section of each of the three propeller blade shims were fractured and a spider impact witness mark was visible on each shim. A Collins Aerospace protractor template was used to approximate the propeller blade angle at the time of impact (**Photos 43, 44, and 45**) and summarized in **Table 3**. Propeller blade 2 (recovered rotated 180° relative to the other blades) had one bushing retaining screw fractured. Both the propeller blade bushing retaining screws and one of the retaining pins was fractured on blade 3 (**Photo 46**).

**Photo 42- Blade 1 Thrust Bushing Split, (R) Metal Shavings in Split**

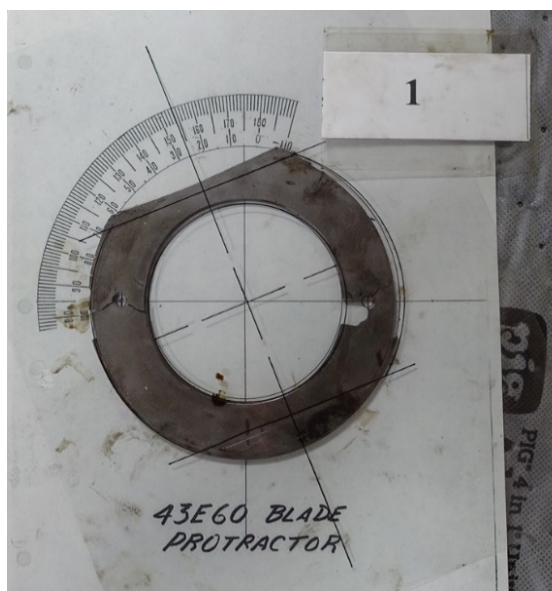
**Photo 43- Right Propeller, Blade 1 Witness Mark with Blade Angle Protractor**

| Blade Shim | Witness Mark Angle (degrees) |
|---|---|
| 1 | 26 |

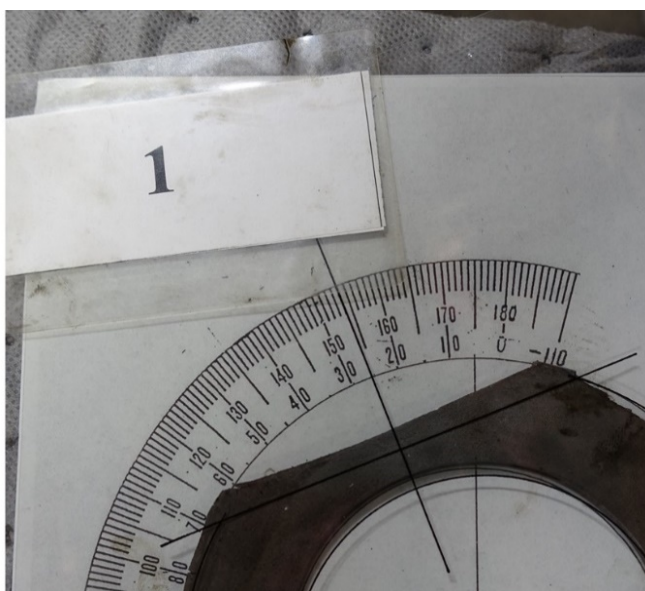
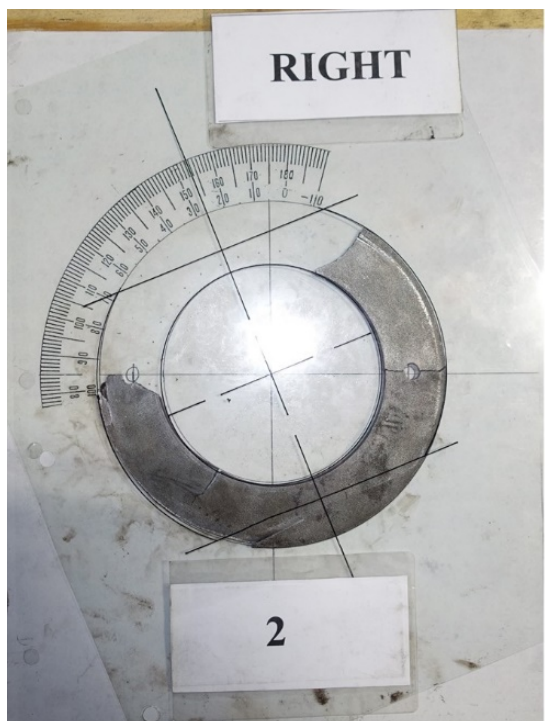
**Photo 44- Right Propeller, Blade 2 Witness Mark with Blade Angle Protractor**

| Blade Shim | Witness Mark Angle (degrees) |
|---|---|
| 2 | 27 |

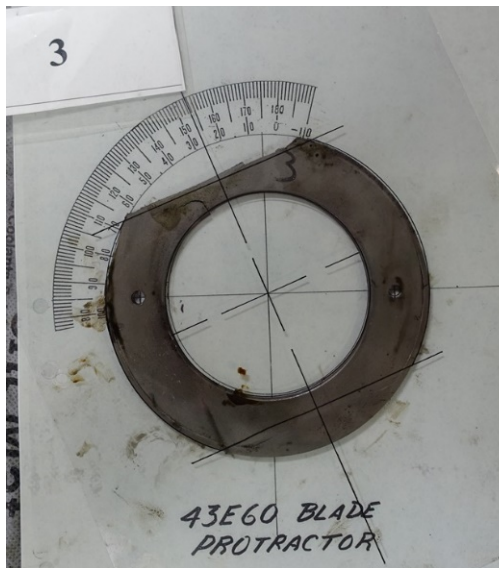
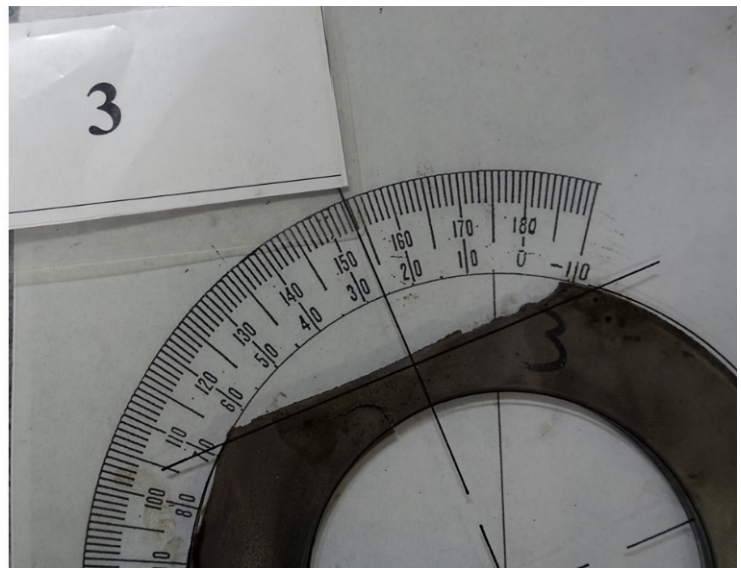
**Photo 45- Right Propeller, Blade 3 Witness Marks with Blade Angle Protractor**

| Blade Shim | Witness Mark Angle (degrees) |
|---|---|
| 3 | 26 |
