**NATIONAL TRANSPORTATION SAFETY BOARD**  
**Office of Aviation Safety**  
**Washington, D.C. 20594**

**POWERPLANT GROUP CHAIRMAN'S FACTUAL REPORT**  
**NTSB No: CEN19MA312**

Location: Monclova, Ohio

Aircraft: Convair 440, Registration Number N24DR

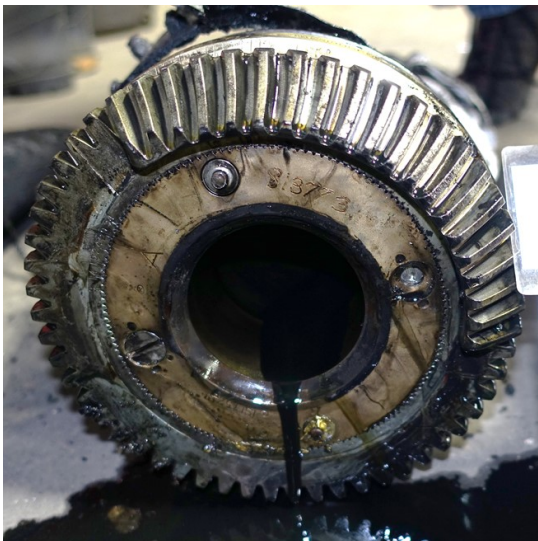
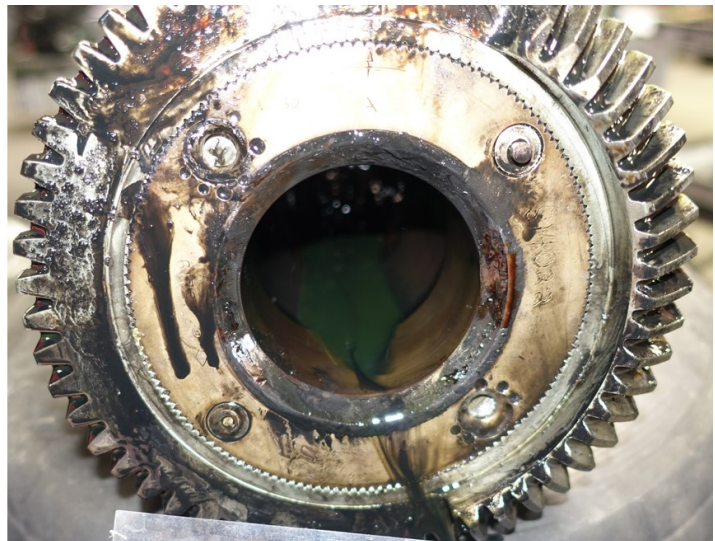
The blade 1 bevel washer was split and partially separated. Metal shavings had accumulated between the split halves (**Photo 42**). A coincident rub with material loss was observed on the arm bore. A section of each of the three propeller blade shims were fractured and a spider impact witness mark was visible on each shim. A Collins Aerospace protractor template was used to approximate the propeller blade angle at the time of impact (**Photos 43, 44, and 45**) and summarized in **Table 3**. Propeller blade 2 (recovered rotated 180° relative to the other blades) had one bushing retaining screw fractured. Both the propeller blade bushing retaining screws and one of the retaining pins was fractured on blade 3 (**Photo 46**).

**Photo 46- Blades 2 and 3, Bushing Retaining Pin and Screw Damage**
