# **NATIONAL TRANSPORTATION SAFETY BOARD**

## **Airworthiness Group Chairman's Factual Report**

### **A. ACCIDENT CEN19MA312**

Location: Monclova, Ohio  
Date: September 11, 2019  
Time: 0239 eastern daylight time  
Aircraft: Convair 440, registration N24DR

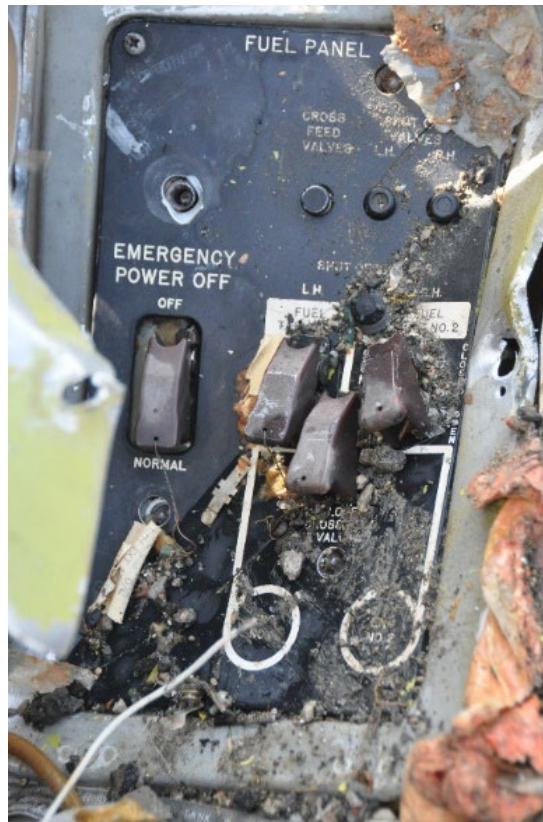
Figure 1 - Fuel Panel

- Emergency Power Off switch intact, in NORMAL setting
- Cross Feed and Shutoff Valves circuit breakers intact and not tripped
- Fuel Shutoff Valves switch for left and right tank intact in the OPEN position
- Cross Feed intact, in the CLOSED position

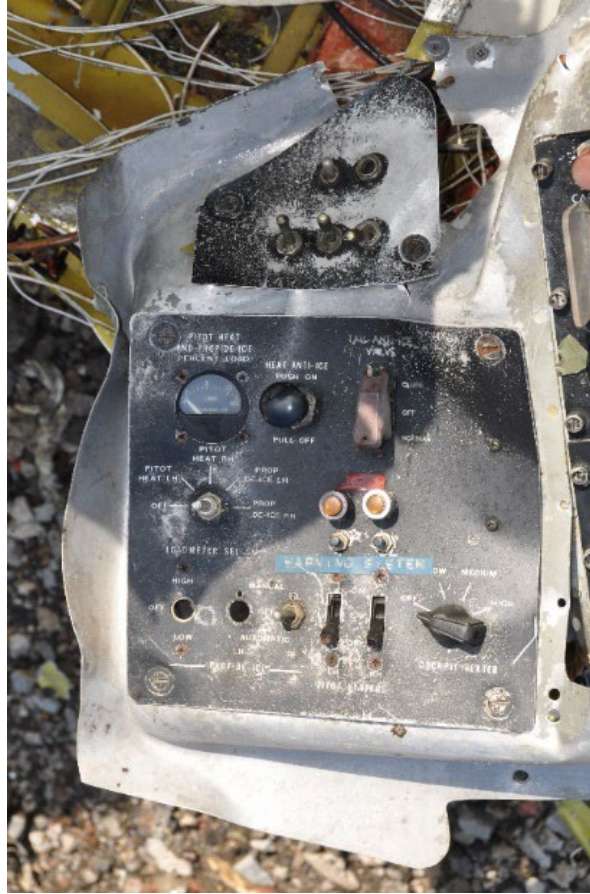
Figure 2 - Landing Light and Pitot Heat Panels

- Left landing light switch was intact
- The right landing light switch was not found
- Pitot Heat and Prop De-Ice Percent Load gauge appeared intact
- Heat Anti-Ice in the PULL OFF position
- Load Master Selector Switch Knob separated
- Prop De-Ice right hand switch intact, in the OFF position
- The Left Prop De-Ice switch was separated
- Left- and Right-hand Pitot Heater switches in the OFF position
- Tail Anti-Ice Valve switch armed in the NORMAL position
- Cockpit Heater selector knob in the OFF position

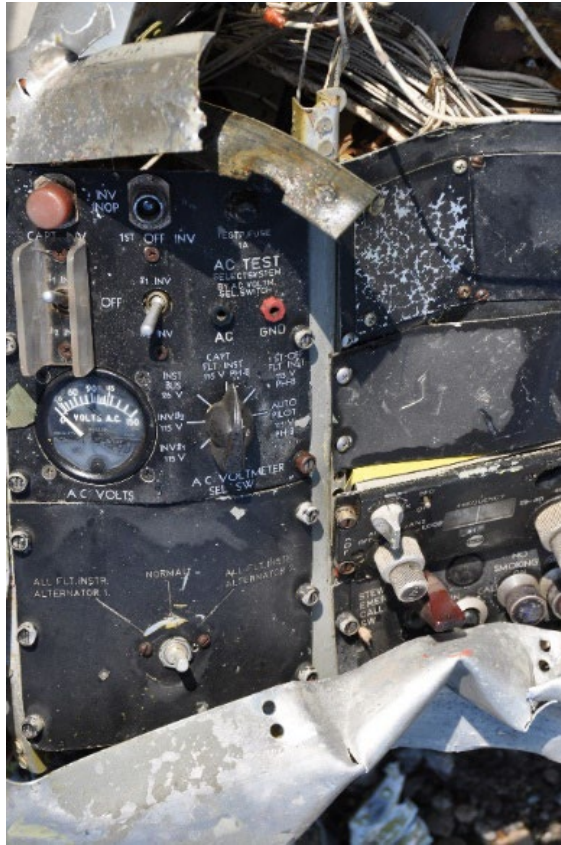
Figure 3 - Inverter Panel Section

- Inverter switches set to #1 INV (Inverter) and #2 INV (Inverter)
- Volt AC gauge intact, indicated zero
- AC Voltmeter selector switch in the CAPT FLT INST 115v PH-B (Captain Flight Instrument) position
- Alternator selector knob separated, missing

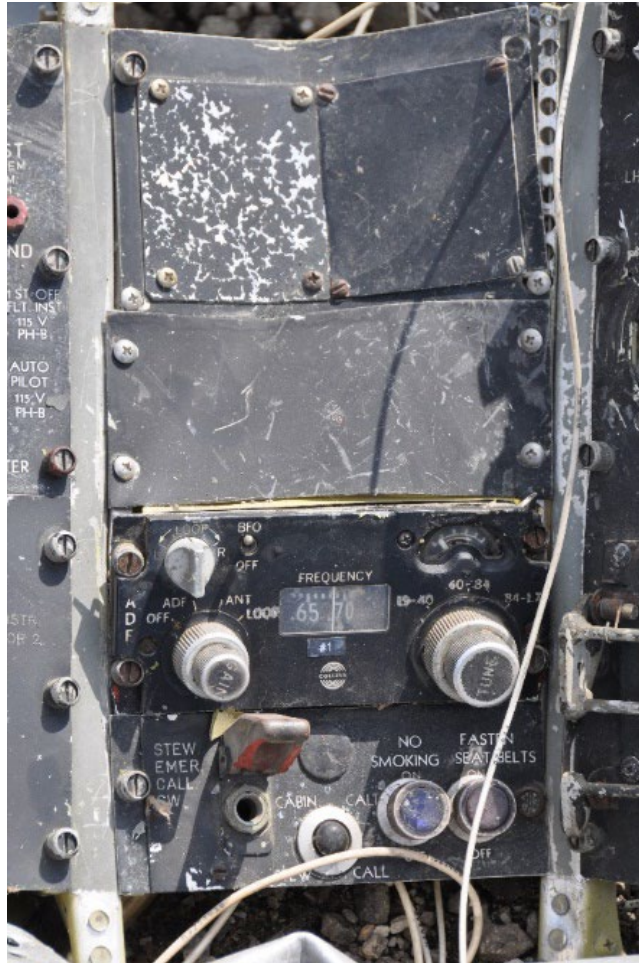
Figure 4 - ADF Panel

- GAIN and TUNE dial knobs intact
- ADF Frequency #1 set to 68
- Steward Emergency Call Switch, missing and not found

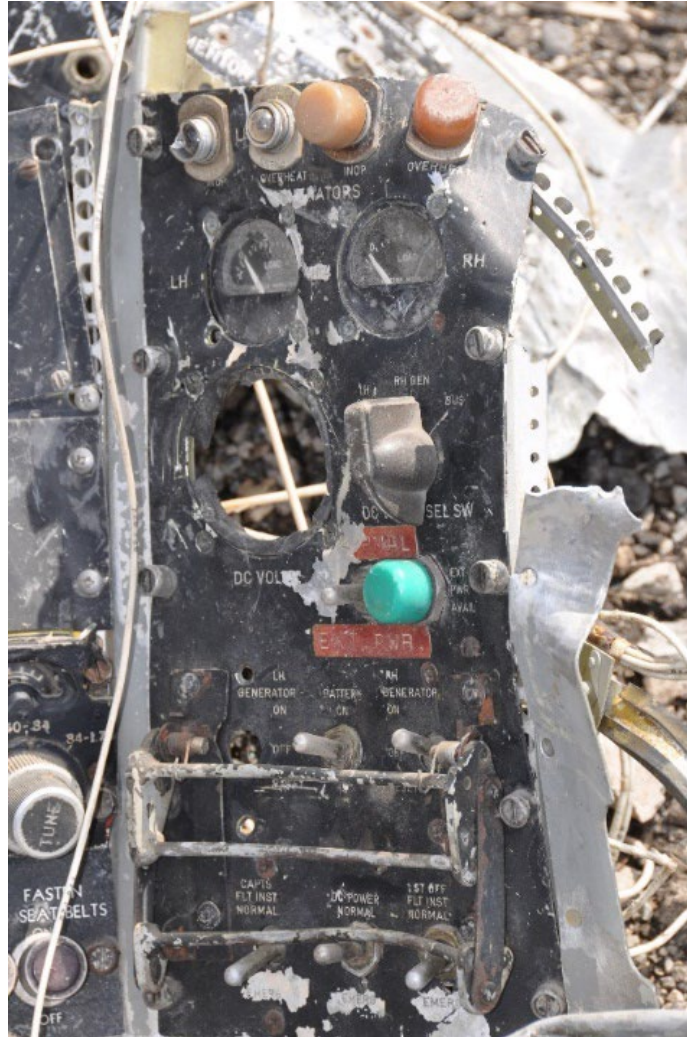
Figure 5 – Generator Section of Panel

- Left- and Right-hand generator gauges intact
- DC Volt gauge separated from panel
- DC Selector Switch in the 6 o'clock position
- Battery Switch ON
- Left Hand Generator switch separated from panel
- Right Hand Generator switch in the ON position
- Captain Flight Instrument Normal switch in EMERG position
- DC Power in the NORMAL position
- 1<sup>st</sup> Officer Flight Instrument Normal switch in the EMERG position

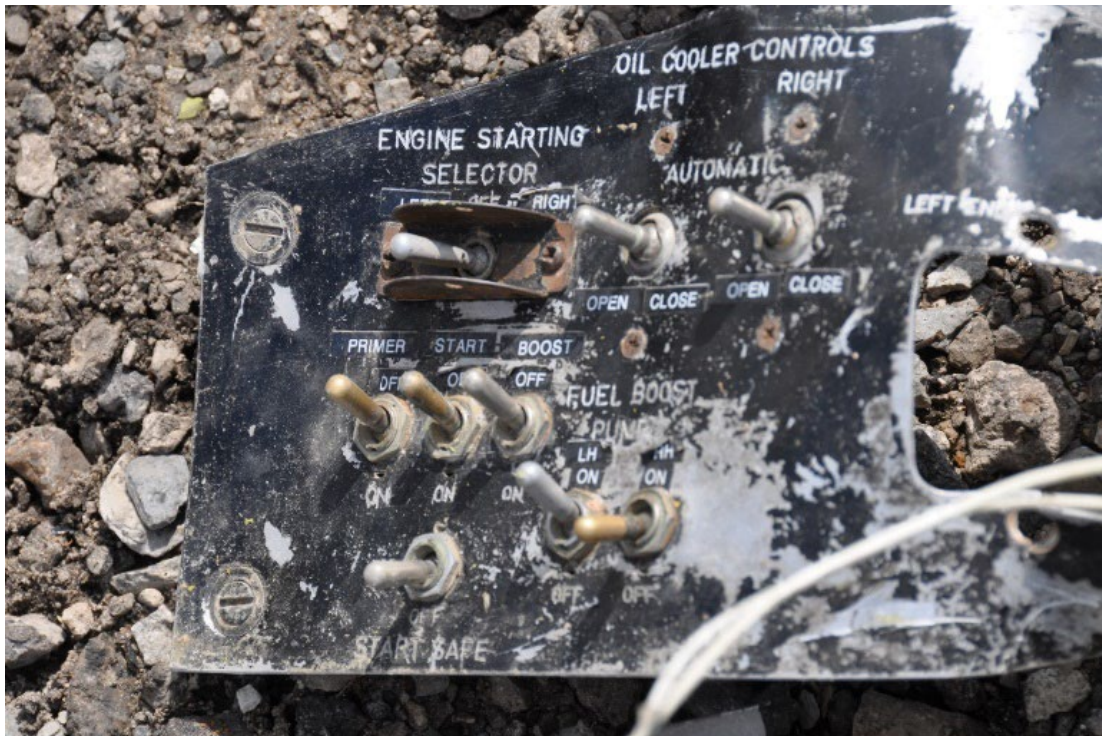
Figure 6 - Engine Starting Selector and Oil Cooler Portion of Panel

- Engine Selector Switch in the LEFT position
- Primer, Start, Boost switches all in the OFF position
- Oil Cooler Controls Left and Right switches in the OPEN position
- Left Hand Fuel Boost Pump switch in the ON position; Right Hand Fuel Boost Pump in the OFF position
- Start Safe Switch in OFF position

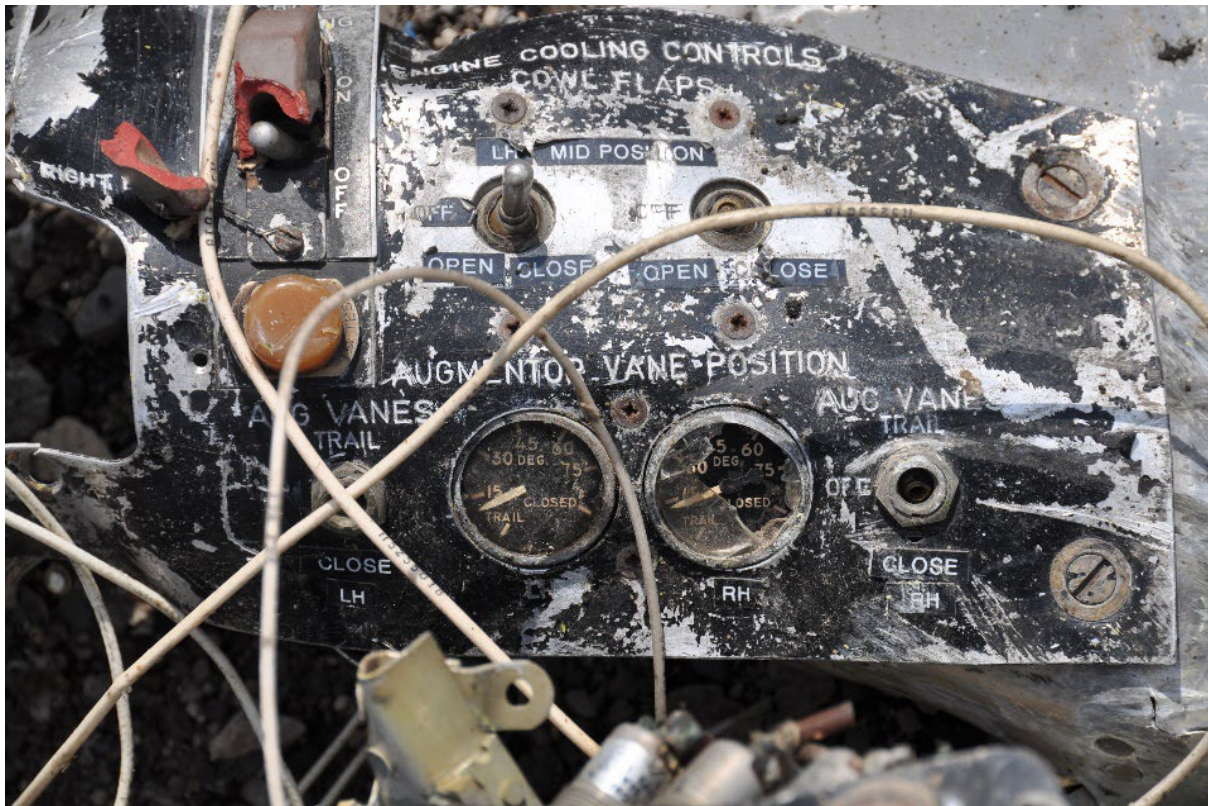
Figure 7 - Engine Cooling Controls Section of Panel

- Primer Selector Switch in the OFF position with red switch guard fractured, portion missing
- Engine Cooling Controls Cowl Flaps - Left Hand Switch in the OFF position; Right Hand Switch separated and missing
- Augmentor Vane Position, Left and Right-hand switches were fractured and separated
- Left Hand Augmentor Vane Position gauge intact with the needle positioned to about 14°
- Right Hand Augmentor Vane Position gauge with broken glass face, needle positioned to about 14°

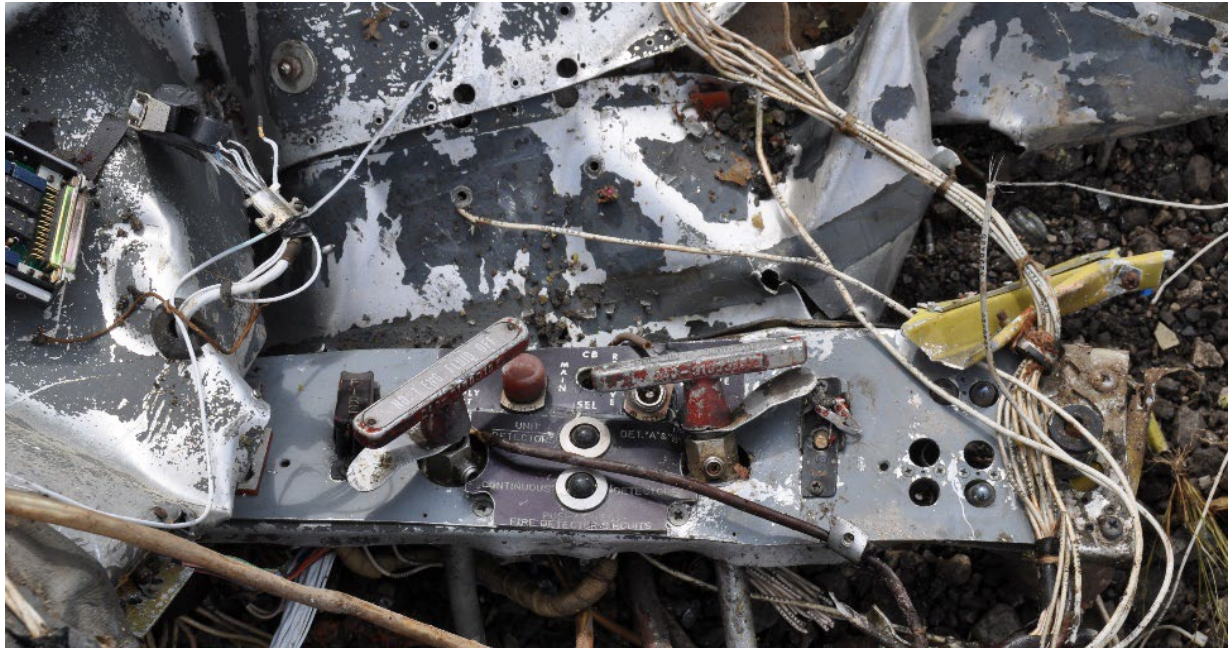
Figure 8 - Engine Fire Control Panel

- Left Hand (No. 1) Engine Fire switch and guard intact, noted in the down position
- Right Hand (No. 2) Engine Fire switch and guard missing
- No. 1 and No. 2 Engine Fluid Shutoff handle in the stowed position
- CB (Chlorobromomethane) Supply Select switch dislodged, missing from panel

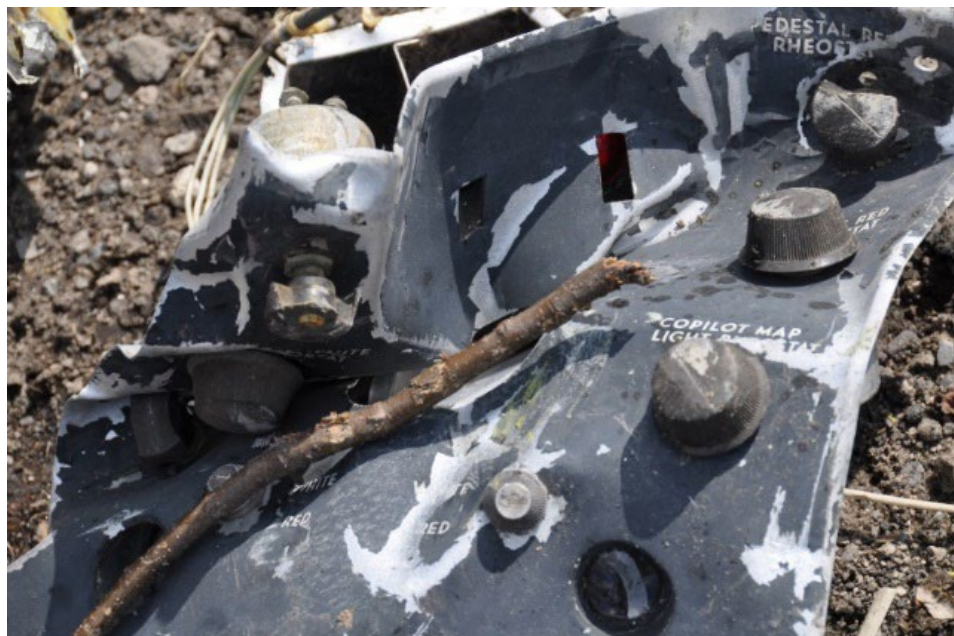
Figure 9 - Instrument Lights Panel

- Pedestal, Pilot, and Copilot Map light intensity dial knobs intact

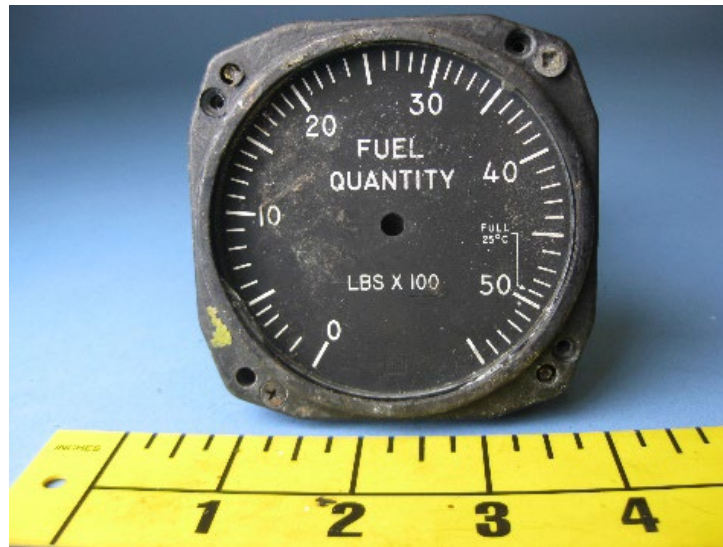
Figure 10 - Fuel Quantity Indicator

10. The first gauge had no indicator needle and no indication assessment possible. See Figure

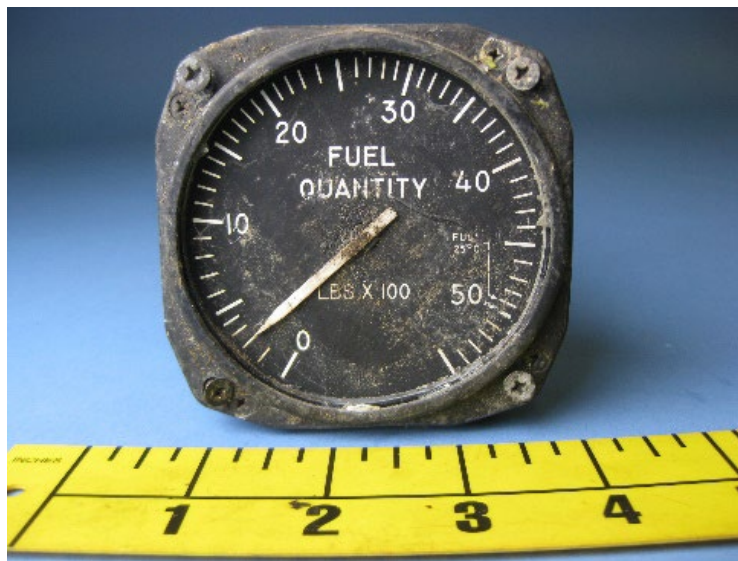
Figure 11 - Second Fuel Quantity Indicator

The second fuel quantity indication was about two hundred pounds (lbs.). See Figure 11.

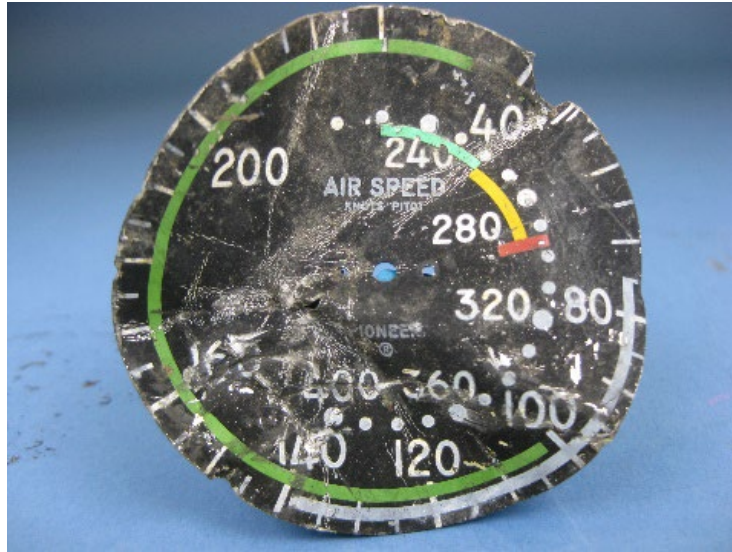
Figure 12 - Airspeed Indicator

The instrument face from two airspeed indicators were found in the wreckage. Since both were dislodged from their panel, it could not be determined for pilot position each gauge was from. Both instrument faces were separated from their respective instruments, and neither had indicator needles.

No indication assessment was possible, due to impact damage.

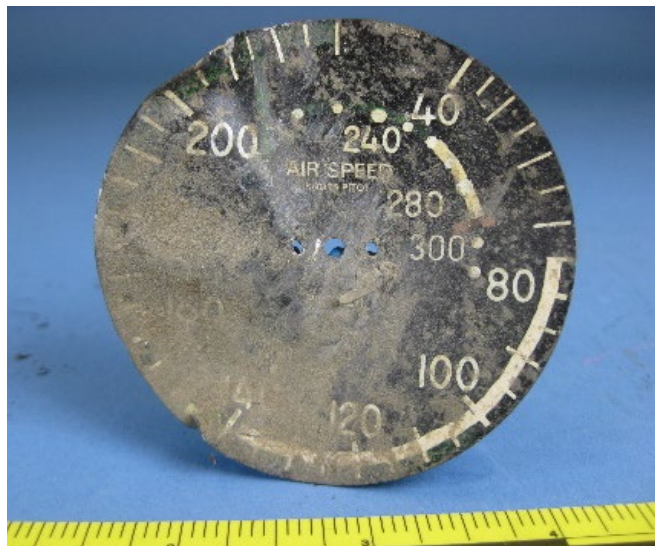
Figure 13 - Second Airspeed Indicator

No indication assessment was possible, due to impact damage.

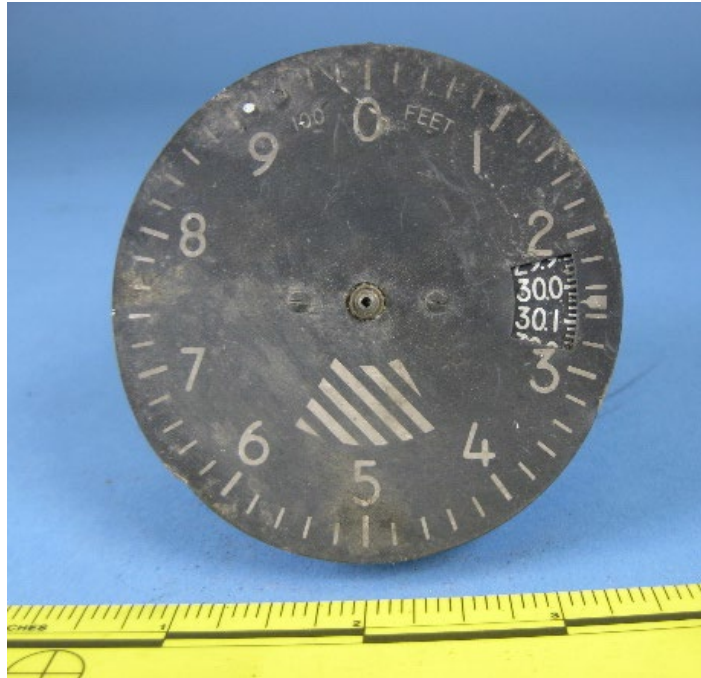
Figure 14 - Altimeter Face

The instrument face from two altimeters were found in the wreckage. Since both were dislodged from their panel, it could not be determined which pilot position each gauge was from. Both instrument faces were separated from their respective instruments, and one of the two still had an indicator needle.

No indication assessment was possible, due to impact damage.

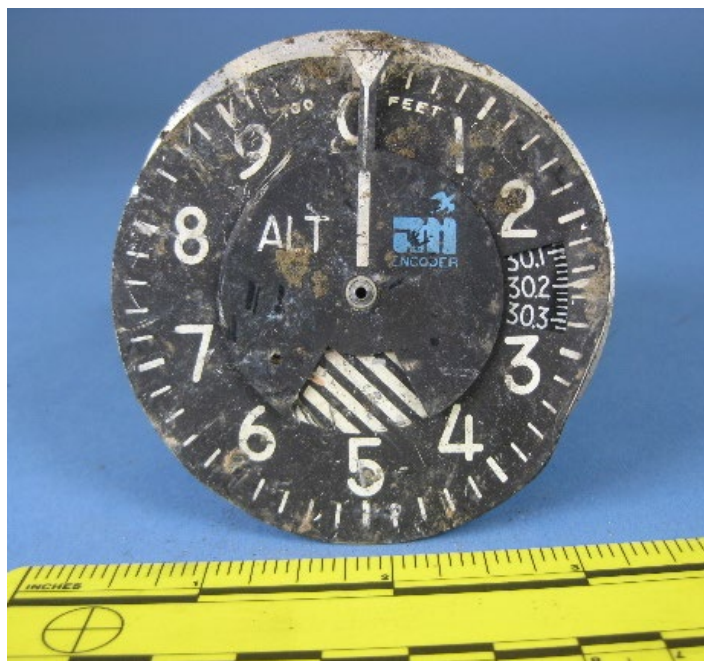
Figure 15 - Second Altimeter

No indication assessment was possible.

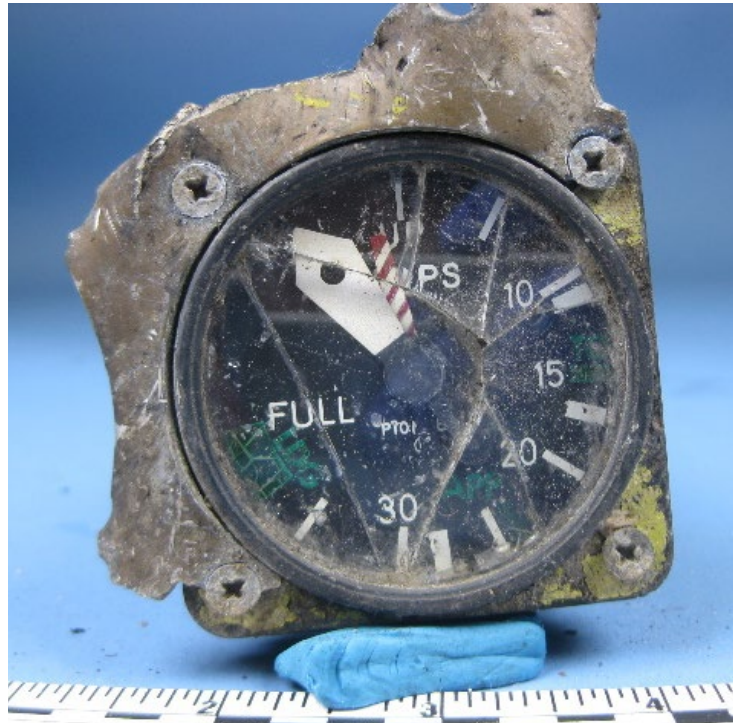
A flap indicator was found in the wreckage. The glass face was cracked, and the white indicator needle would not move when the instrument was rotated. See Figure 16.

Figure 16 - Flap Indicator, Before Glass Removal

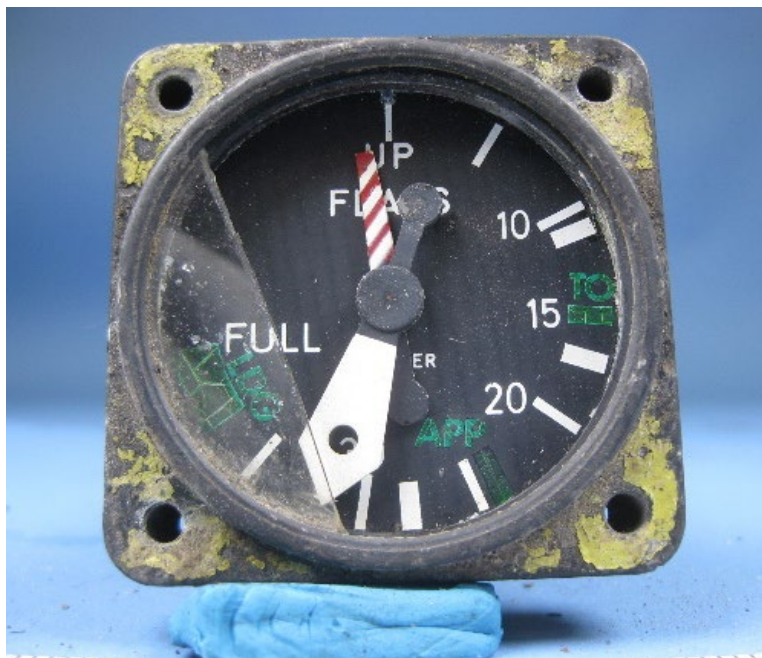
After the glass face was removed, the white indicator moved freely, and no indication assessment possible. See Figure 17.

Figure 17 - Flap Indicator, After Glass Face Removed

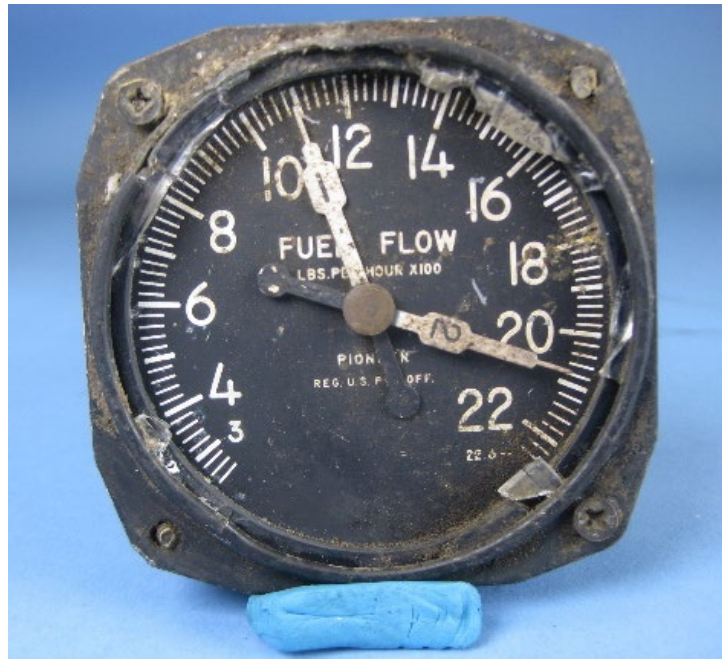
Figure 18 - Fuel Flow Indicator

A Fuel Flow Indicator was found in the wreckage. When the instrument's glass face was removed, the white indicator labelled "2" was free to move when the instrument was rotated. The white indicator labelled "1" however, was stationary and indicated about 1100 lbs. of fuel per hour. See Figure 18.

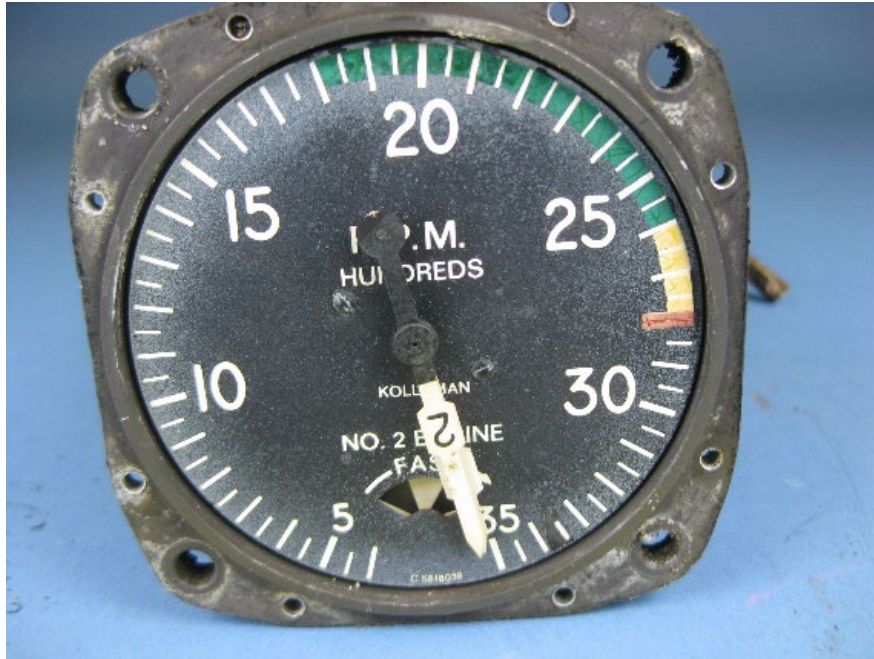
An Engine Tachometer Indicator was found in the wreckage. The glass face was removed, and moisture was noted inside the glass of the instrument.

Two indicator needles were observed – one was labelled "1" and the other "2". The "1" indicator was noted directly behind "2". Both indicators were off scale; both were at a value greater than 35x100 Revolutions Per Minute (rpm). See Figure 19.

Figure 19 - Engine Tachometer, with Glass Face Removed

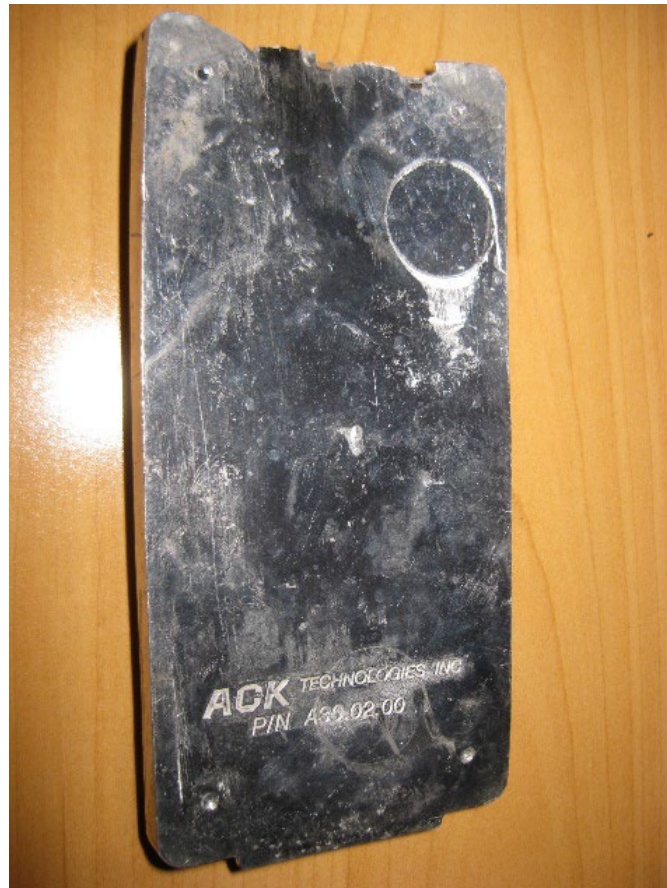
Figure 20 - ACK Technologies A-30

An ACK Technologies A-30 Digital Altitude Encoder (part number A30.02.00) was in the debris field. See Figure 20.

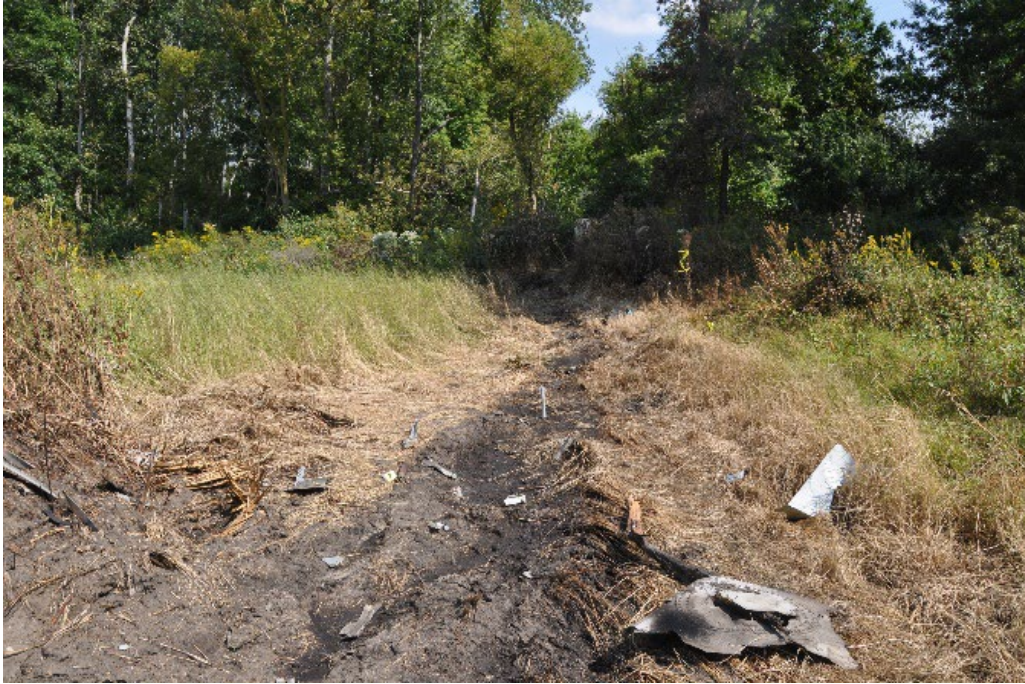
After the impact with trees, at the edge of the wooded tree area, the aircraft left a ground scar that was consistent with the airplane impacting the ground in a right wing down attitude. Airplane wreckage from the right wing was identified in the ground scar. See Figure 21.

Figure 21 - Airplane ground scar leaving the wooded area.

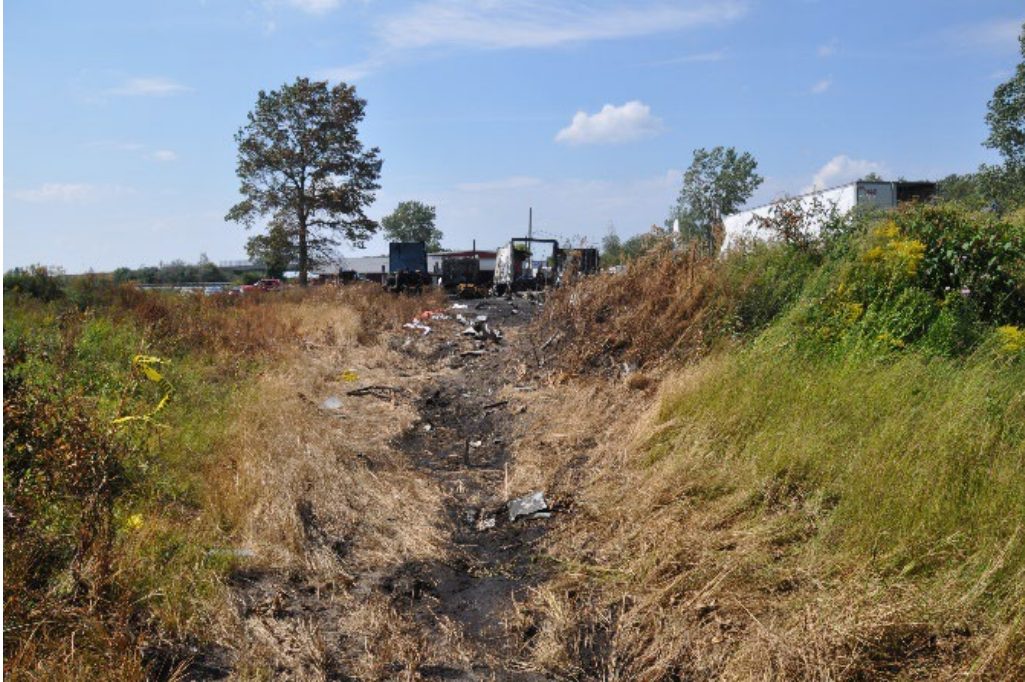
The ground scar covered the area from the wooded area to the parking lot. See Figure 22.

Figure 22 - Ground scar from the wooded area to the truck parking lot.

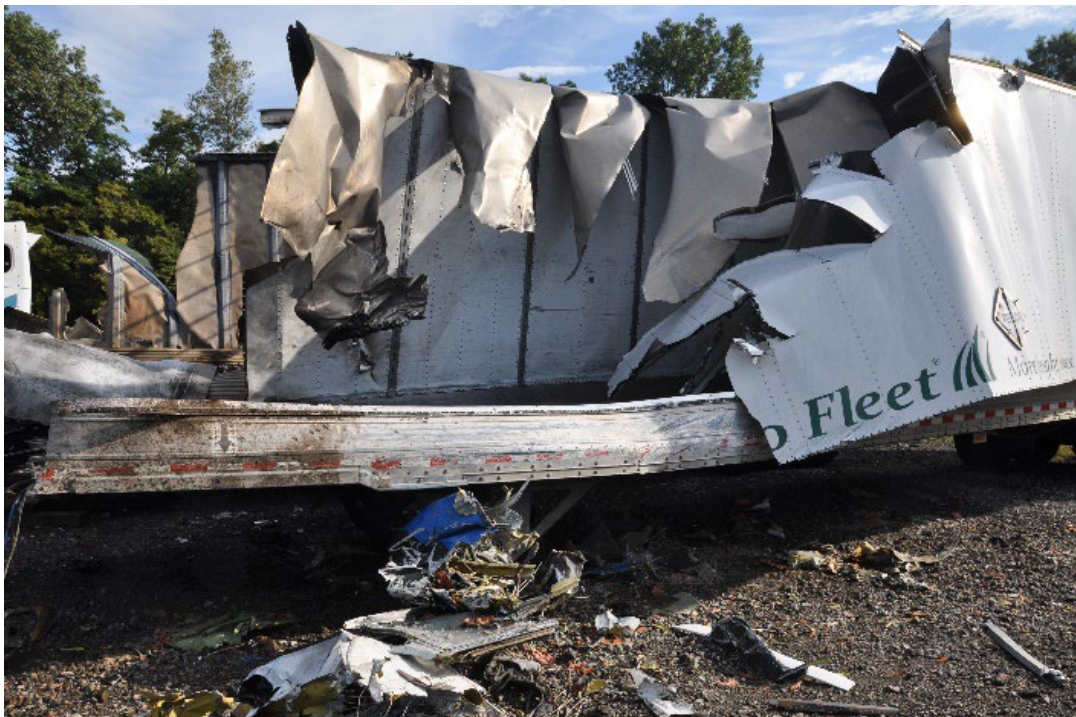
Further in the direction of flight in the impact area, the side of a parked tractor-trailer showed evidence of blue and white paint transfer, consistent with the airplane's paint scheme. The top of the trailer also showed impact marks consistent with propeller strikes. See Figure 23.

Figure 23 - Side of trailer showing impact strikes and airplane wreckage.

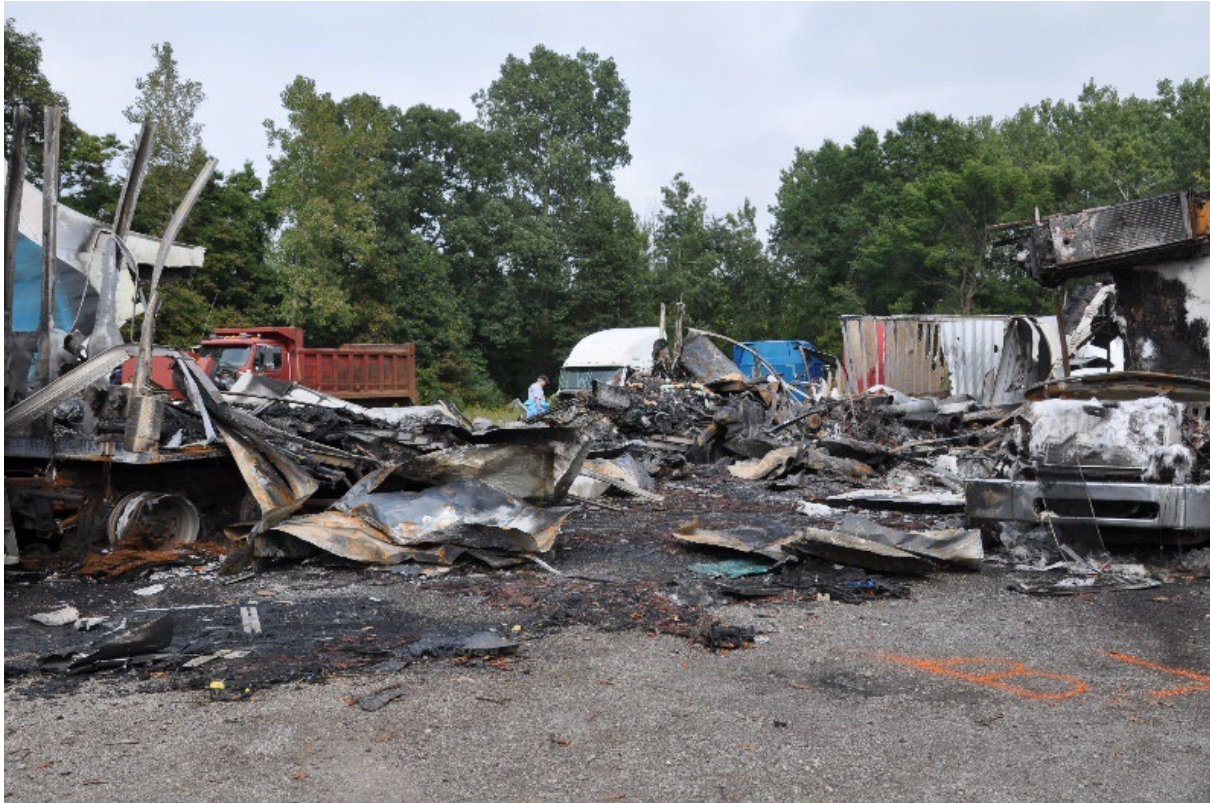
Figure 24 - Portion of Main Section of Wreckage

The main section of wreckage, located in the parking among the parked trucks and trailers, was mostly consumed by post-crash fire. The main fuselage and cargo area (including the cargo), portions of the right and left wings, main landing gears, nose landing gear structure, flight deck, engine nacelles, and left engine, were found in the burned area of the parking lot. Wreckage was also found on top of the parked trailers. See Figure 24.

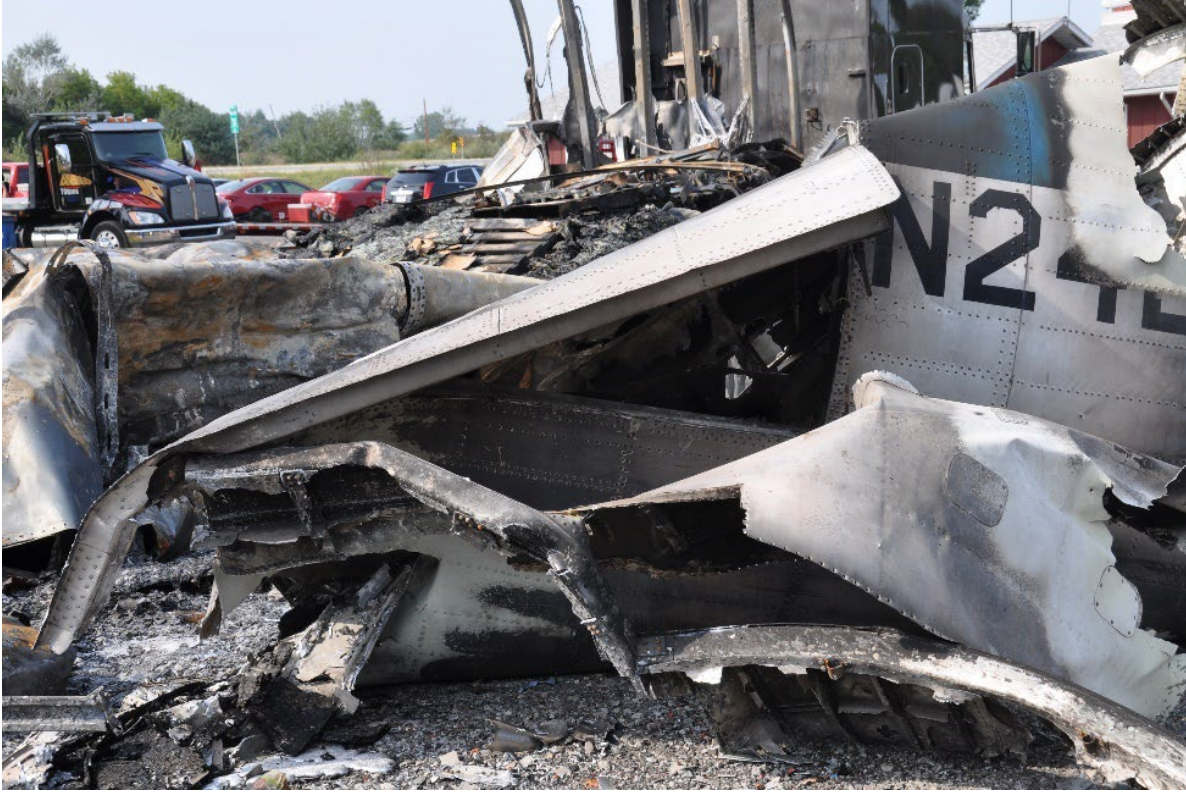
The main cargo door was identified in the wreckage. The door, located on the left side of the fuselage, was partially consumed by post-crash fire, in the upper left section of the door. The supporting fuselage and framing were also consumed by fire; most of the upper hinge of the door remained but was bent from partial melting and fire damage. The door was bent over at the approximate middle. See Figure 25.

Figure 25 - Main Cargo Door, bent over but still in fuselage doorway.

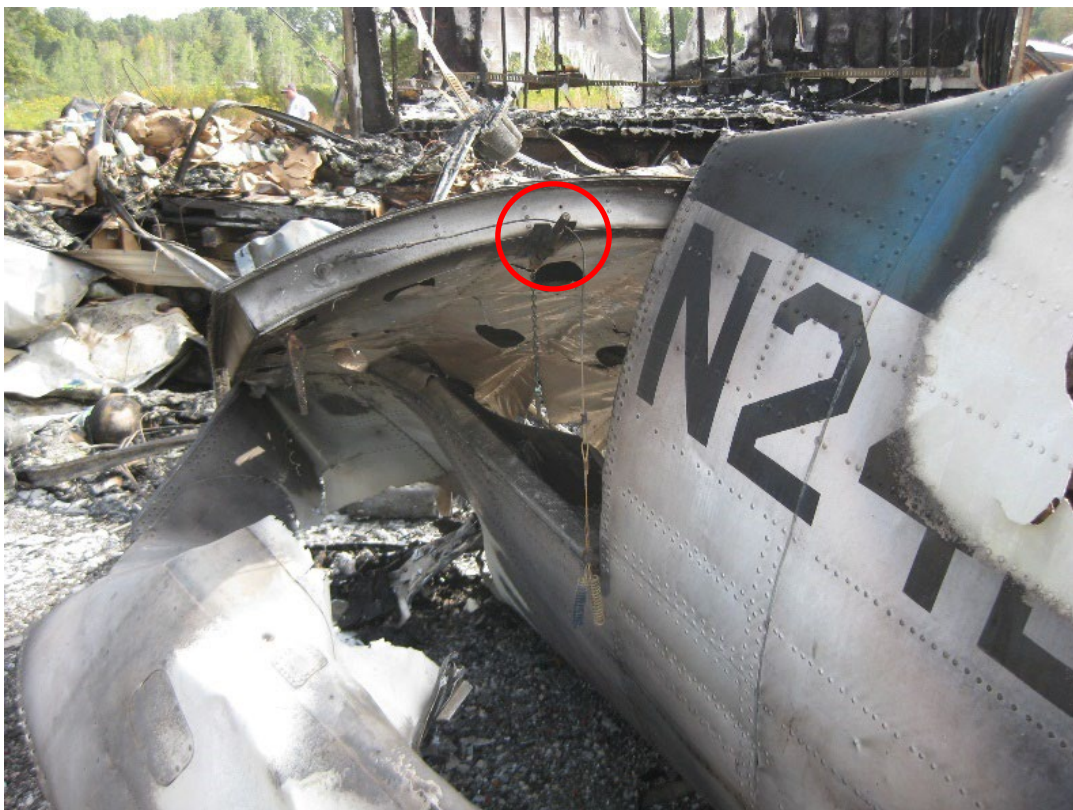
On the aft (right-hand) side of the door, two “dead-bolt” locks were noted; the lower dead bolt was in the locked (actuated) position but was not inserted into the mating (fuselage) side of the lock; the upper lock was missing the “bolt” and the frame for the bolt was bent. See Figure 26.

Figure 26 - Side View of Main Cargo Door, with bolt-style latch in red circle.

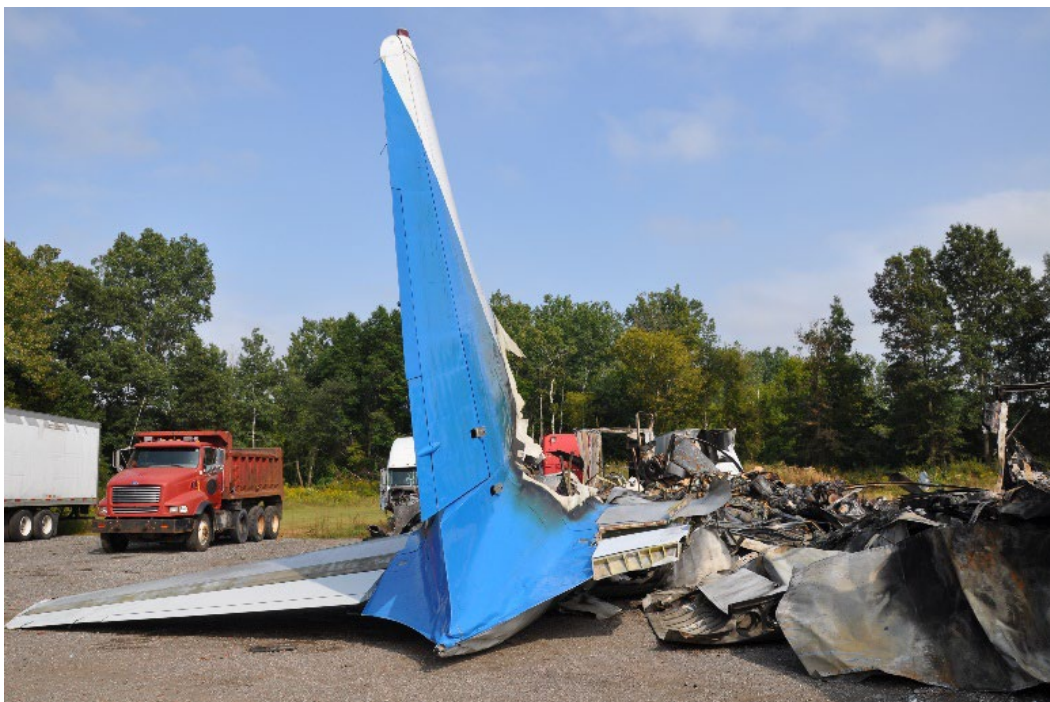
Except for the outboard portion of the right stabilizer, the empennage (horizontal and vertical stabilizers) remained attached to each other but separated from the fuselage. The empennage was found upright, just aft of the fuselage segments and sitting on the parking lot. The empennage was facing opposite the direction of flight. See Figure 27.

The edges of empennage section appeared consumed by fire. The empennage section separated about four feet forward of the aft pressure bulkhead on the left side of the fuselage.

Figure 27 - Airplane Empennage, facing opposite direction of flight. Note missing section of right-hand stabilizer.

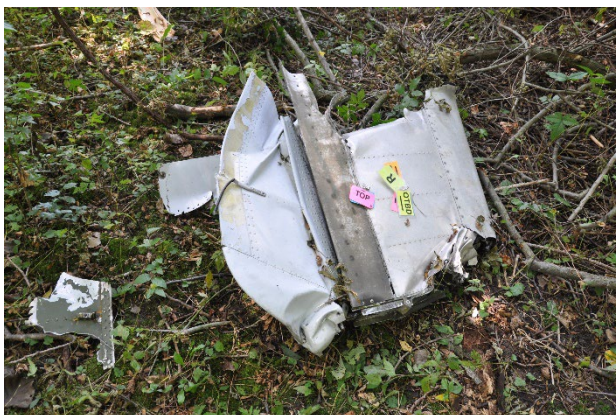
Figure 28 - Outboard Section of Right Horizontal Stabilizer and Elevator

- The most outboard piece of the stabilizer was found in the wooded tree area, below the flight path, near the outboard section of right wing.
- The piece measured thirty inches in length at the leading edge and thirty-nine inches of elevator at the aft edge.
- The tip of the leading edge was crushed aft.
- A tree branch was noted in the piece.

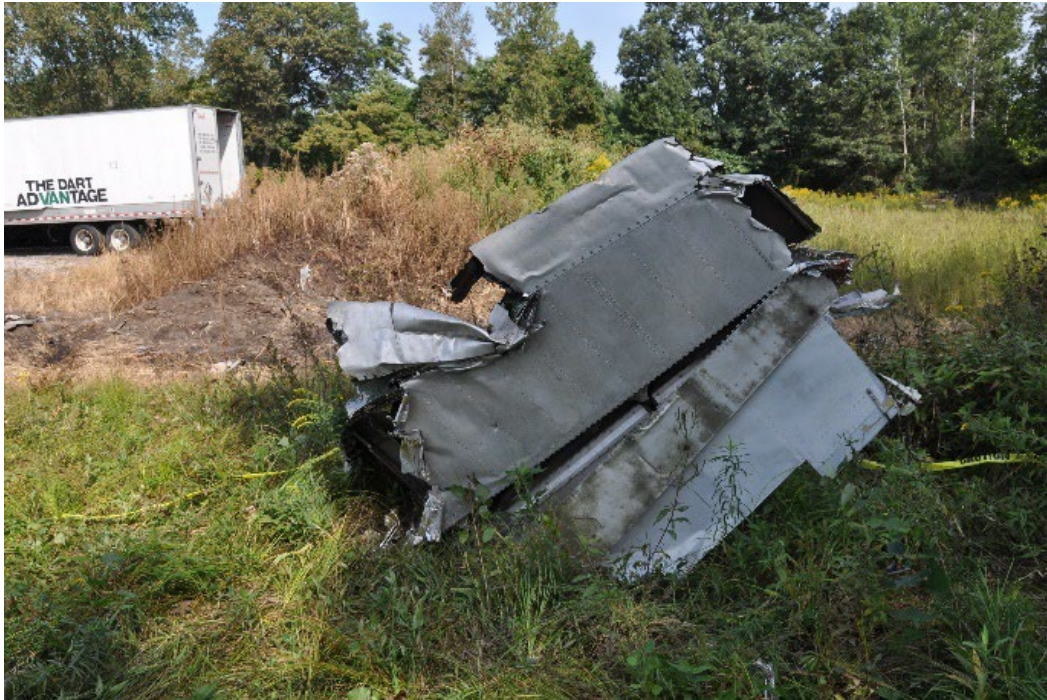
- Another section of the right stabilizer was in the wreckage path, standing on edge. See Figure 29.
- The segment was 140 inches in length, measured along the midspan of the stabilizer.
- A section of elevator, between two linkages, measured at sixty inches in length. The inboard linkage was still attached; the outboard linkage was separated/broken.
- The leading edge is crushed aft starting at about thirty-eight inches from the outboard edge.
- A piece of elevator and elevator trim tab were found near the piece of right horizontal stabilizer, near the ground scar mark.
- The length of the elevator and tab was measured at 43 inches and contained two intact linkages to the tab.
- One of the edges of the trim tab near the elevator was separated along its length.

Figure 29 - Section of Right Horizontal Stabilizer and Elevator, stuck in ground. The top of the stabilizer is facing the photographer.

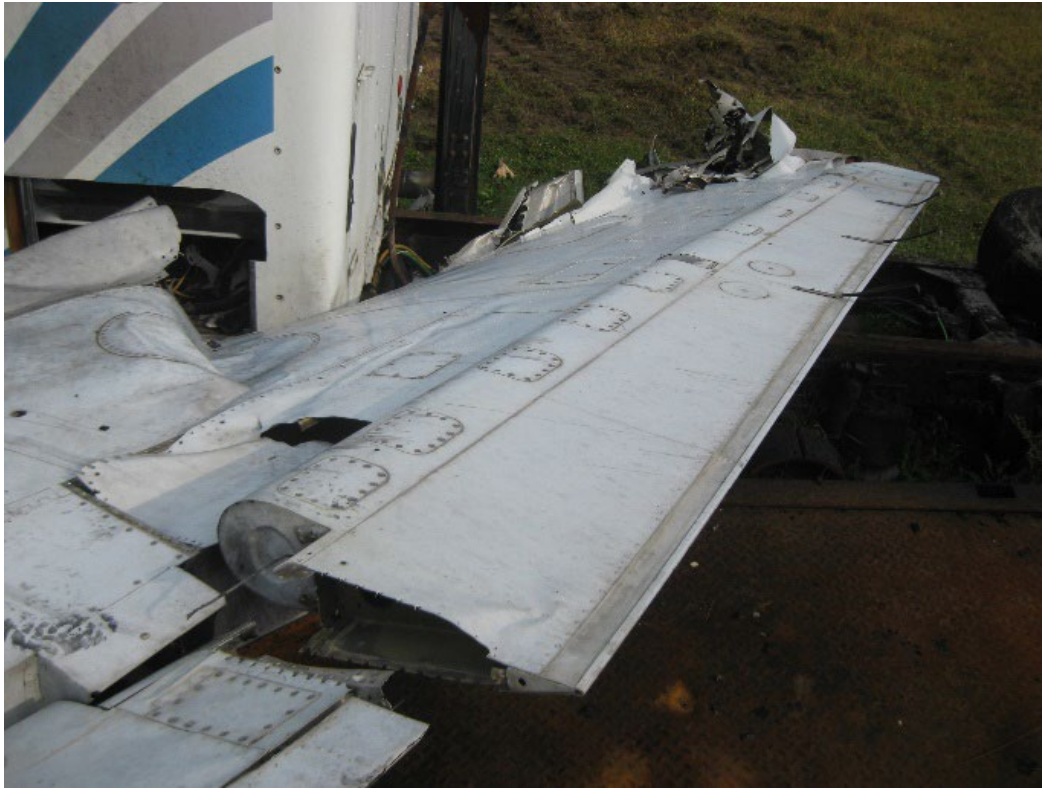
The portions of the left wing located in the wreckage was found in two sections. The first section, measured as the longer section of left wing, started from the left wingtip inboard. The section was measured at 17 feet, seven inches (211 inches) from the inboard side of the wingtip cap to the inboard end of the section. See Figure 30.

Figure 30 - Outboard Section of Left Wing, found upside down on a truck and trailer.

The piece was found upside down, on top of a truck and trailer. Approximately ten feet of the furthest outboard section of aileron was still attached to the wing. The red wingtip light was noted on the end of the wing. Overall, the segment was bent, the underside was sooted, and a portion of the leading edge, near the outboard tip, was crushed aft.

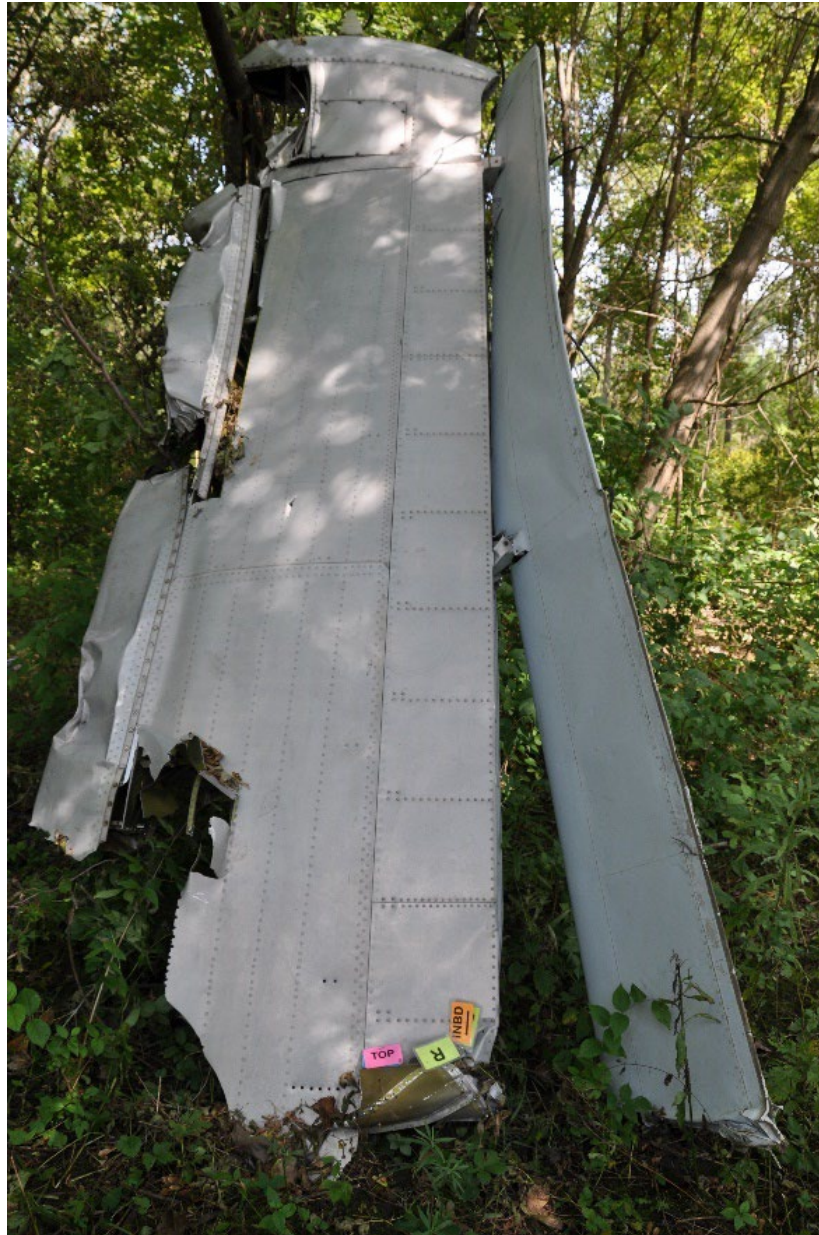
- A 142-inch segment of the furthest outboard section of right wing was found in the woods, beneath the airplane's flight path, leaning against a tree. See Figure 31.
- A 147-inch section of aileron was connected to the wing section. Two aileron linkages were visible.
- A portion of the leading edge was crushed aft near the furthest outboard section.
- A wingtip light was noted at the end of the piece.

Figure 31 - Outboard Section of Right Wing, in wooded area. Note aileron attached to rear of wing section.
