# **NATIONAL TRANSPORTATION SAFETY BOARD**

## **Airworthiness Group Chairman's Factual Report**

### **A. ACCIDENT CEN19MA312**

Location: Monclova, Ohio  
Date: September 11, 2019  
Time: 0239 eastern daylight time  
Aircraft: Convair 440, registration N24DR

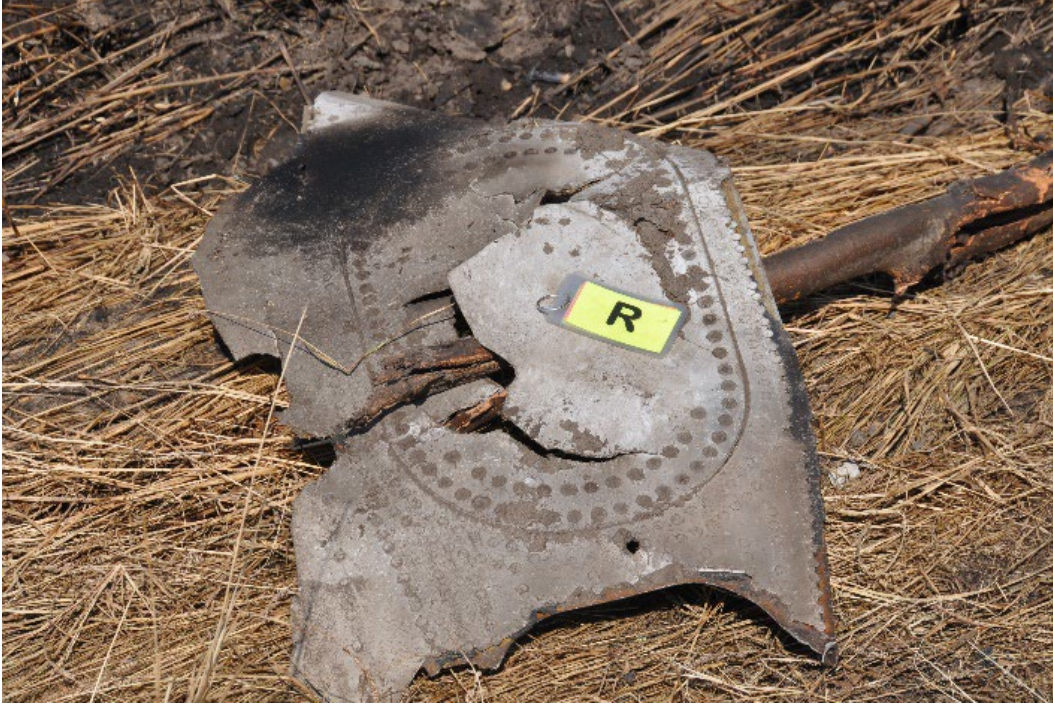
- Right wing debris was found in the burnt ground scar along the airplane's impact path.
- The right-wing landing light was found in the portion of wing leading edge noted in the ground scar area, with dirt, grass, and weeds impacted around the light.
- A fuel tank quantity gauge assembly was noted.
- An internal wing structure piece was found with the part number 340 1610217 "393" stamped on it.
- A wing access panel was found with a tree branch through it. See Figure 32.

Figure 32 - Wing Access Panel from Right Wing, with tree branch.

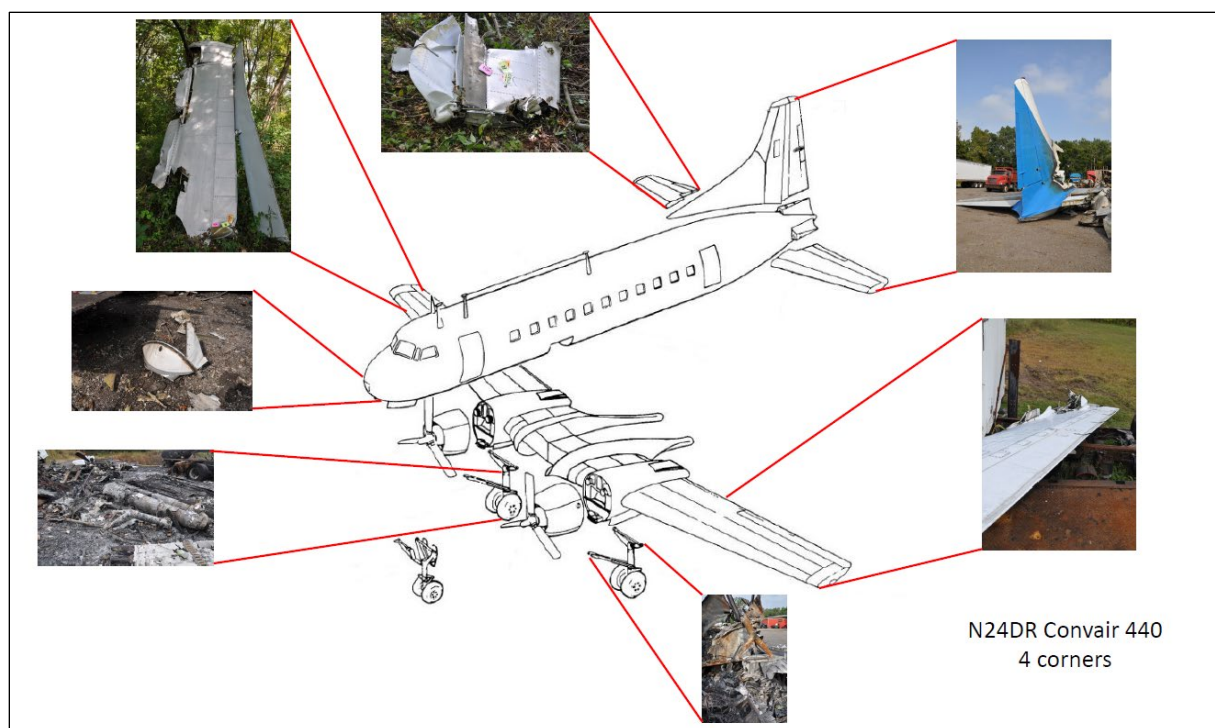
Figure 33 - "Four Corners Assessment" of Airplane

All four corners of the airplane were found at the site. See Figure 33.

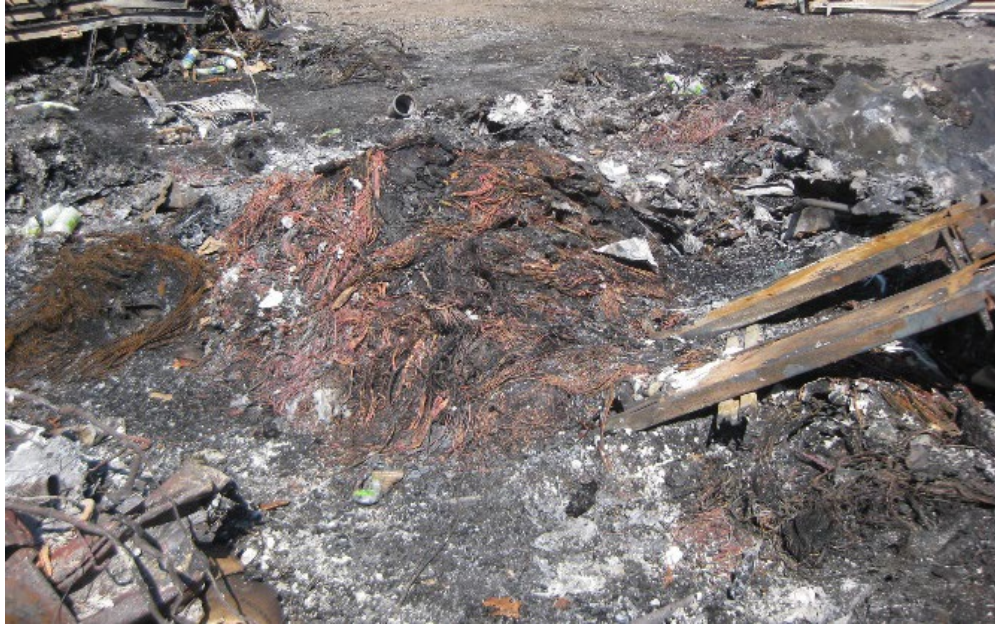
The cargo operator indicated that the cargo was pallets of automotive wiring harnesses. Several areas in the main wreckage were identified as cargo by melted plastic and copper wiring. See Figure 34.

Figure 34 - Mound of Copper Wiring and Melted Plastic from Airplane Cargo
