# **NATIONAL TRANSPORTATION SAFETY BOARD**

## **UAS Aerial Imagery Report**

### **A. ACCIDENT CEN19MA312**

Location: Monclova, Oh.  
Date: Sept 11, 2019  
Time: 0239 Local Time (EDT)  
Event: Impact with trees and terrain

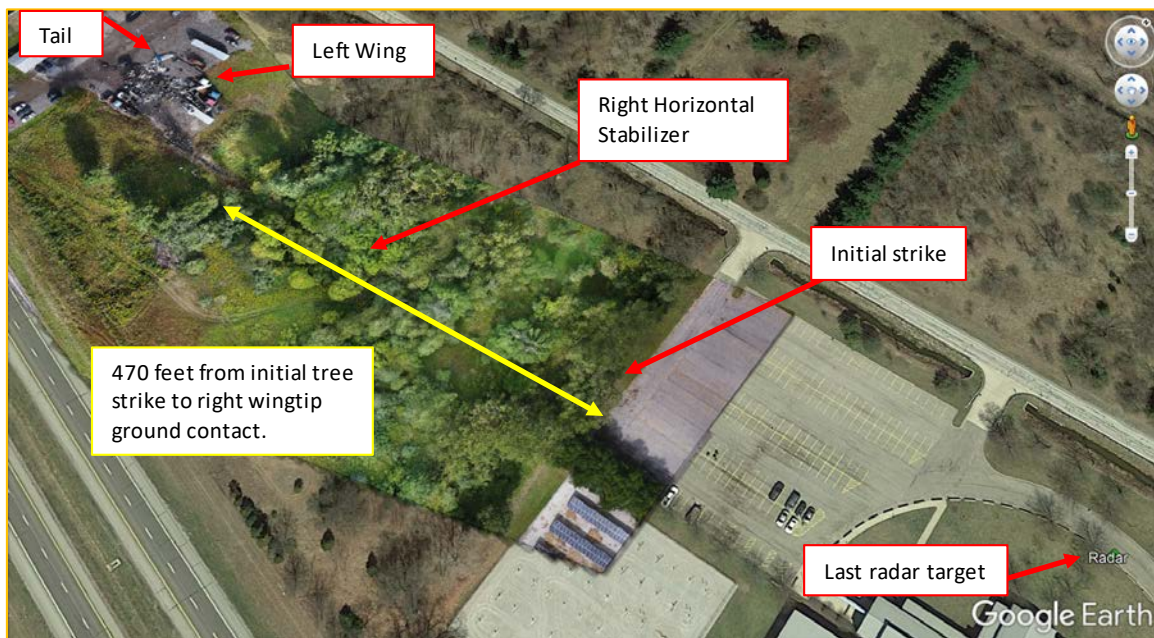
Figure 1 – Google Earth orthomosaic

Figure 1 depicts the overall accident area. The last radar target was about 140 feet above ground level, the initial tree strikes were between 80-100 feet above ground level. The westernmost building of the Armory is visible at the bottom of the map. A general rightward curve was noticable in the swath through the trees and the ground scar. Final orientation was about 285 degrees true, 3,340 feet from the runway threshold.

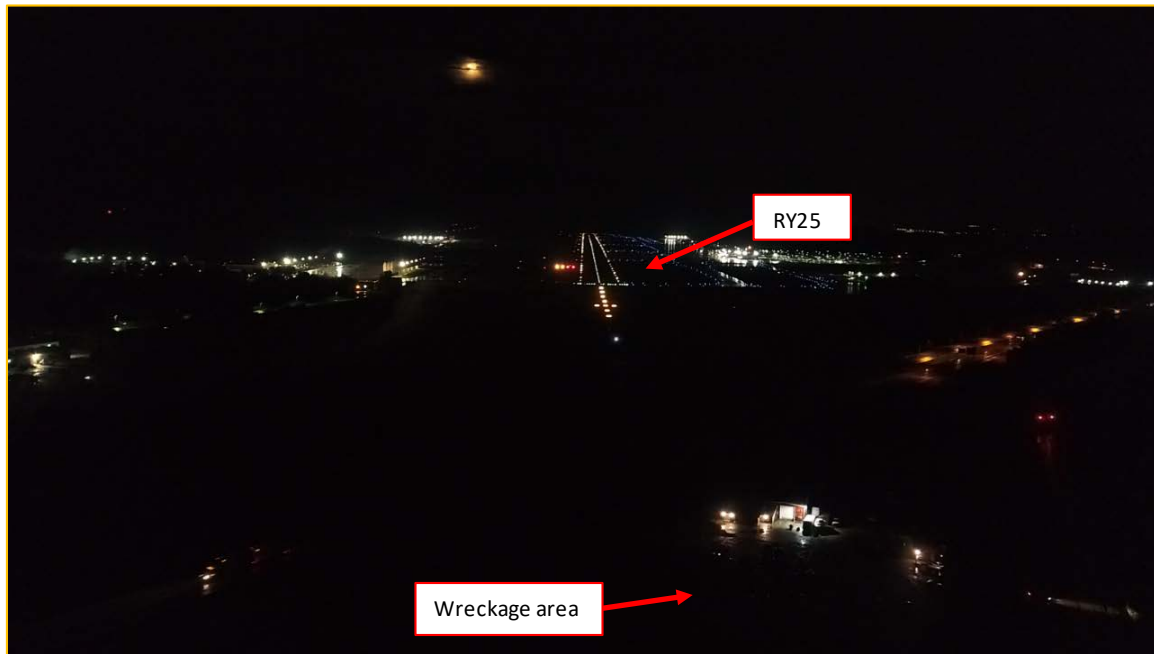
Figure 2 – Night view of accident site and runway 25 approx 300 feet agl

Figure 2 was taken from 300 feet above the tree swath area, note PAPI lights.

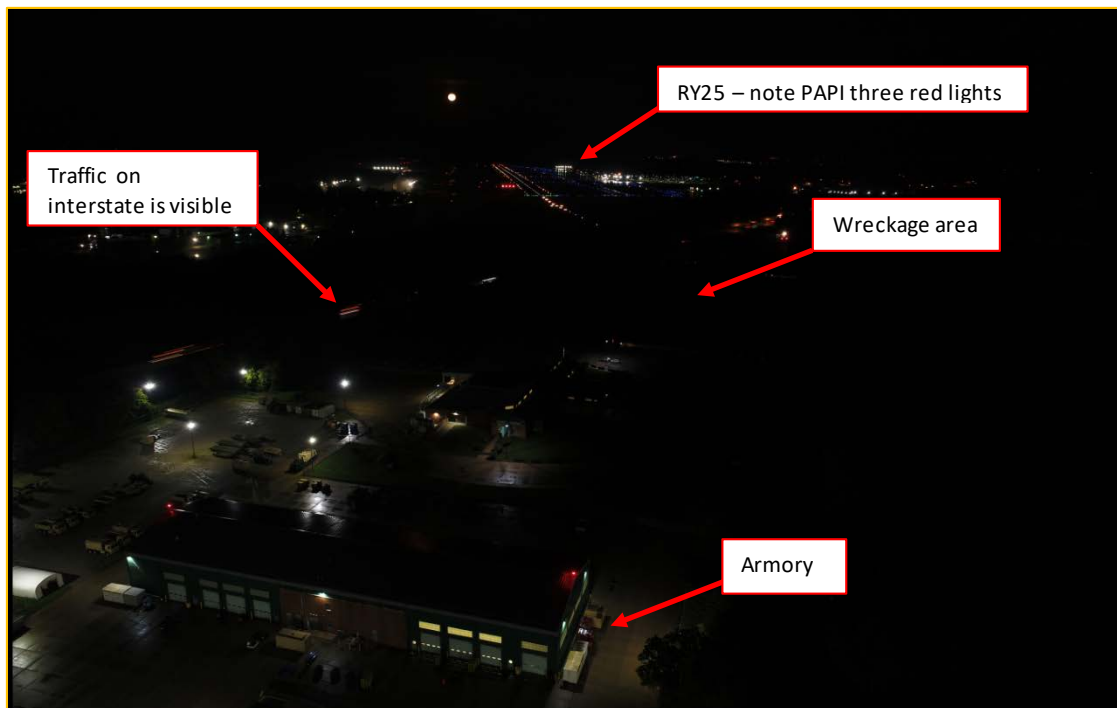
Figure 3 – View from east of Armory at 360 feet agl, note Armory lights; PAPI and approach lights are visible.

Figure 3 depicts the view toward the runway from a position between the last two radar targets. Radar data obtained by the NTSB ATC investigator indicated the airplane was about 140 feet above the runway threshold at this point (about 200 feet lower than the photo).

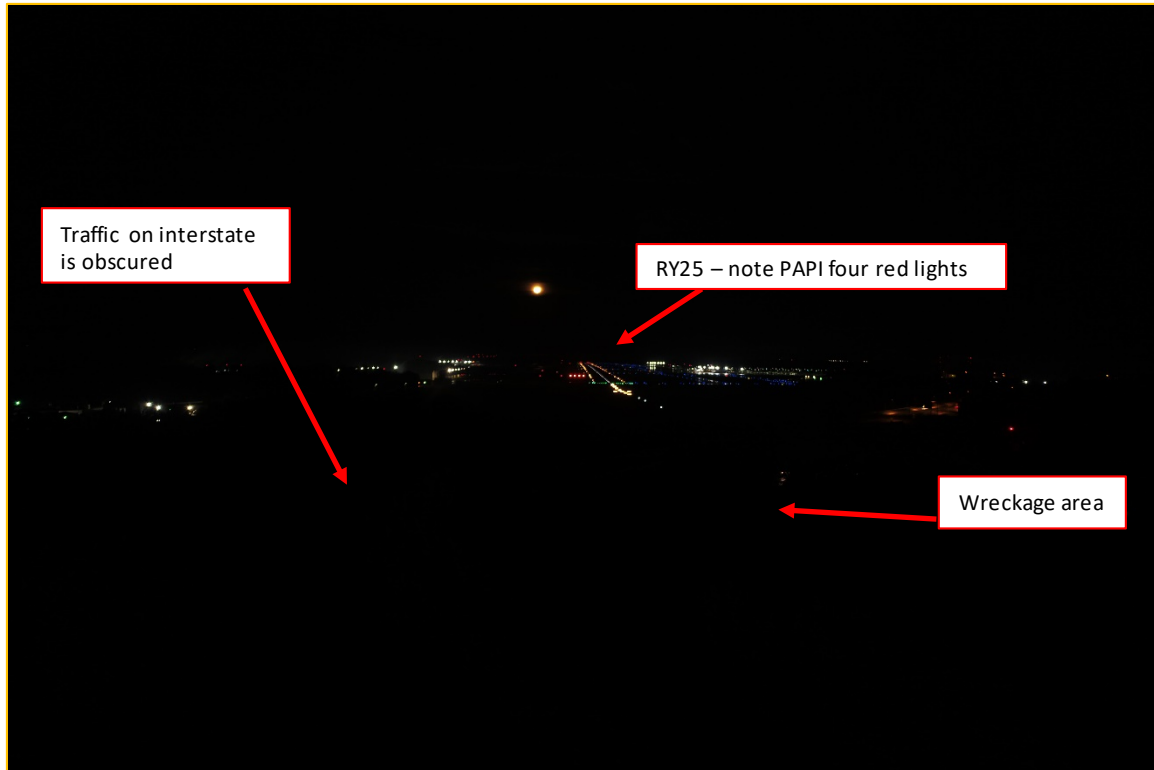
Figure 4 – Night view of accident site over Armory approx 200 feet

The UAS team observed that the view of the approach lights began to be obscured by trees when the camera position descended below 100 feet over the Armory building, or 80 feet over the parking lot. Figure 4 was taken from 200 feet above the Armory building – the RAIL lights began to be obscured, note the traffic on the interstate is also obscured.

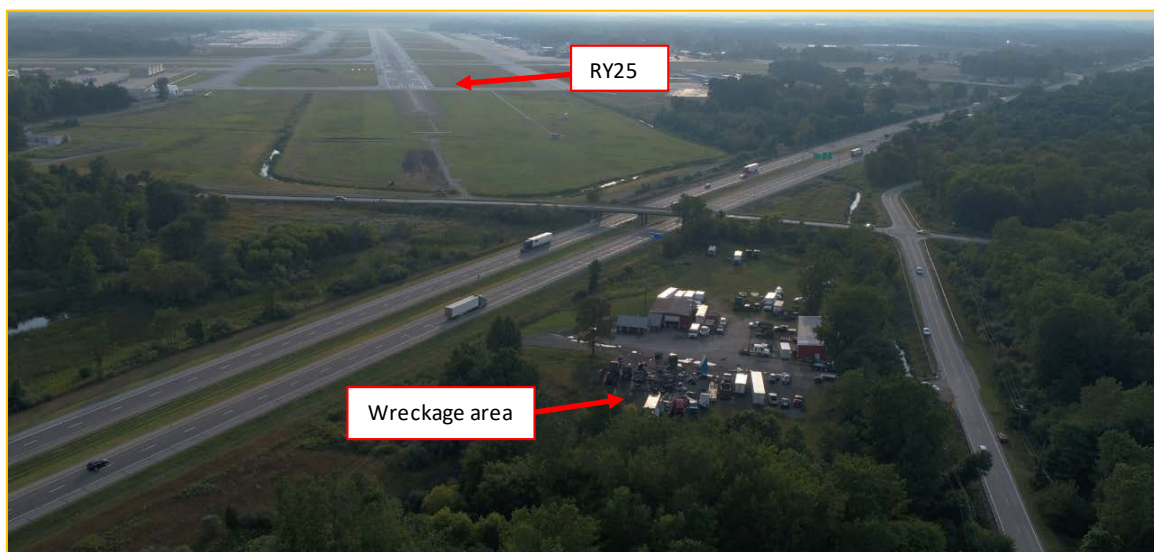
Figure 5 - Daytime overview looking toward accident site and runway 25 approx 300 feet agl

For an aid to visualization, Figure 5 is a daylight view of the approach area from over the tree swath at approximately 300 feet, (similar to Figure 2.)

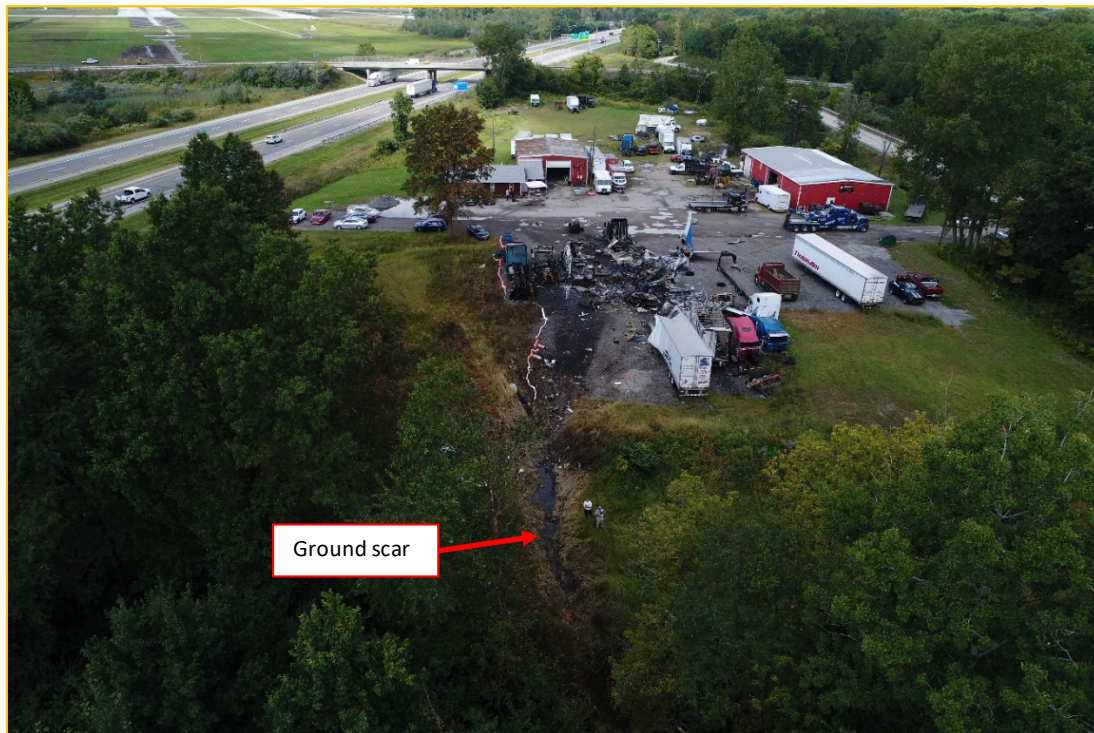
Figure 6 – Daylight view along tree swath toward wreckage, note runway threshold at top left.

Figure 6 is an overview of the ground scar leading to the main wreckage area. The runway threshold is in the background. Note the rightward curve of the scar and orientation.

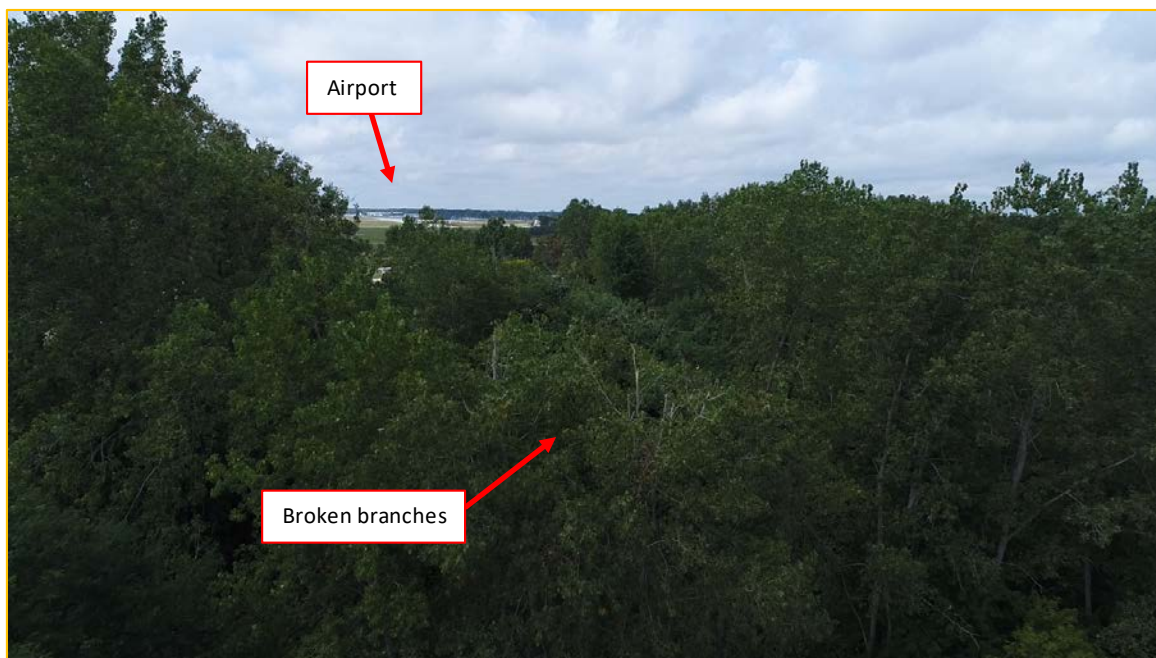
Figure 7 – Initial tree impact at Armory parking lot, approx 470 feet to main wreckage site.

Figure 7 is a photograph from approximately 80 feet above the parking lot, aligned with the initial tree strikes – note the airport is partially visible, the interstate is obscured.

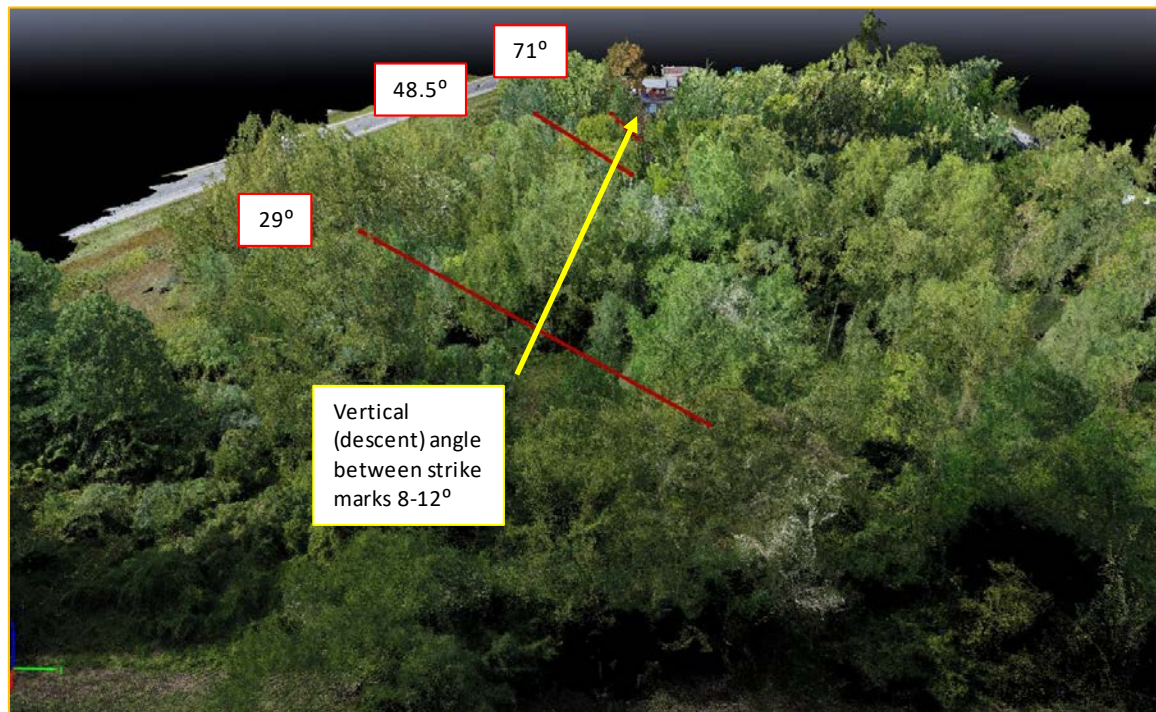
Figure 8 – Measurements of tree strike angles.

A 3D point cloud model of the entire scene was constructed and used to make measurements of the angles of impact. Figure 8 depicts a snapshot of three sequential angular measurements between tree strikes perpendicular to the direction of travel – consistent with a right bank angle of the airplane. The initial angle is 27 degrees, progressively steepening to 48.5 degrees, and 71 degrees just after the location of a large tree break and the separated horizontal stabilizer.

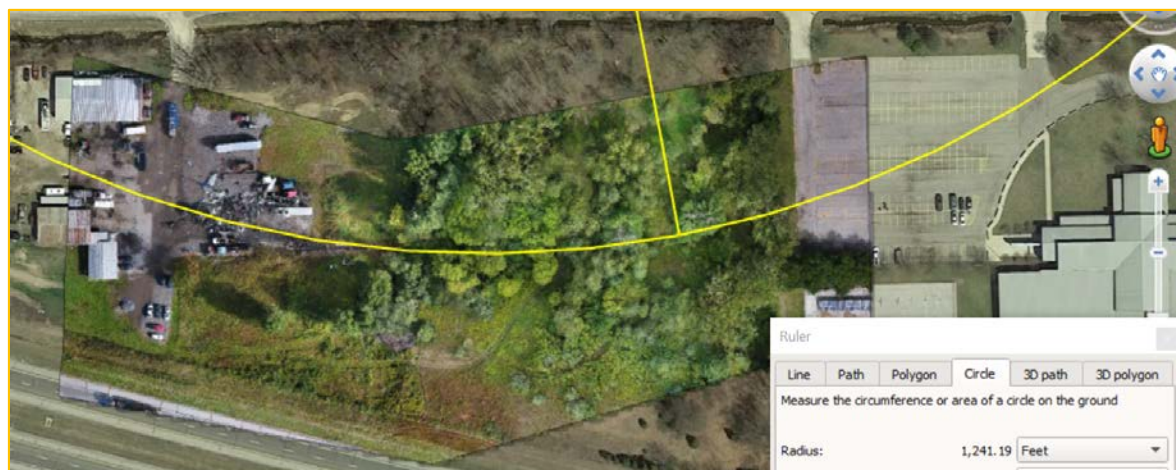
Figure 9 – Measurement of turn radius.

Google Earth tools were applied to the orthomosaic map to estimate the radius of the turn visible in the tree swath. Figure 9 indicates the radius is about 1,241 feet. Applying the standard formula  $R = v^2 / 11.26 * \tan \text{BankAngle}$  results in 84 knots groundspeed, consistent with ATC radar data.

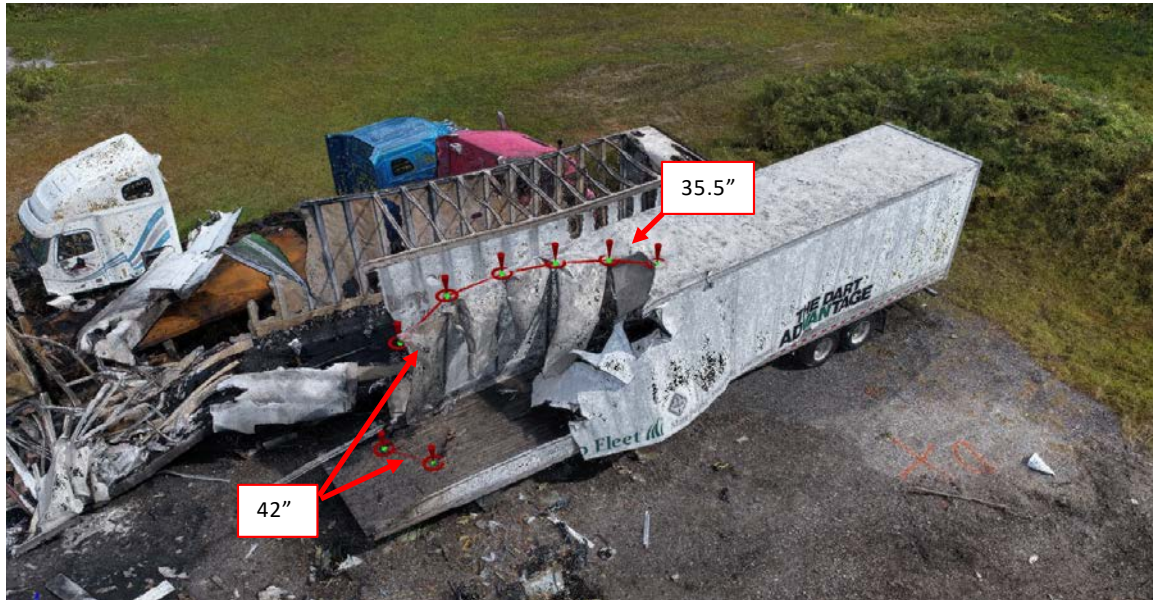
Figure 10 – Measurement of prop slash marks.

Proceeding to the main wreckage area, a detailed point cloud of the airplane and damaged trucks was created with the low altitude double grid, and oblique imagery around a trailer that exhibited prop slash evidence. The spacing between slash marks was measured at 35.5 inches increasing to 42 inches (Figure 10), however the team noted that there was ground evidence that the trailer moved during the impact sequence, likely making the slash marks less usable for RPM or speed estimation.

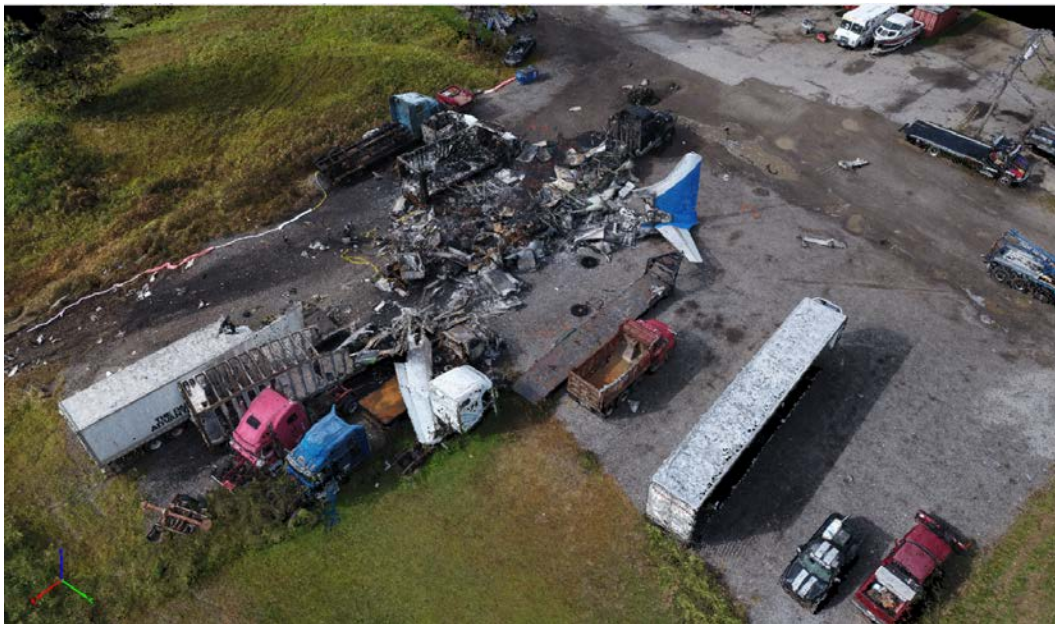
Figure 11 – Point cloud of main wreckage.

The detailed point cloud is included in the docket for this investigation, enabling measurements between any points in the main wreckage area. A snapshot view of the point cloud is shown in Figure 11.

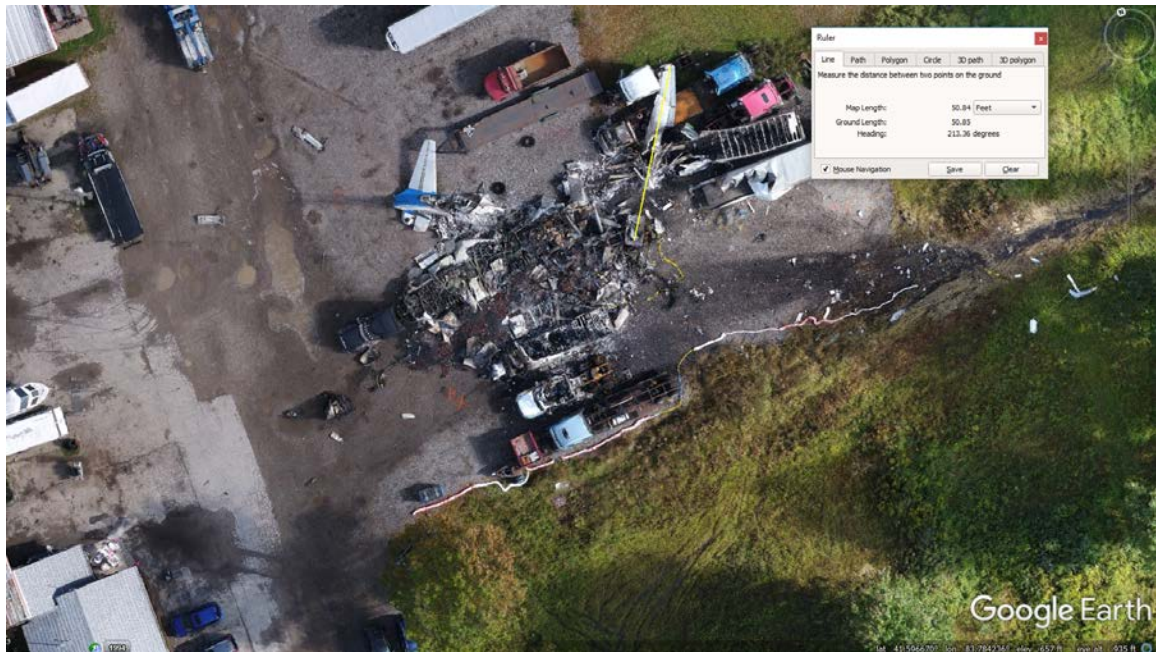
Figure 12 – Exemplar use of Google Earth map.

The orthomosaic map is included in the docket, enabling visualization in Google Earth or GIS software. Figure 12 is an exemplar snapshot of the map in Google Earth showing a measurement of the distance from the left wingtip to the centerline of the main wreckage.
