**Photo 1 – N36PS at the accident site.**

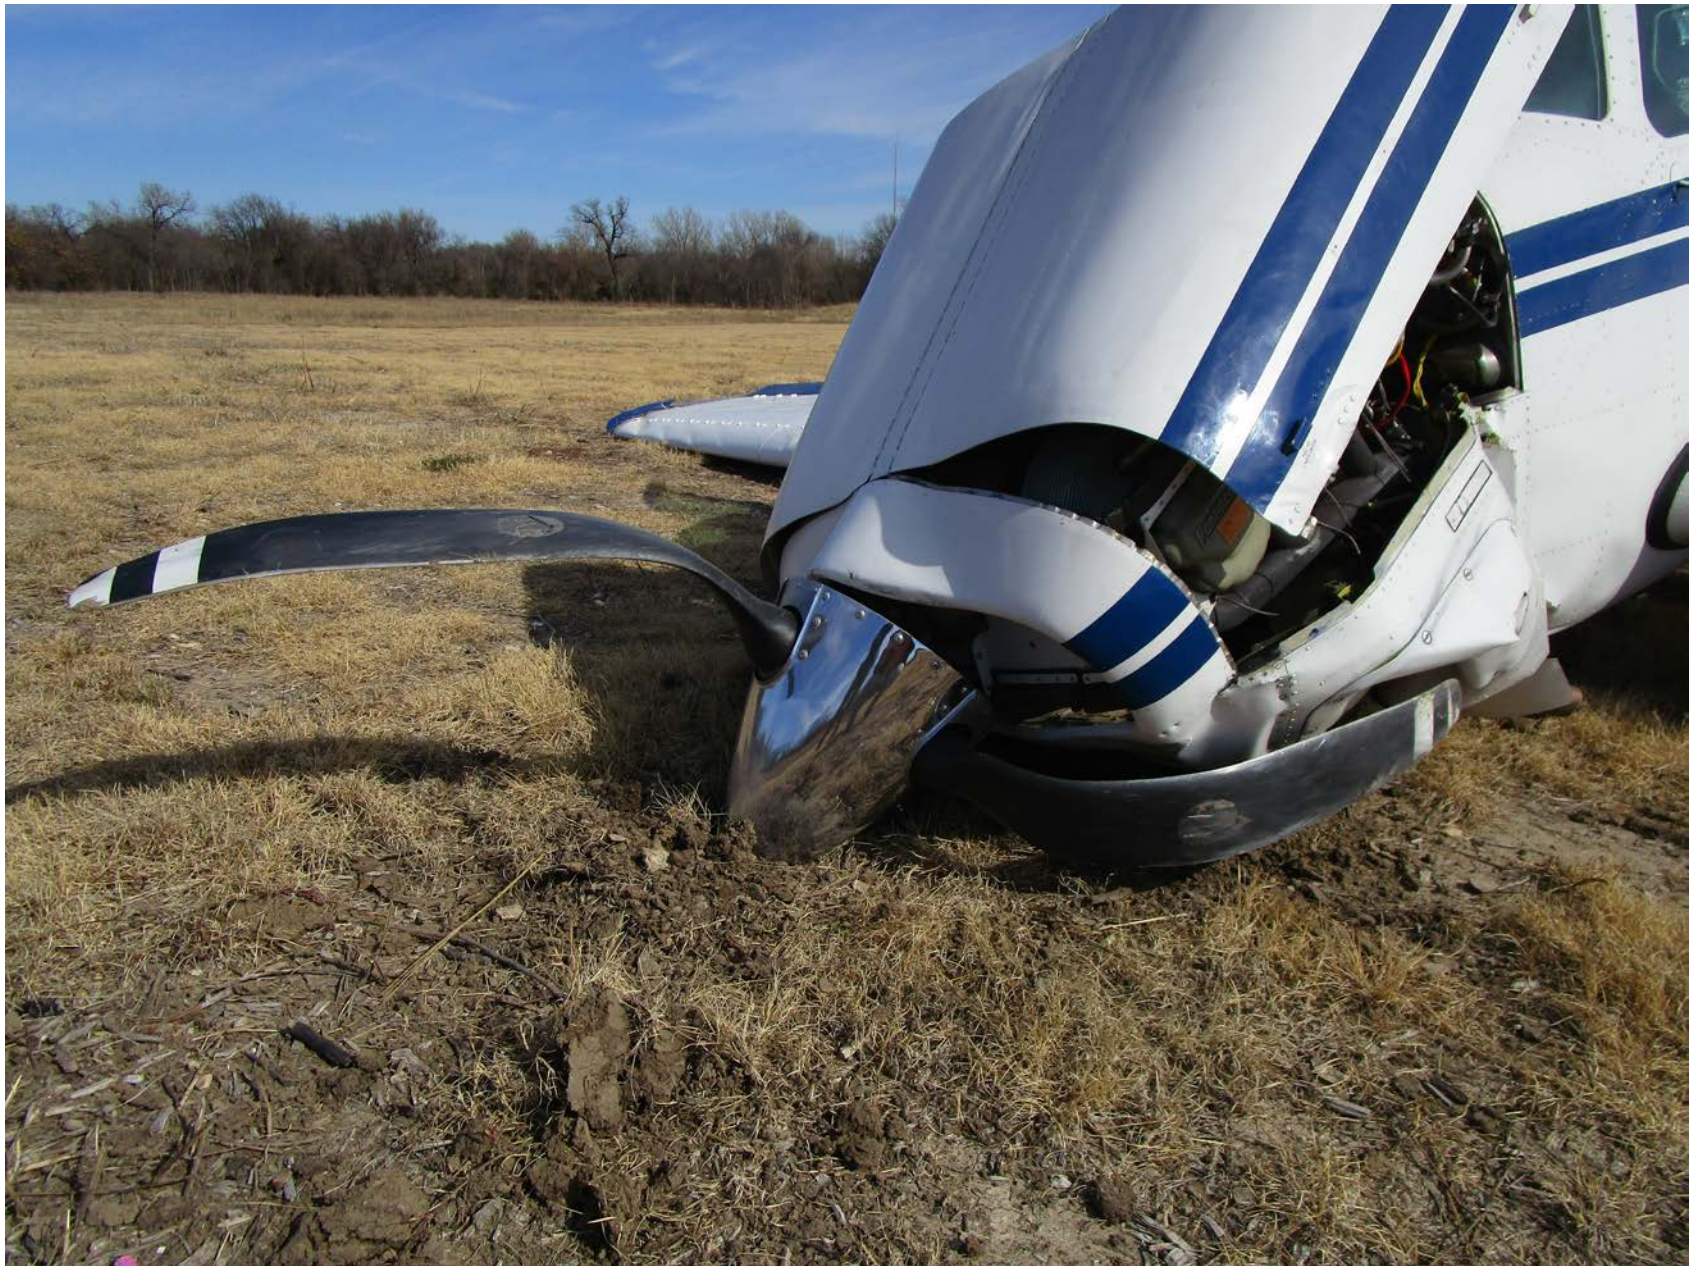
**Photo 2 – Nose section and propeller.**

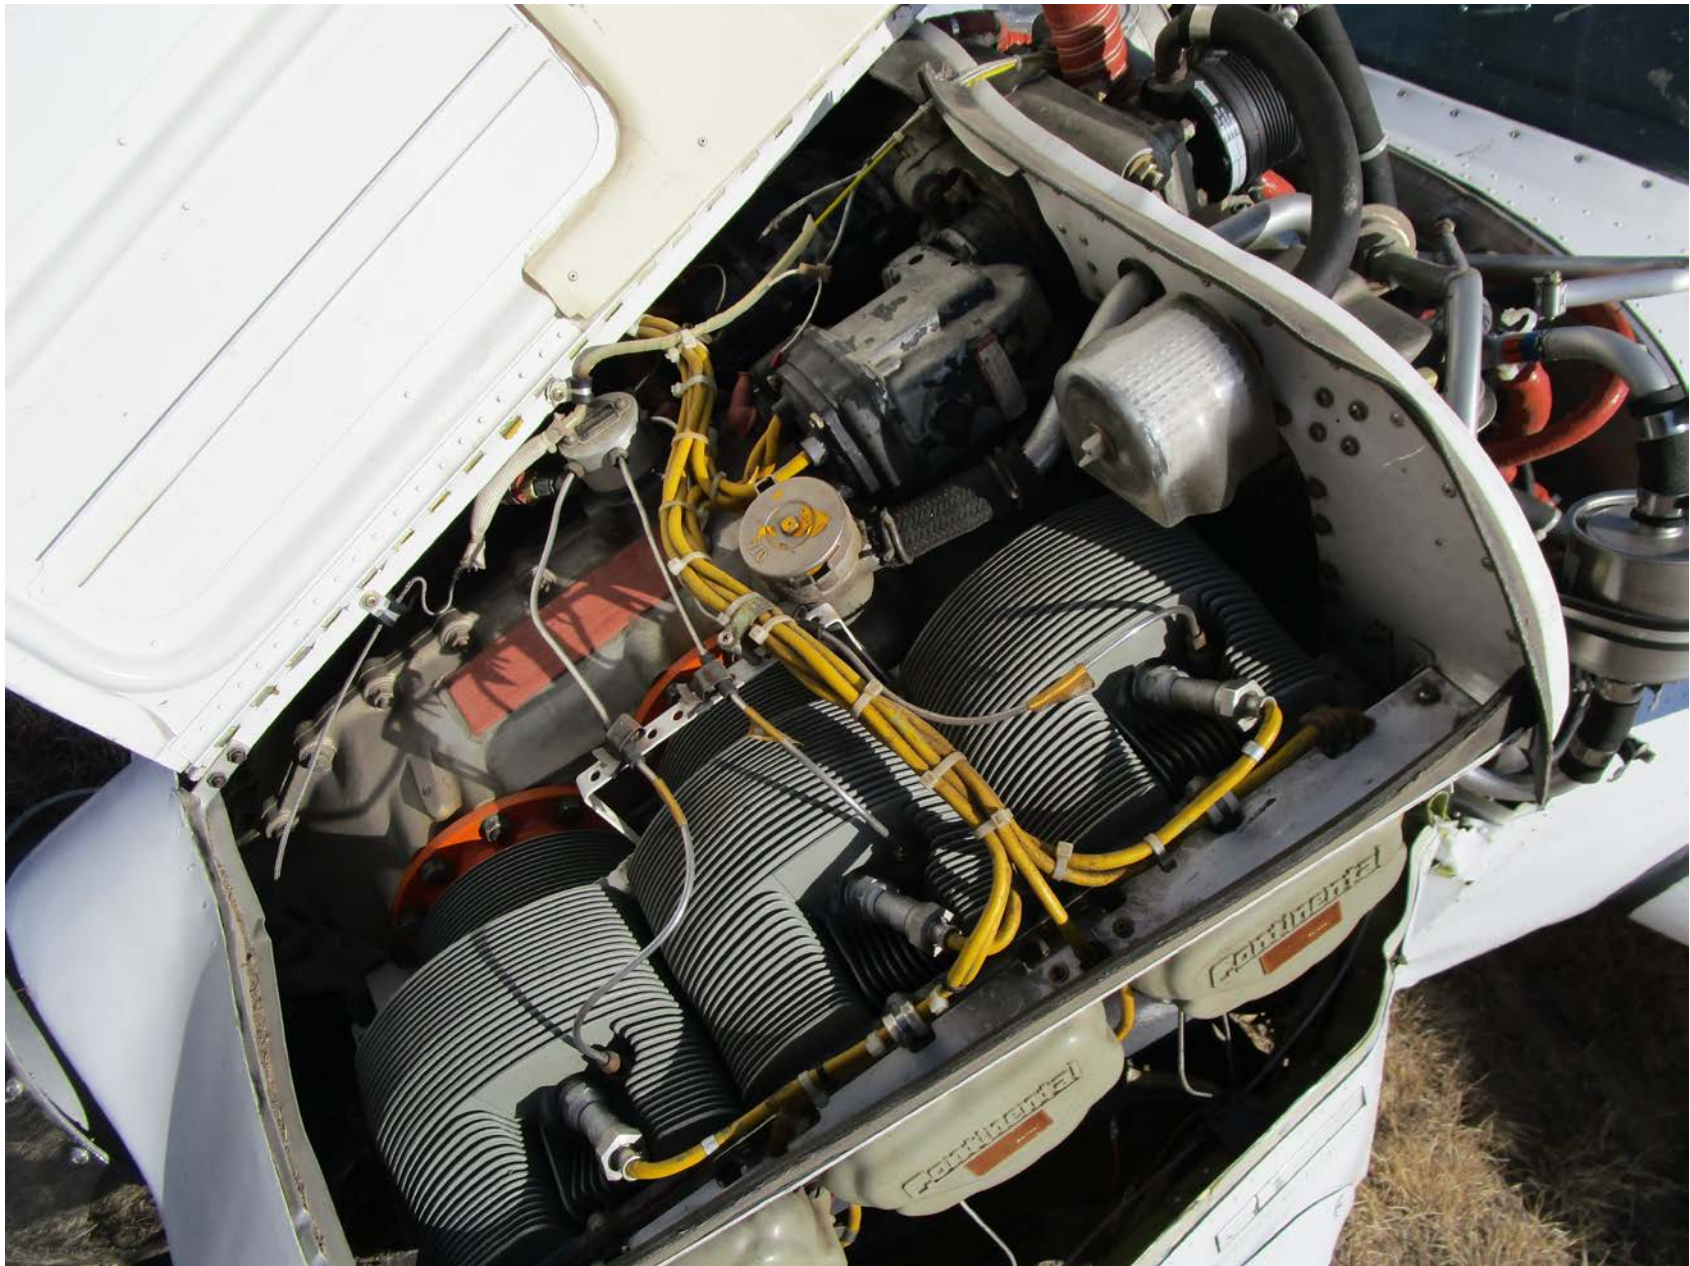
**Photo 3 – The engine.**
