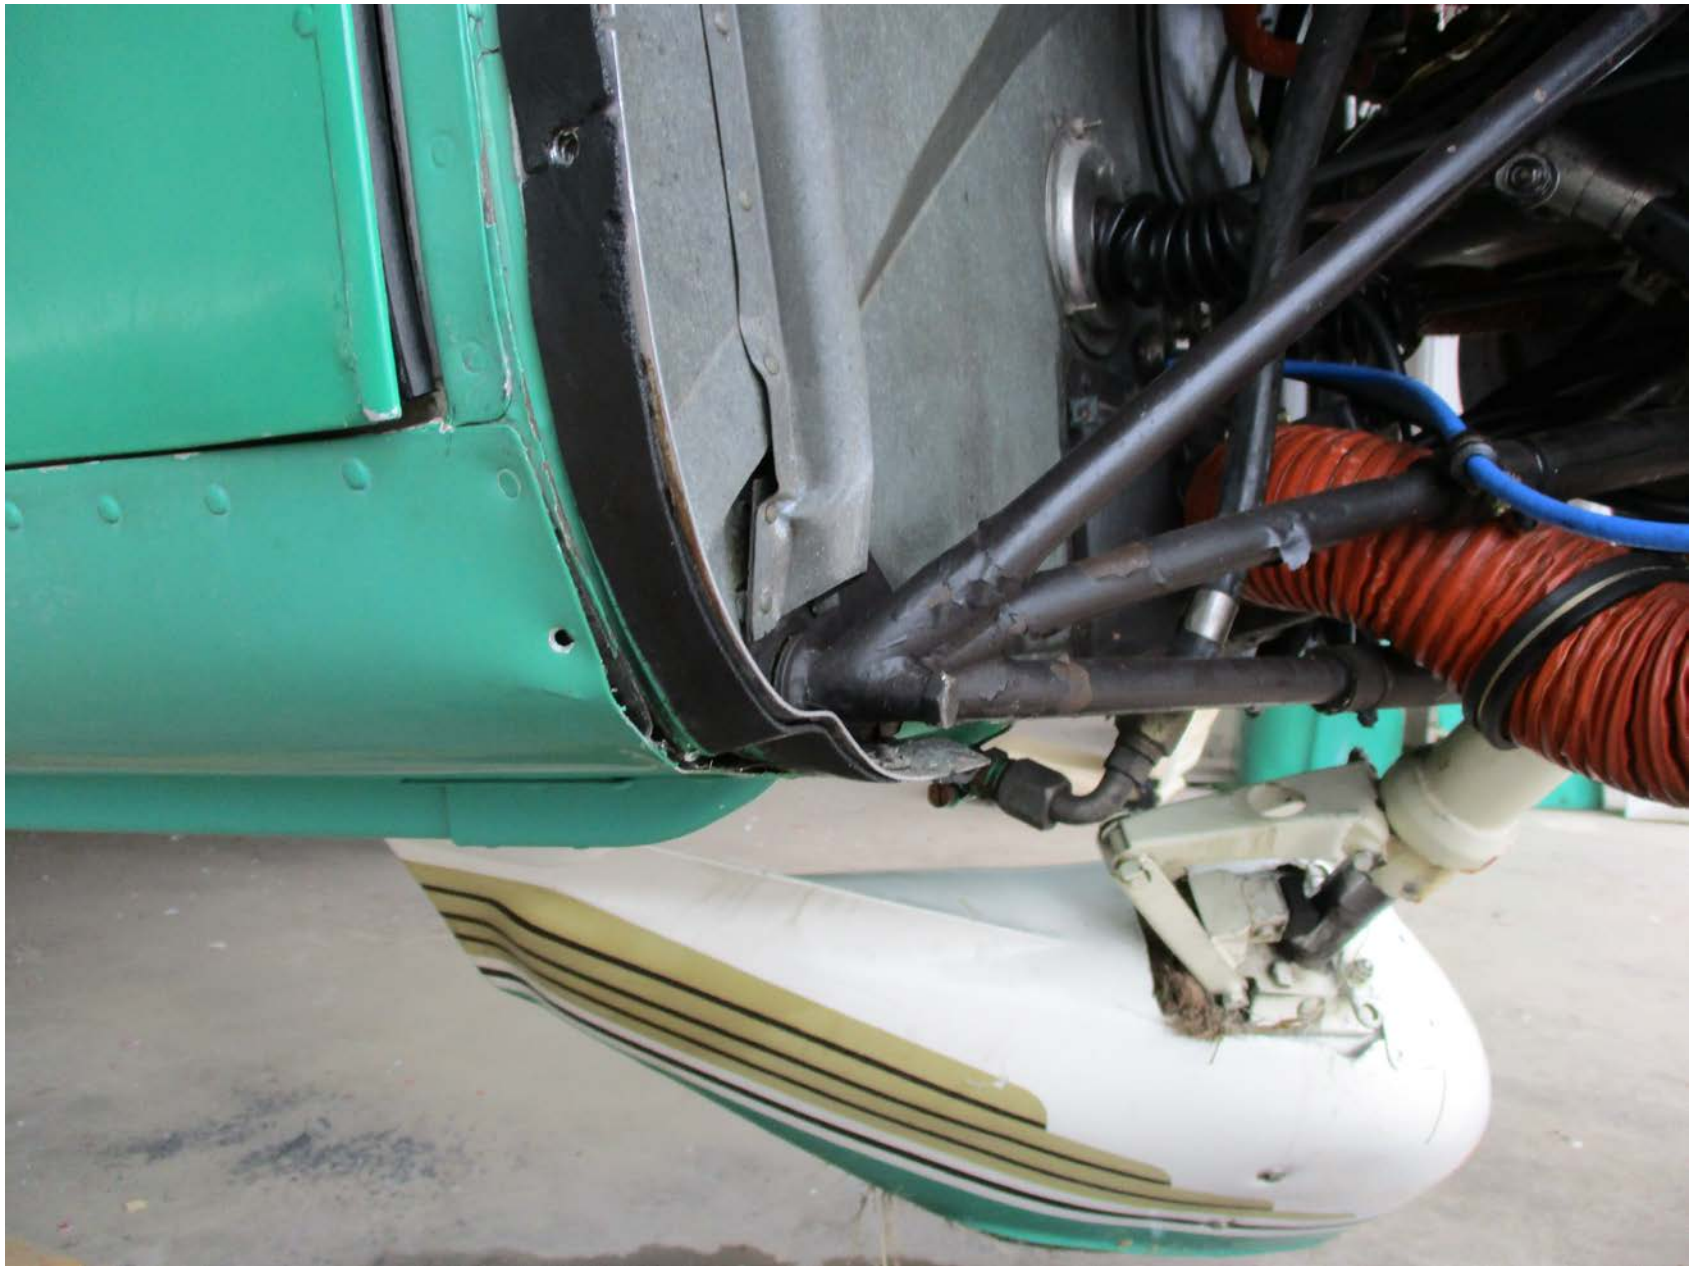
**Photo 1 – View of damage to the engine mounts (Courtesy of FAA)**

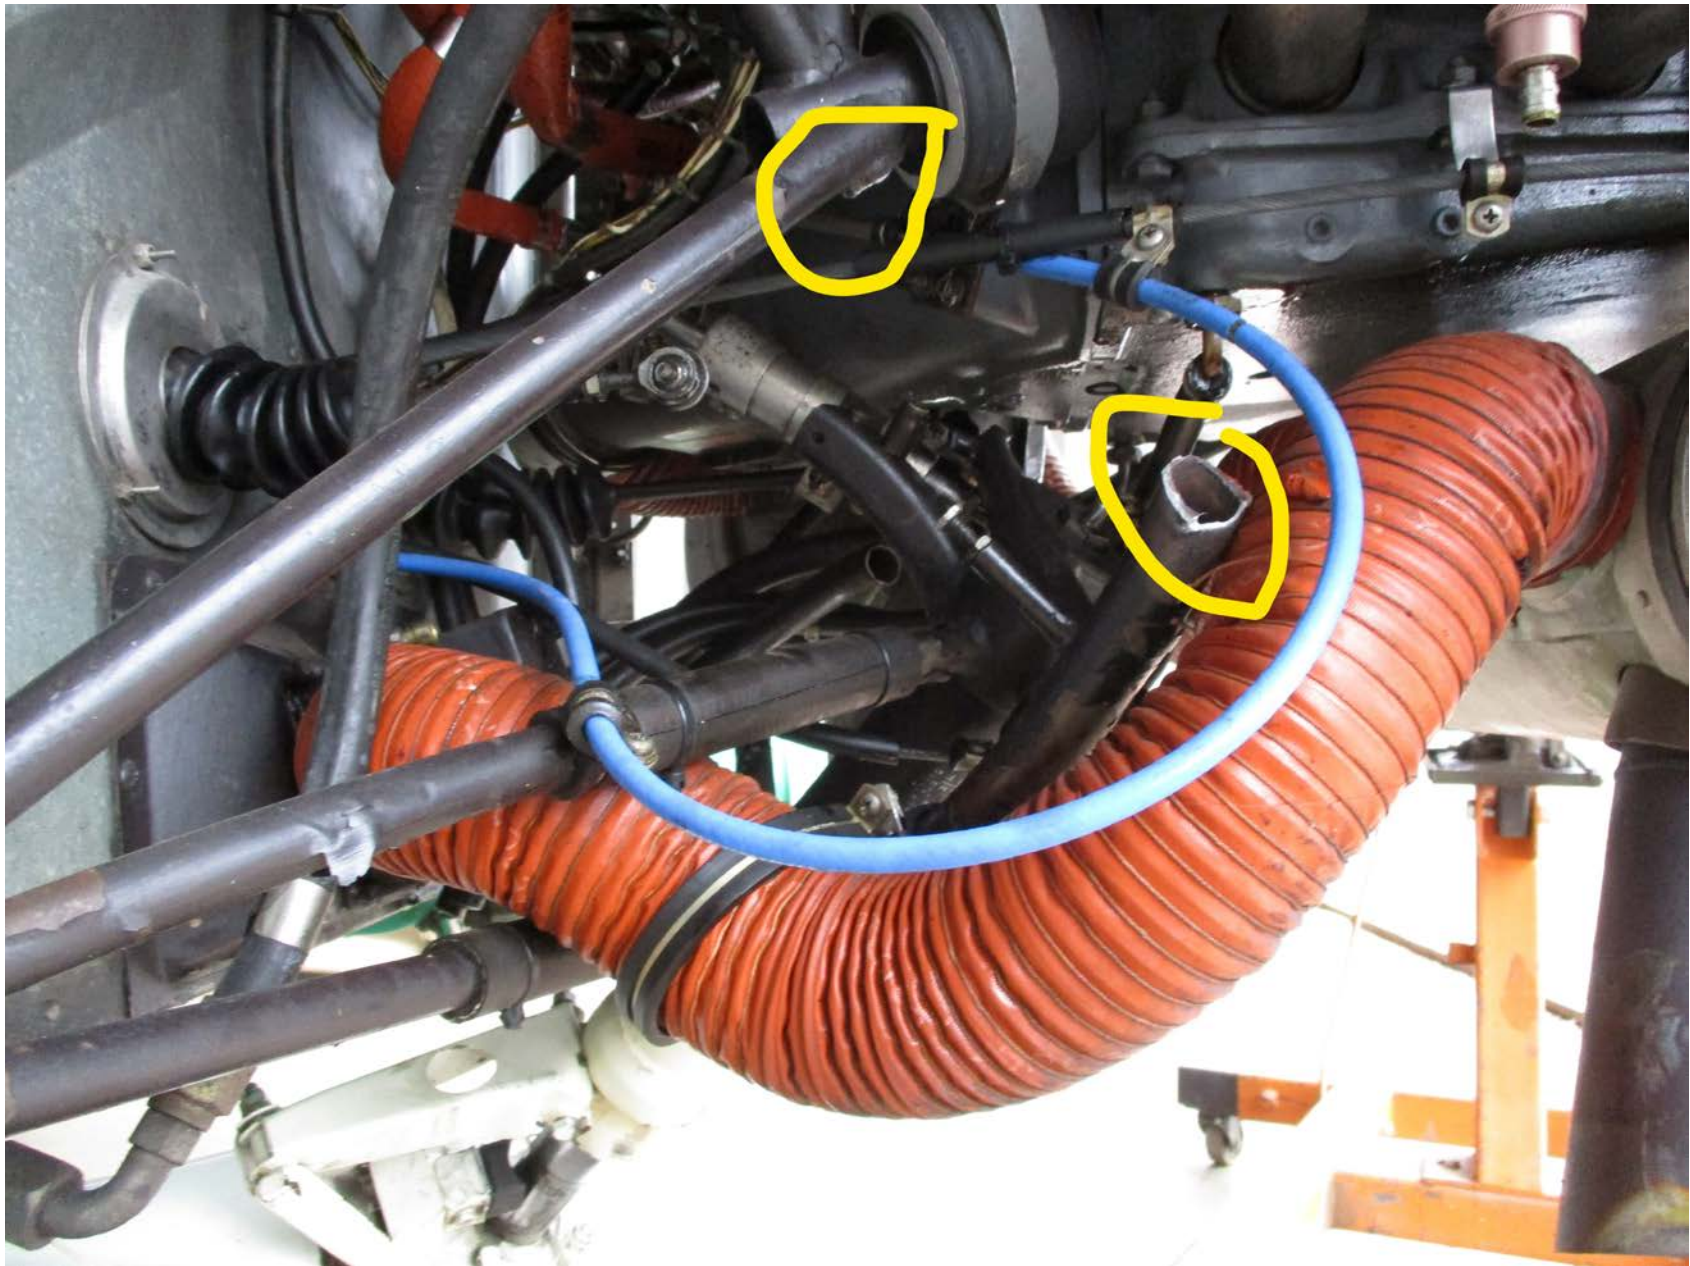
**Photo 2 – View of damage to the engine mounts (Courtesy of FAA)**
