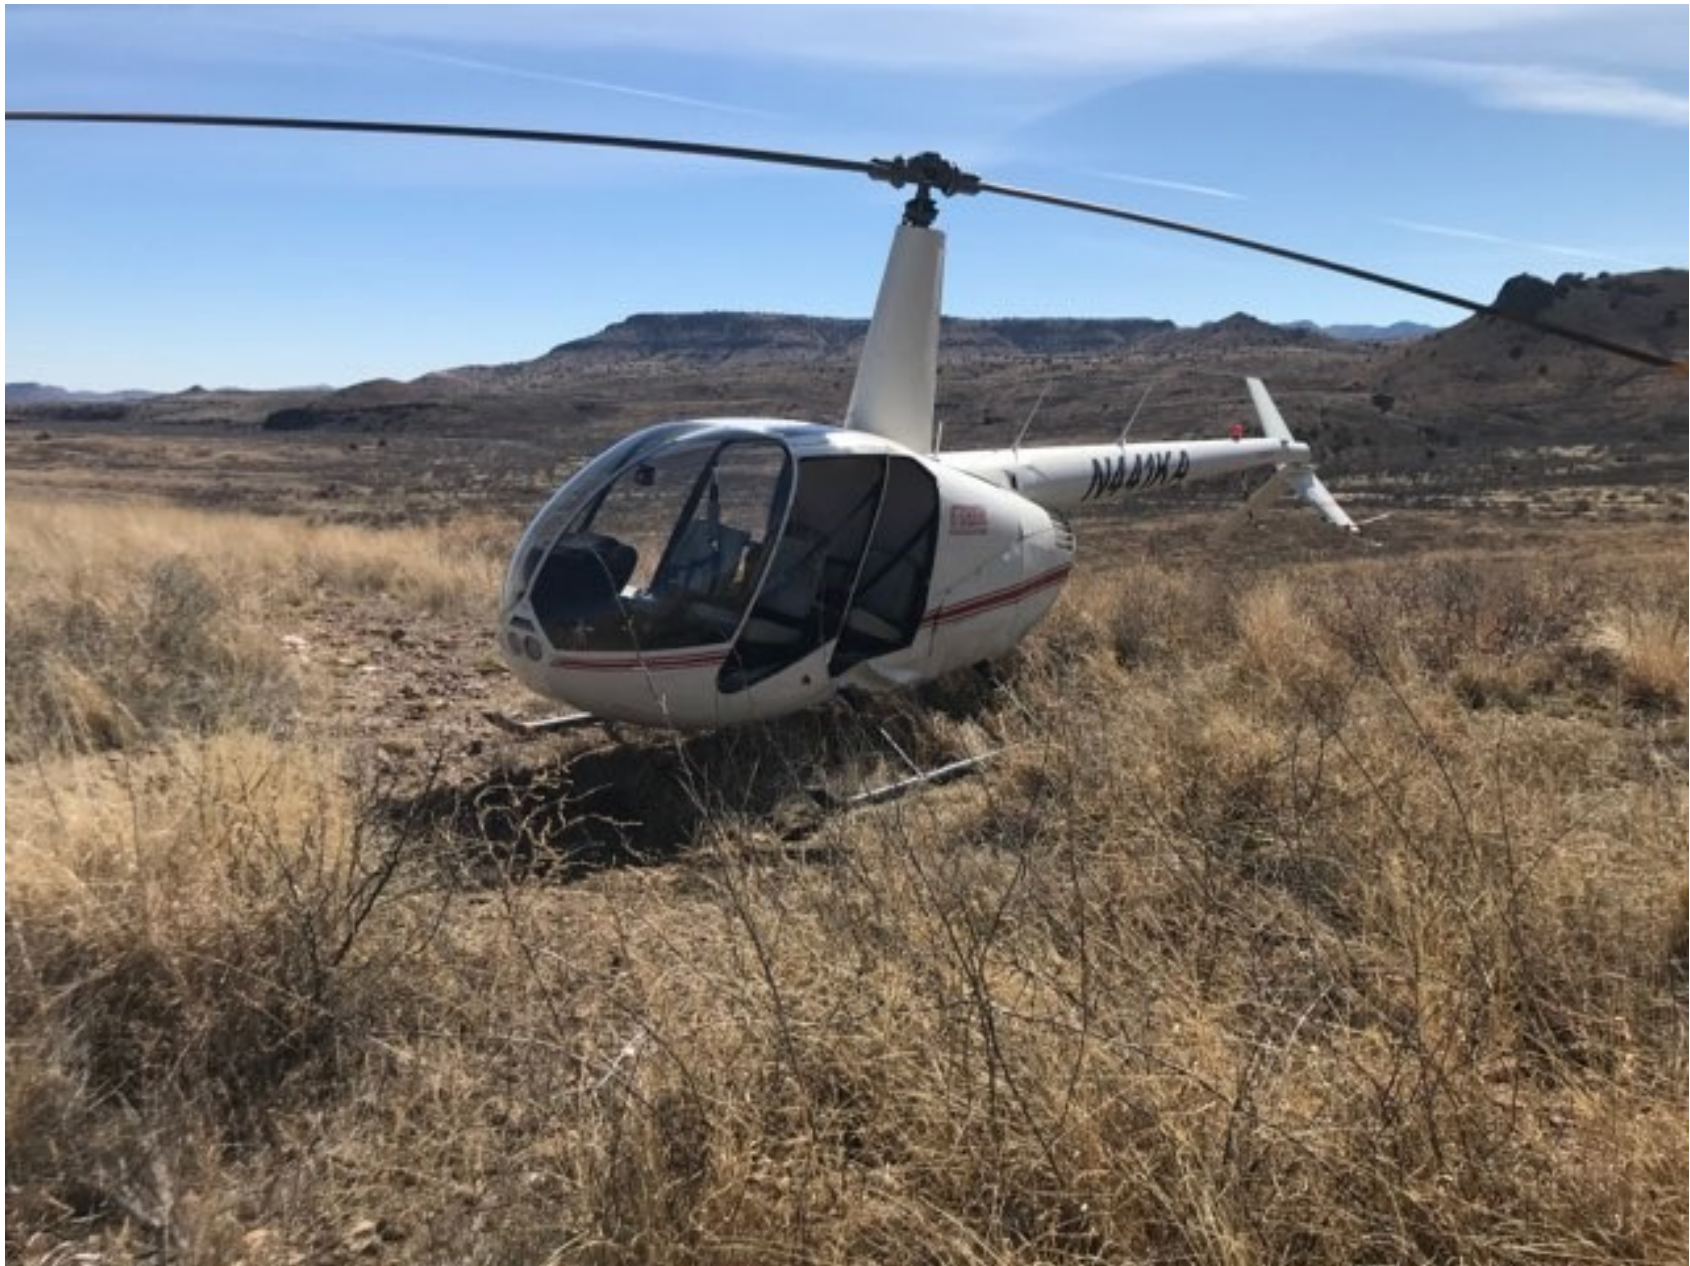
**Photo 1 – View of damage to the tail rotor drive system and the lower left side of fuselage (Courtesy of Operator)**
