NTSB Accident Number: CEN20CA193

Aircraft: N5179D

## AIRFRAME EXAMINATION REPORT

Date: 06/05/2020

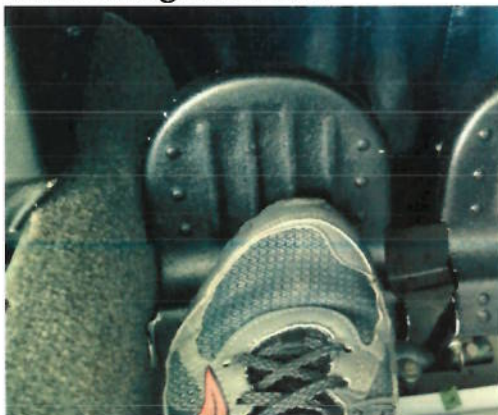
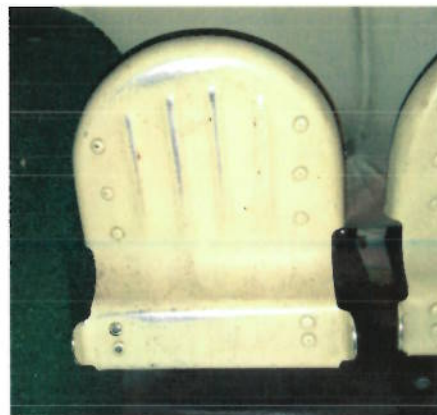
A) Rudder pedals and associated linkages inspected for condition and operation, no issues found. Function check carried out including attempting to side load copilots left pedal to jam the rudder, operationally tested normal with feet situated on the pedals and inside the pedal side tab. Pedal is installed correctly and unobstructed in all conditions. Note that the co-pilots left pedal does come in close proximity to the center console side carpet, as standard from factory. Refer images below.

SMAT 1958 C182A N5179D Copilots pedals/1959 C182B example shows contact between carpet and pedal

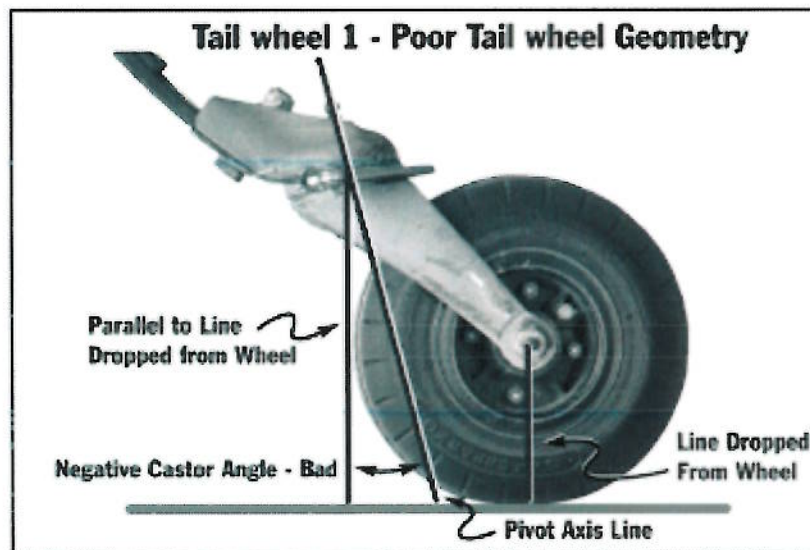
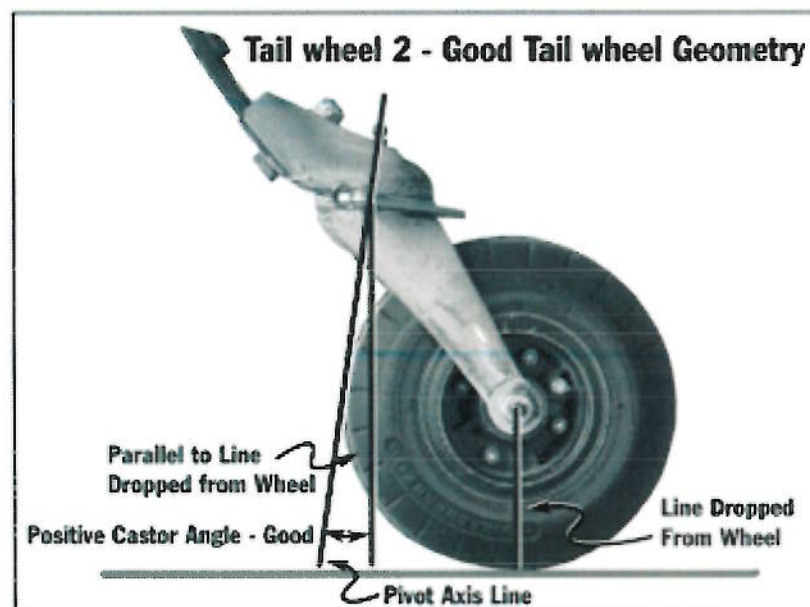
- (Observation / not verifiable) Tail spring has lost its original profile since installation. Bowing of rear 10” of the spring before tail wheel head has increased, this in turn changed the castor angle of the tail wheel. No original measurements were taken of the serviceable spring

prior to installation, but previously it was closer to a neutral castor angle at gross weight and positive castor angle when the aircraft was empty. No heavy landings have been reported in the 18 hours of initial operation, and it is unknown if the harsh tail wheel shimmy and ground loop caused the spring angle to change, or if the spring has just lost its tension.

- King pin / tail wheel negative castor angle can contribute to a greater tendency to shimmy. As mentioned previously the tail spring shows signs of increased bowing leading to a negative 9° king pin / castor angle under current conditions with no pilots, 40gal fuel and 100lbs ballast in the baggage area.  
Ideally this should be 0° or slightly positive under gross weight.

18. Lack of internal lubrication (grease zerks located on head and axle bolt for lubrication)
- Tail wheel was recently assembled and greased correctly.
19. Tail wheel is incomplete or has been reassembled incorrectly
- Tail wheel is assembled correctly
20. Too much negative castor angle (not enough tail spring arch)
- Refer previous notes. Negative castor angle found to be  $-9^{\circ}$  at 2125lbs aircraft weight (No pilots, 40gal fuel and 100lbs ballast in baggage area)

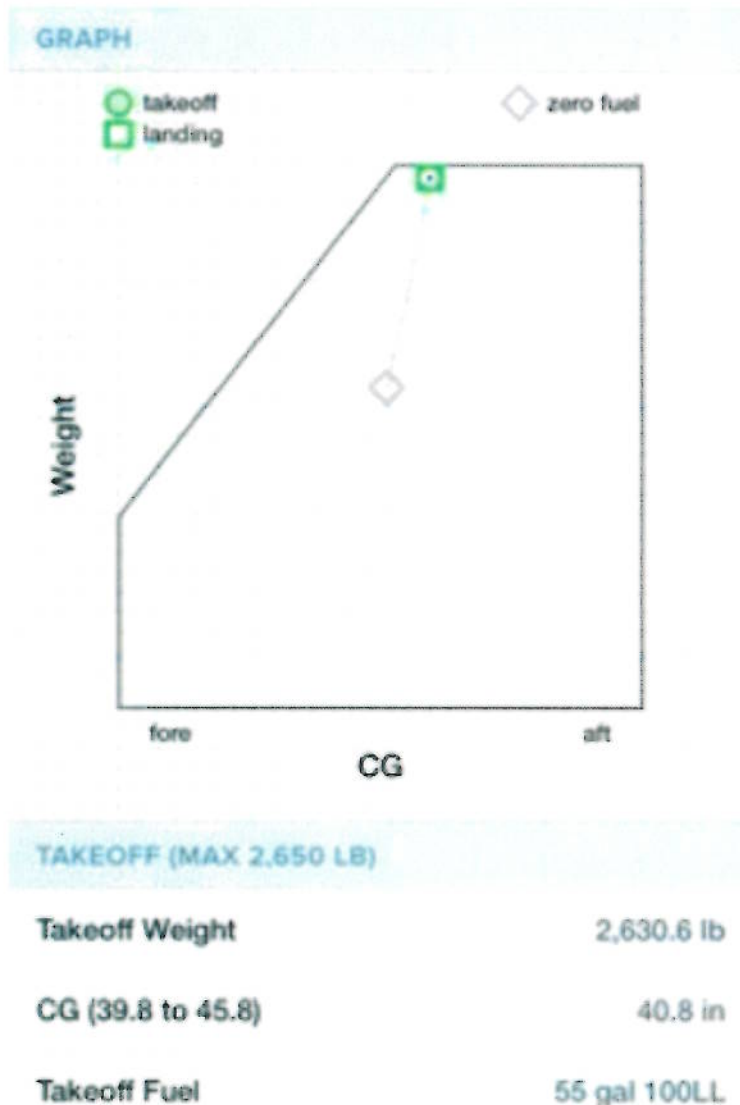
- On landing the aircraft was 110# below Max Gross Wt and had a CG of 40.3", which was within the CG limits. (Photo from pilot's ForeFlight app)

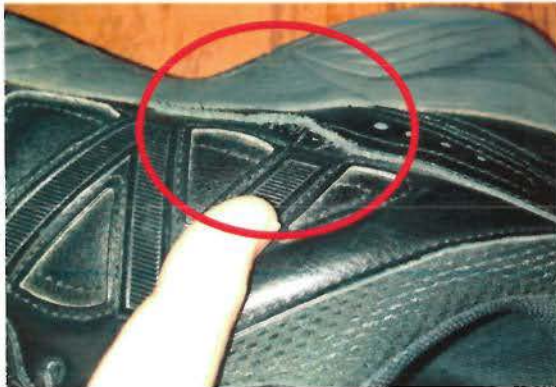
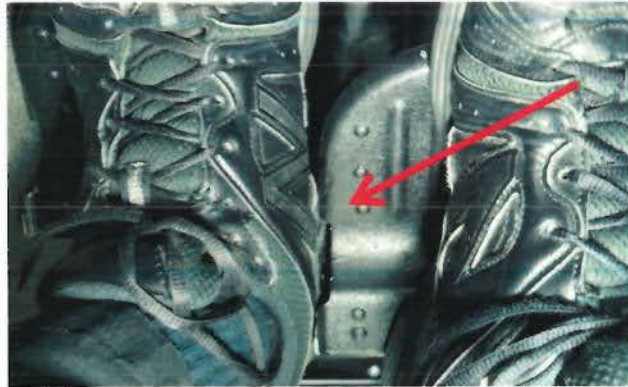
- 6) Additional Observations
  - A) The pilot shared that after the accident he discovered an inside seam in his left shoe had been torn. It is unknown when this actually occurred. They are leather shoes with double-stitched seams. The pilot sat in the right seat (seat occupied during accident) and tests were conducted to determine if the left shoe could have moved between the rudder pedals and been caught. After several attempts, the torn seam in the shoe was caught by the right rudder pedal. It was determined that during the violent tailwheel shimmy, the shoe could have moved to a point where the right rudder pedal caught on that seam, preventing movement of both rudder pedals, and keeping the left rudder pedal depressed.
