**Photo 2 – N52794 at the accident site**

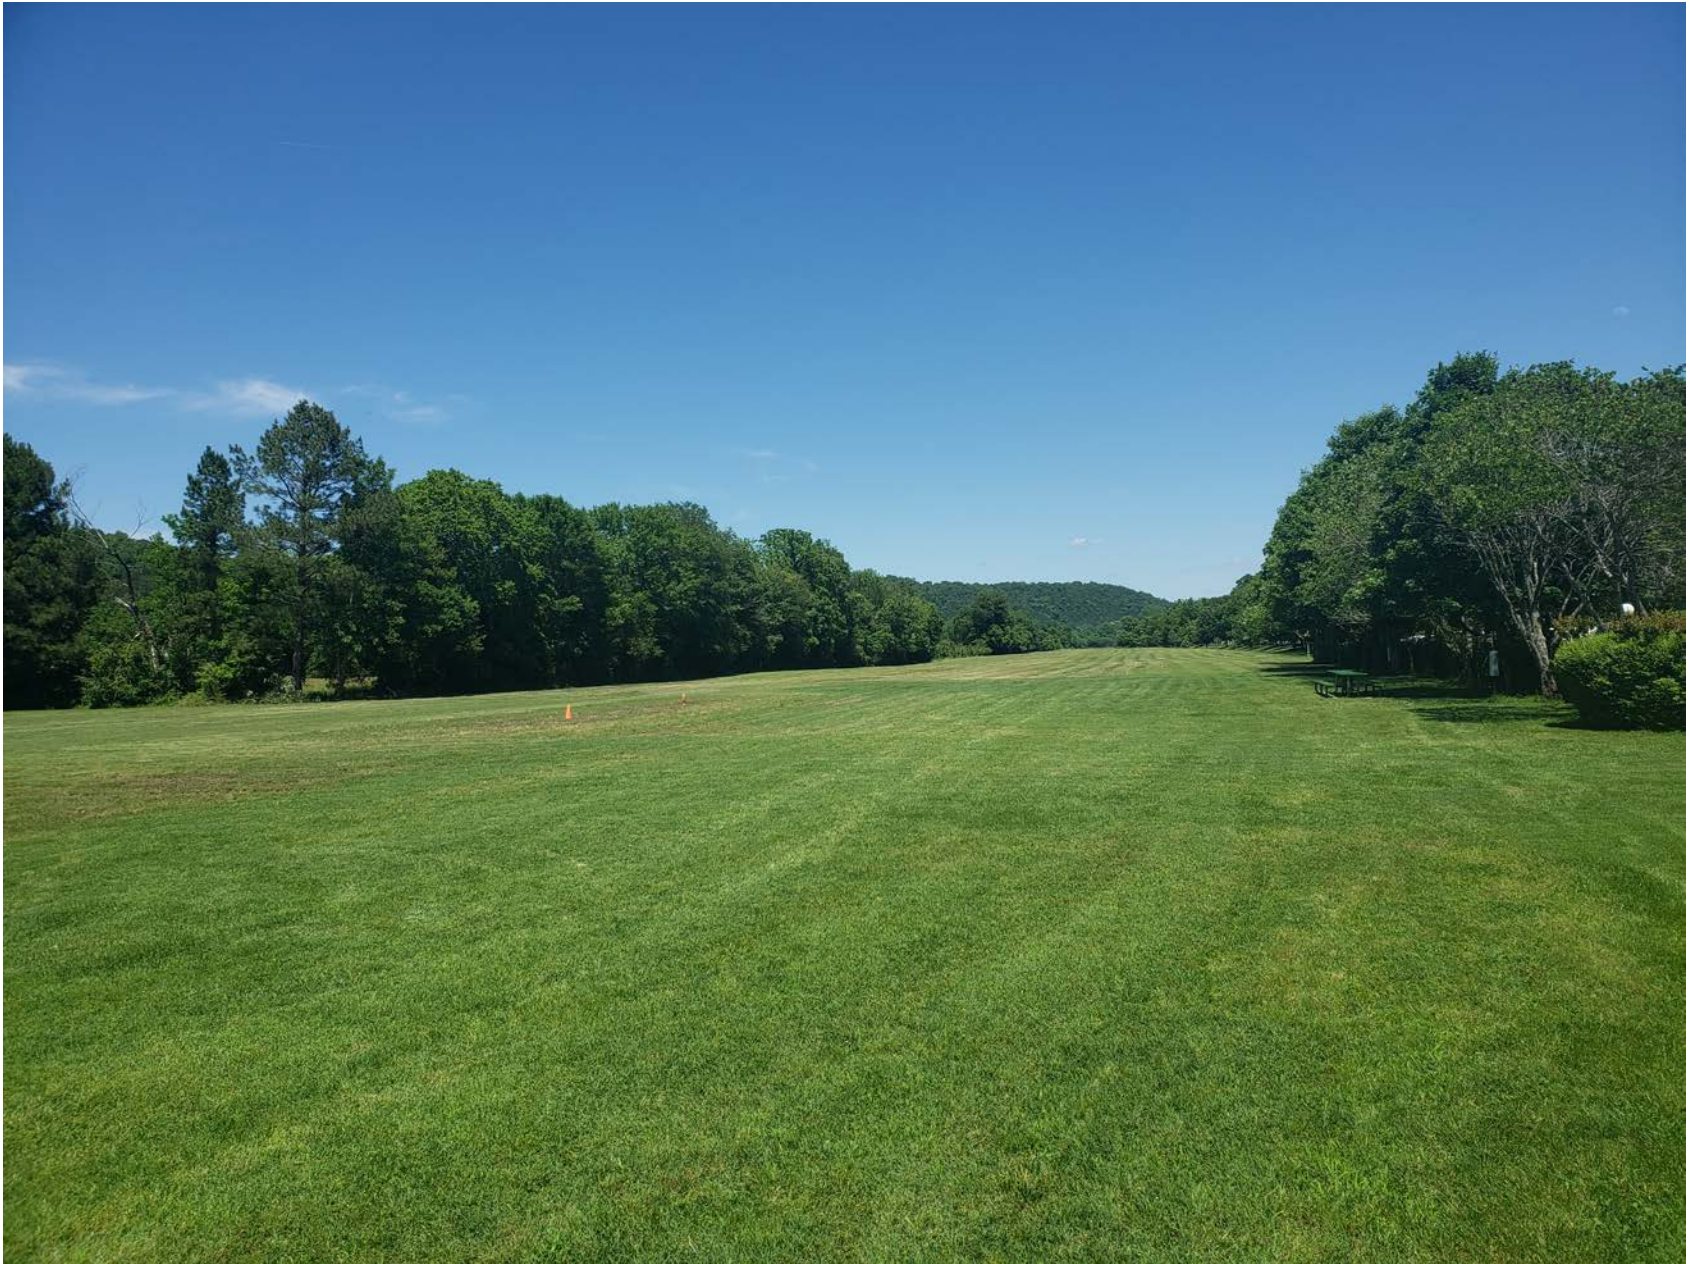
**Photo 1 – View down runway 6's departure path. Pylons on runway mark muddy or soft spots**

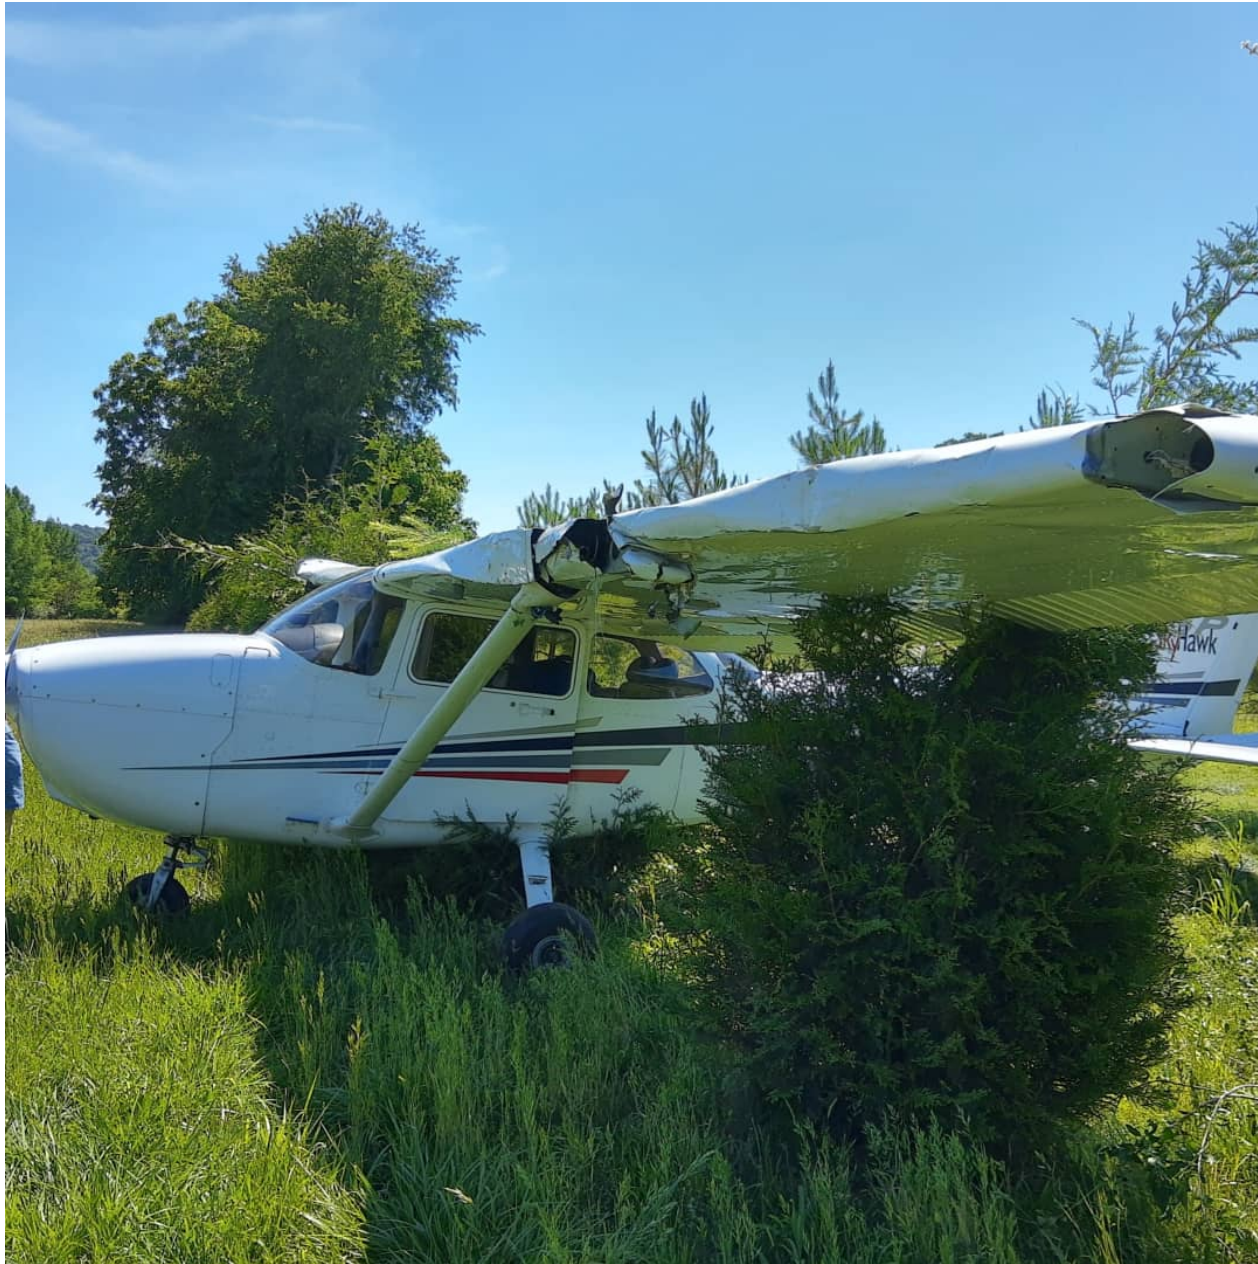
**Photo 3 – Left wing leading edge damage**

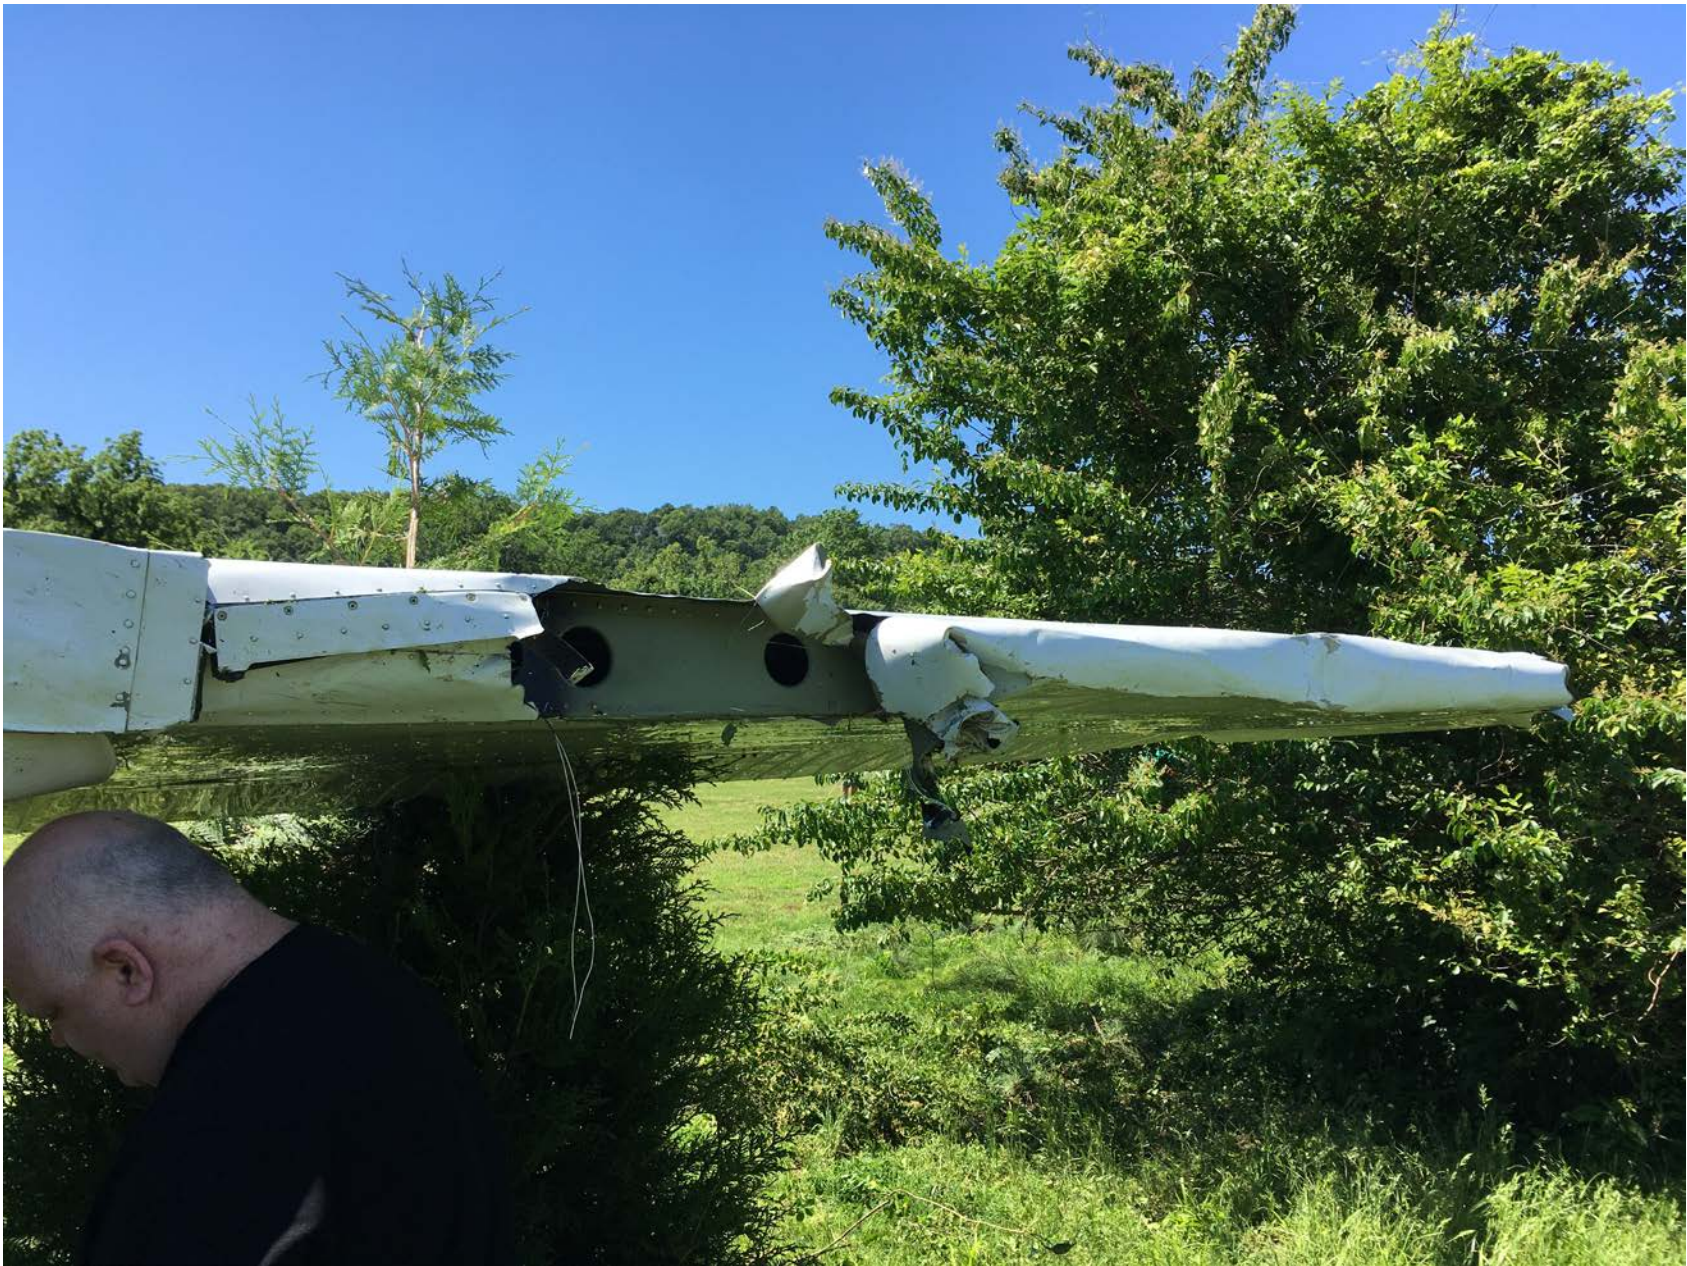
**Photo 4 – Left wing leading edge damage (another view)**

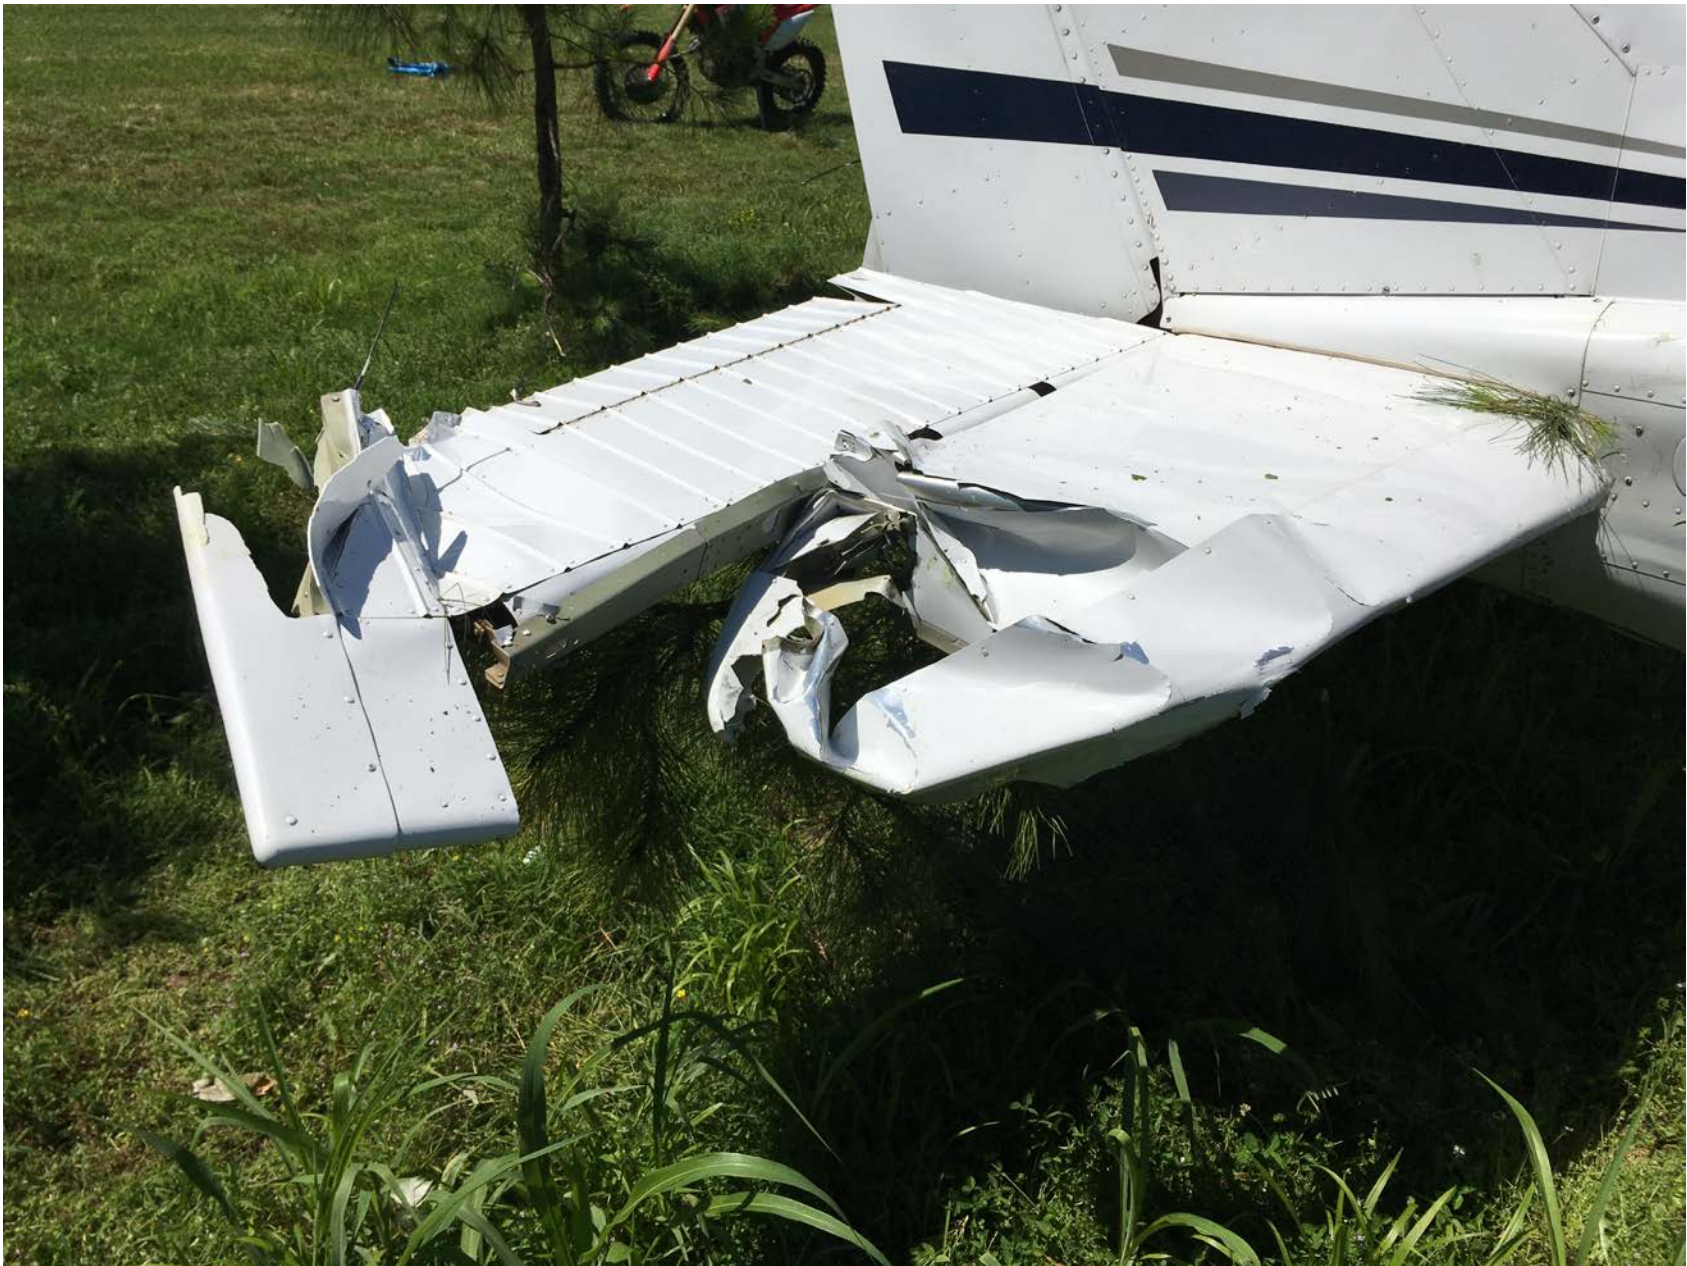
**Photo 5 – Right horizontal stabilizer, elevator, and rudder damage and skin wrinkling**
