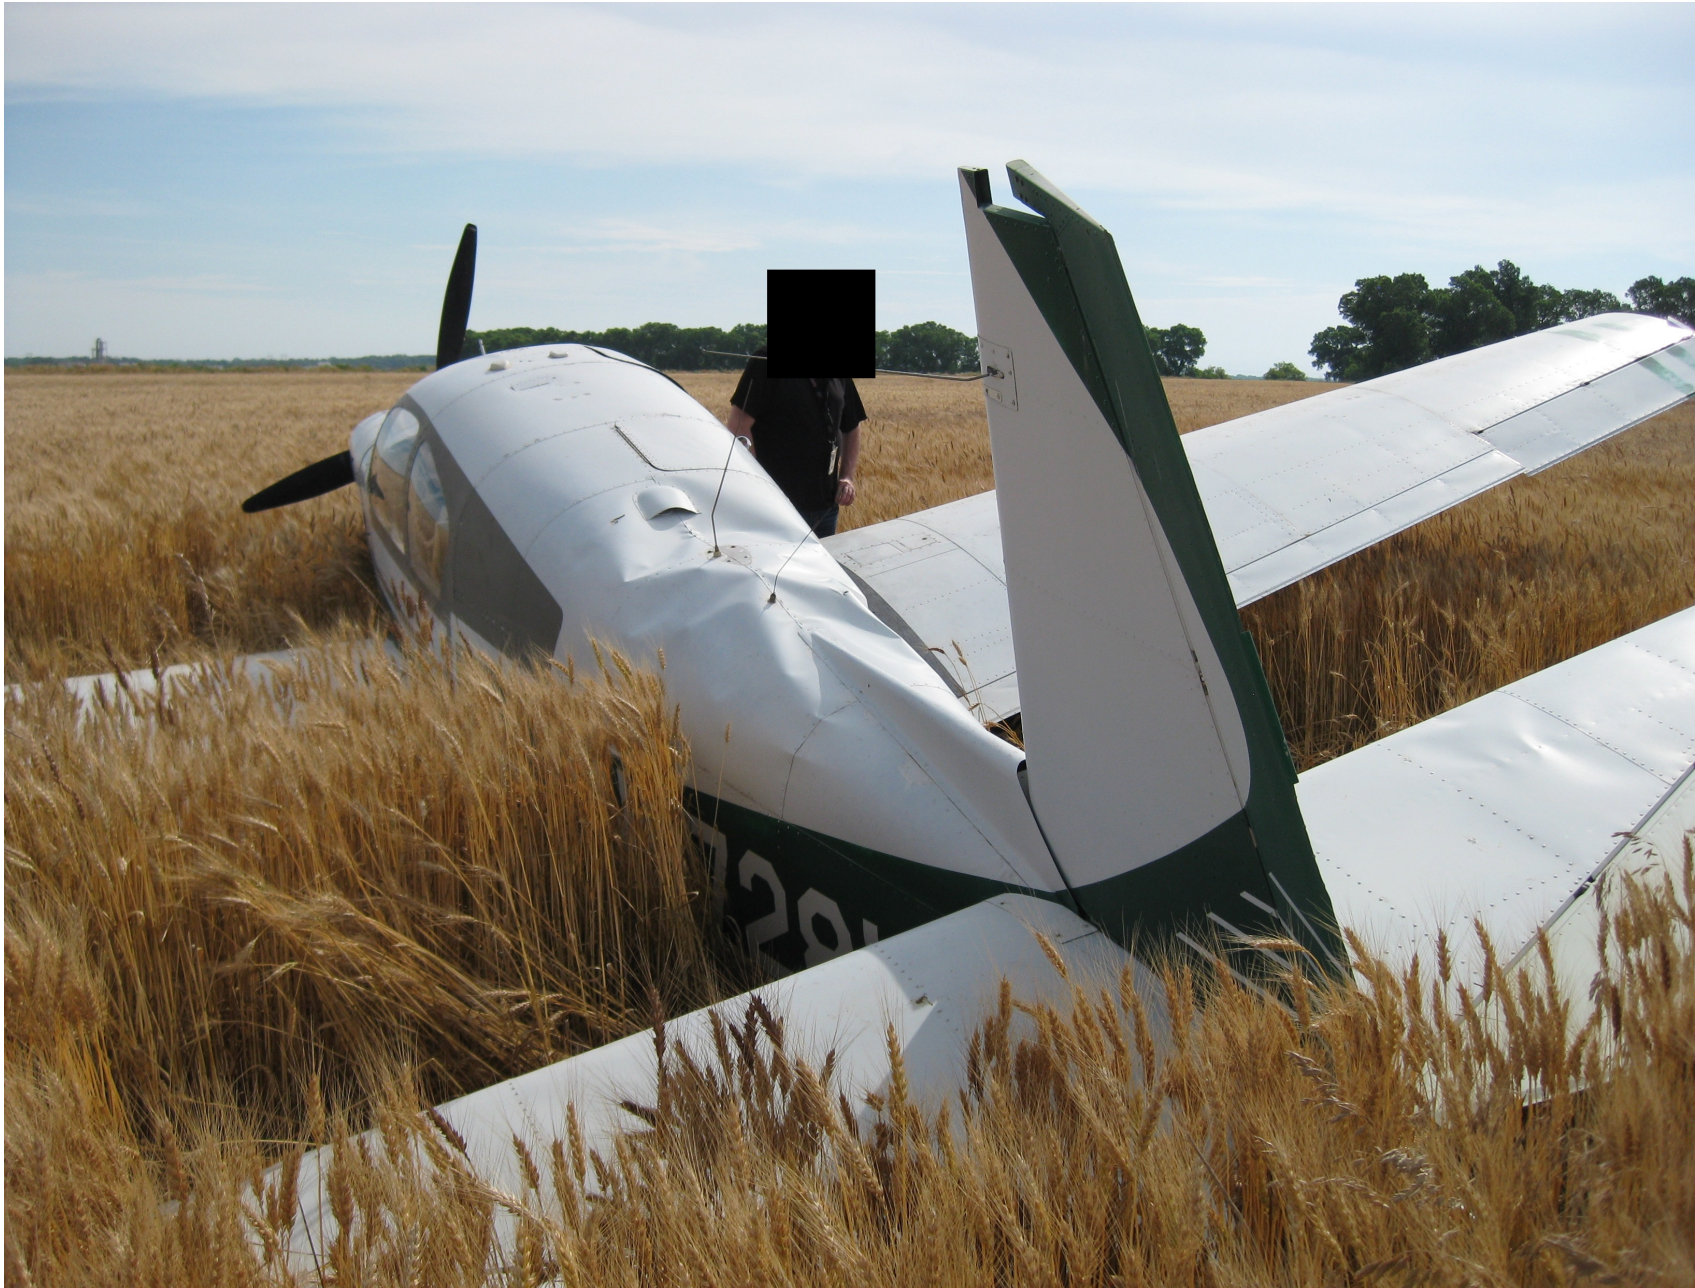
**Photo 1 – Airplane at Accident Site**

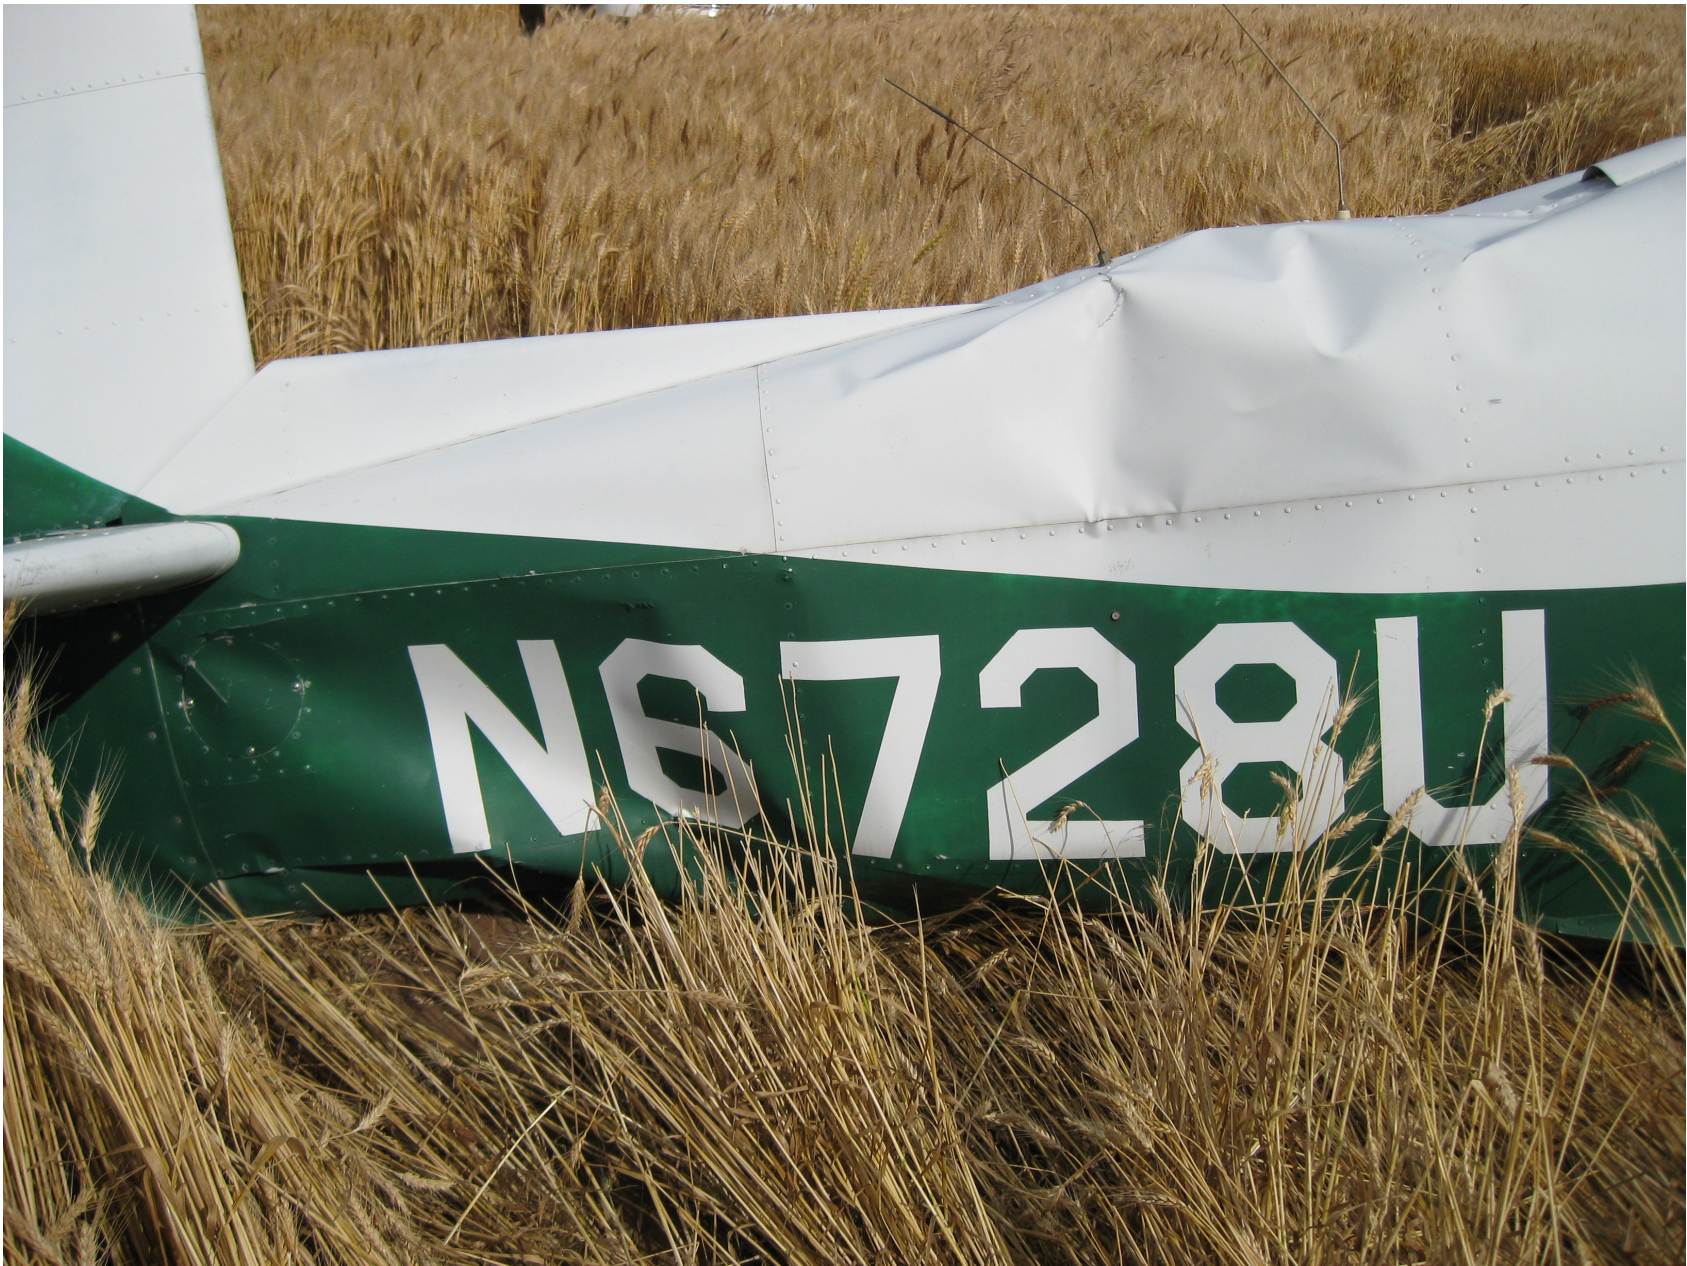
**Photo 2 – Closeup of Deformation to Empennage**
