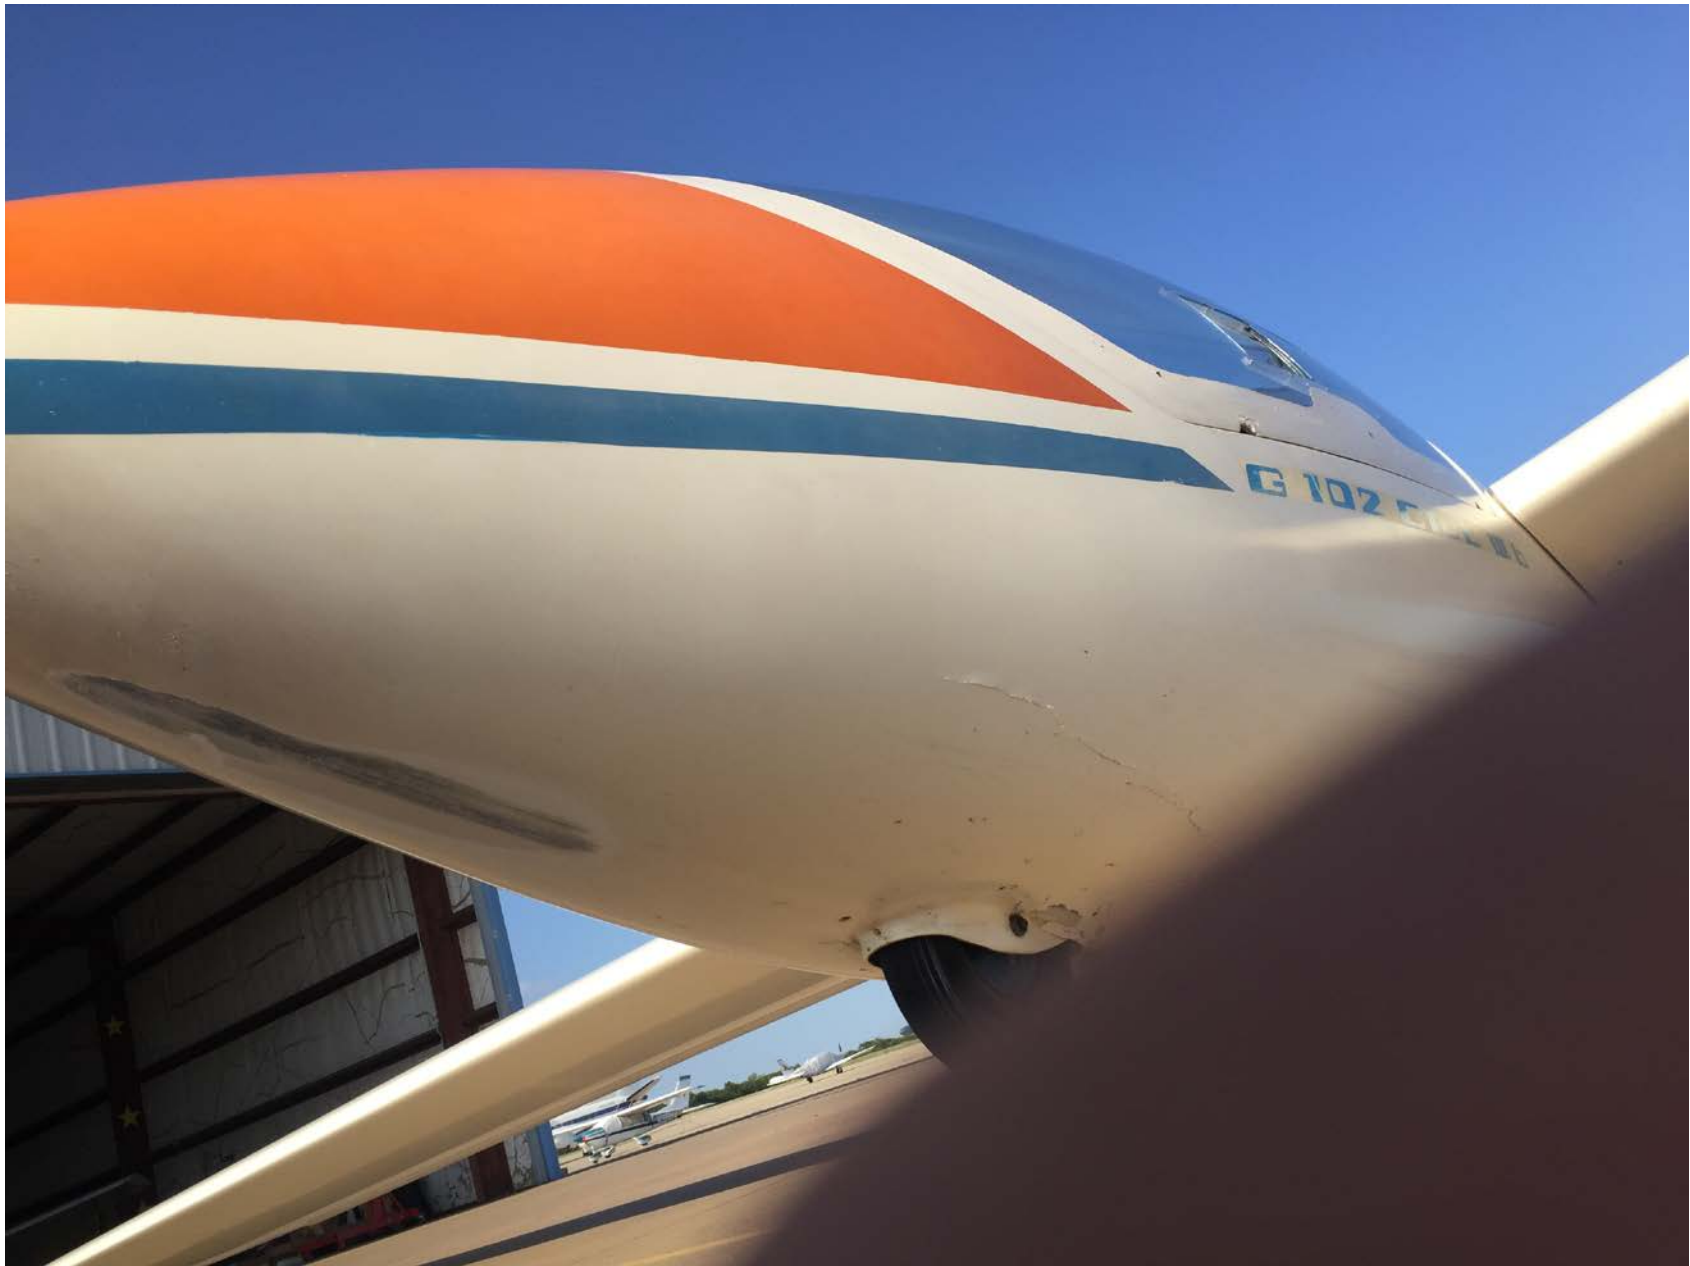
**Photo 1 – Scuff mark on nose and cracked fiberglass on left side (FAA photo)**

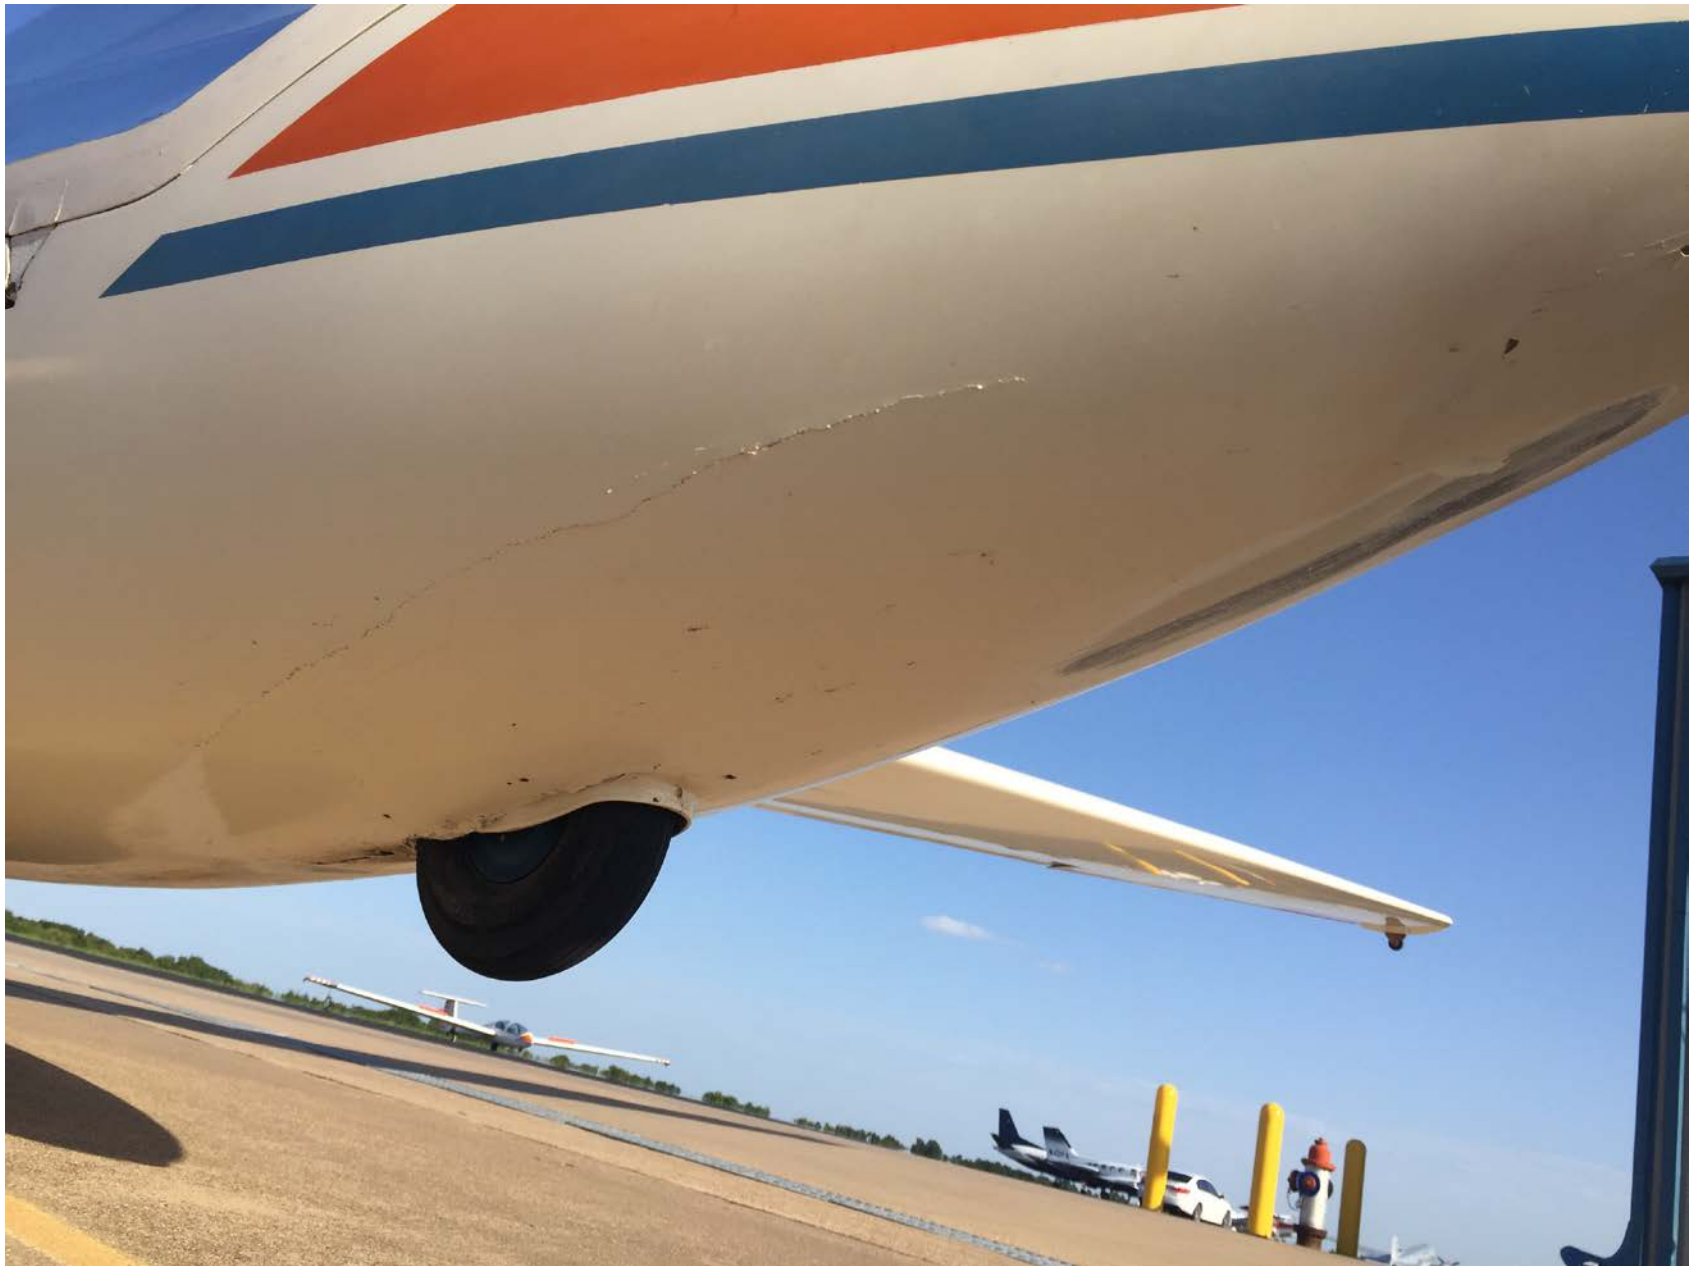
**Photo 2 – Cracked fiberglass on right side of nose (FAA photo)**

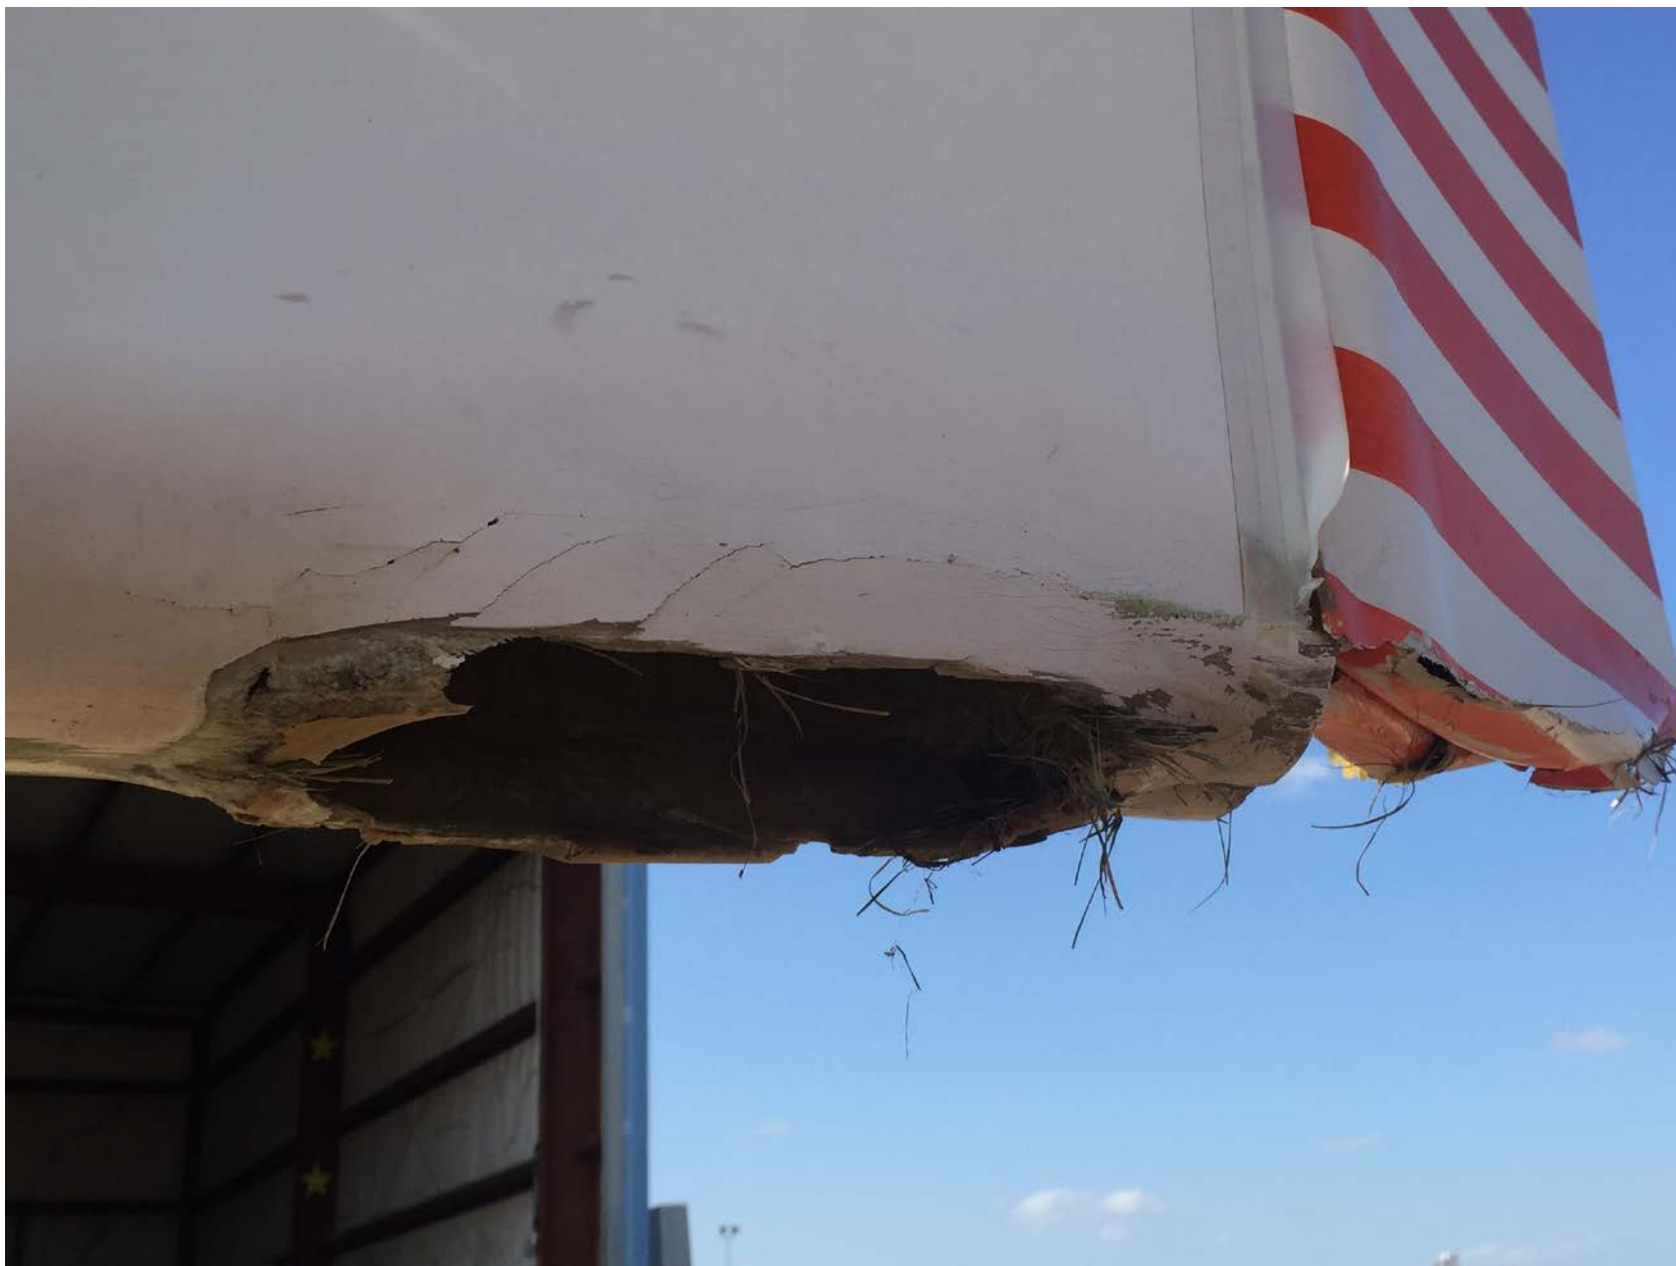
**Photo 3 – Tail cone and rudder damage (FAA photo)**

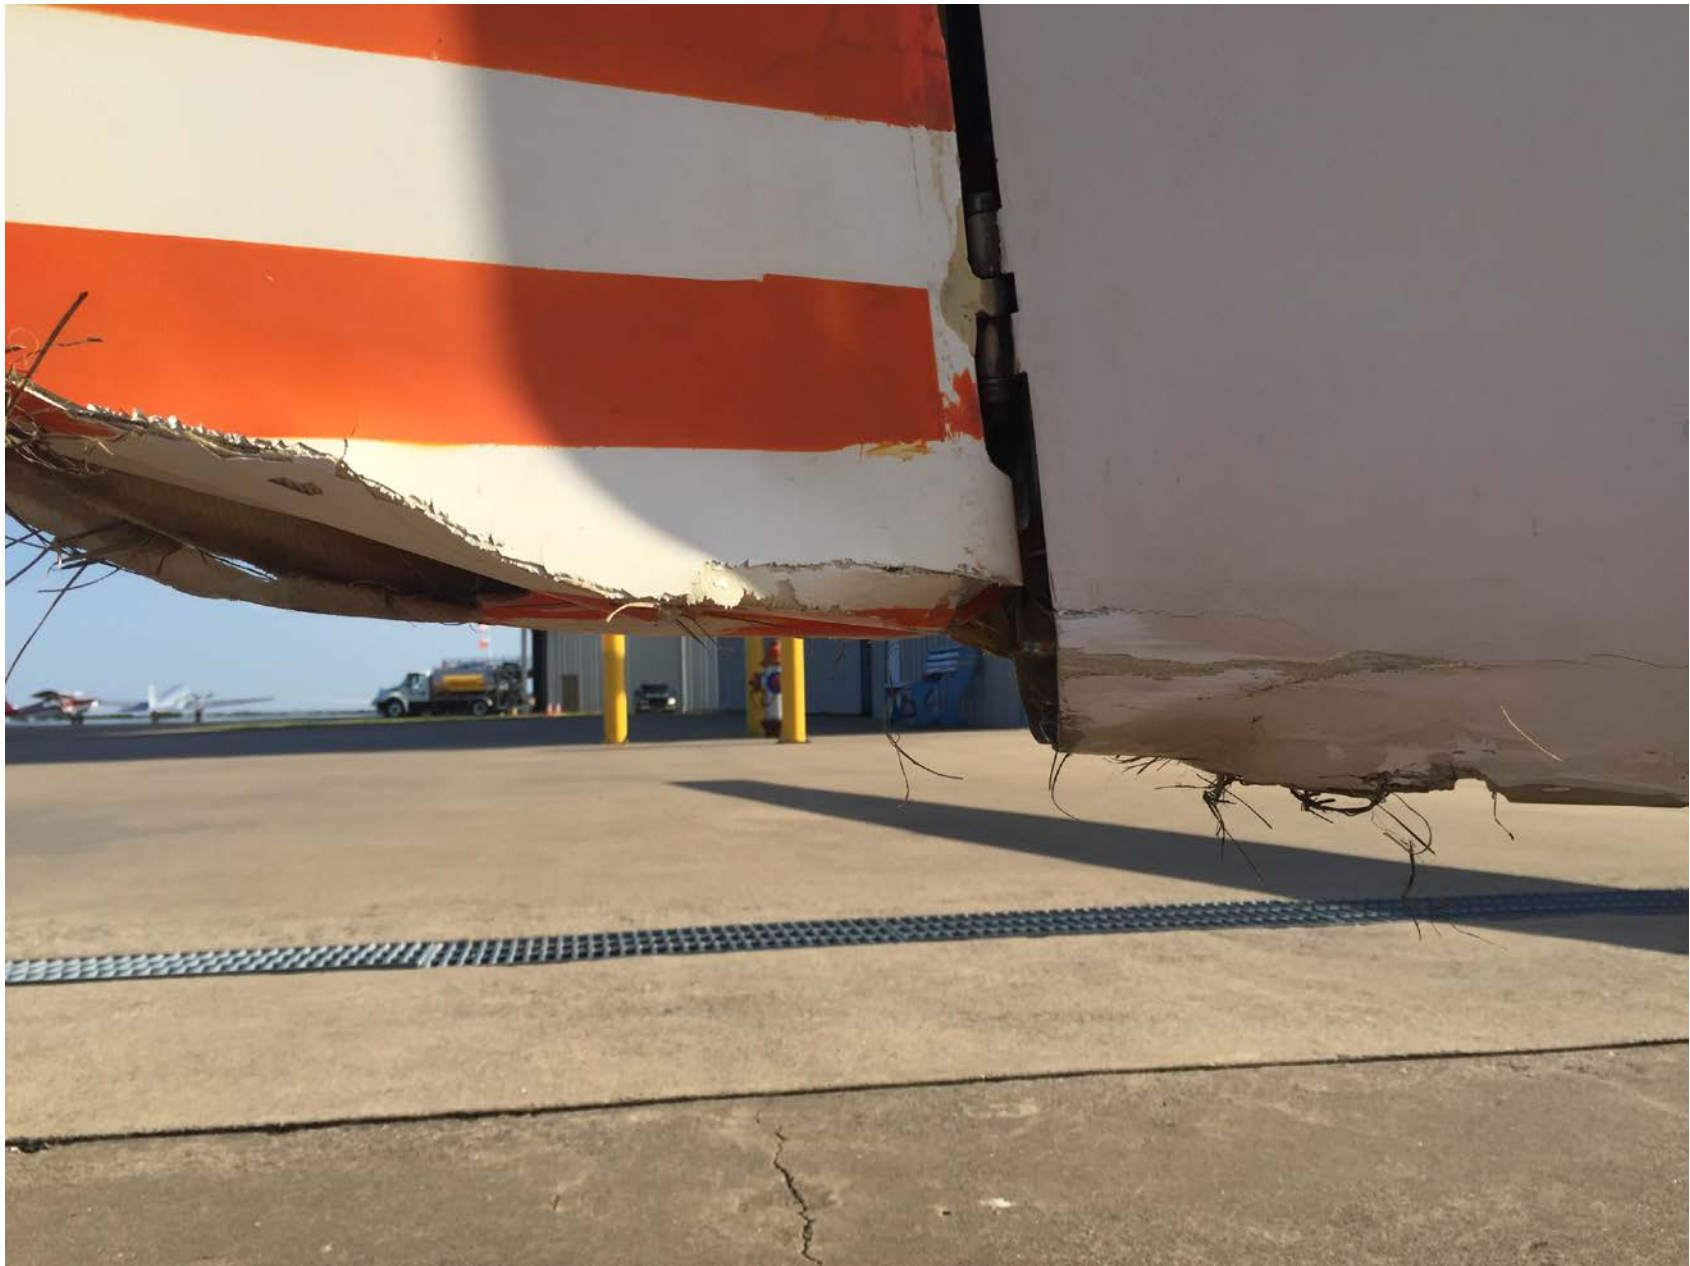
**Photo 4 – Tail cone and rudder damage (FAA photo)**

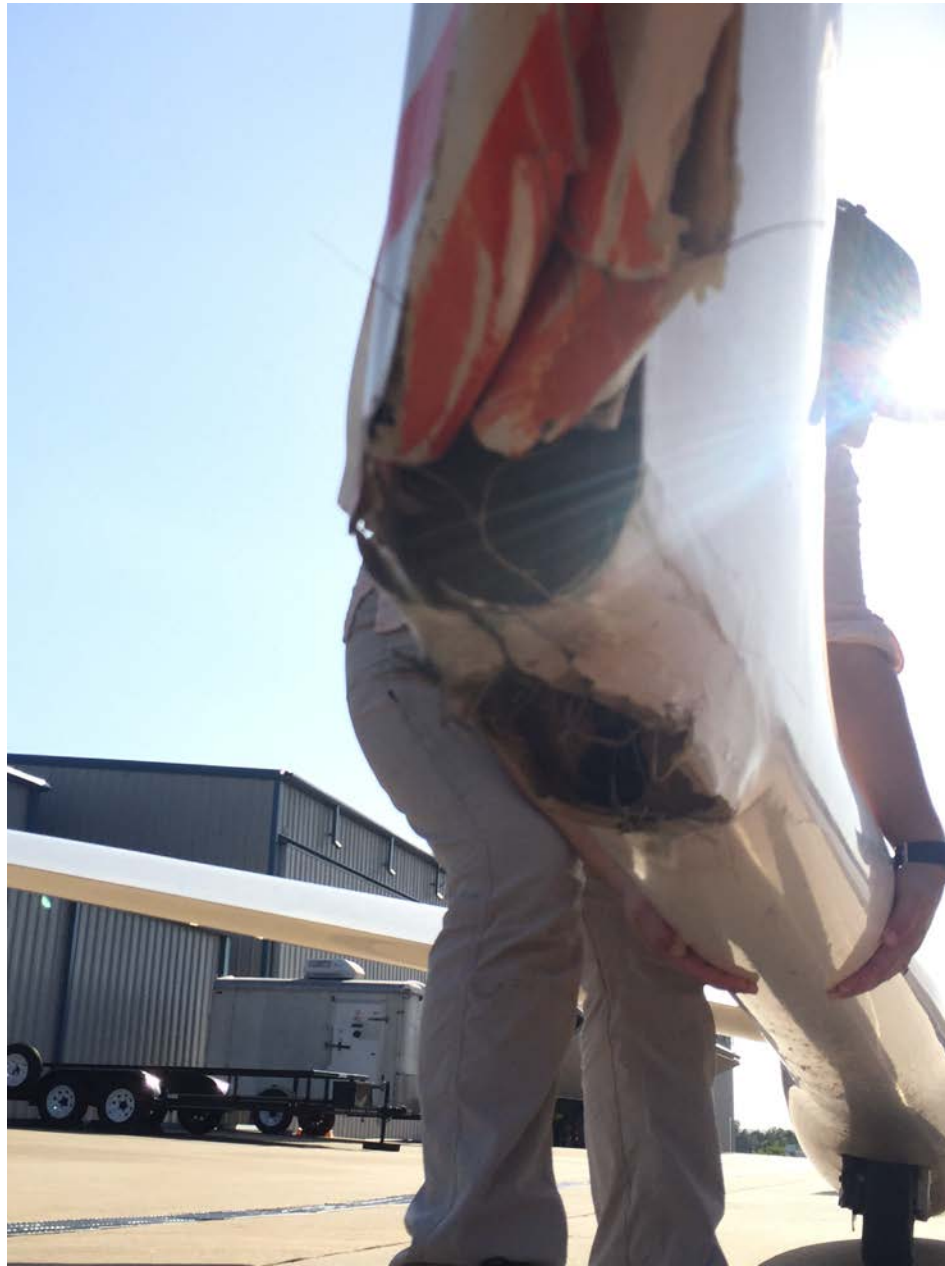
**Photo 5 – Tail cone and rudder damage (FAA photo)**
