**From:** Mayo, Tracy (FAA) [REDACTED]  
**Sent:** Sunday, September 20, 2020 10:11 AM  
**To:** Fox Todd  
**Subject:** FW: 09/18 N43020 accident

**From:** Nathan Otto [REDACTED]  
**Sent:** Saturday, September 19, 2020 5:55 PM  
**To:** Mayo, Tracy (FAA) [REDACTED]  
**Subject:** 09/18 N43020 accident

Nathan Otto here. We just spoke on the phone regarding my incident last night in the Piper Cherokee at Phyllis Field; identifier 6IL2.

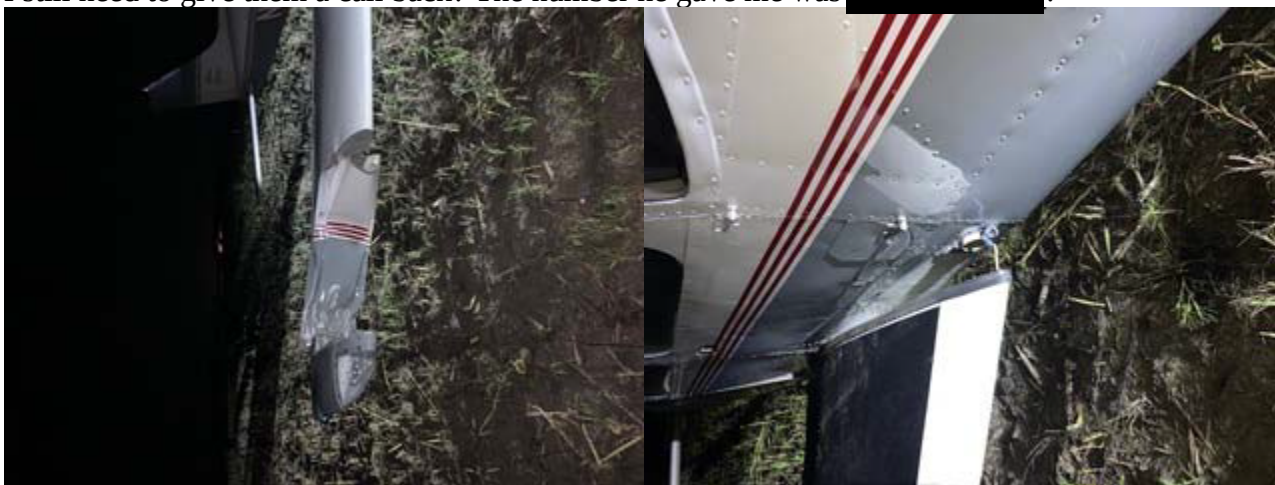
I ended up landing to the right of the runway offset by about 10 feet from the right end of the runway. Upon the final moment before touchdown I do recall recognizing that the grass seemed longer than I had recalled but I did not process that I could be off of the runway and continued with landing. A few moments after landing and on the rollout, the right wingtip hit a very small tree about 3 inches in diameter and smashed in the wing near the wingtip landing light. Additionally, the right wing became separated from the fuselage at the root of the wing. I have included pictures below.
