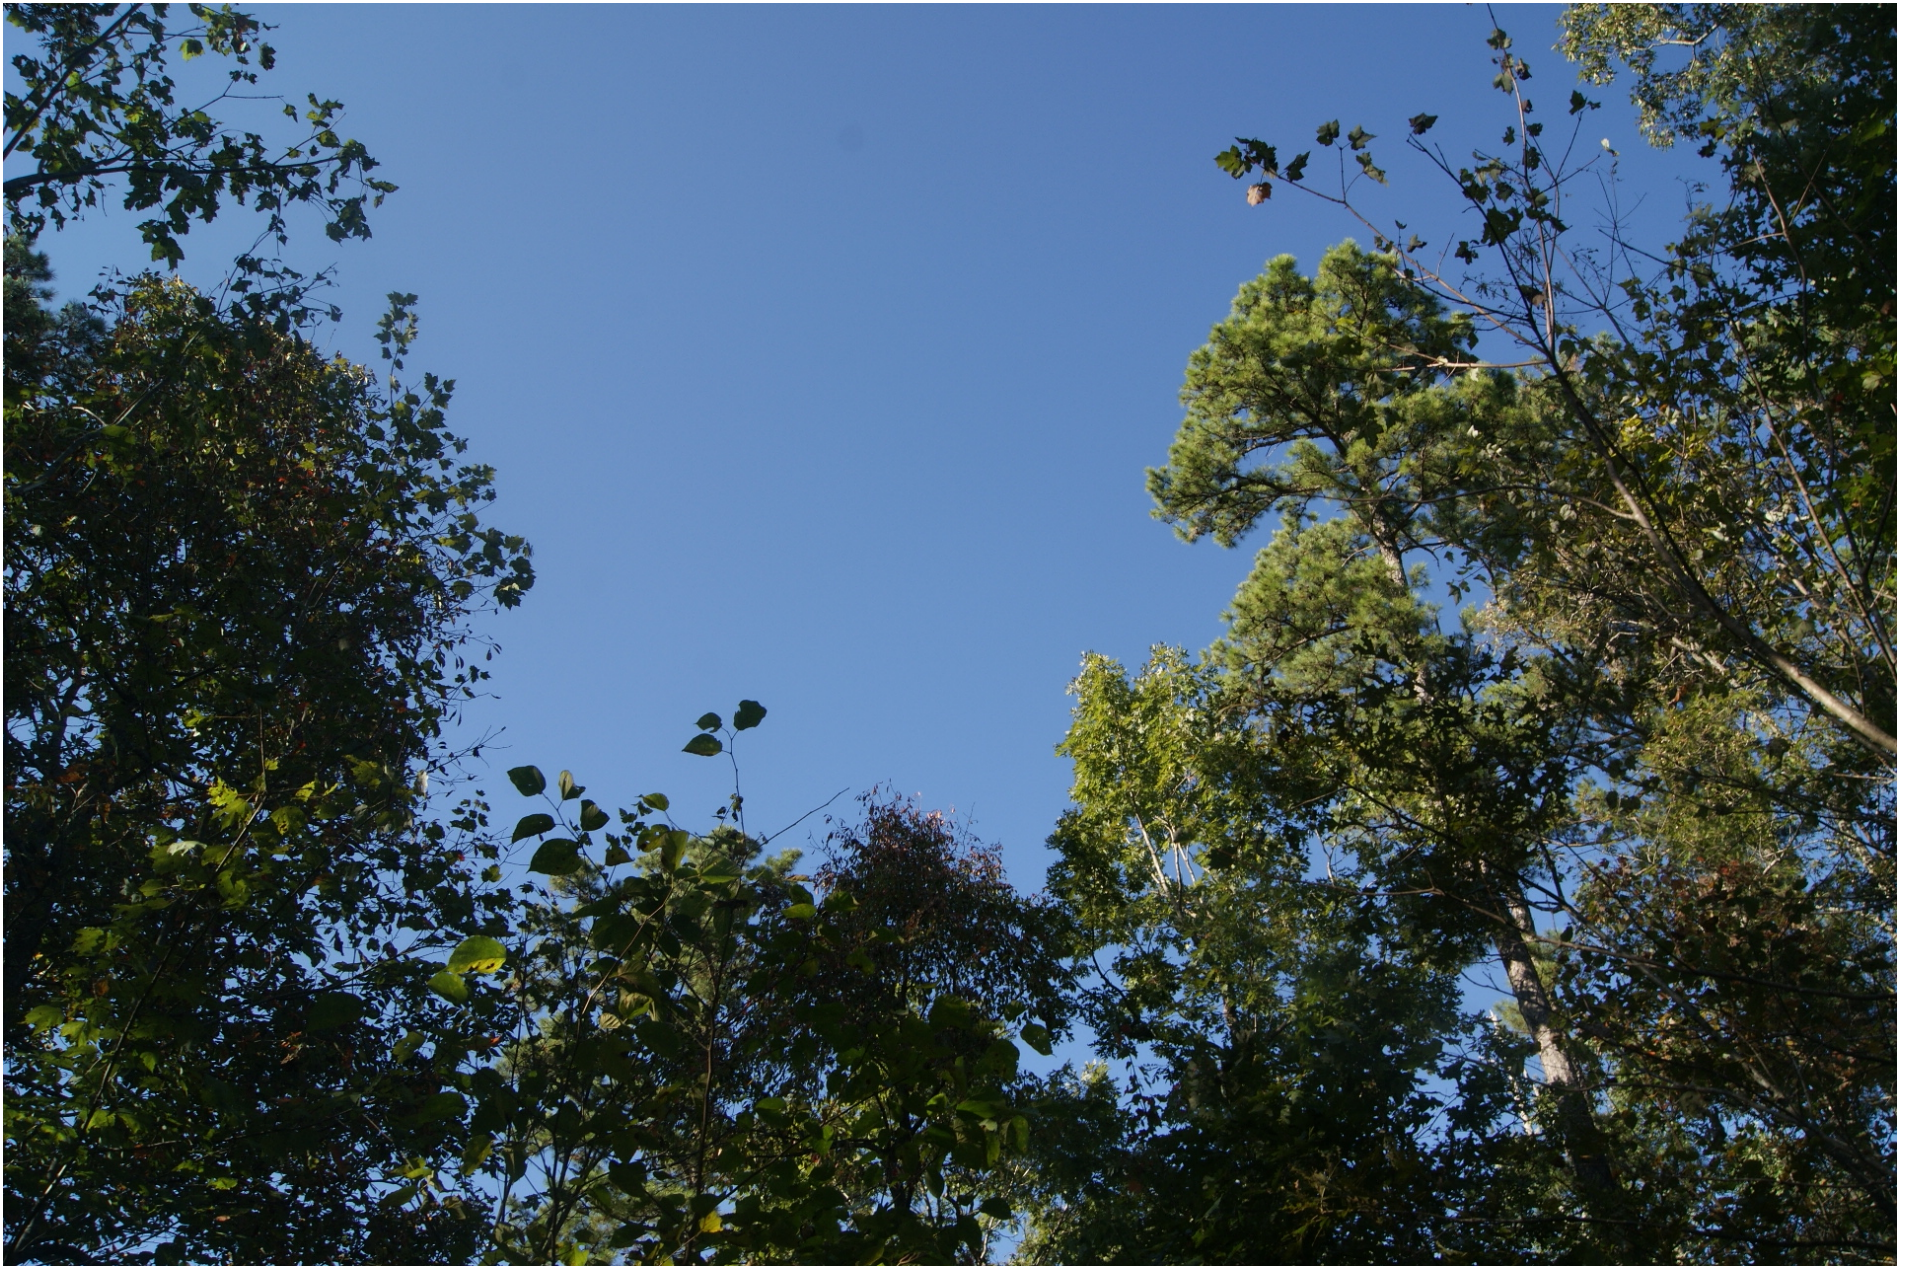
**Photo 1 – Opening in overhead tree canopy, consistent with near-vertical descent (NTSB photo)**

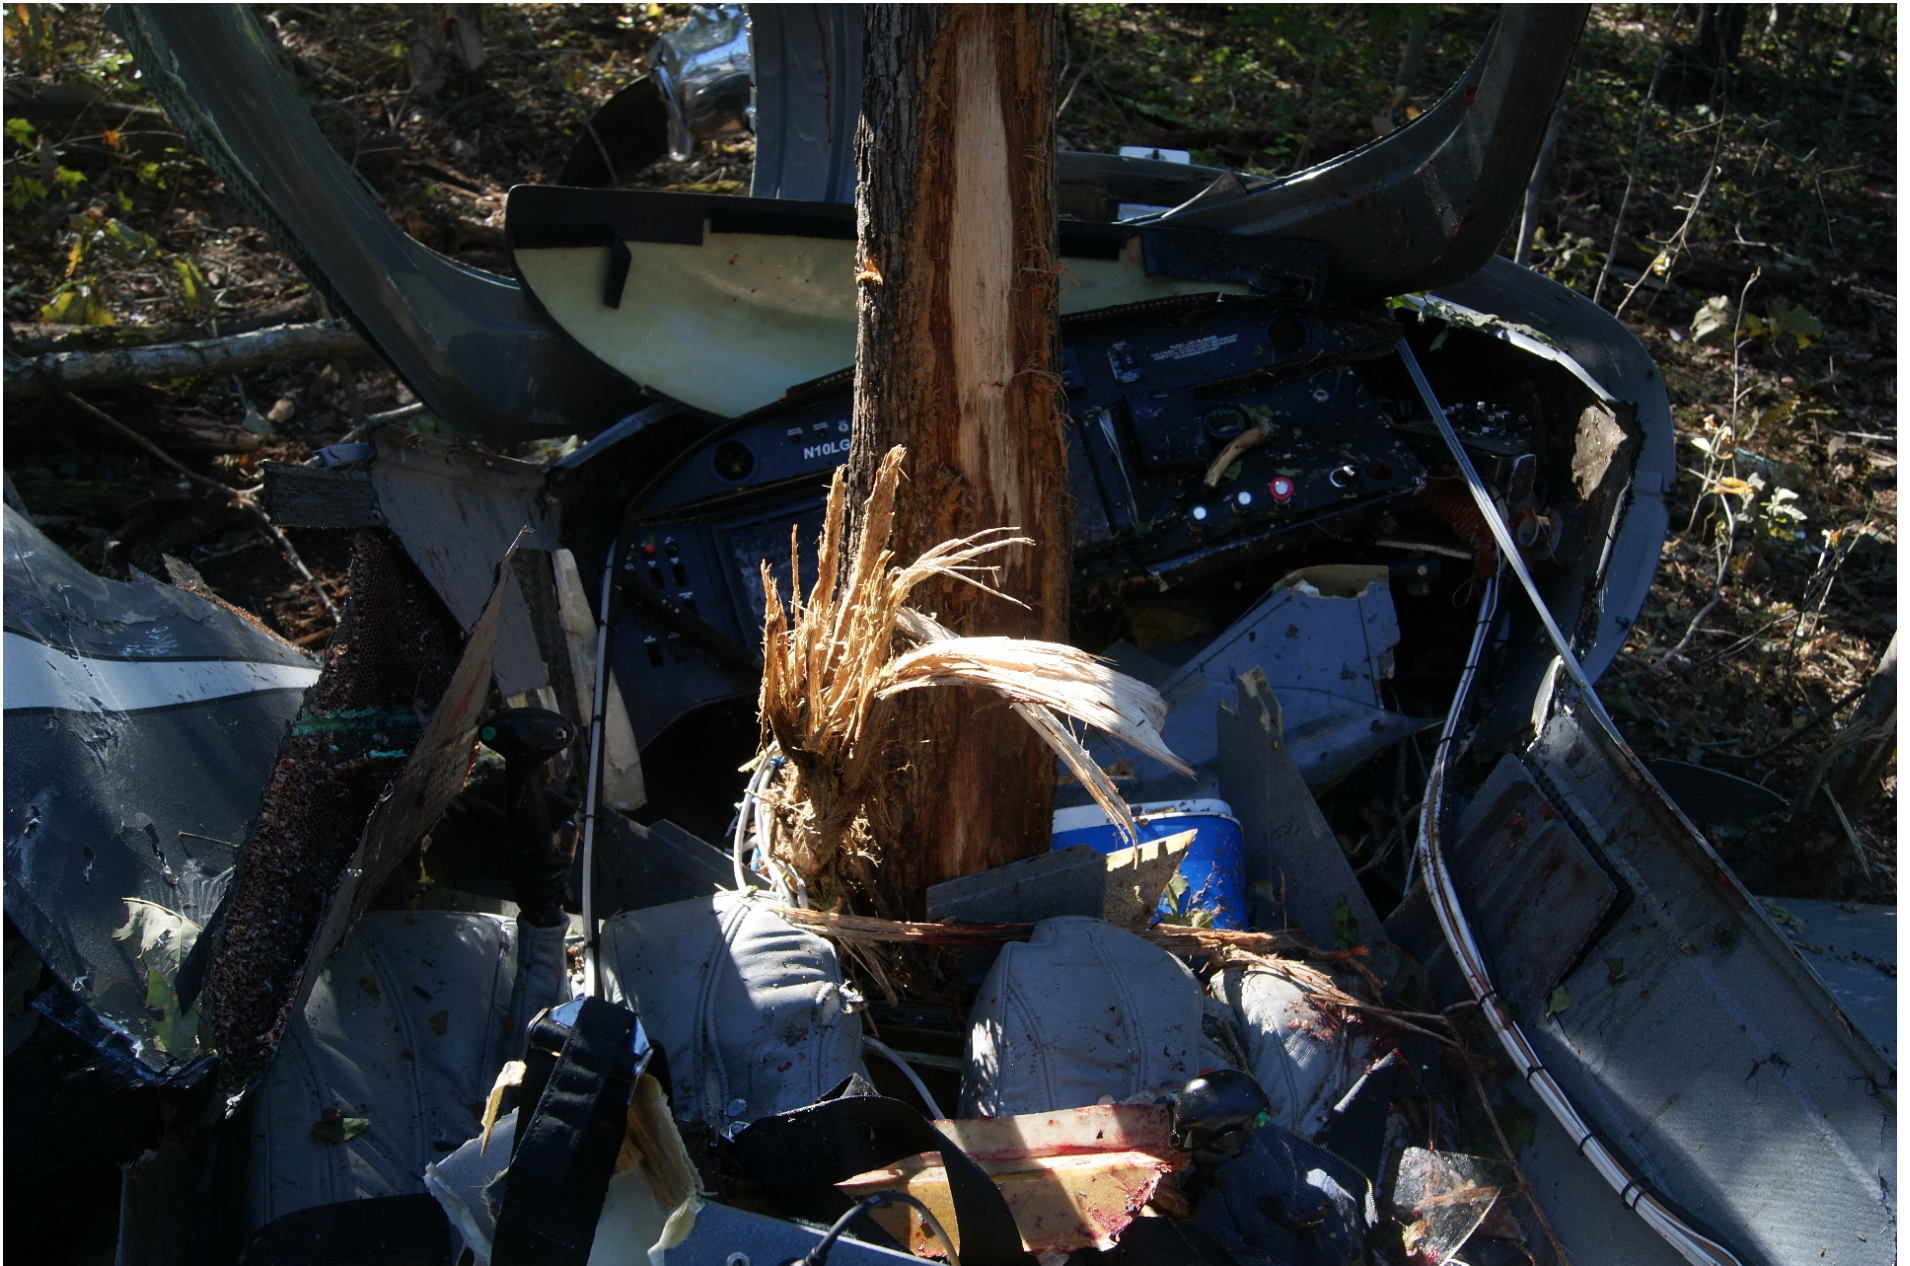
**Photo 2 – Tree stump coming straight up through cockpit floor, further consistent with near-vertical descent (NTSB photo)**

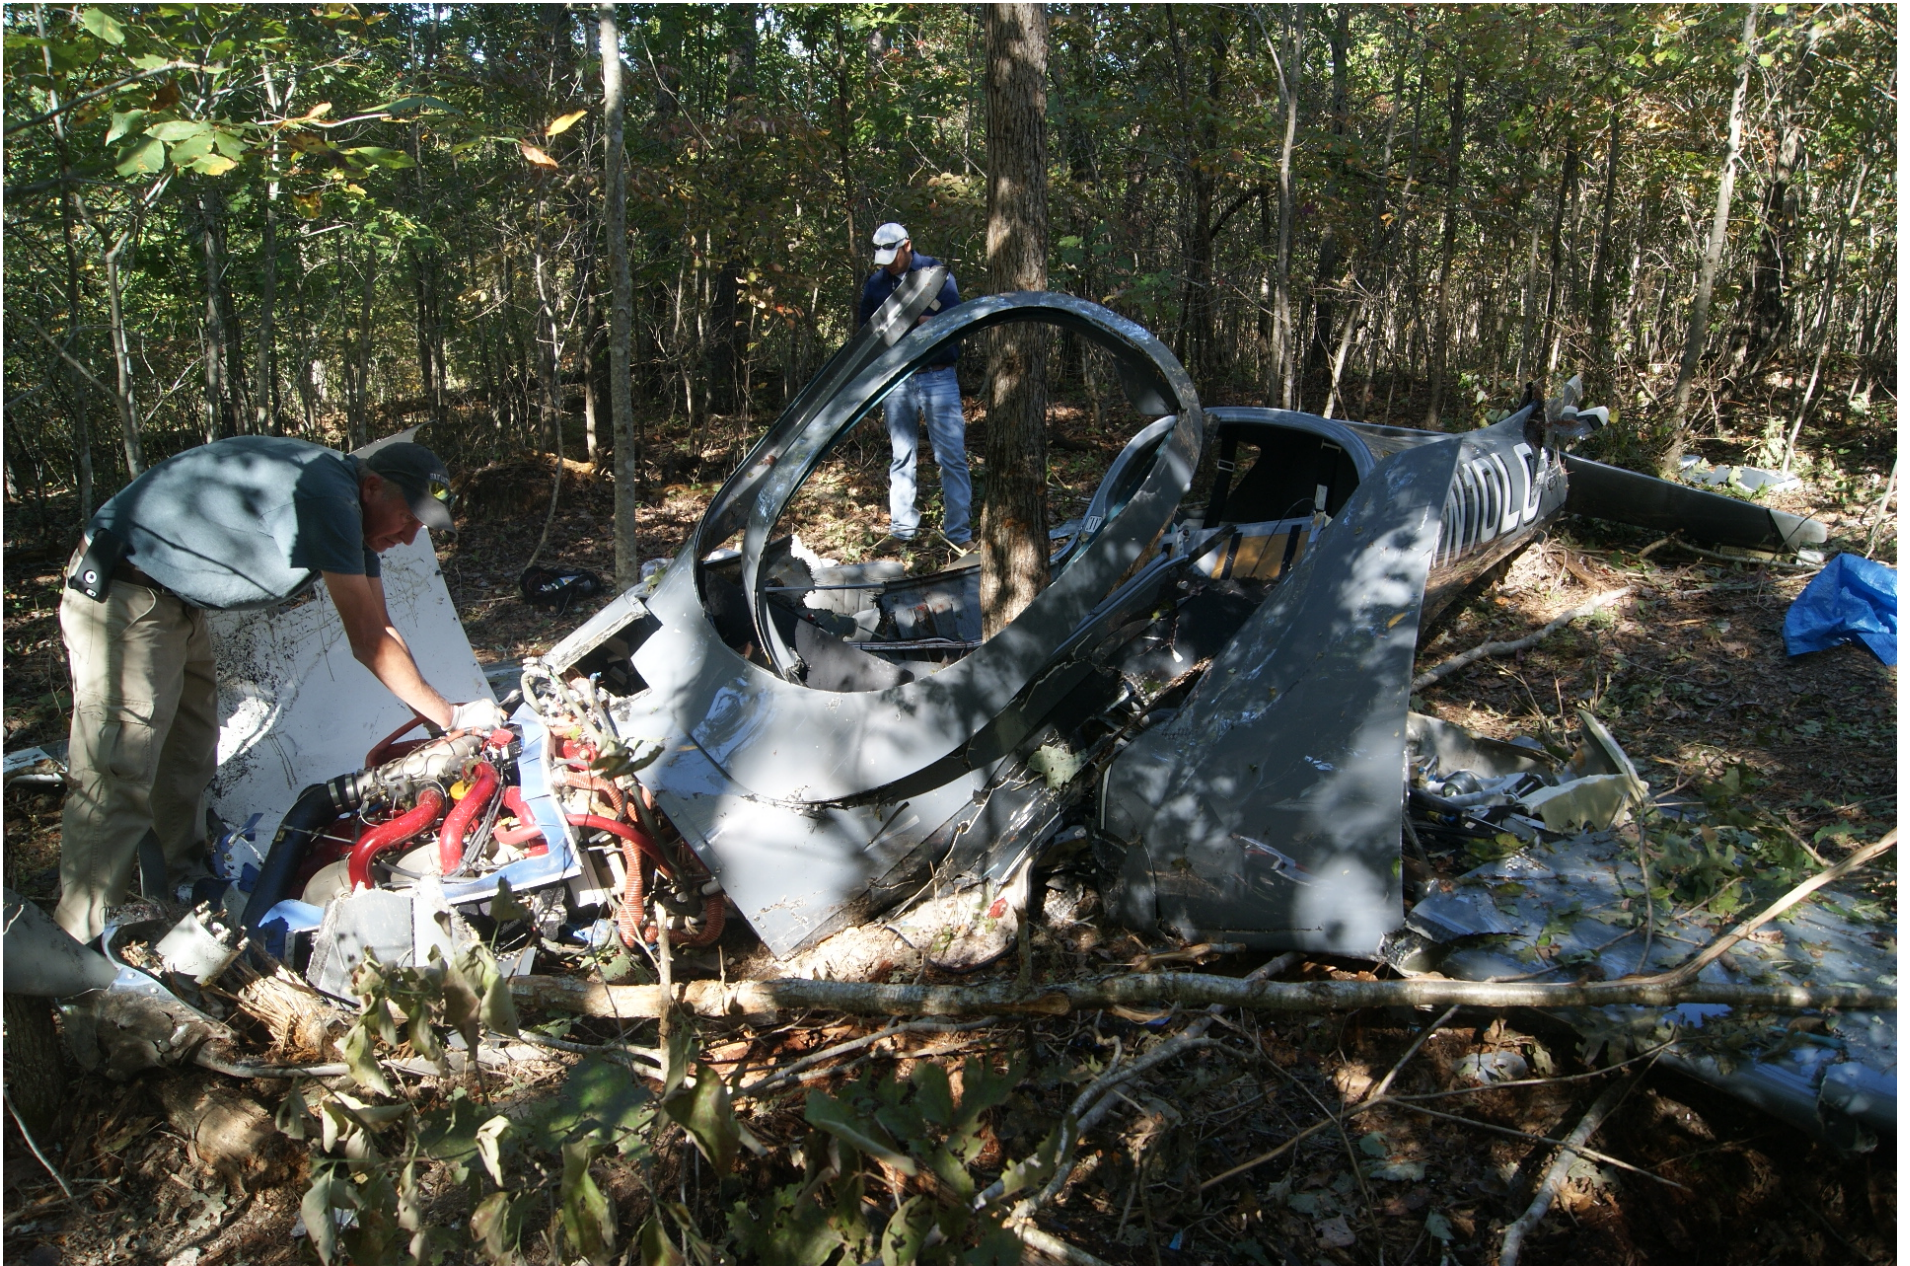
**Photo 3 – Left front of airplane. Note engine is skewed to the right (NTSB photo)**

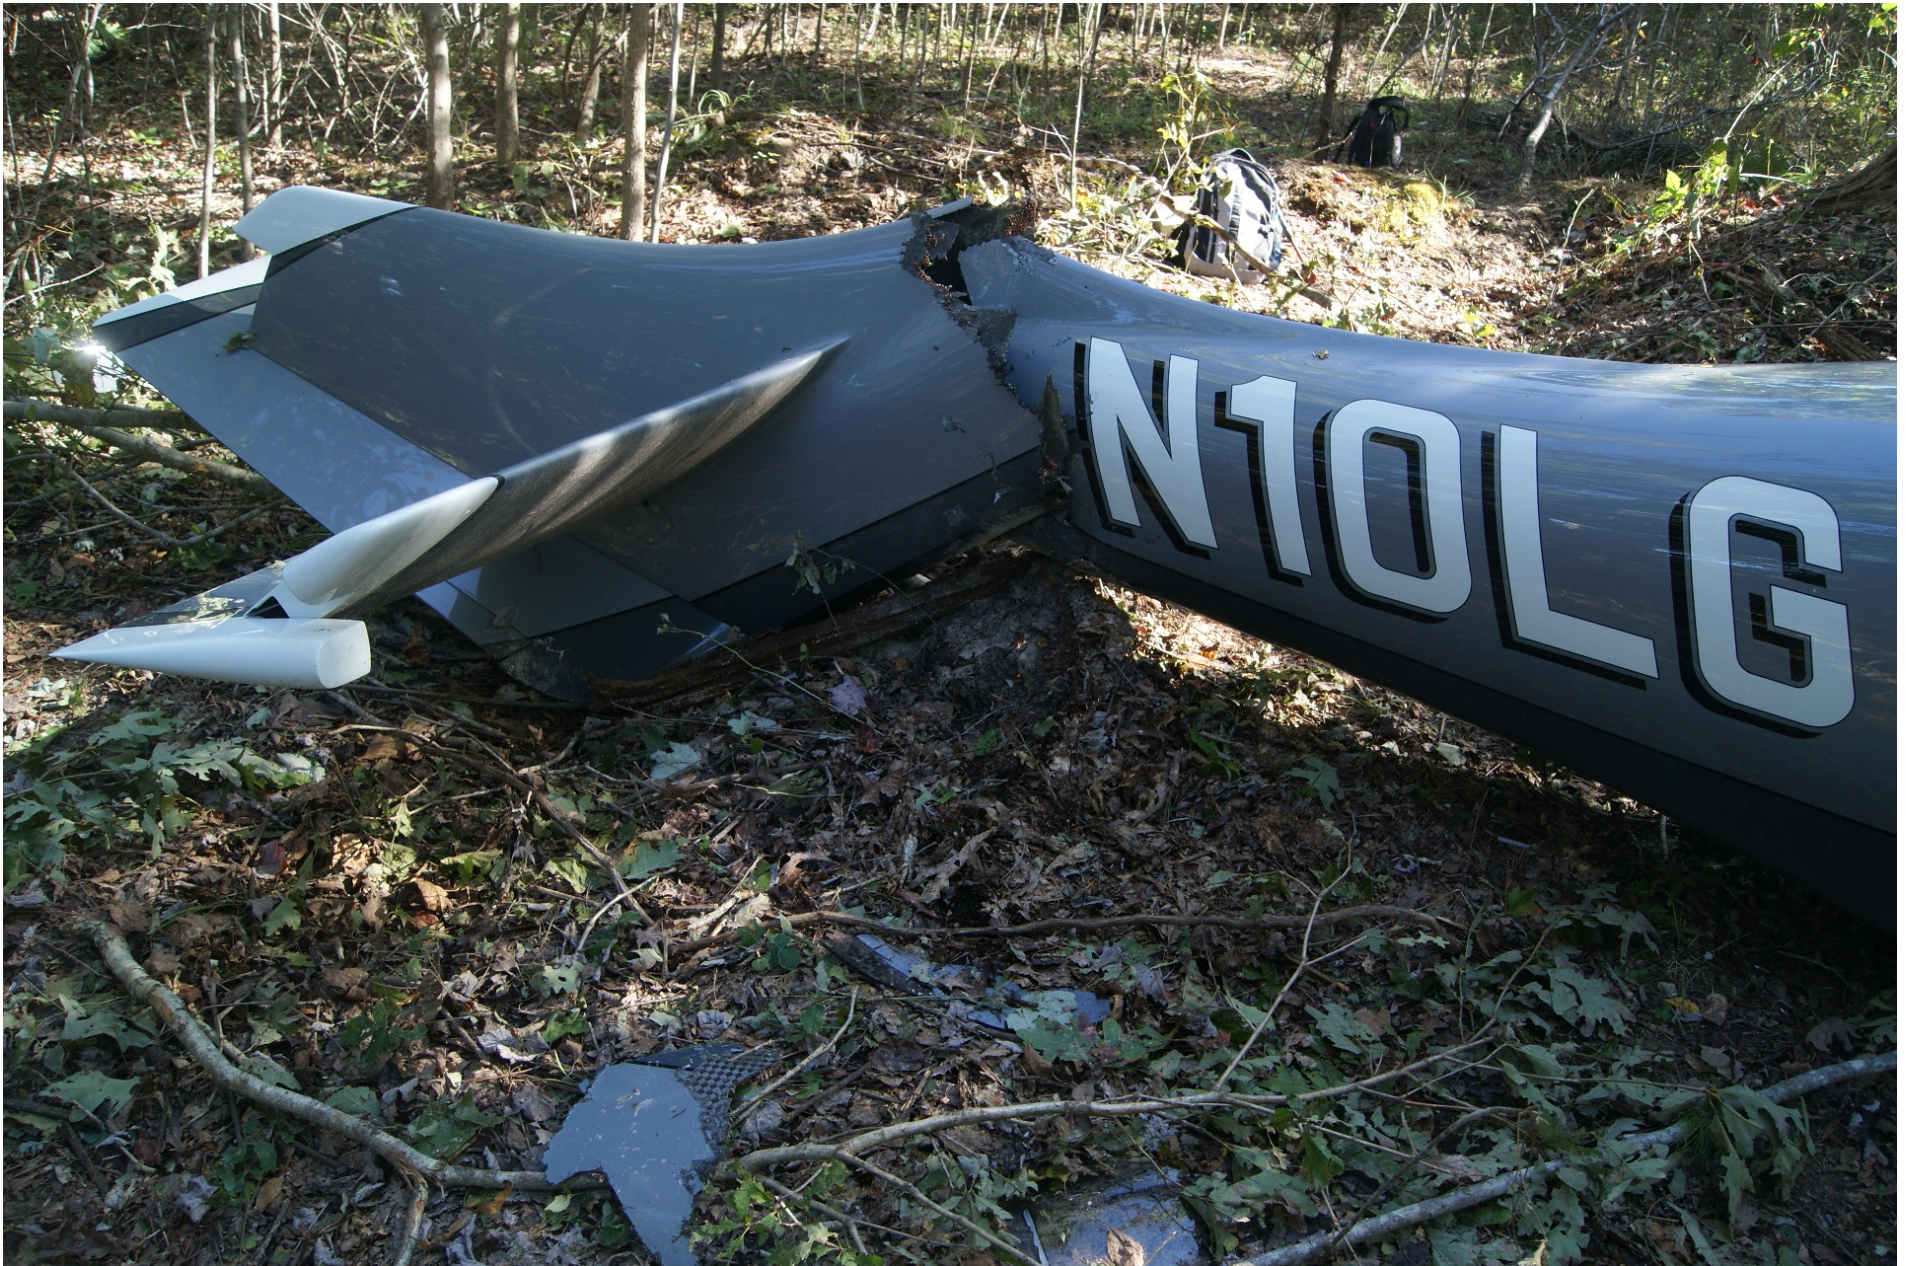
**Photo 4 – Aft portion of the fuselage is fractured just forward of the empennage and skewed to the right (NTSB photo)**

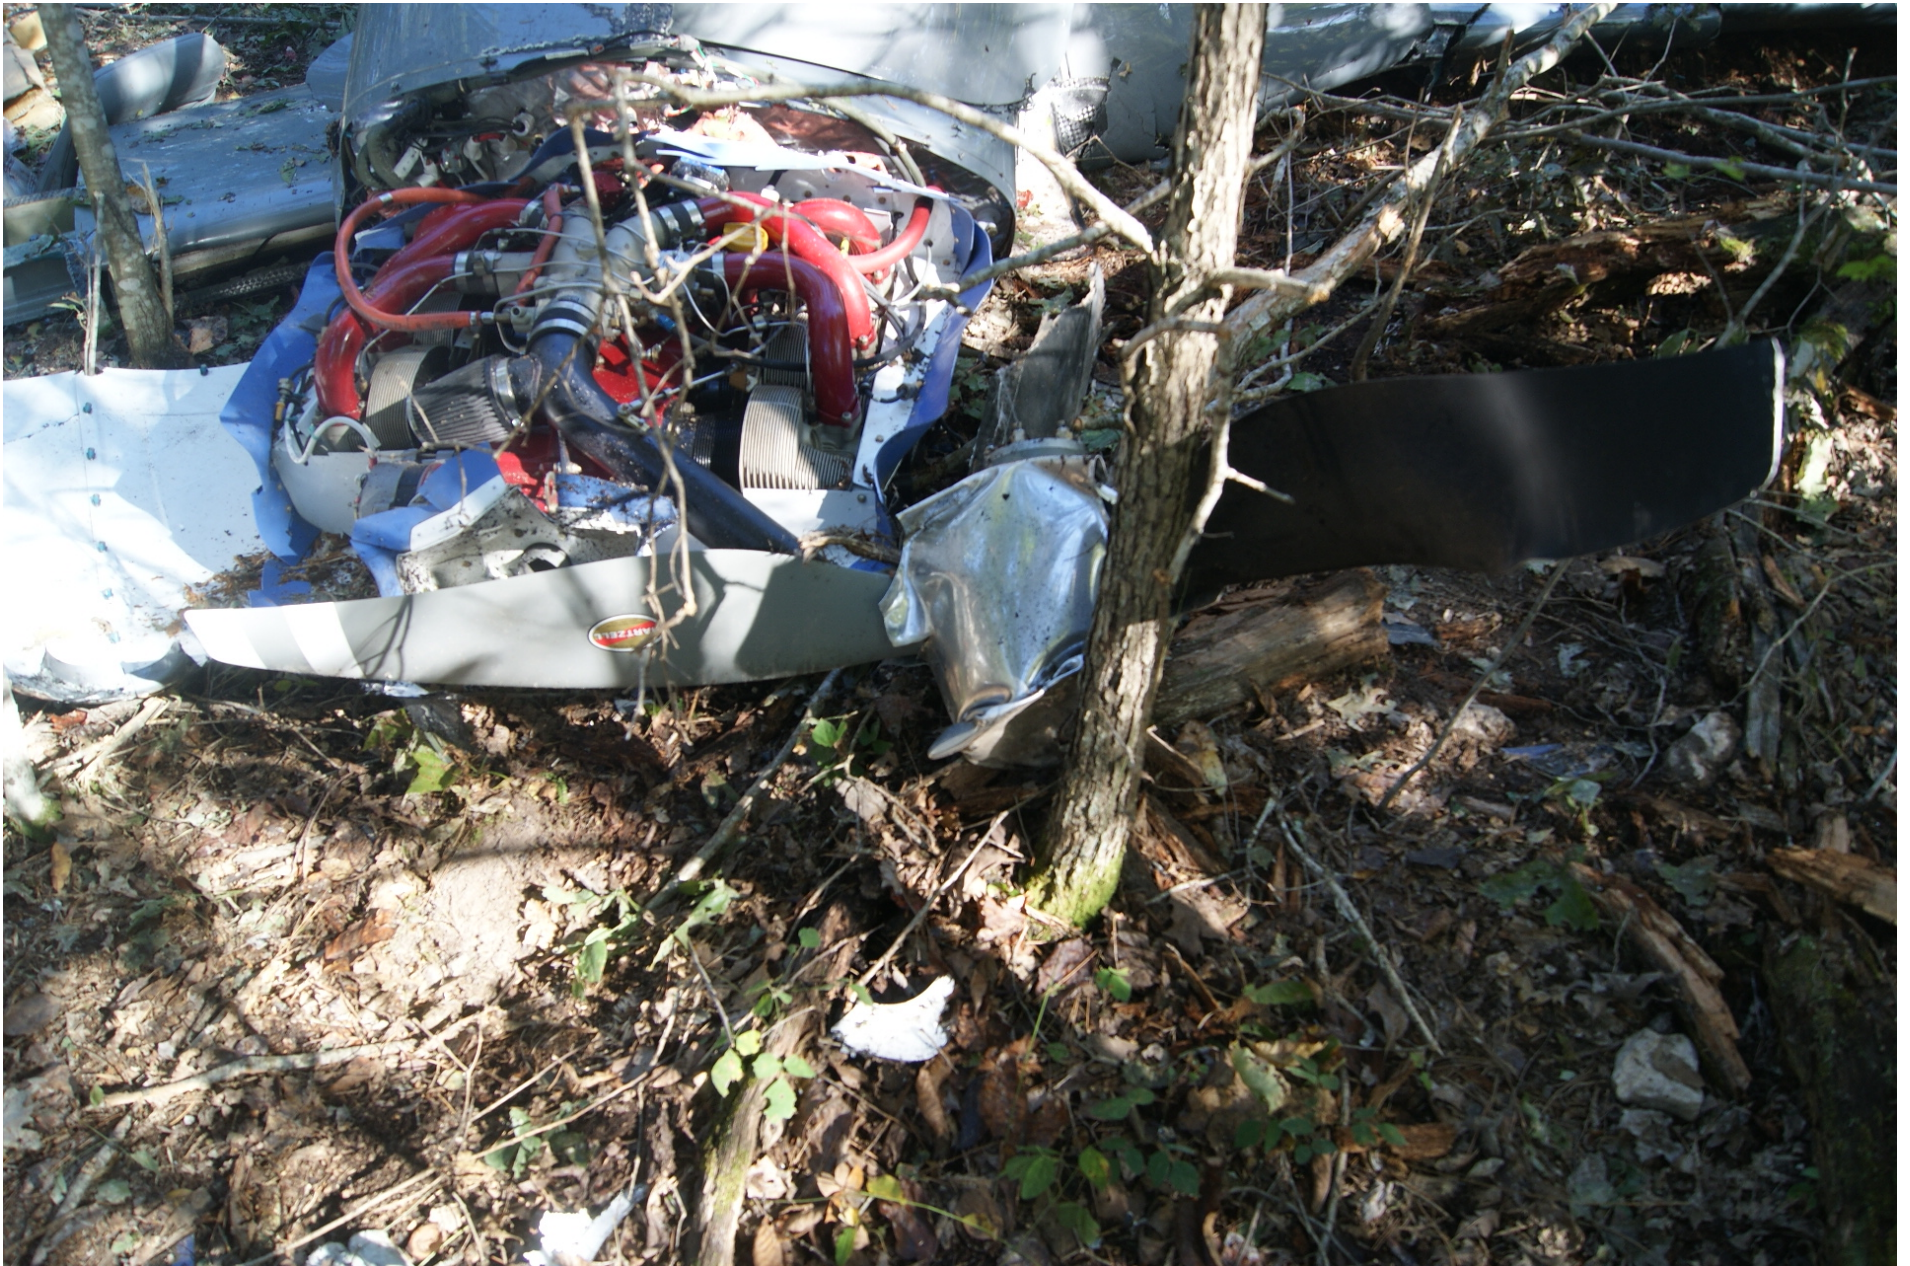
**Photo 7 – The engine and separated propeller assembly (NTSB photo)**

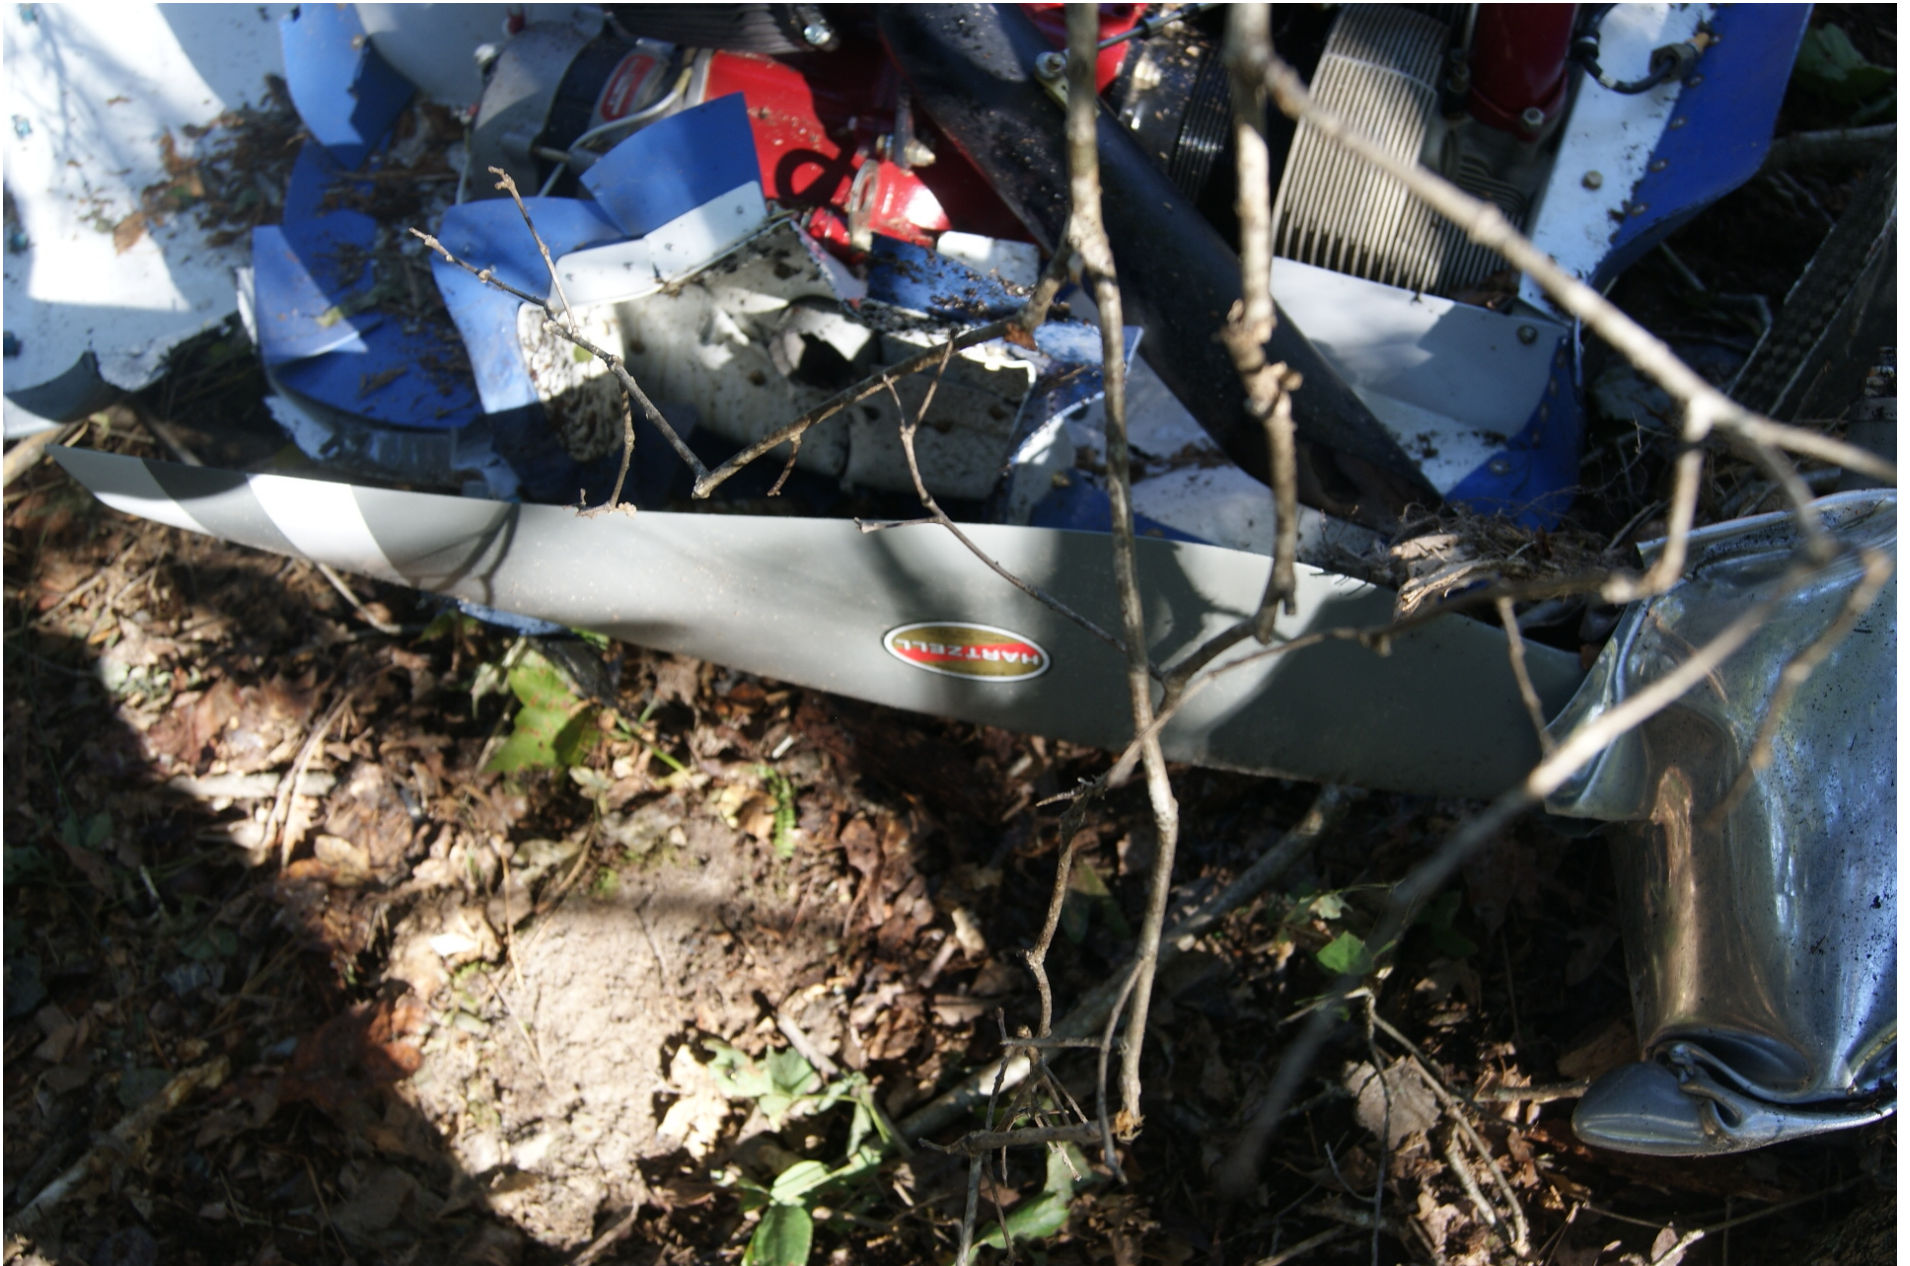
**Photo 8 – Propeller spinner. Note the direction the spinner tip is crushed (NTSB photo)**

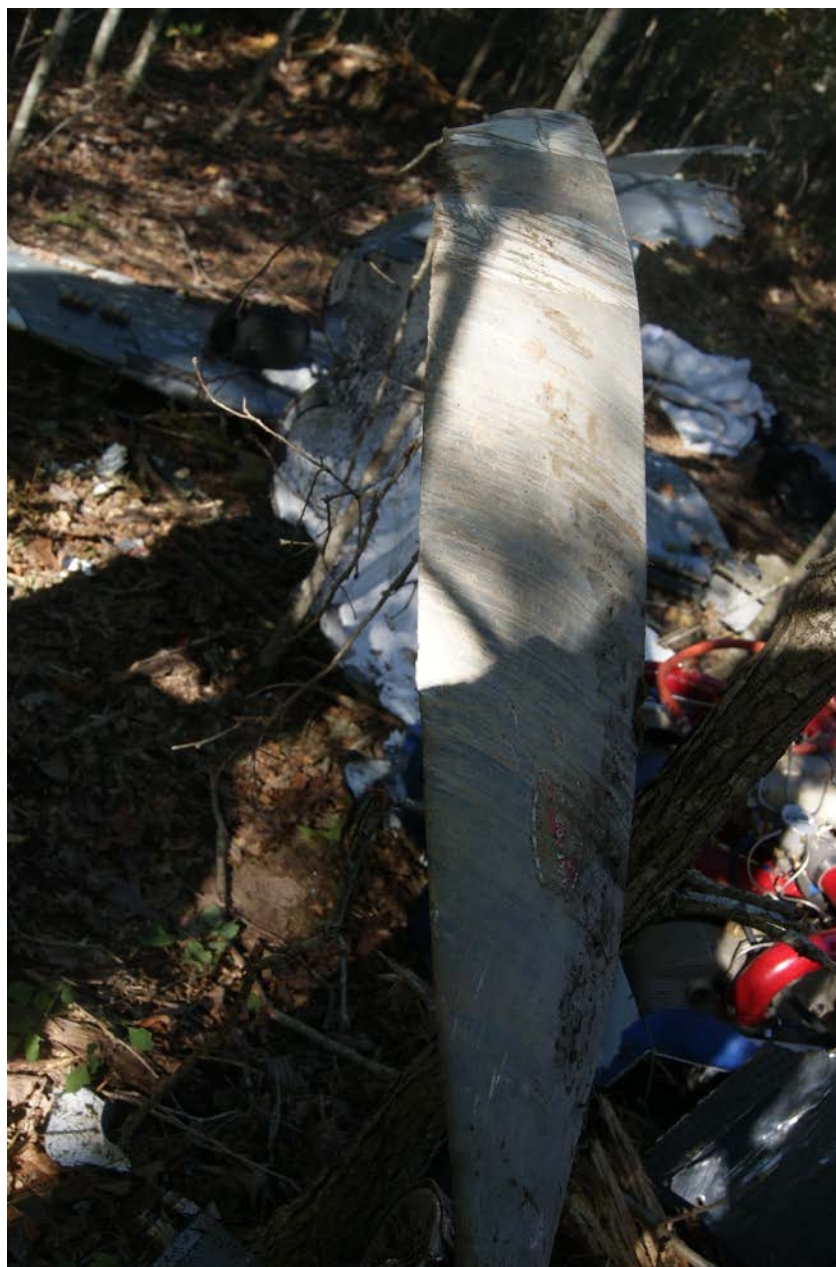
**Photo 10 – Propeller blade “B.” Note 90° chordwise scratches on cambered surface (NTSB photo)**

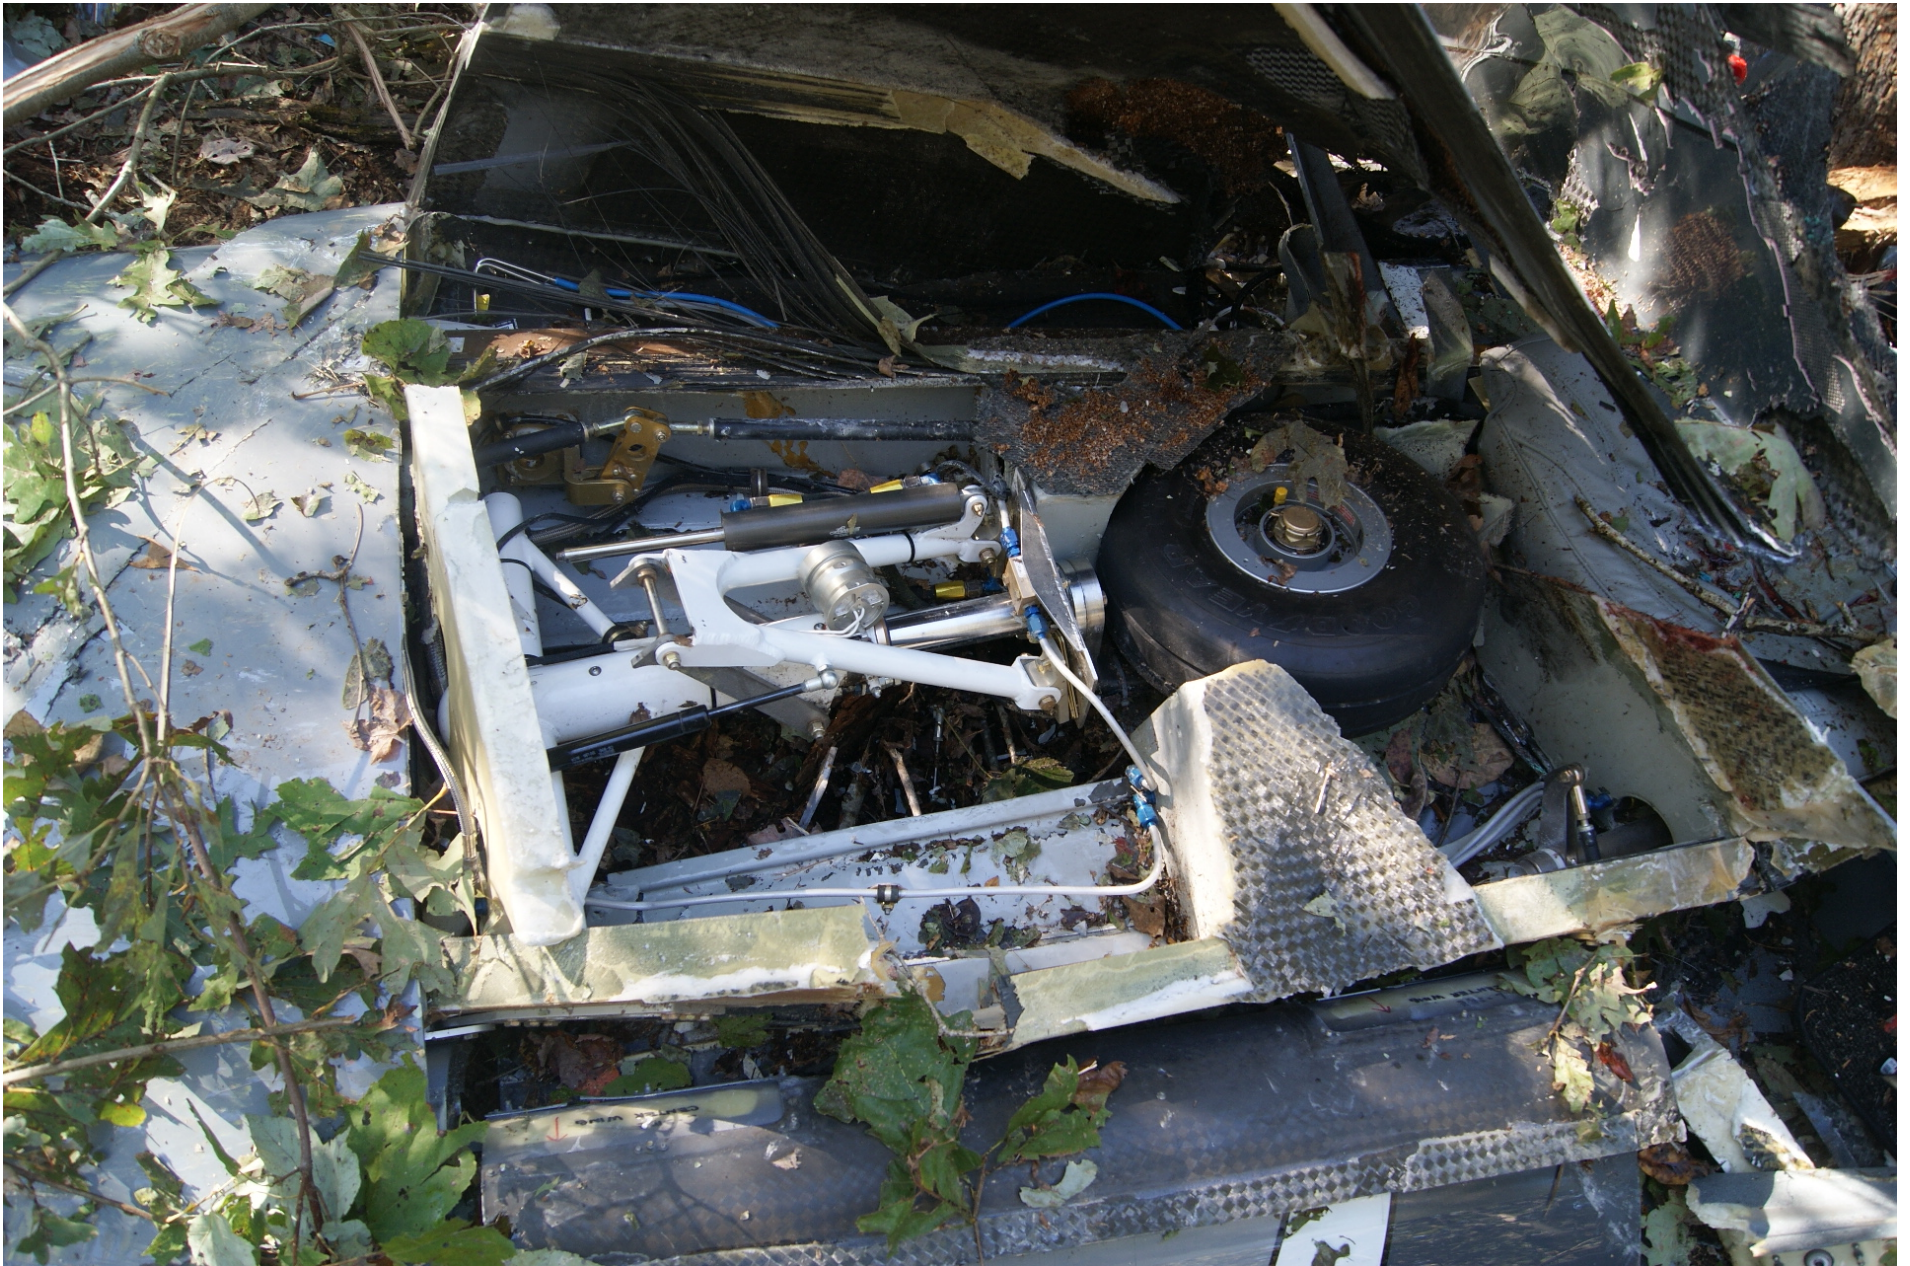
**Photo 11 – Retracted left main landing gear and inverted wing (NTSB photo)**

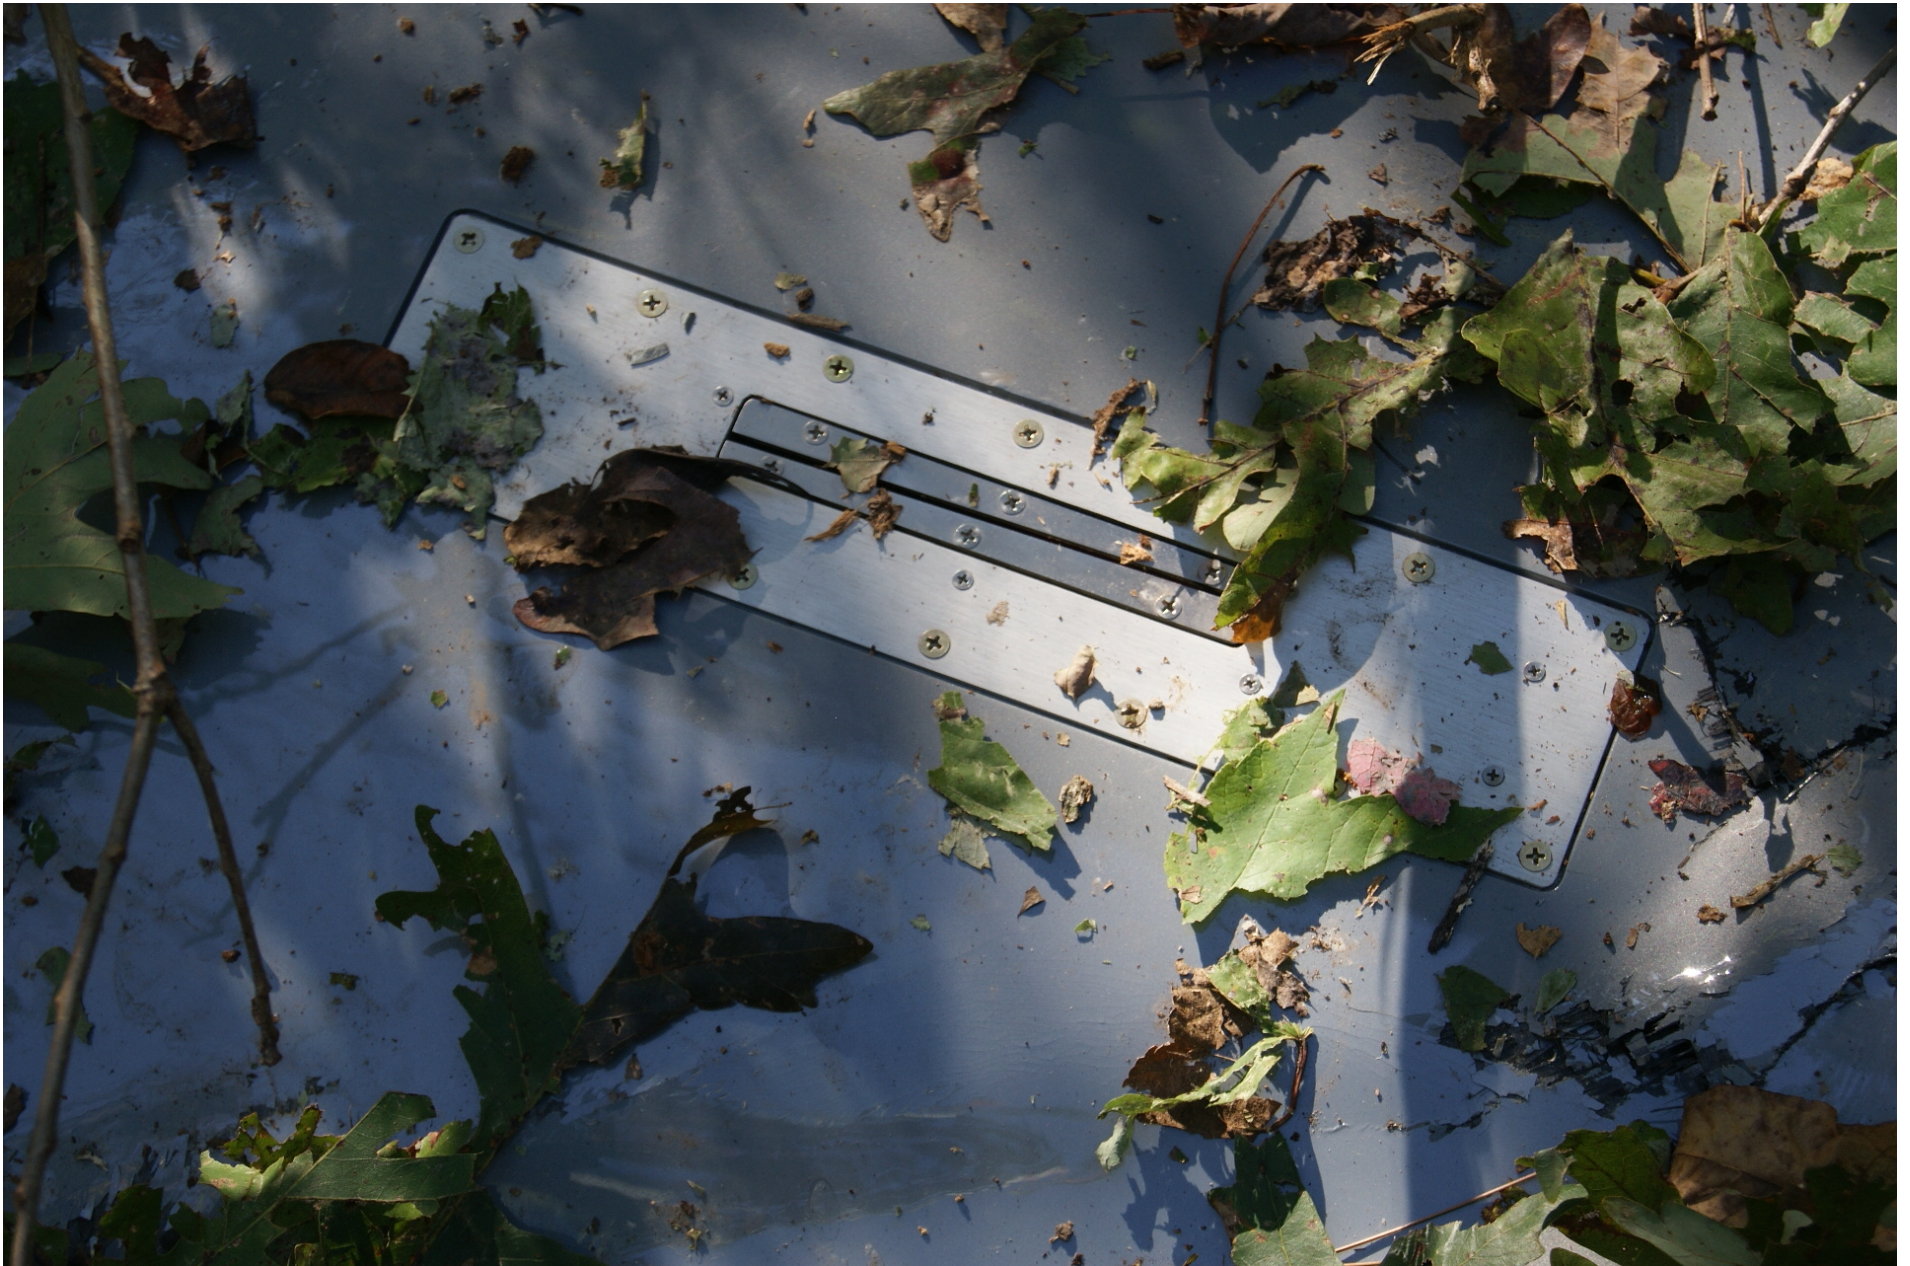
**Photo 12 – Stowed speed brake (NTSB photo)**

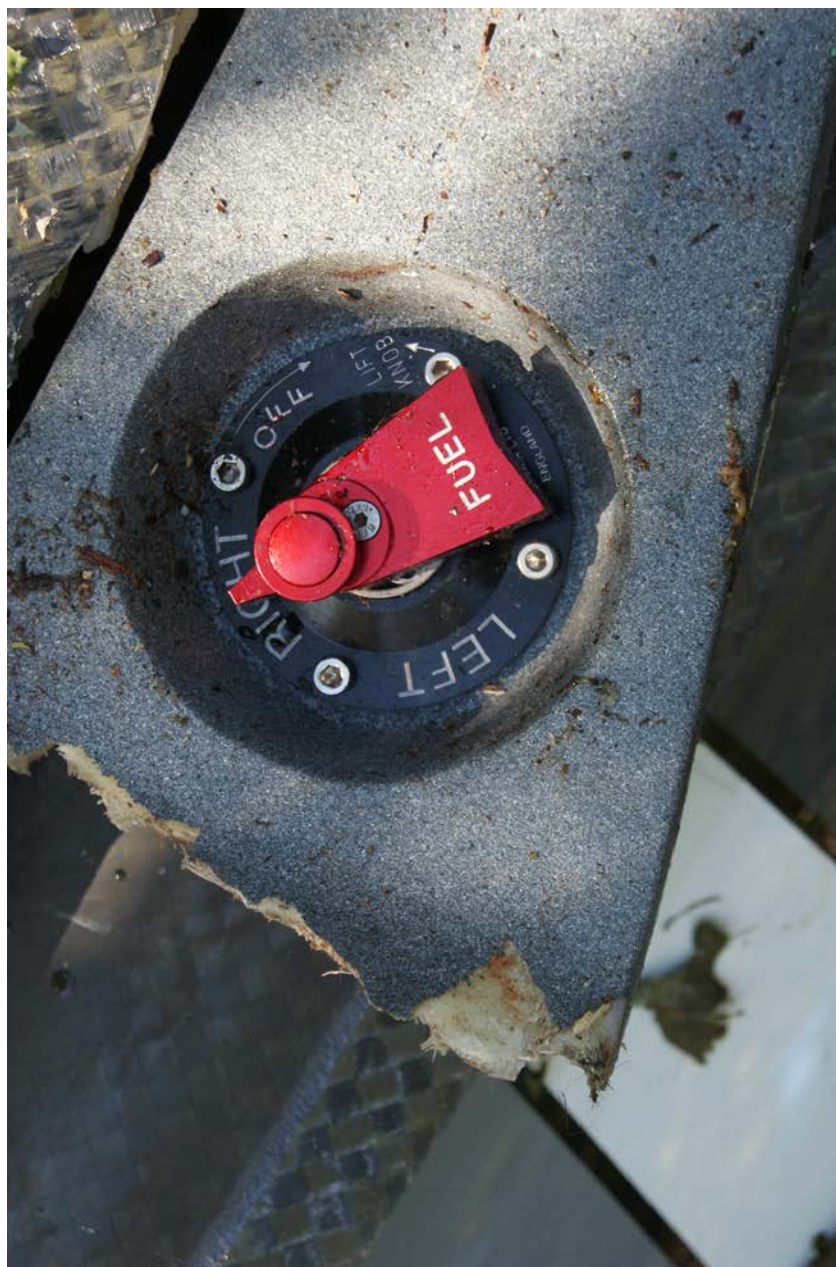
**Photo 13 – Fuel selector handle was positioned on the right tank (NTSB photo)**
