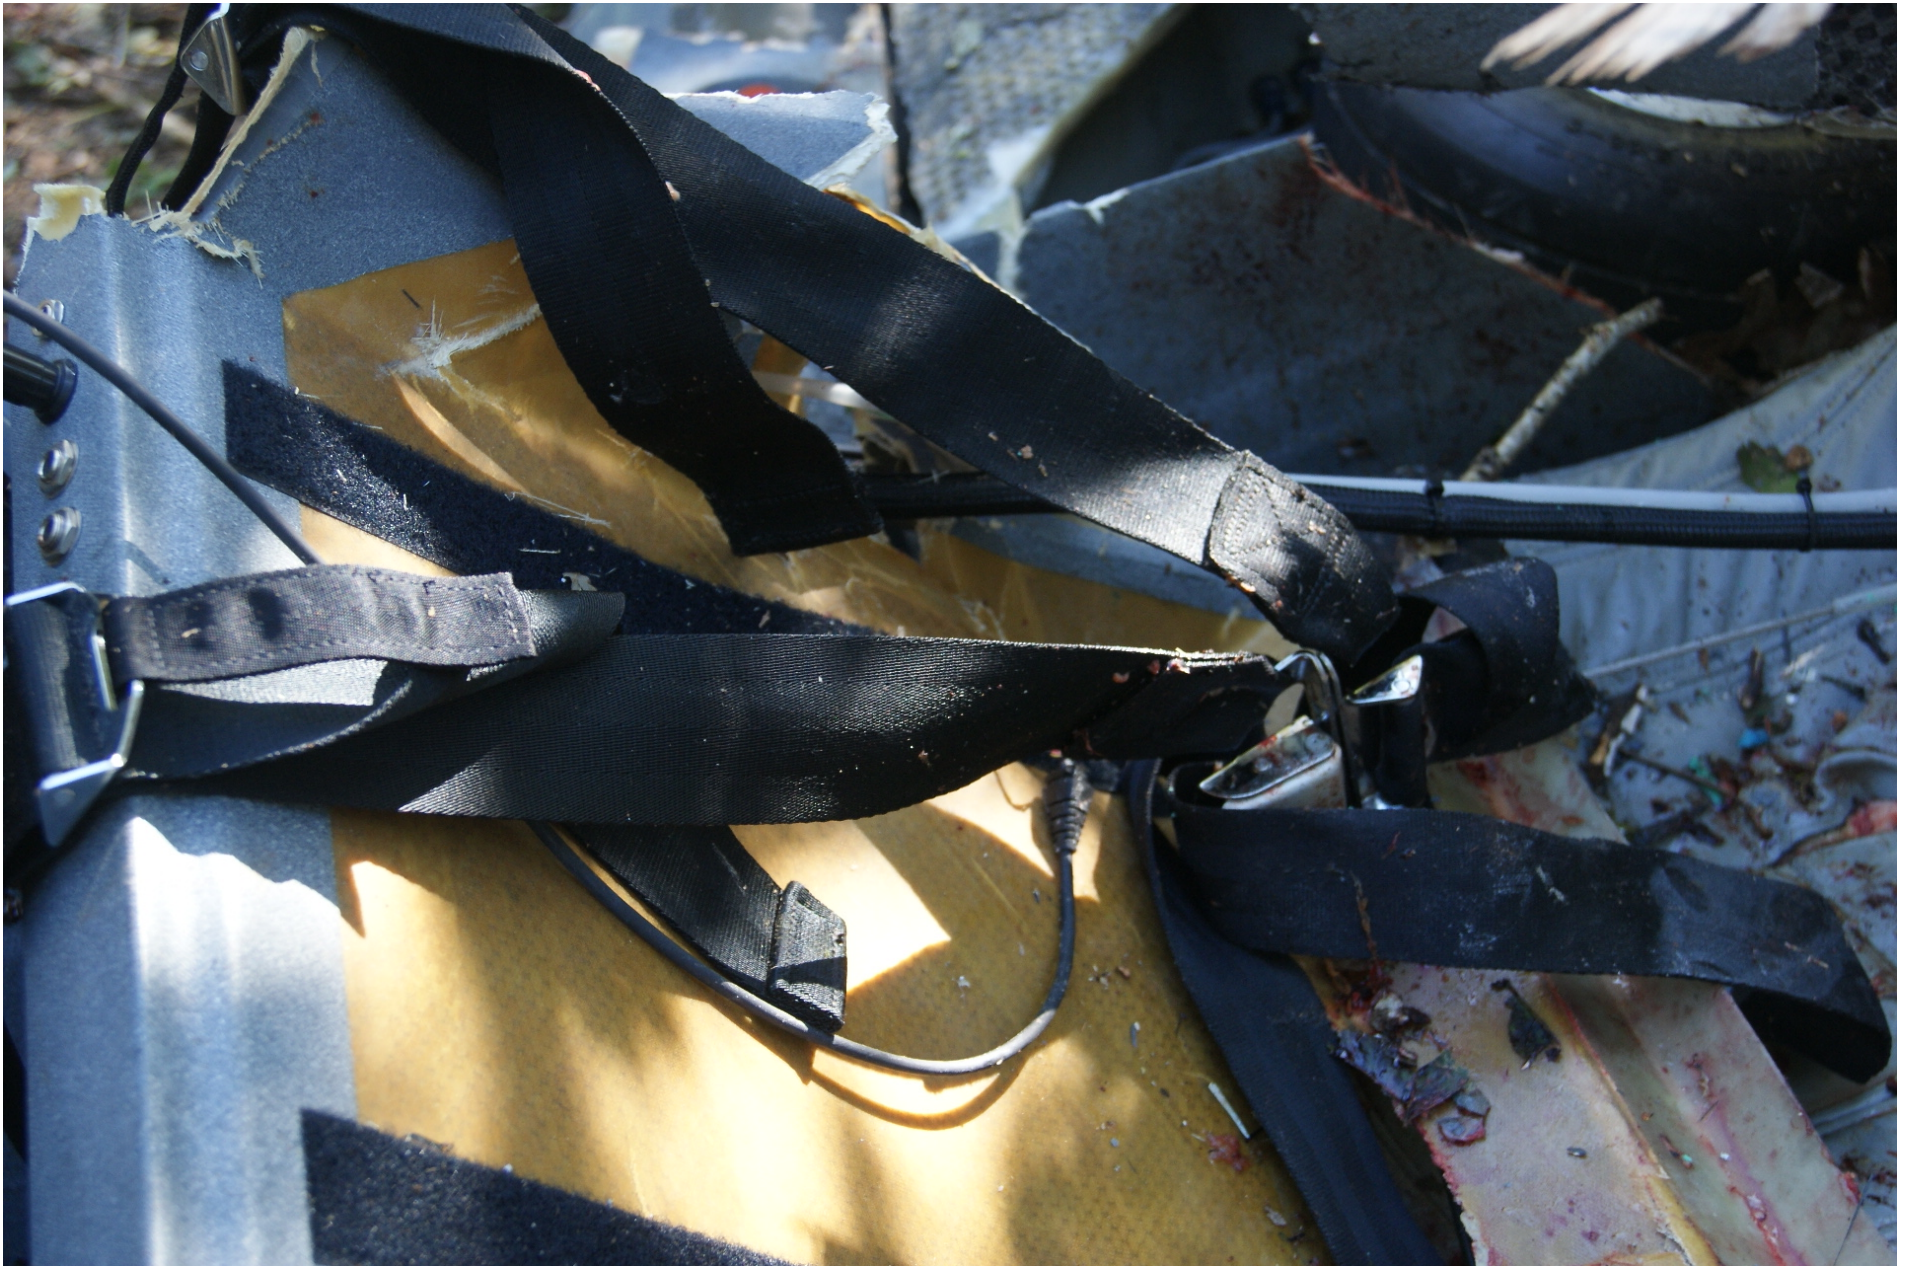
**Photo 14 –4-point restraint system showed evidence of use (NTSB photo)**

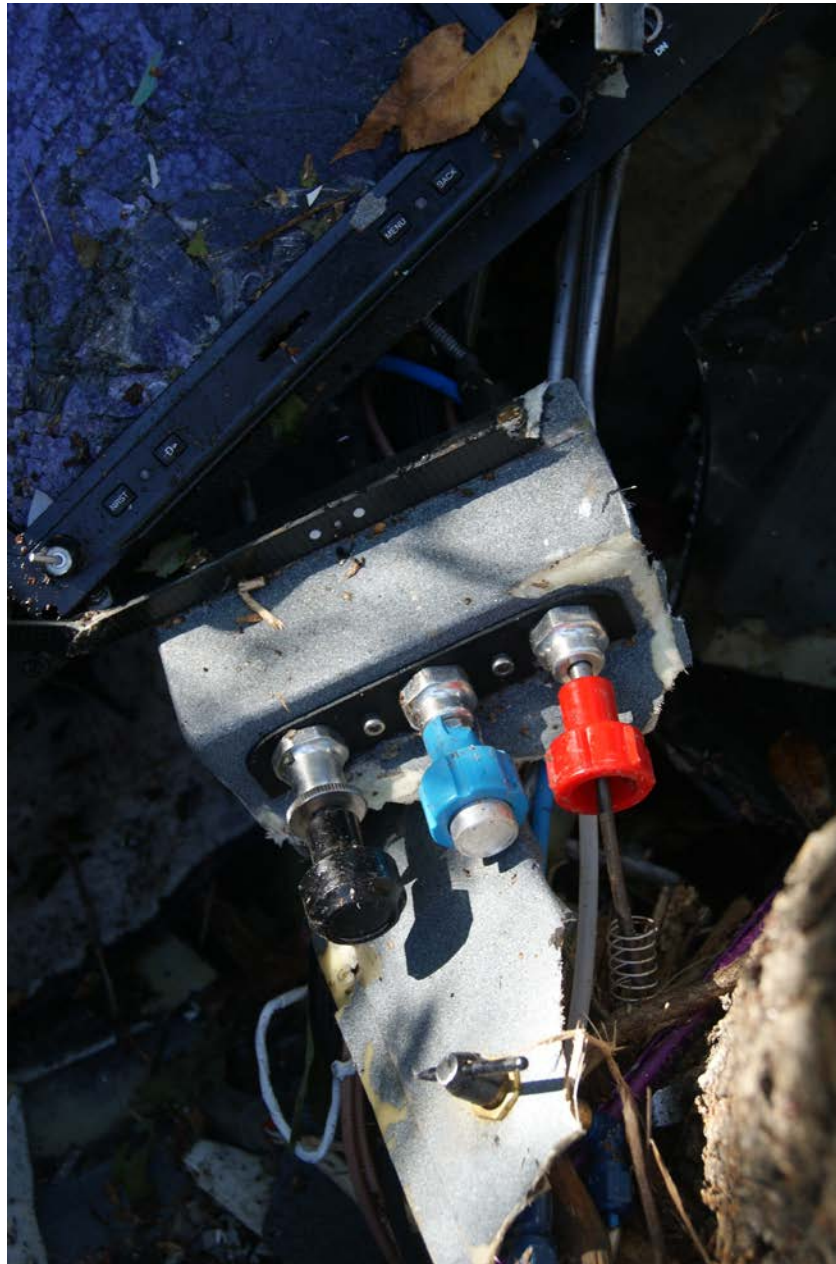
**Photo 15 – Throttle, propeller, and mixture controls were found full forward (NTSB photo)**

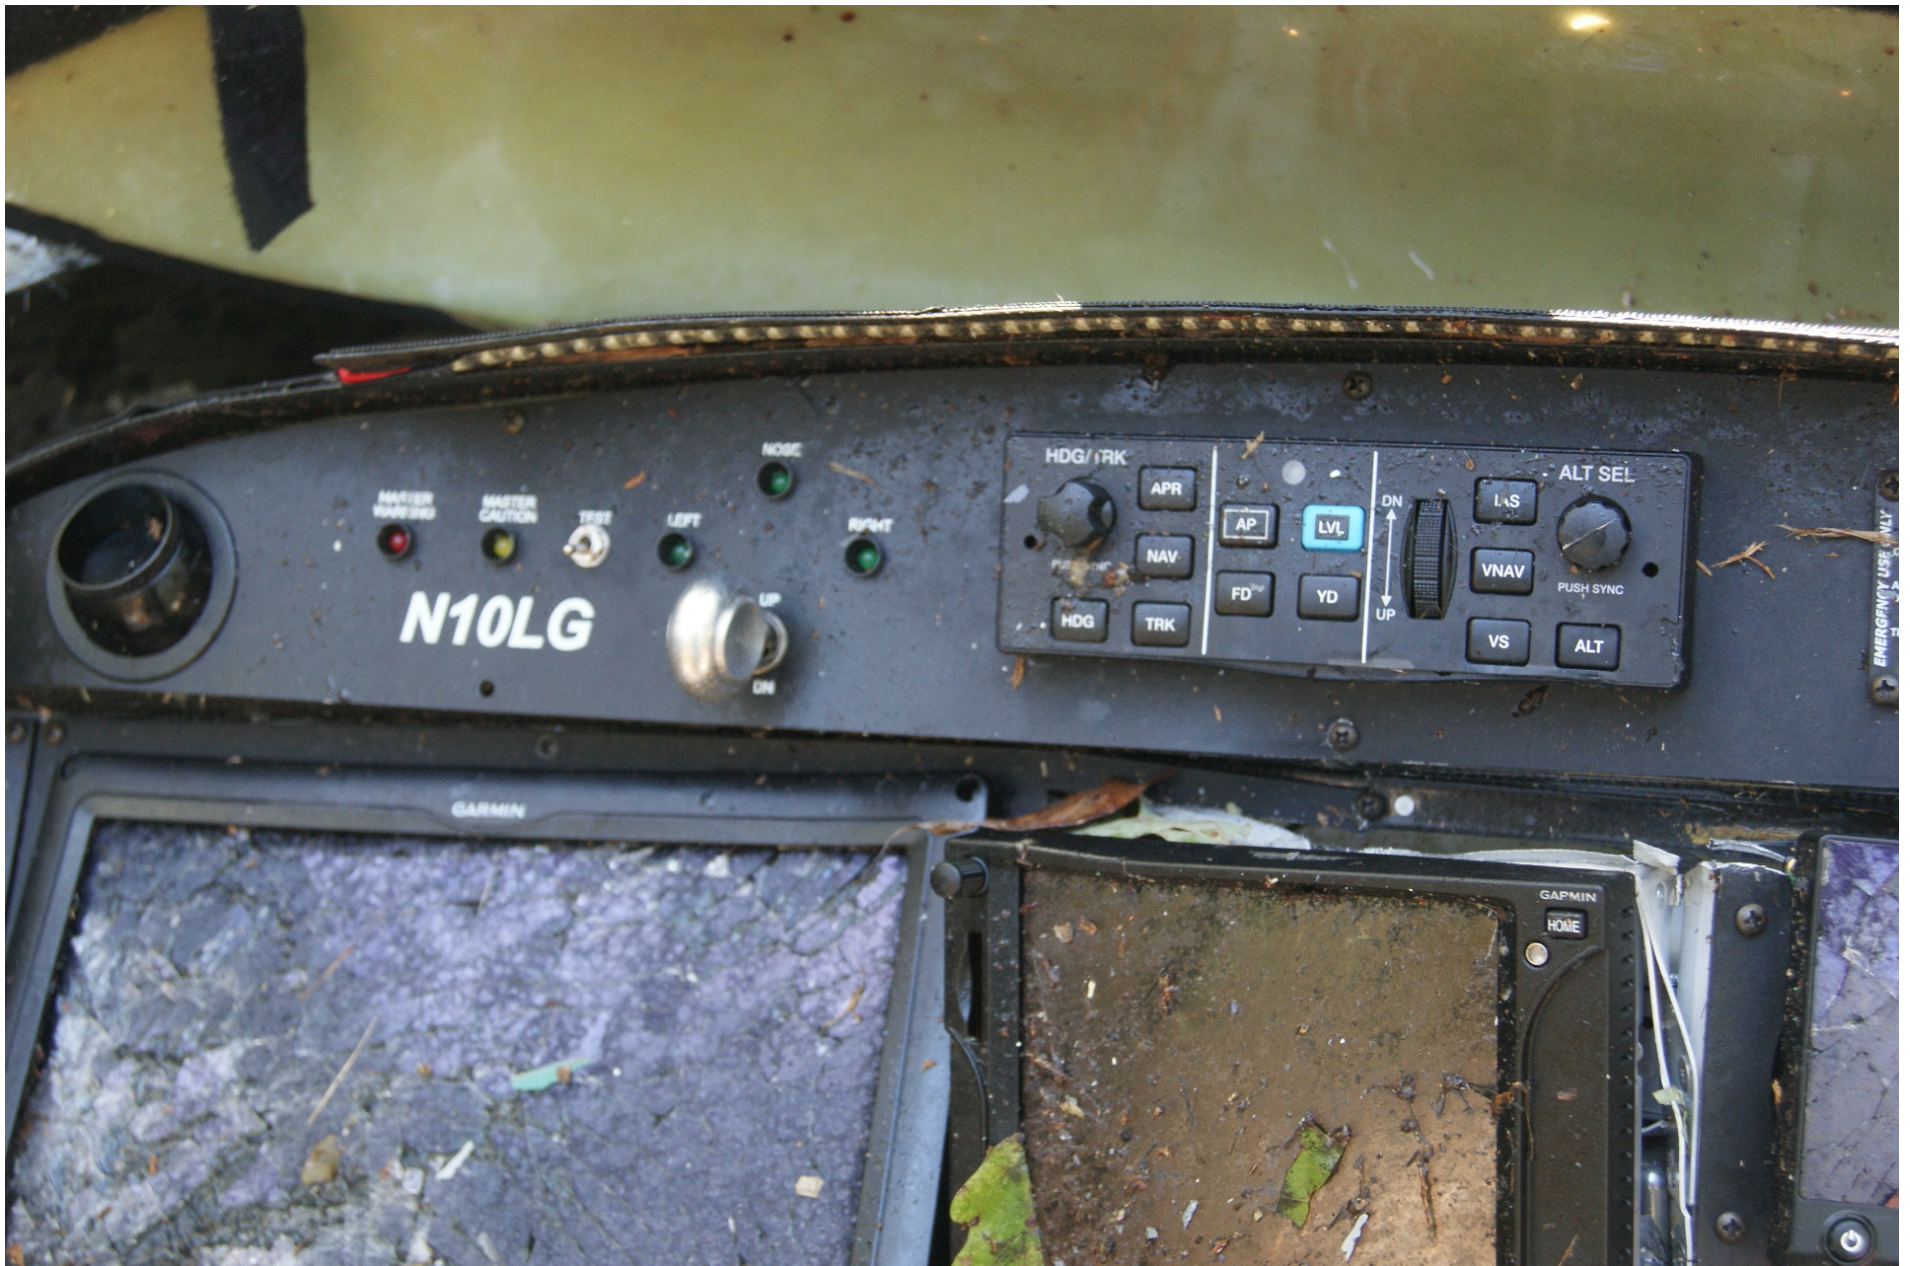
**Photo 16 – Landing gear switch (up) and autopilot control head (NTSB photo)**
