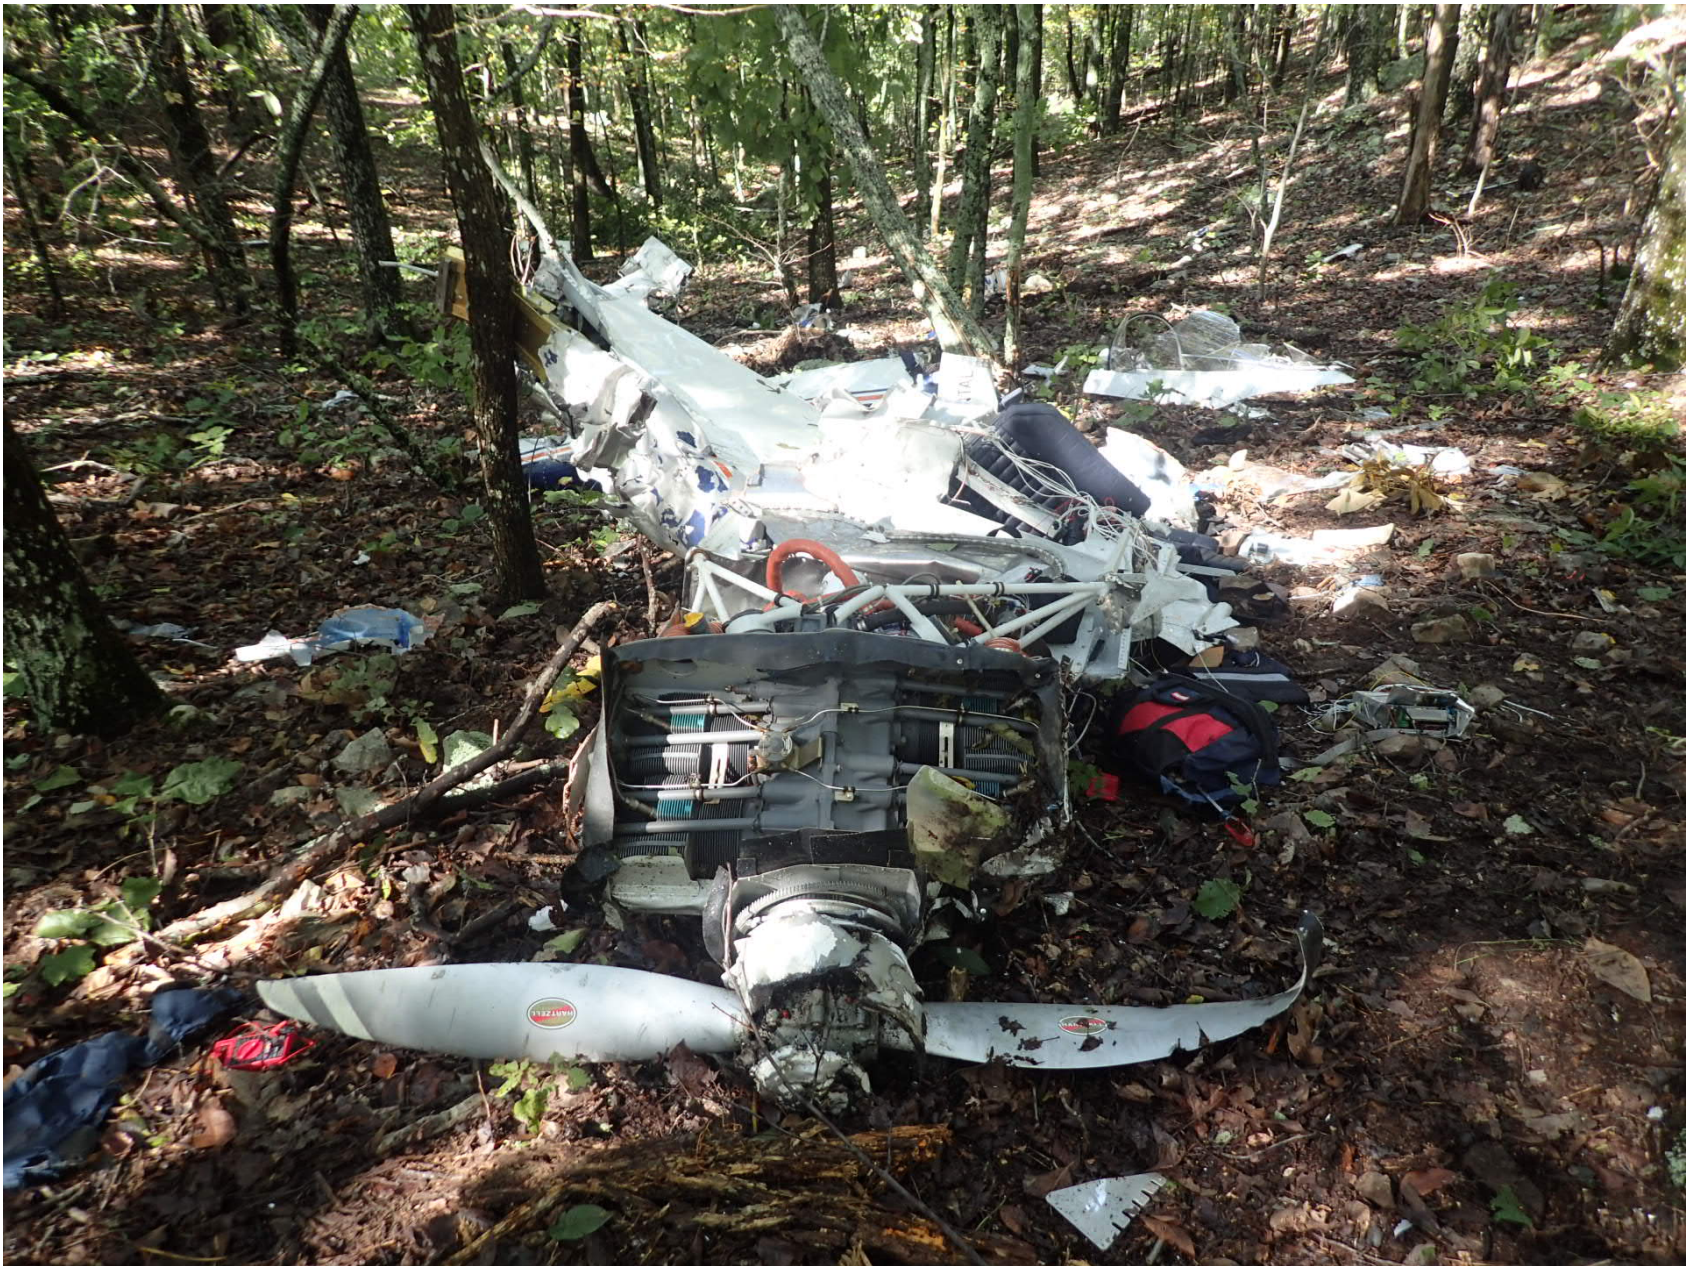
**Photo 1 – Front view of the airplane at the accident site.**

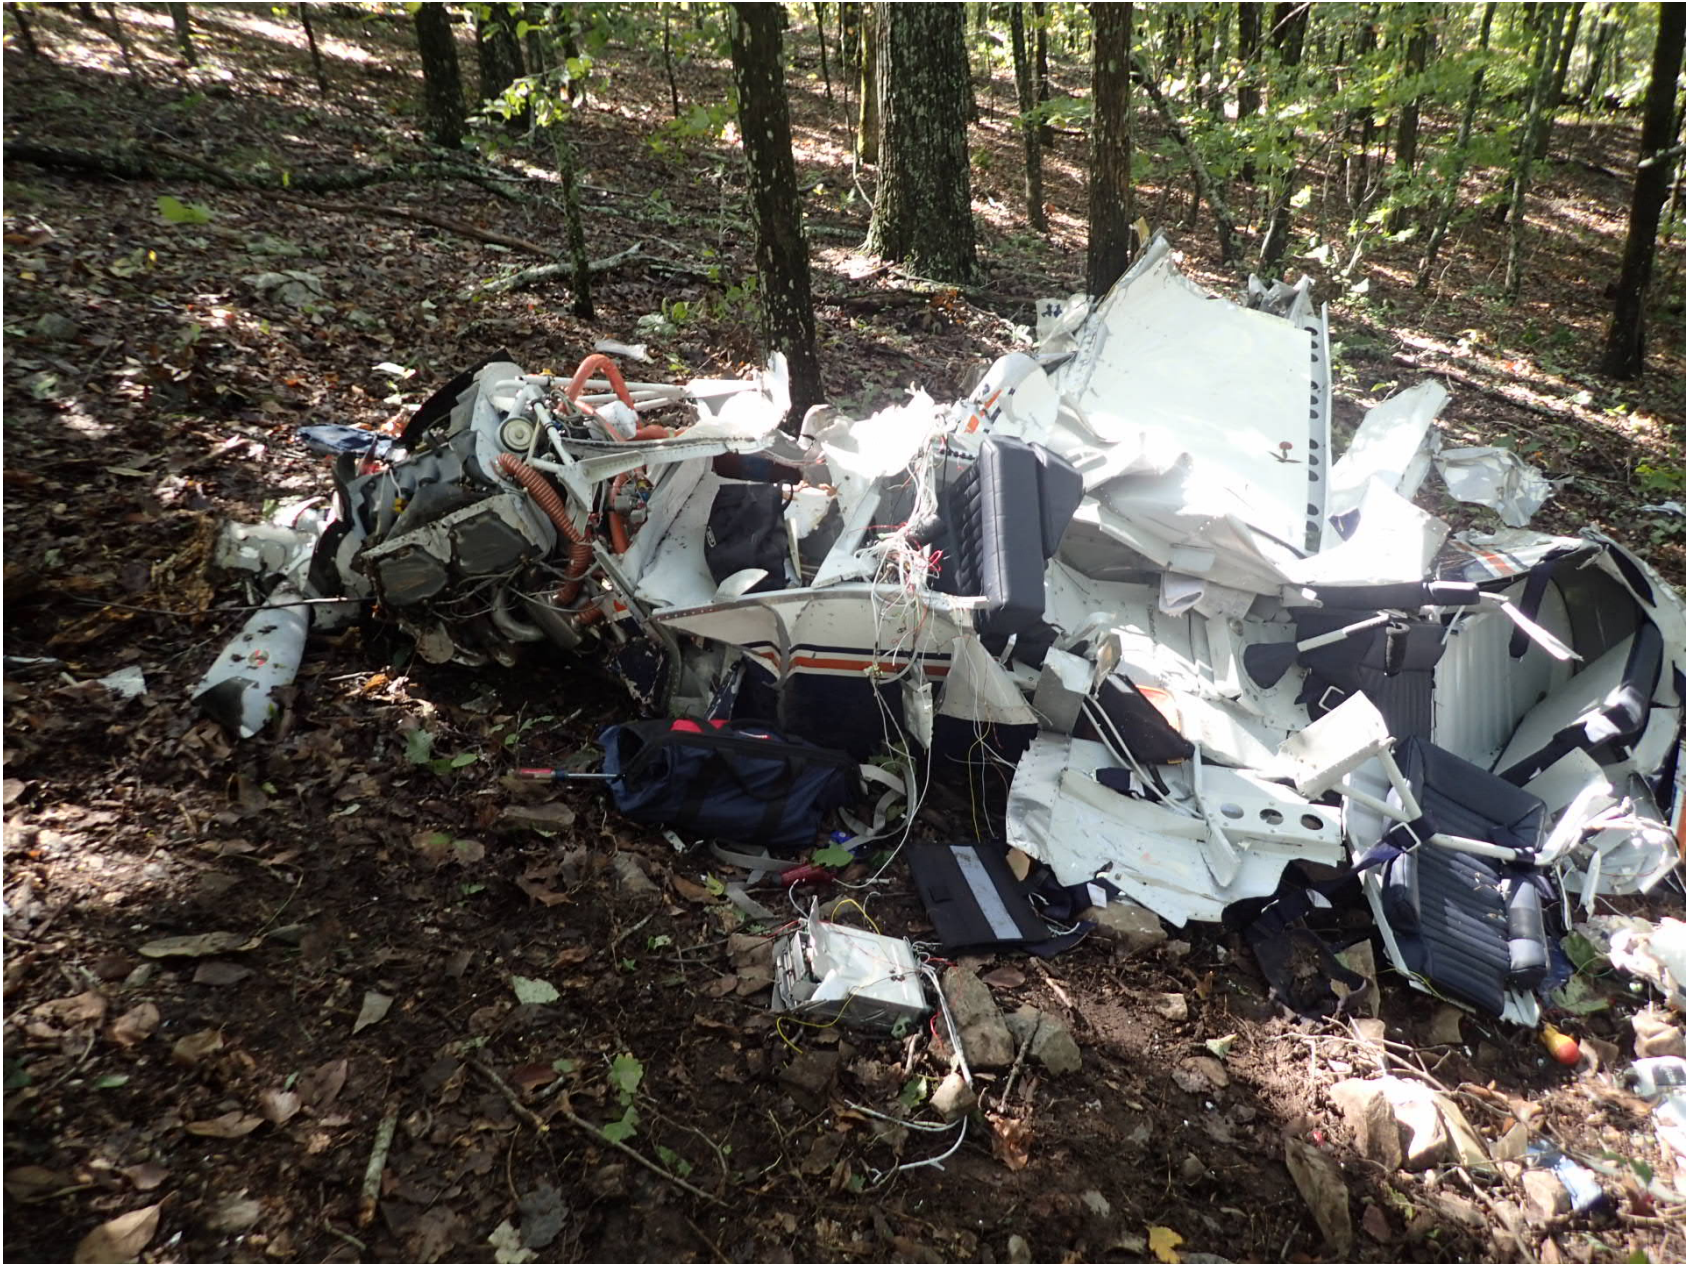
**Photo 2 – Left side view of the airplane at the accident site.**

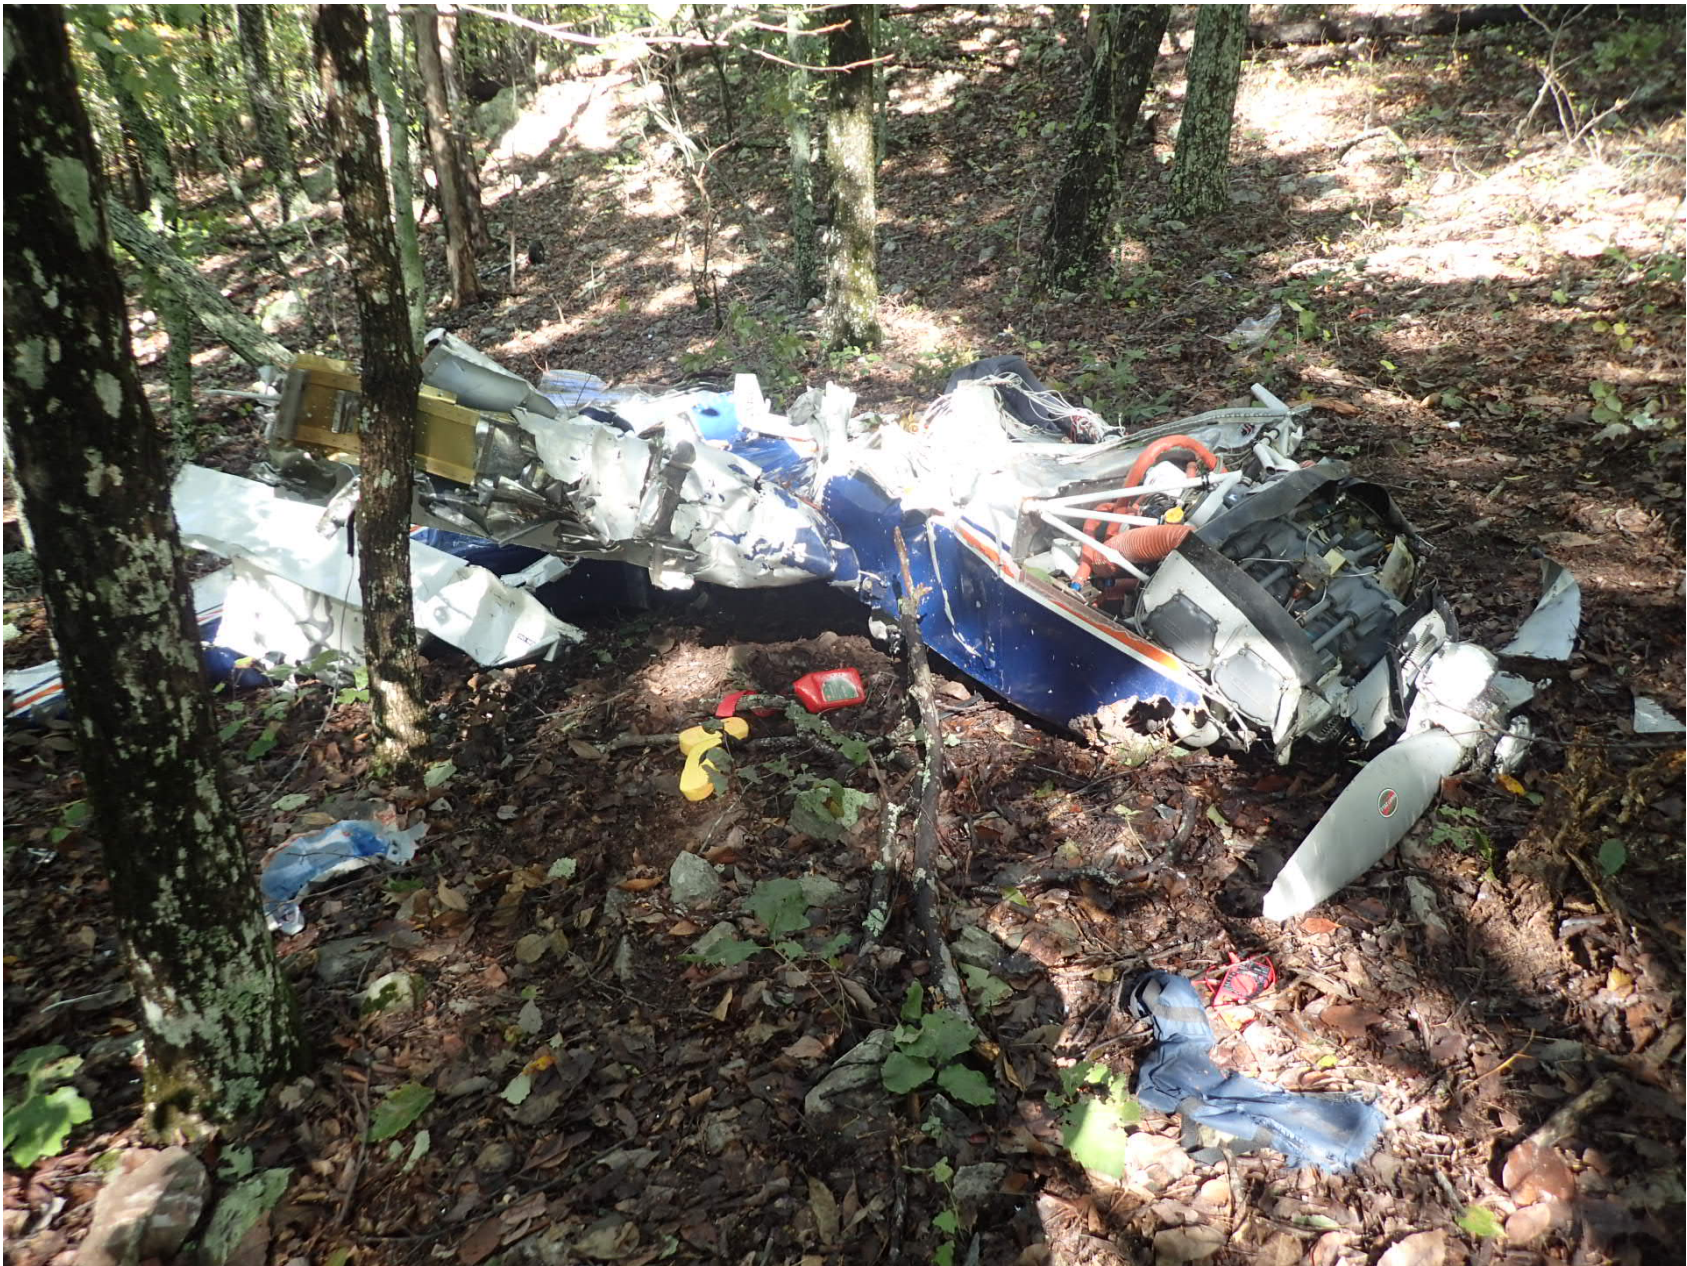
**Photo 3 – Right side view of the airplane at the accident site.**

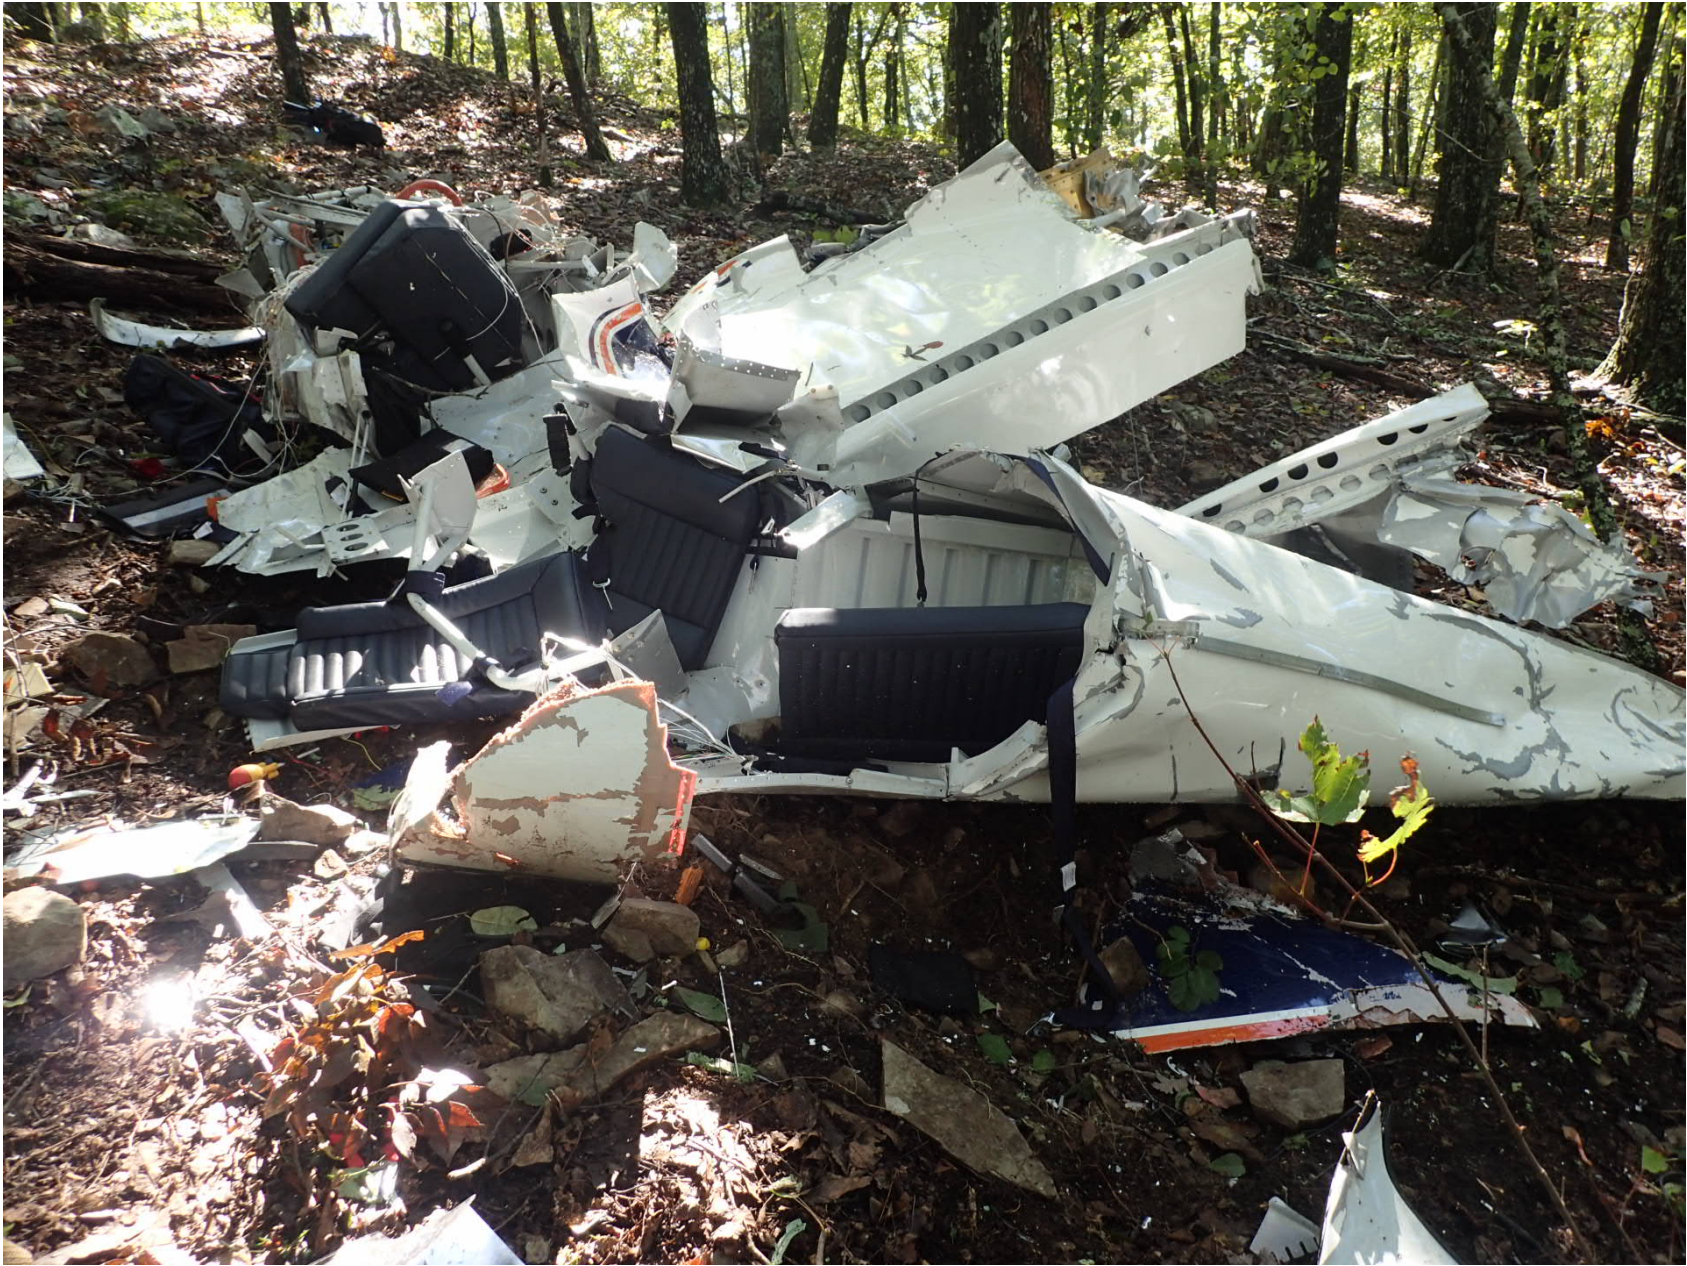
**Photo 4 – Rear view of the airplane at the accident site.**

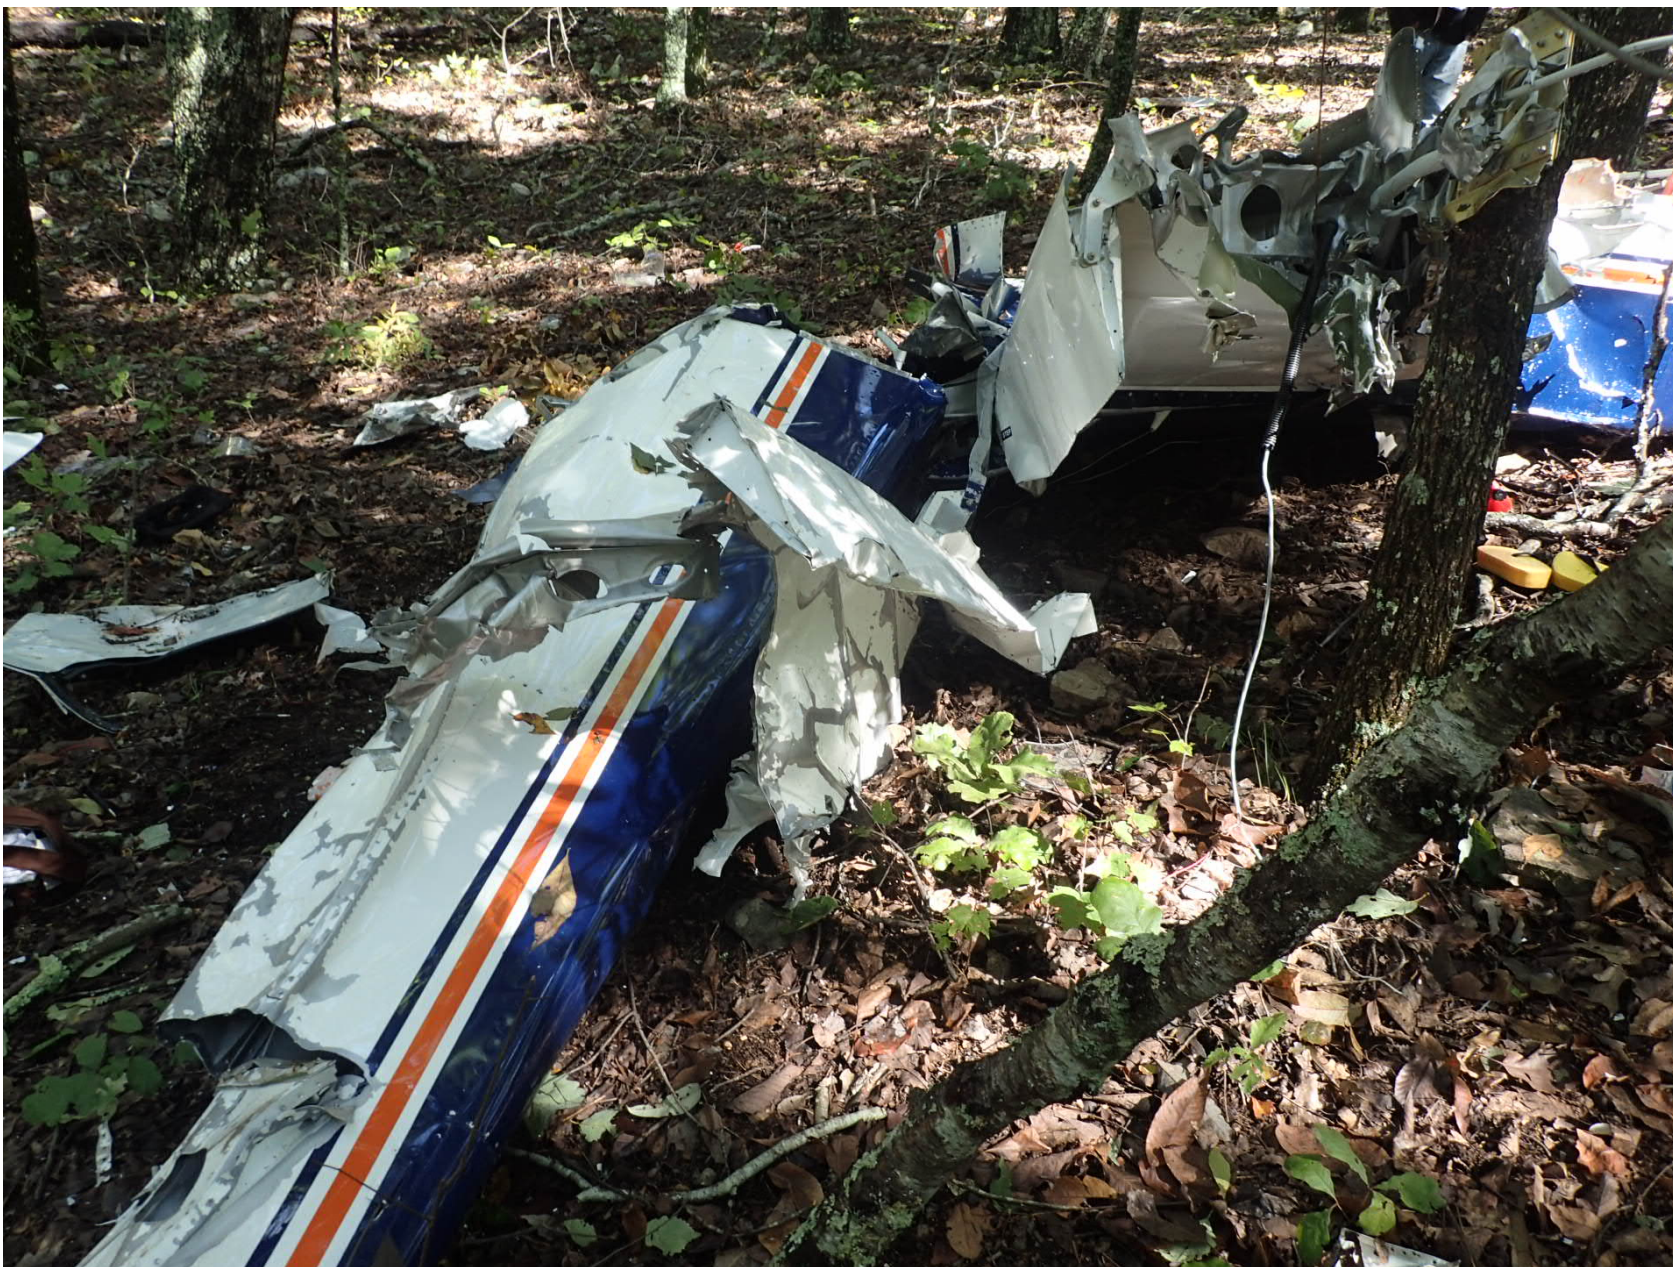
**Photo 5 – Rear view of the airplane at the accident site.**

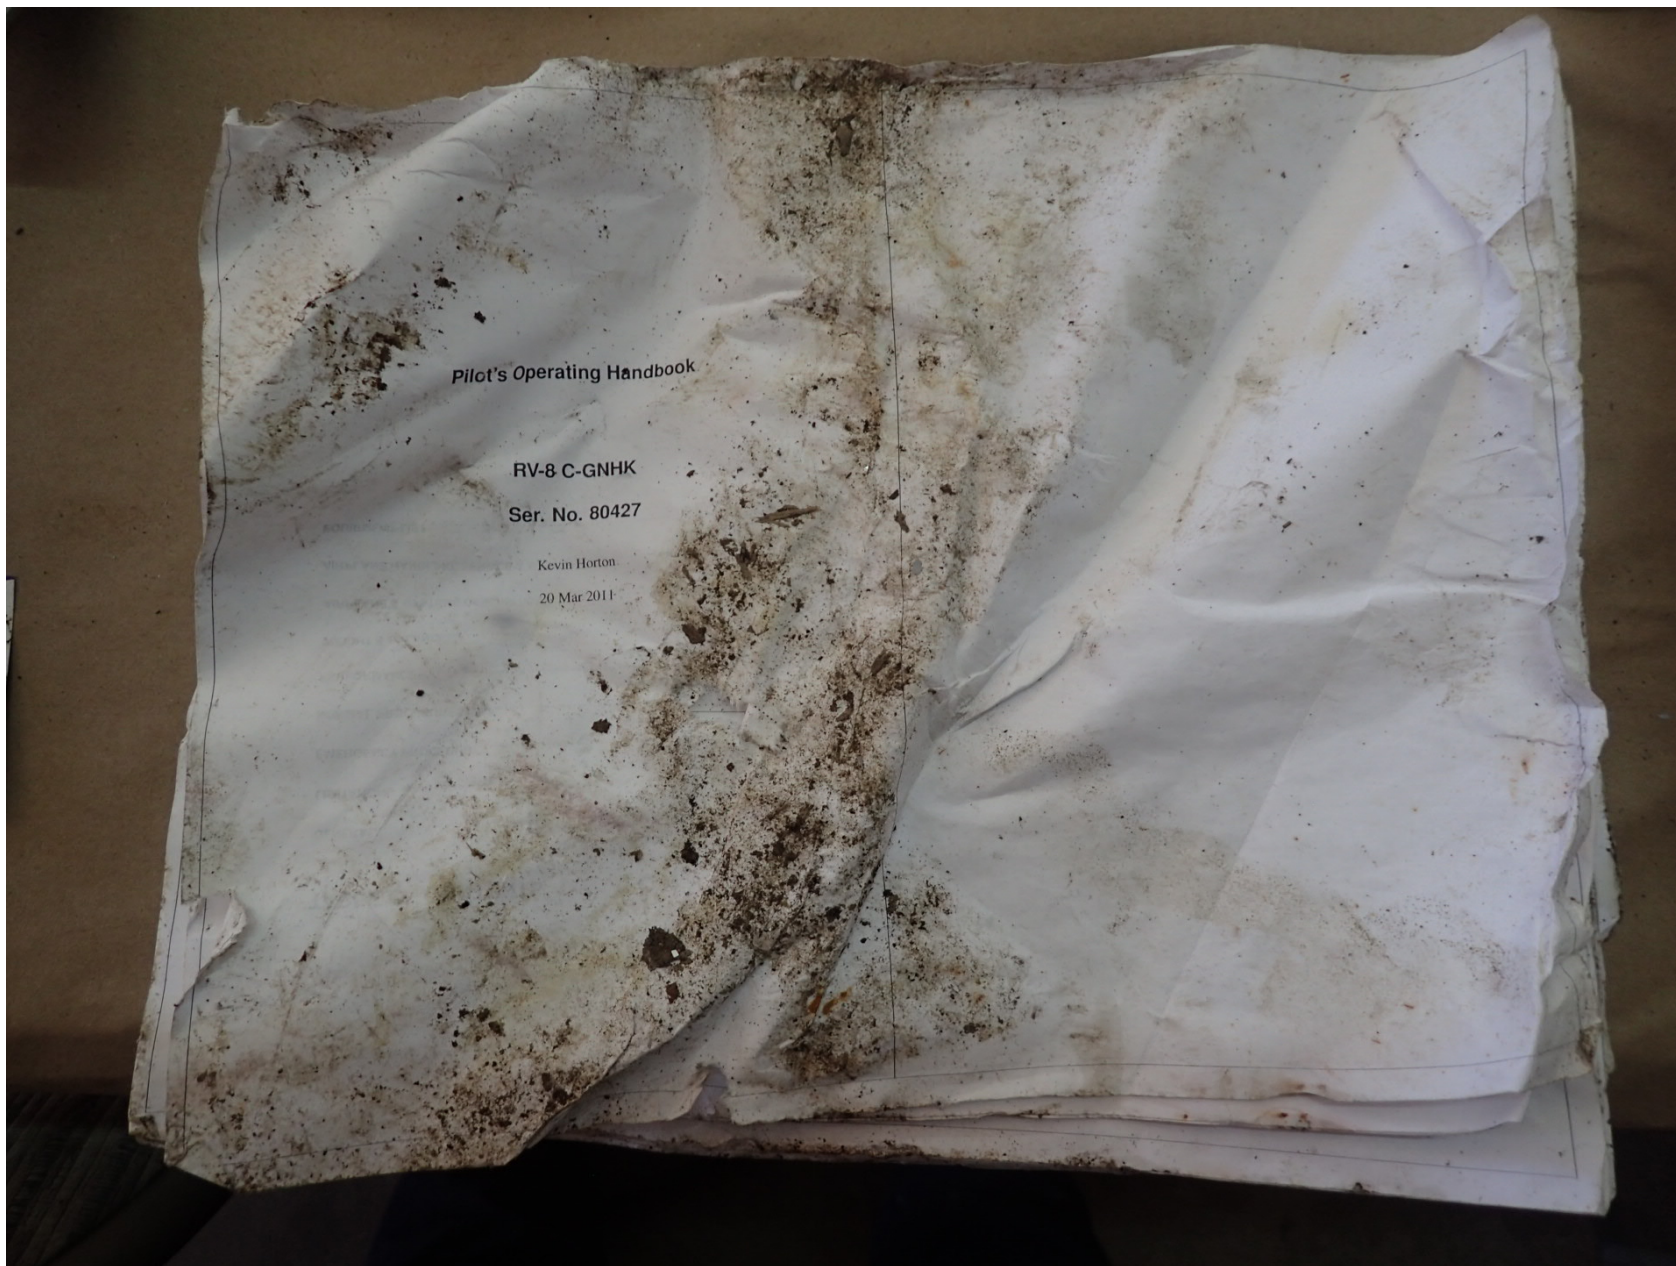
**Photo 6 – View of the pilot's operating handbook (POH) recovered from the airplane. The POH is for Vans RV-8 airframe serial number 80427 (Canadian registration, C-GNHH).**

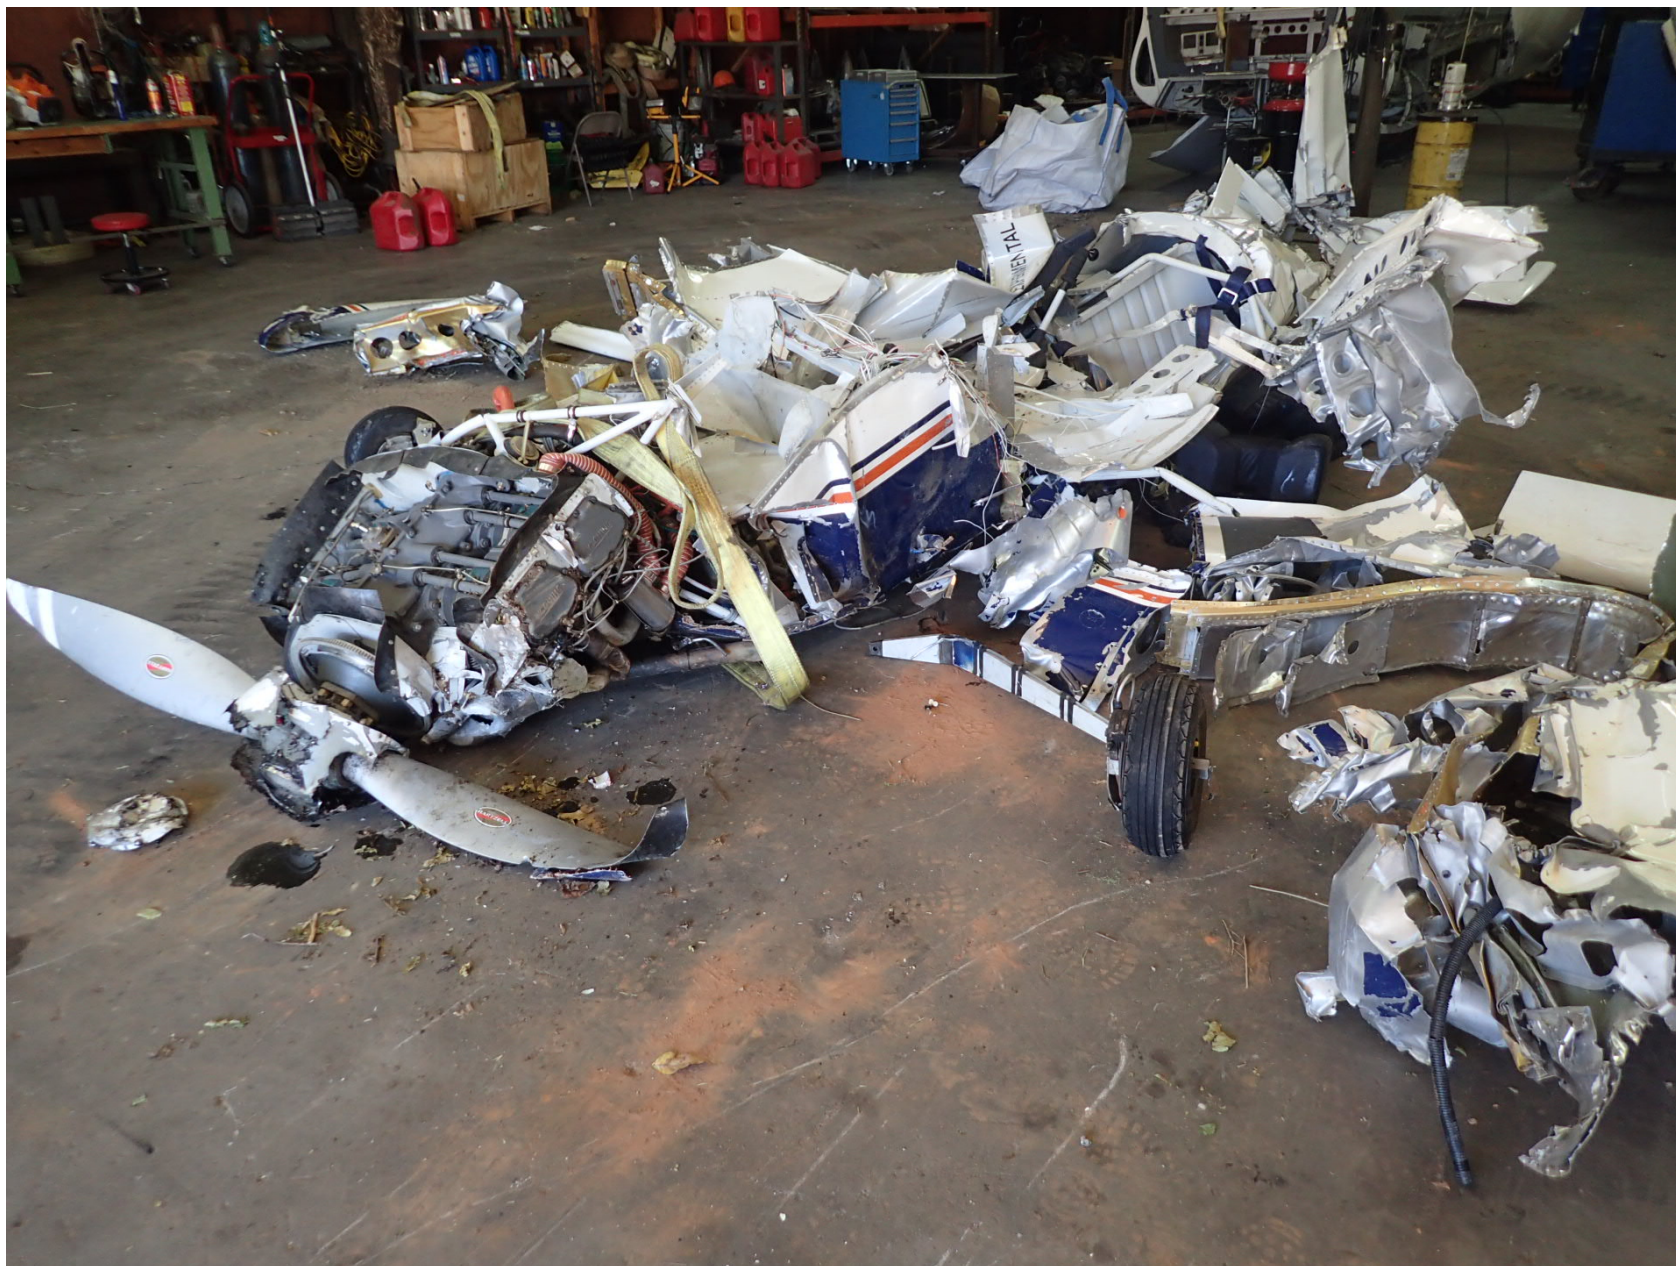
**Photo 7 – Front view of the airplane at the recovery facility.**

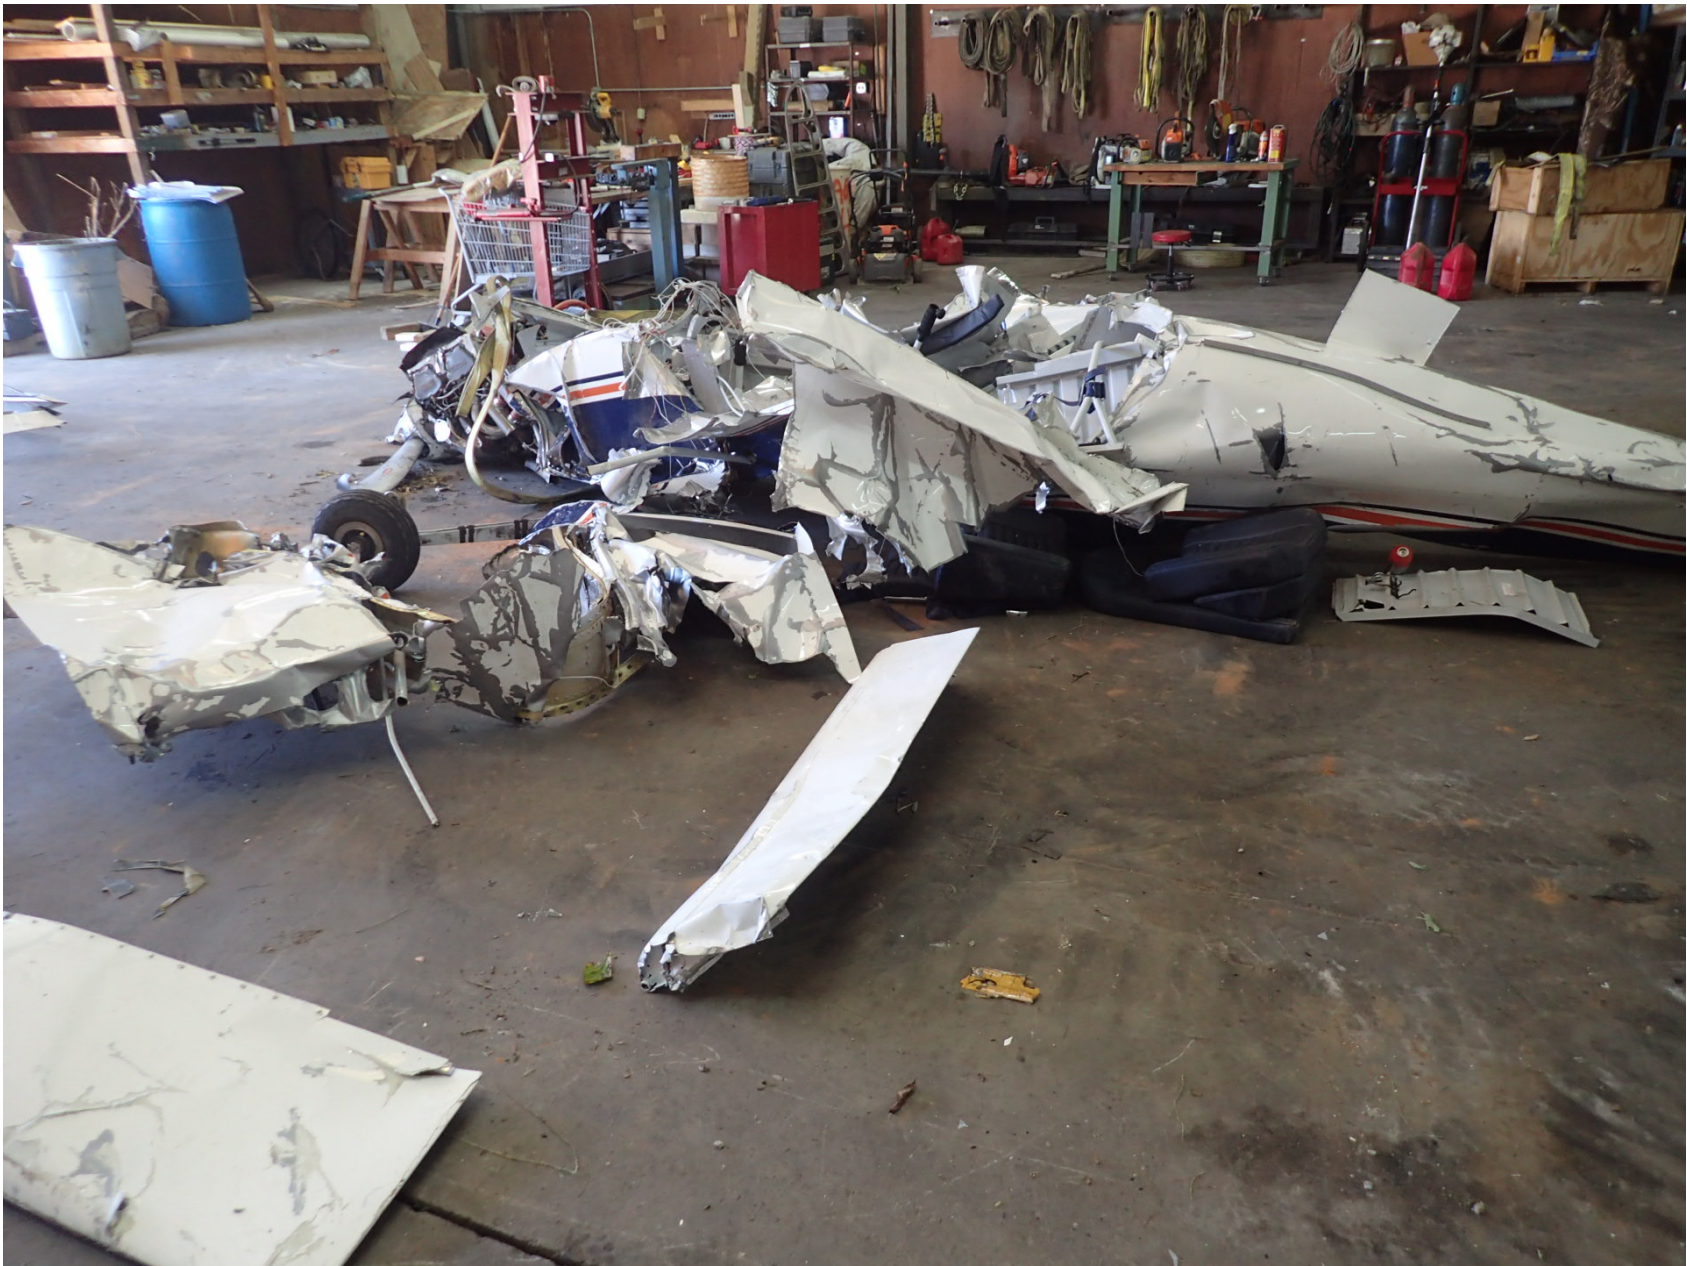
**Photo 8 – Left side view of the airplane at the recovery facility.**

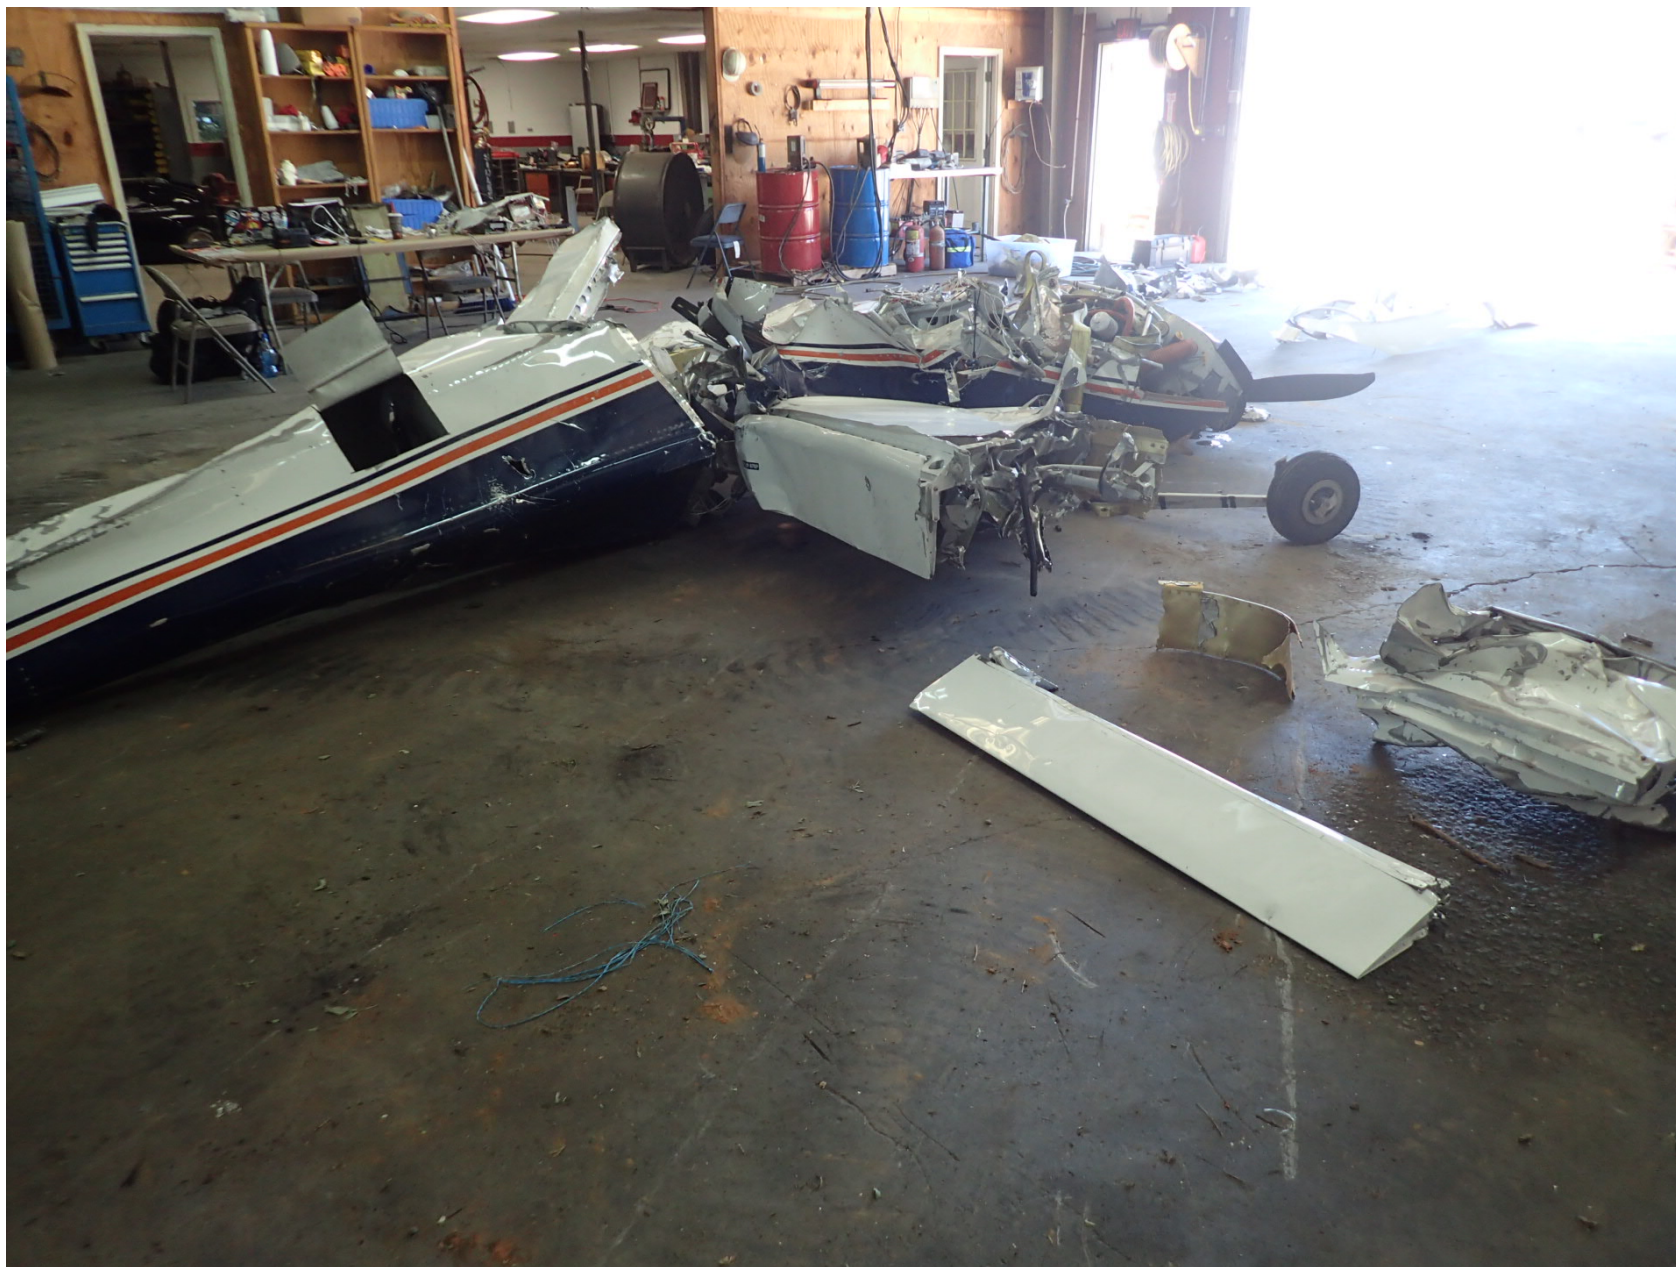
**Photo 9 – Right side view of the airplane at the recovery facility.**

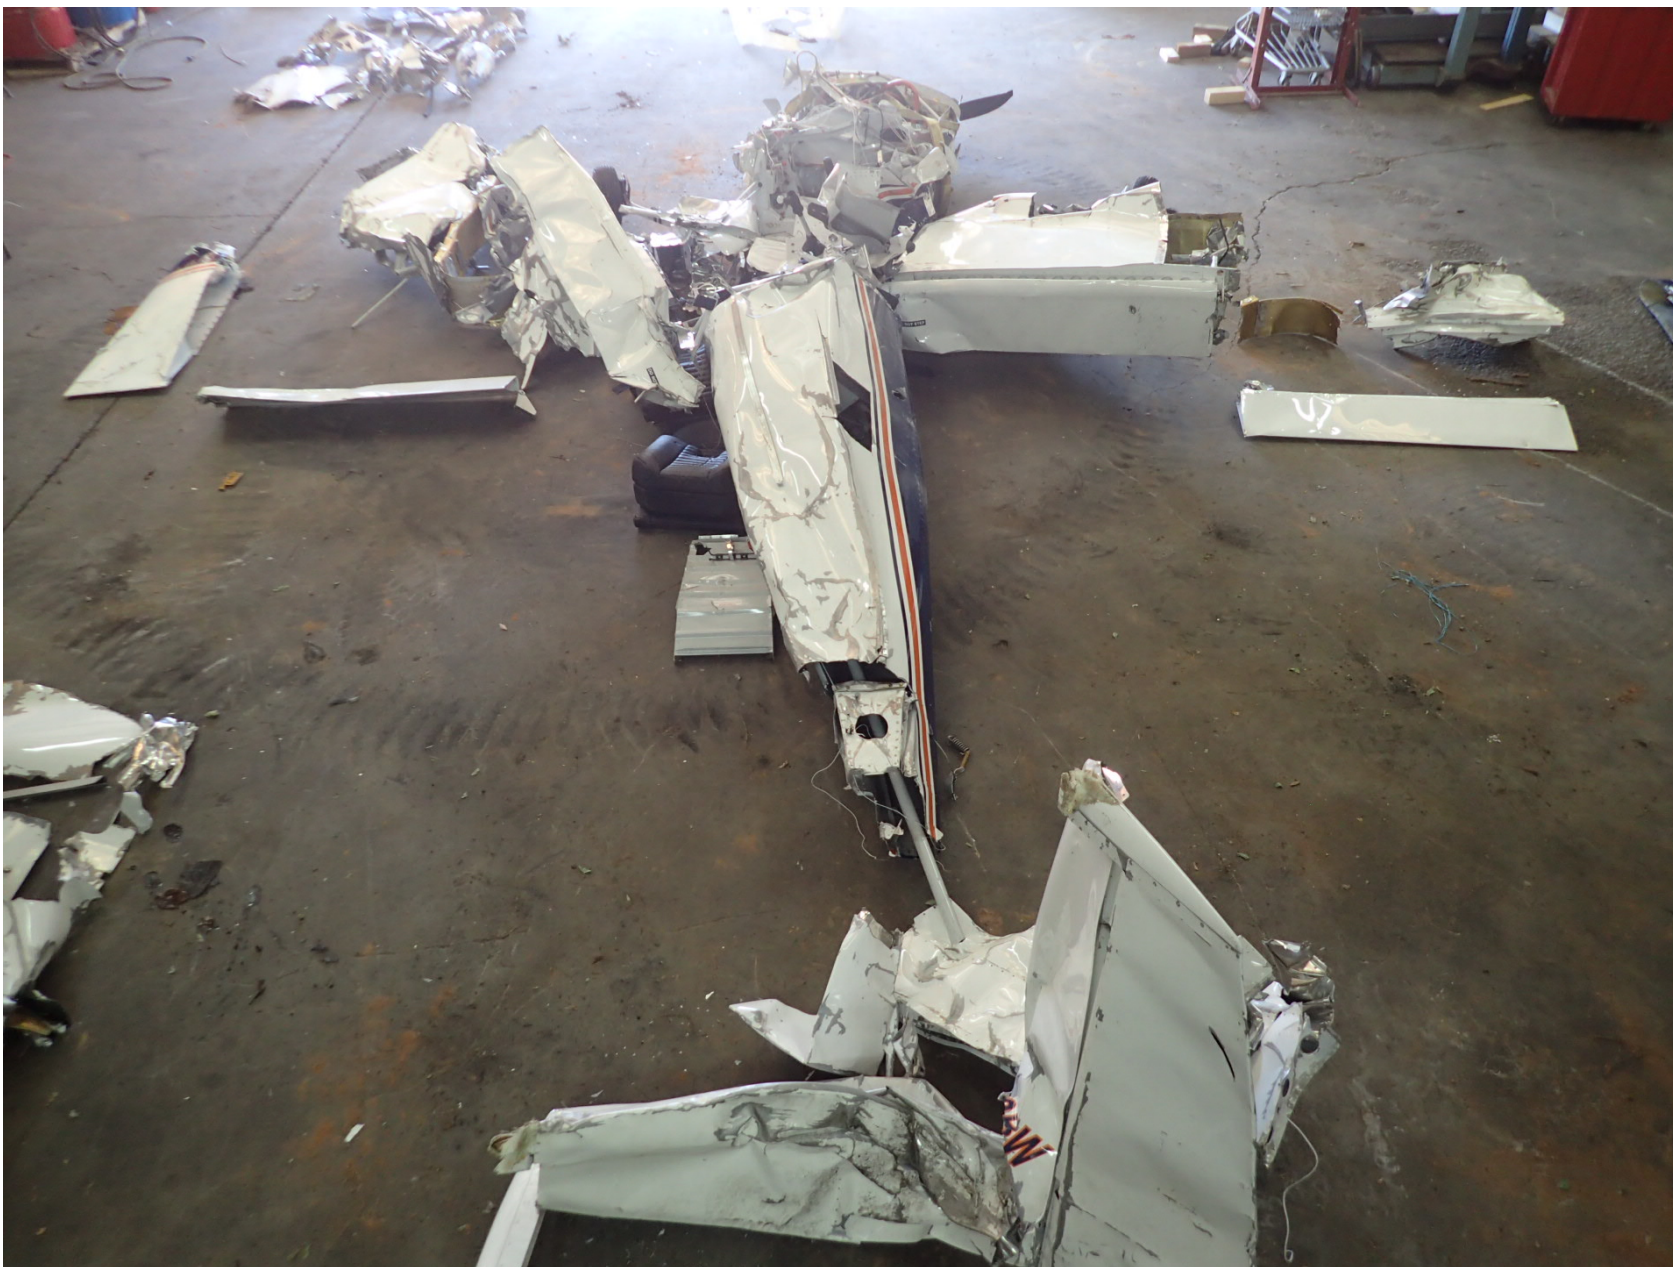
**Photo 10 – Rear view of the airplane at the recovery facility.**
