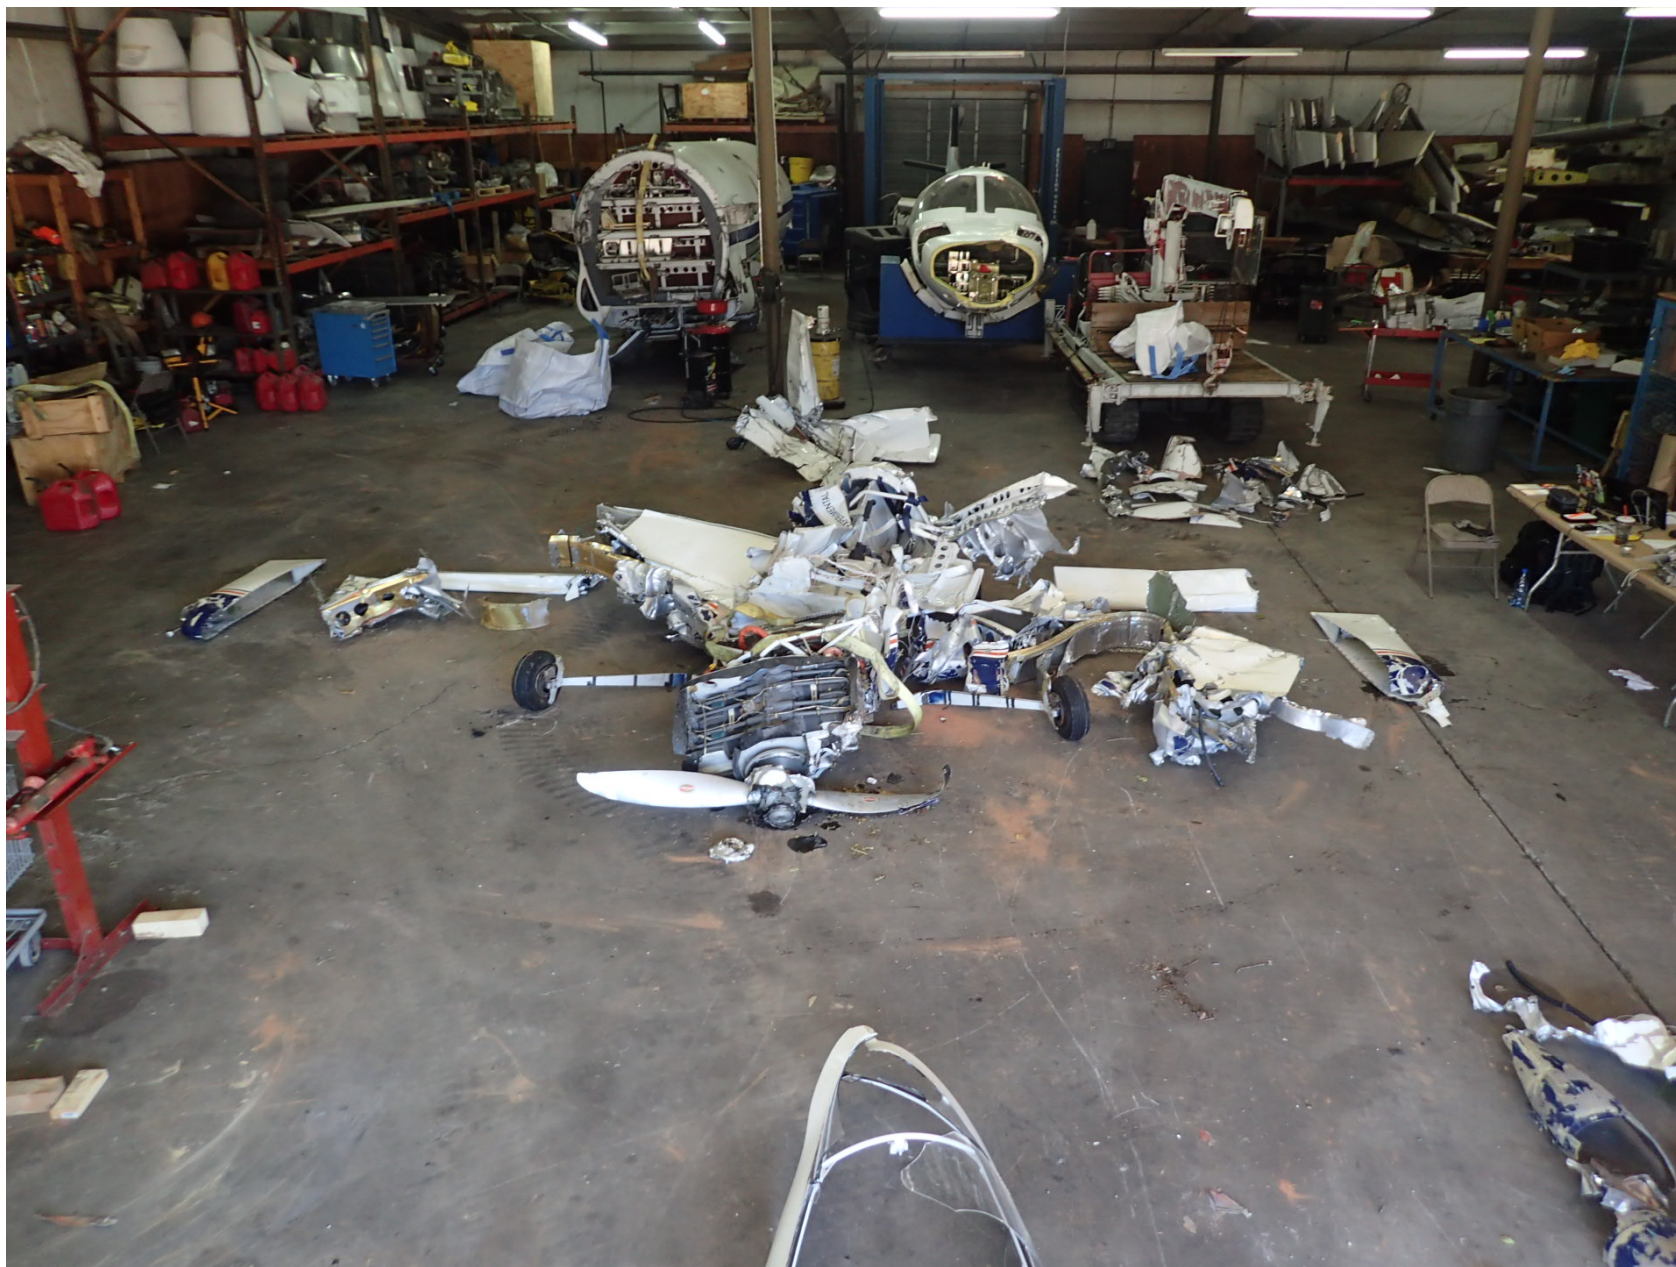
**Photo 11 – Overview of the airplane at the recovery facility.**

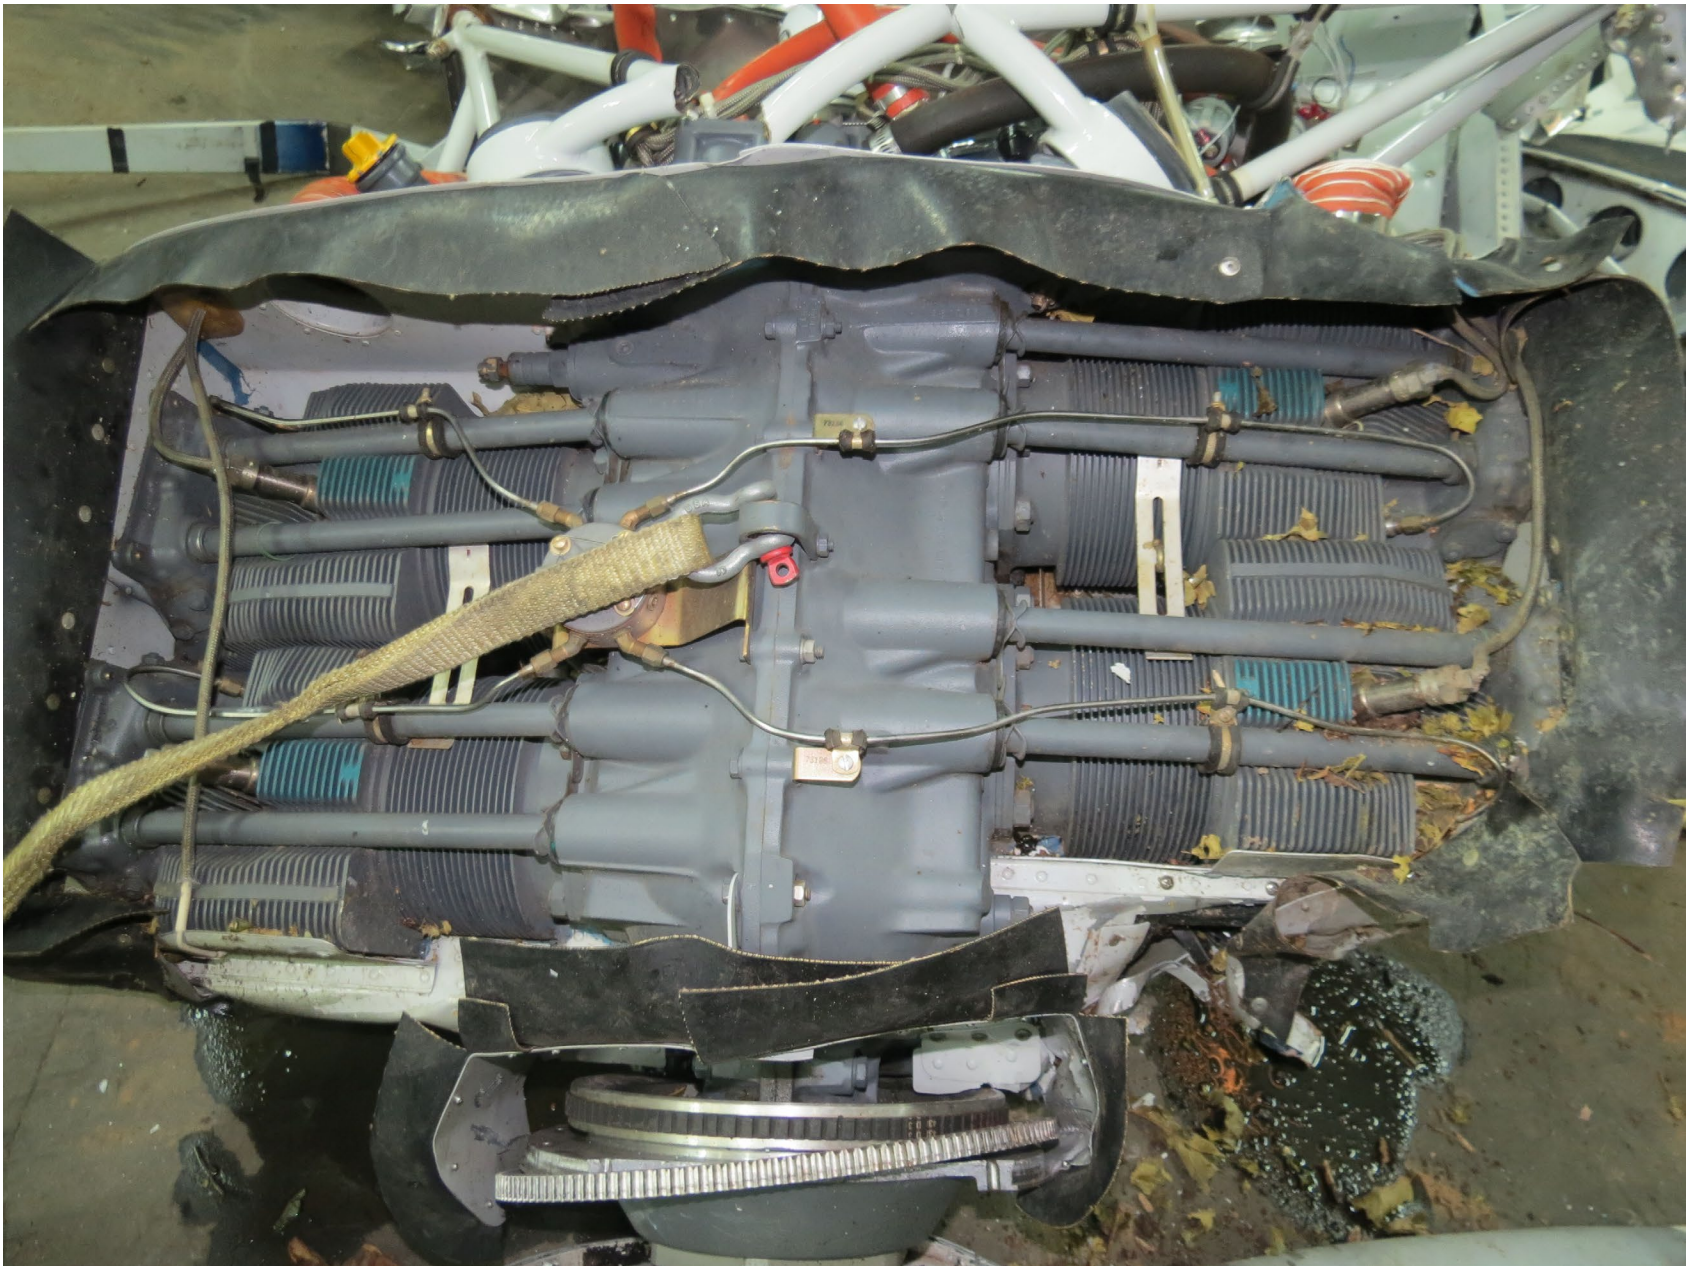
**Photo 12 – Top view of the engine at the recovery facility (courtesy of Lycoming Engines).**

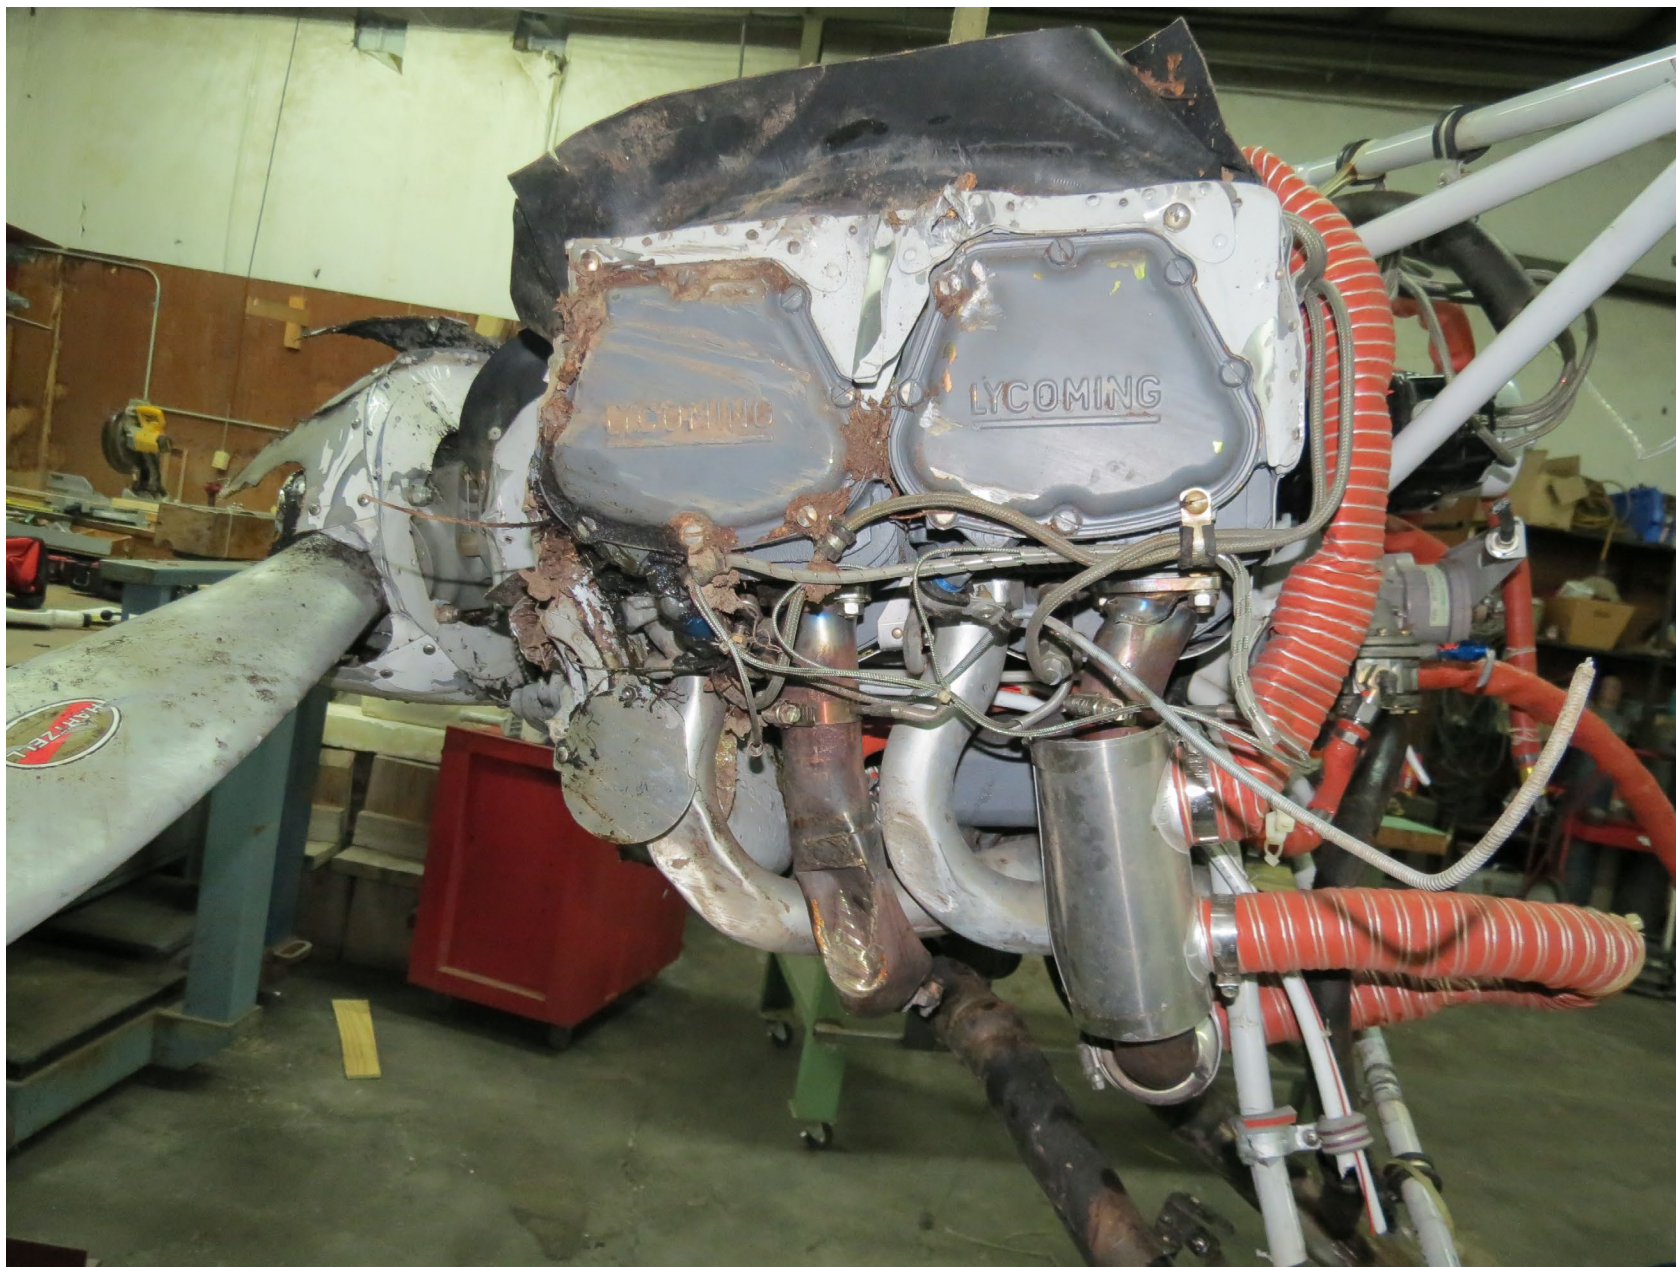
**Photo 13 – Left side view of the engine at the recovery facility (courtesy of Lycoming Engines).**

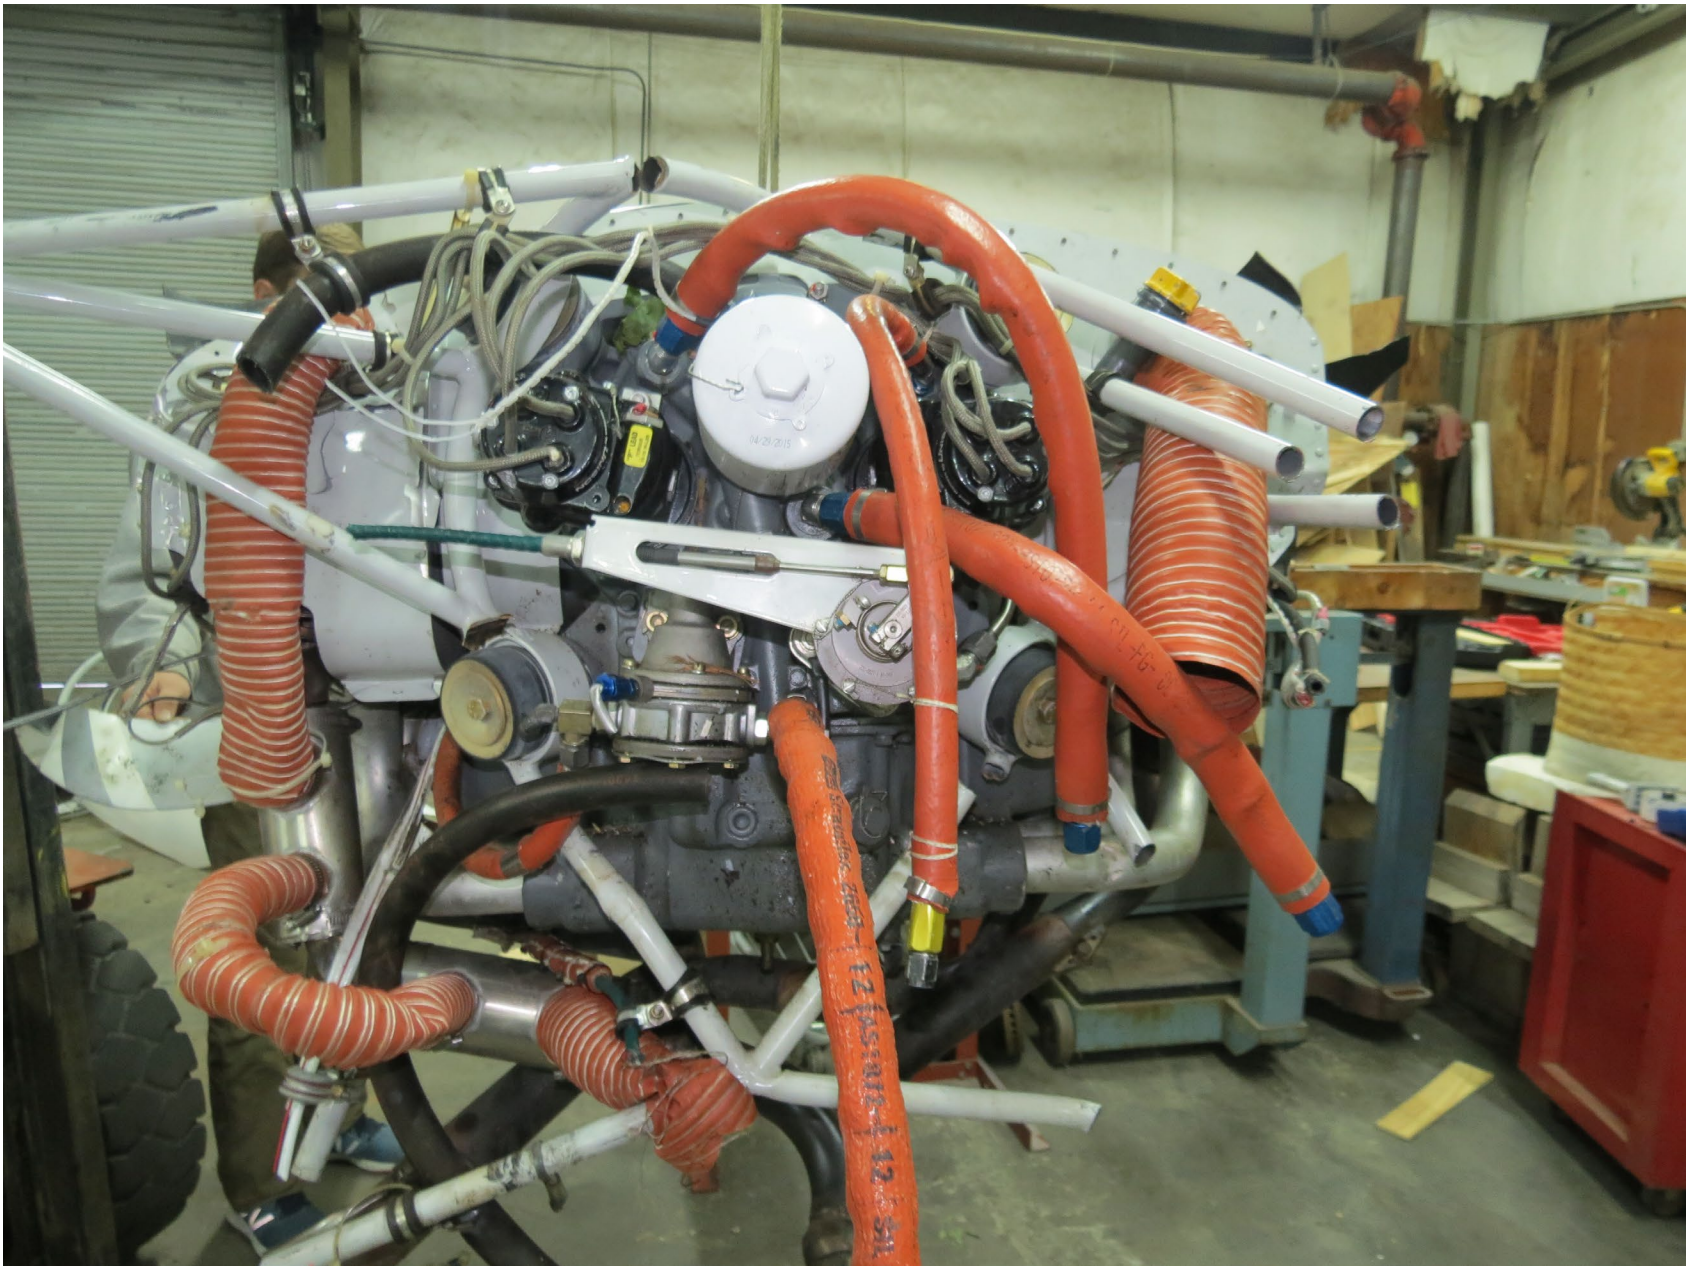
**Photo 14 – Rear view of the engine at the recovery facility (courtesy of Lycoming Engines).**

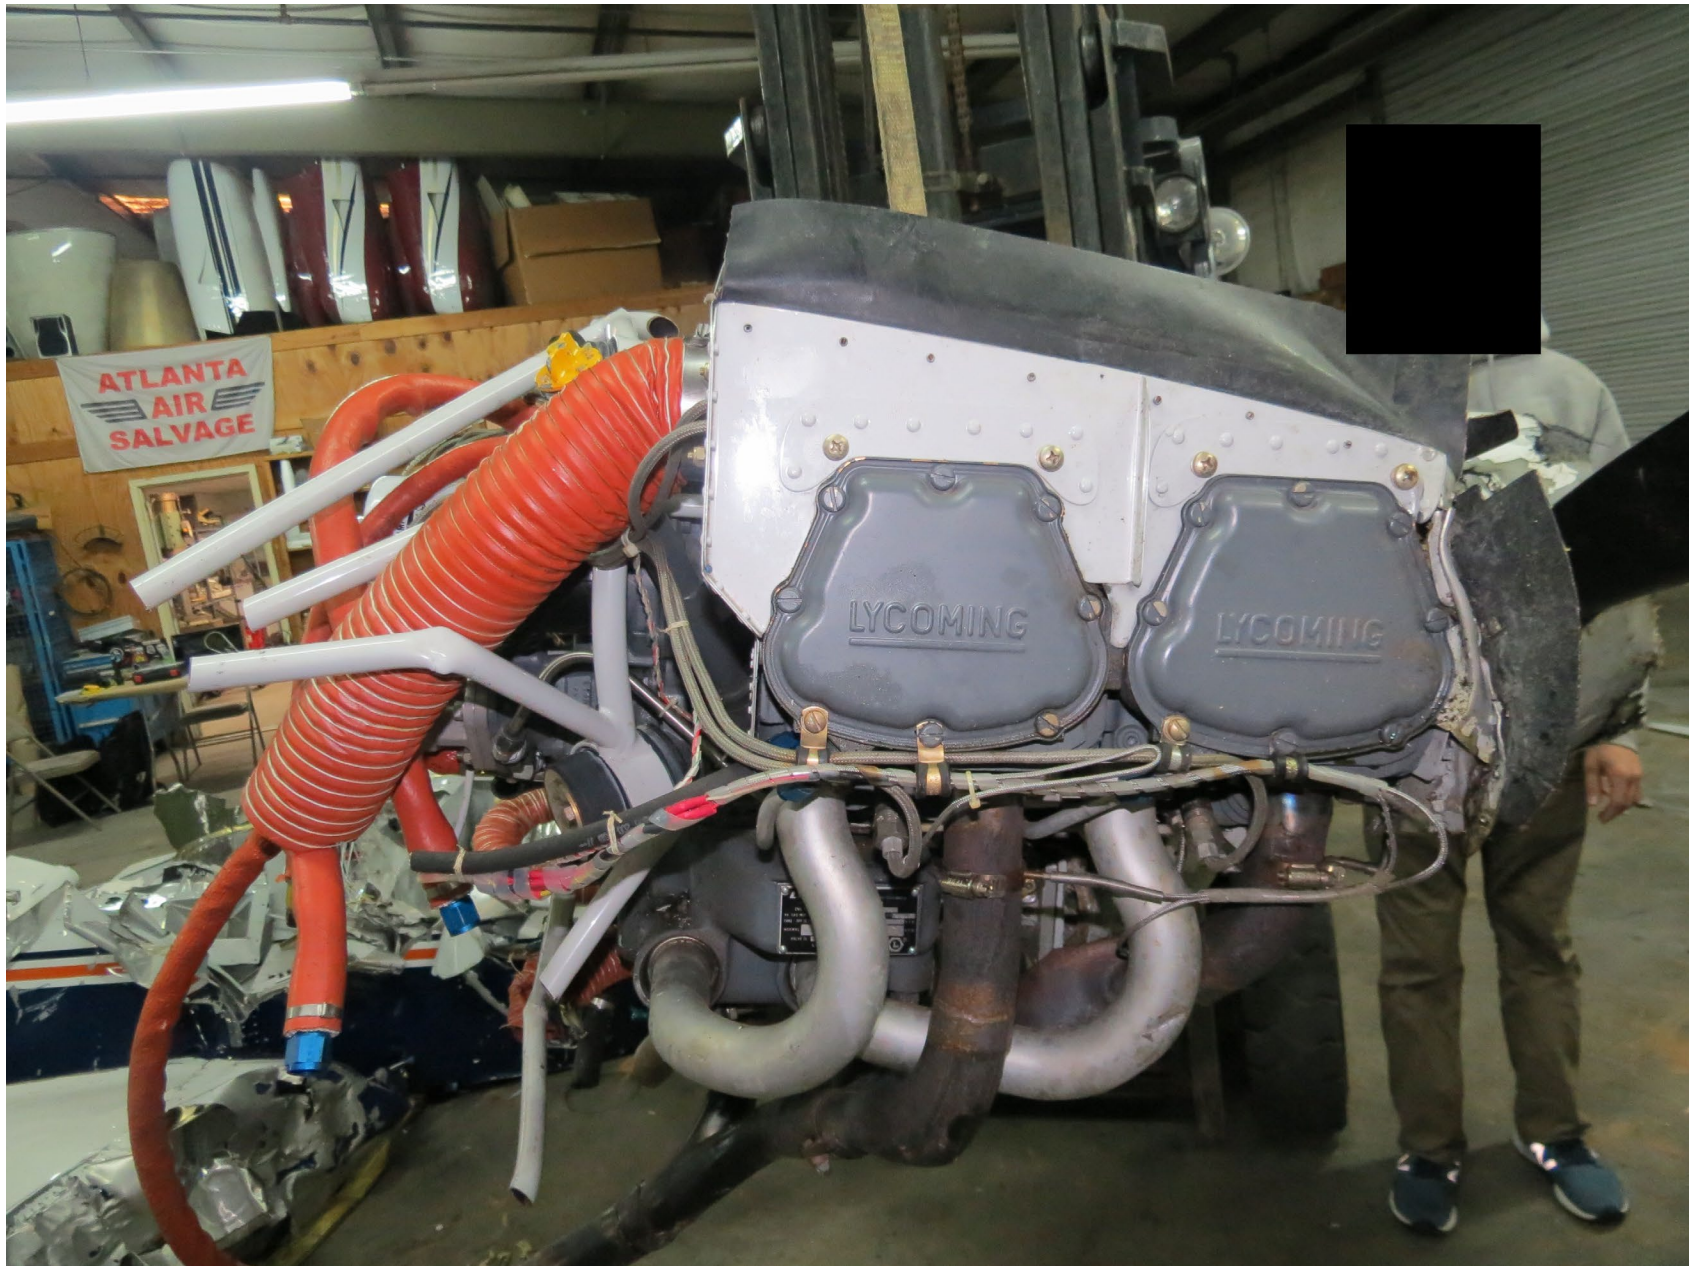
**Photo 15 – Right side view of the engine at the recovery facility (courtesy of Lycoming Engines).**

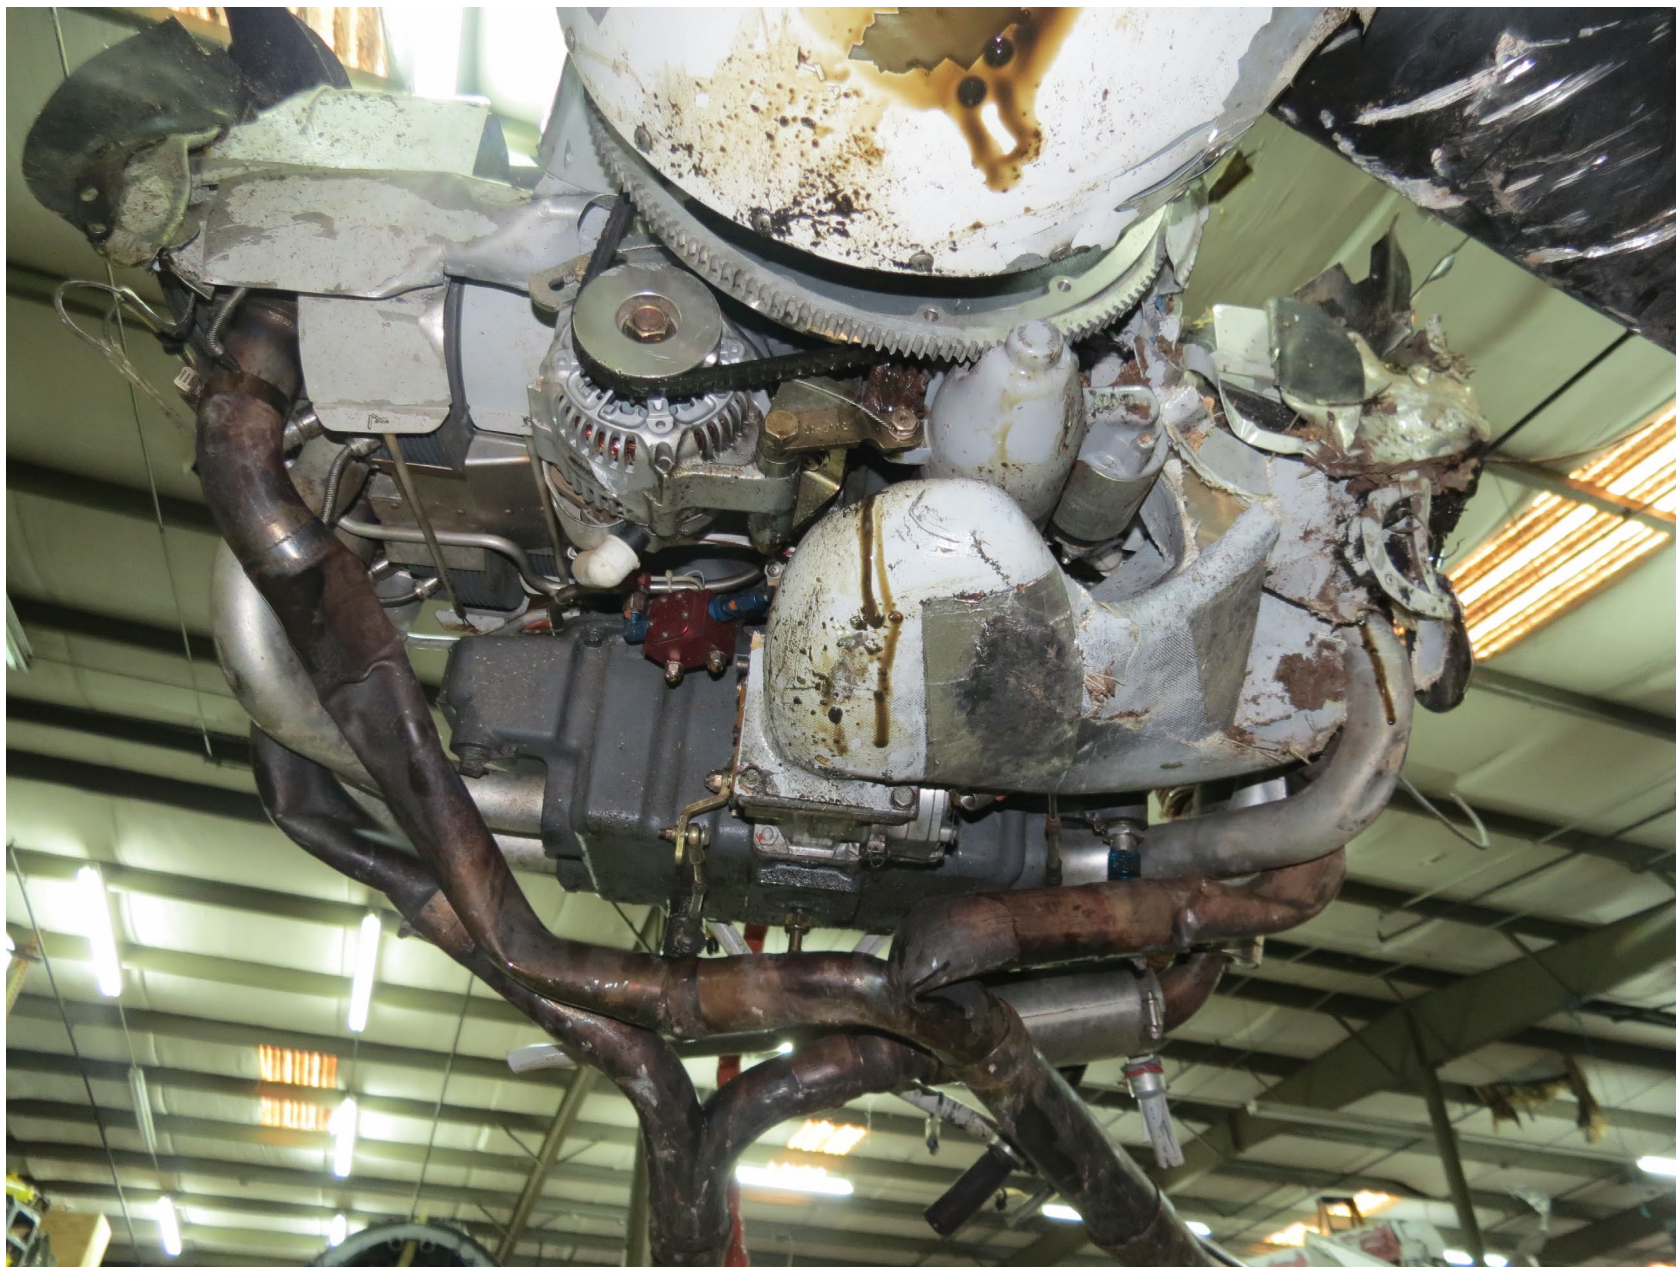
**Photo 16 – Bottom view of the engine at the recovery facility (courtesy of Lycoming Engines).**

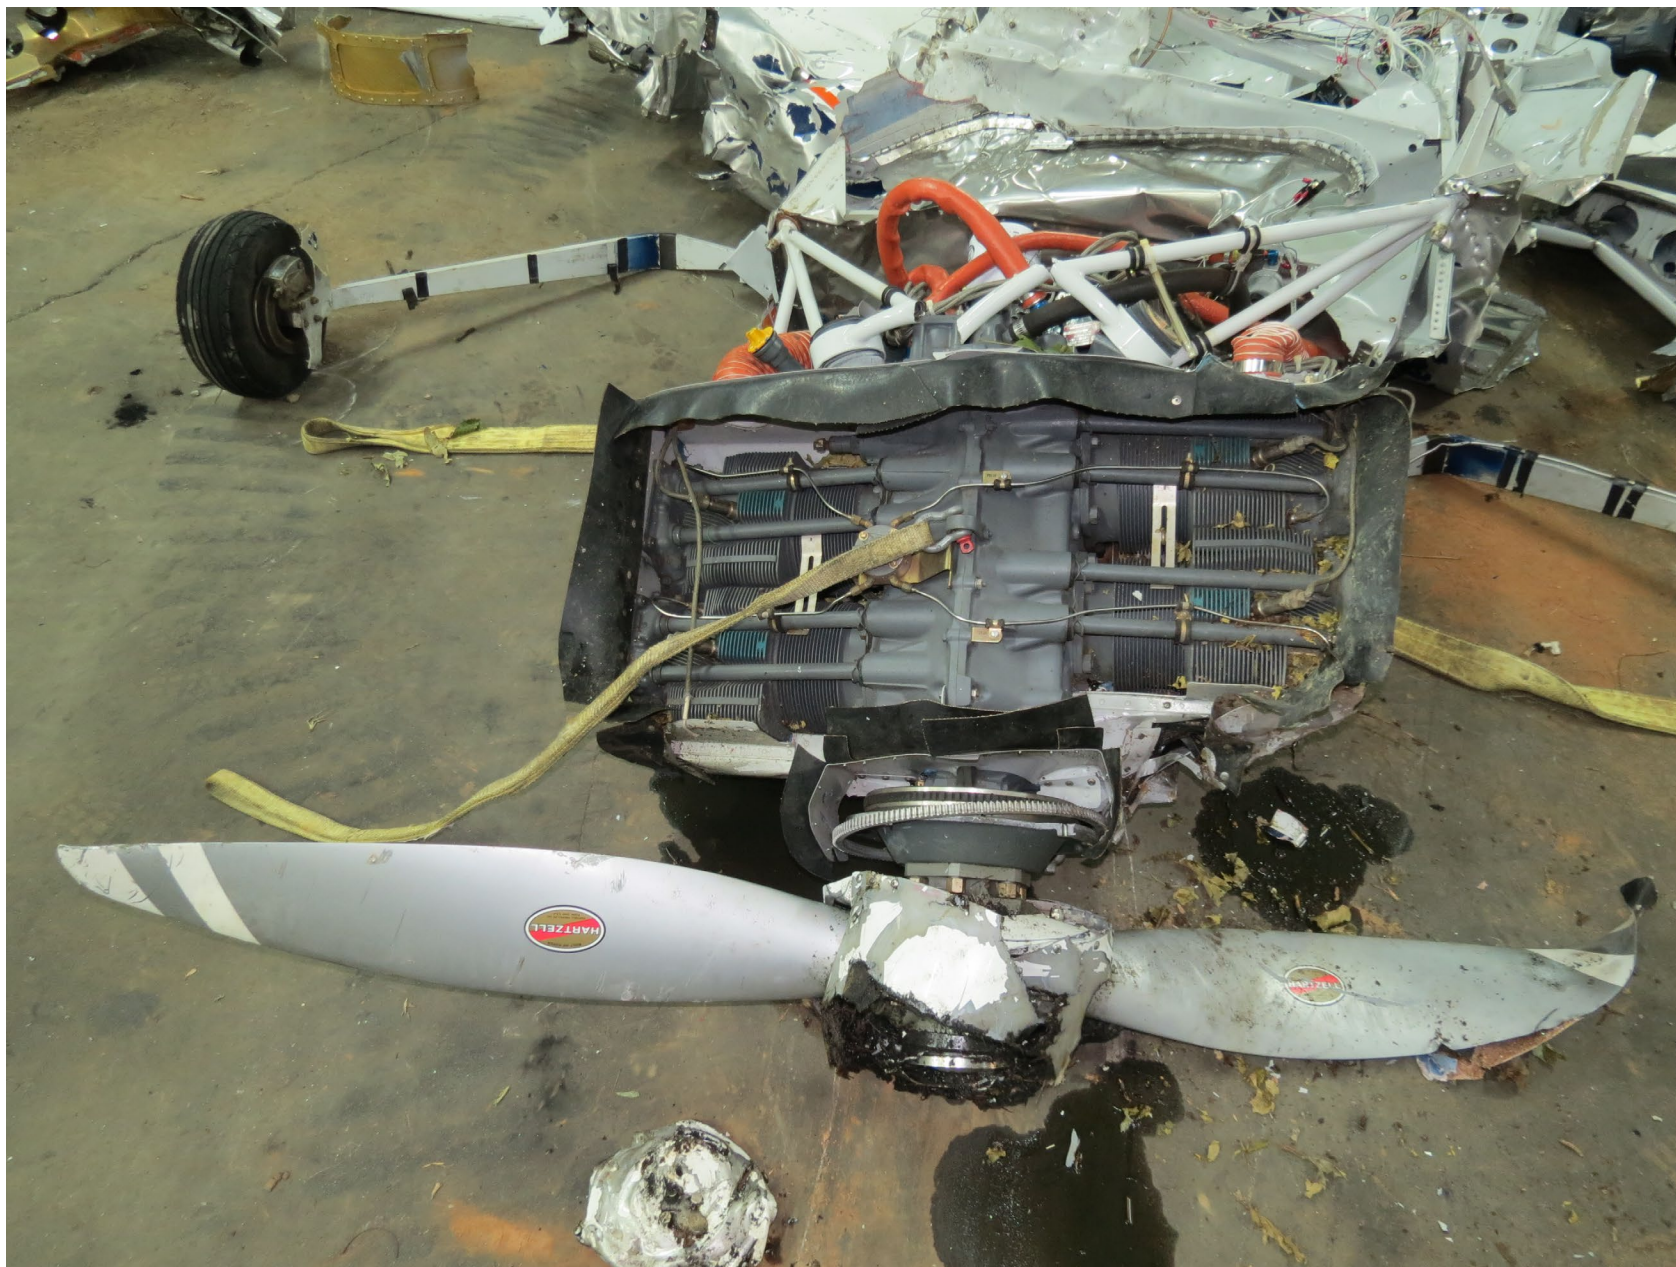
**Photo 17 – View of the propeller at the recovery facility (courtesy of Lycoming Engines).**

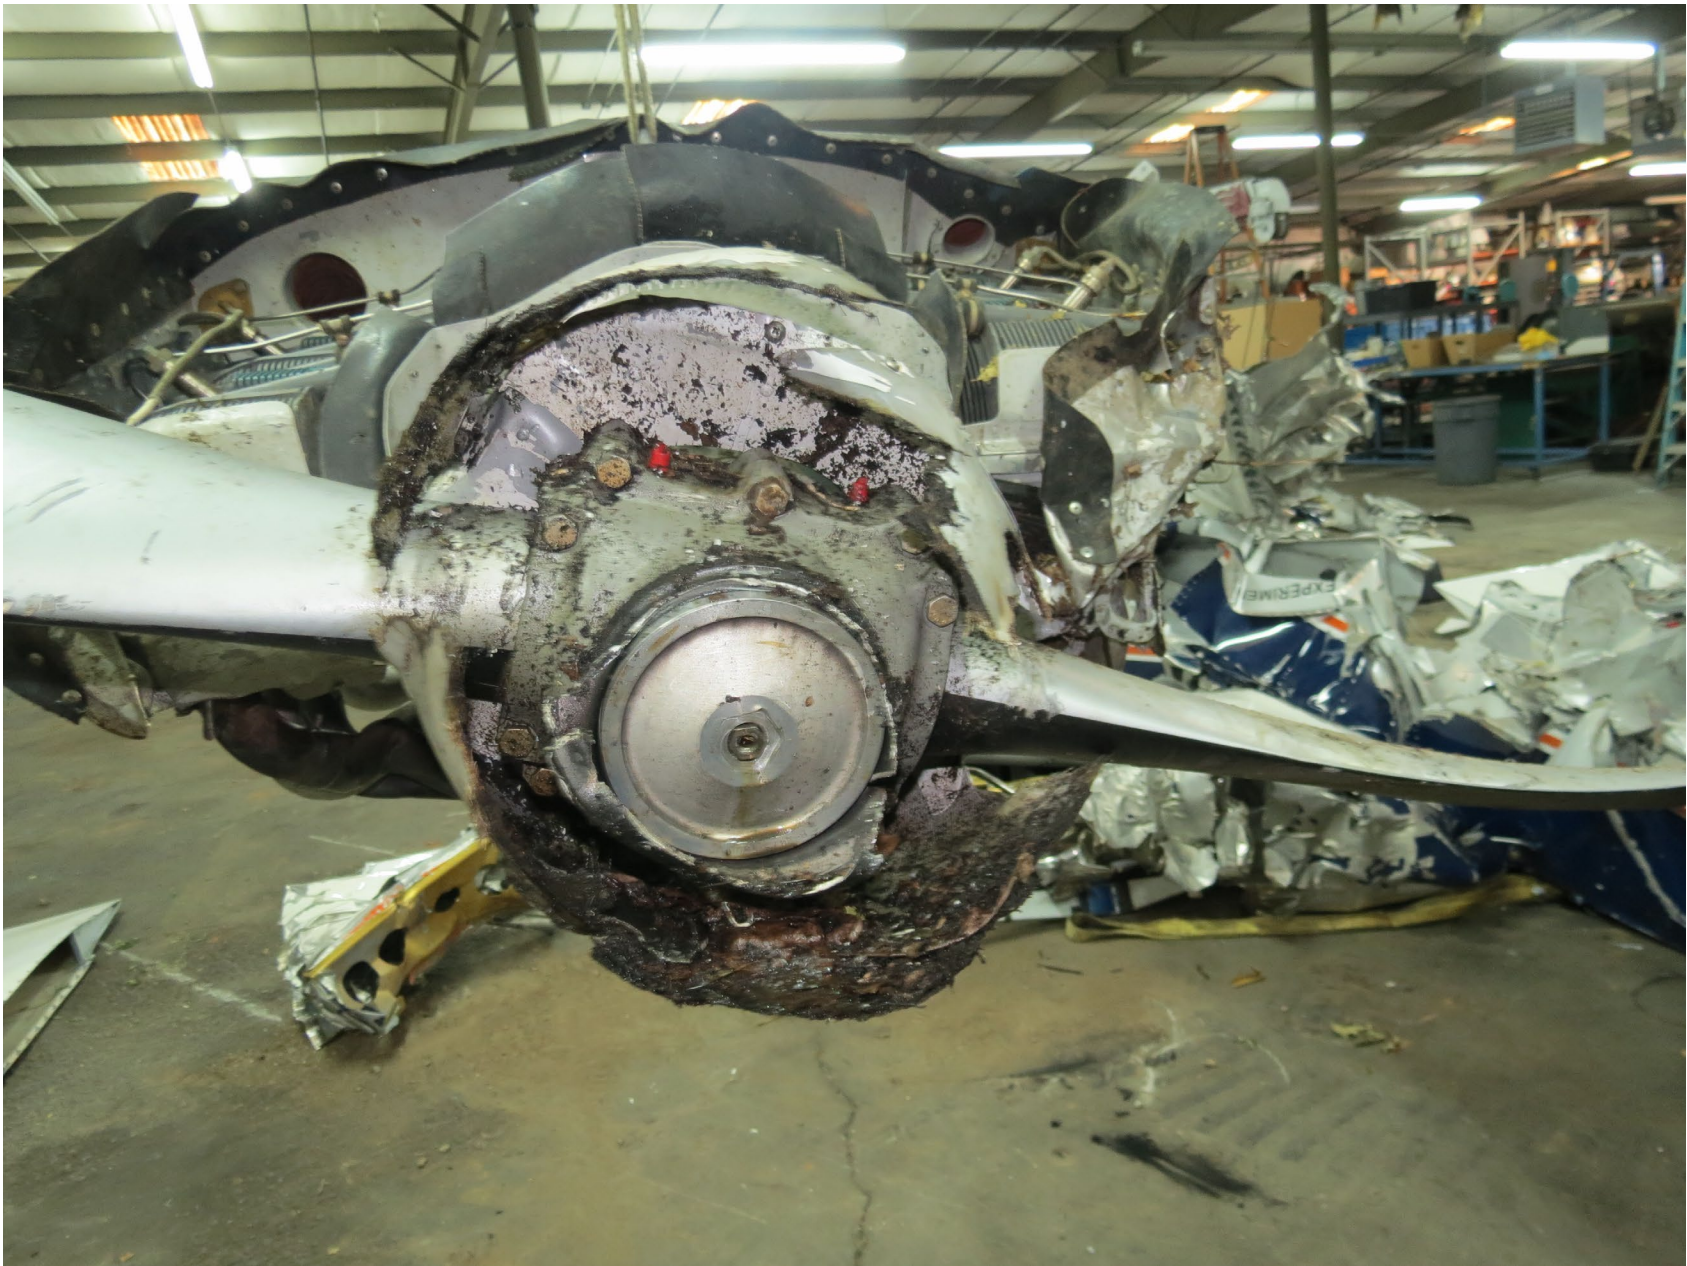
**Photo 18 – Close up view of the propeller at the recovery facility (courtesy of Lycoming Engines).**
