# The National Transportation Safety Board

Office of Aviation Safety  
Central Region  
Memorandum for the Record  
Accident Site and Wreckage  
Examinations  
CEN20FA010  
Aberdeen South Dakota  
October 9 2019

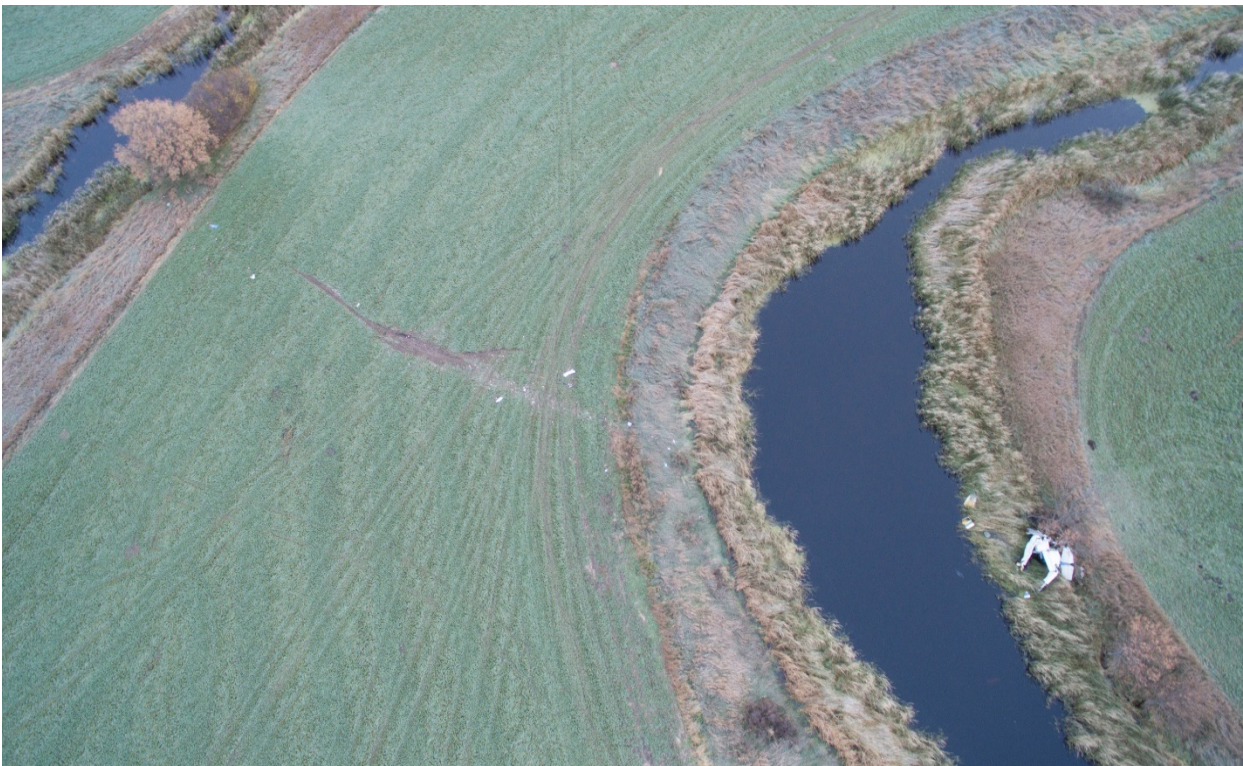
Photo 1 Aerial View of Accident Site

The airplane's wreckage was in a farmer's field, about 7 miles north of ABR, grid coordinates: 45.561709 N - 098.460366 W. On scene observations showed evidence that the airplane initially impacted a 60-foot-tall tree with its left wing. Debris was scattered beyond the initial impact of the tree on a heading of 148 degrees. The fuselage skidded along the ground for about 500 feet, coming to rest on the edge of standing water. The engine was separated from the fuselage and submerged in the standing water. Note: The wreckage was not found until 12 days after the accident, and engine was submerged in water.

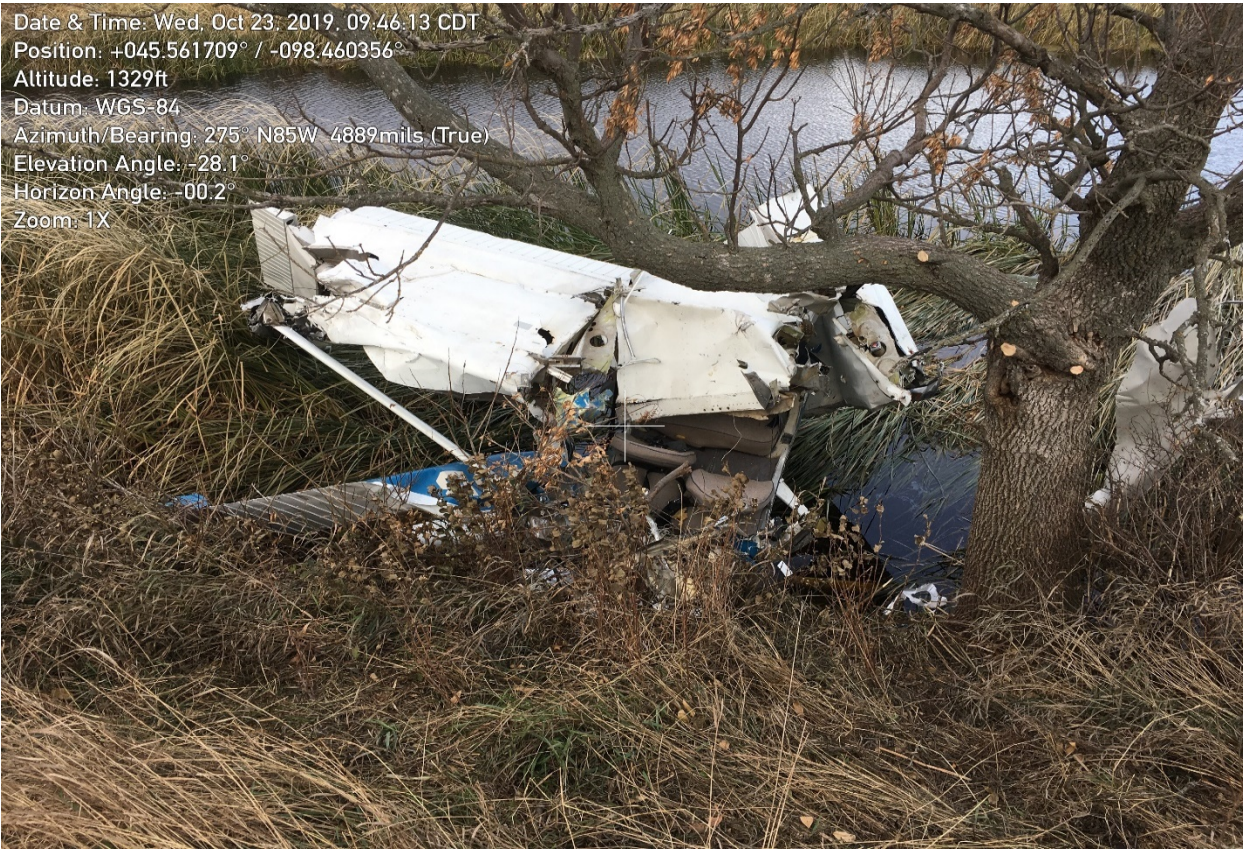
Photo 2 Airplane Wreckage at Accident Site

**Airframe:** Both wings remained attached to the fuselage. The fuselage and empennage were severely crushed and fragmented. The empennage was separated about flight station (FS) 90 and was partially attached by control cables. The vertical fin and rudder separated during the impact sequence and were found about 15 feet in front of the main wreckage.
