# NATIONAL TRANSPORTATION SAFETY BOARD

## MATERIALS LABORATORY FACTUAL REPORT

Report No. 20-002

Place : San Antonio, Texas  
Date : December 1, 2019  
Vehicle : Piper PA-24-250, N6678P  
NTSB No. : CEN20FA023  
Investigator : Jason Aguilera, AS-CEN

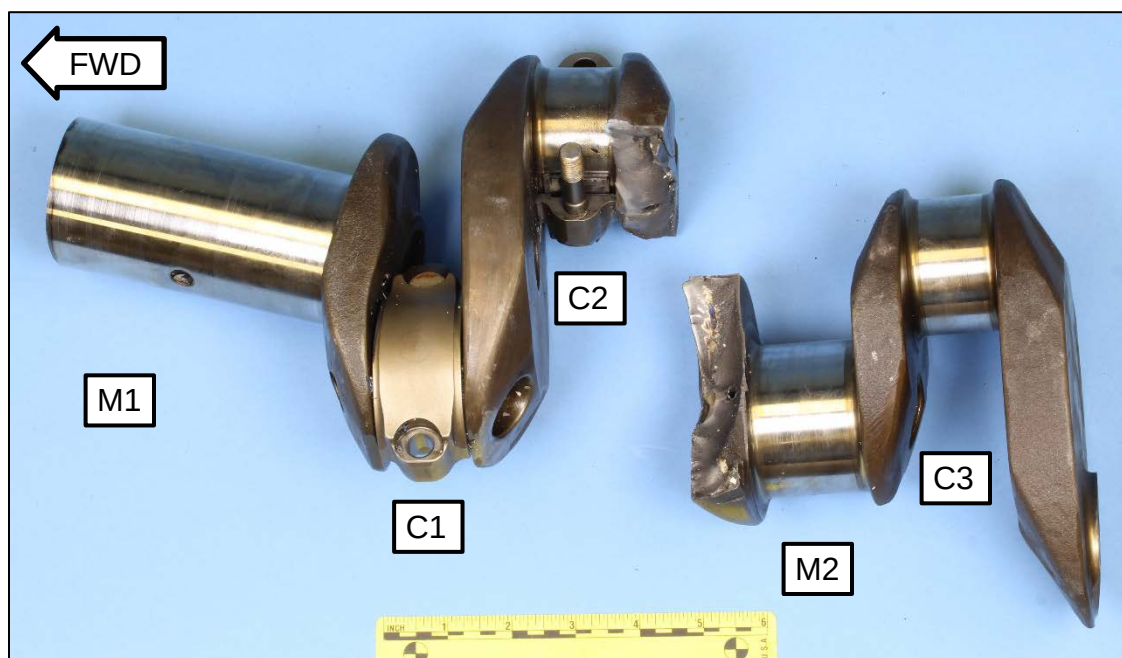
An overall view of the submitted crankshaft pieces from a Lycoming O-540-A1D5 engine is shown in figure 1. The crankshaft had been cut through the number 4 connecting rod journal and was fractured through the cheek between the number 2 main journal (labeled M2 in figure 1) and the number 2 connecting rod journal (labeled C2 in figure 1). The cheek between the number 1 main journal and the number 1 connecting rod journal was bent aft.

A close view of the fracture surface on the aft piece is shown in figure 1. Fracture features had a uniform matte gray appearance across most of the fracture surface consistent with ductile overstress fracture. Near the surfaces, the fracture surface had a smooth flat appearance consistent with overstress fracture through a hardened surface layer. Secondary cracks were observed in the cheek surface adjacent to the fracture as shown in figure 2 consistent with bending overstress fracture in a surface-hardened steel. All fracture features and deformation observed were consistent with bending overstress fracture with no evidence of preexisting damage.

Figure 1. Overall view of the submitted crankshaft pieces (above) with a closer view of the fracture surface on the aft piece (right).

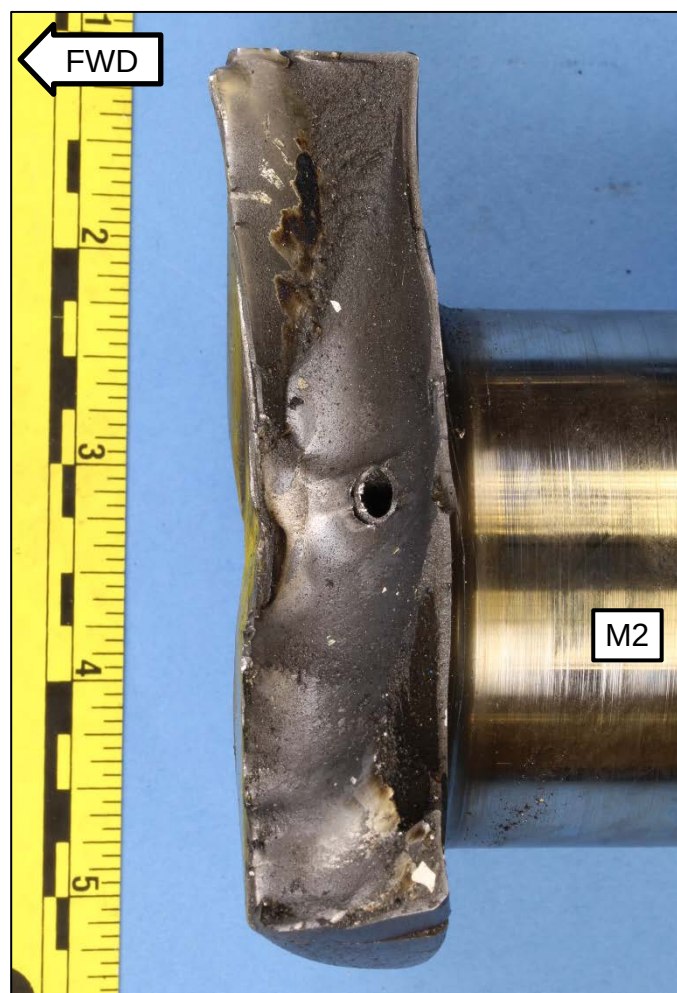
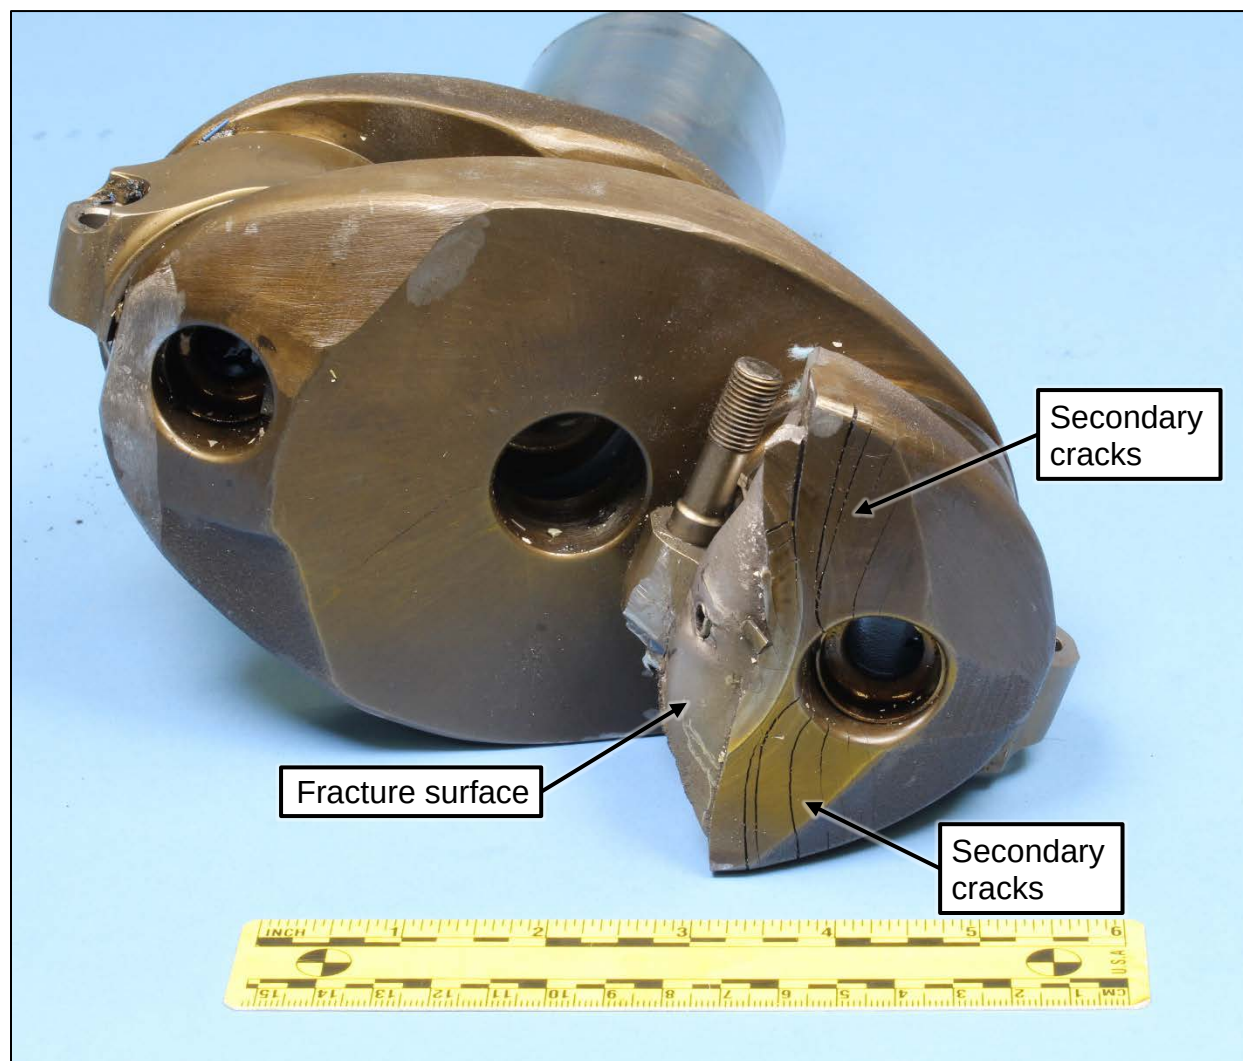
Figure 2. Fracture surface in the forward piece viewed looking forward showing secondary cracks in the cheek adjacent to the fracture surface.
