### NATIONAL TRANSPORTATION SAFETY BOARD Office of Aviation Safety Washington, DC 20594

#### SUMMARY OF AIRCRAFT EXAMINATION

-- CEN20FA032 --

Aircraft: N4602B, Cessna 208B (s/n 208B0140)

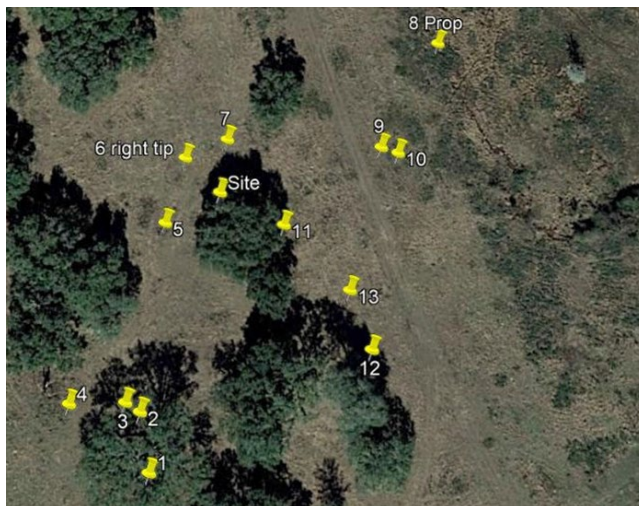
The accident aircraft impacted flat terrain in a nearly vertical attitude and came to rest inverted on a 240° magnetic heading.

The propeller hub was buried about 5 ft deep into clay soil and the airplane was highly fragmented, with remnants of the fuel tank and engine tubing located 225 ft from the main wreckage.
