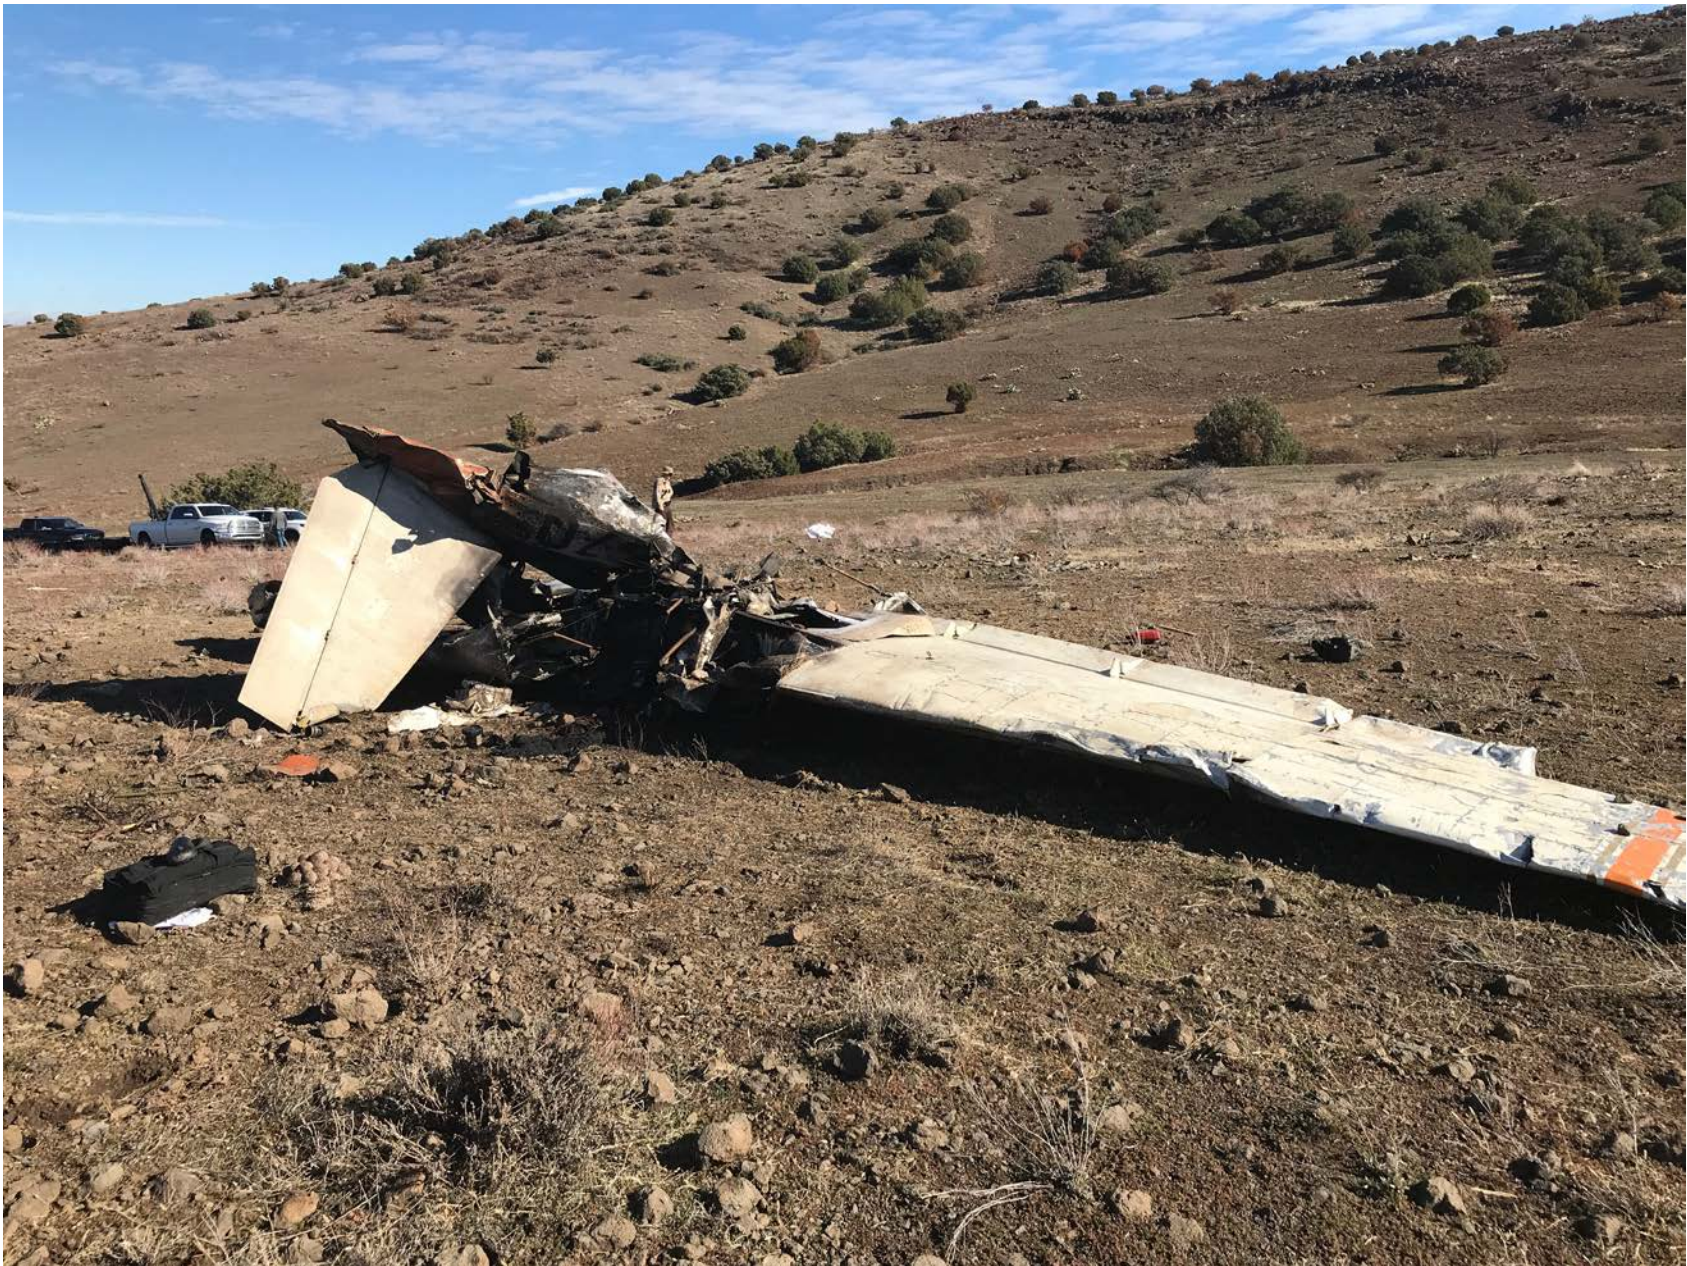
**Photo 1 – View of main wreckage looking toward the northeast**

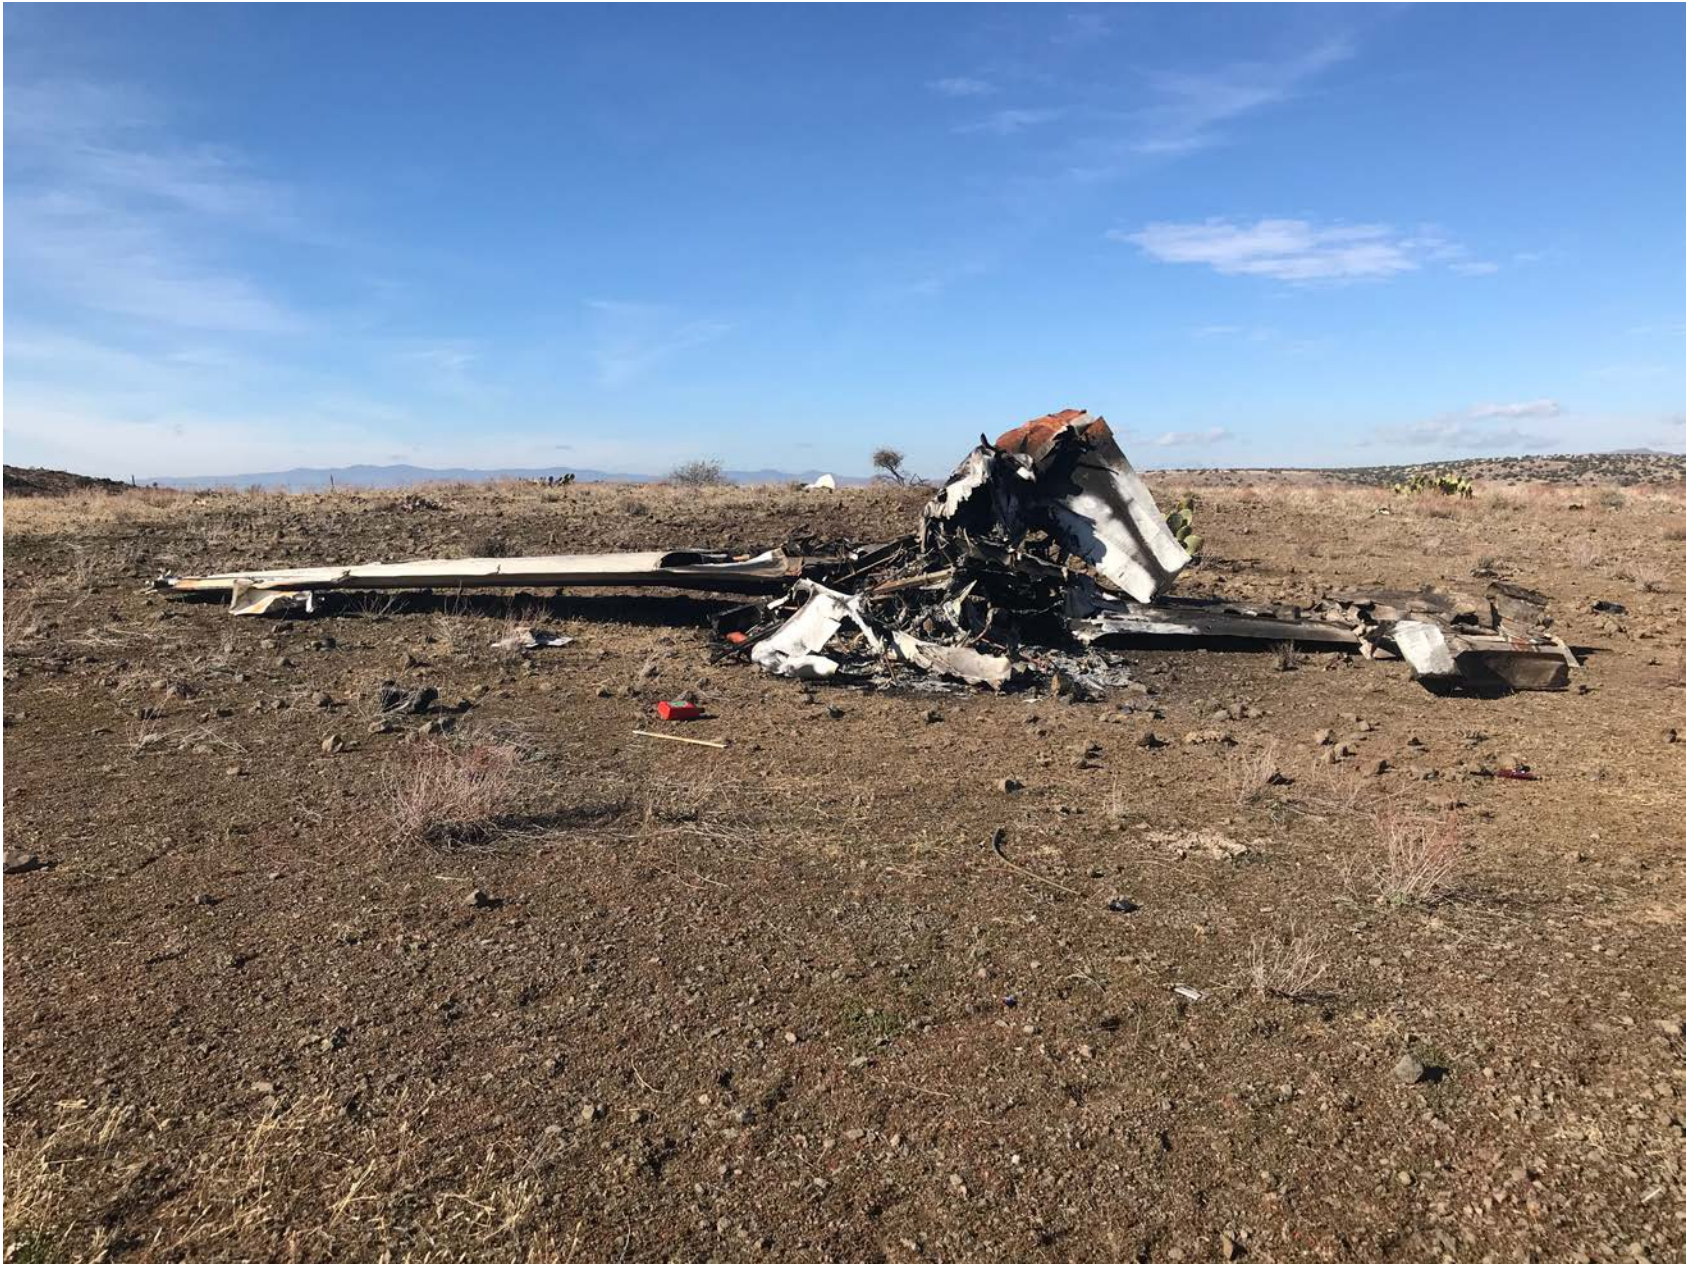
**Photo 2 – View of main wreckage looking toward the west**

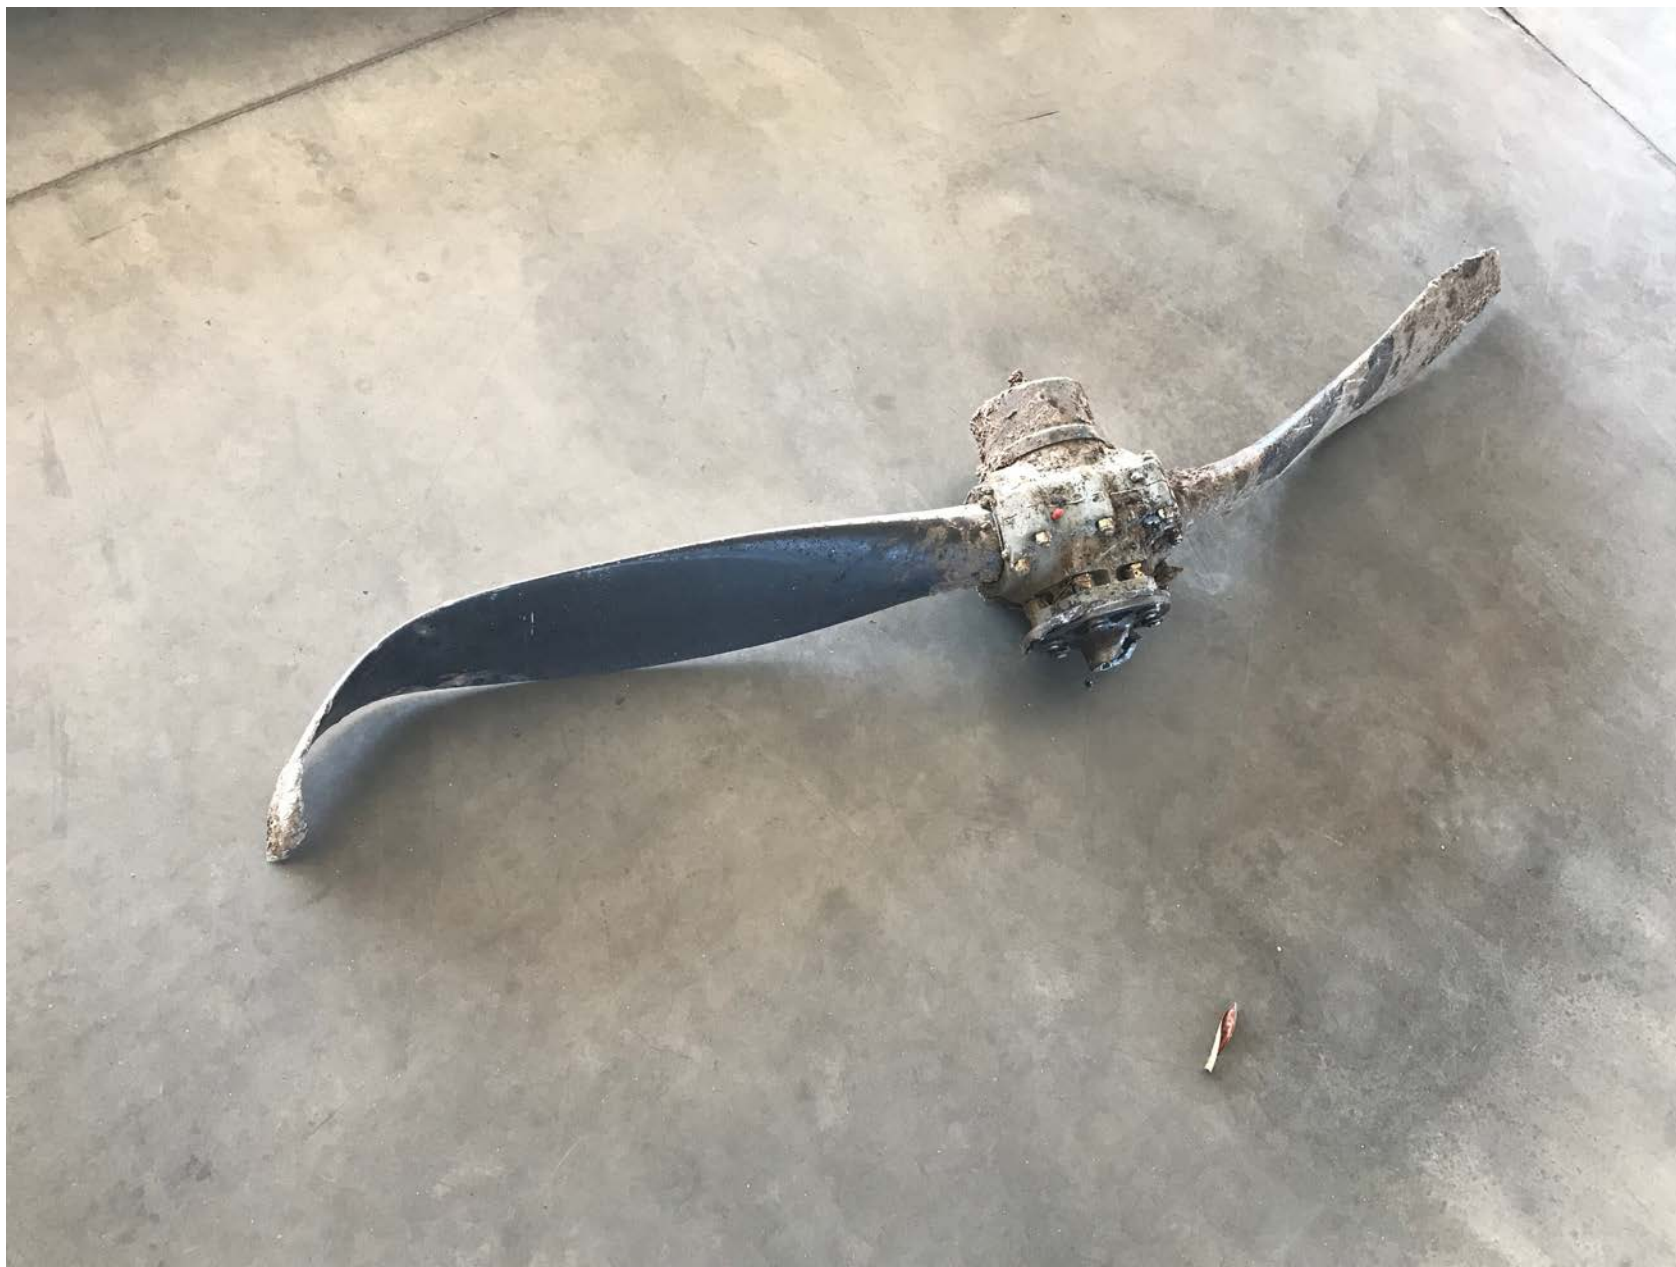
**Photo 3 – View of propeller during post-scene examination**

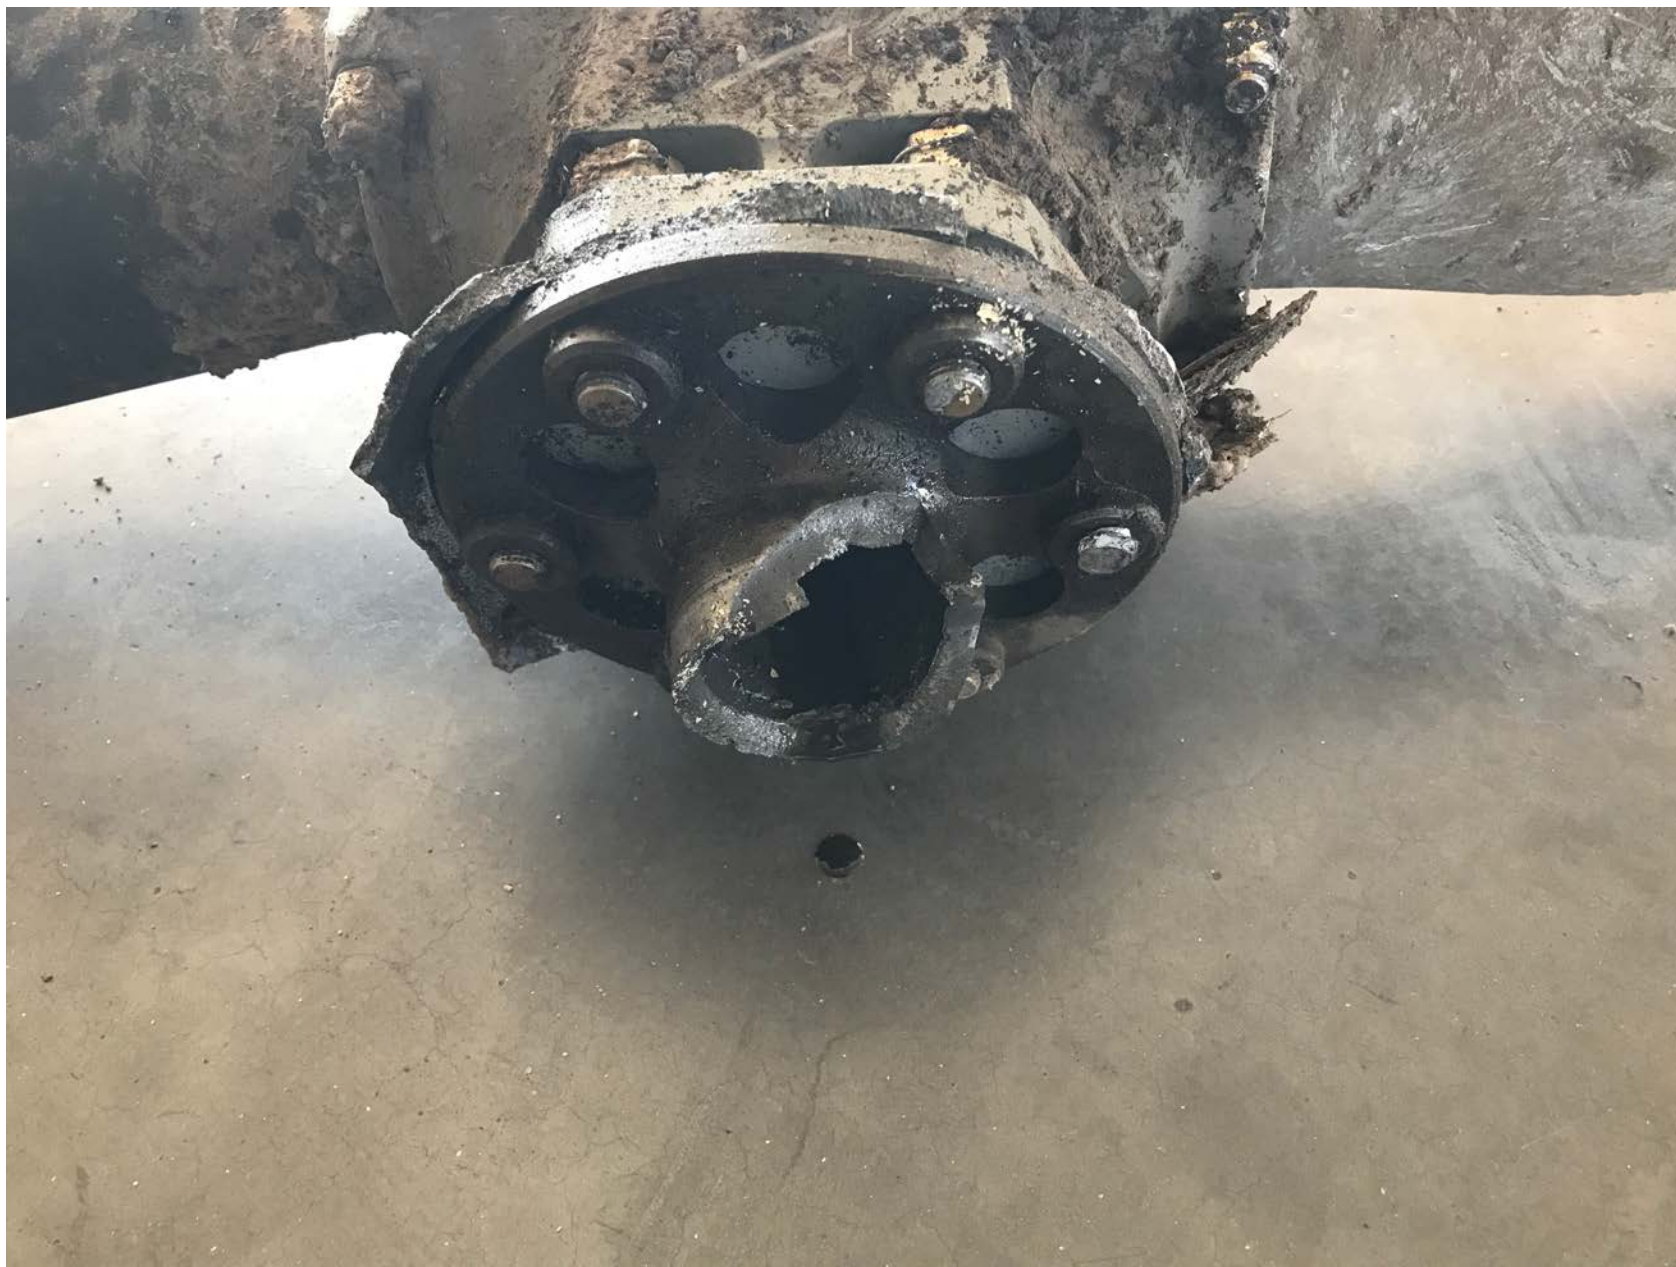
**Photo 4 – View of crankshaft flange during post-scene examination**

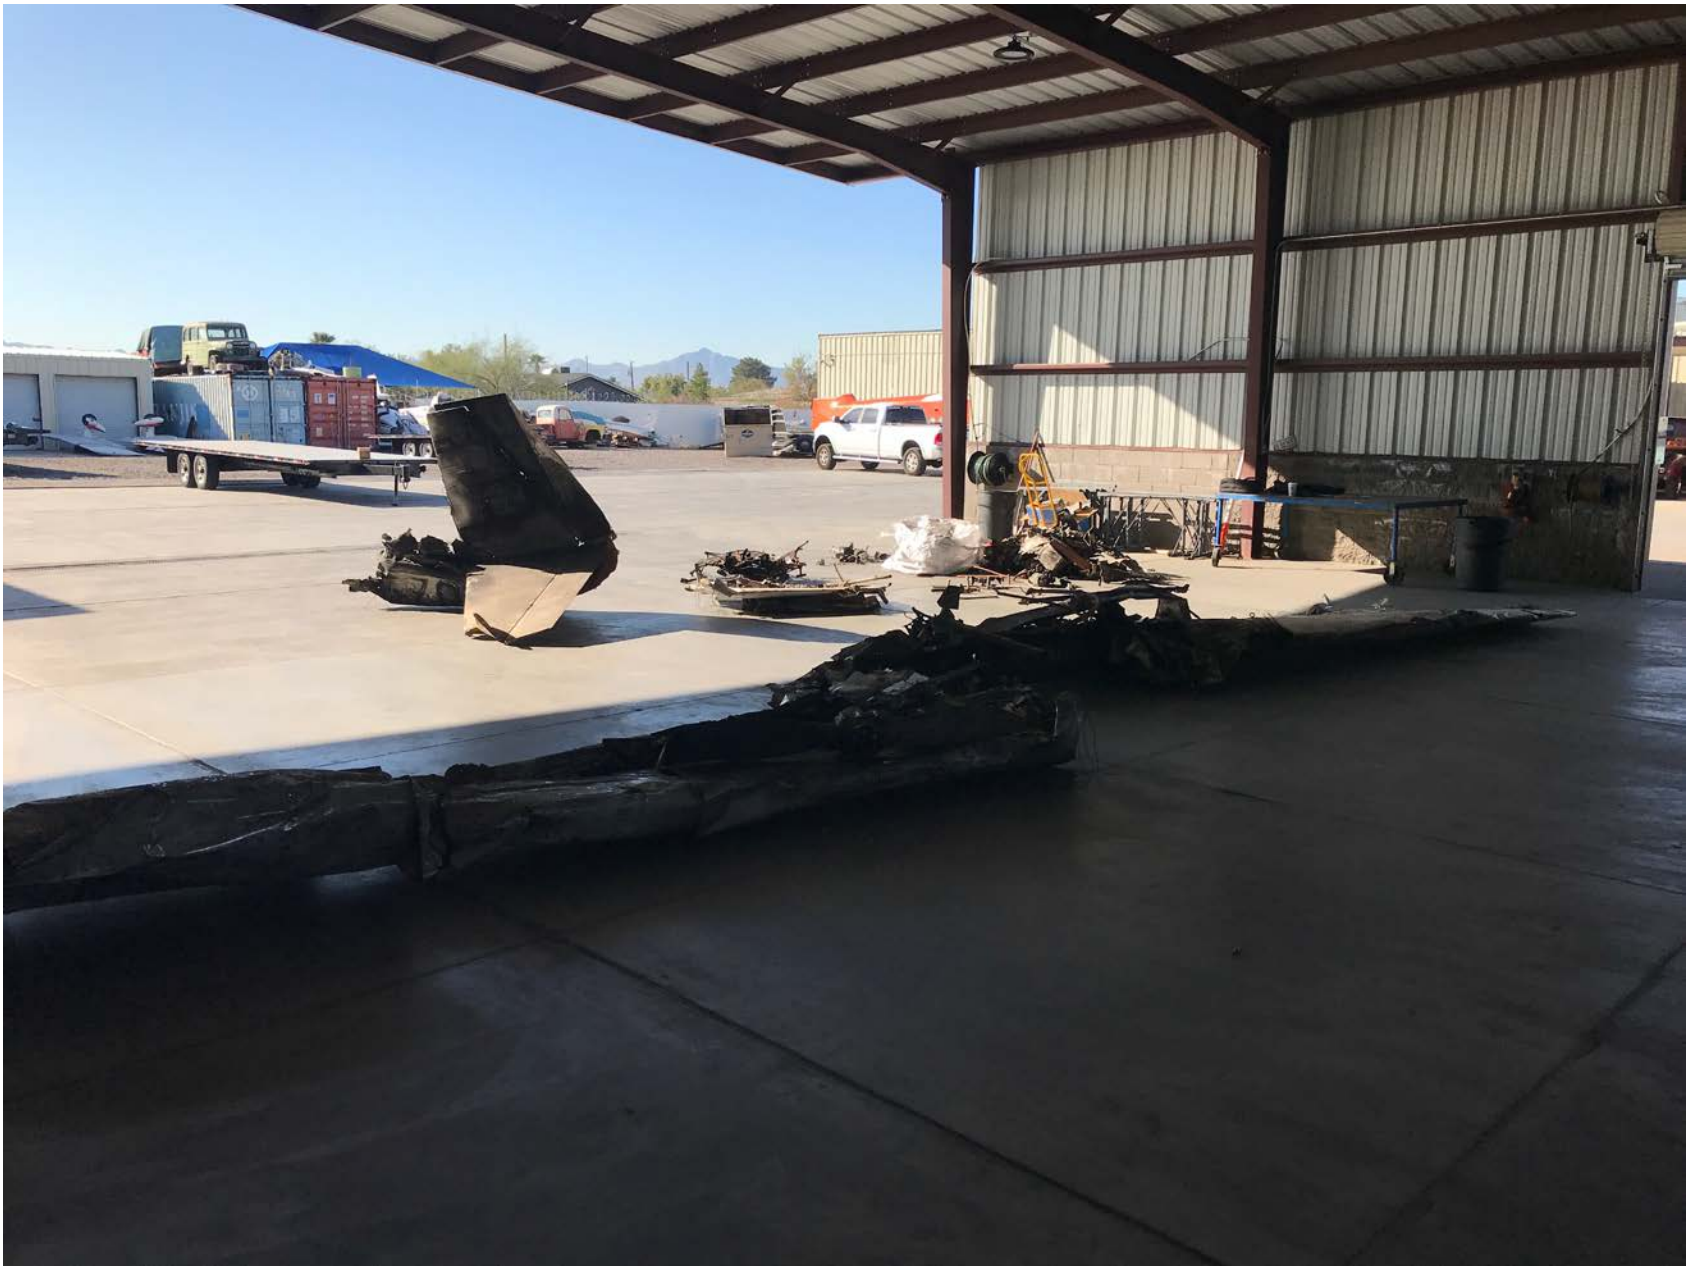
**Photo 5 – Overall view of the wreckage during post-scene examination**

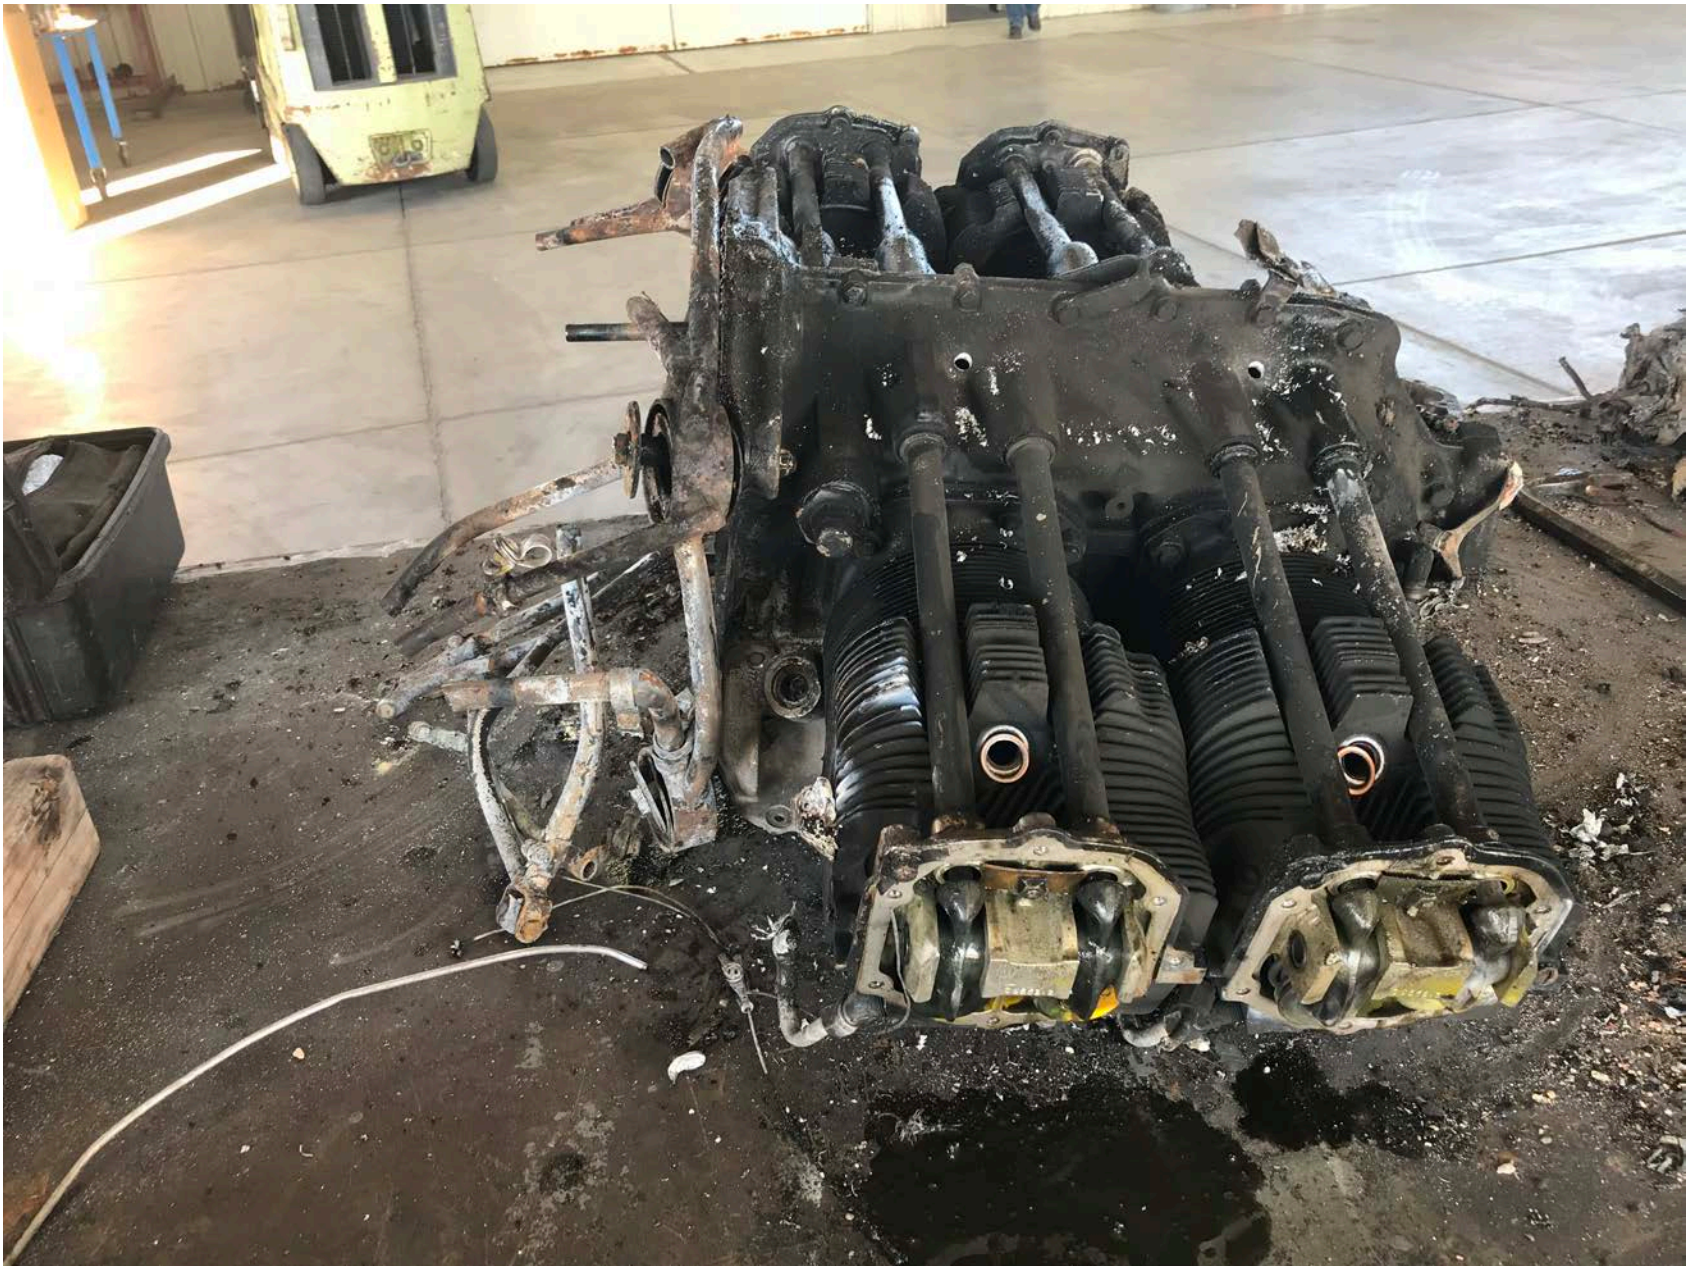
**Photo 6 – View of engine during post-scene examination**
