**NATIONAL TRANSPORTATION SAFETY BOARD**  
**Office of Aviation Safety**  
**Washington, D.C. 20594**

**AIRWORTHINESS GROUP CHAIRMAN'S FACTUAL REPORT**

**NTSB No: CEN20FA035**

Operator: Panther Helicopters, Inc.  
Aircraft: Bell 407, Registration N79LP  
Location: Gulf of Mexico  
Date: December 7, 2019  
Time: 0917 central standard time

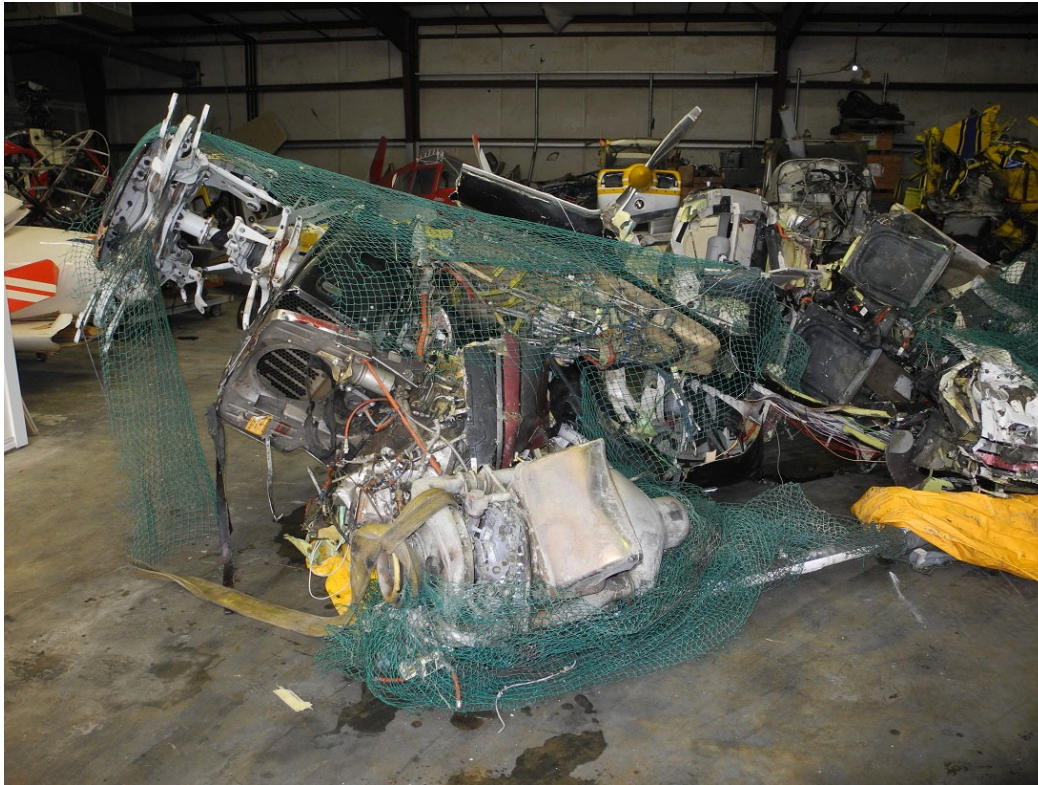
The main fuselage was fractured, folded, and twisted in multiple locations, but remained together via wiring as well as netting from the shrimp trawler (**Figure 1**). The cockpit and a portion of the cabin, containing the rear-facing seats, were present. The left and right cockpit seats remained attached to the airframe hard points and the restraints in both seats remained buckled.

**Figure 1. The recovered helicopter wreckage.**

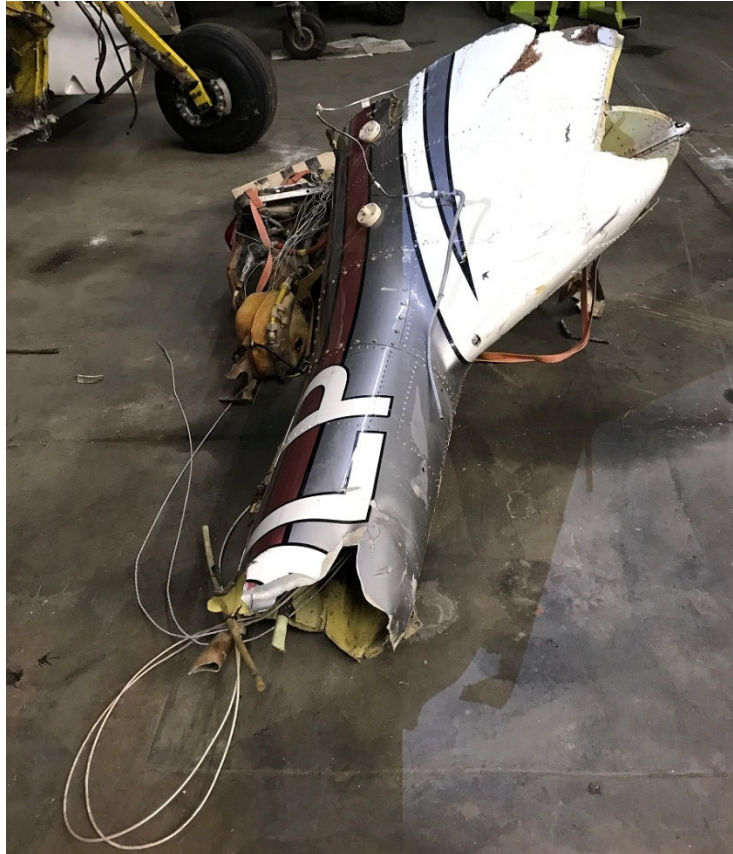
The forward portion of the tail boom remained connected to the intermediate fuselage but was fractured at the tail boom tube structure at the painted registration marks (**Figure 2**). The engine oil reservoir was partially attached to the intermediate fuselage. The drain plug and oil filler cap were not installed on the reservoir but remained attached via ball chain. No residual oil was observed within the reservoir. The oil cooler blower and radiator remained attached to the intermediate fuselage. The blower could not be manually rotated. The remainder of the tail boom, including the vertical and horizontal stabilizers, was not recovered.

**Figure 2. The separated section of intermediate fuselage and tail boom.**

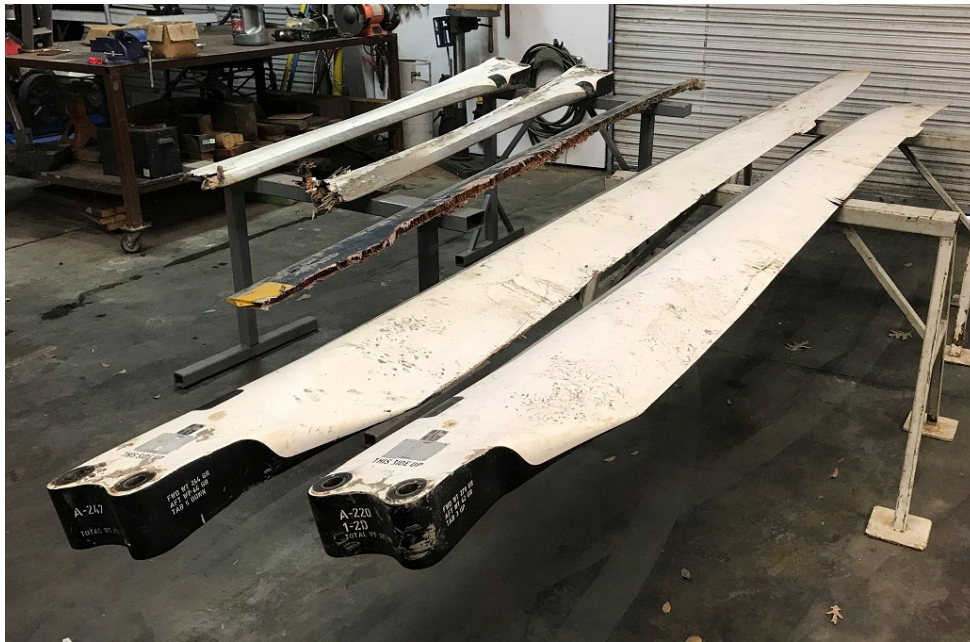
Two of the four main rotor blades did not exhibit fragmentation and were generally whole (**Figure 3**). For the remaining two main rotor blades, only their inboard sections, from the blade attachment bolt bores outboard about 72-74 inches, were recovered. The inboard sections of these blades did not exhibit fragmentation. An outboard section of a blade, about 113 inches in length up to the blade tip end, was recovered; this section was missing the majority of its afterbody.

**Figure 3. The recovered main rotor blades.**

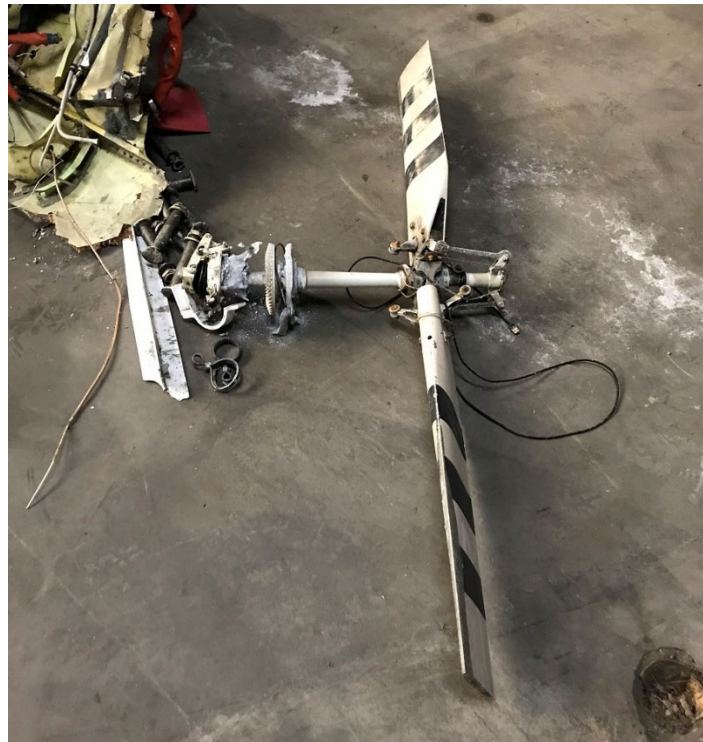
The two tail rotor blades remained attached to the yoke (**Figure 4**). The tail rotor blades did not exhibit fragmentation and were generally whole. Each of the two tail rotor PCLs were whole and remained attached to their respective tail rotor blade and the pitch change spider. The input control lever remained installed, but the input rod end tube was fractured and separated.

**Figure 4. The recovered tail rotor and tail rotor gearbox.**

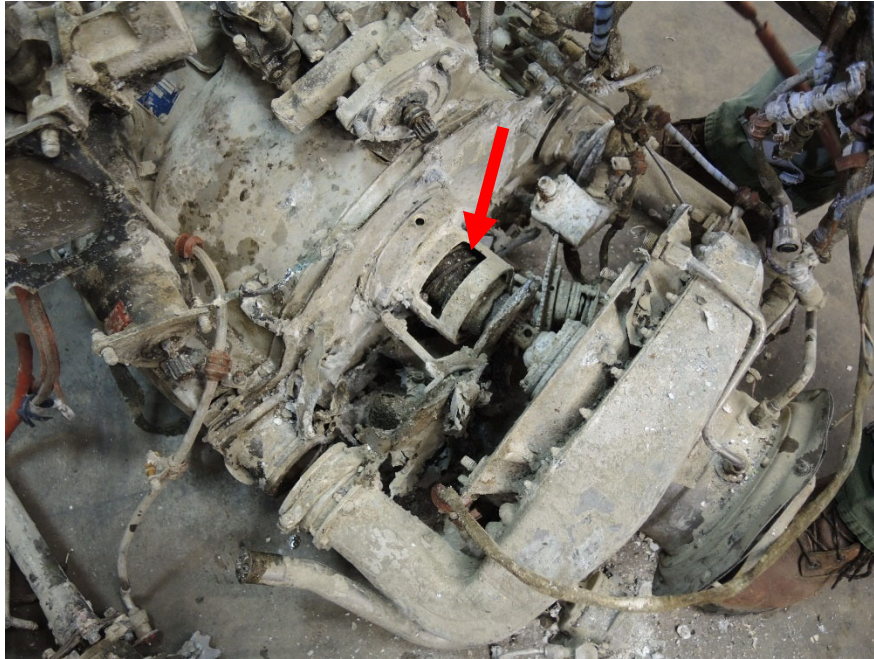
**Figure 6. A view of the area where the engine accessory gearbox housing is normally present. The red arrow points to the area of the power turbine pinion gear and the Nos. 3 and 4 roller bearings.**

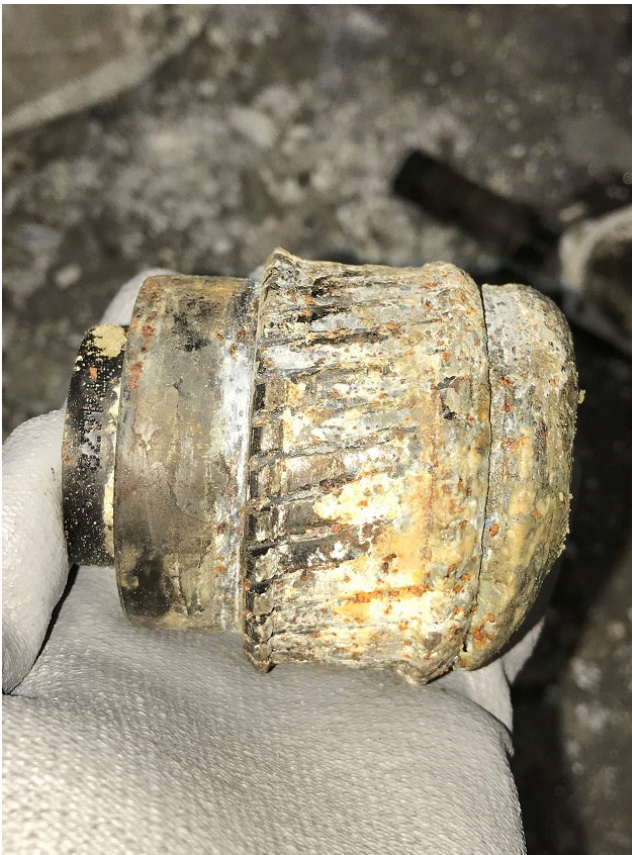
**Figure 7. The recovered power turbine pinion gear exhibited smearing damage.**

Examination of the power turbine pinion gear<sup>15</sup> revealed evidence of fatigue fractures on six consecutive gear teeth. The fatigue fractures originated on the drive side tooth root fillets and exhibited multiple origins. The fatigue fractures progressed toward the coast side (the non-drive and non-contact side) of the gear tooth. No dimensional anomalies were observed at the fracture origins or the gear tooth root surfaces adjacent to the origins. All pinion gear teeth exhibited circumferential rubbing and smearing. The Nos. 3 and 4 bearing journals, on the power turbine pinion gear, also exhibited circumferential rubbing damage and thermal distress, with the No. 3 bearing journal showing substantial deformation and material loss compared to the No. 4 bearing journal. Analysis of the material composition and core microstructure of the power turbine pinion gear, away from areas of thermal distress, showed they met drawing requirements.

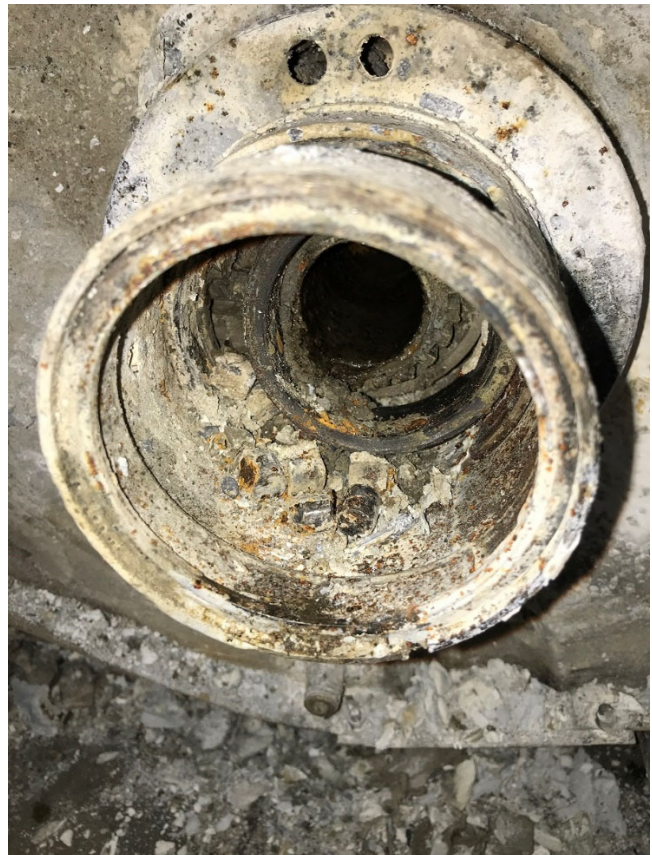
**Figure 8. Roller elements from the No. 4 bearing found in the bearing support housing.**

The No. 4 bearing outer ring exhibited material removal on its roller path and circumferential rubbing on the aft shoulder corner. Transferred material and roller impressions were observed on the raceway of the inner ring. The inner ring's forward shoulder also exhibited deformation in the forward direction. The inner diameter of the inner ring exhibited circumferential rubbing and transferred material. The outer ring's raceway and forward shoulder corner, the roller diameters, and the inner ring exhibited thermal distress. The recovered rollers all exhibited a circumferential rub step on one end. Analysis of the material composition of the outer ring, inner ring, and rollers met drawing requirements. Microstructure analysis away from the area of thermal distress was only able to be accomplished on the outer ring and a representative roller. The microstructure for both components met drawing requirements.

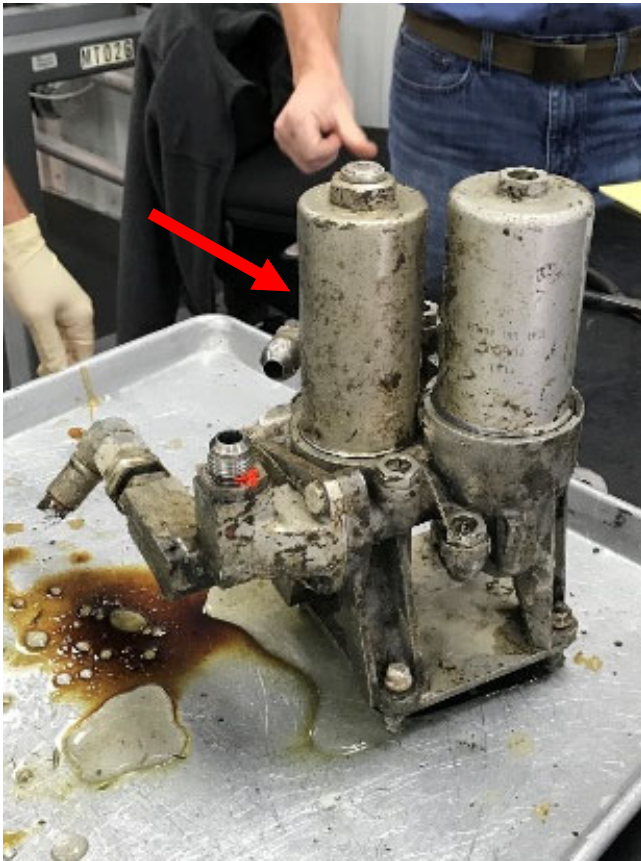
**Figure 9. The recovered CEFA. The red arrow points to the scavenge oil filter assembly.**

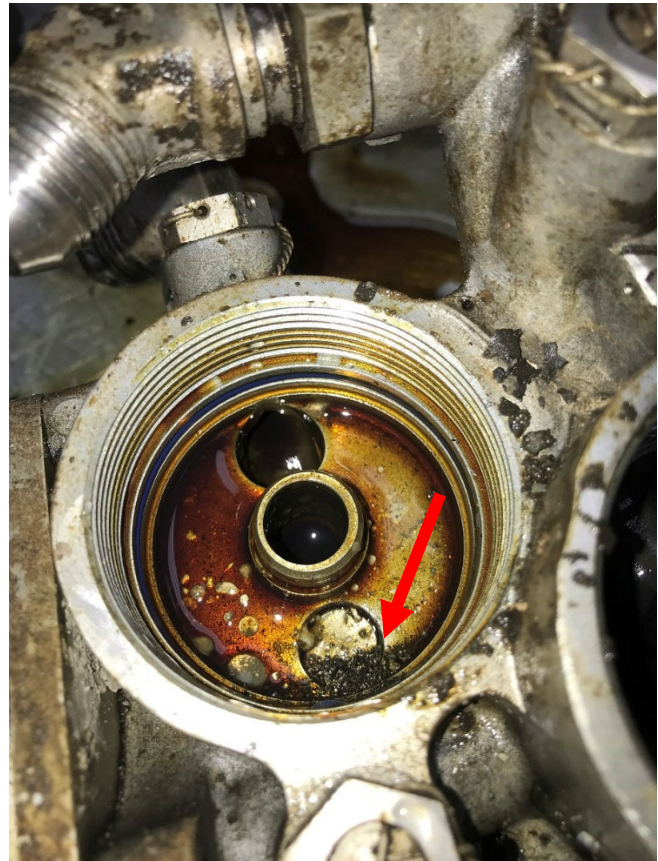
The combined engine filter assembly (CEFA), which is an engine-mounted assembly for fuel and scavenge oil filtration, was separated from the wreckage. The CEFA's oil filter bypass indicator had not extended, consistent with the filter not in bypass mode (**Figure 9**). Residual oil and fuel, along with salt water, were present in the CEFA, including the filter bowls. The fuel filter element was removed and no debris was observed. The scavenge oil filter element was removed and magnetic debris was found on the filter element and its filter bowl (**Figure 10**).

**Figure 10. Magnetic debris (red arrow) found in the scavenge oil filter housing of the CEFA.**

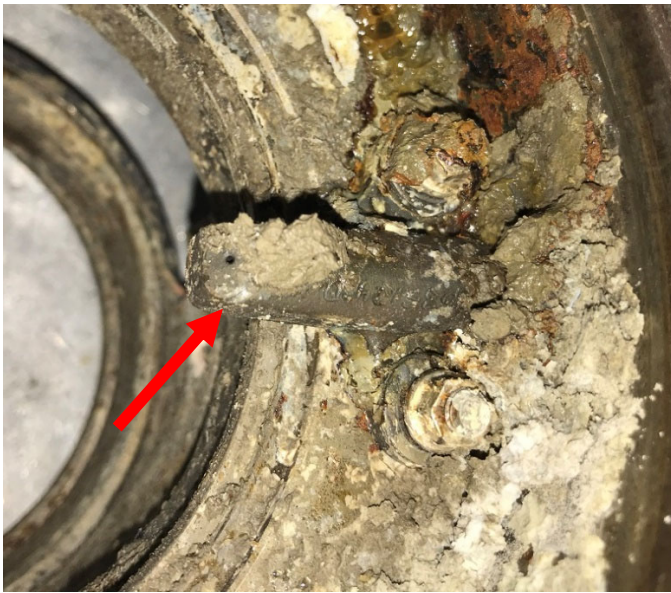
**Figure 11. The oil nozzle (red arrow) located on the Nos. 3 and 4 bearing support housing.**

The CT scan of the oil nozzle for the Nos. 4 and 5 bearings showed material deposits on the internal passageway walls and all of its oil jets appeared to be blocked. The oil nozzle was sectioned in multiple locations for further analysis. The oil nozzle material was consistent with drawing requirements. The blockage material was consistent with byproducts of aluminum (oil nozzle) corrosion and dirt. Additionally, fine metallic particles observed within the deposits was consistent with an iron-based alloy, as well as byproducts of magnesium corrosion. A representative iron-based alloy particle was measured to be about 0.0028 inches long.

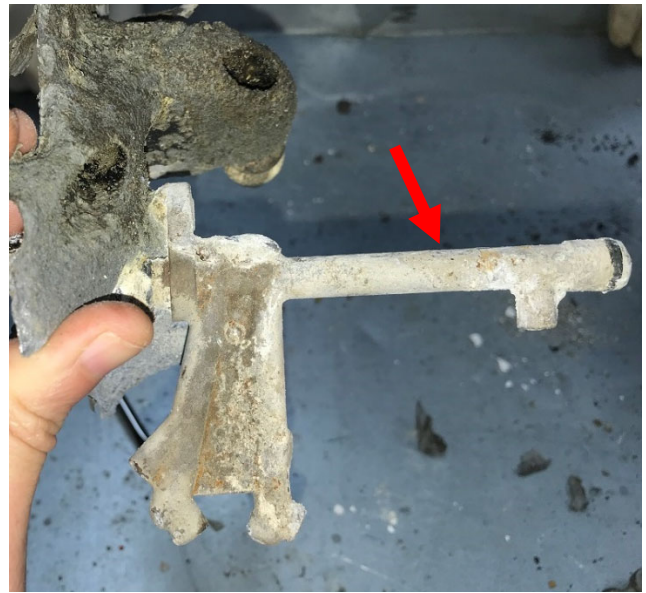
**Figure 12. The recovered oil delivery tube (red arrow).**

The CT scan of the piccolo tube showed material deposits on the internal passageway walls and all of its oil jets appeared to be blocked. Additionally, material was observed within the oil screen of the remnant gearbox housing material attached to the piccolo tube. The piccolo tube was sectioned in multiple locations to analyze the tube, the remnant gearbox housing material, and deposits within the tube. The oil delivery tube and gearbox housing material were consistent with

drawing requirements. The deposits within the oil jets were consistent with byproducts of aluminum (piccolo tube) corrosion and dirt. Additionally, fine metallic particles observed in the deposits were consistent with an iron-based alloy. A representative iron-based alloy particle was measured to be about 0.0008 inches long. Material seen within the oil screen was consistent with byproducts of magnesium (gearbox housing) corrosion.

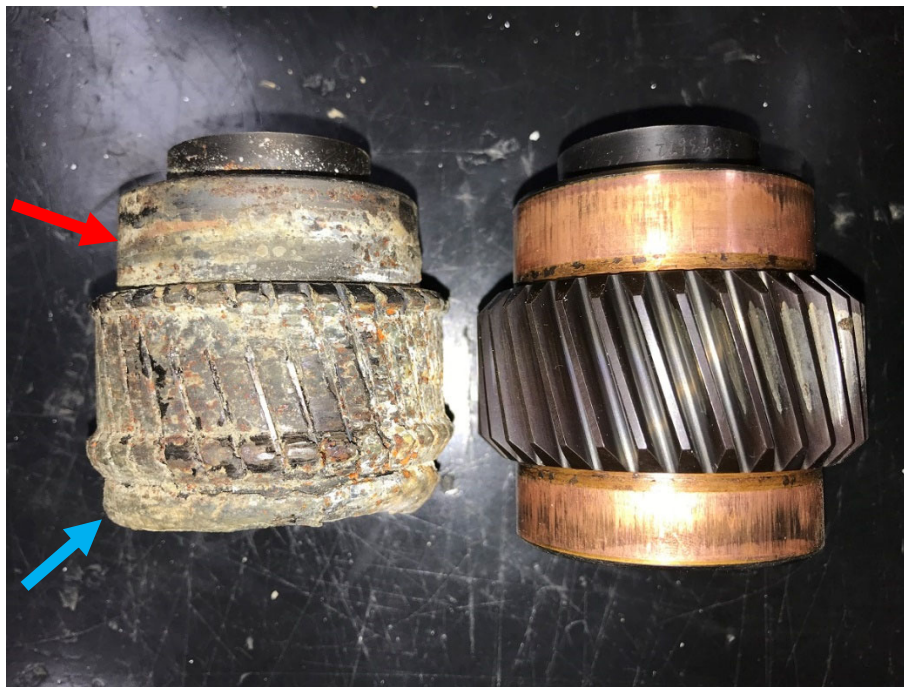
**Figure 13. A comparison of the recovered power turbine pinion gear (left) and an exemplar power turbine pinion gear (right). The blue arrow points to the No. 3 bearing shoulder and the red arrow points to the No. 4 bearing shoulder.**

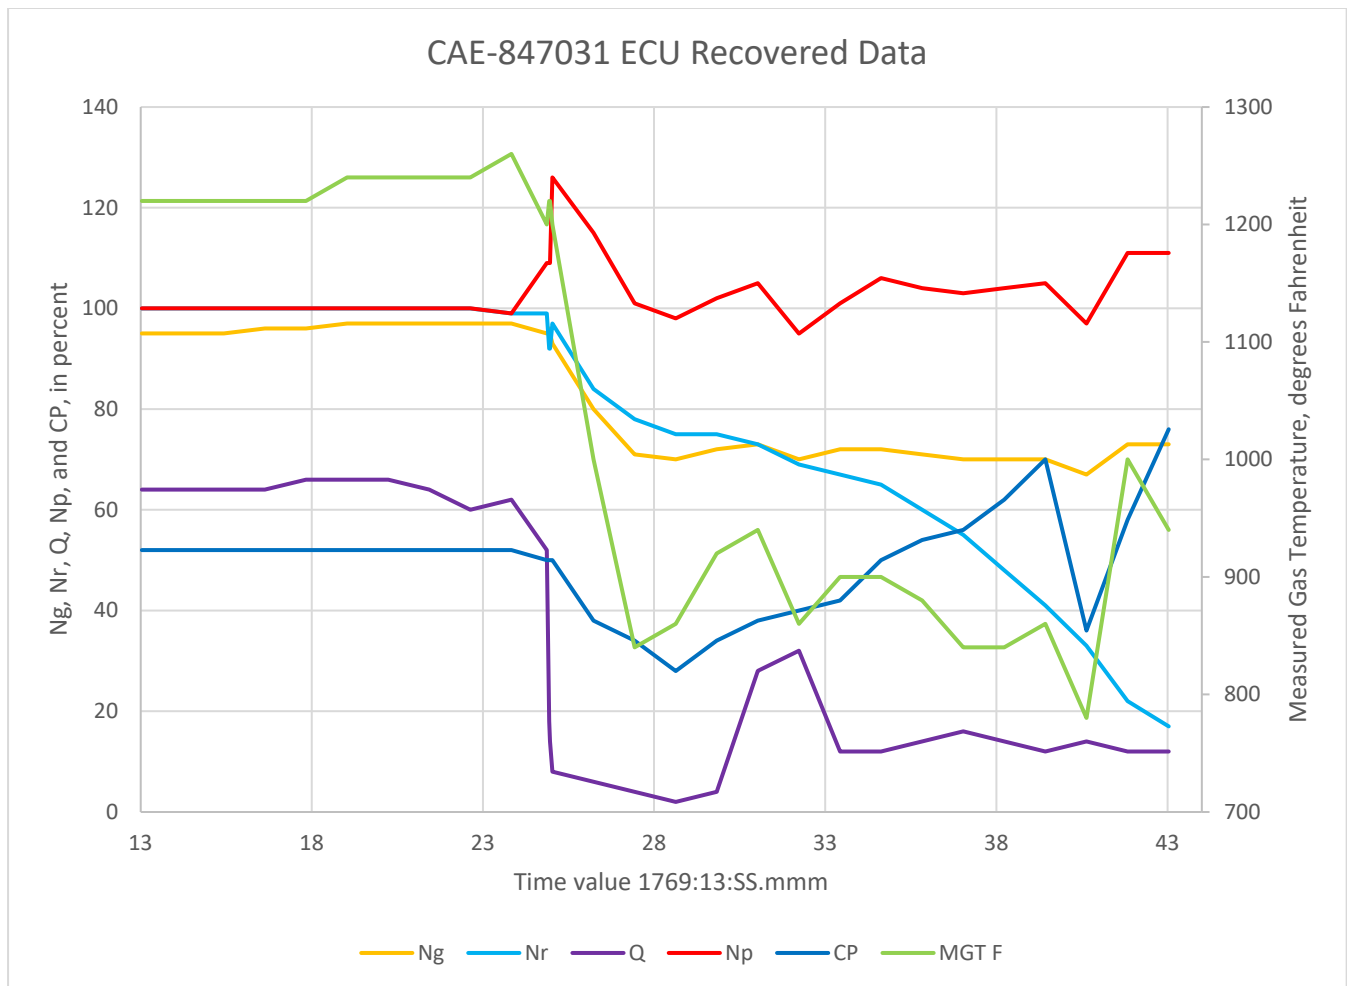
**Figure 13. Graph of the recovered data from the ECU.**  
**(Q=torque; CP=collective position; MGT F = measured gas temperature in Fahrenheit)**
