| <b>Rolls-Royce</b> | Rolls-Royce Corporation<br>450 S. Meridian Street<br>Indianapolis, Indiana<br>46225-1103, USA | <b>REPORT NO.</b><br>20FAE-014-PR | <b>REV.</b><br>Initial | <b>PAGES</b><br>1 of 135 |
| <b>TITLE</b><br><br><b>METALLURGICAL INVESTIGATION OF A HELICAL POWER TURBINE PINION GEAR, P/N 6893672, INSTALLED IN AN M250-C47B ENGINE, S/N CAE847031, OPERATED BY PANTHER HELICOPTERS</b> | | <b>PREPARED</b><br><br>Signatures on file | | |

| Engine Model: | M250-C47B |
| Evaluations: | Failure Analysis |

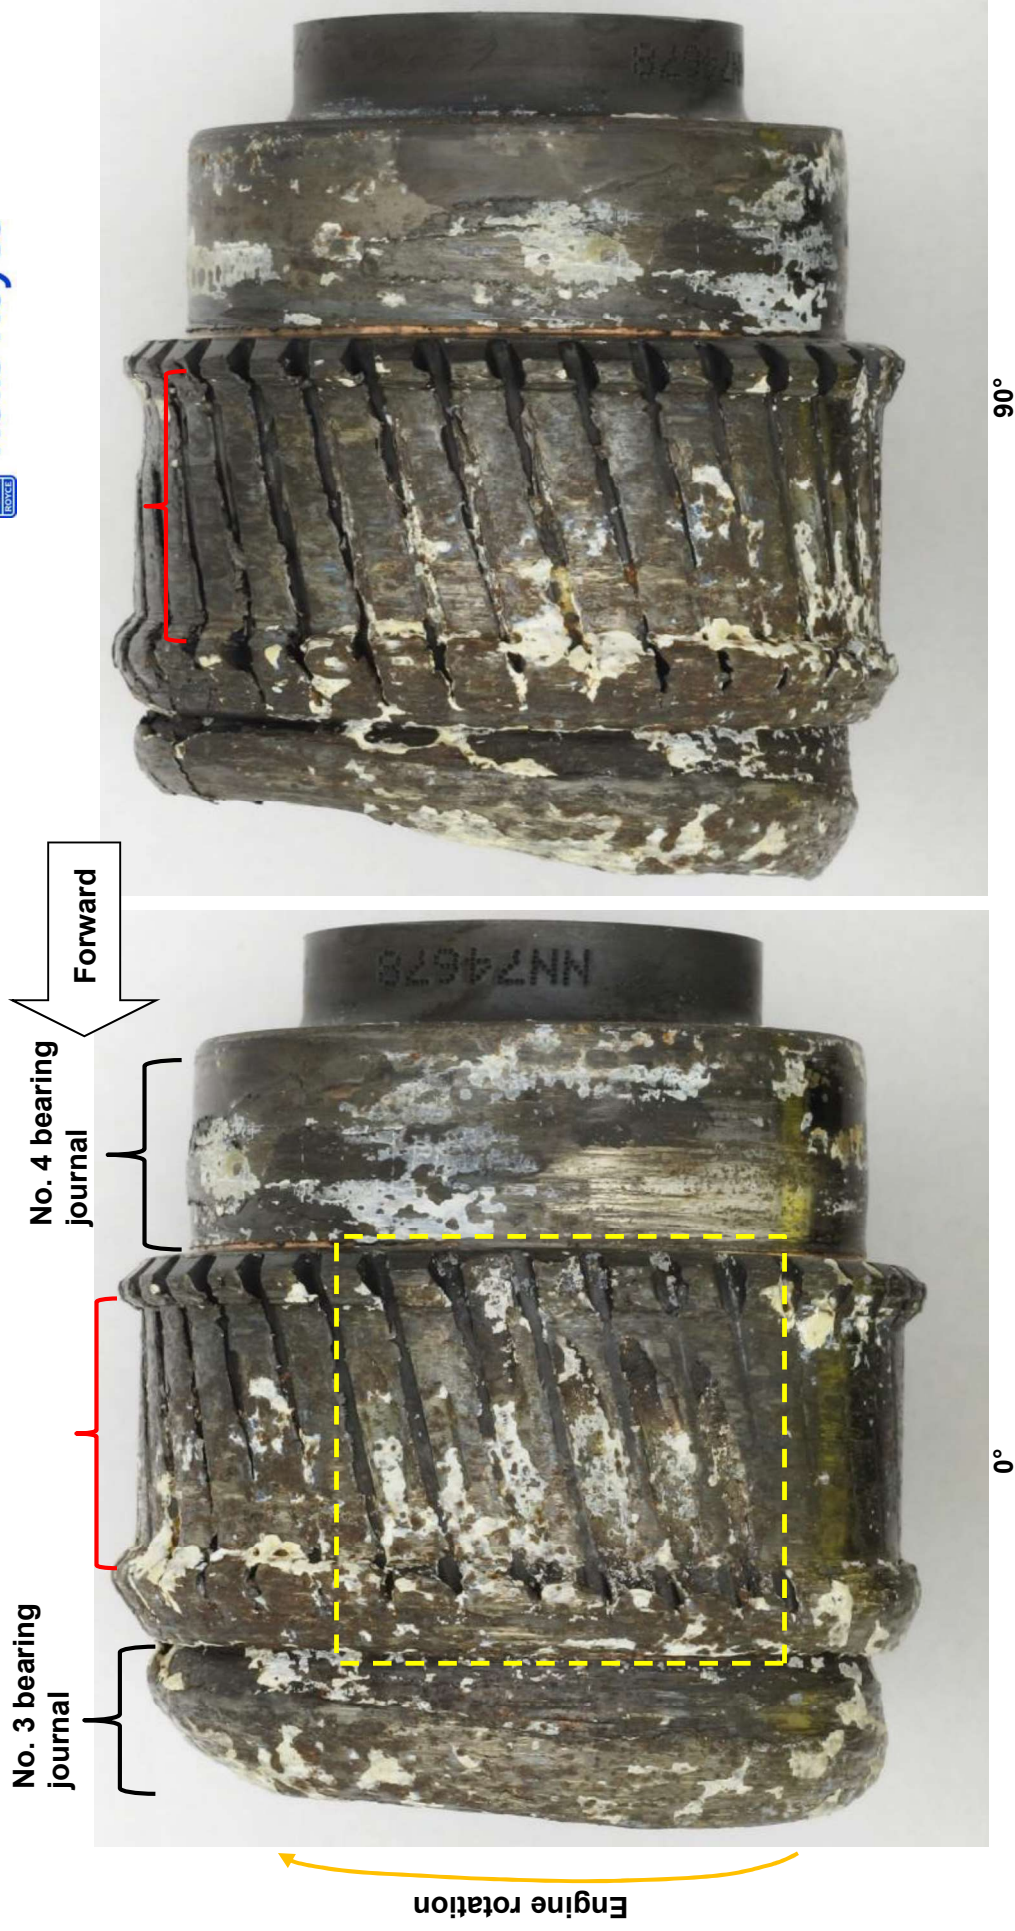
Figure 2 and Figure 3 show the general condition of the helical power turbine pinion gear after ultrasonic cleaning and manual cleaning with pumice soap in the laboratory. For the purposes of this investigation, a circumferential location was arbitrarily designated the 0° position. Other circumferential locations increased by degrees in the direction of engine rotation. The pinion gear exhibited oxidation and lighter colored deposits. All the gear teeth exhibited circumferential rub and smearing. The least severe rub damage was observed at the 90° position, and the most severe rub damage was observed at the 270° position. Six consecutive gear teeth exhibited intact fracture surfaces at the approximate 0° position, as shown in Figure 4. The No. 3 bearing journal exhibited deterioration. Figure 5 and Figure 6 show detailed views of the No. 4 bearing journal, which also exhibited circumferential rub and transferred material. Figure 7 shows a lip of aftward deformed material localized near the 270° position of the No. 4 bearing journal at the same circumferential location as the most severe rub damage on the gear teeth. The aft end of the gear teeth, the inner diameter, and the inner flange forward face exhibited circumferential rub (see Figure 8 and Figure 9). Figure 10 shows representative views of the loaded and unloaded flanks of the inner splines, which exhibited mechanical deformation on the aft end of both sides. The loaded flank on one spline exhibited a region where material had fractured away.

**Figure 2.** General condition of the helical power turbine pinion gear after cleaning. The red braces mark the location of circumferential rub and smearing on the gear teeth, the yellow boxed area is shown in more detail in Figure 4. The least severe rub damage was observed at the 90° position (right). Each image shows the part rotated ~90° from the previous.

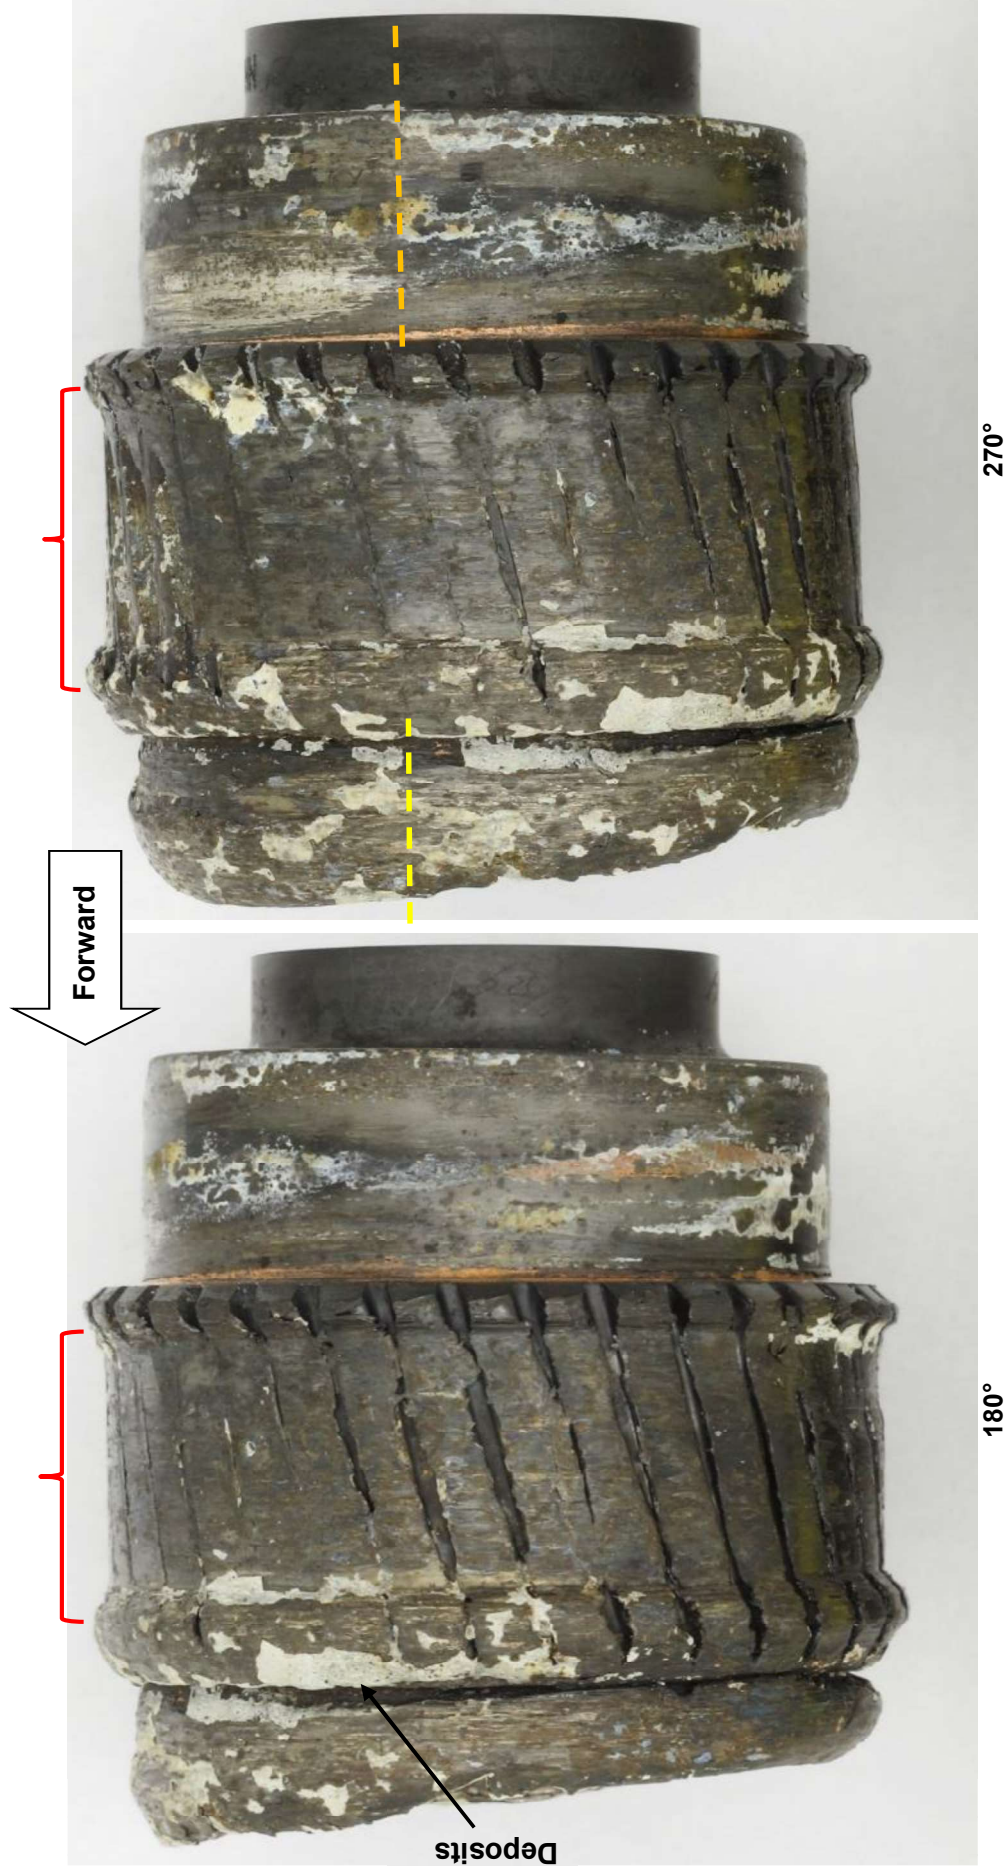
**Figure 3.** General condition of the helical power turbine pinion gear after cleaning. Red braces mark the location of circumferential rub and smearing on the gear teeth, and the yellow and orange dashed lines mark planes for metallographic evaluation (see Figure 22) The most severe rub damage was observed at the 270° position (right). Each image shows the part rotated ~90° from the previous.

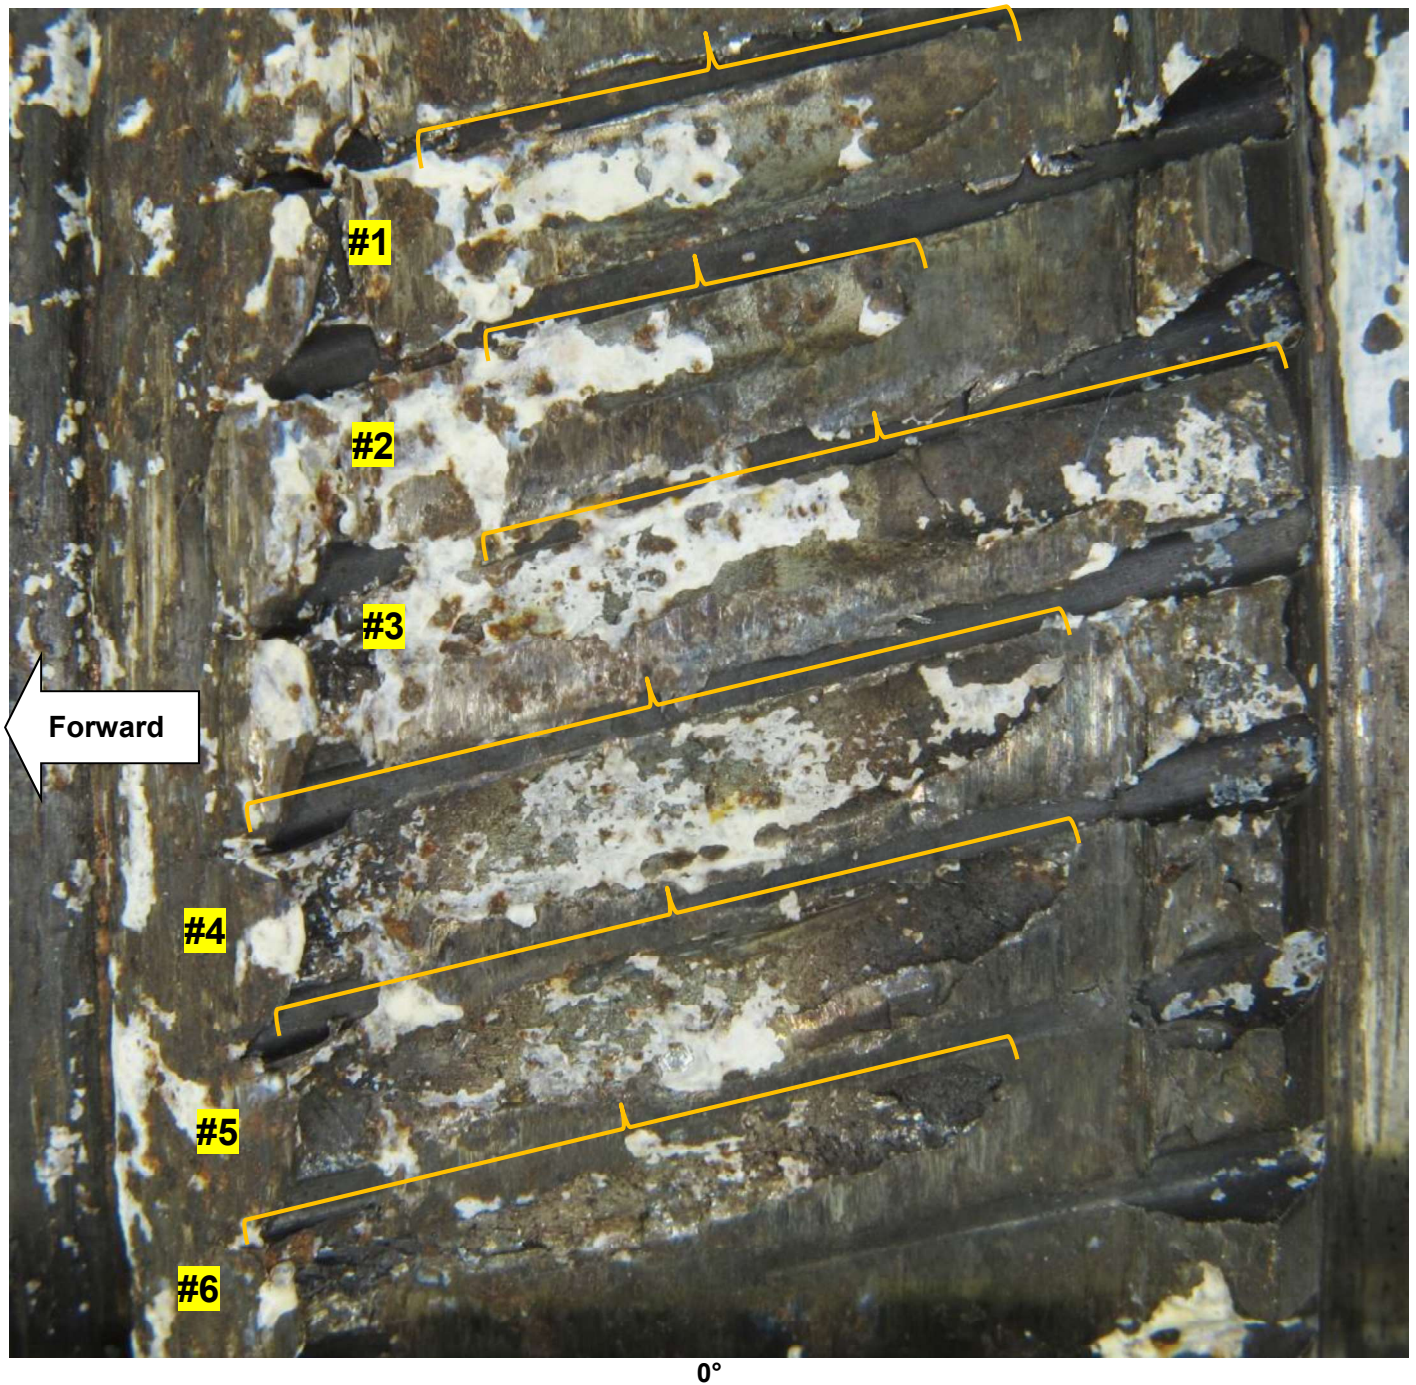
- 2.1 The helical power turbine pinion gear exhibited fatigue fractures at six consecutive gear teeth. The fractures initiated from multiple origins at the drive side tooth root fillets and progressed in fatigue towards the coast side flanks. No material or geometric anomalies were observed near the fracture origins or the adjacent tooth root surfaces. All the pinion gear teeth exhibited circumferential rub and smearing.

Figure 4. Detailed view of the gear teeth at the 0° position, which exhibited six consecutive intact fracture surfaces (orange braces).

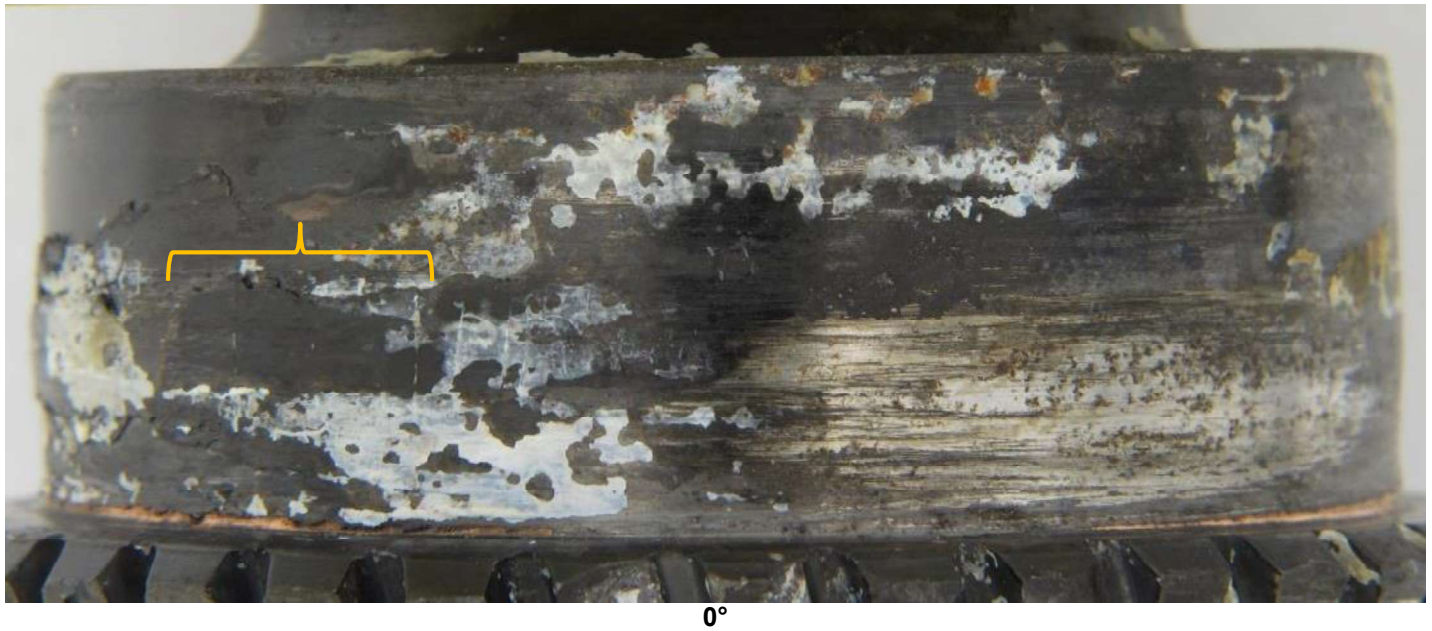
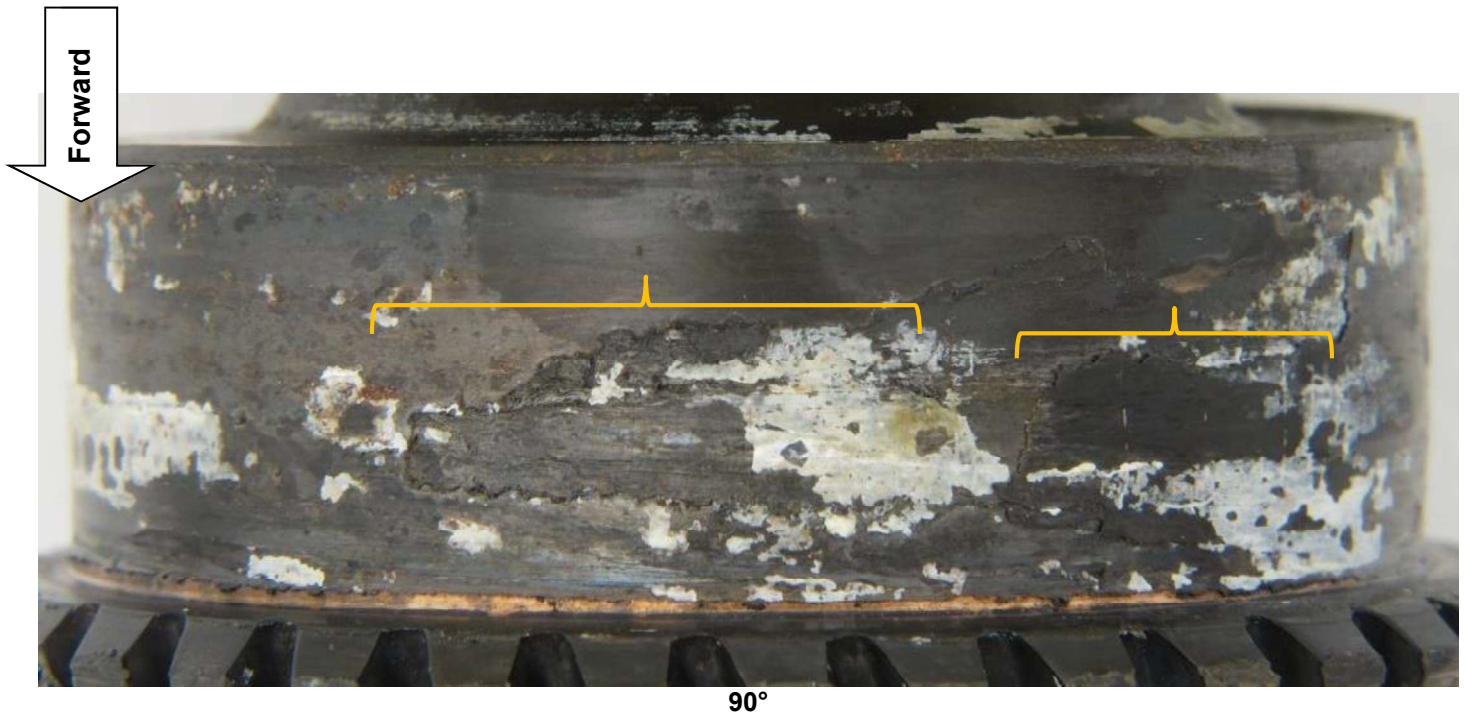
**Figure 5.** Detailed views of No. 4 bearing journal, which exhibited circumferential rub and transferred material (orange braces). Each image shows the part rotated  $\sim 90^\circ$  from the previous.

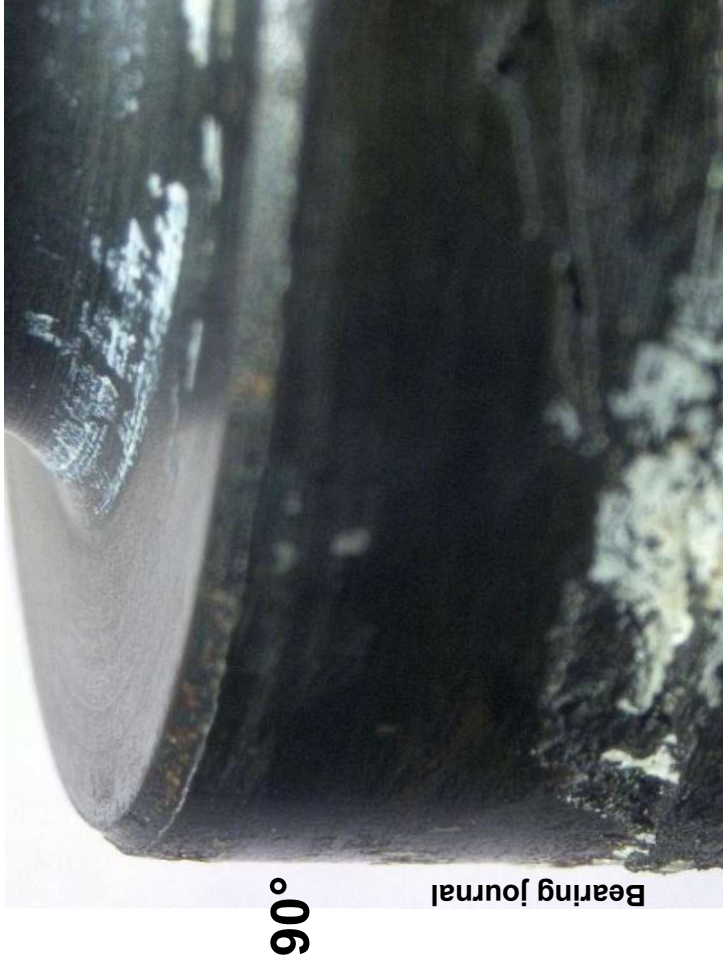
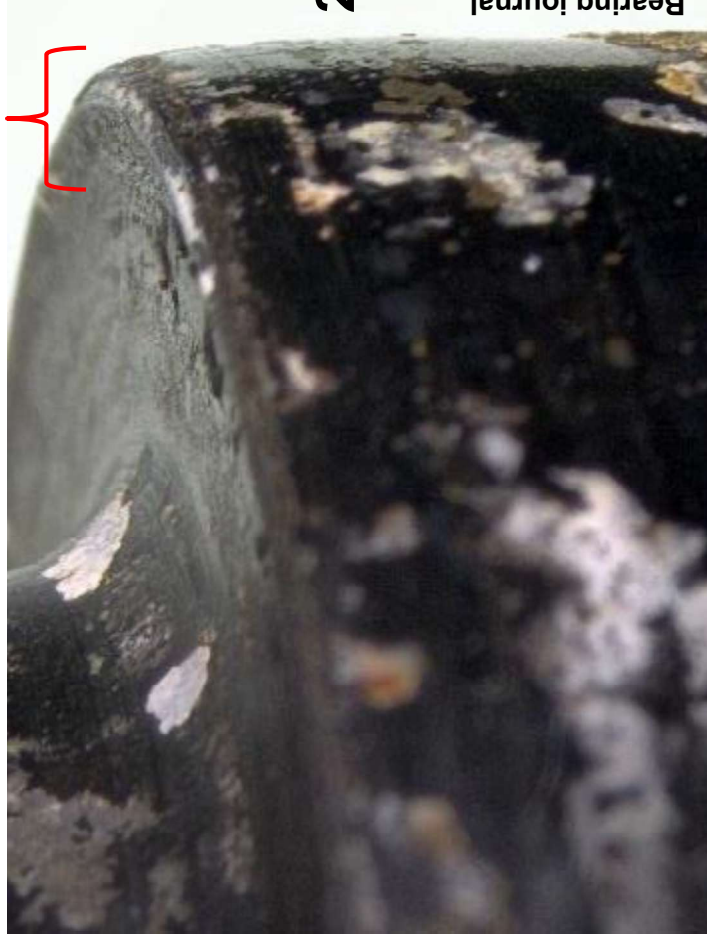
Figure 7. Detailed views of the aft end of the No. 4 bearing journal at the least severe (90° position, left image) and most severe (270° position, right image) rub damage. Red brace marks a lip of deformed material at the region of most severe journal rub damage.

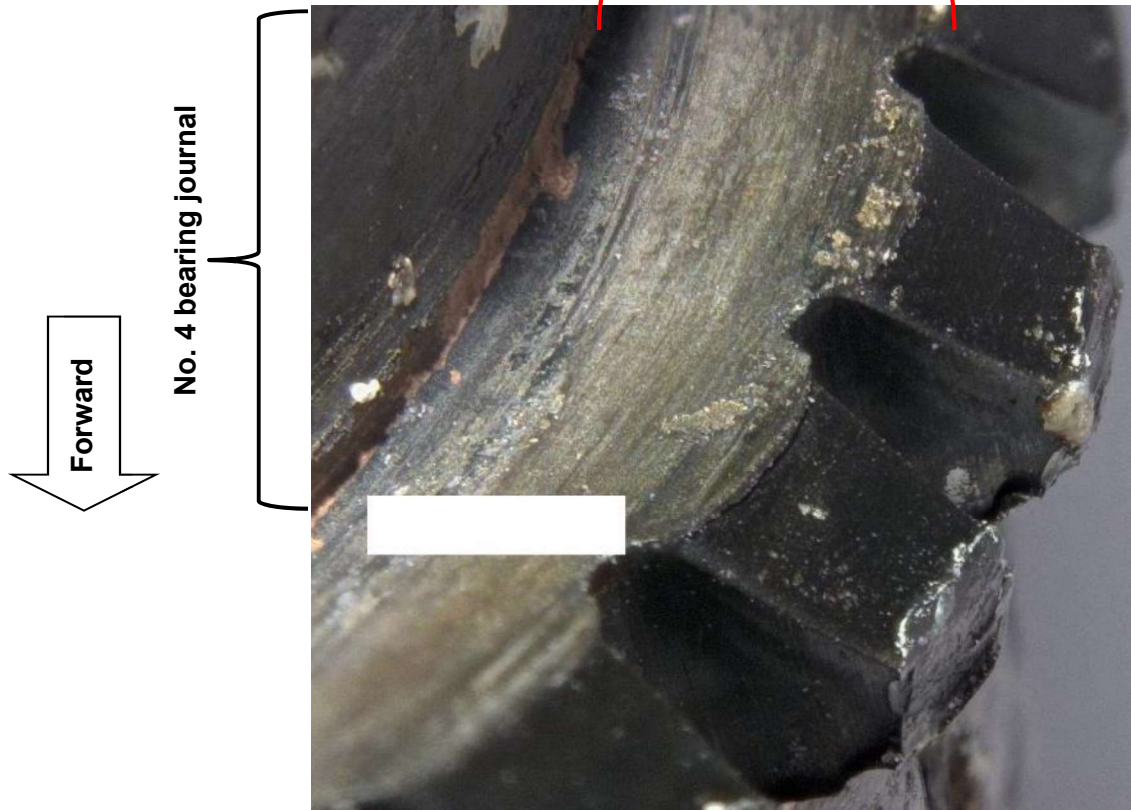
Figure 8. Detailed view of the aft end of the gear teeth, which exhibited circumferential rub (red brace).

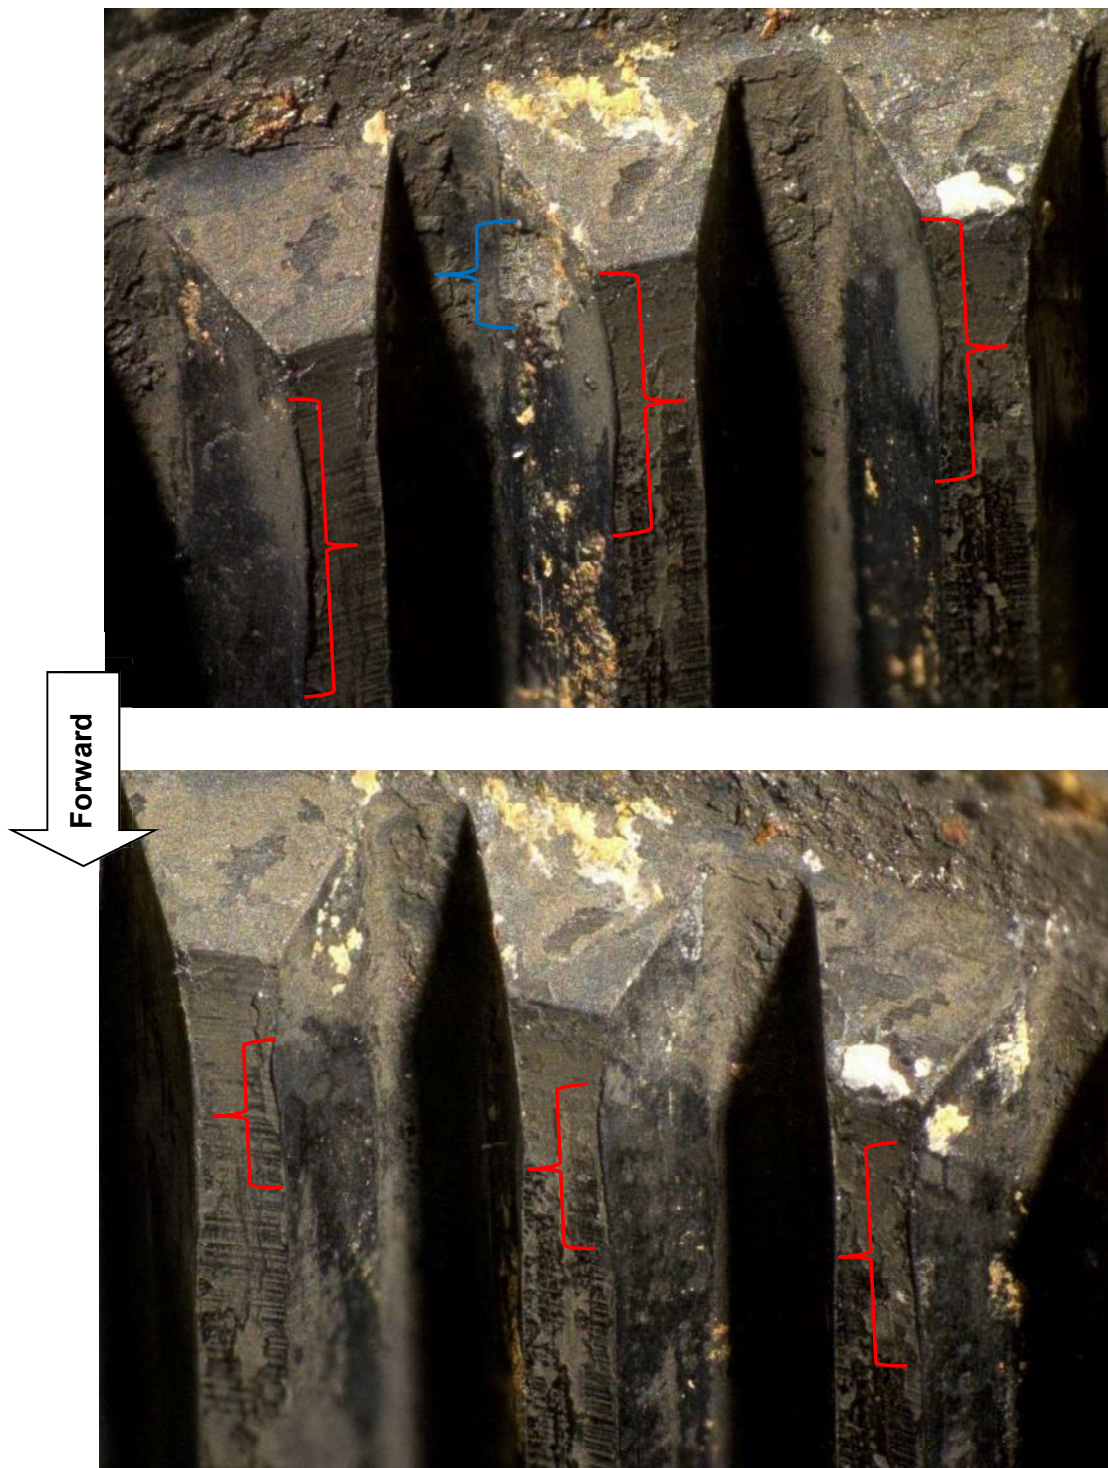
**Figure 10.** Detailed views of the loaded (top) and unloaded (bottom) flanks of the inner splines, which exhibited mechanical deformation on the aft end of both sides (red braces). The blue brace marks a region on the loaded flank on one spline where material fractured away.

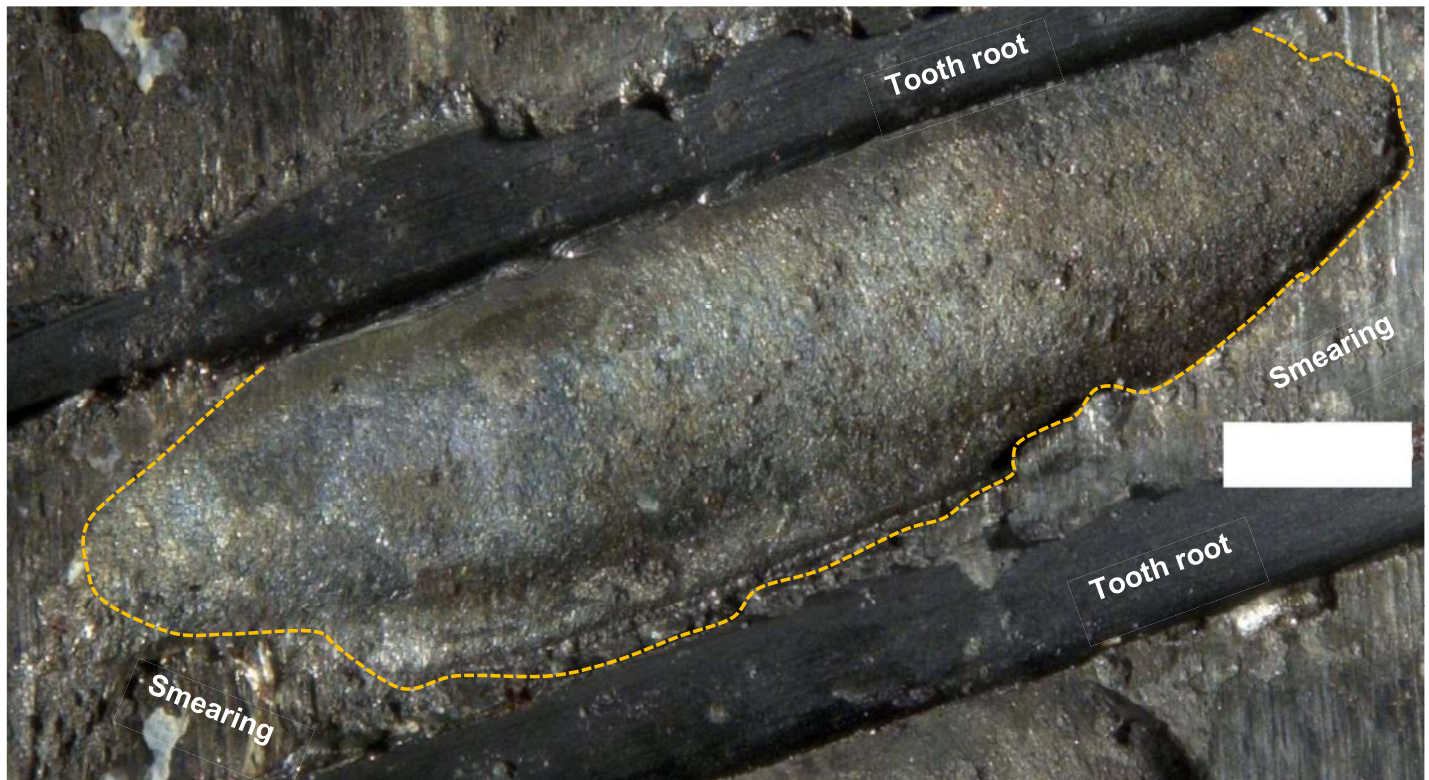
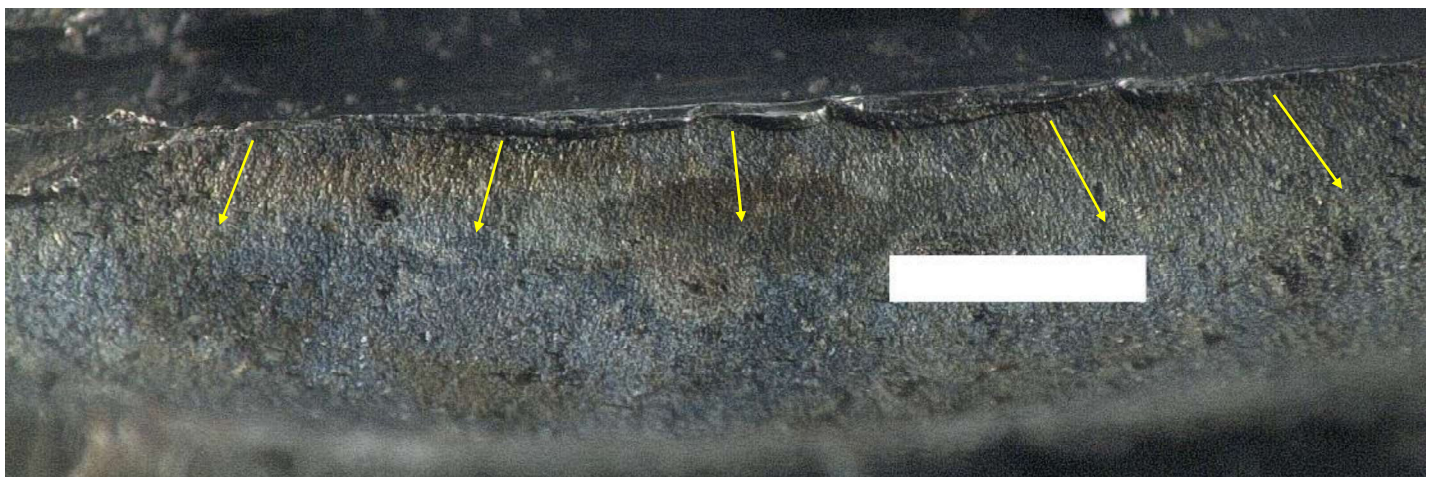
After ultrasonic cleaning and manual cleaning with pumice soap, the fracture surfaces at the gear teeth (see Figure 4) were also dry ice blasted in the laboratory to remove deposits. Figure 11 through Figure 19 show detailed views of fracture surfaces at gear teeth numbers 1 and 6. In general, the fractures progressed in fatigue from the drive side tooth root fillets towards the coast side flanks. The fracture surfaces at gear teeth numbers 2, 3, and 4 (see Figure 12, Figure 13, and Figure 16) exhibited ratchet marks, which are consistent

**Figure 11.** Detailed views of fracture surface at gear tooth number 1 after cleaning. The yellow arrows mark the direction of fatigue progression, the orange dotted line marks the transition from fatigue to smearing damage.

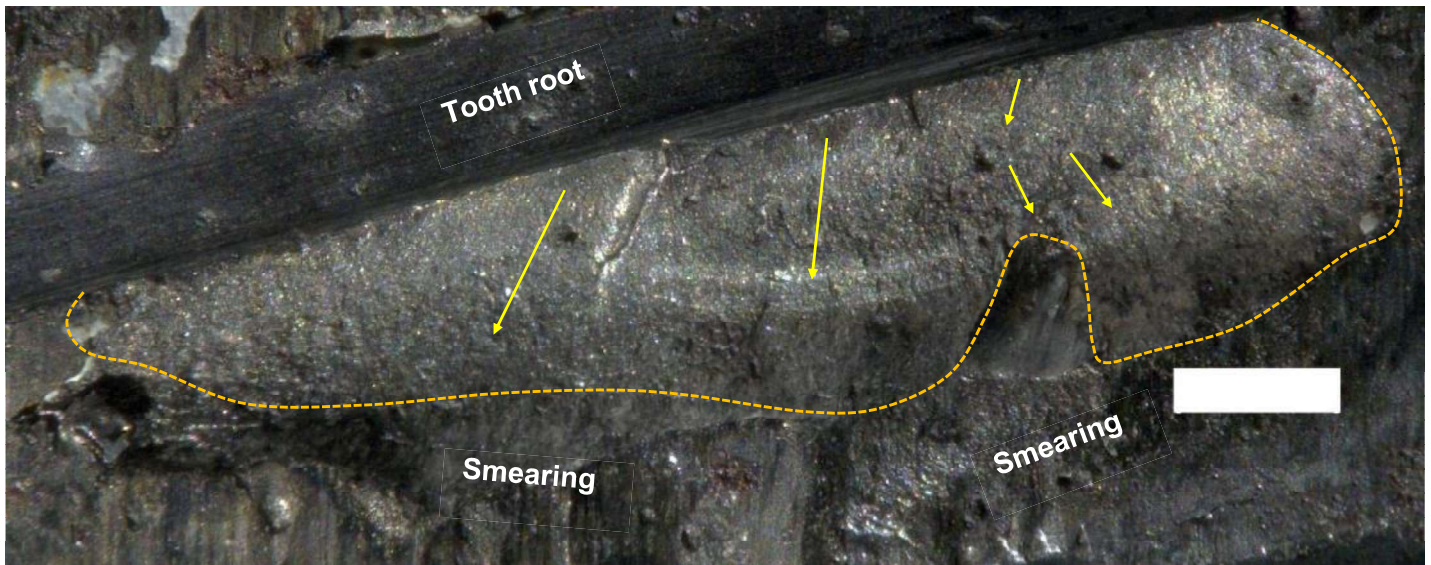
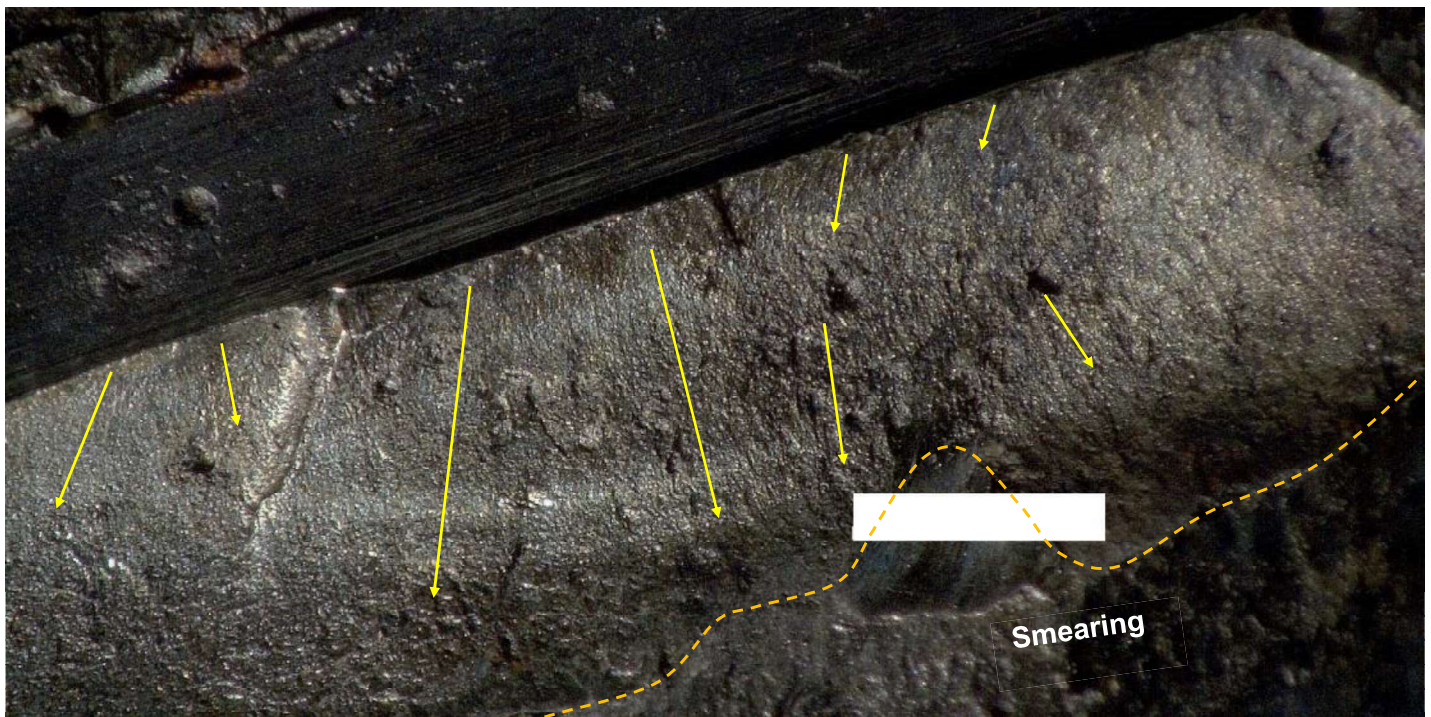
**Figure 12.** Detailed views of fracture surfaces at gear tooth number 2 after cleaning. The yellow arrows mark the direction of fatigue progression, and the orange dotted line marks the transition from fatigue to smearing damage.

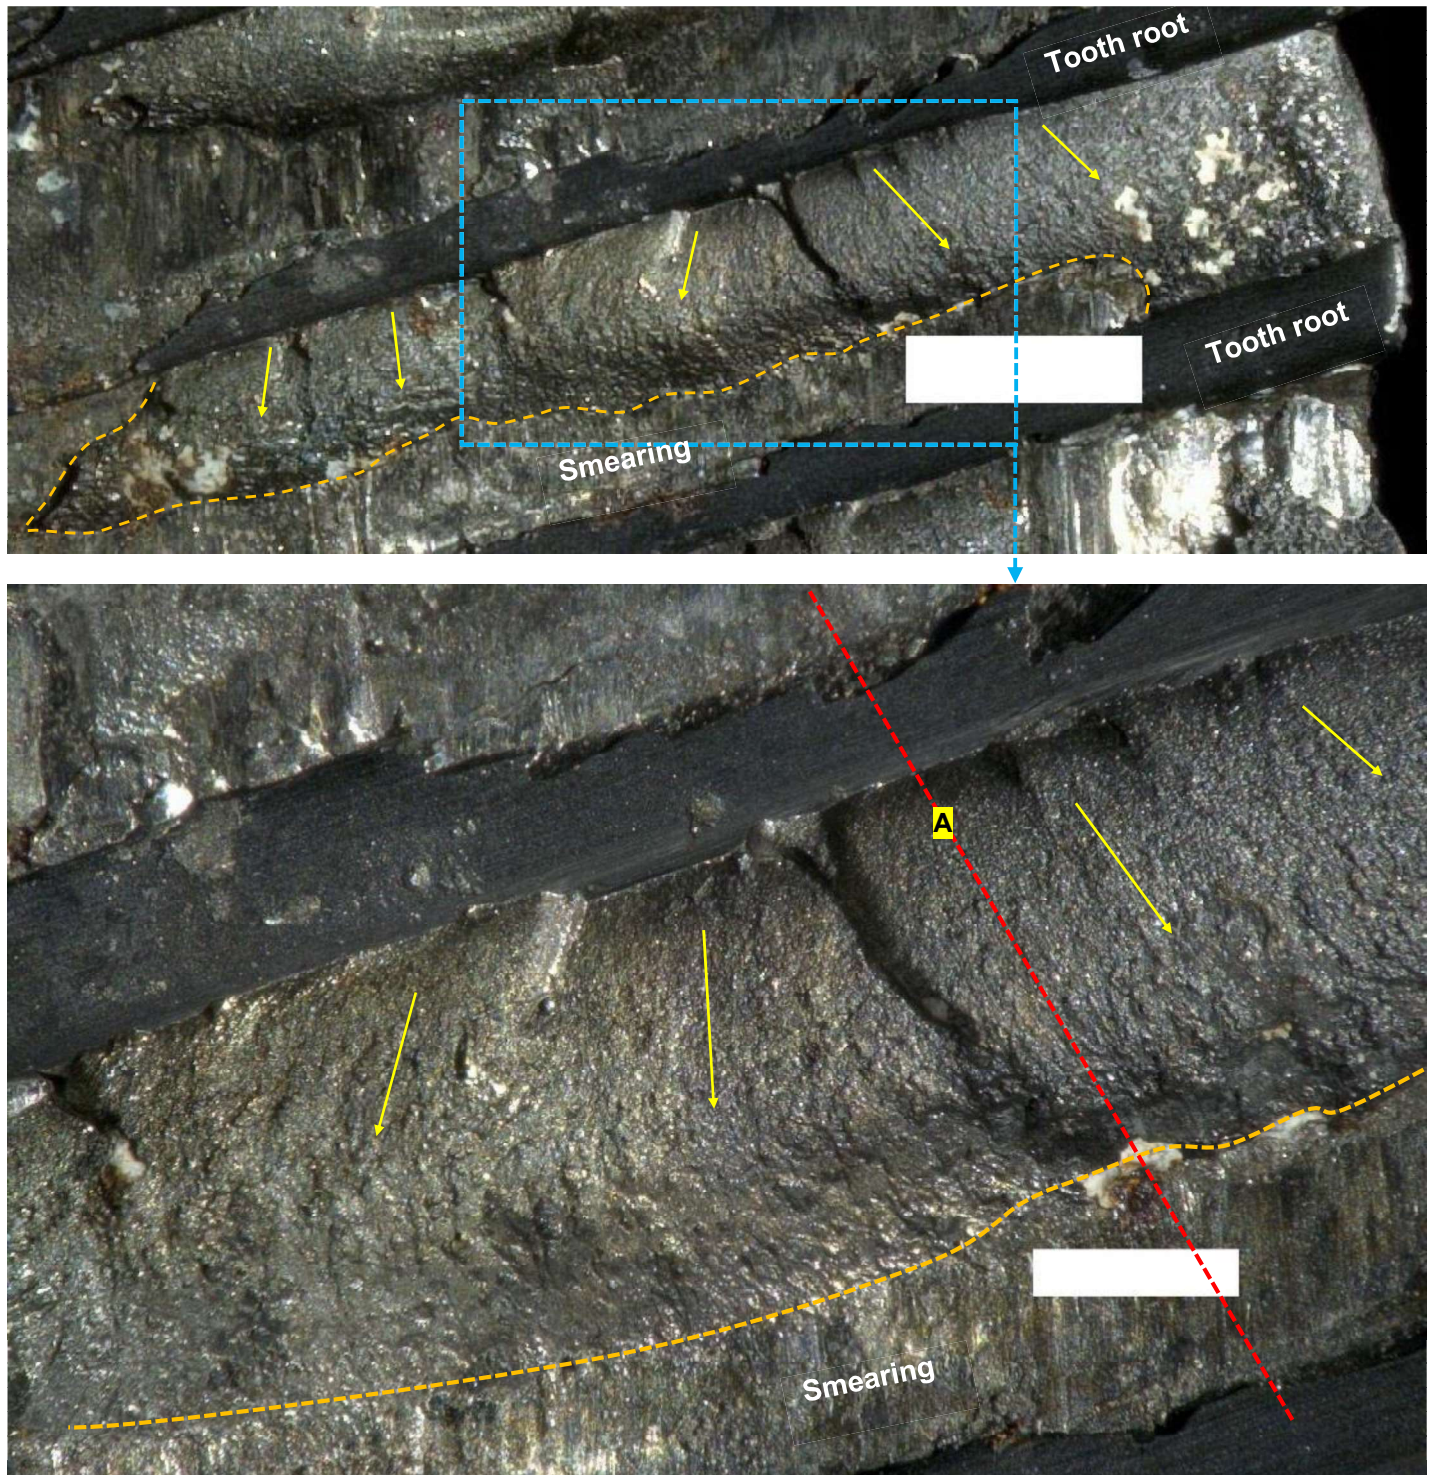
**Figure 13.** Detailed views of fracture surfaces at gear tooth number 3 after cleaning. The yellow arrows mark the direction of fatigue progression, the orange dotted line marks the transition from fatigue to smearing damage, the red dashed line marks the plane of metallographic evaluation (see Figure 20), and location A is shown in more detail in the following figure.

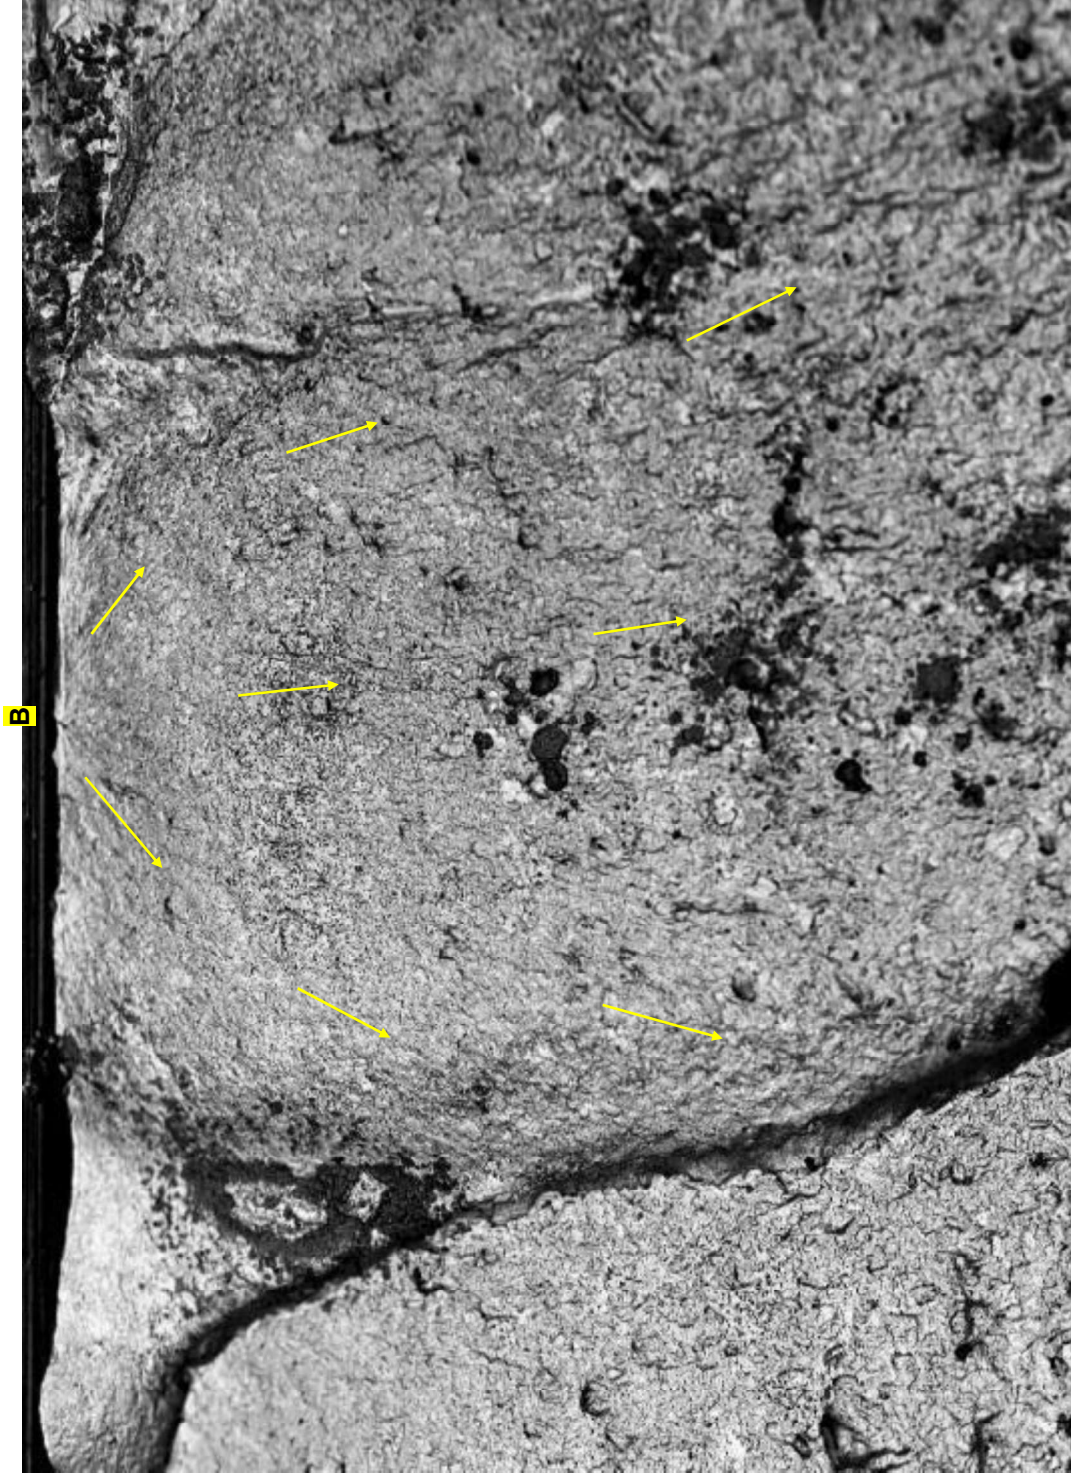
with multiple origins. Figure 14 and Figure 15 (tooth number 3), as well as Figure 17 (tooth number 4), show scanning electron microscope images of representative origin areas, which exhibited localized smearing damage, but no material or geometric anomalies were observed at the fracture surface or adjacent tooth root surface. Smearing damage precluded examination of the fracture origins and full extent of the fracture areas, and oxidation obfuscated fine fracture features.

Figure 14. Backscattered electron SEM image of fracture surfaces at gear tooth number 3 (location A in previous figure). The yellow arrows mark the direction of fatigue progression, and location B is shown in more detail in the following figure.

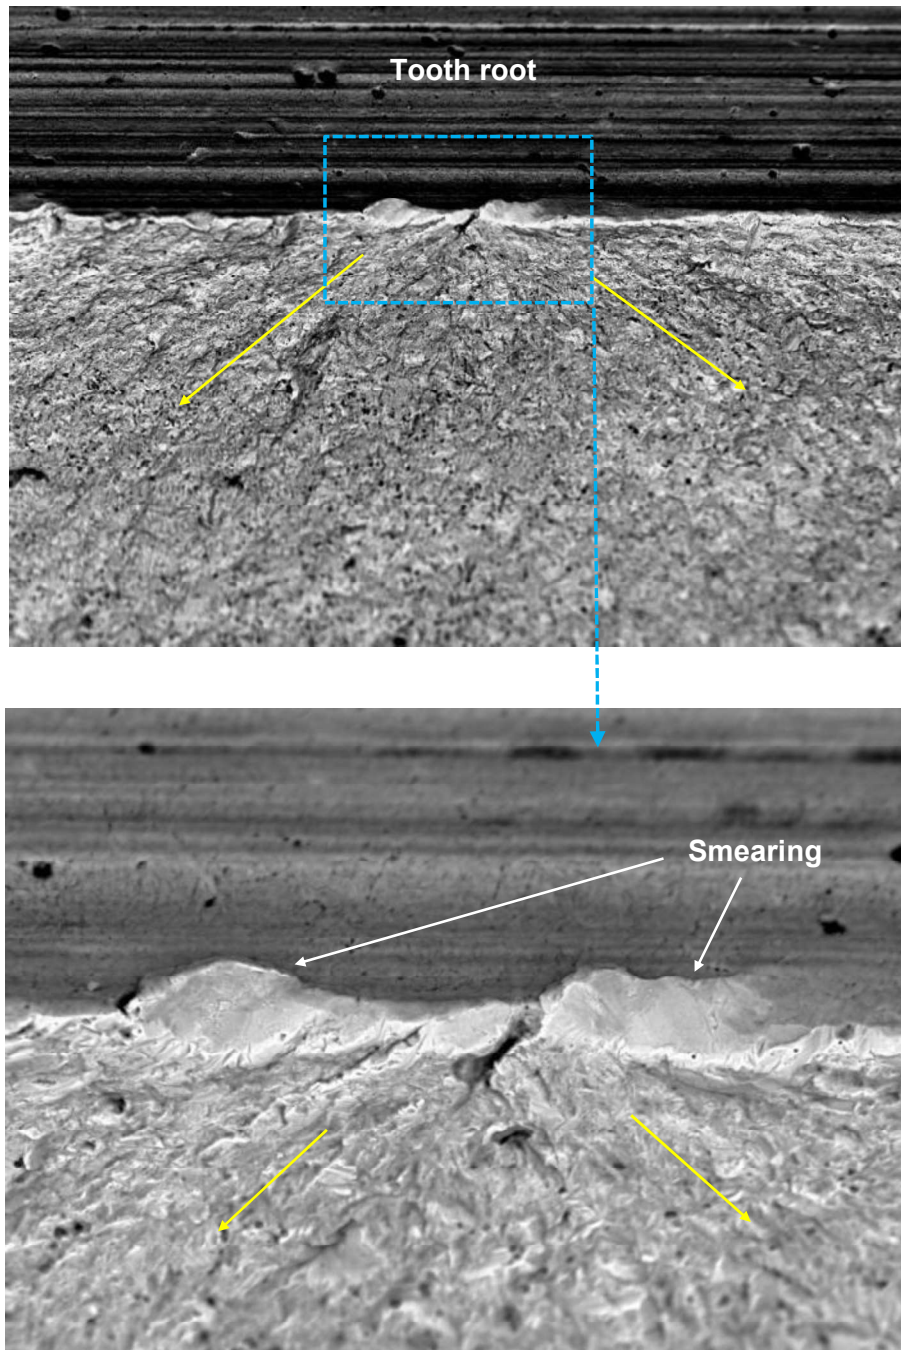
**Figure 15. Backscattered electron SEM images of fracture surfaces at gear tooth number 3 (location B in previous figure). The yellow arrows mark the direction of fatigue progression.**
